**Region 6 - Enforcement & Compliance Assurance Division**  
**INSPECTION REPORT**

| Regulatory Program: | Water (CWA) Brine Program (Oil & Gas Inspection) | |
| Company Name: | Drake Operating, LLC | |
| Facility Name: | Charivari Creek Nacatoch Sand Unit | |

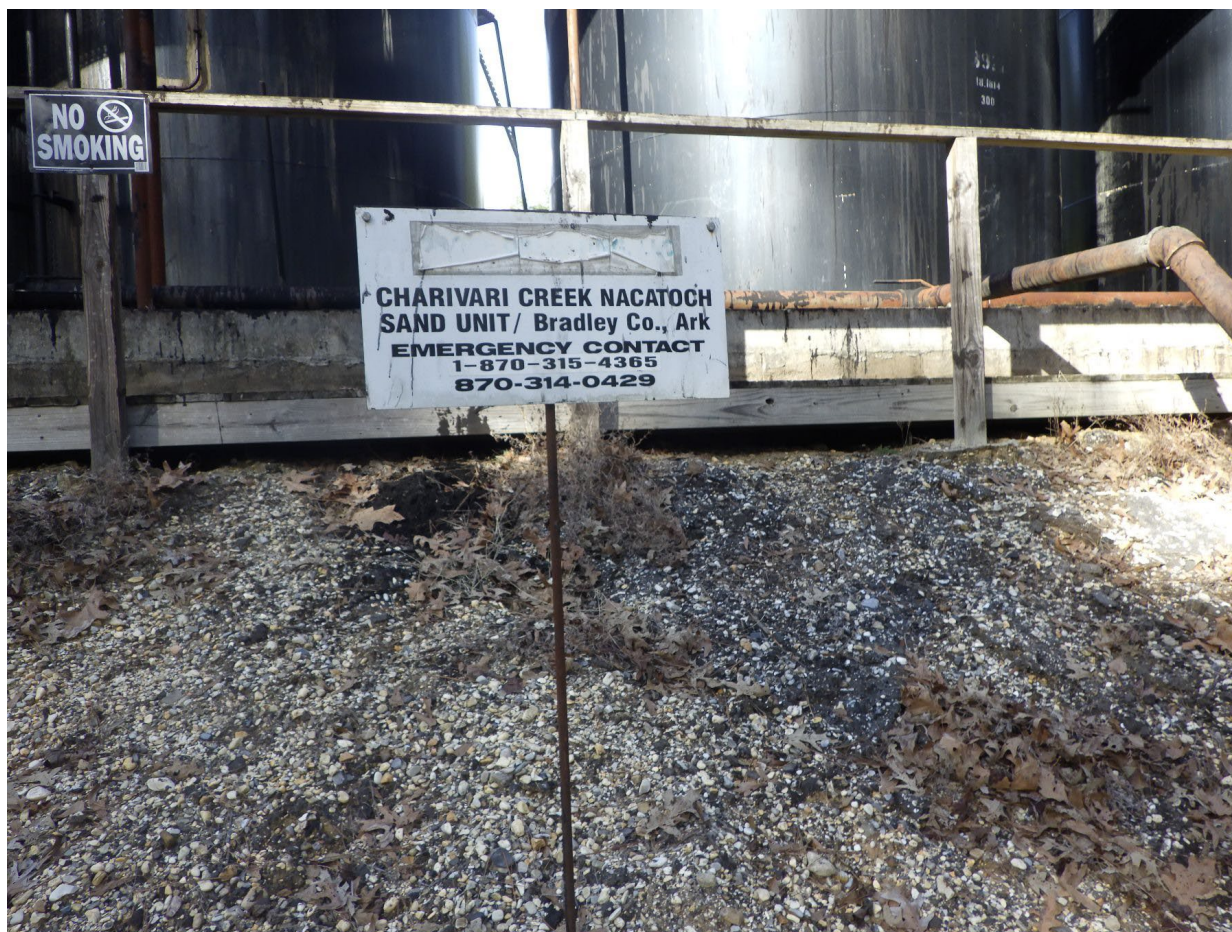
Photo No. 1

| Description: | This photo was taken facing southwest and shows the facility sign. | | |

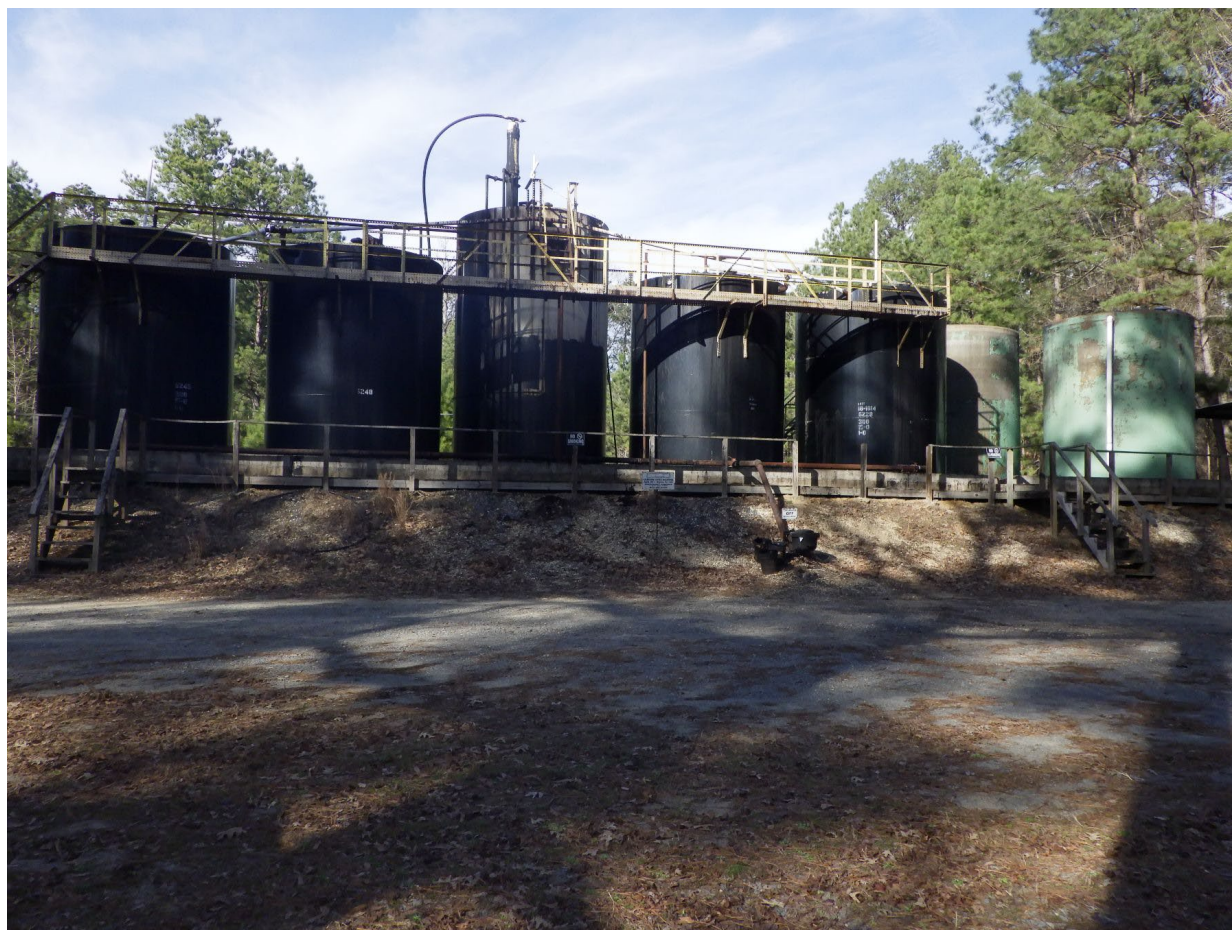
Photo No. 2

I observed the facility, associated signage, production well, SWD injection well, separators, gun barrel separator, storage tanks and secondary containment, and a catchment basin outside secondary containment; see Appendix 1 (Photograph Log), Photo No. 1 through No. 3 and Photo No. 7 and No. 9. For additional GPS location and photo metadata, see Appendix 1.

| Description: | This photo was taken facing southwest and shows a facility overview. | | |

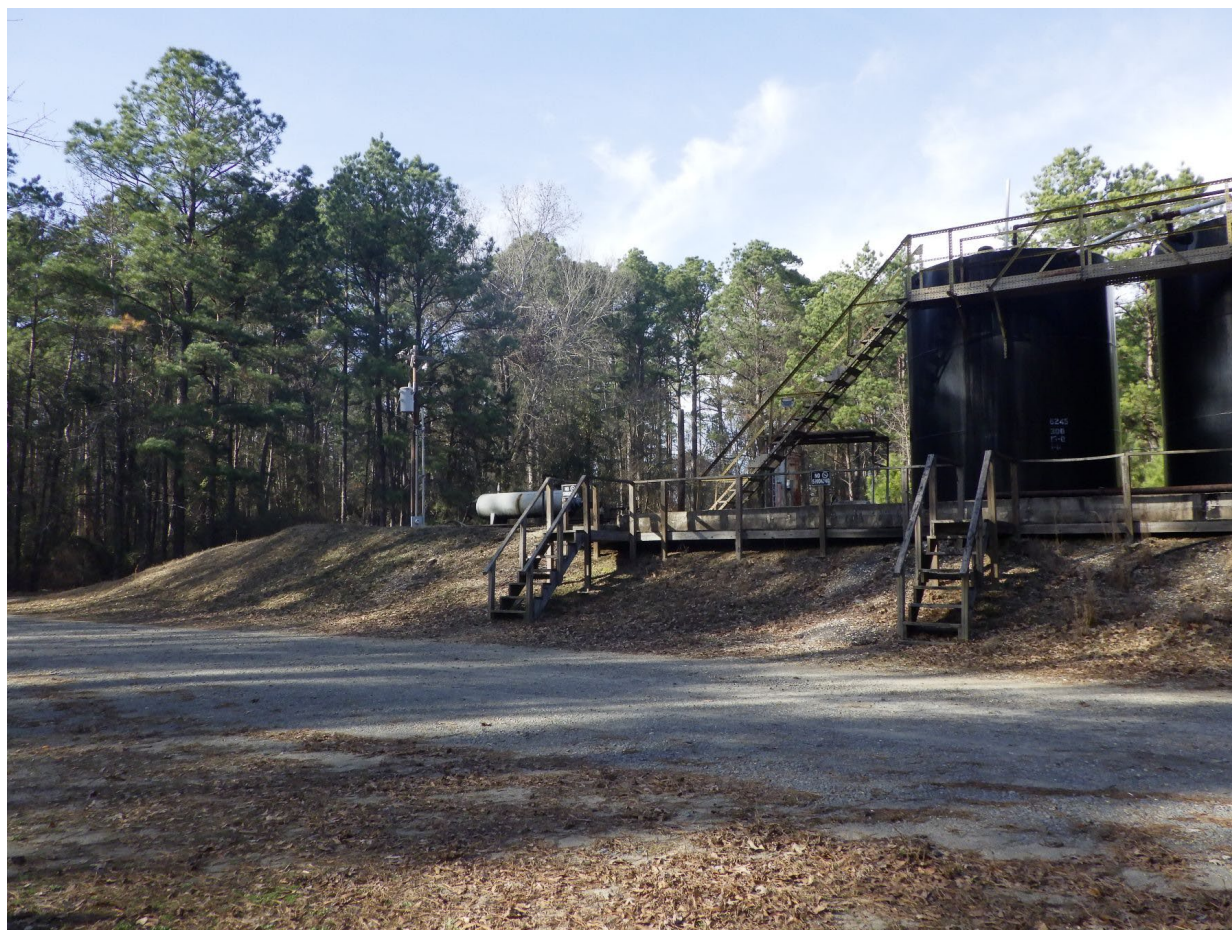
Photo No. 3

| Description: | This photo was taken facing southwest and shows another facility overview. | | |

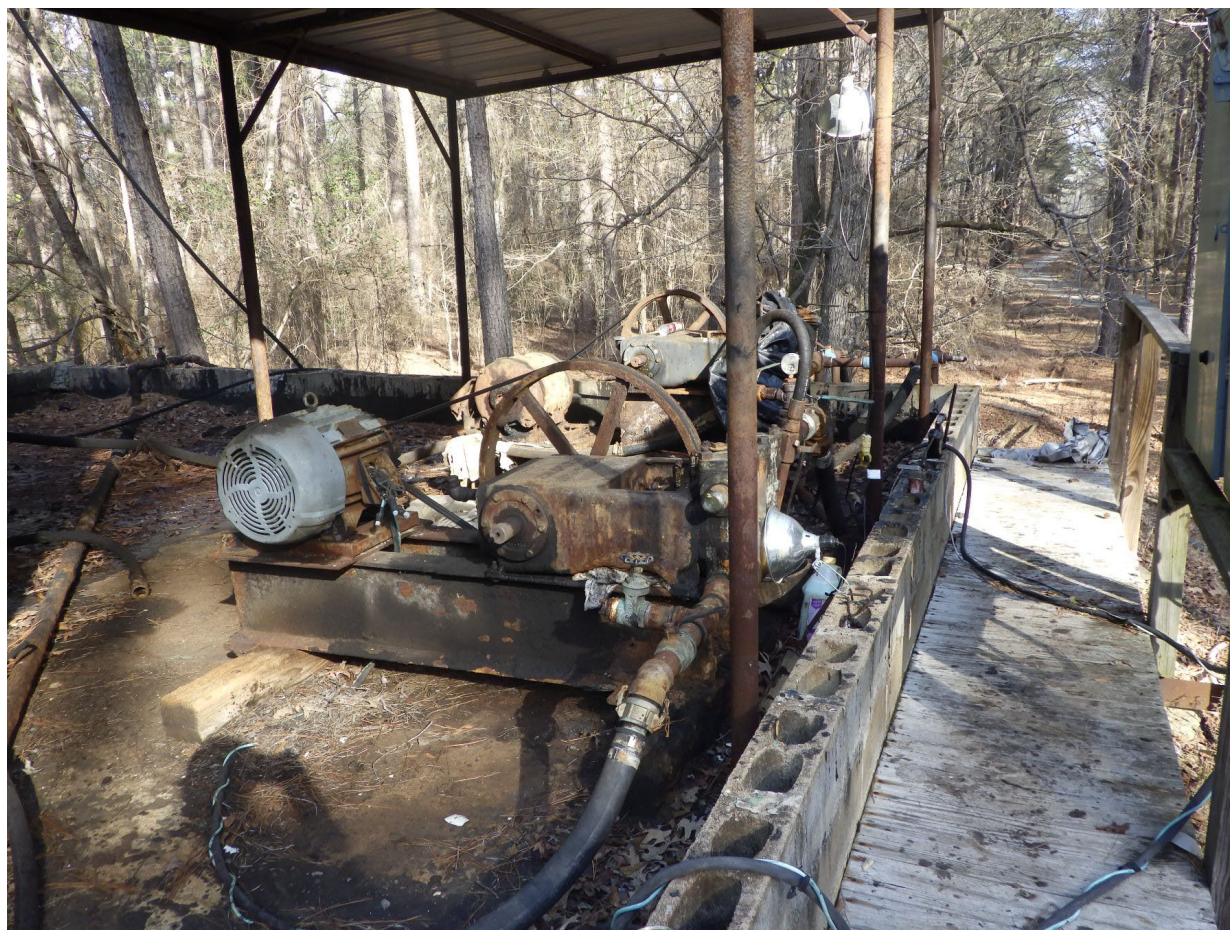
Photo No. 4

| Description: | This photo was taken facing south-southwest and shows the pump to the SWD well. | | |

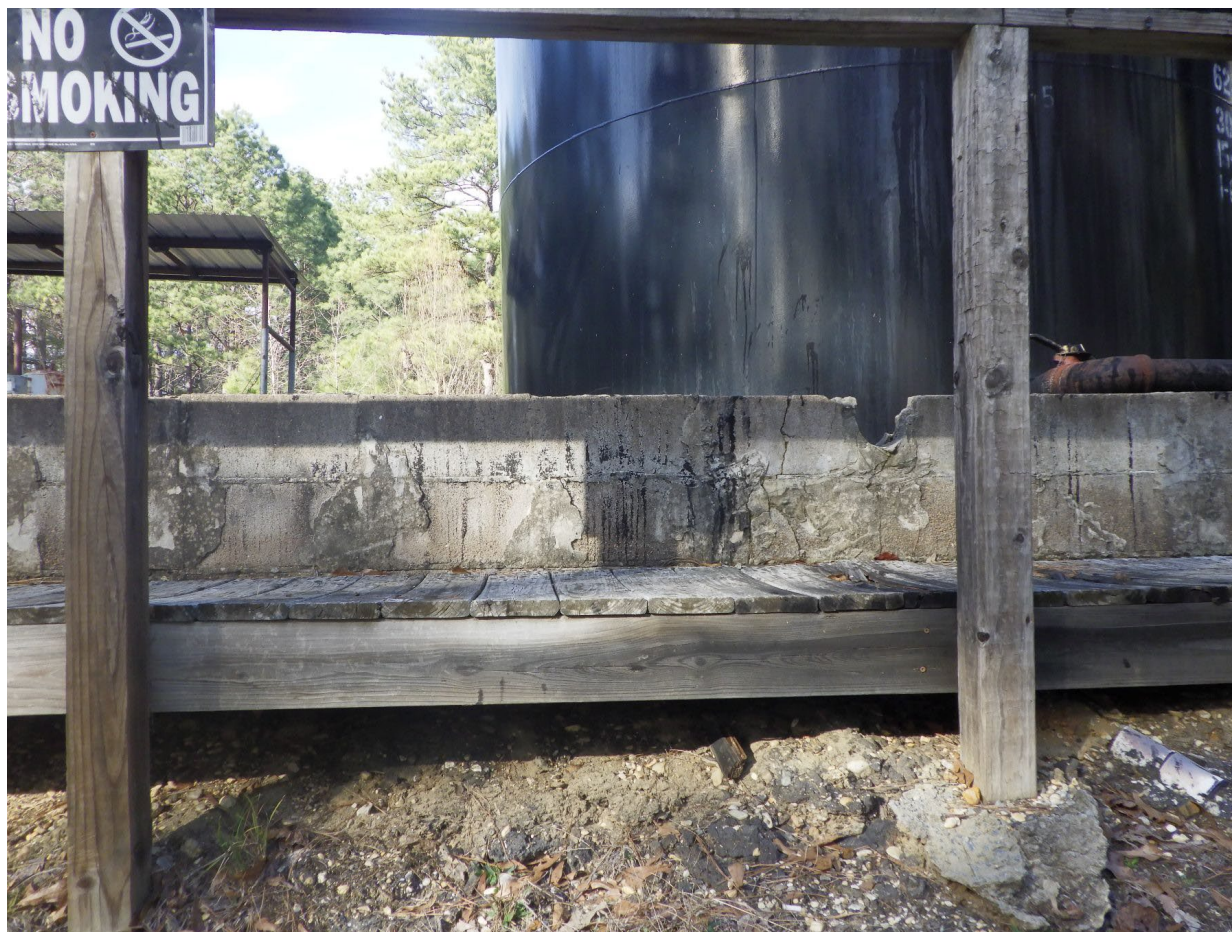
Photo No. 5

I observed a concrete secondary containment wall with cracks, see Photo No. 5.

- A concrete secondary containment wall with cracks, which can impact the wall's ability to contain oil in the event of a discharge;
- Loose oil around inside secondary containment;
- Loose oil at the production well;
- Potential indicators of past saltwater discharge based on lack of or dead vegetation outside secondary containment at the facility.

| Description: | This photo was taken facing southwest and shows cracks in the concrete secondary containment. | | |

Inspector will conduct follow-up phone calls with the company representatives over the coming weeks and months to ensure areas of concern are properly addressed.

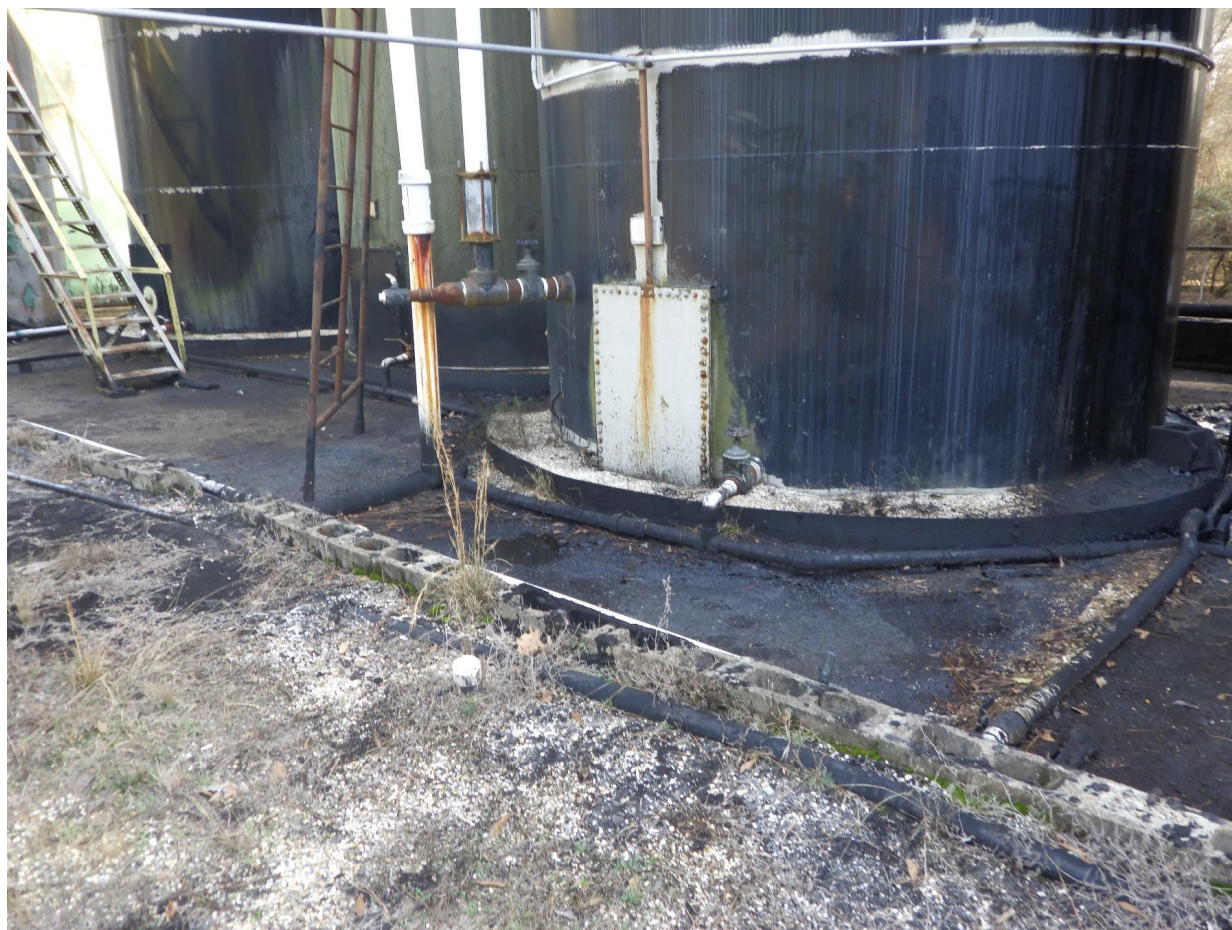
Photo No. 6

I observed loose oil inside secondary containment, see Photo No. 6. I observed loose oil at the production well, see Photo No. 10.

| Description: | This photo was taken facing south and shows loose oil inside secondary containment. | | |

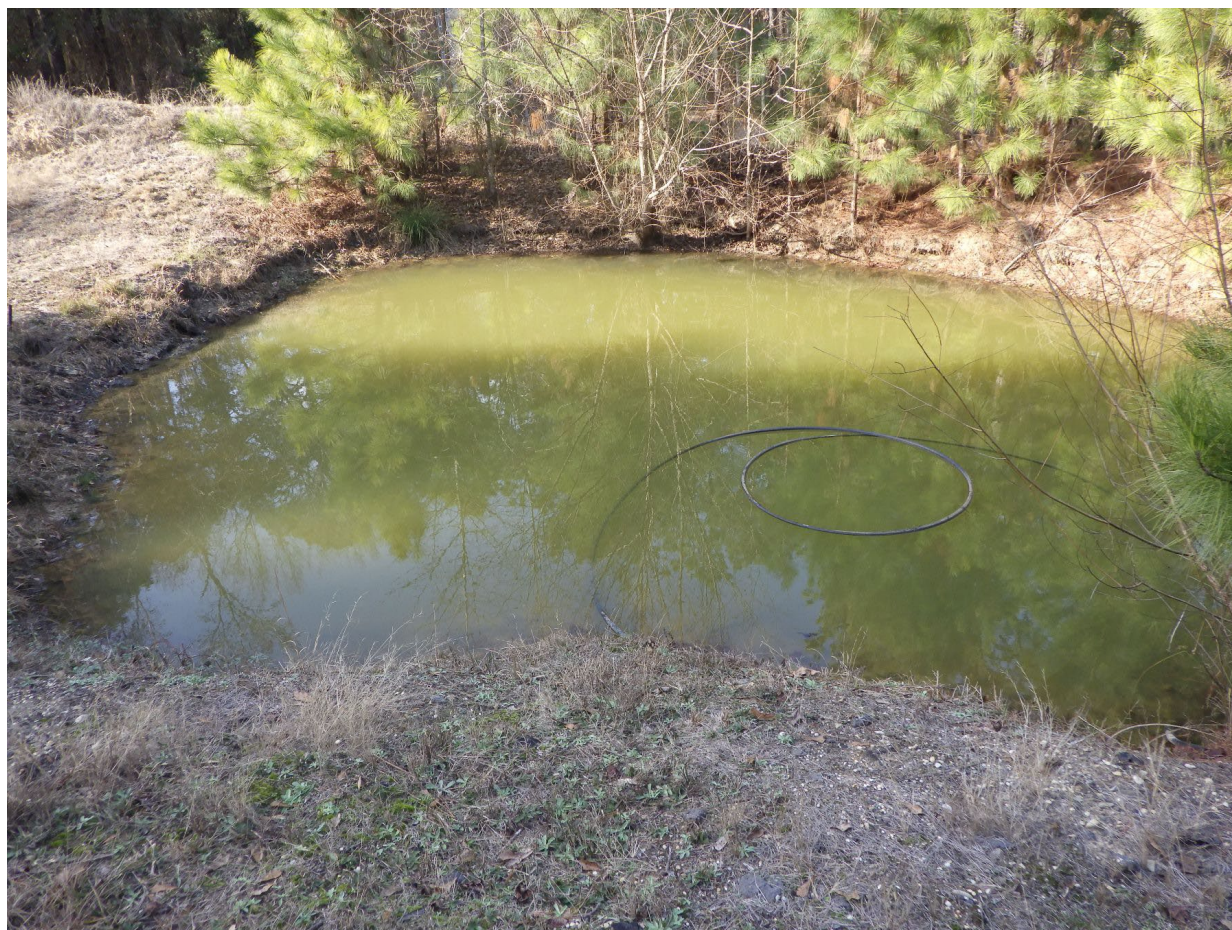
Photo No. 7

| Description: | This photo was taken facing west-southwest and shows a catchment basin behind the tank battery. | | |

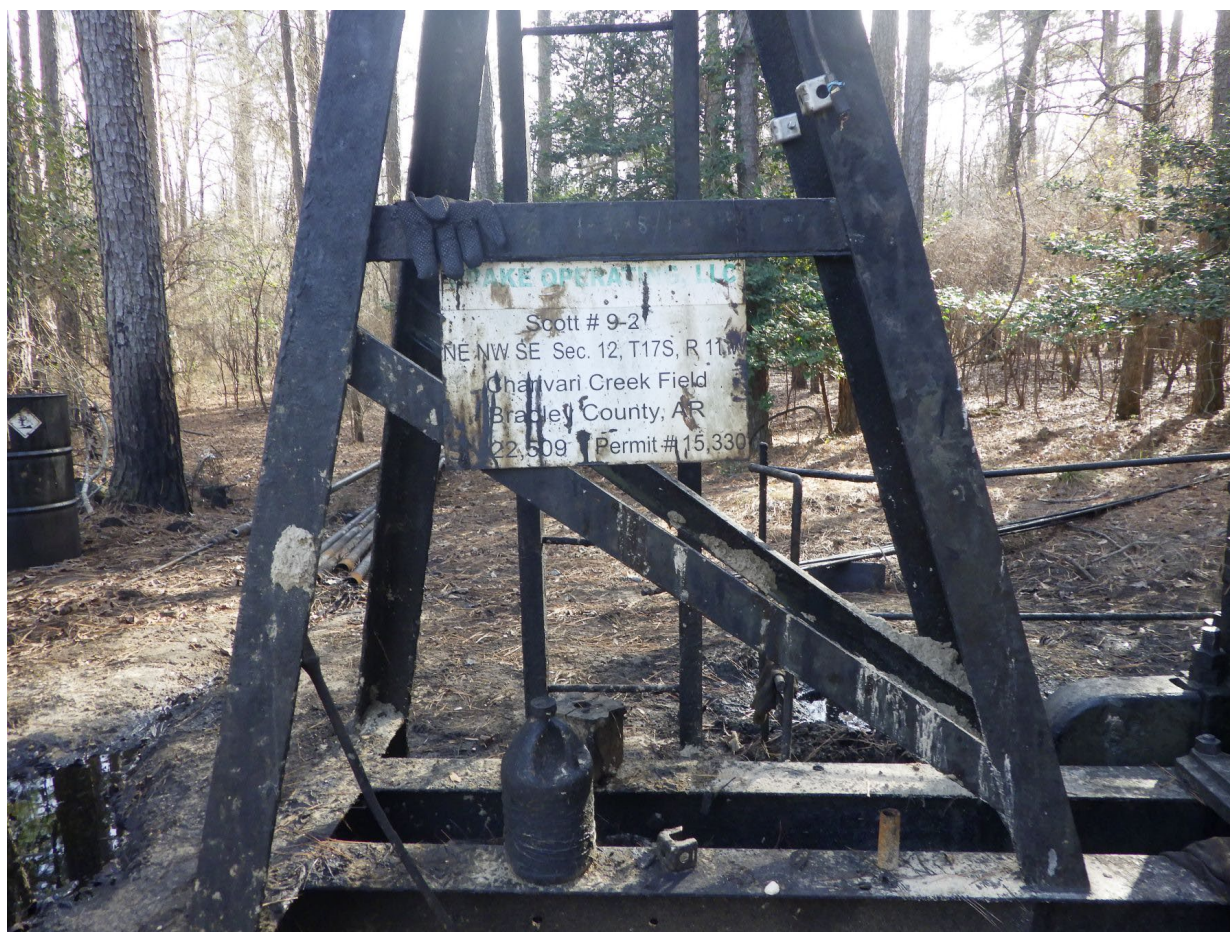
Photo No. 8

| Description: | This photo was taken facing south-southwest and shows the sign on the production well. | | |

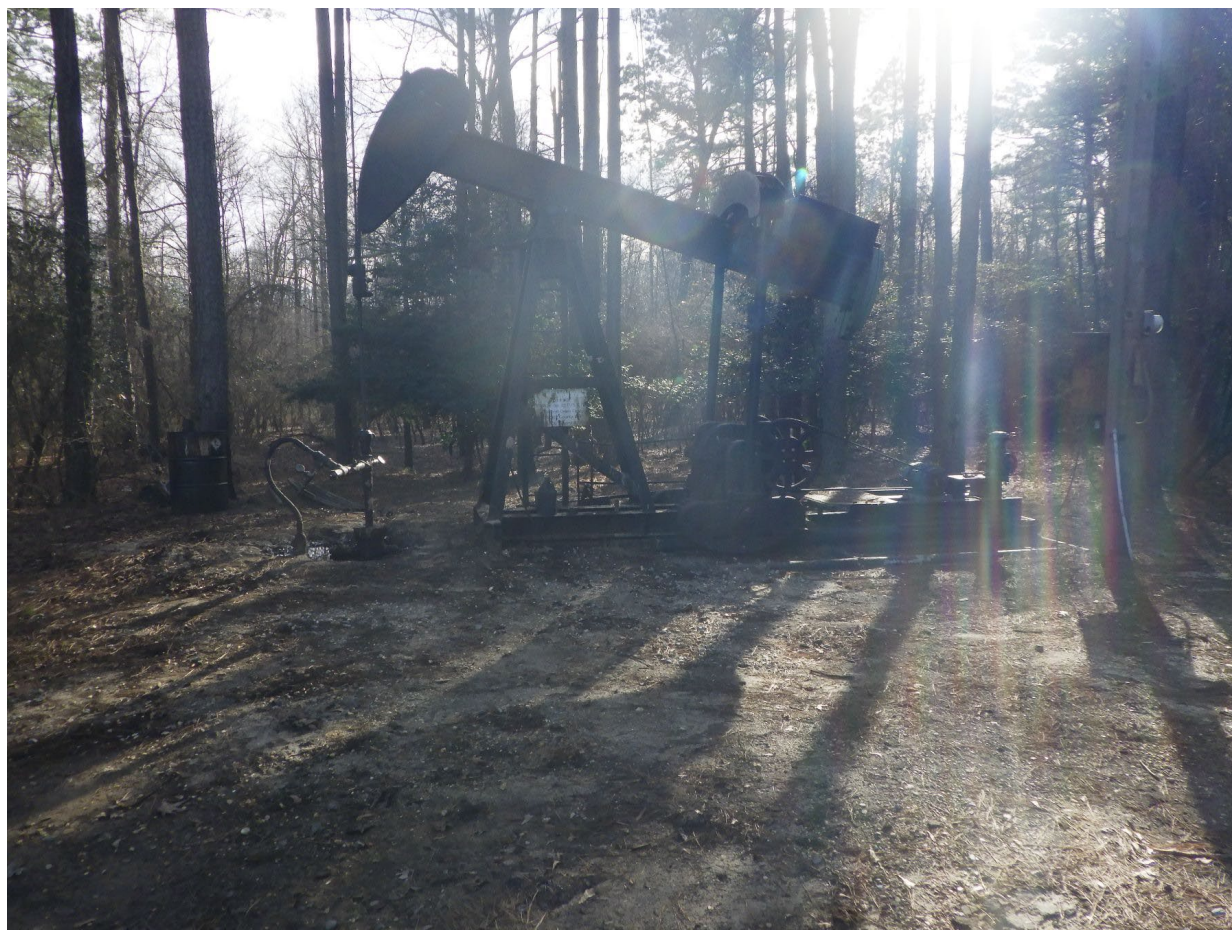
Photo No. 9

| Description: | This photo was taken facing south-southwest and shows the production well at the facility. | | |

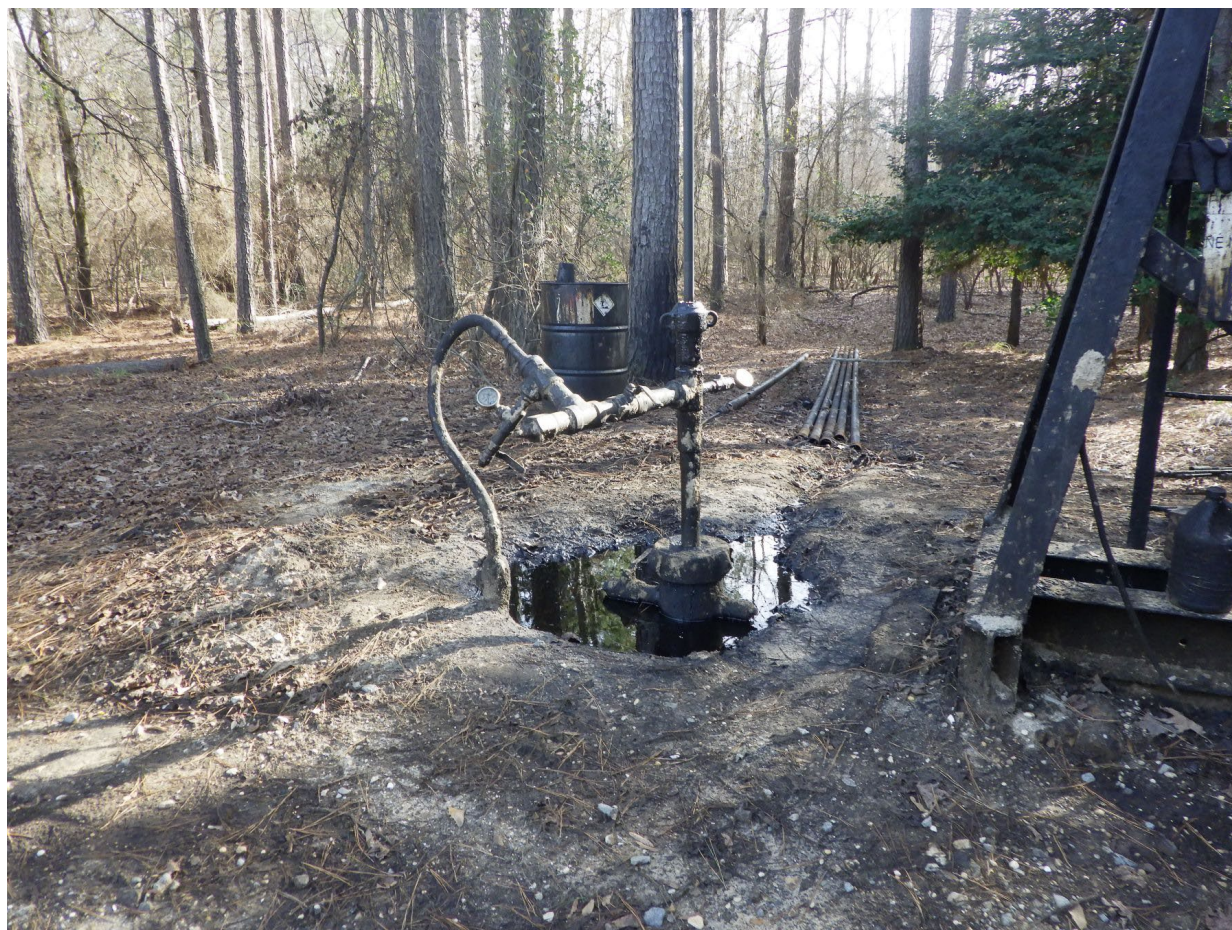
Photo No. 10

| Description: | This photo was taken facing south-southwest and shows loose oil at the pumpjack. | | |

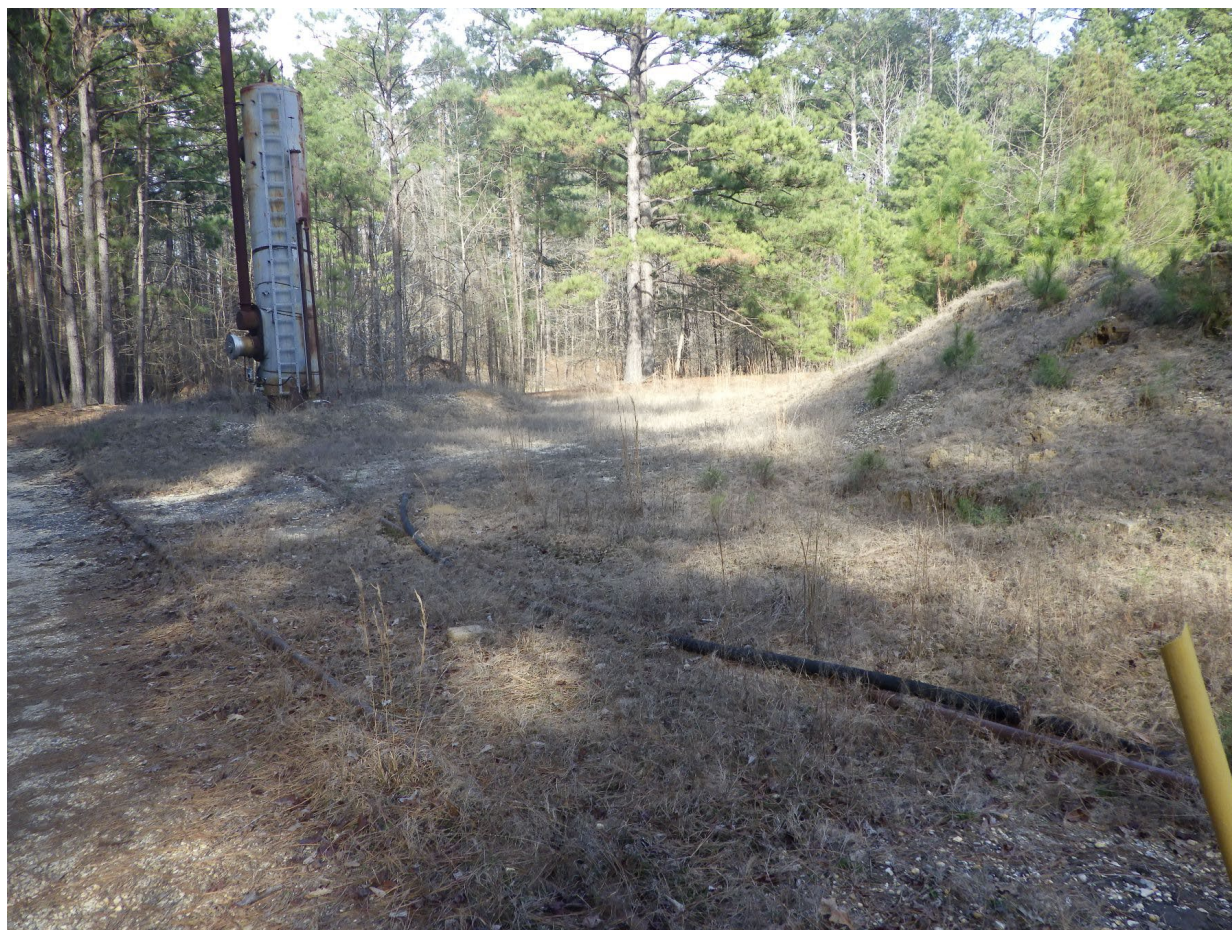
Photo No. 11

I observed dead vegetation or lack of vegetation outside of secondary containment, which can be an indicator of a past saltwater discharge, see Photo No. 11.

| Description: | This photo was taken facing south-southwest and shows an area on the side of the facility, outside of secondary containment, with a lack of vegetation or dead vegetation, which is one indicator of past saltwater discharge. | | |
