## **RCRA Inspection Report**

BAE Systems Land and Armaments, LP      EPA ID: KYR000007112  
163 Rochester Drive  
Louisville, Jefferson County, Kentucky 40214

October 19, 2022

The purpose of this inspection was for the U.S. Environmental Protection Agency, Region 4, and the Kentucky Department for Environmental Protection to conduct a joint unannounced compliance evaluation inspection (CEI) at BAE System Land and Armaments, LP (hereinafter, “BAE” or the “facility”). The CEI was conducted to determine compliance with the applicable requirements of the Resource Conservation and Recovery Act (RCRA) and the corresponding Kentucky Department for Environmental Protection (KDPEP) regulations. This was an EPA lead inspection.

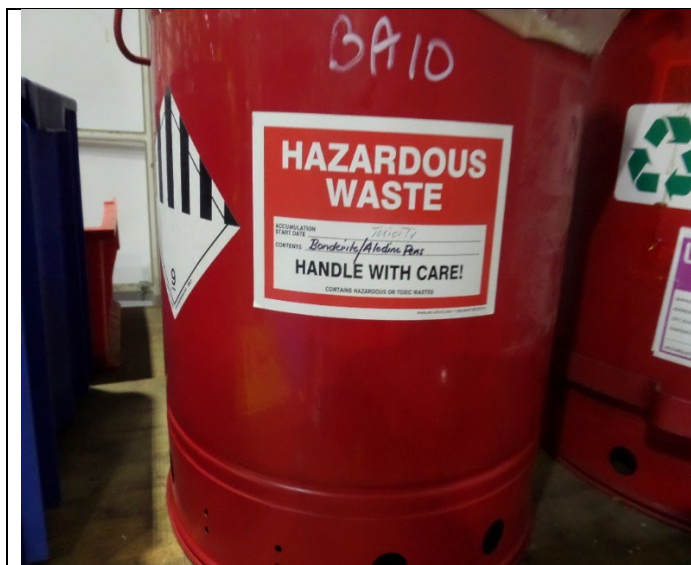
BAE manages five SAAs in BA018. The inspectors observed one 55-gallon container accumulating waste paint in the first SAA, one 55-gallon container accumulating waste solvent in the second SAA, one 10-gallon container accumulating waste aerosol cans in the third SAA, and one 5-gallon container accumulating waste MEK rags in the fourth SAA (Photograph 2). The containers were closed, in good condition, labeled with the words "hazardous waste", and labeled with a hazard indicator. The inspectors also observed one 10-gallon container accumulating waste "bonderite" and waste "alodine" pens in the fifth BA018 SAA. The container was closed, in good condition, labeled with the words "hazardous waste", and labeled with a DOT Class 9 (miscellaneous hazardous materials) pictogram. The 10-gallon container was not marked or labeled with an indication of the hazards. BAE representatives marked the container's hazardous waste label with the word "toxicity", indicating the hazard of the waste accumulating in the container, prior to inspectors leaving this area (Photograph 1). The

Building A. BA018 SAA. Observed one 10-gallon container not marked or labeled with a hazard indicator. Observed BAE representatives marked the container with the word toxicity. Photograph 1 taken at 11:04 a.m.

**Pursuant to 401 KAR 39:080 Section 1 [40 C.F.R. § 262.15(a)(5)(ii)], which is a condition of the SAA Permit Exemption, a generator must mark or label its containers with an indication of the hazards of the contents (examples include, but are not limited to, the applicable hazardous waste characteristic(s) (i.e., ignitable, corrosive, reactive, toxic); hazard communication consistent with the Department of Transportation requirements at 49 CFR part 172 subpart E (labeling) or subpart F (placarding); a hazard statement or pictogram consistent with the Occupational Safety and Health Administration Hazard Communication Standard at 29 CFR 1910.1200; or a chemical hazard label consistent with the National Fire Protection Association code 704).**

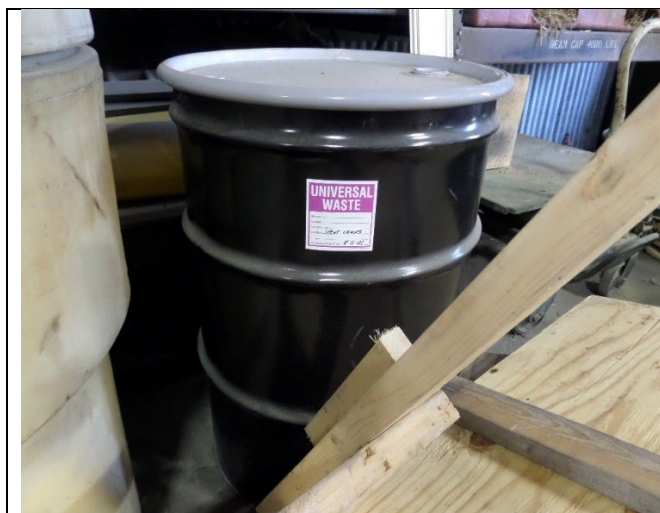
The inspectors observed one four-foot container and one eight-foot container for accumulating waste lamps. The eight-foot container was empty. The containers were closed, in good condition, labeled with the words “universal waste”, and marked with the date October 13, 2022. The inspectors observed one 55-gallon container accumulating small lamps that was closed, in good condition, labeled with the words “universal waste”, and marked with the date August 11, 2021 (Photograph 3). The inspectors asked the BAE representatives to ship the container to a destination facility.

Building 66 UW Storage. Observed one 55-gallon container accumulating waste lamps dated August 11, 2021. Photograph 3 taken at 11:54 a.m.

**Pursuant to 401 KAR 39:080 Section 3(1) [40 C.F.R. § 273.15(a)], a SQHUW may accumulate universal waste for no longer than one year from the date the universal waste is generated, or received from another handler, unless the requirements of paragraph (b) of this section are met.**

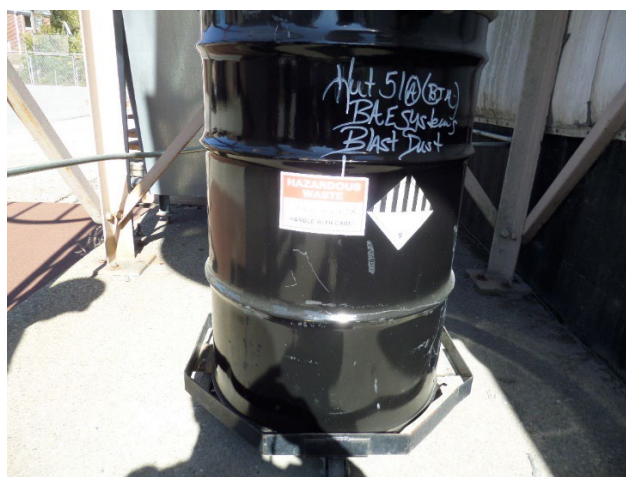
The facility blasts metal parts using aluminum oxide media in an enclosed blast machine. The inspectors observed one 55-gallon container accumulating spent aluminum oxide media in a SAA. The container was closed, in good condition, labeled with the words “hazardous waste”, and labeled with a DOT Class 9 (miscellaneous hazardous materials) pictogram. The 55-gallon

container was not marked or labeled with an indication of the hazards. BAE representatives marked the container's hazardous waste label with the word "toxicity", indicating the hazard of the waste accumulating in the container (Photographs 4 and 5).

Building 51 Blasting Process. Observed one 55-gallon container labeled with a #9 hazard indicator. Photograph 4 taken at 12:03 p.m.

**Pursuant to 401 KAR 39:080 Section 1 [40 C.F.R. § 262.15(a)(5)(ii)], which is a condition of the SAA Permit Exemption, a generator is required to mark or label its containers with an indication of the hazards of the contents.**

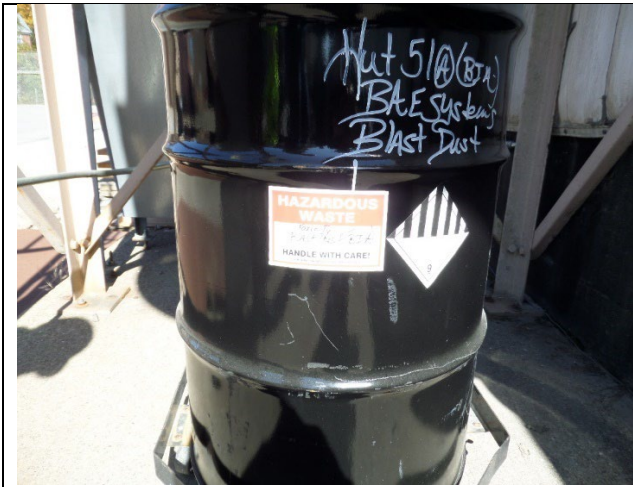
Building 51 Blasting Process. Observed BAE representatives mark the container with the word toxicity. Photograph 5 taken at 12:04 p.m.

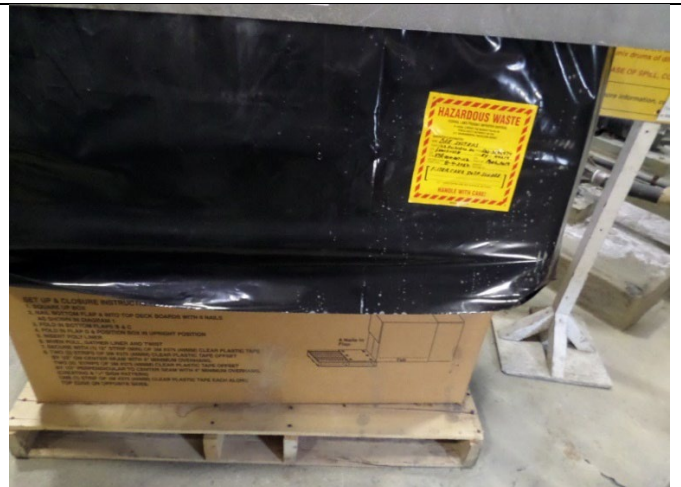
BAE operates a wastewater treatment plant (WWTP) for the treatment of rinse waters from its plating operations. Sandra Tucker is the WWTP operator. Waste solids are generated from the wastewater treatment operation. The inspectors observed a one cubic yard container accumulating waste filter cake. The container was closed, in good condition, labeled with the words "hazardous waste" (F006/F019), and marked with the date August 4, 2022. The inspectors did not observe the container marked or labeled with a hazard indicator. Sandra Tucker marked the container with the word "toxicity" (Photographs 6 and 7).

Building 118 WWTP. Observed a one cubic yard container of F006, F019 filter cake not marked or labeled with a hazard indicator. Photograph 6 taken at 12:15 p.m.

**Pursuant to 401 KAR 39:080 Section 1 [40 C.F.R. § 262.15(a)(5)(ii)], which is a condition of the SAA Permit Exemption, a generator is required to mark or label its containers with an indication of the hazards of the contents.**

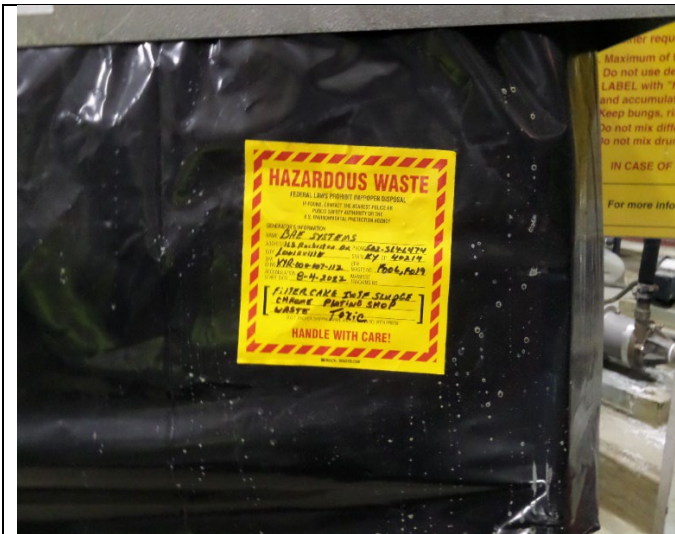
Building 118 WWTP. Observed BAE representatives mark the one cubic yard container of F006, F019 filter cake with the word toxicity. Photograph 7 taken at 12:20 p.m.

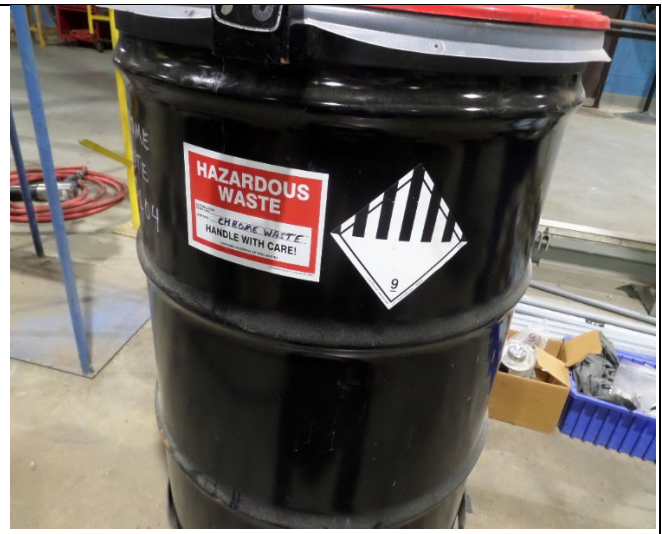
The inspectors observed one 55-gallon container accumulating chromium related waste in the PL04 SAA. The container was closed, in good condition, labeled with the words "hazardous waste", and labeled with a DOT Class 9 (miscellaneous hazardous materials) pictogram. The 55-gallon container was not marked or labeled with an indication of the hazards. BAE

Building 117 Chromium Platin Line. Observed one 55-gallon container labeled with a #9 hazard indicator. Photograph 8 taken at 12:28 p.m.

**Pursuant to 401 KAR 39:080 Section 1 [40 C.F.R. § 262.15(a)(5)(ii)], which is a condition of the SAA Permit Exemption, a generator is required to mark or label its containers with an indication of the hazards of the contents.**

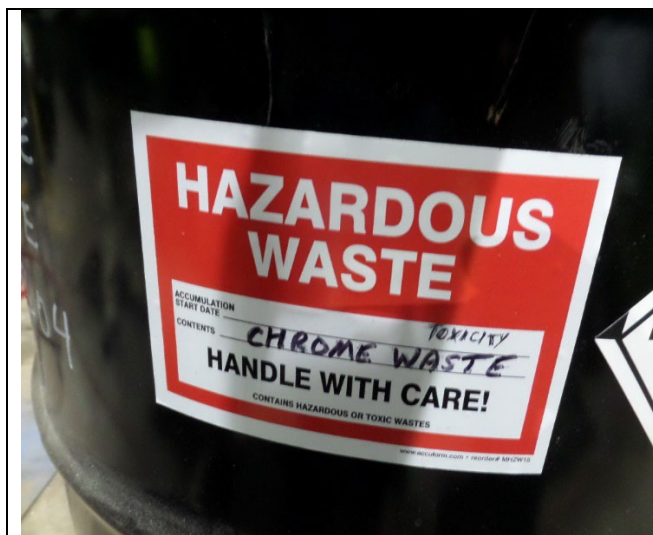
representatives marked the container's hazardous waste label with the word "toxicity" to indicate the hazard of the waste accumulating in the container (Photographs 8 and 9).

Building 117 Chromium Plating Line. Observed BAE representatives mark the container with the word toxicity. Photograph 9 taken at 12:29 p.m.

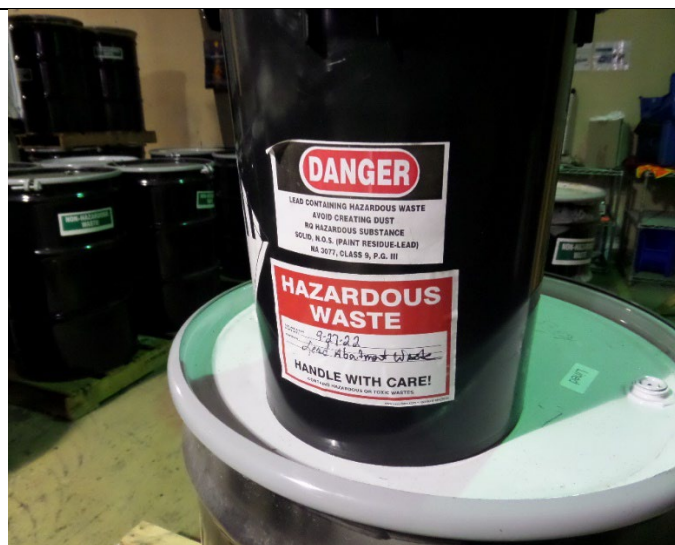
Containers accumulate hazardous waste in this area for 90-days or less, prior to offsite shipment to a destination facility. The inspectors observed one 10-gallon container accumulating lead abatement waste and one 55-gallon container accumulating waste blast dust on a wooden pallet. The containers were closed, in good condition, with aisle space, and labeled with the words "hazardous waste". The 10-gallon container was marked with the date September 27, 2022, and the 55-gallon container was marked with the date October 5, 2022. Each container was labeled with a DOT Class 9 (miscellaneous hazardous materials) pictogram (Photographs 10 and 11). The 10 gallon and the 55-gallon container were not marked or labeled with an indication of the hazards. BAE representatives labeled each container with the word "toxic" to indicate the hazard of the contents of the container. (Photograph 12).

Building 87A CAA. Observed one 10-gallon container labeled with a #9 hazard indicator. Photograph 10 taken at 12:37 p.m.

**Pursuant to 401 KAR 39:080, Section 1(1) [40 C.F.R. § 262.17(a)(5)(i)], which is a condition of the LQG Permit Exemption, a generator must mark or label its containers with the following: an indication of the hazards of the contents clearly visible for inspection on each container.**

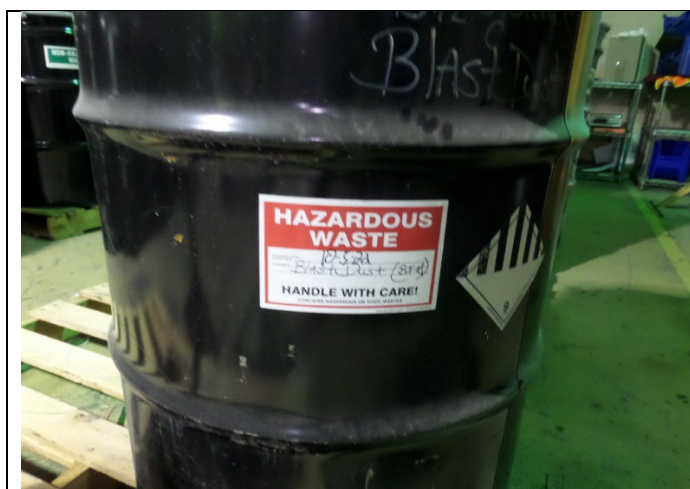
Building 87A CAA. Observed one 55-gallon container labeled with a #9 hazard indicator. Photograph 11 taken at 12:37 p.m.

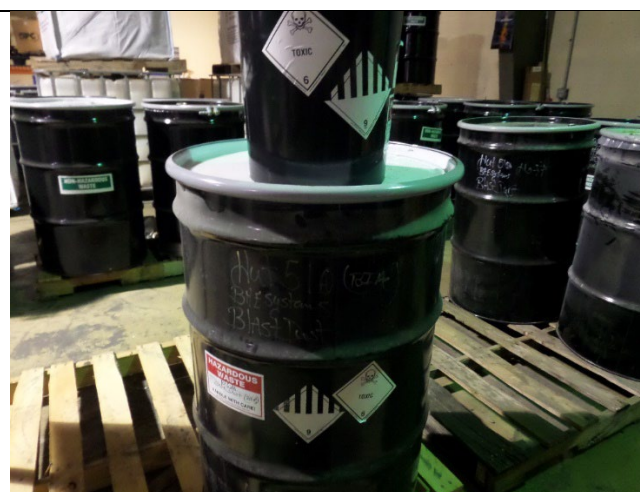
Building 87A CAA. Observed BAE representatives label the containers with a toxic hazard indicator. Photograph 12 taken at 12:39 p.m.
