## UNITED STATES ENVIRONMENTAL PROTECTION AGENCY

**Subject:** Sampling Inspection Report  
Clean Water Act – National Pollutant Discharge Elimination System  
Worcester, MA

- A. Facility Name: City of Worcester, MA*
- B. Facility Location: Worcester, MA*
- C. Facility Contact: Jay J. Fink, Commissioner, Dept. of Public Works and Parks,  
[dpw@worcesterma.gov](mailto:dpw@worcesterma.gov), (508) 929-1300*
- D. NPDES Permit ID: MAS010002 (MS4)*

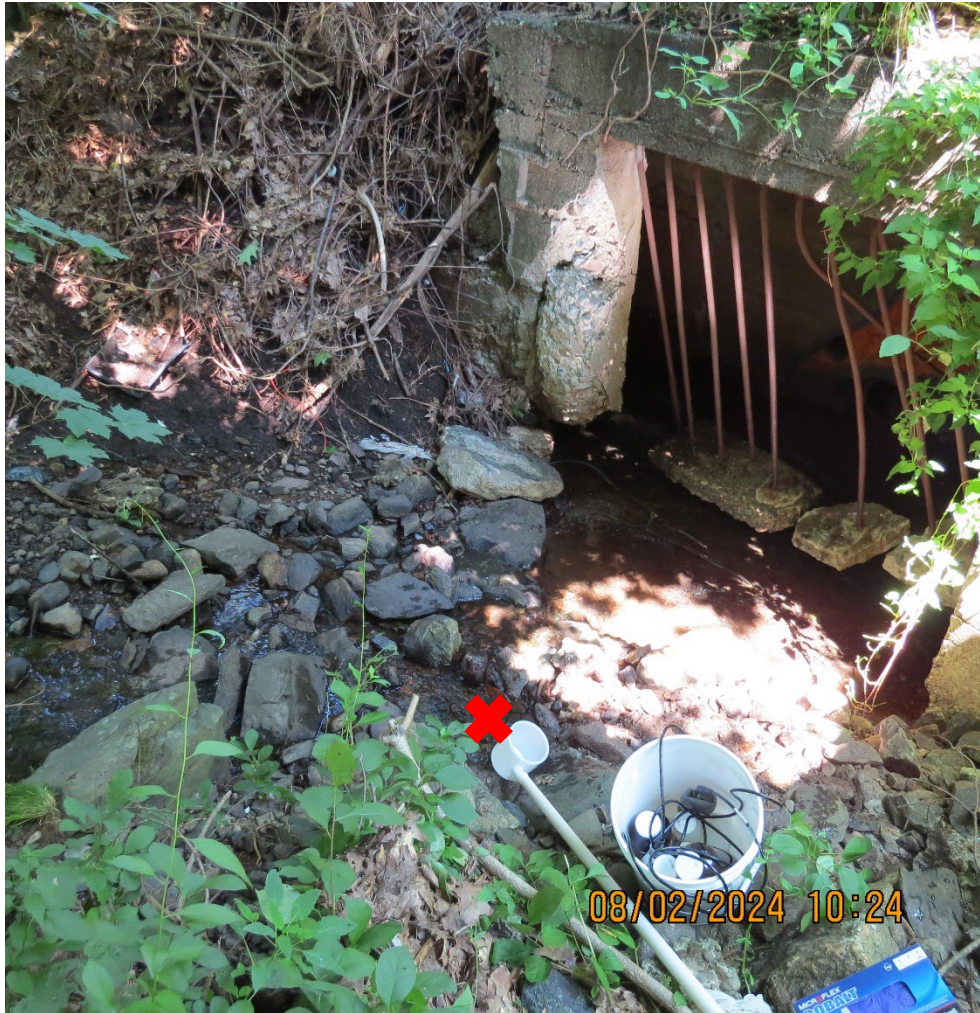
- **LQ-13B**: in-stream sample of an unnamed stream discharging to Lake Quinsigamond collected on the east side of the stone wall located at 240 Coburn Ave. Sample was collected approximately 2.5 feet from the western bank of the stream and 4 feet upstream from the entrance to the concrete stormwater conveyance structure. The concrete structure entrance is blocked by metal bars with broken concrete at the base. No odor was observed. Color was clear with fine particulate matter. No floatables were observed.

**Photo 1: LQ-13B** (photo taken 08/02/2023 at approx. 10:24) Stream located near 240 Coburn Ave, discharging into the unnamed stream to Lake Quinsigamond. Sample point is indicated by a red X.

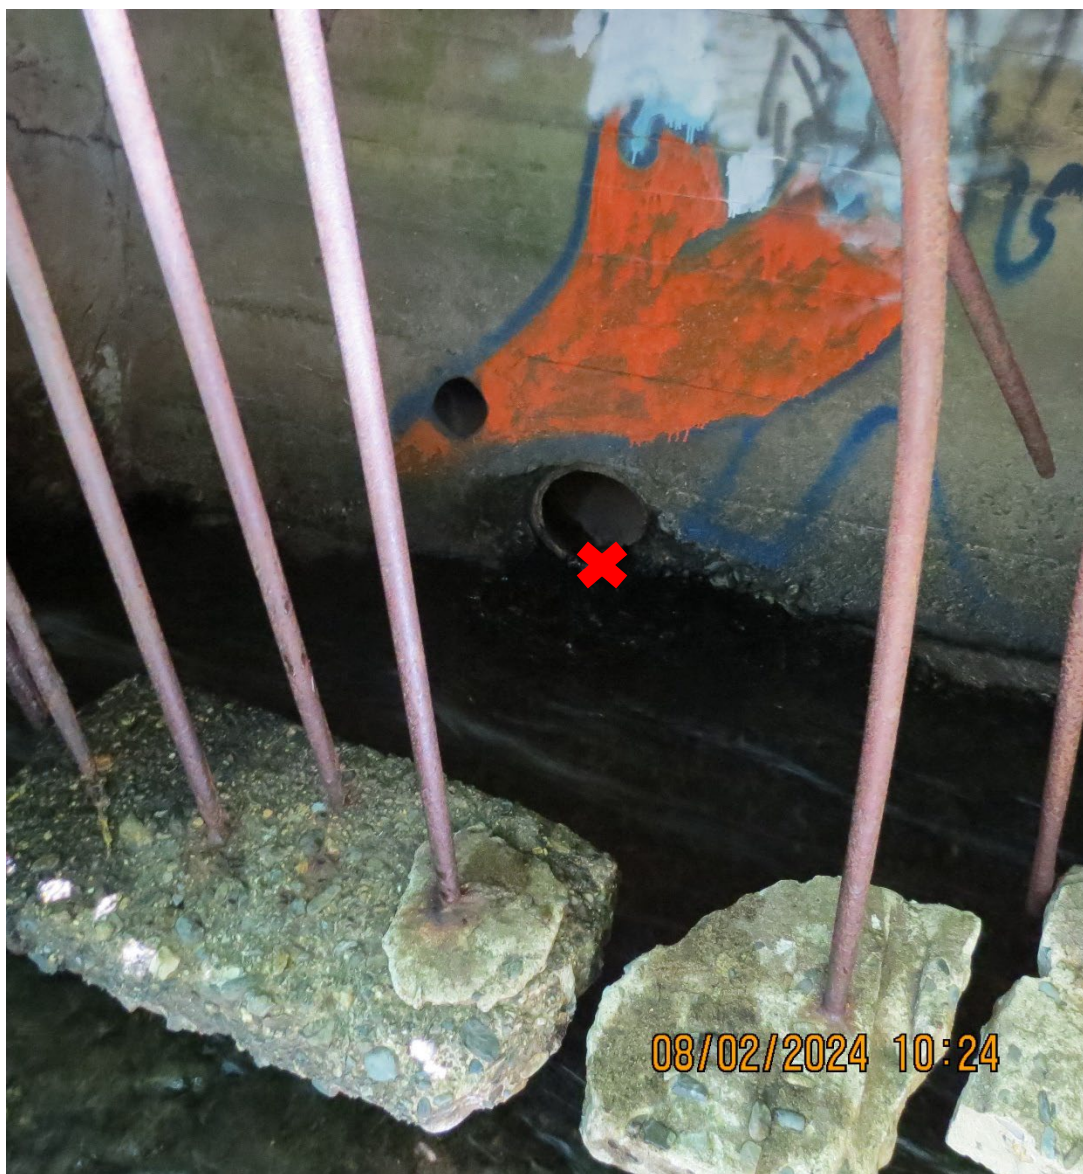
- **LQ-13C**: a single, PVC, circular outfall, approximately 12 inches in diameter, located on the east side of the stone wall located at 240 Coburn Ave inside the concrete stormwater conveyance structure. Discharge flow was approximately less than 5 gallons per minute (gpm) into an unnamed stream discharging to Lake Quinsigamond. Sample was collected at the mouth of the outfall. A sulfur odor was observed. Color and turbidity were clear. No floatables were observed.

**Photo 2: LQ-13C** (photo taken 08/02/2023 at approx. 10:24) Outfall located near 240 Coburn Ave, discharging into the unnamed stream to Lake Quinsigamond. Sample points are indicated by a red X.

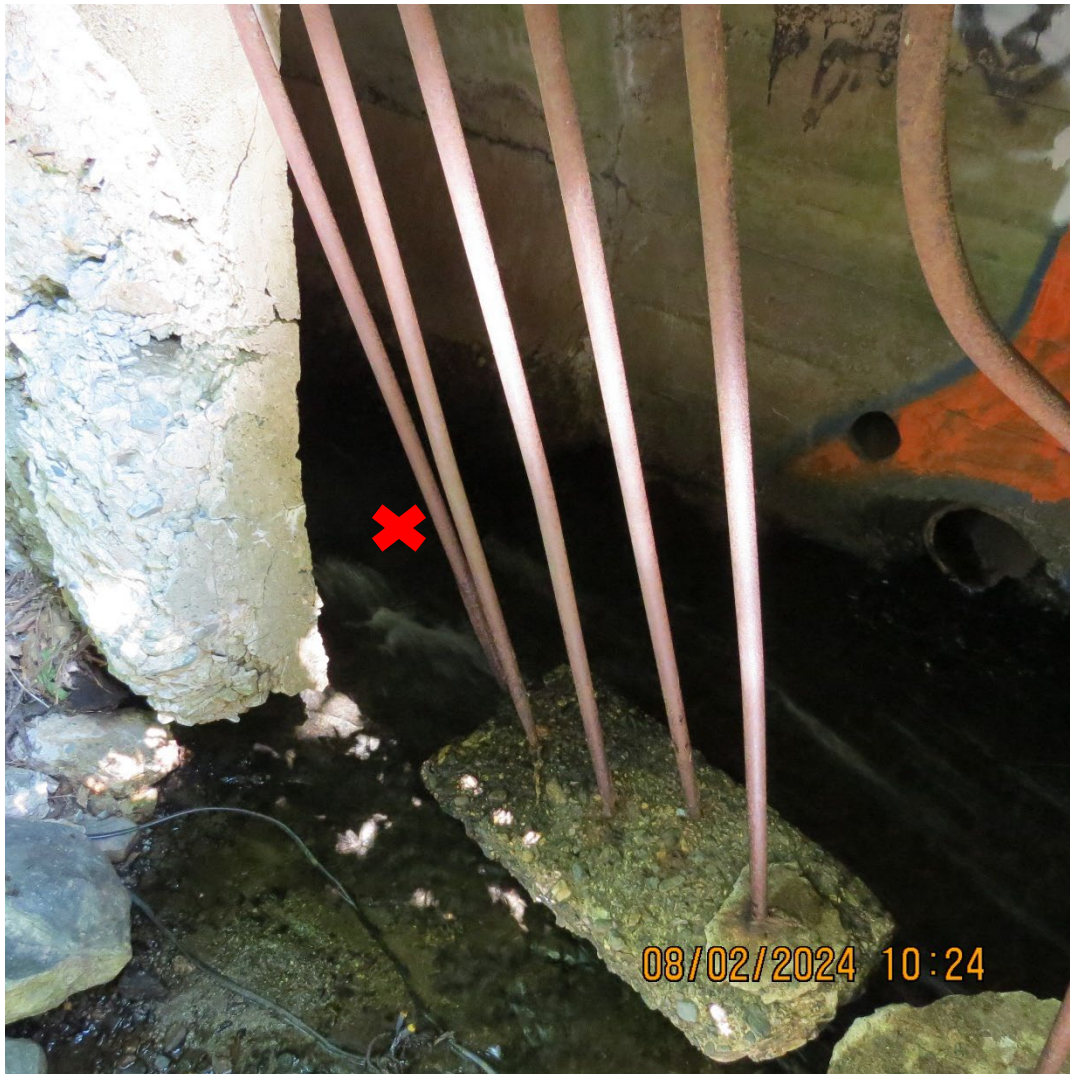
- **LQ-13A**: in-stream sample of an unknown source discharging to Lake Quinsigamond collected on the east side of the stone wall located at 240 Coburn Ave. Sample was collected inside the concrete stormwater conveyance structure approximately 2 feet upstream of outfall LQ-13C and prior to convergence with the unnamed stream. A sulfur/feces odor was detected. Color and turbidity were clear. No floatables were observed.

**Photo 3: LQ-13A** (photo taken 08/02/2023 at approx. 10:24) Stream located near 240 Coburn Ave, discharging into the unnamed stream to Lake Quinsigamond. Sample points are indicated by a red X

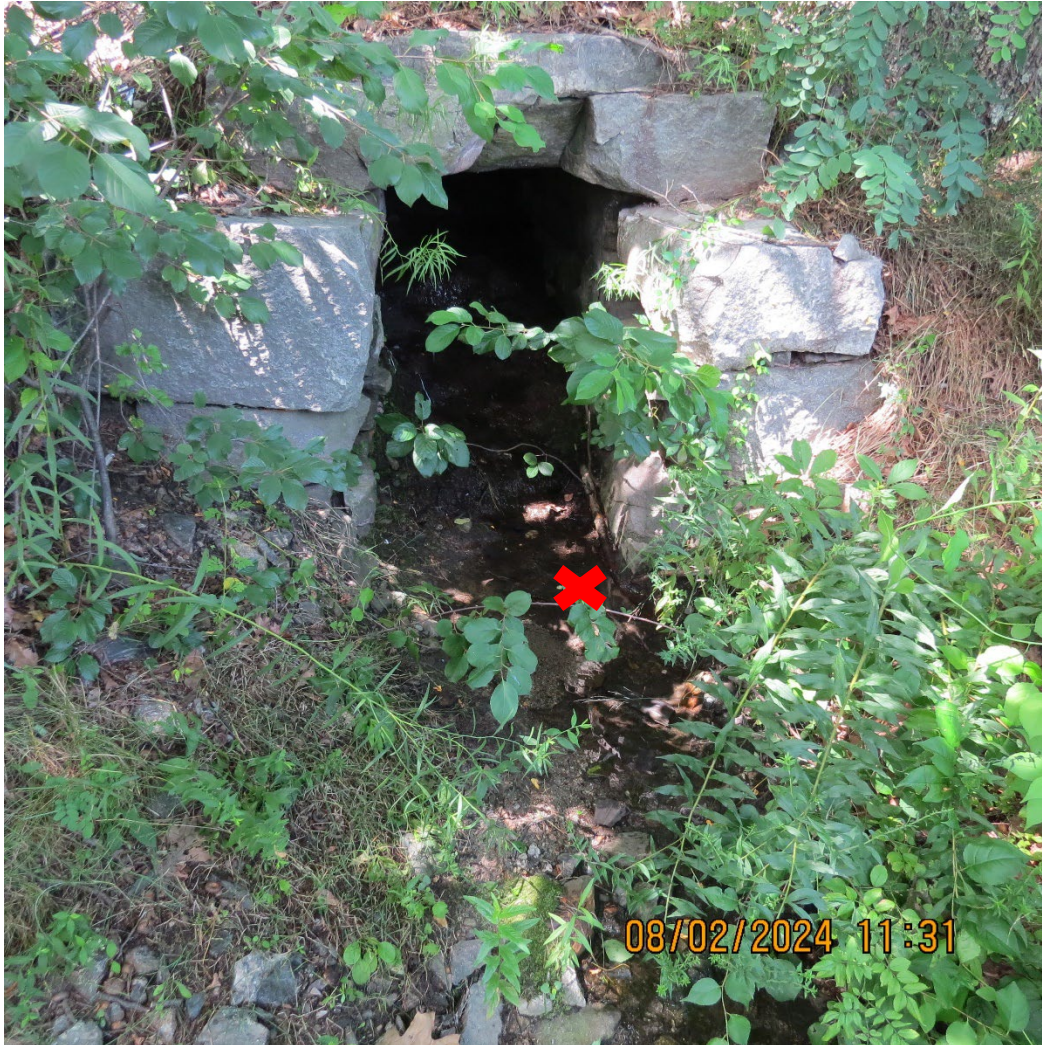
- **CM06**: a single, stone, rectangular outfall, approximately 36 inches in height and 30 inches in width, located at 630 Plantation St. Discharge flow was approximately 5 gpm into Lake Quinsigamond. Sample was collected at the mouth of the outfall. A musty odor was observed. Color and turbidity were clear. Floatables observed include leaves and vegetation. Green algae growth was observed on the rocks downstream of the outfall. Heavy sediment build up was observed at the mouth of the outfall.

**Photo 4: CM-06** (photo taken 08/02/2023 at approx. 11:31) Outfall located near 630 Plantation Street, discharging into the unnamed stream discharging to Lake Quinsigamond. Sample points are indicated by a red X

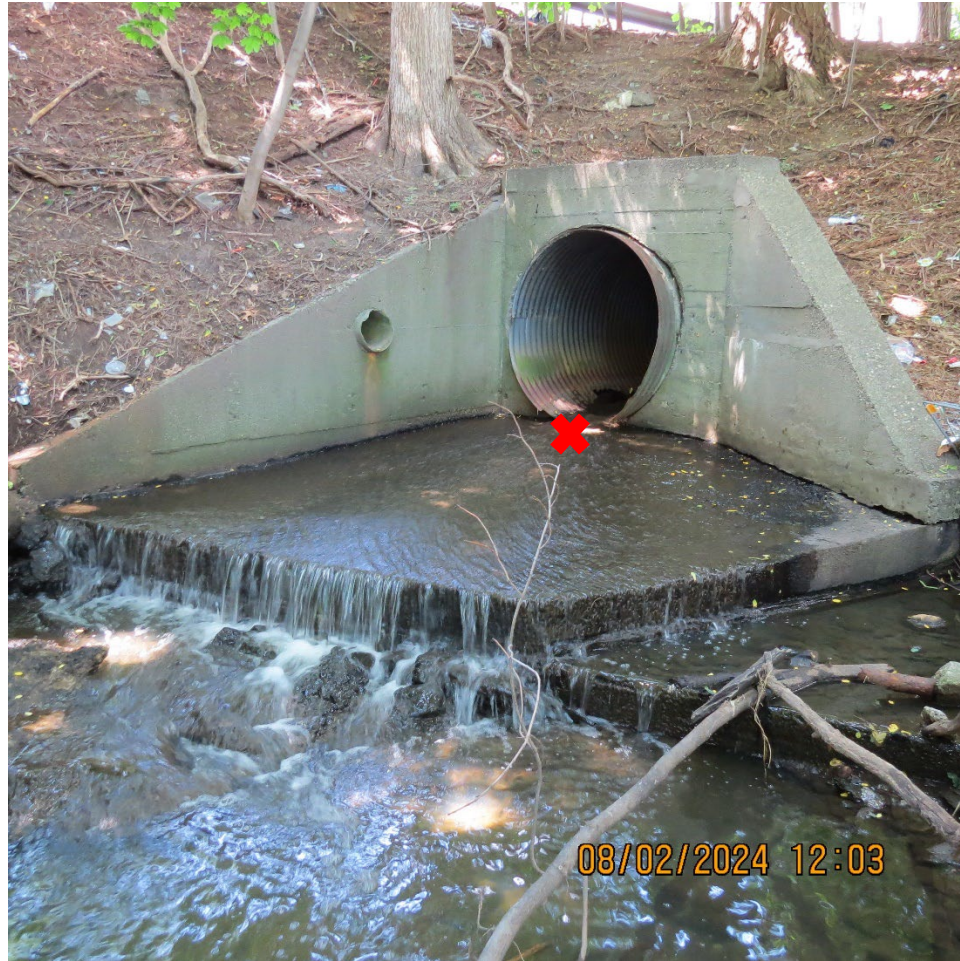
- **CM05**: a single, steel circular outfall, approximately 42 inches in diameter, located at 481 Lincoln Street. Discharge flow was approximately 20 gpm into Coal Mine Brook. Sample was collected at the mouth of the outfall. No odor was detected. Color and turbidity were clear. No floatables observed. Brown algae growth observed on the bottom of the pipe. Outfall rusted and corroded. Holes present on the bottom of the pipe. A murky gray/brown color was observed in the stream directly downstream of the outfall.

**Photo 5: CM-05** (photo taken 08/02/2023 at approx. 12:03) Outfall located near 481 Lincoln Street, discharging into the unnamed stream discharging to Cole Mine Brook. Sample points are indicated by a red X

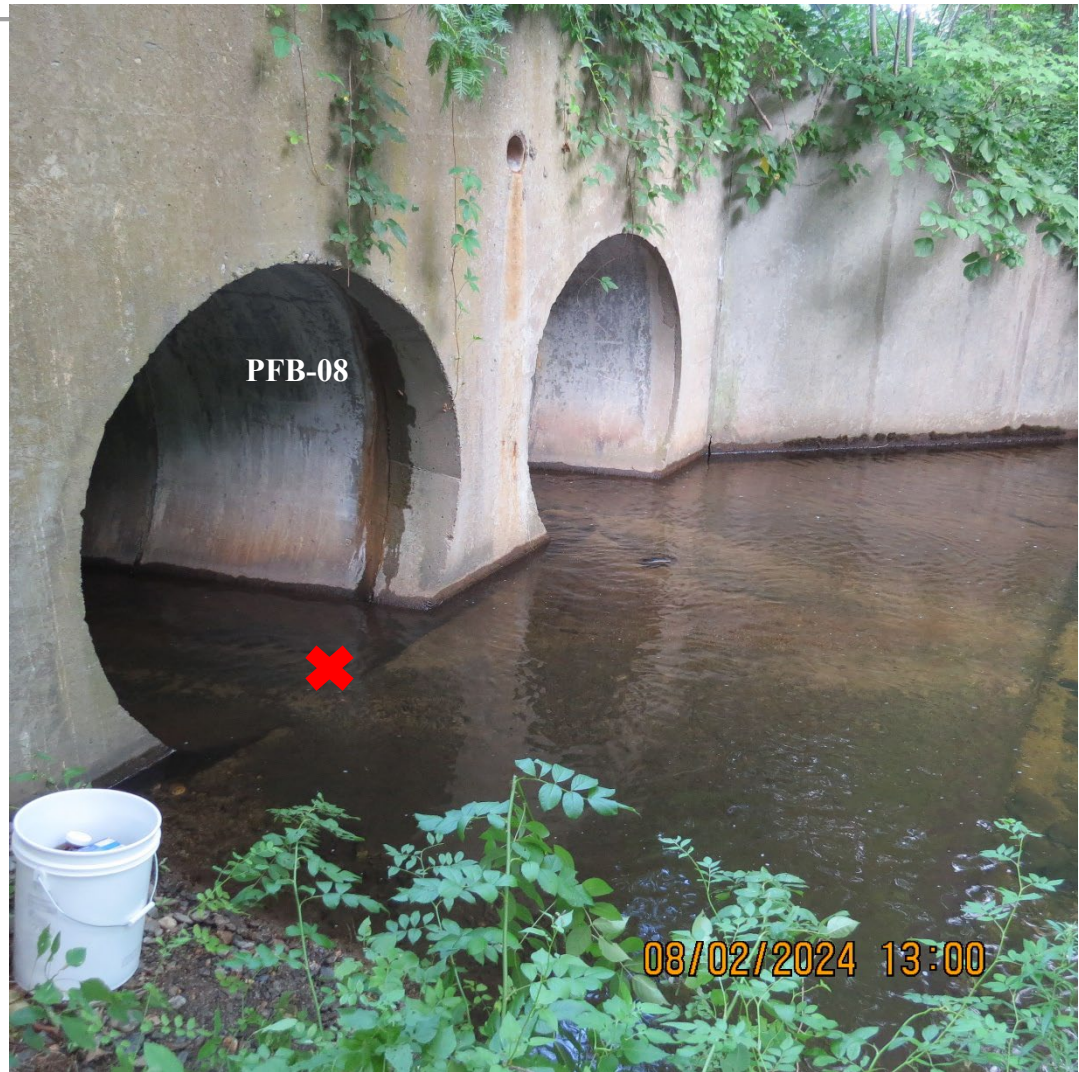
- **PFB-08(left)**: a double (with PFB-15(right)), concrete, circular outfall, approximately 60 inches in diameter, located at 275 Clark Street. Discharge flow was approximately 20 gpm into Poor Farm Brook. Sample was collected at the mouth of the outfall. No odor was detected. Color and turbidity were clear. Some suds were present on the effluent surface. Brown and green algae growth was observed inside the pipe. Light to medium sediment build up was observed on the bottom of the pipe and at the mouth of the outfall.

**Photo 6: PFB-08(left)** (photo taken 08/02/2023 at approx. 12:45) Outfall located near 275 Clark Street, discharging into the unnamed stream discharging to Poor Farm Brook. Sample points are indicated by a red X

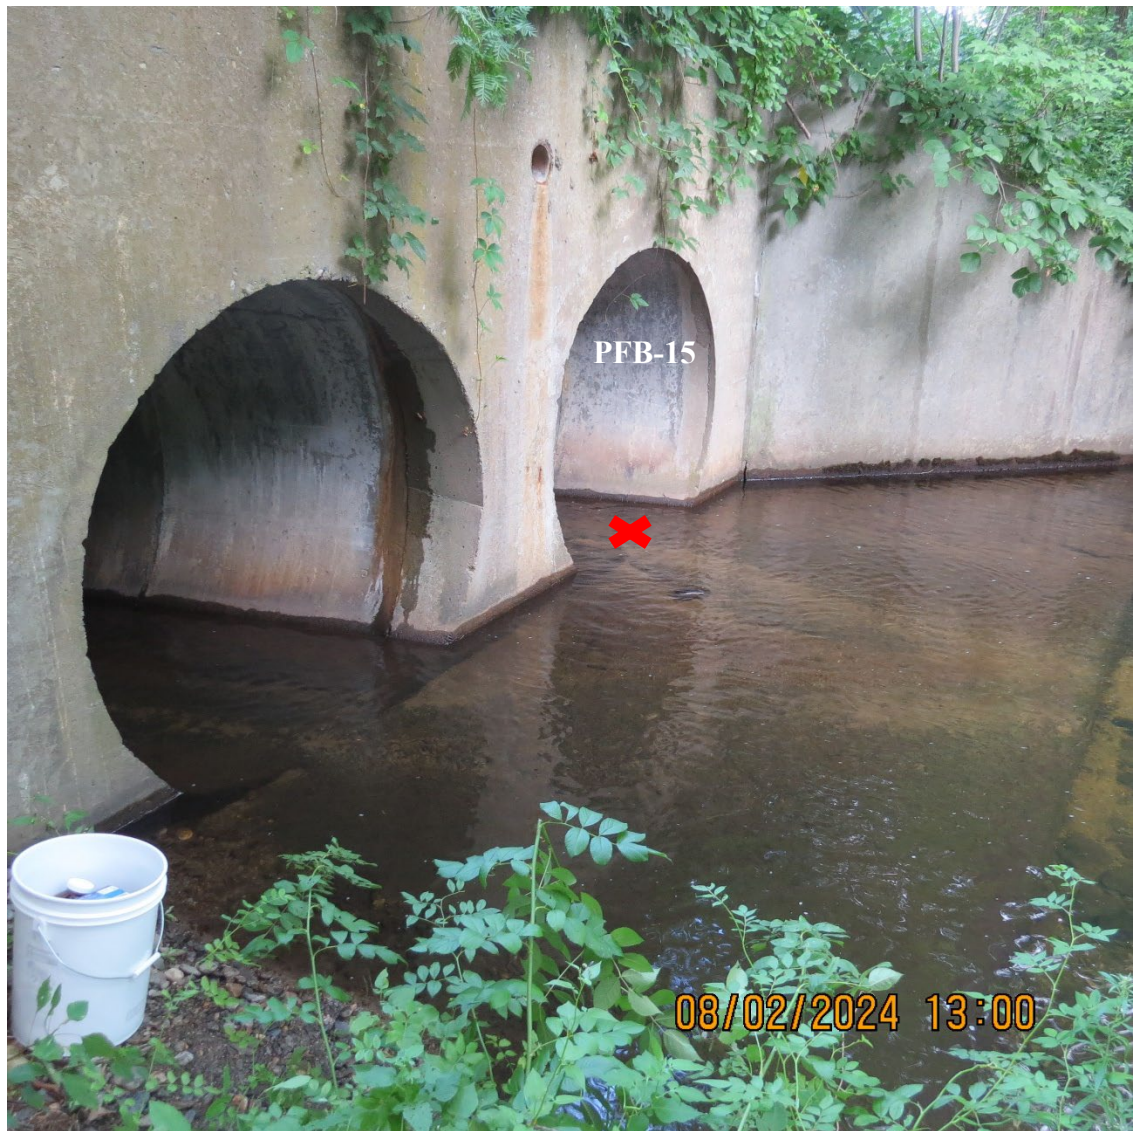
- **PFB-15(right)**: a double (with PFB-08(left)), concrete, circular outfall approximately 60 inches in diameter, located at 275 Clark Street. Discharge flow was approximately 20 gpm into Poor Farm Brook. Sample was collected at the mouth of the outfall. No odor was detected. Color and turbidity were clear. Some suds were present on the effluent surface. Brown and green algae growth was observed inside the pipe. Light to medium sediment build up was observed on the bottom of the pipe and at the mouth of the outfall.

**Photo 7: PFB-15(right)** (photo taken 08/02/2023 at approx. 13:00) Outfall located near 275 Clark Street, discharging into the unnamed stream discharging to Poor Farm Brook. Sample points are indicated by a red X
