**Industrial Site
NPDES Stormwater Reconnaissance Inspection**

TROPICAL SHIPPING CONSTRUCTION COMPANY LIMITED, LLC

Inspection Dates: September 8, 2022

TROPICAL SHIPPING-CROWN BAY, NPDES Stormwater Reconnaissance Inspection (RI) Photo Album; 9-8-2022 Walkthrough

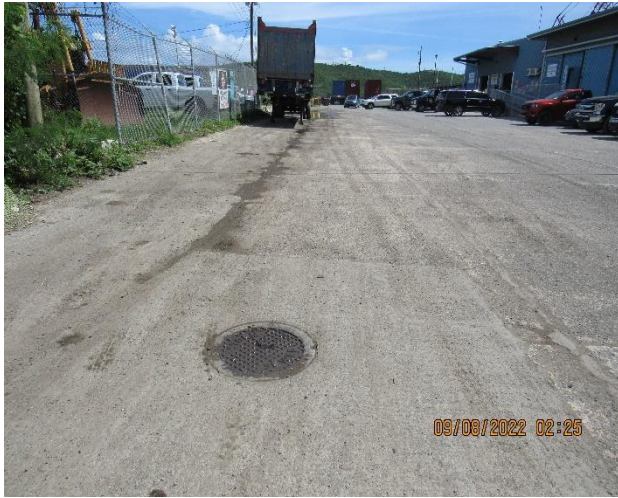
IMG 477-Road going into the dock area. Sediment transported by storm water runoff from Field seen in the stormwater flow path along the road.

The EPA Inspector observed ponding of storm water along the left side of the road and noticed that several stormwater catchment basins were partially clogged by accumulated sand and gravel transported by storm water runoff flow. According to Mr. Farrington, the series of stormwater catchment basins is part of the stormwater drainage system in that section of the Facility, that eventually discharge into the nearby Charlotte Amalie Harbor. ***The EPA inspector did not observe any provision that serves as protection of inlets of the stormwater catchments basins*** in the referenced area of the Facility. See IMGs 477 thru 480 of TROPICAL'S September 8, 2022 NPDES Stormwater RI Photo Album, ATTACHMENT 2, of the 2022 Inspection Report.

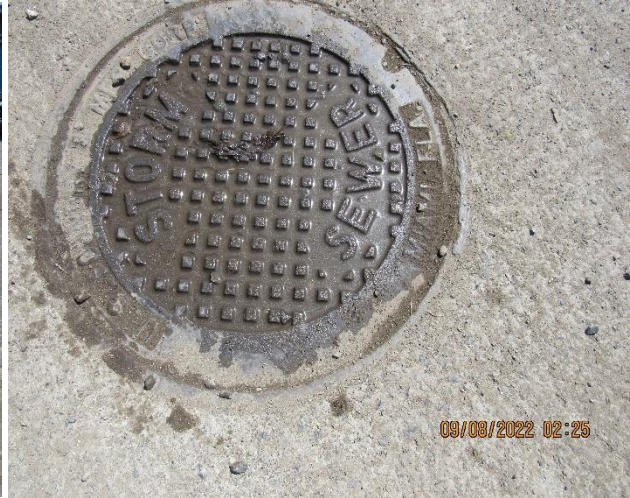
IMG 478-Picture of cover to storm sewer that conveys stormwater from upstream area.

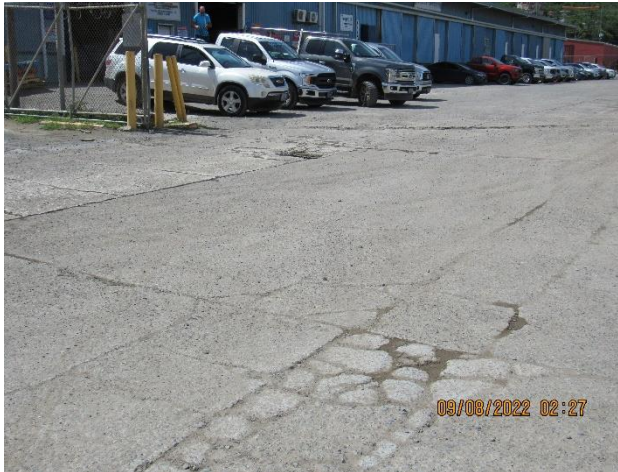
IMG 479-A stormwater catch basin of stormwater drainage system in the Crown Bay port area.

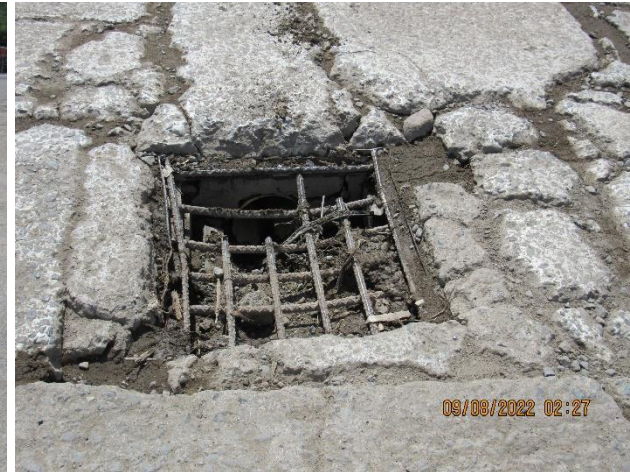
IMG 480-Close-up of the stormwater catch basin partially clogged with sediment from upstream. The inlet of the catch basin is not protected.

Throughout the course of the 2022 Inspection, the EPA inspector did not observe any provisions that served as protection of the inlets to stormwater catchment basins anywhere in the Facility. In addition, evidence revealed that inlets of stormwater catchment basins in the Facility were not properly maintained. See **IMGs 480, 486, 500 and 514 of TROPICAL’S September 8, 2022 NPDES Stormwater RI Photo Album, ATTACHMENT 2**, of the 2022 Inspection Report.

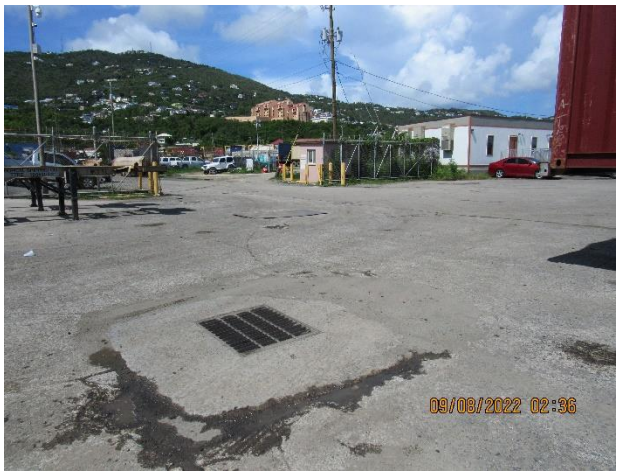
IMG 485-Stormwater catch basin with raised inlet just in front of Tropical's fenced dock area. The inlet of the catch basin is not protected.

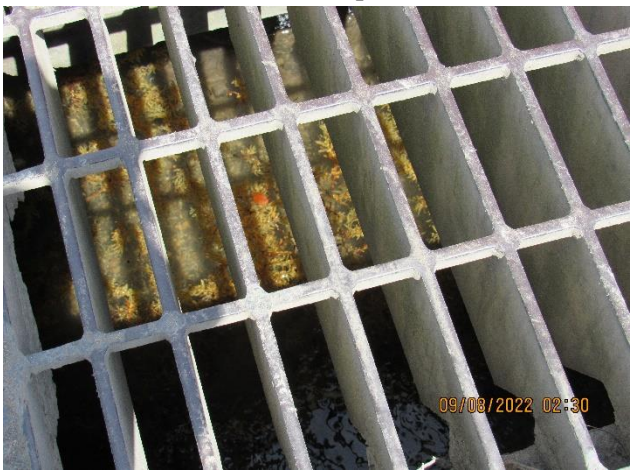
IMG 484-Close-up view of stormwater catch basin with raised inlet. Observed sea water intrusion with large amount of marine vegetation inside catch basin.

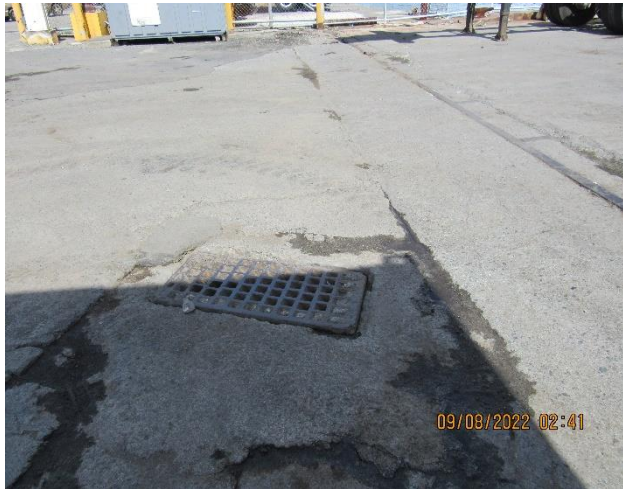
IMG 486-A storm water catch basin within the fence line. The inlet of the catch basin is not protected.

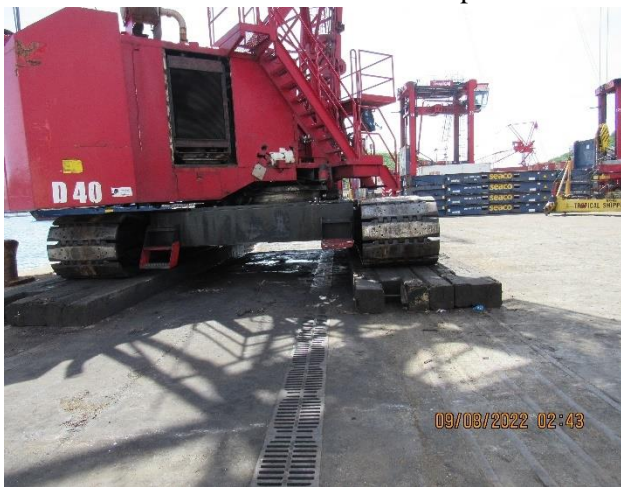
IMG 489-Crain staged on dock platform for loading and unloading cargo. Drain collects stormwater runoff, oil and grease leaks and spills installed in place. **IMG 490-**View of the drain along the entire dock bulkhead.

- i. Potential discharge of oil and grease into Charlotte Amalie Harbor through stormwater contact with the "crane pad" operations* – Observed that the paved surface and wooden pads on which cranes track along the dock bulkhead appeared saturated with oil and grease residues that is a result of operation of the cranes. Stormwater readily comes into contact with the accumulated pollutant residues and are washed-off into the stormwater catch basins, which drain into the nearby Charlotte Amalie Harbor. See **IMGs 489, 490 and 495 of TROPICAL'S September 8, 2022 NPDES Stormwater RI Photo Album, ATTACHMENT 2**, of the 2022 Inspection Report.

In addition, the EPA Inspector observed a grate-covered drain situated between the crane pads and runs the entire length of the paved dock bulkhead. According to Mr. Farrington, the referenced drain is installed to capture releases that may occur from oil spills and grease residues during servicing of the cranes, and leaks from ruptured hydraulic and engine block fluid lines. See **IMGs 490 and 495 of TROPICAL'S September 8, 2022 NPDES Stormwater RI Photo Album, ATTACHMENT 2**, of the 2022 Inspection Report.

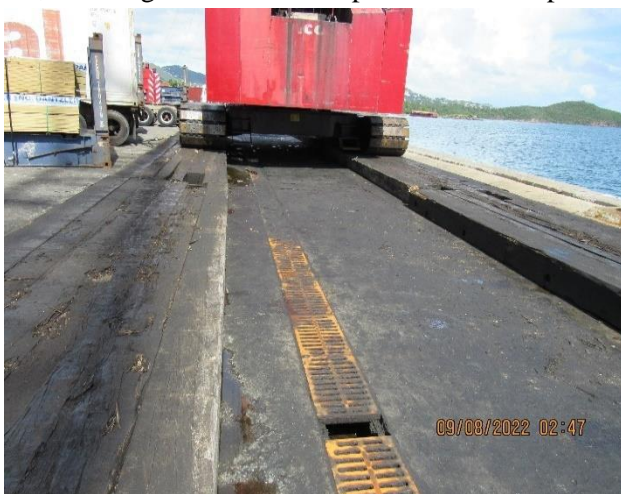
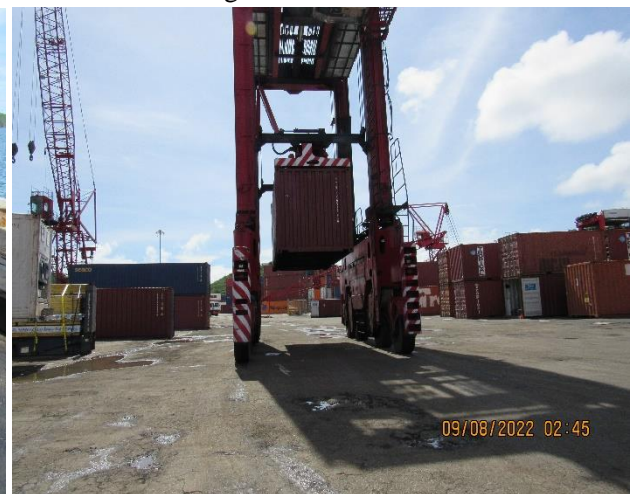
IMG 495-Evidence of oil and grease residue open to all environmental conditions. Dock graded to allow stormwater to drain towards inner yard and the catch of spills and leaks of oil and grease in yard area basins. **IMG 492-**Container transport vehicle in operation in dock area and inner yard. Increased possibilities

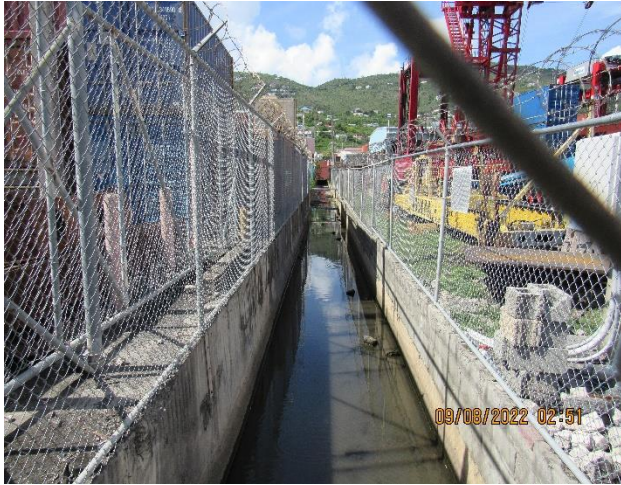
IMG 498-Large stormwater drainage canal that runs through Tropical, north to south, and drains into the Bay.

The EPA Inspector observed a relatively large section of the Facility, completely paved with brick-like tiles, and surrounded by chain-linked fencing, and identified as the MT Yard. The MT Yard is separated from the rest of the Facility by a large square stormwater drainage canal that runs from north to south and through the Facility, which discharges into the Charlotte Amalie Harbor. The MT Yard is strictly used for staging of cargo containers and is drained by stormwater catchment basins. The EPA observed one of the stormwater catchment basins situated in the center of the MT Yard of the Facility. Mr. Farrington could not confirm whether stormwater runoff from the MT Yard is discharged to the stormwater canal mentioned above. See **IMGs 498, 500, 518 and 519 of TROPICAL’S September 8, 2022 NPDES Stormwater RI Photo Album, ATTACHMENT 2**, of the 2022 Inspection Report.

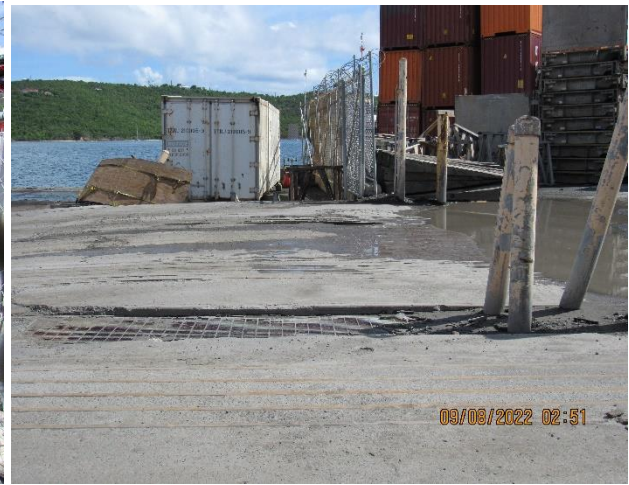
IMG 500-Large catch basin in which mid-section of the Facility through which stormwater enters the large drainage canal, and into the Bay.

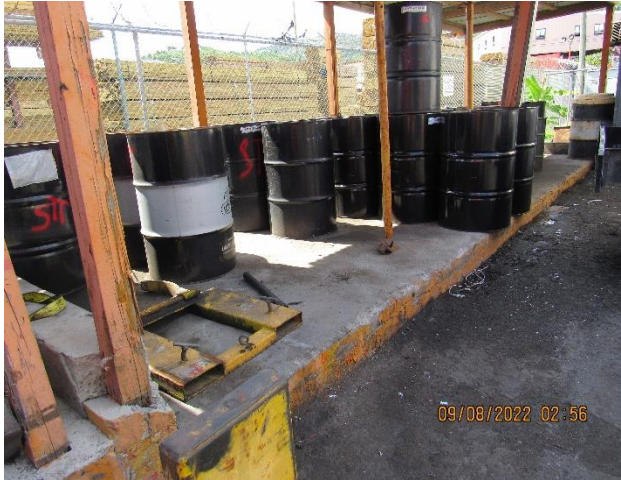
IMG 503-Lubricant and chemical storage area. No containment to capture spills and leaks onto concrete base. Will be washed-off by stormwater runoff flow.

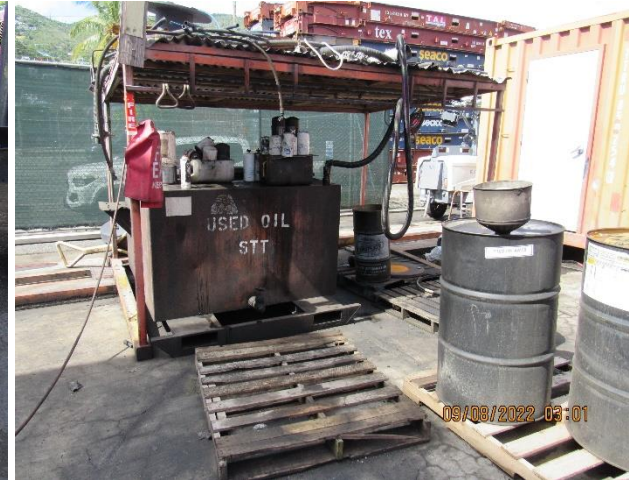
IMG 510-Use Oil management tank not within containment to capture used oil spills and prevent releases that are exposed to stormwater runoff flow.

- iii. Potential for release of pollutant from operation of the Facility's Used Oil Management Station – Evidence observed revealed that operation of the Used Oil Management System leads to releases of the wastes outside of a containment erected. Spilled waste is exposed to and readily washed-off by storm water runoff flow away from the referenced area and drains towards stormwater catchment basins in the Facility. See **IMGs 510 thru 512 of TROPICAL'S September 8, 2022 NPDES Stormwater RI Photo Album, ATTACHMENT 2**, of the 2022 Inspection Report.

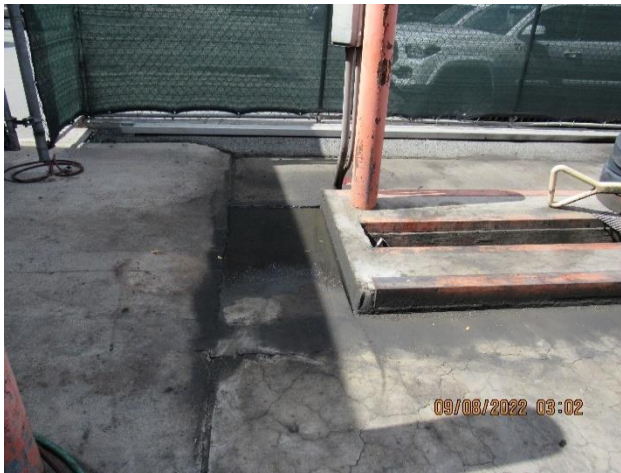
IMG 511-Evidence of spilled used oil on platform washed-off by stormwater runoff flow away from the used oil storage system.

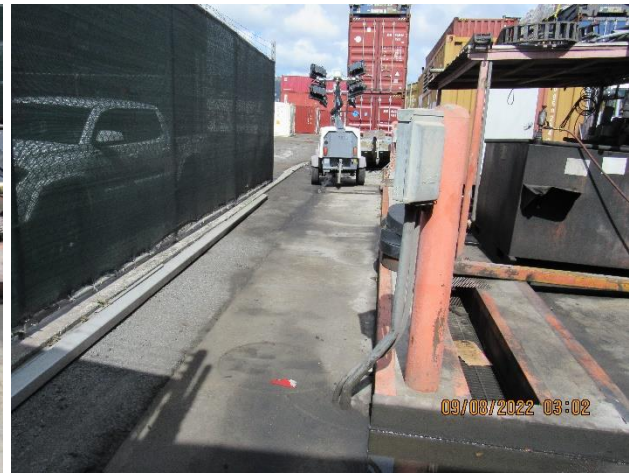
IMG 512-Evidence that used oil residue washed-off by stormwater runoff flow towards stormwater catch basins in the central area of the Facility.

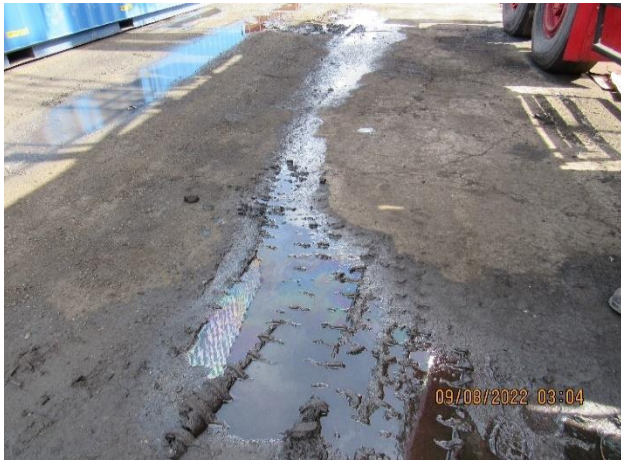
IMG 513-Evidence of oil and grease residues draining into inlet of a submerged Oil/Water Separator in operation at the Facility.

- ii. Potential discharge of process wastewater into Charlotte Amalie Harbor through the Facility's Oil-Water Separator – According to Mr. Farrington, the oil-water separator is situated below grade in the yard adjacent to the mechanical maintenance shed. Wastes generated (including engine fluids with oils, and greases) from vehicles and equipment being repaired falls onto the pavement and drains into the inlet port of the Oil-Water Separator. Mr. Farrington could not confirm whether there is an outlet to the Oil-Water Separator unit, and were it discharges. See **IMGs 513 and 514 of TROPICAL'S September 8, 2022 NPDES Stormwater RI Photo Album, ATTACHMENT 2**, of the 2022 Inspection Report.

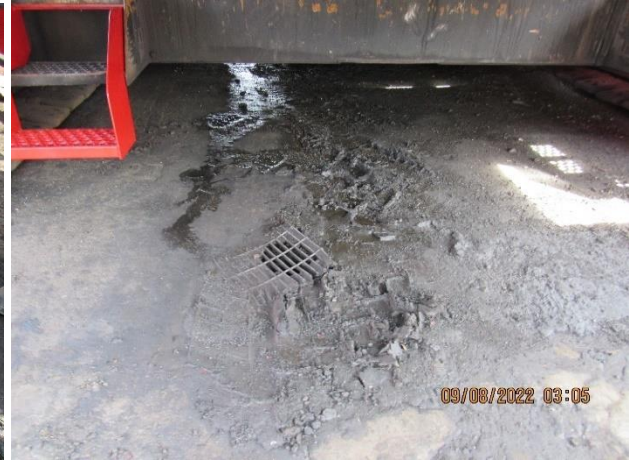
IMG 514-View of the inlet submerged in oily-mud. Oily-water runoff and sediment entering the Oil/Separator unit. Did not identify discharge port.

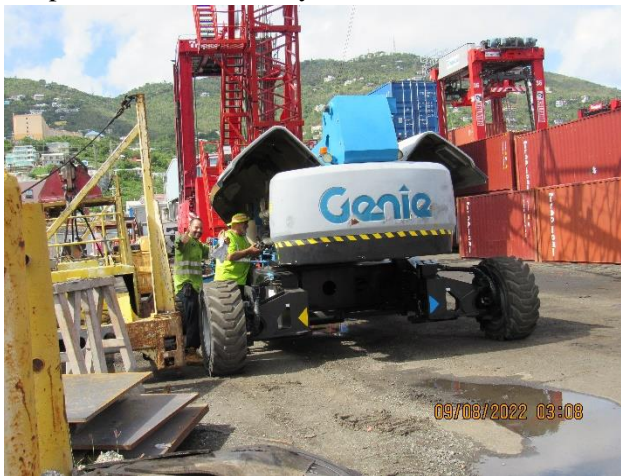
IMG 517-Observed personnel actively engaged in maintenance of heavy-load equipment outside of the maintenance shed.

The EPA Inspector observed operations that involved movement of shipping containers from one staging location to another within the Main Container Yard Area. In addition, the EPA Inspector observed mechanical repair of vehicles and other load management equipment, such as Cranes and large front load-lifters, being carried out within, and in spaces immediately outside the mechanical maintenance shed. Evidence of the concerns that may lead to potential discharge of pollutants from various operations within the area in question, as observed and documented by the EPA Inspector, are presented below:

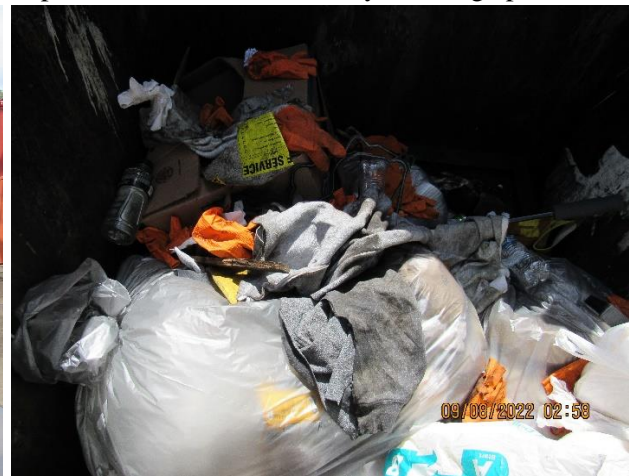
IMG 506-Identified oil-soaked rags and absorption pads thrown among regular garbage in dumpster Staged outside of the maintenance shed.

iv. *Improper disposal of potentially regulated wastes* – Observed oil-soaked rags and gloves mixed with generated refuse in a dumpster staged just outside of the mechanical maintenance shed. According to Mr. Farrington, waste in the dumpster in question is disposed along with regular garbage. See **IMG 506 of TROPICAL’S September 8, 2022 NPDES Stormwater RI Photo Album, ATTACHMENT 2**, of the 2022 Inspection Report.

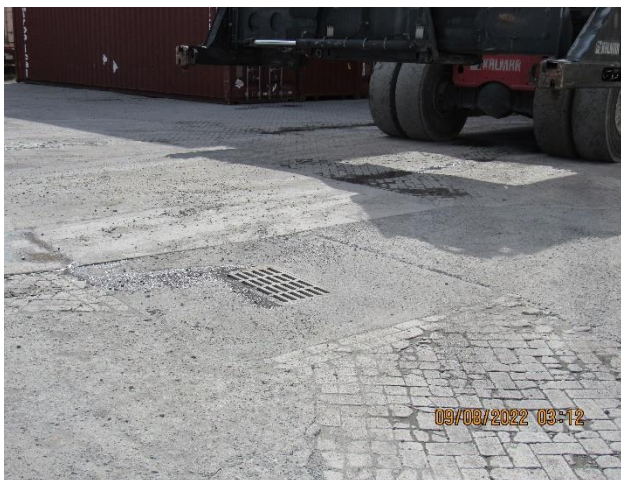
IMG 518-Stormwater catch basin that drains entire area of Tropical's MT Yard. Inlet of catch basin not protected.

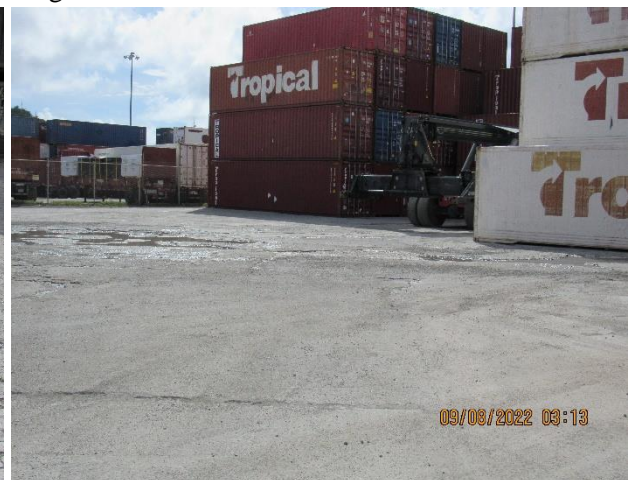
IMG 519-View of Tropical's MT Yard area that drains into the single stormwater catch basin.

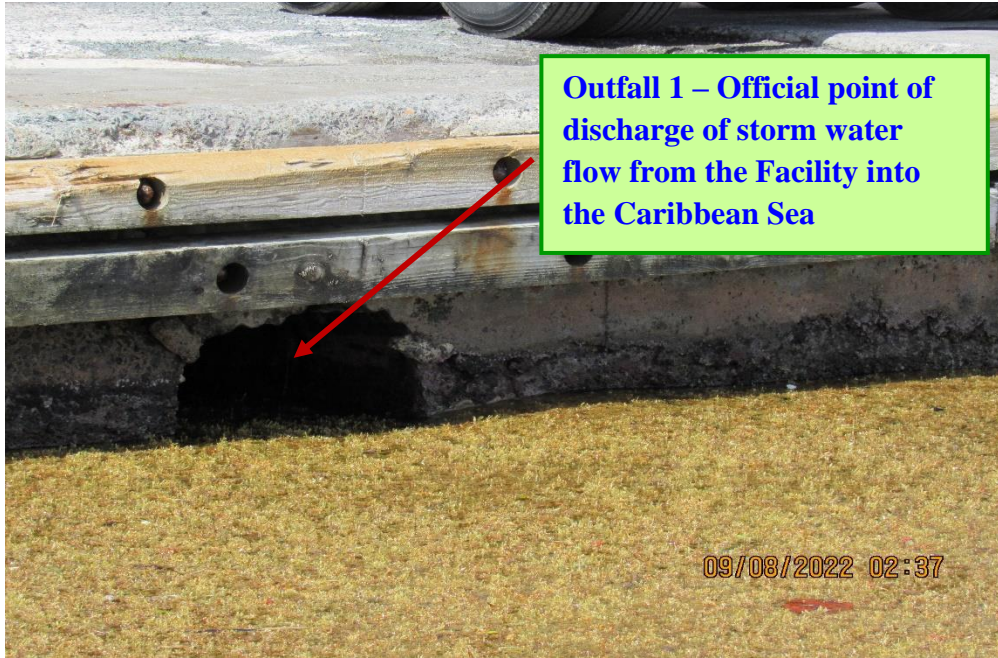
IMG 486-Discharge point where storm water from the Field and Warehouse areas north of the Facility and stormwater runoff drainage from within the Tropical's Main Container Yard combined into Charlotte Amalie Harbor.

Outfall 1 – The stormwater management system through which stormwater runoff flows out of the Cancryn Field, warehouses and roadway, dock bulkhead, and the main container yard areas is conveyed and eventually discharged into Charlotte Amalie Harbor. Outfall 1 is featured in **IMG 486 of TROPICAL’S September 8, 2022 NPDES Stormwater RI Photo Album, ATTACHMENT 2**, of the 2022

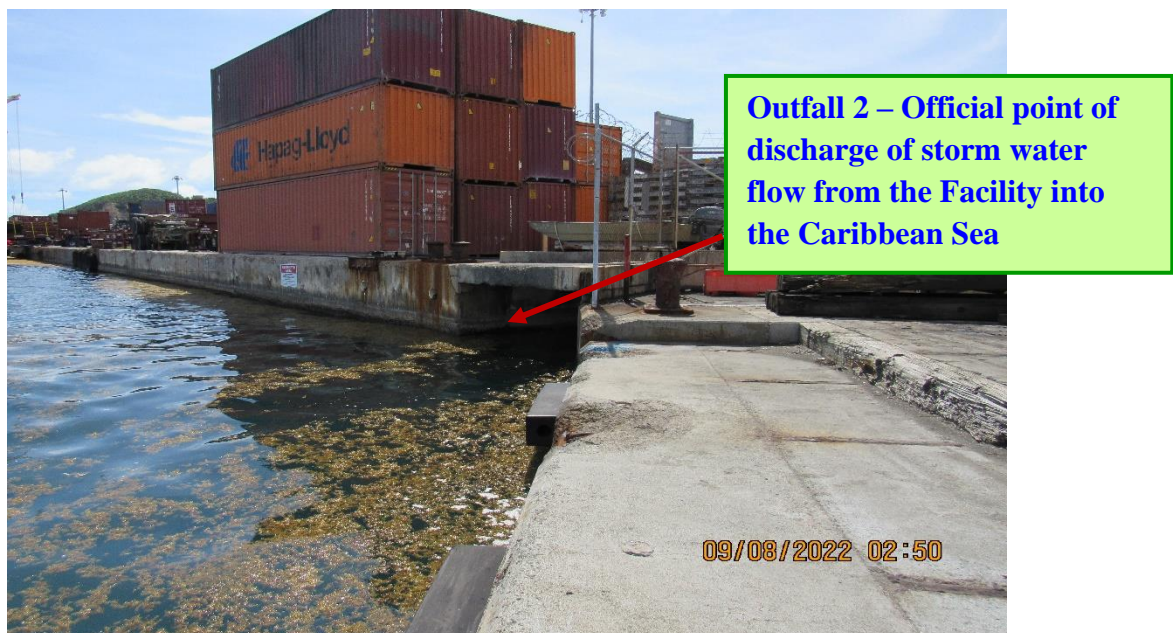
IMG 496-Discharge point of a stormwater channel that traverses the Facility. Stormwater runoff from Tropical's MT Yard drains into the channel before final discharge into the Charlotte Amalie Harbor.

Outfall 2 – The discharge point of the square open channel that traverses the Facility (previously mentioned at Sub-section 8.c.5 of this 2022 Inspection Report) through which stormwater runoff flows from the MT Yard area and possibly other industrial operations of the Facility, flows into Charlotte Amalie Harbor. Outfall 2 is featured in **IMG 496 of TROPICAL’S September 8, 2022 NPDES Stormwater RI Photo Album, ATTACHMENT 2**, of the 2022 Inspection Report.
