**Region 6 Enforcement and Compliance Assurance Division  
INSPECTION REPORT**

| Regulatory Program(s) | Clean Air Act (CAA) § 112(r) and 40 Code of Federal Regulations (C.F.R.)<br>Part 68 Chemical Accident Risk Management Plan (RMP) Program 3 | |
| Company Name: | <b>Hillshire Brands Company</b> | |

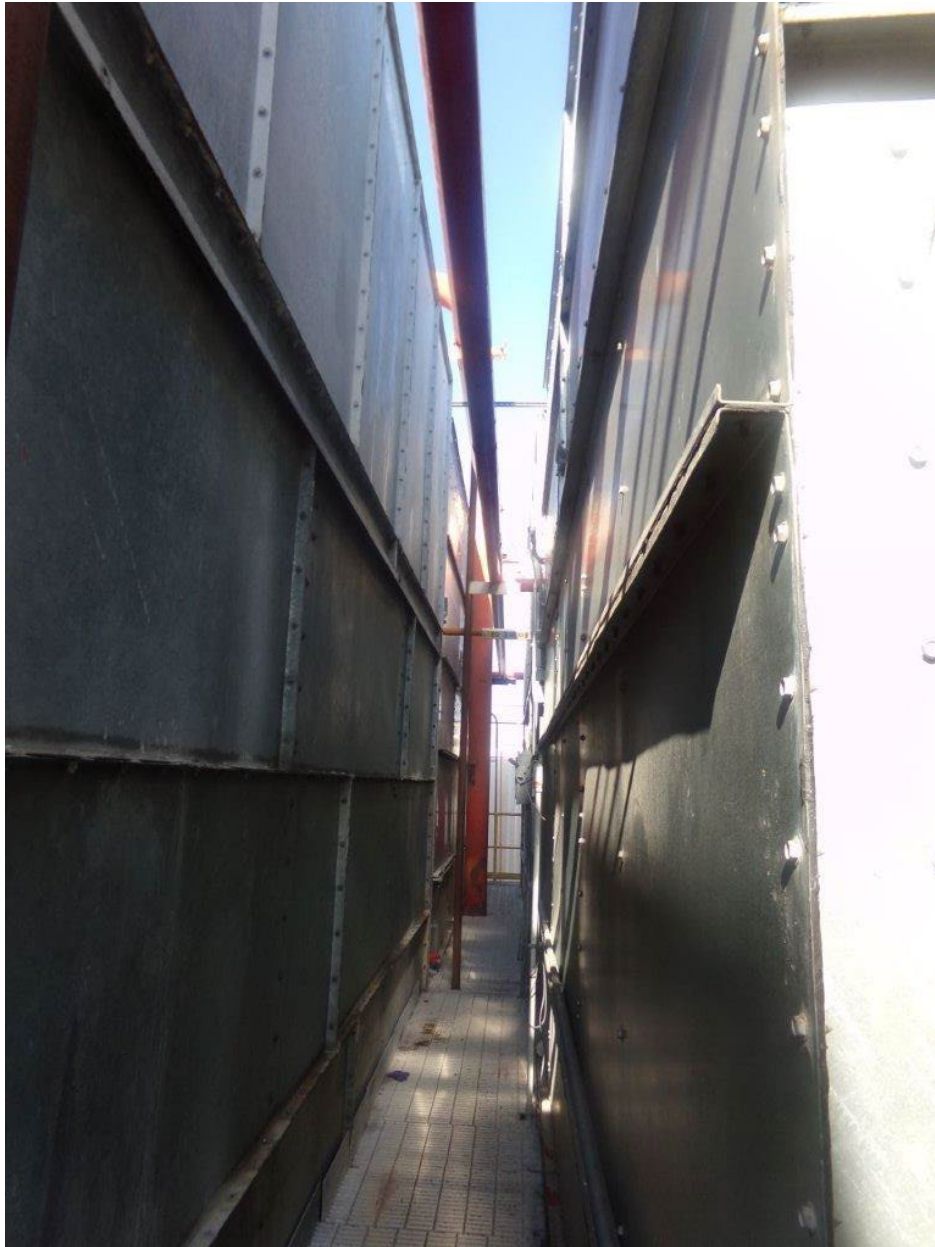
Photo No. 1

During the walk-through, I observed that the facility was missing proper markings on piping – e.g., direction of flow, color-coding to identify the hazardous material present, placement of pipe labels, and type and size of letters on pipe labels, as required by the American National Standards Institute (ANSI) and the American Society of Mechanical Engineers (ASME) Standard ANSI/ASME A13.1, *Scheme for the Identification of Piping Systems*. This standard is considered a recognized and generally accepted good engineering practice for above ground piping systems [AOC 1: § 68.65(d)(2)].
