To J. H. McCulley  
From David H. Jones  
Date March 16, 1976  
Subject VCM Monitoring During Ship Loading  
(Beta Gas - 4:00 pm, 3-09-76 to 6:00 pm, 3-10-76)

During the above VCM ship loading operation, the various jobs connected with ship loading were monitored with the Century Hydrocarbon Analyzer for VCM emissions. Jobs monitored include loading and vent line blind pulling, heel sampling, hydroquinone addition, loading and vent hose disconnect, and loading and vent line blind insertion. Also, the recovery unit area was inspected for possible leaks.

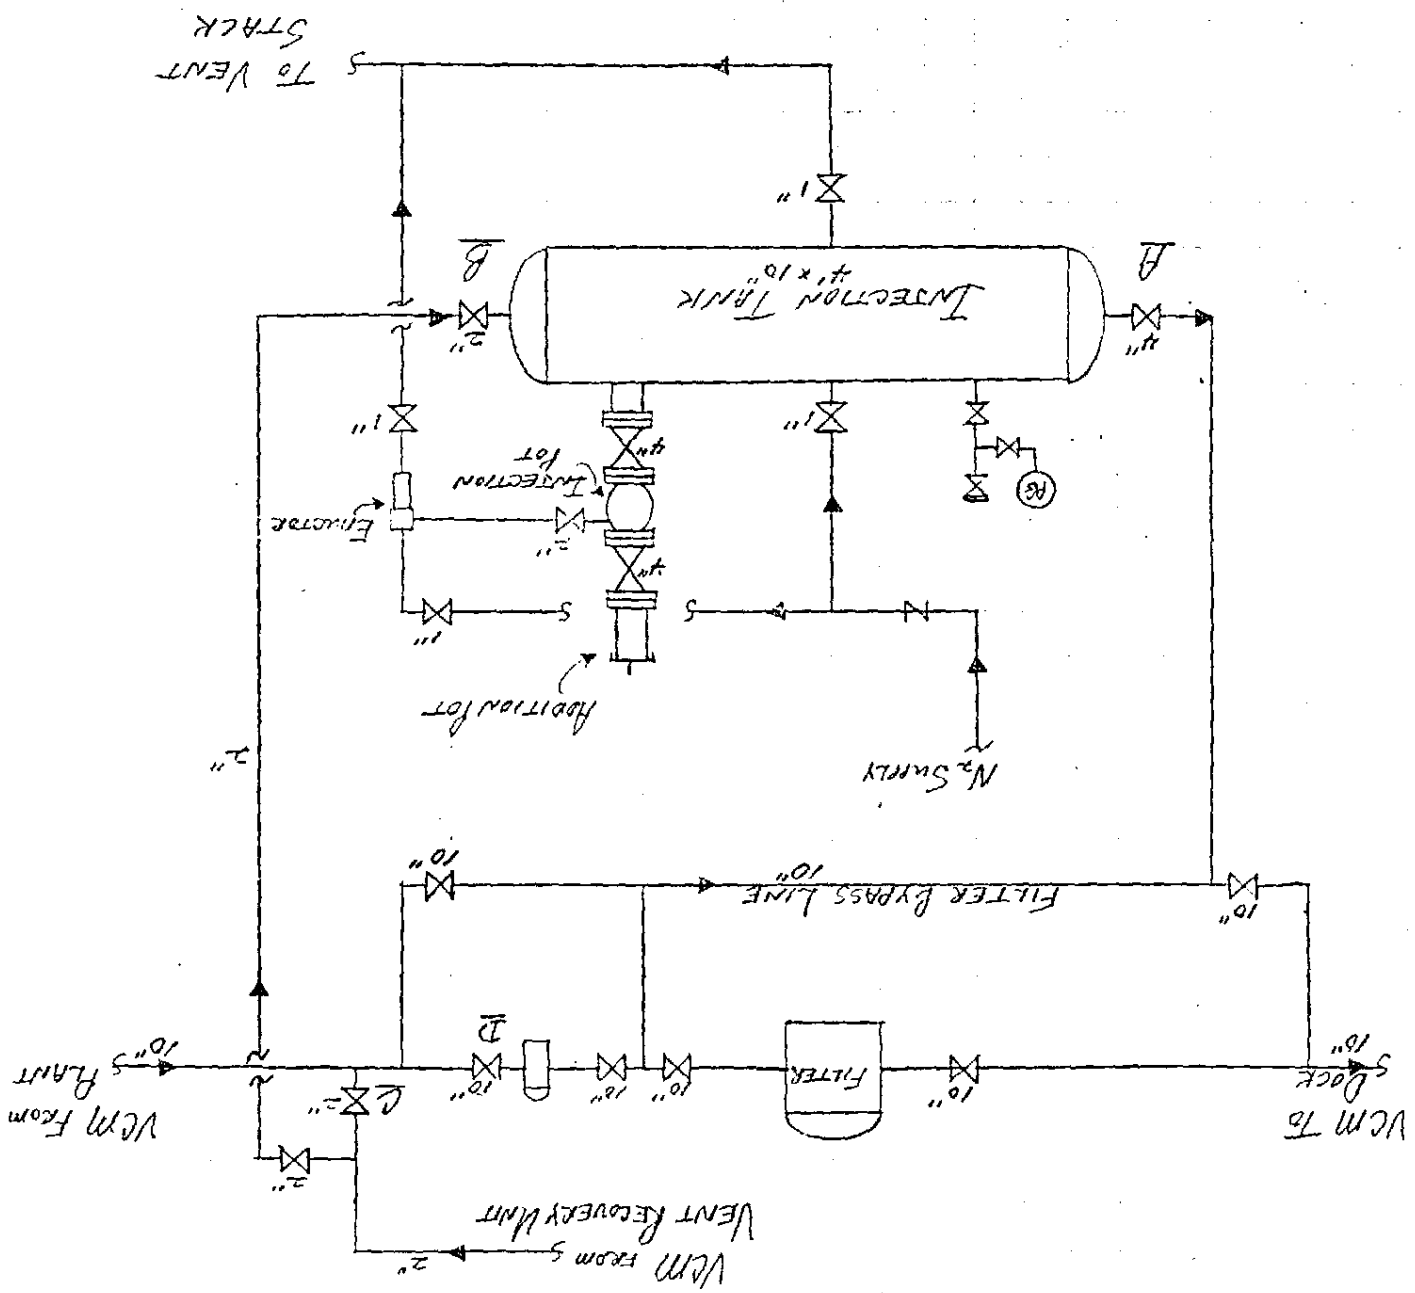
FIGURE 1

The only appreciable leaks found were during the hydroquinone addition. The inlet (2") and outlet (4") valves of the hydroquinone injection tank showed leakage around the valve stem. Also, the 2" valve that allows liquid VCM from the recovery unit to be pumped into the loading line located in the hydroquinone addition area and the 10" valve in the VCM loading line used to pinch flow while adding hydroquinone showed leakage around the valve stem. It is recommended that the valve stem packing of these valves be tightened. These valves (marked A, B, C & D) are shown on the attached figure.

HYDROQUINONE ADDITION
