## Region 6 - Enforcement & Compliance Assurance Division

### INSPECTION REPORT

| Company Name: | City of Yukon | |

Laboratory Inspection Report Appendix 1

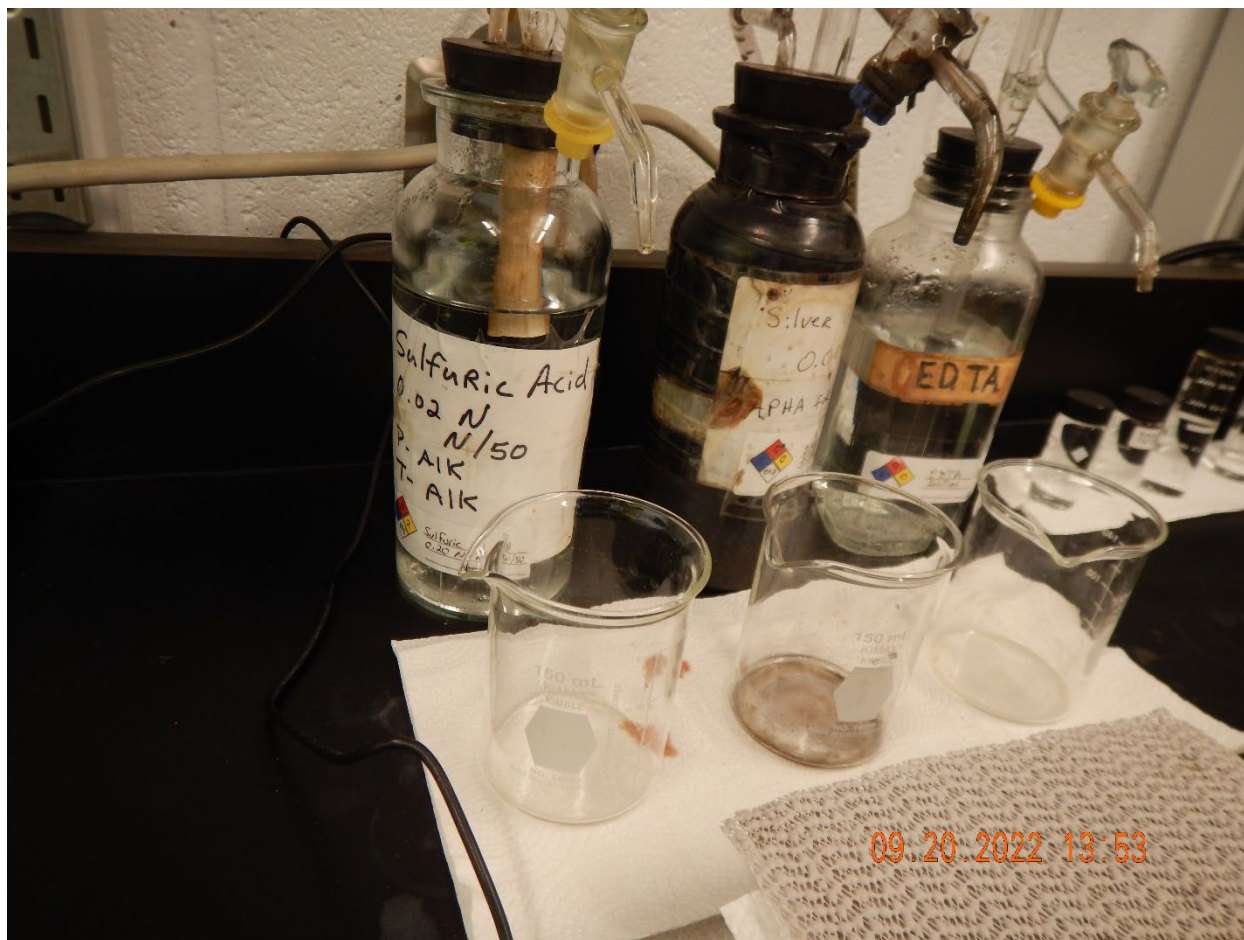
Photo No. 1

Designated containers being utilized for reagent storage are missing an expiration date on label.

1. **Laboratory practices:** Per the SDWA, all methods performed for the monitoring and analytical requirements for public water systems shall comply with EPA approved methods, listed in 40 CFR Part 141, or the EPA approved alternative methods listed in the aforementioned Appendix A to subpart C. Proper use of Personal Protective Equipment (PPE) must be implemented, using clean PPE in good physical condition. All reagents, reagent water, standards, and equipment must meet the requirements per each EPA approved method. Reagents and standards must be clearly labeled with open and updated expiration dates, to ensure they are not used past expiration. Unless otherwise noted by the manufacturer, liquid reagents and standards have a shelf life of one (1) year after opening. Should the manufacturer expiration date occur before the one year mark after opening, the manufacturer's expiration date takes precedence. EPA

approved methods may further specify the shelf life of reagents, standards, or solutions created in house for the purpose of analysis or calibration. Expired reagents and standards must not be used in sample analysis or calibration of laboratory equipment, as they do not meet the quality assurance and quality control (QA/QC) requirements per the EPA approved methods. All reagents and standards used in analysis must be clearly labeled with contents and updated expiration date to ensure all QA/QC requirements are fulfilled.

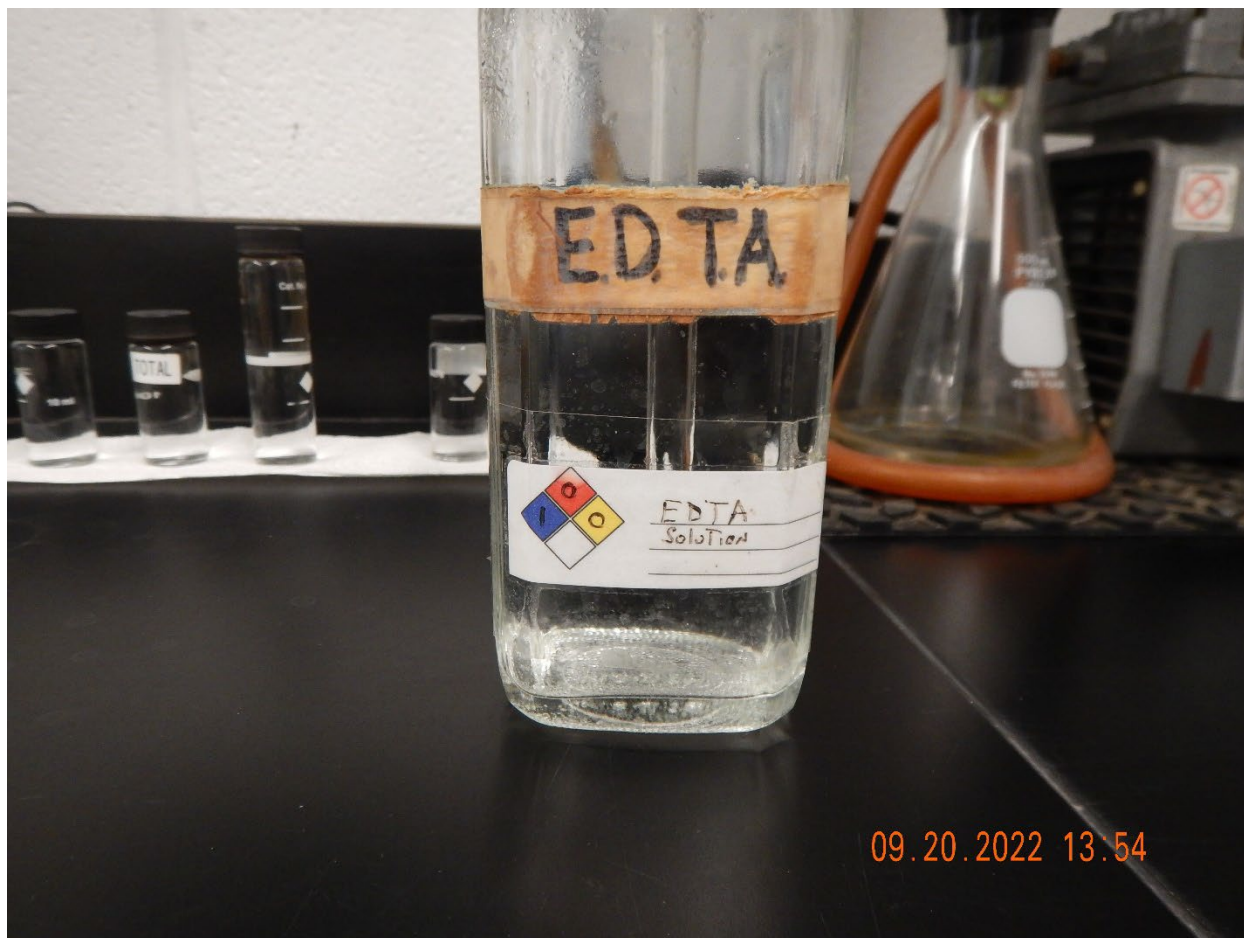
Photo No. 2

Designated containers being utilized for reagent storage and are missing an expiration date on label.

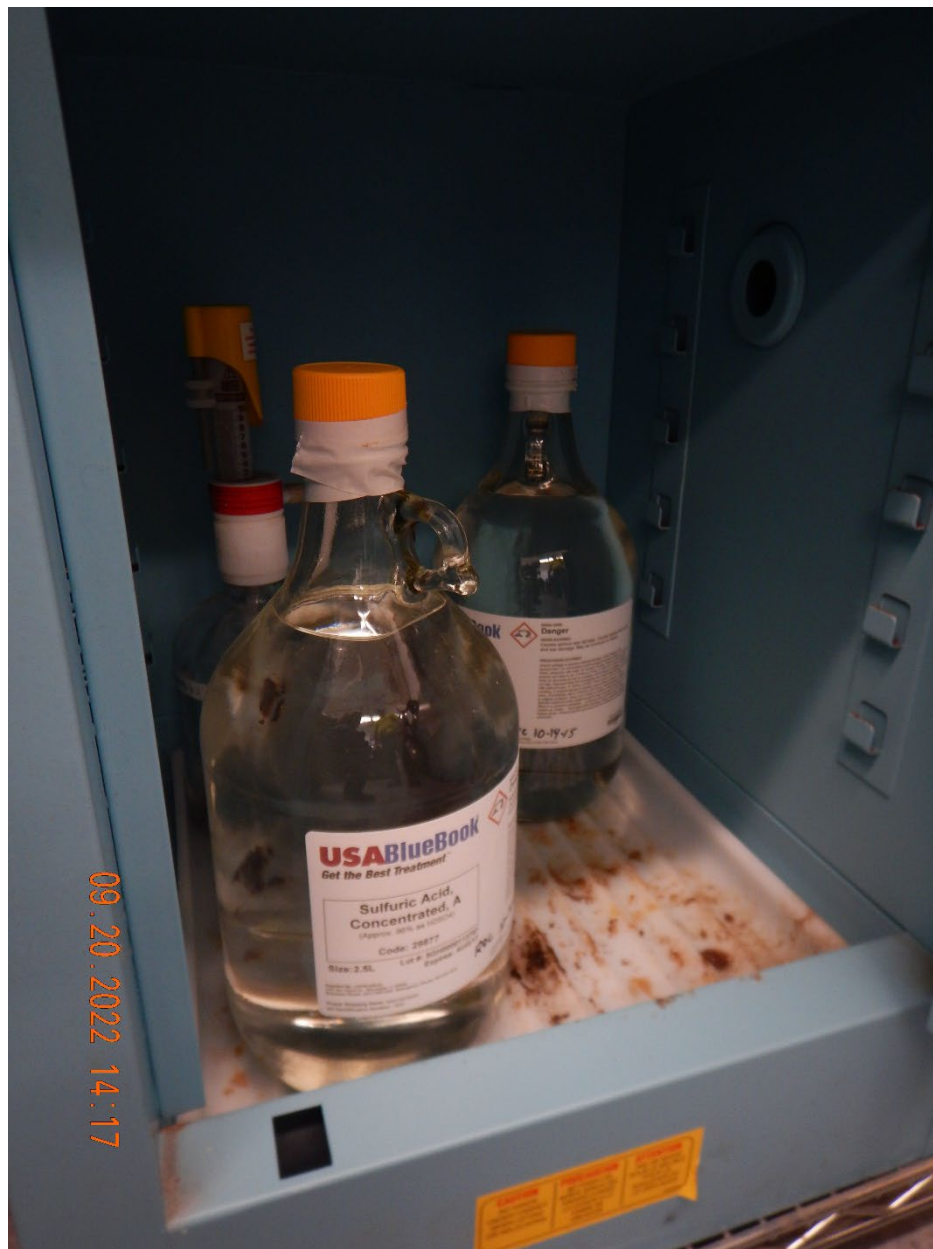
Photo No. 14

Three bottles of expired concentrated sulfuric acid were found in the acids and corrosives storage cabinet.

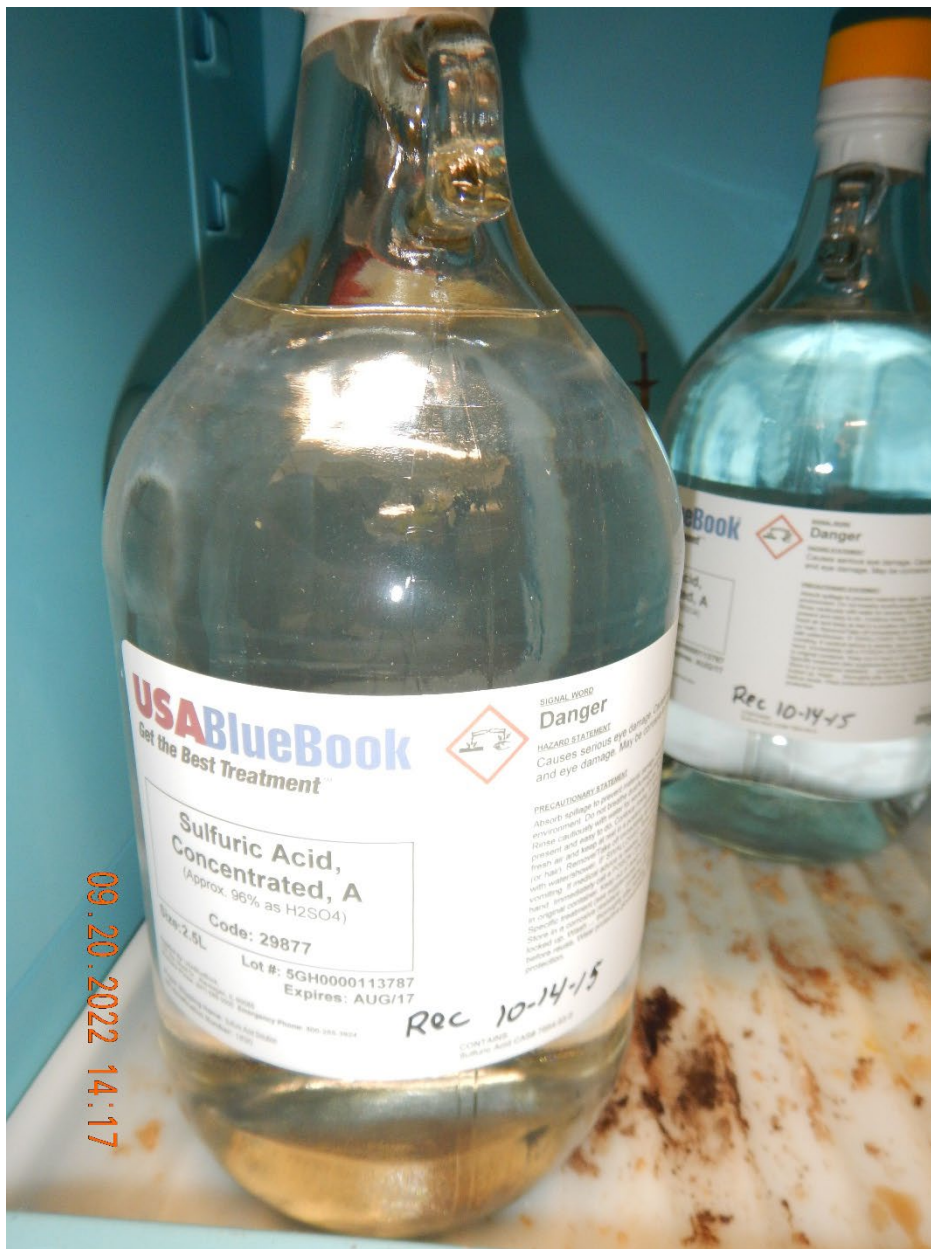
Photo No. 15

Three bottles of expired concentrated sulfuric acid were found in the acids and corrosives storage cabinet.

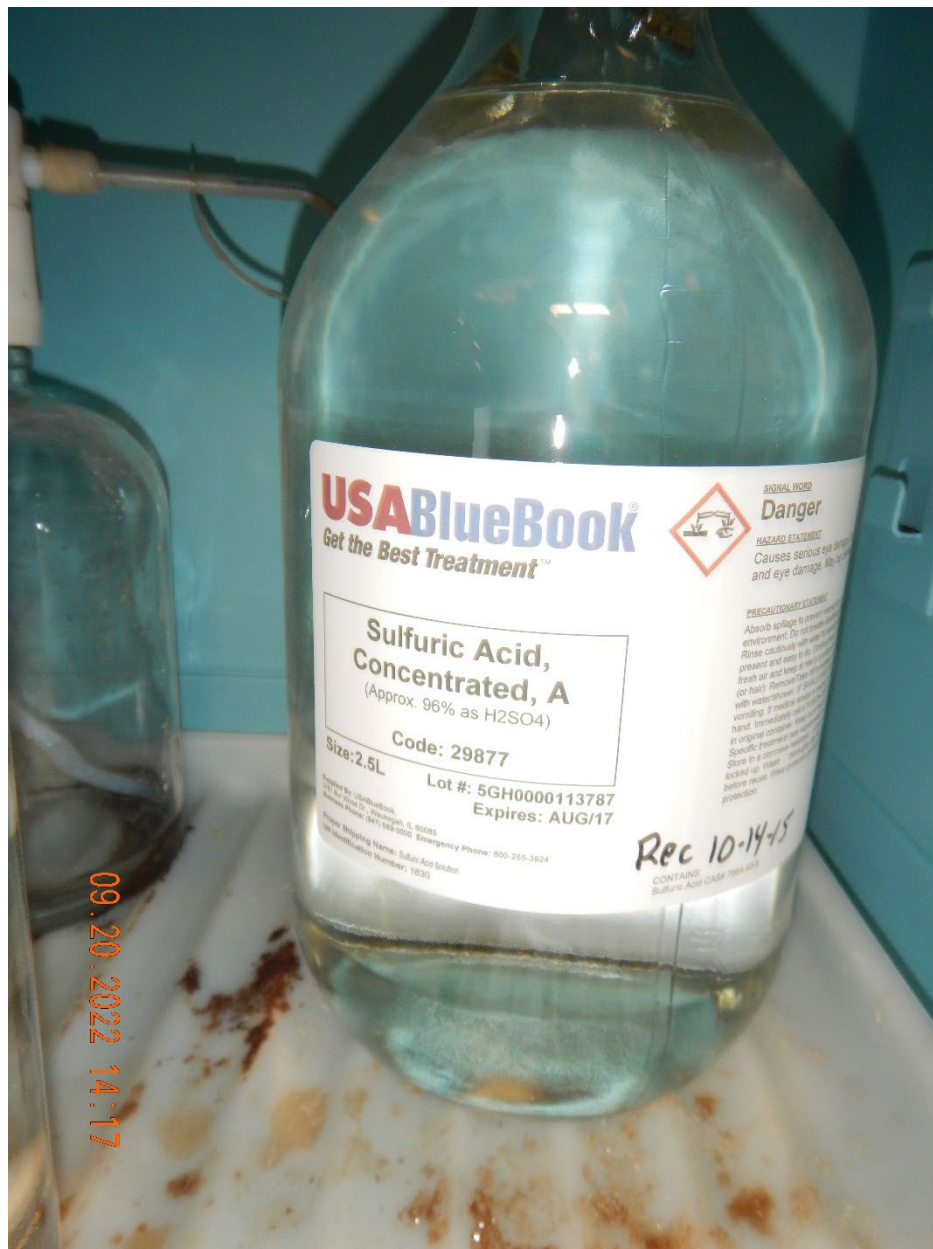
Photo No. 16

Three bottles of expired concentrated sulfuric acid were found in the acids and corrosives storage cabinet.

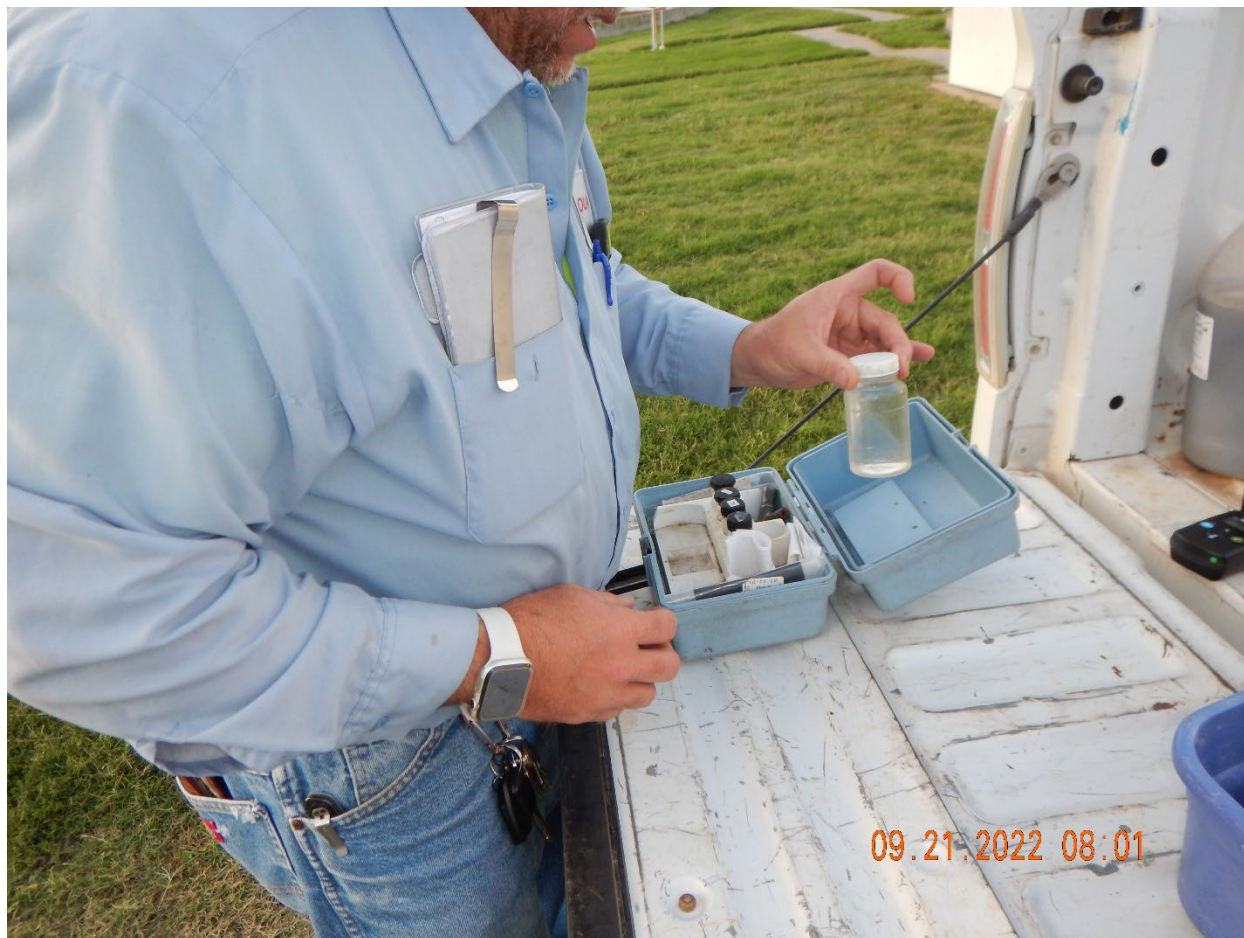
- i. See Appendix 1 Photographs (19 – 20)
  - c. Operator was observed collecting effluent grab sample and performing the Free Chlorine test without using gloves.

Operator was observed collecting an effluent grab sample and performing the Free Chlorine test without using gloves.

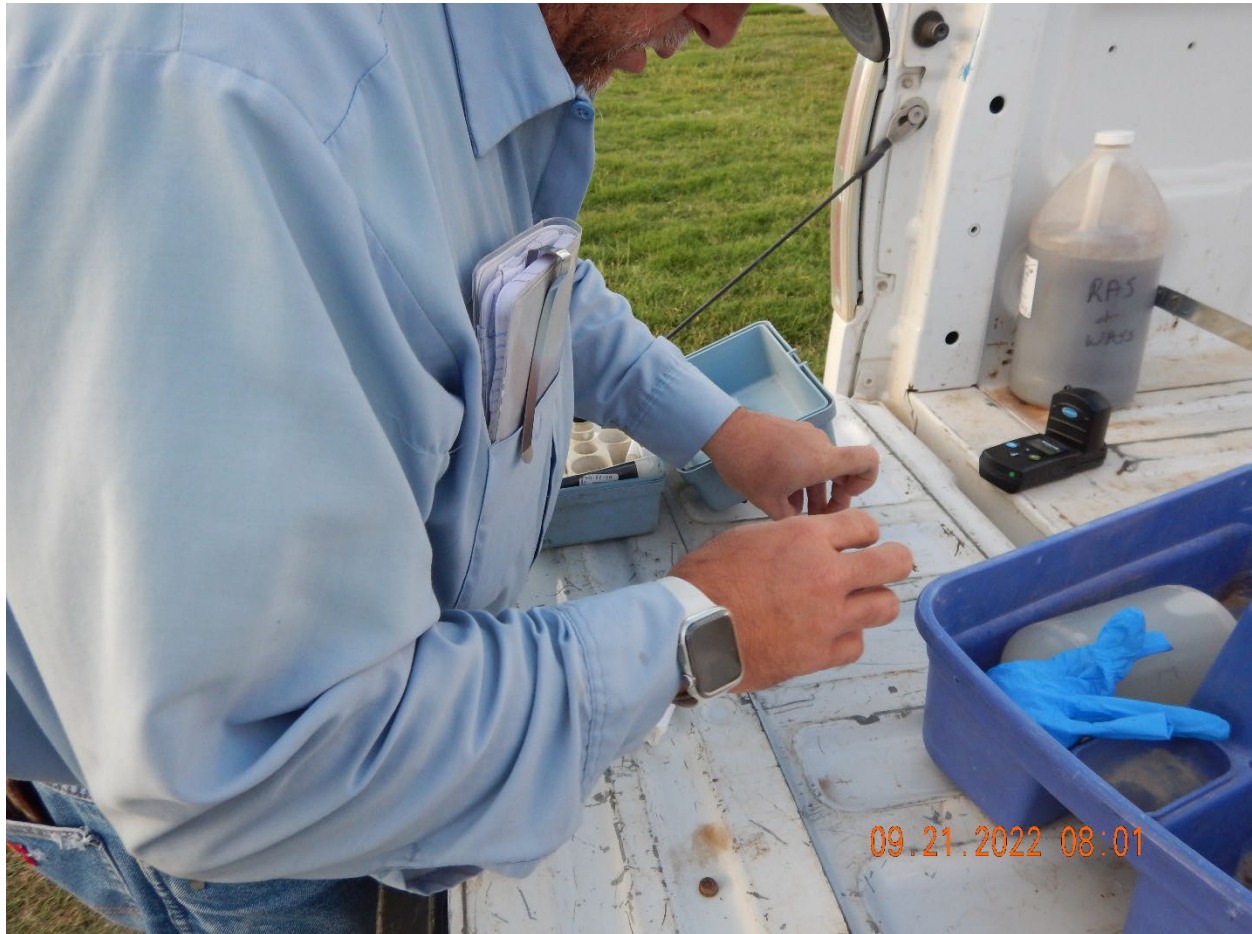
Operator was observed collecting an effluent grab sample and performing the Free Chlorine test without using gloves.
