## RCRA Compliance Evaluation Inspection Report

Indorama Ventures Xylenes & PTA LLC  
1401 Finley Island Road  
Decatur, Alabama 35601  
EPA ID Number: ALD002985554  
Website: www.indoramaventures.com

June 30, 2021, 9:30 a.m.

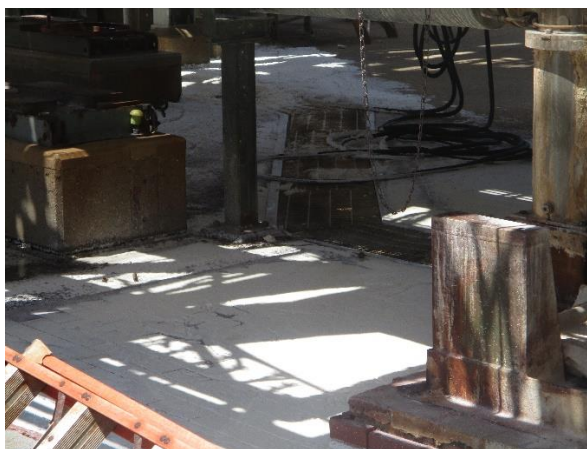
*Picture 1: PTA Unit #5*

During the inspection, the inspectors observed white powdery material covering the floor of the production area. Mr. Stone stated that the material is production material (PTA) and is nonhazardous. He also mentioned that the material on the floor is scheduled for removal and putting back in process (Picture-1).

In response to an additional follow-up regarding the cleanup of the white powdery material observed on the floor of the production area, Ms. McGee, Environmental Superintendent in an email response dated August 3, 2021 mentioned that the white powdery material observed during the inspection was located in the Mother Liquid Solids Separation (MLSS) Area. Maintenance was being performed on the MLSS system the day of the inspection which resulted in some of the PTA material being on the floor of the production area during the inspection. The material was later washed down to the onsite waste treatment system after the inspectors had left the area. IVXP continually works to reduce the production losses to the waste treatment system.

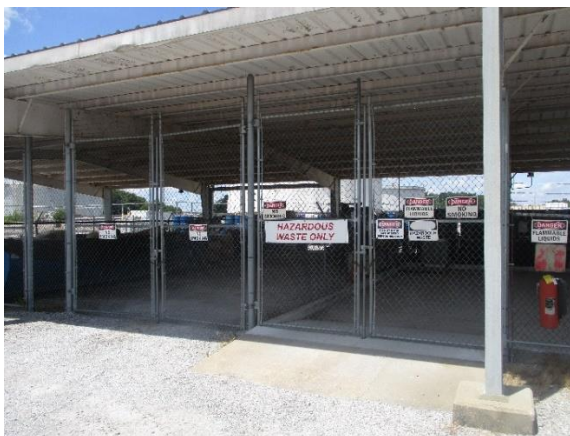
*Picture 2: Hazardous Waste Storage Area*

The hazardous waste storage area consisted of a roofed, stand-alone, open-sided structure for storing hazardous waste, non-hazardous waste, used oil, and universal waste. The area was enclosed with a locked fence. The area was separated into three sections; Used Oil, Hazardous Waste, and Ignitable Hazardous Waste. The inspectors observed a sign at the entrance indicating that it is a hazardous waste storage area and a warning sign as “danger” and “no smoking” (Picture-2). A logbook is maintained in the storage area to track the waste in storage. Mr. Stone retrieved the logbook while we were conducting the inspection so that it could be reviewed as part of the weekly storage logs. The logs were observed to be complete. No deficiencies were noted in the storage area.
