**Subj:** Inspection Report  
Clean Water Act - National Pollutant Discharge Elimination  
System ("NPDES")  
Warner Village Water District WWTF

# Inspection Photo Album

Facility: Warner Village Wastewater Treatment Facility

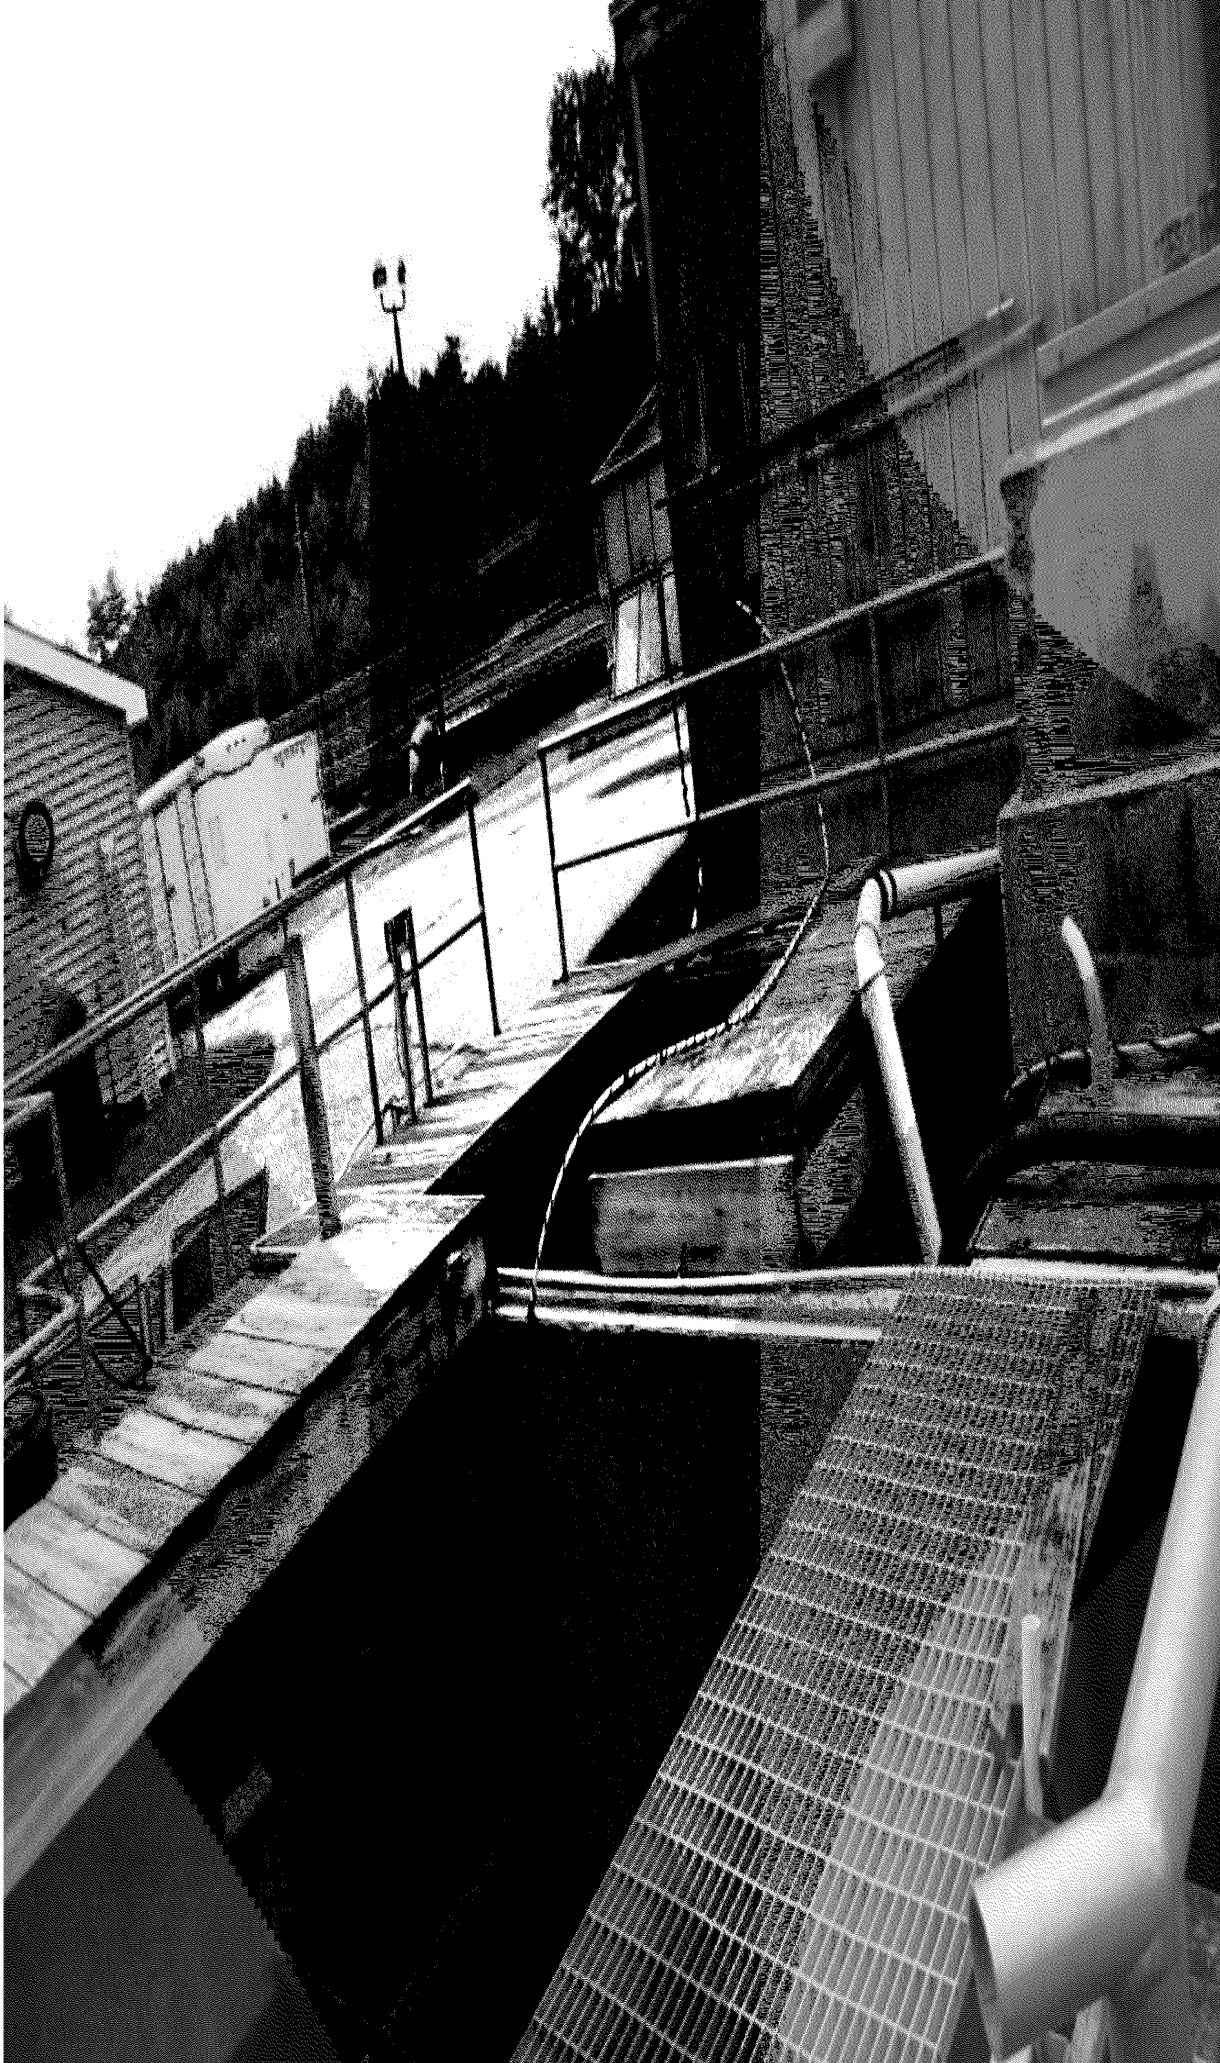
After this, the wastewater flows to the chlorine contact chamber (slide 9), where it is in contact with liquid chlorine for about thirty minutes and dechlorinated via sodium bisulfite. Effluent that is discharged to the groundwater test site passes through a screen to remove grease and oil and is then pumped via a temporary pipe (slide 10, 11) to the discharge site on the property. A flow meter monitors the amount of effluent that is directed to the groundwater test site. An overflow pipe in the contact chamber carries excess treated effluent to the outfall and is discharged directly into the Warner River (slide 10).

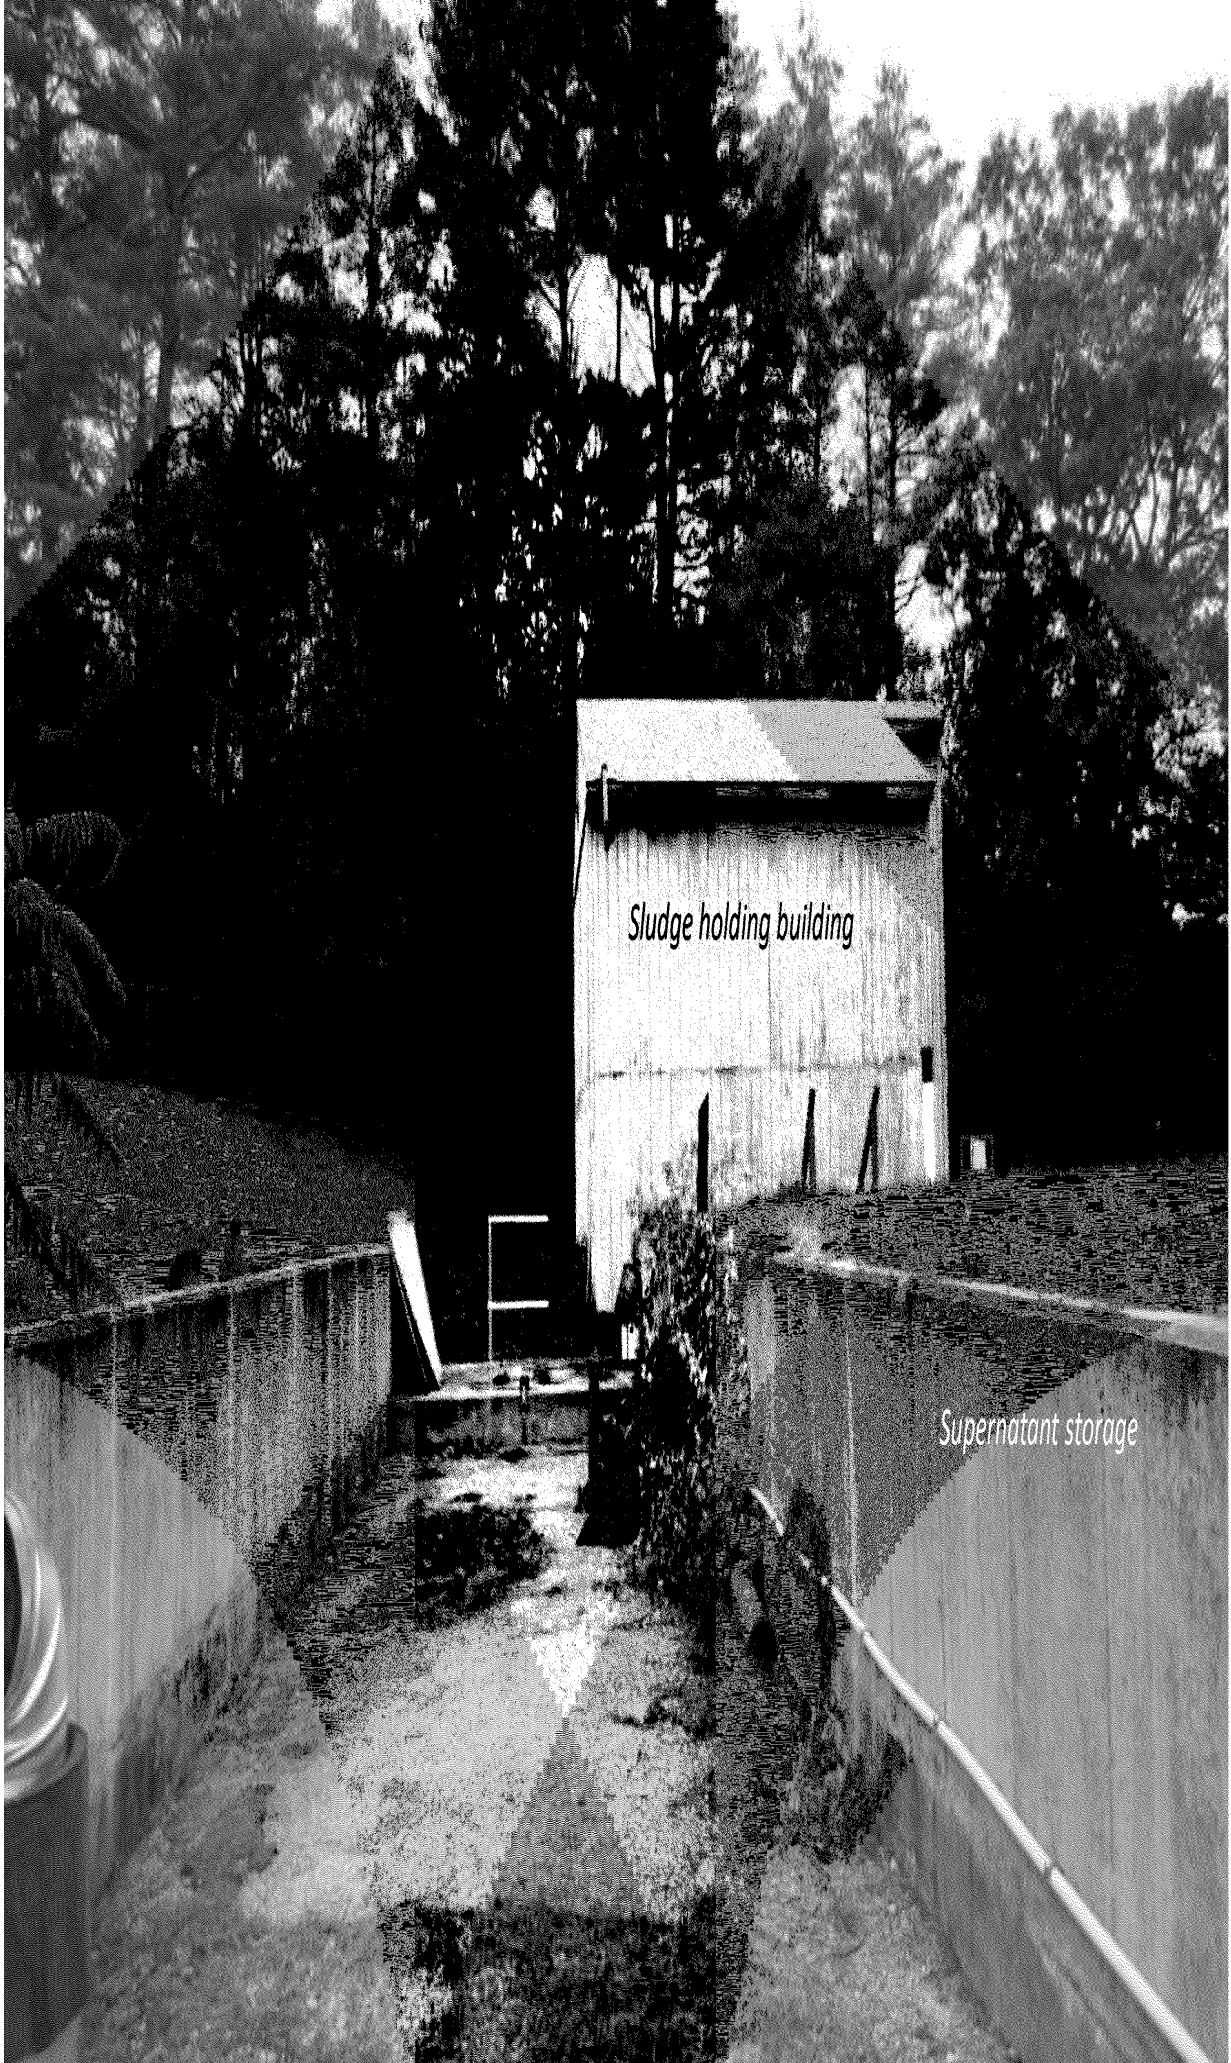
Sludge is stored in a building on-site, and the supernatant is stored in tanks below a grass cover (slide 12). Sludge is pumped into receiving trucks via a pump structure near the

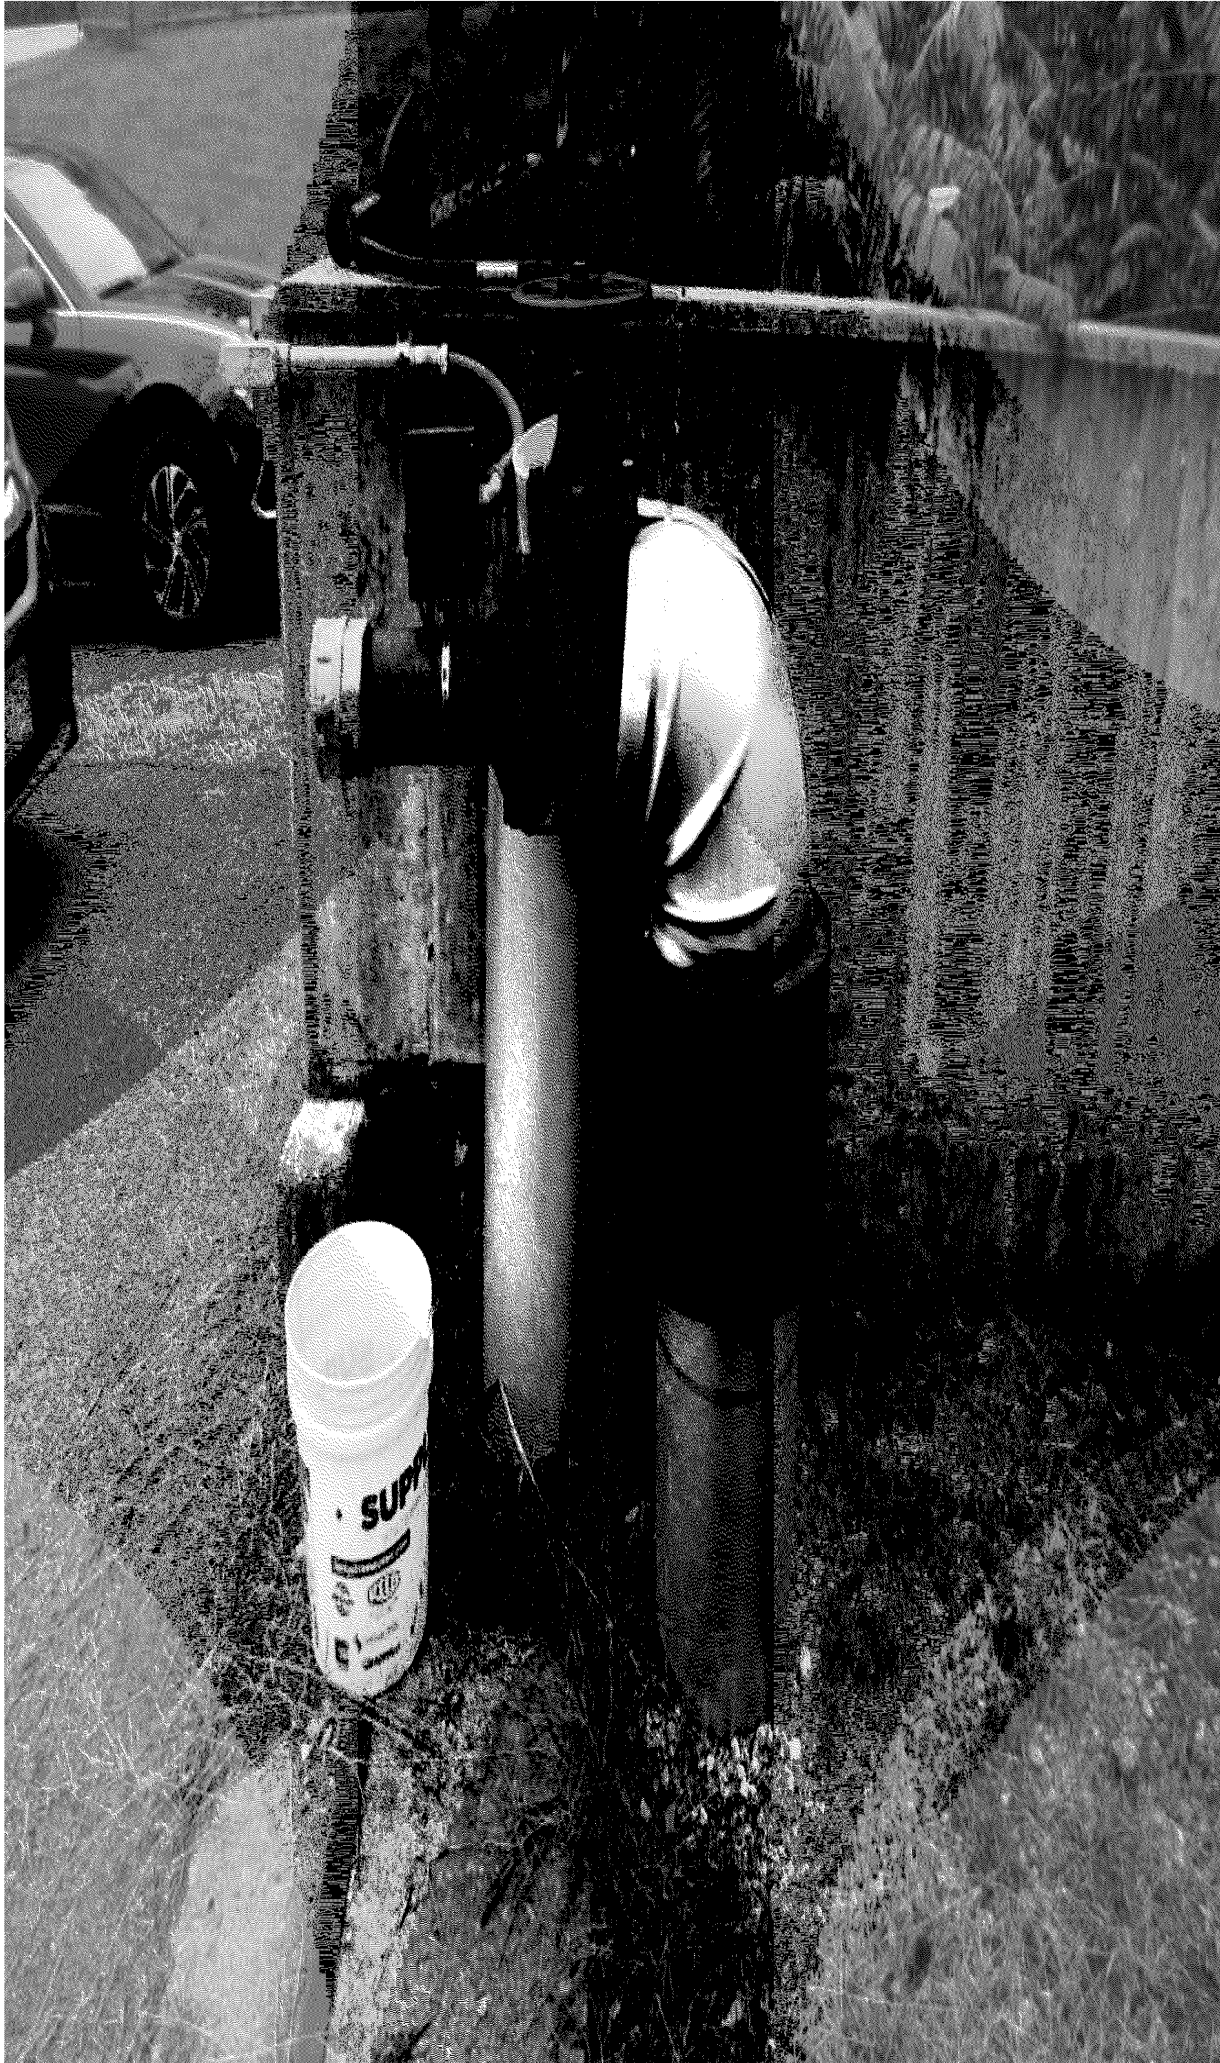
Facility parking lot (slide 13). Sludge from the Facility is sent to the Concord WWTF about twice per month.

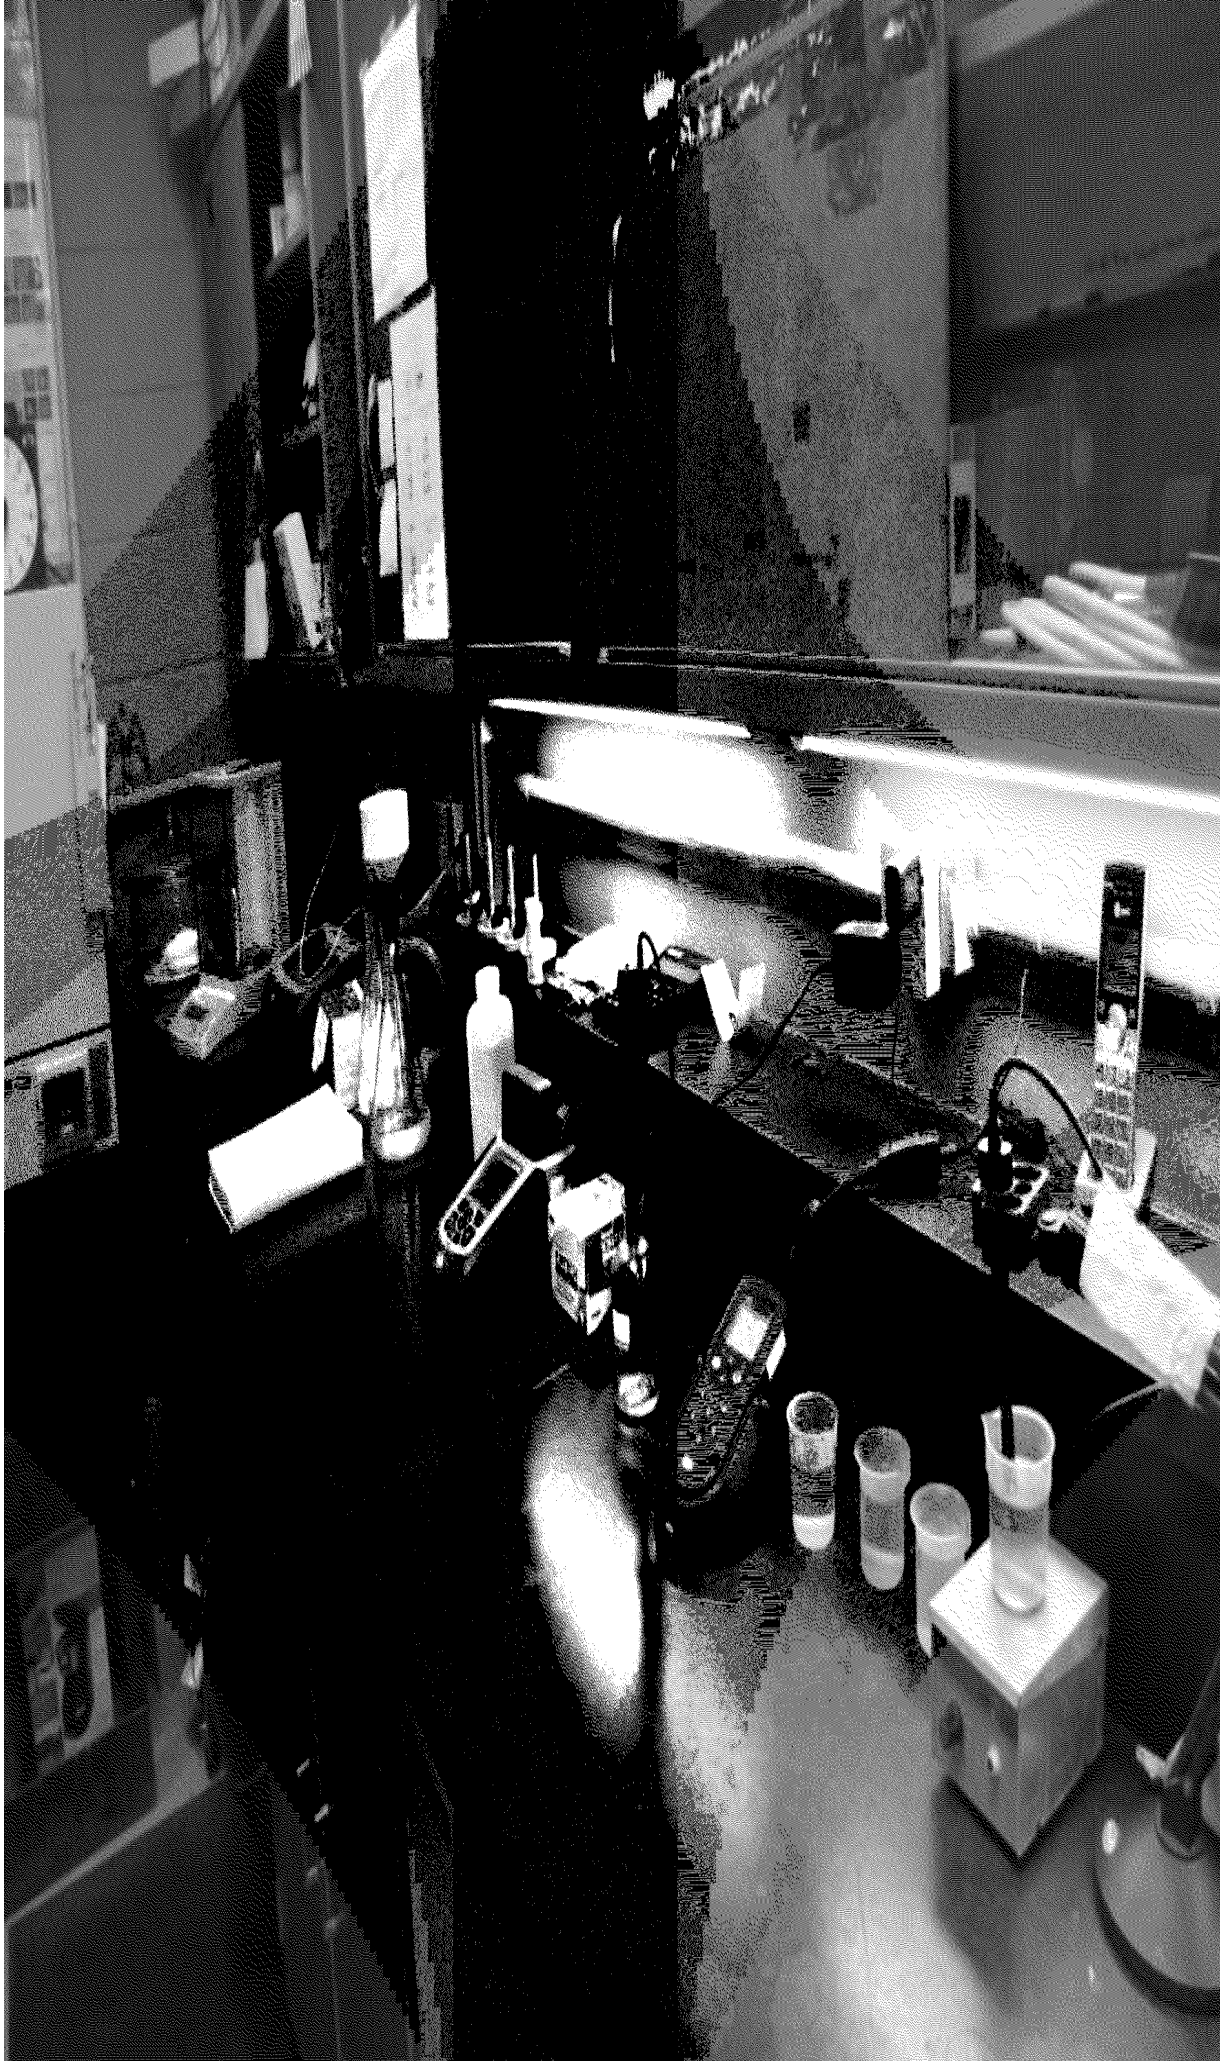
Finally, the group entered the in-house laboratory (slide 14), where Mr. Come conducts testing for pH, residual chlorine, dissolved oxygen (DO), and process control. All other testing is conducted by a third-party laboratory, Eastern Analytical.
