## RCRA Compliance Evaluation Inspection Report

Jones Chemical, Incorporated (JCI)  
1433 Talleyrand Avenue  
Jacksonville, Florida 33206-5435  
Latitude: 30.341440  
Longitude: -81.627370  
EPA ID Number: FLD004071890

December 15, 2021, 9:00 a.m.

**COMPLIANCE EVALUATION INSPECTION**

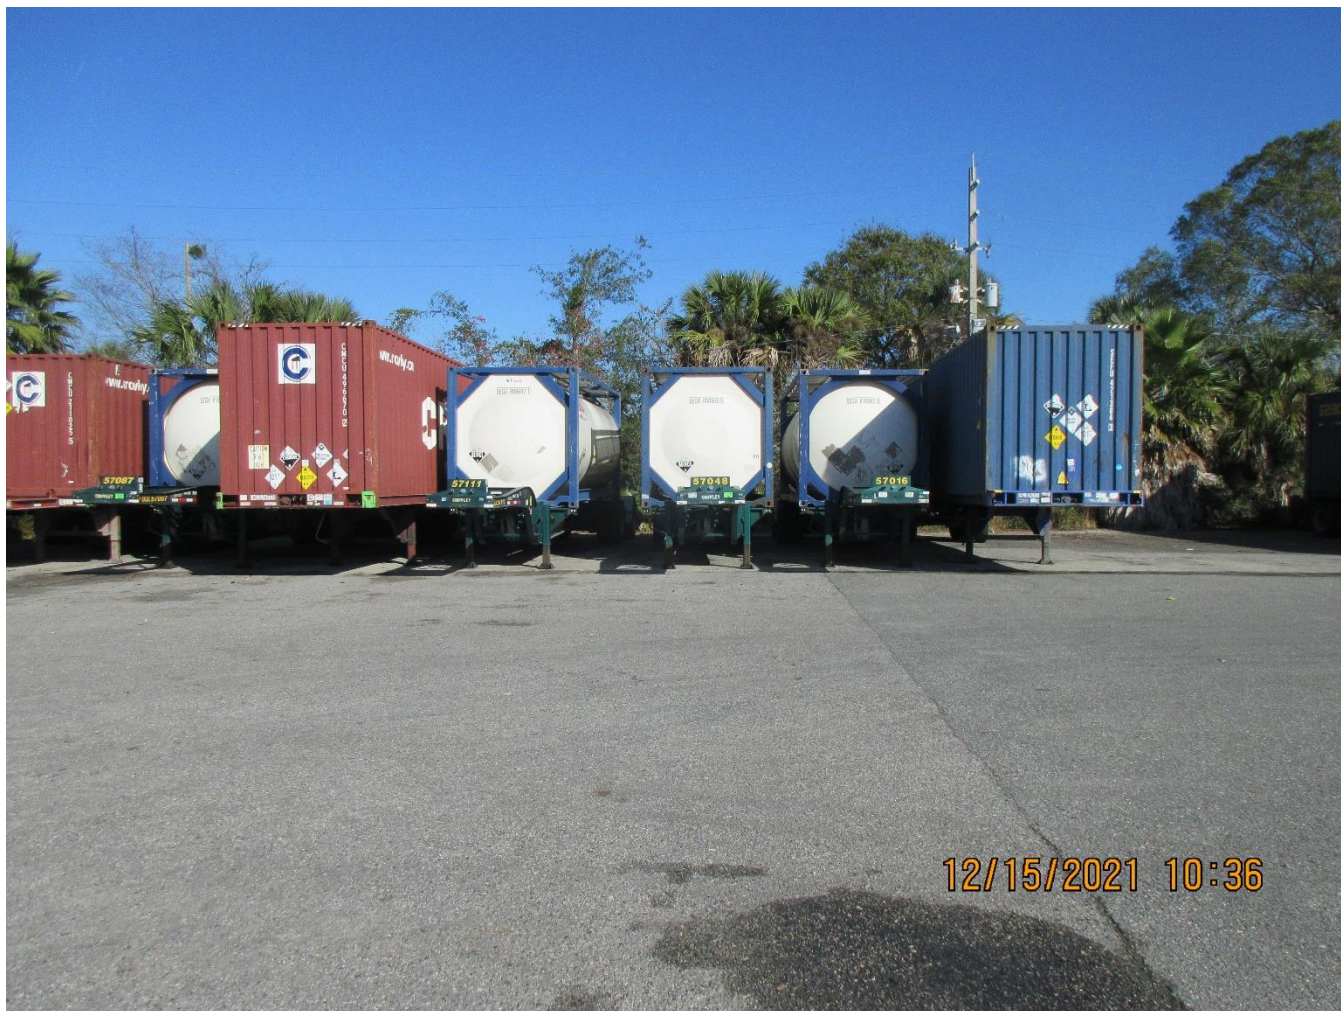
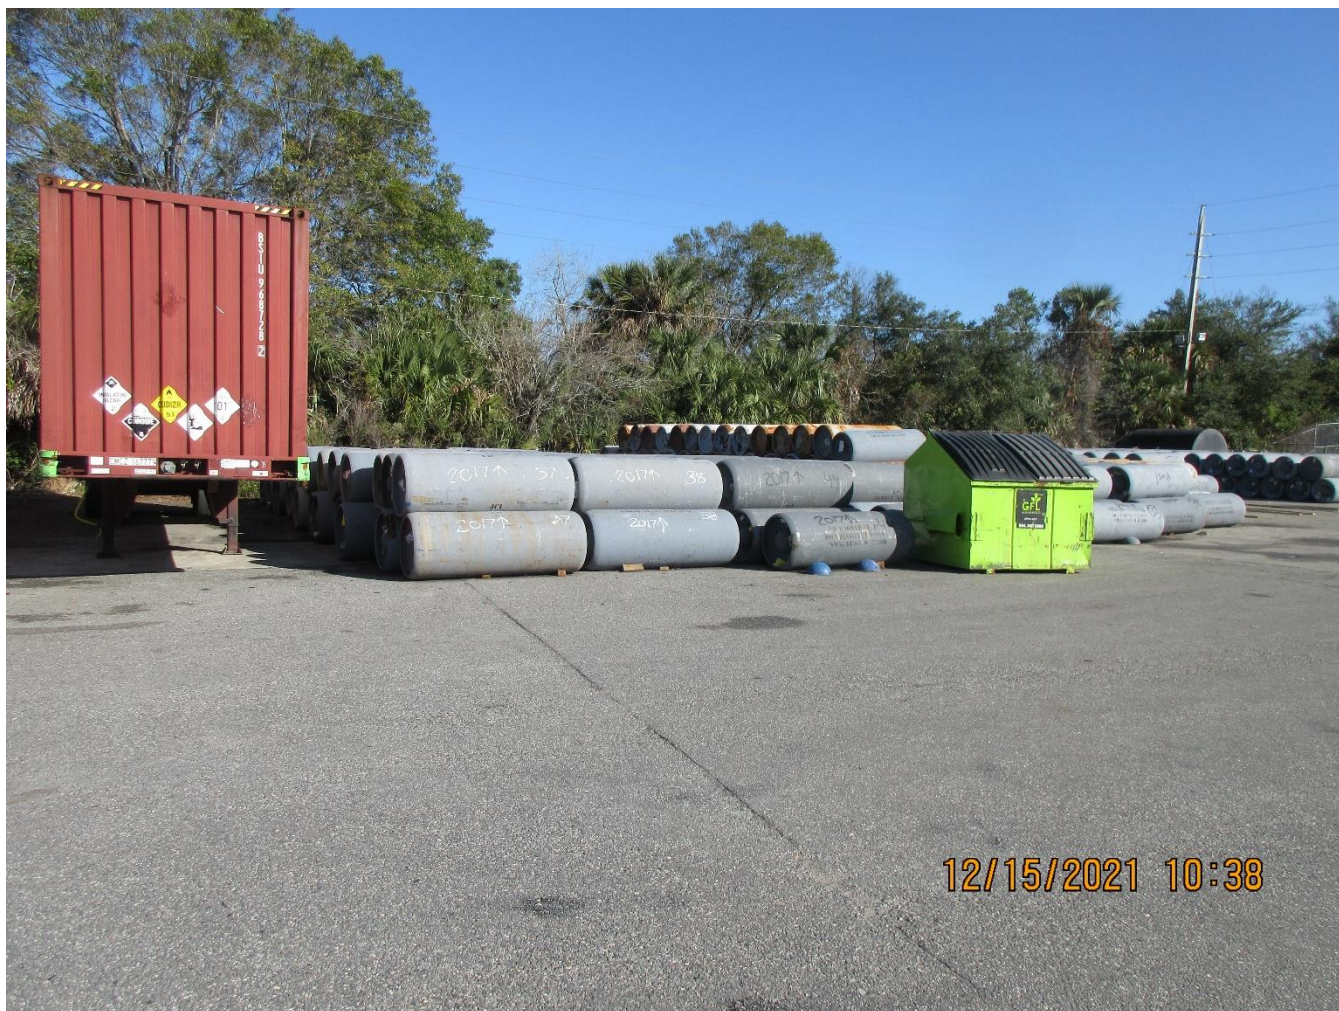
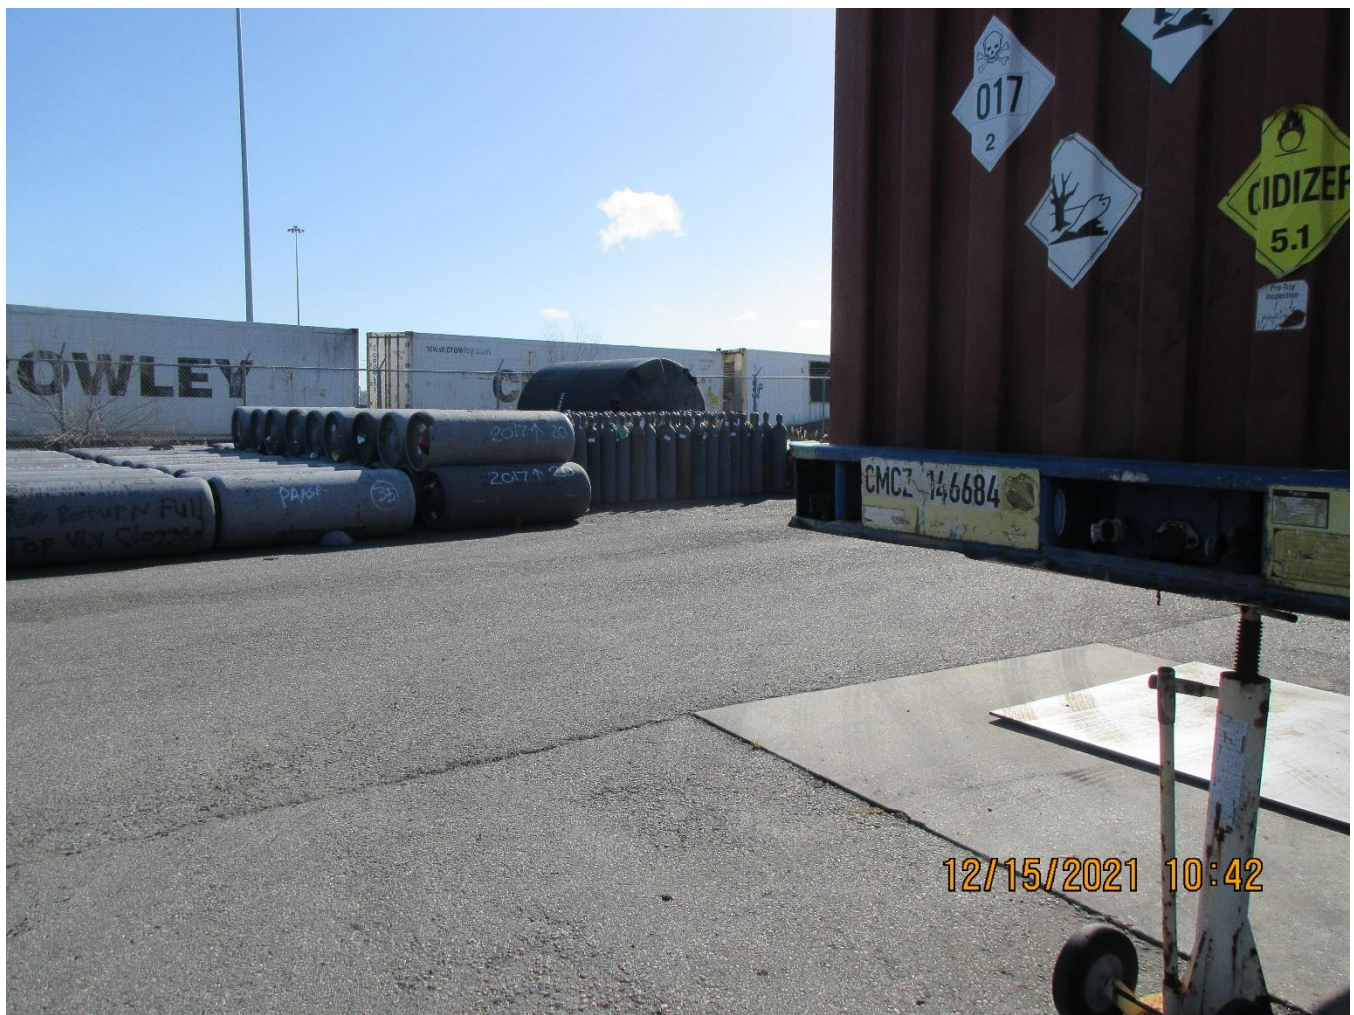
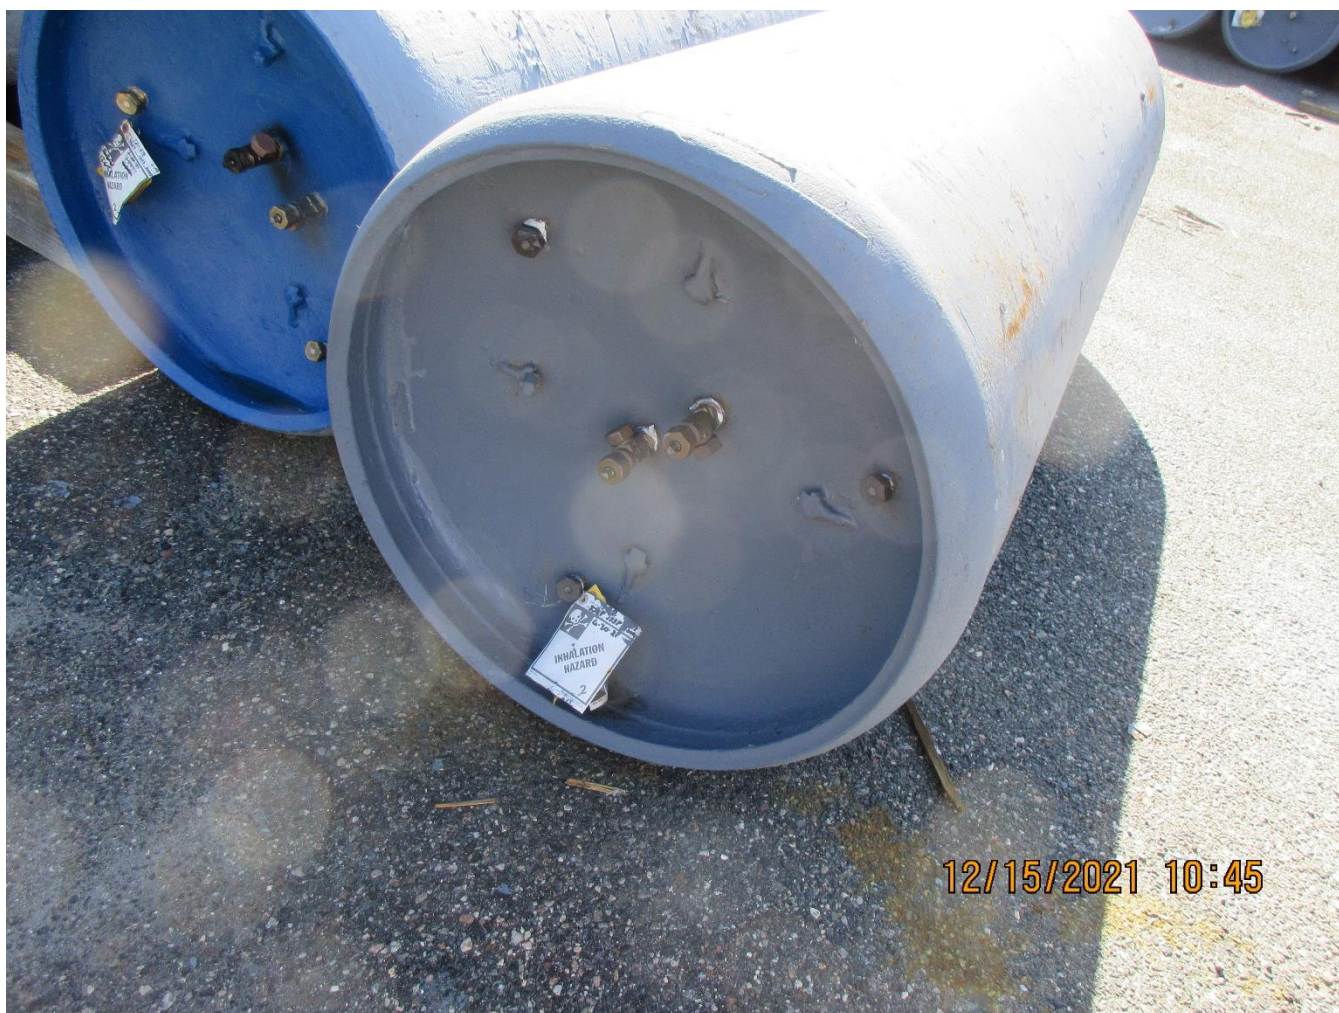
Cylinders (chlorine containers which manage 150-lbs of gas), Tons (chlorine containers which manage one ton of chlorine gas), and other equipment are stored in the outside area of the facility buildings. No wastes were observed in this area (Photos 1-4)

Photo 1 – Outside Area

Photo 2 - Outside Area with ton container storage

Photo 3 - Outside Area with Ton and 150-pound container storage

Photo 4 – One Ton Container observed in the Outside Area

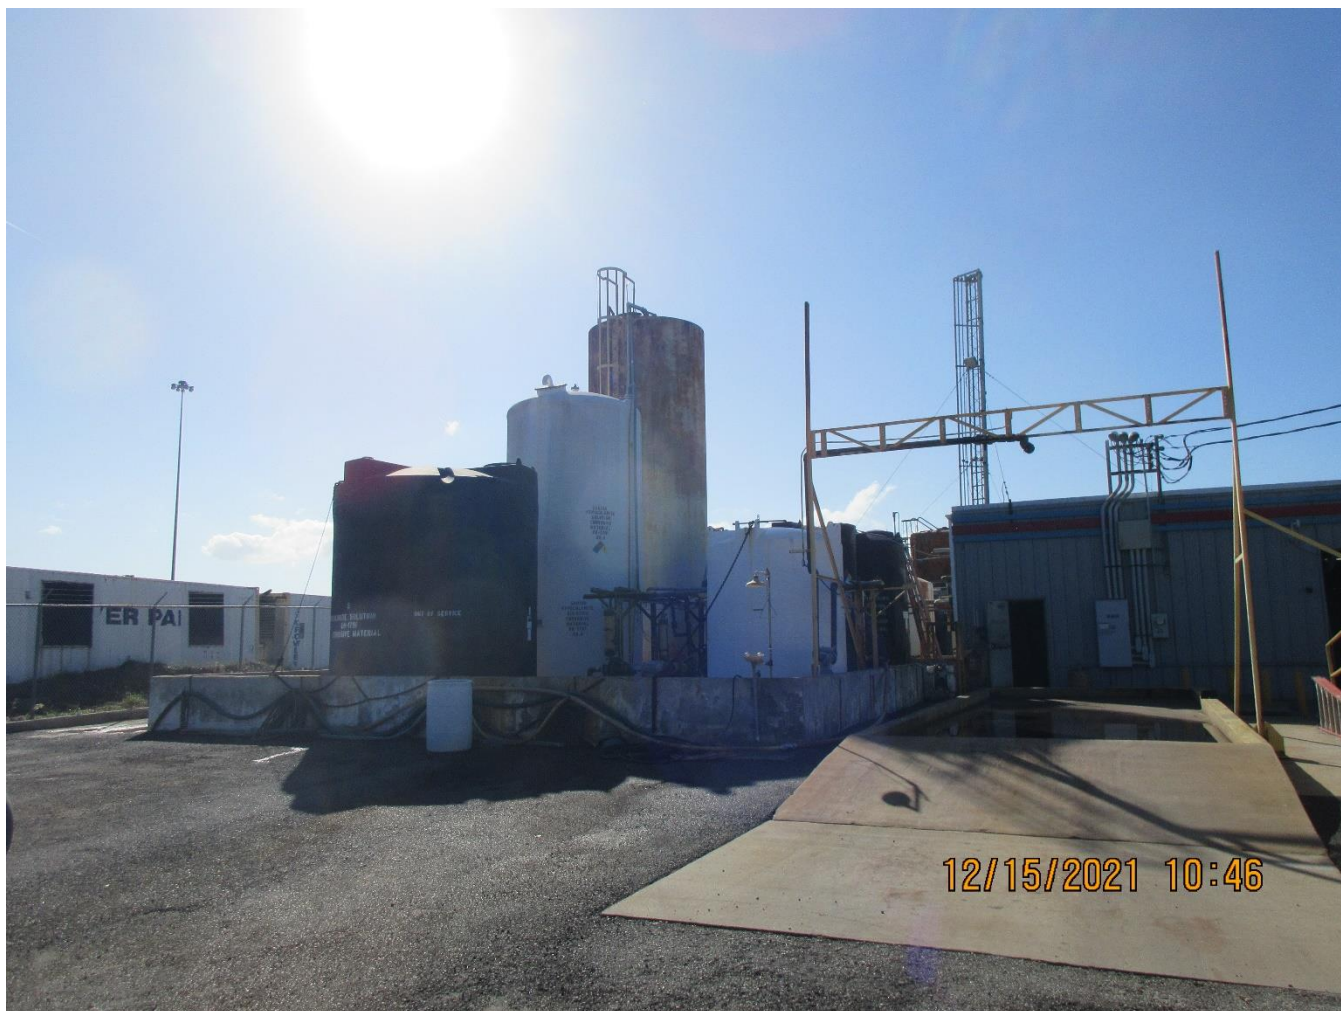
In the Bleach Manufacturing Area located in a tank farm (Photo 5), sodium hydroxide is diluted from 50% to 18%. Residual chlorine from the chlorine cylinders that are returned to the facility is pumped into the sodium hydroxide to form sodium hypochlorite bleach. Tanks 1 and 2 are used as bleach manufacturing tanks. The finished product bleach is placed into Tank 4. Adjacent to the bleach manufacturing area is the tanker truck load out area. This is where the facility loads and off-loads tanker trucks of caustic. Liquid within the secondary containment of the loading pad was sampled for pH at the time of the inspection and found to be nonhazardous with a pH of approximately 7.

Photo 5 – Tank farm and bleach manufacturing area

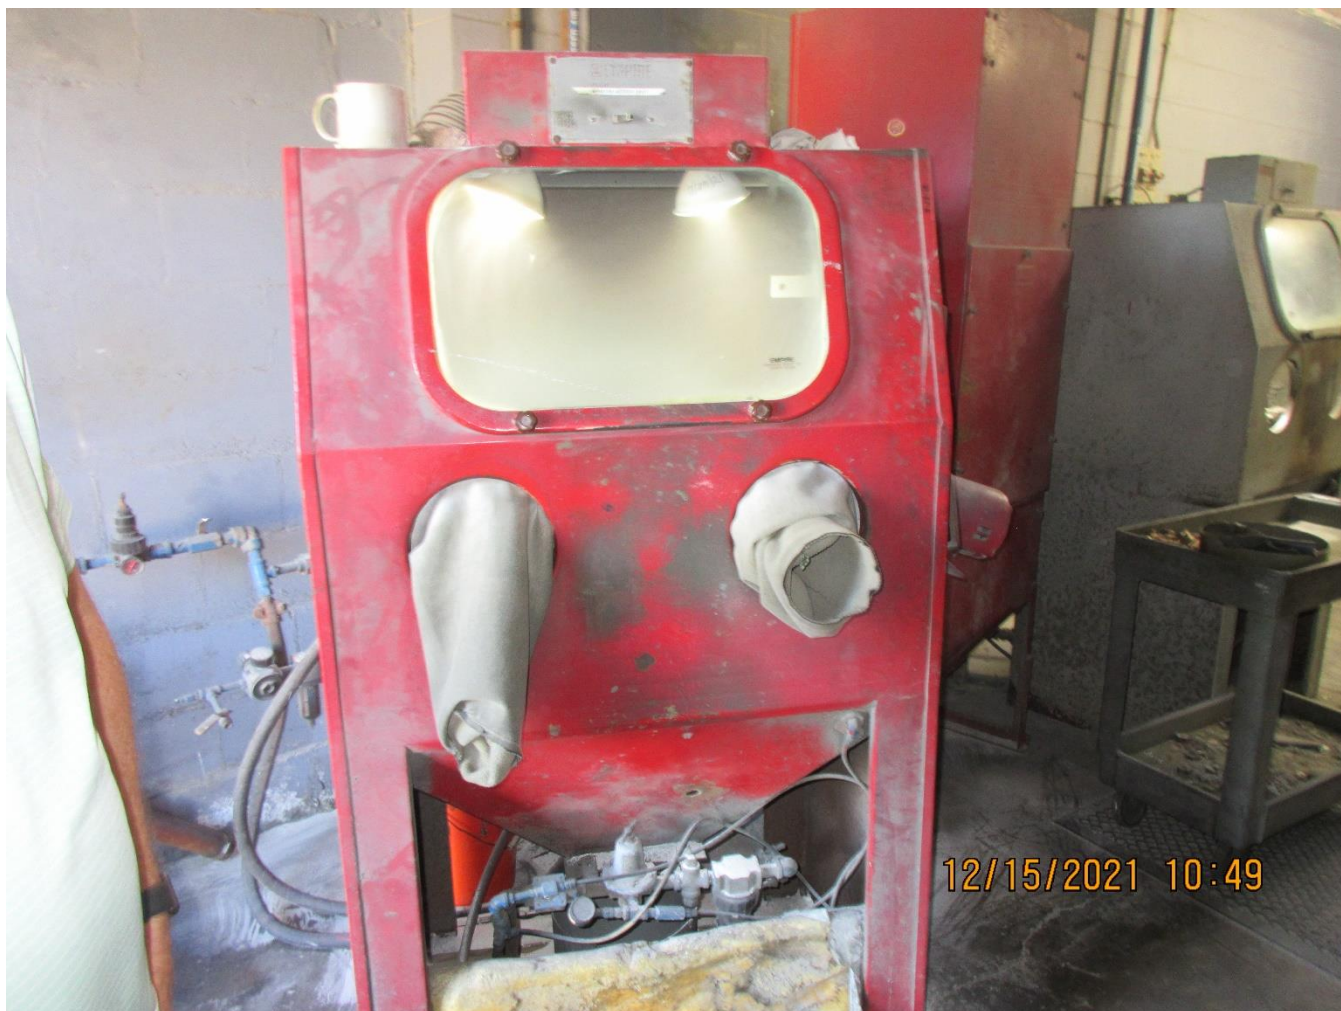
JCI removes and refurbishes cylinder valves that have been removed from the cylinders. The valves are blasted in a small glass-media blast unit (Photo 6) to remove corrosion resulting from the cylinders management of chlorine. The valves subsequently receive a reconditioned stem and new parts as necessary. The valves are then reassembled, tested, and taken back to the chlorine cylinder area to be placed on a cylinder. Waste glass blast media resulting from reconditioning the valves is managed as D006/D008 hazardous waste. The facility generates approximately one 55-gallon drum of this waste stream every six months to one year. There was one drum of this waste stream accumulating on-site at the time of the inspection (Photo 7). The drum was labeled with a "Hazardous Waste" label and closed at the time of the inspection. Spent glass media from the media blast machine is initially collected in a metal pail (Photo 8) positioned beneath the base of the machine under a port which allows spent media to be discharged. The pail is emptied at the end of each shift by personnel working in this area. Less than an inch of spent glass media blast waste was observed in the pail at the time of the inspection. **It was recommended that facility personnel put a "Hazardous waste" label on the pail to properly identify its contents.**

Photo 6 – Glass bead media blast unit

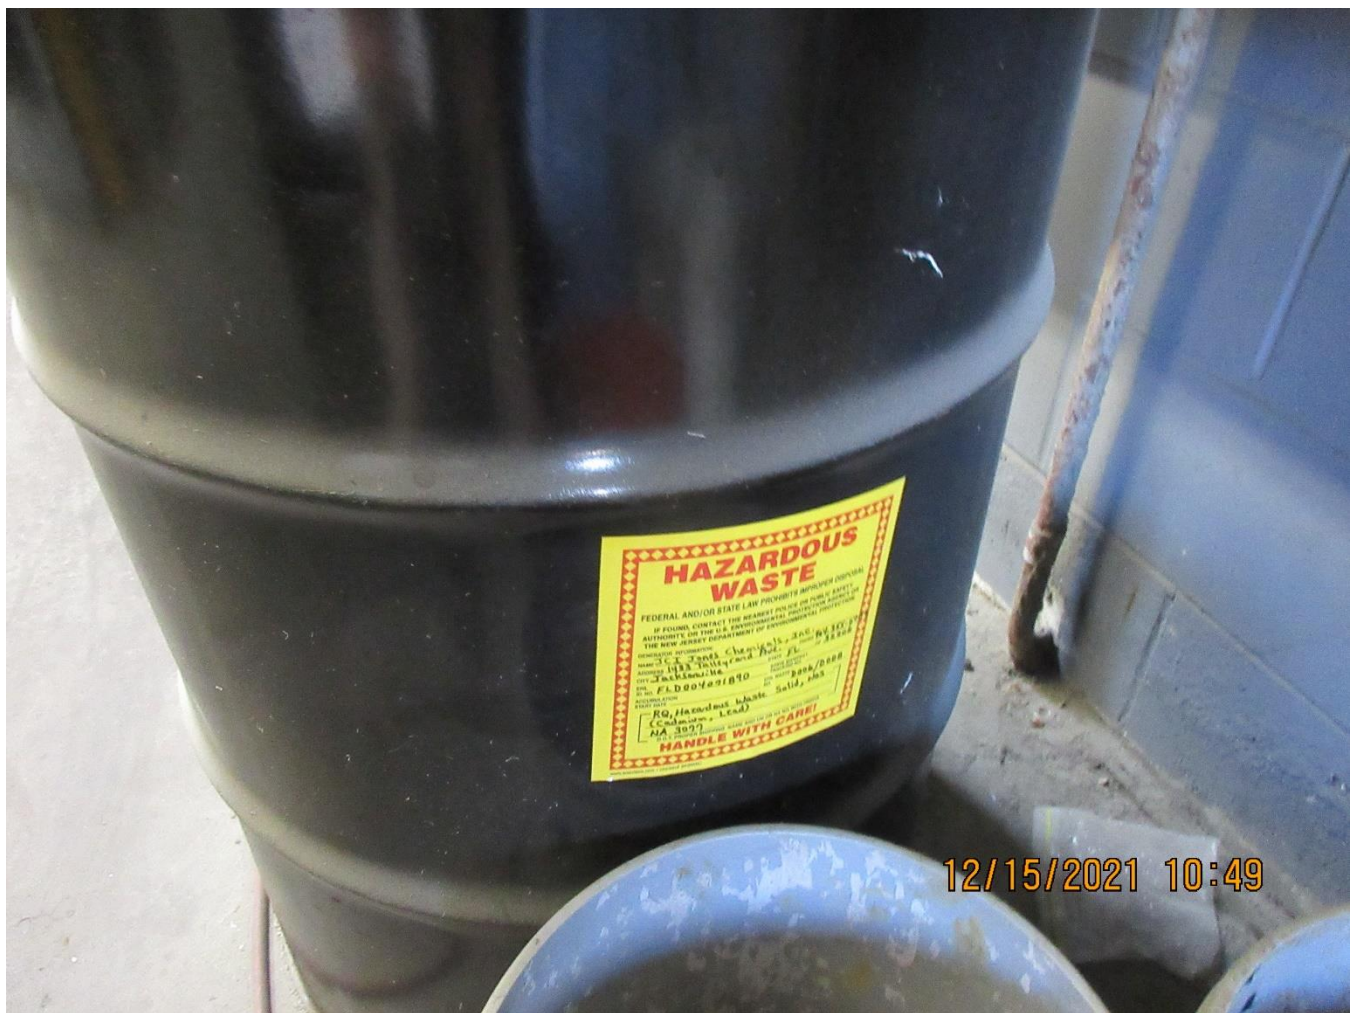
Photo 7 - Glass bead media blast unit hazardous waste container

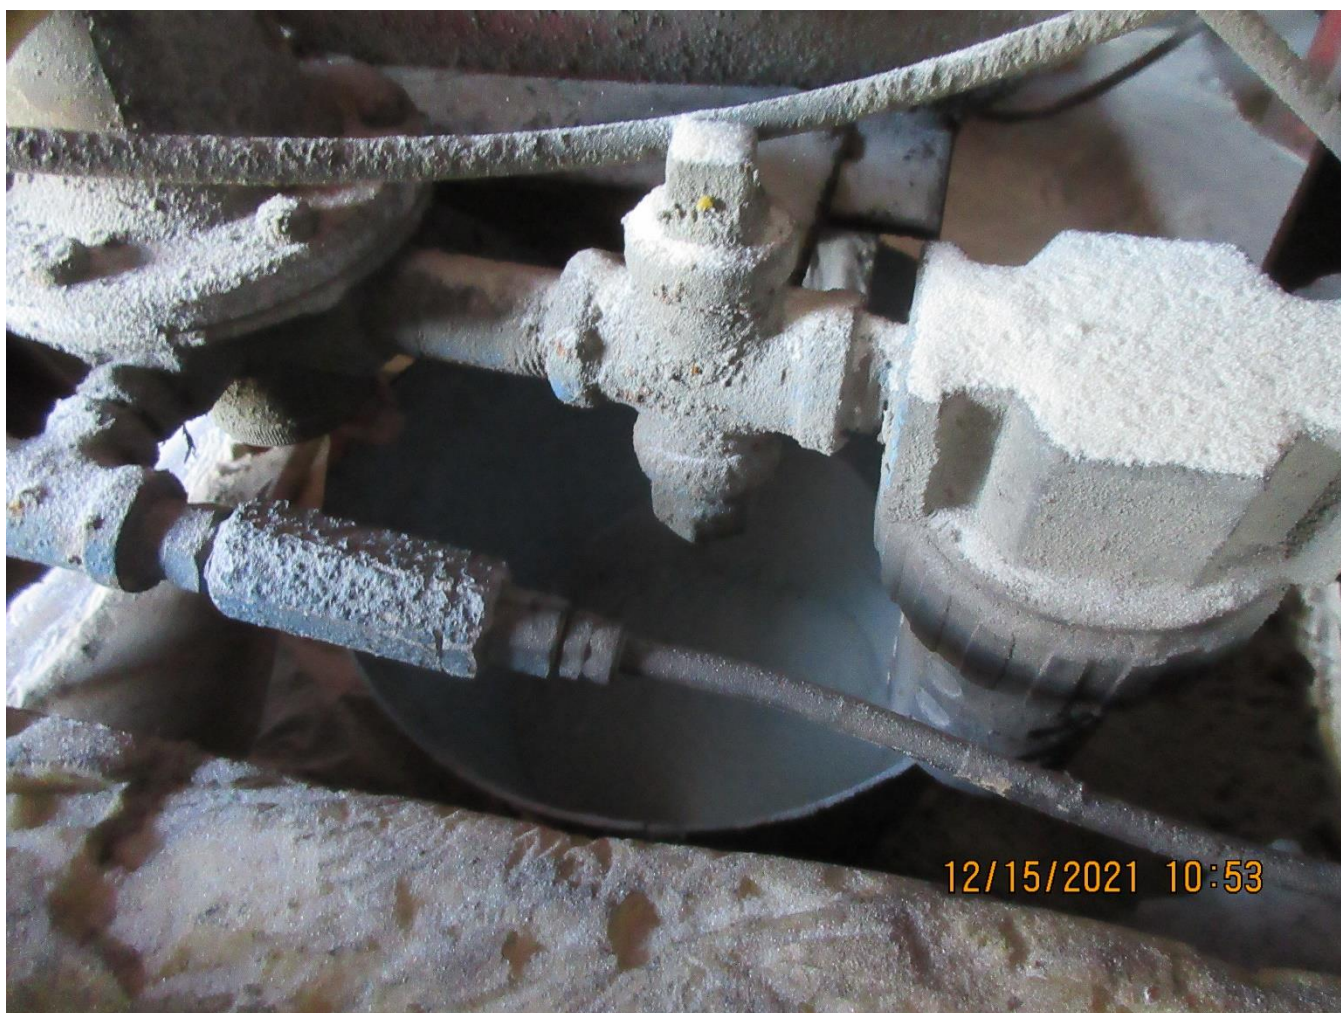
Photo 8 - Glass bead media blast unit

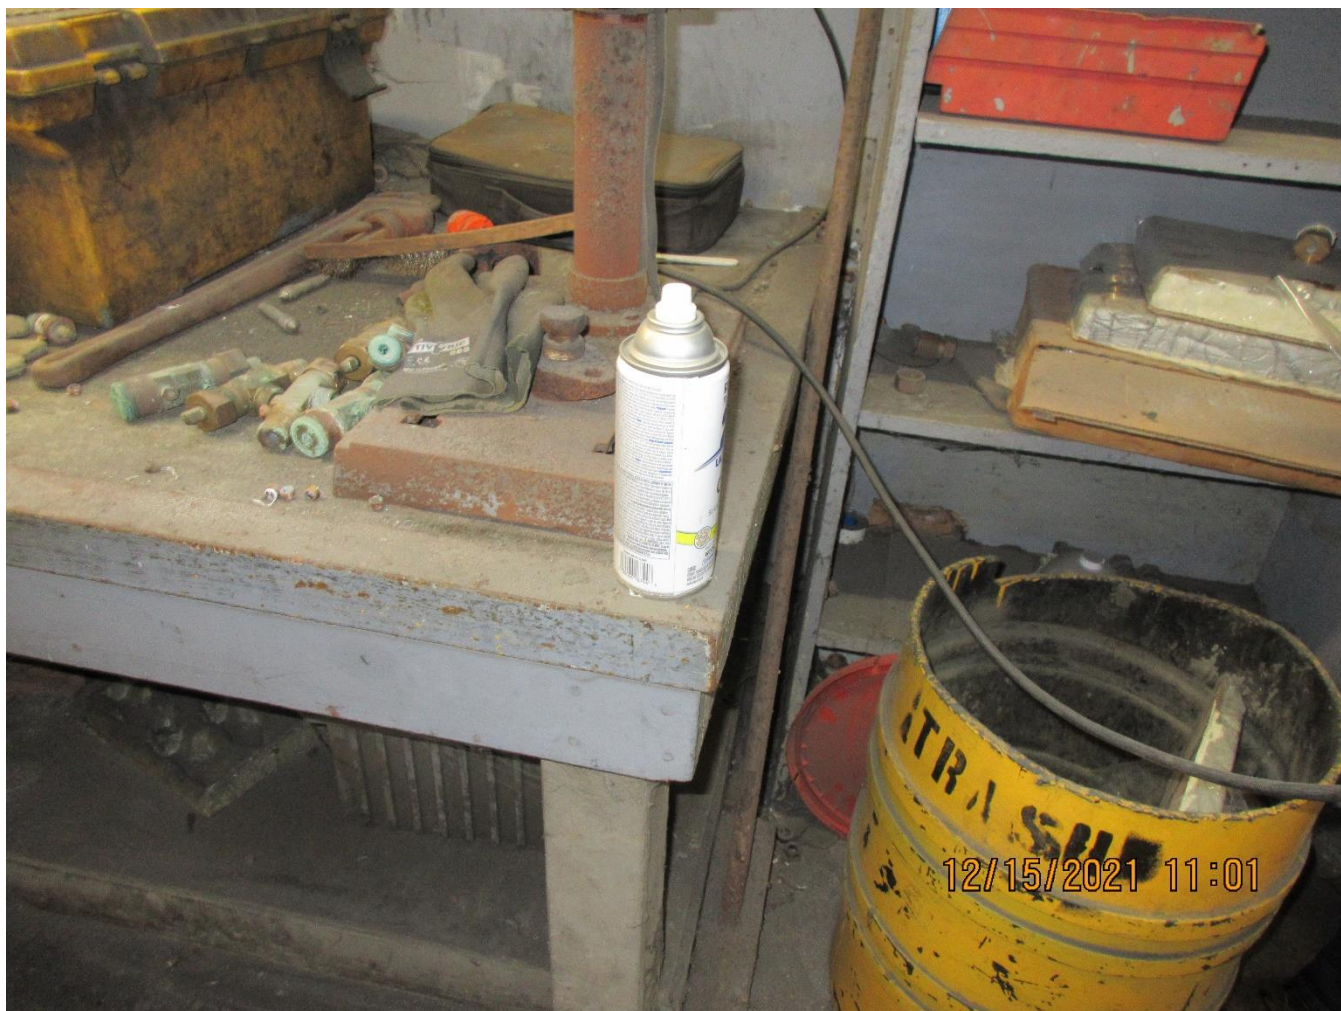
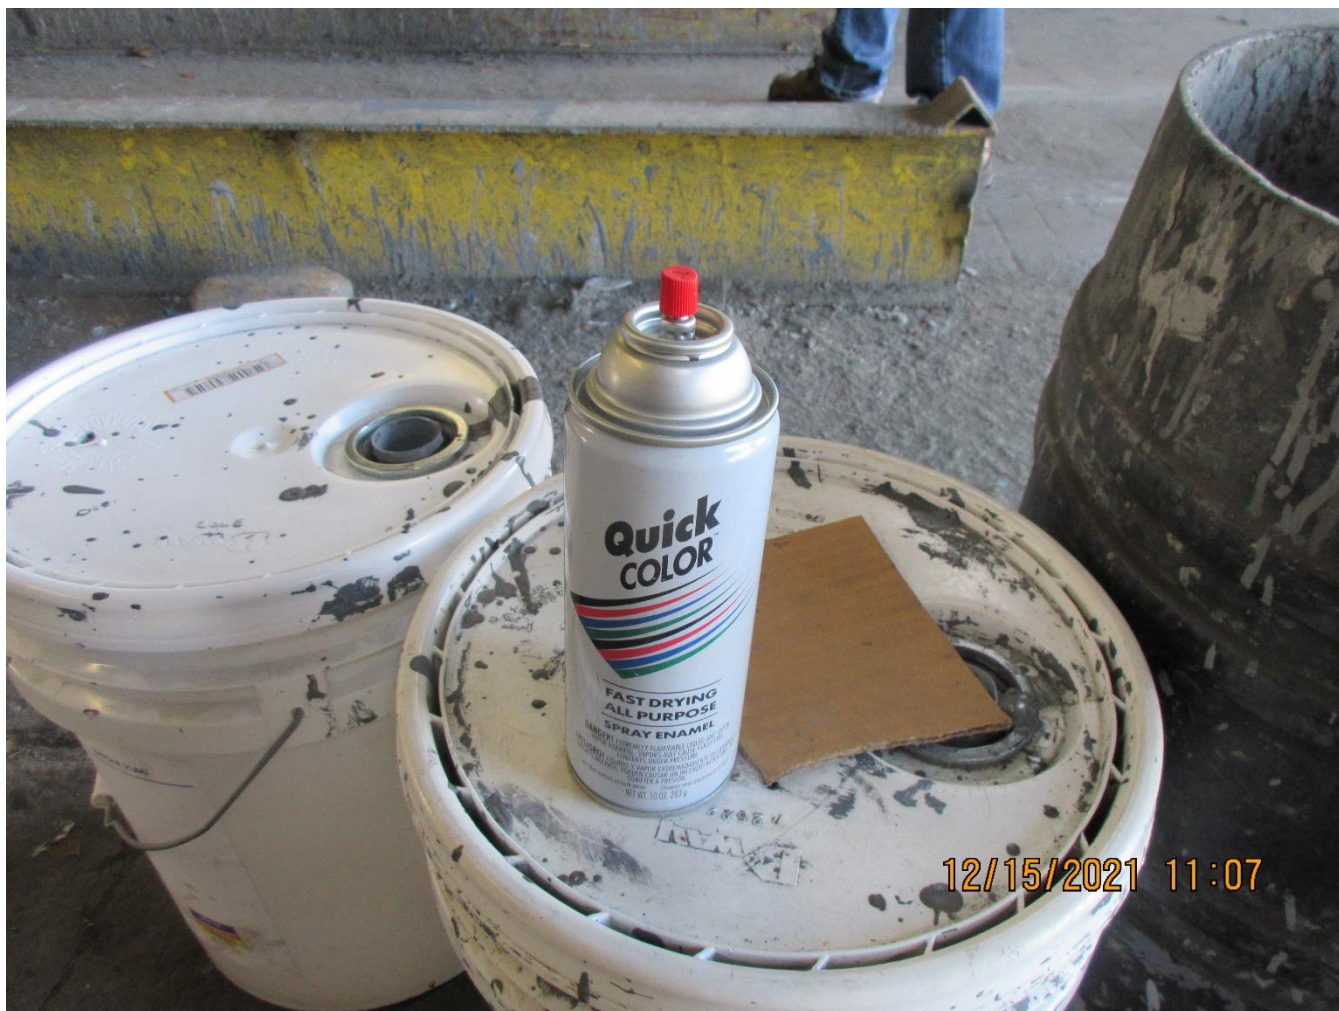
The facility repackages chlorine into Ton containers in this area. The volumes of the Ton containers is approximately 250 gallons. After chlorine is added to the Ton containers, they are subsequently painted with gray latex paint. The non-hazardous waste rollers are thrown into the trash when spent. The Tons may also be stenciled with ink (Photo 11) using rollers for identification purposes. Two types of black aerosol paint cans (Photos 9 and 10) were observed for use in this area for use in stenciling if the ink is not available. A clearcoat is sprayed over the ink or paint used for stenciling. Spent aerosol paint cans were observed within an open 55-gallon container used to collect trash which would be added to a solid waste dumpster on the facility property. One of the cans within the drum was not empty.

Photo 9 – Aerosol paint used by facility

Photo 10 - Aerosol paint used by facility

Mr. Solomon was advised that the paint cans, containing paint liquids, must not be placed into the facility's solid waste dumpster. The cans must be managed as Universal Waste or Hazardous Waste.

**Pursuant to Fla. Admin. Code Ann. r. 62-730.160(1) [40 C.F.R. § 262.14(a)(5)], provided a very small generator (VSG) meets all the conditions for exemption listed in this section, hazardous waste generated by the very small quantity generator is not subject to the requirements of parts 124, 262 (except §§ 262.10 through 262.14) through 268, and 270 of this chapter, and the notification requirements of section 3010 of RCRA and the very small quantity generator may accumulate hazardous waste on site without complying with such requirements. One of the conditions for exemption are as follows: (5) A very small quantity generator that accumulates hazardous waste in amounts less than or equal to the limits in paragraphs (a)(3) and (4) of this section must either treat or dispose of its hazardous waste in an on-site facility or ensure delivery to an off-site treatment, storage, or disposal facility.**

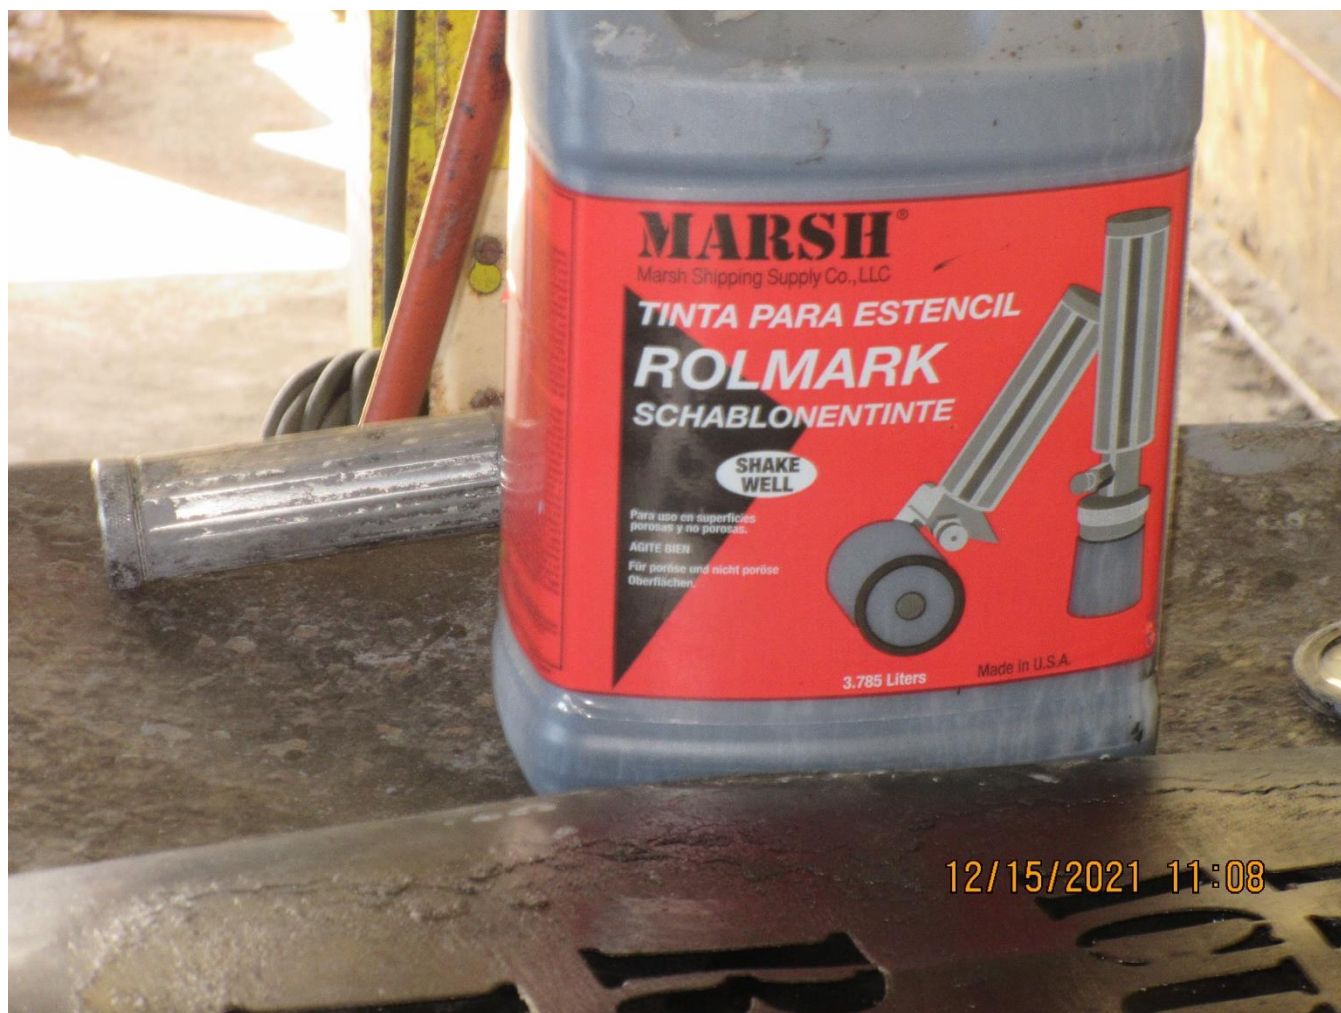
Photo 11 – Stencil Ink for Ton Containers of Chlorine

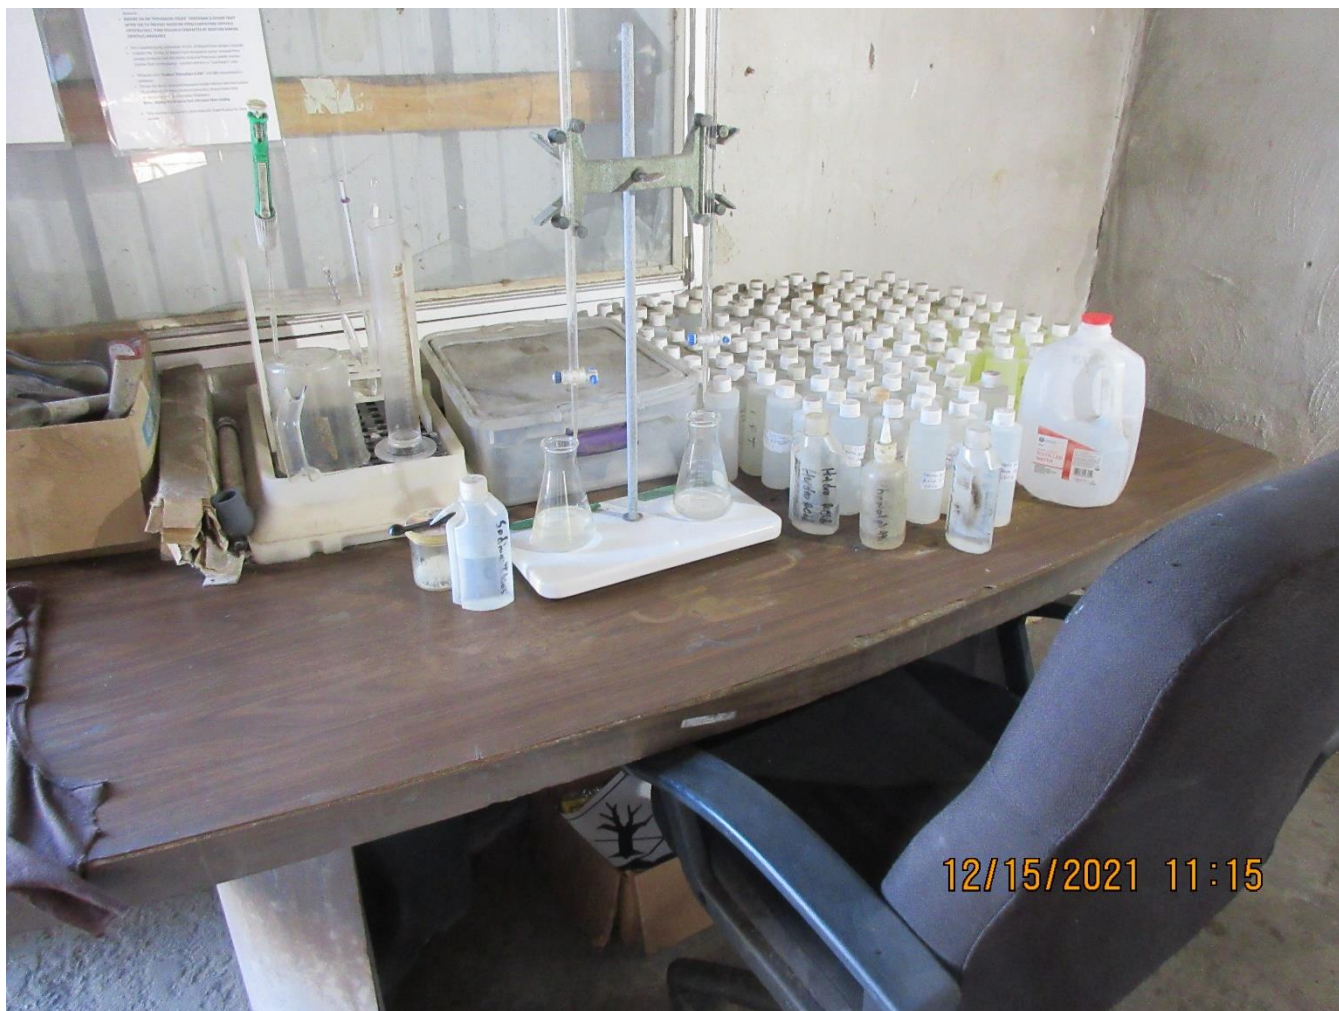
JCI maintains a small Quality Control Lab (Photo 12). Products are analyzed using titration tests to ensure the bleach is at the correct strength. The QC Lab uses acetic acid, sodium thiosulfate, potassium iodide and hydrogen peroxide in small amounts to check the manufactured bleach. After analysis QC samples are added back into the manufacturing process. No hazardous waste is generated in this area.

Photo 12 – QC Lab Area

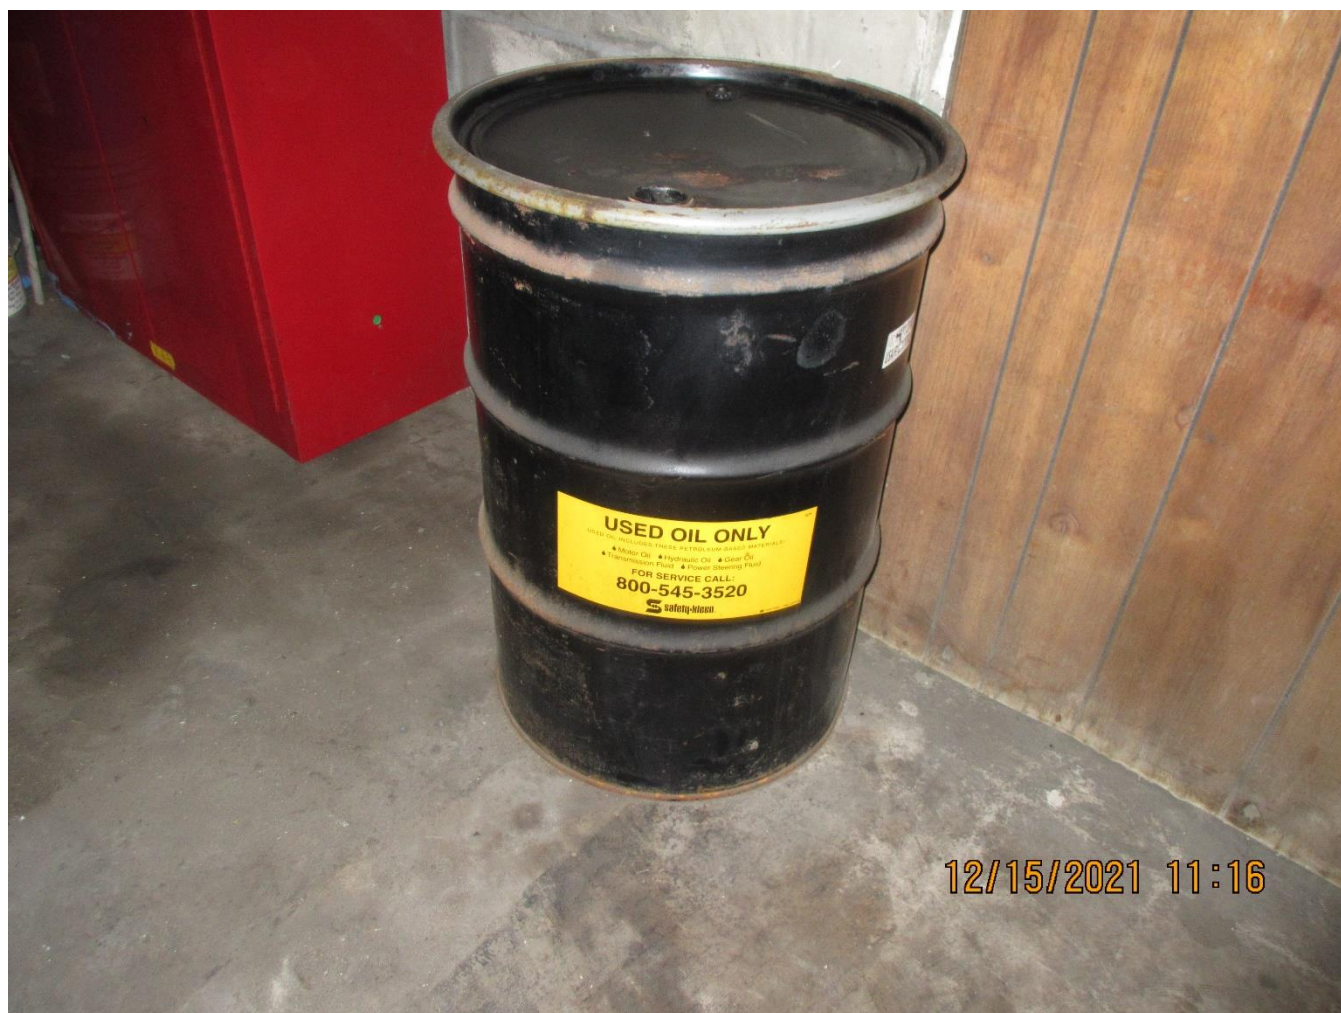
One drum of used oil was also observed in this room (Photo 13). The drum was labeled with the words "Used Oil."

Photo 13 – Used oil from condenser blowdown
