## RCRA Compliance Evaluation Inspection Report

Jones Chemical, Incorporated (JCI)  
1433 Talleyrand Avenue  
Jacksonville, Florida 33206-5435  
Latitude: 30.341440  
Longitude: -81.627370  
EPA ID Number: FLD004071890

December 15, 2021, 9:00 a.m.

**COMPLIANCE EVALUATION INSPECTION**

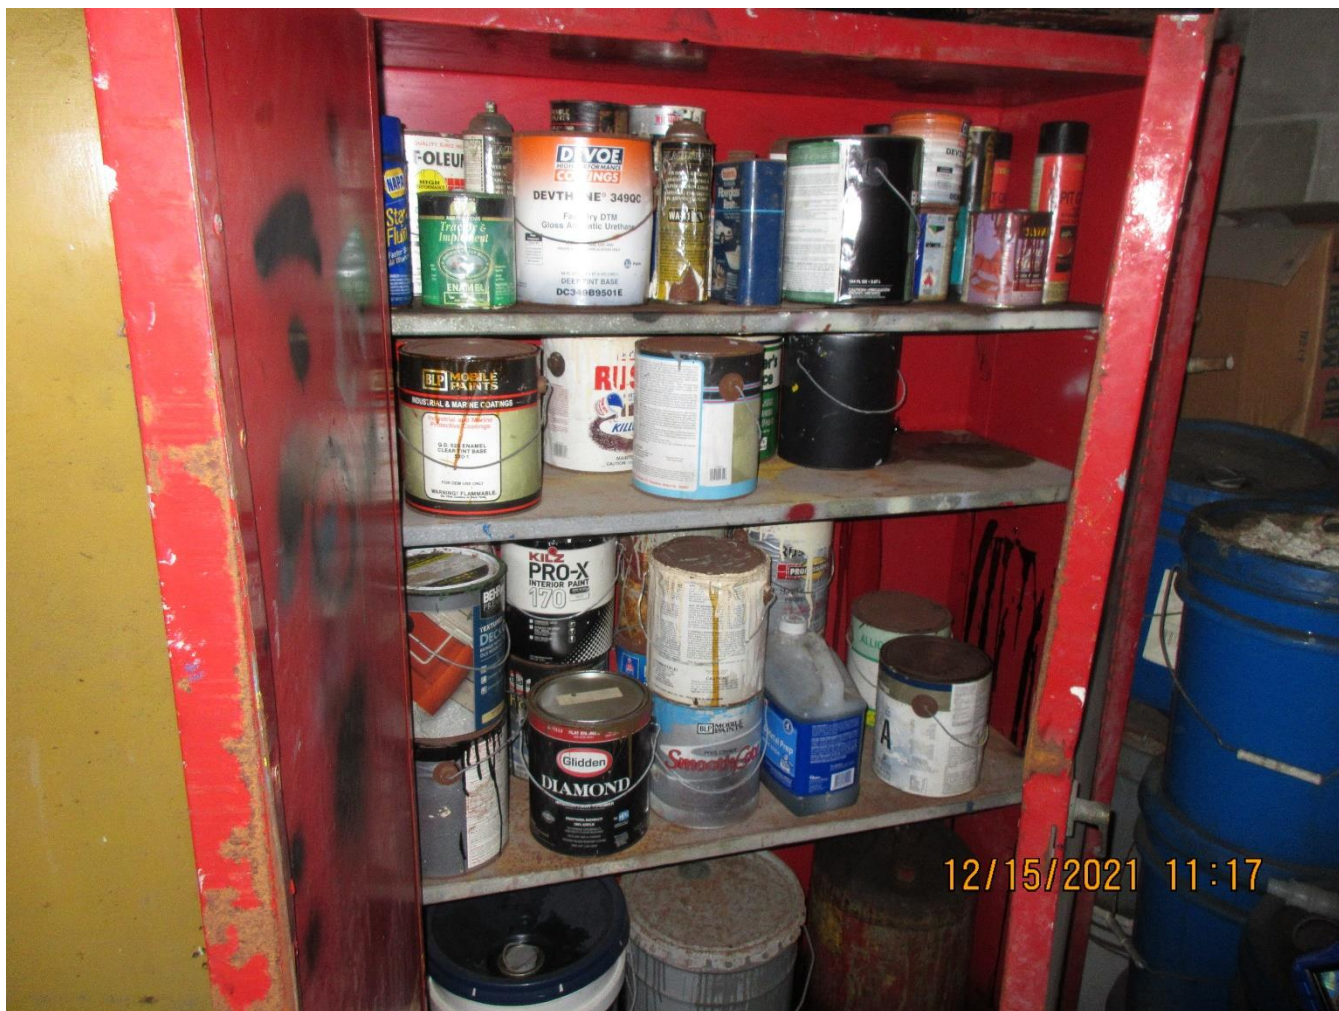
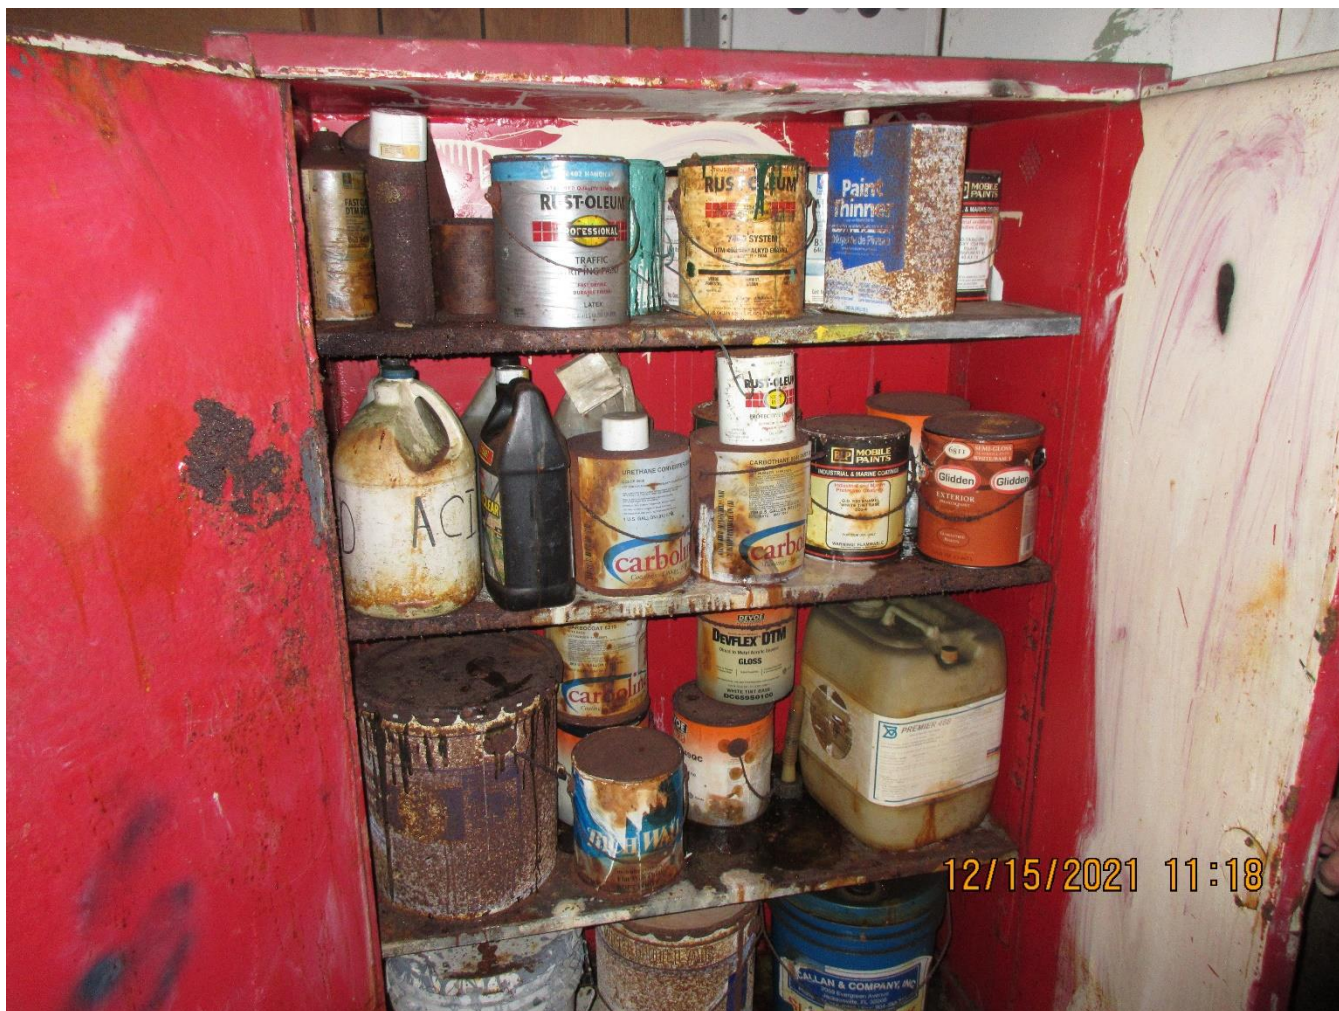
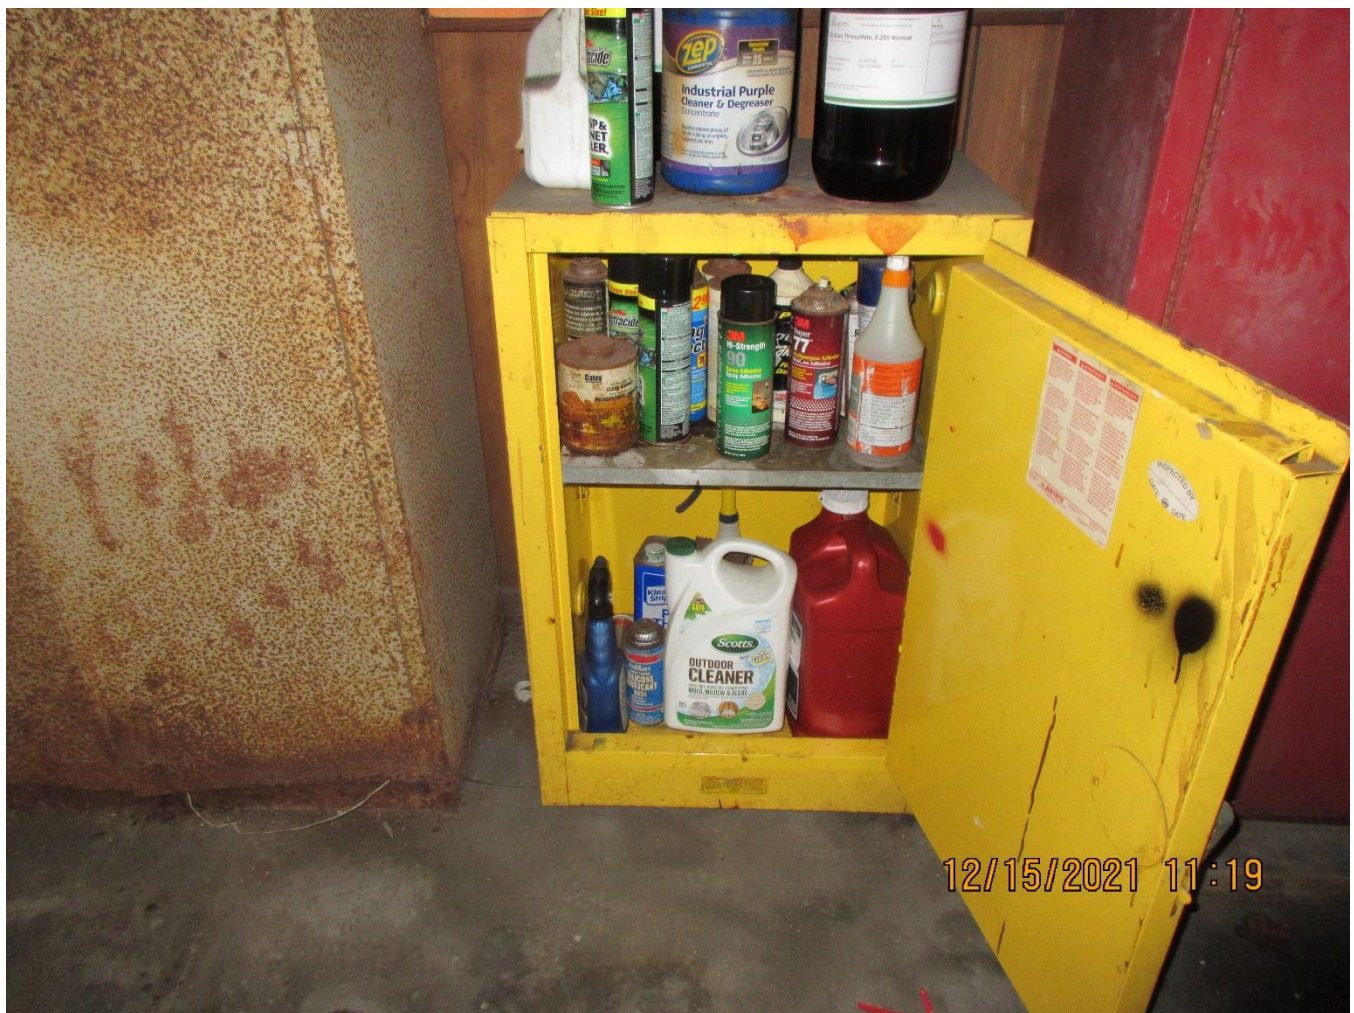
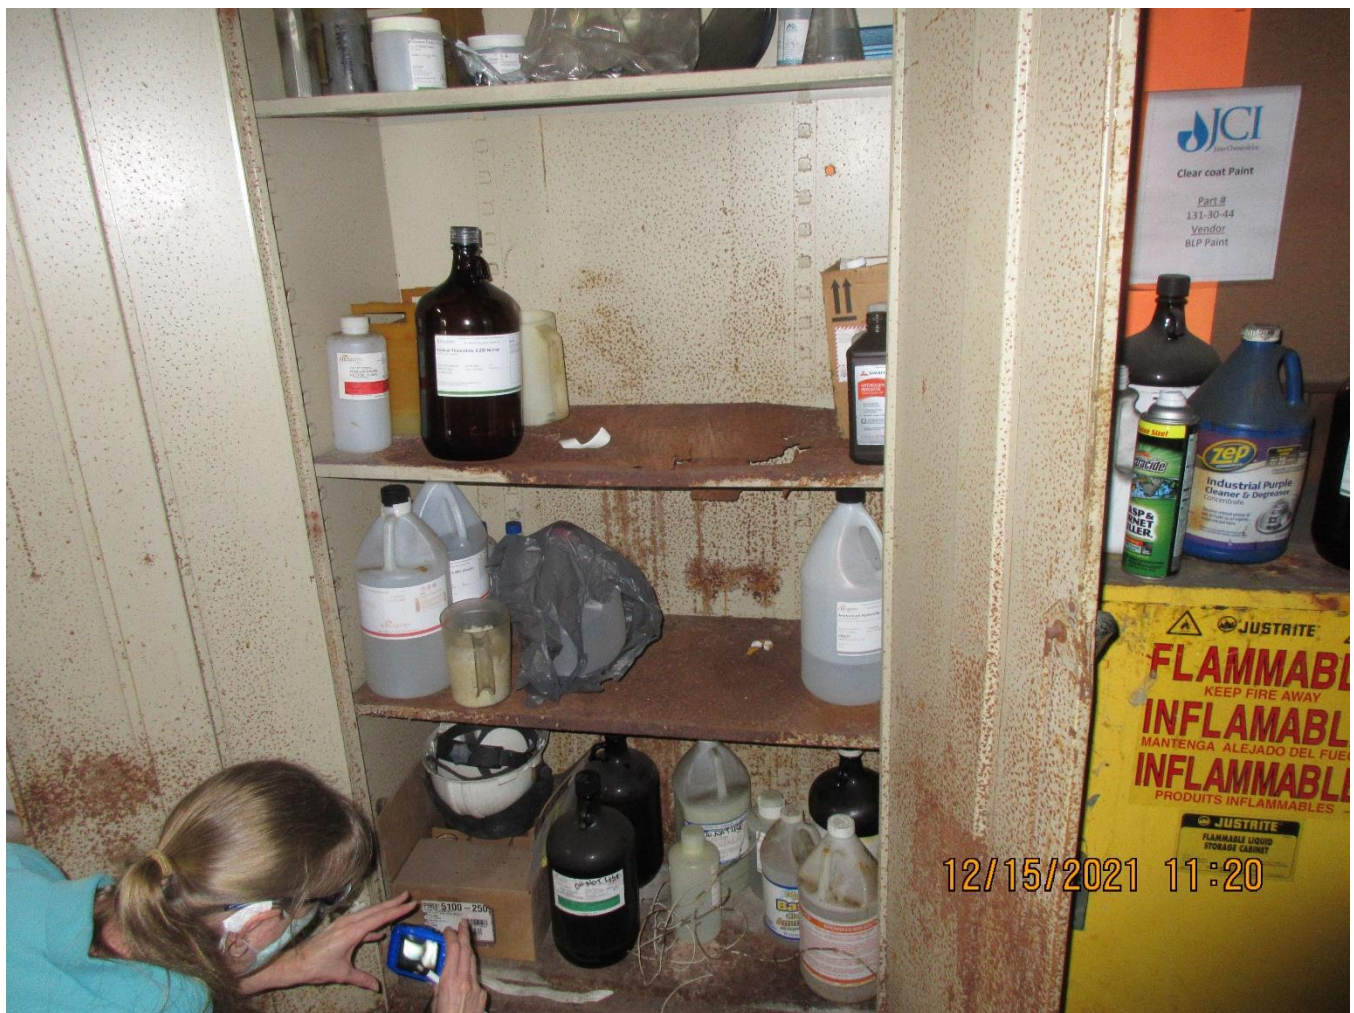
Five metal cabinets were observed in a storage room in Building 1. The cabinets held various coatings, paints, and miscellaneous materials. Mr. Solomon could not identify which of the materials were still in use at the time of the inspection. A significant portion of the paints observed appeared to be water-based (Photos 14-17).

Photo 14 – Cabinet of Paints

Photo 15 - Cabinet of Paints

Photo 16 - Cabinet of Paints, Cleaners and Miscellaneous Products

Photo 17 - Cabinet of Miscellaneous Materials

**Pursuant to Fla. Admin. Code Ann. r. 62-730.160(1) [40 C.F.R. § 262.11], a person who generates a solid waste, as defined in Fla. Admin. Code Ann. r. 62-730.160(1) [40 C.F.R. § 261.2], must make an accurate determination as to whether that waste is a hazardous waste in order to ensure wastes are properly managed according to applicable RCRA regulations articulated in Fla. Admin. Code Ann. r. 62-730.160(1) [40 C.F.R. § 262.11].**

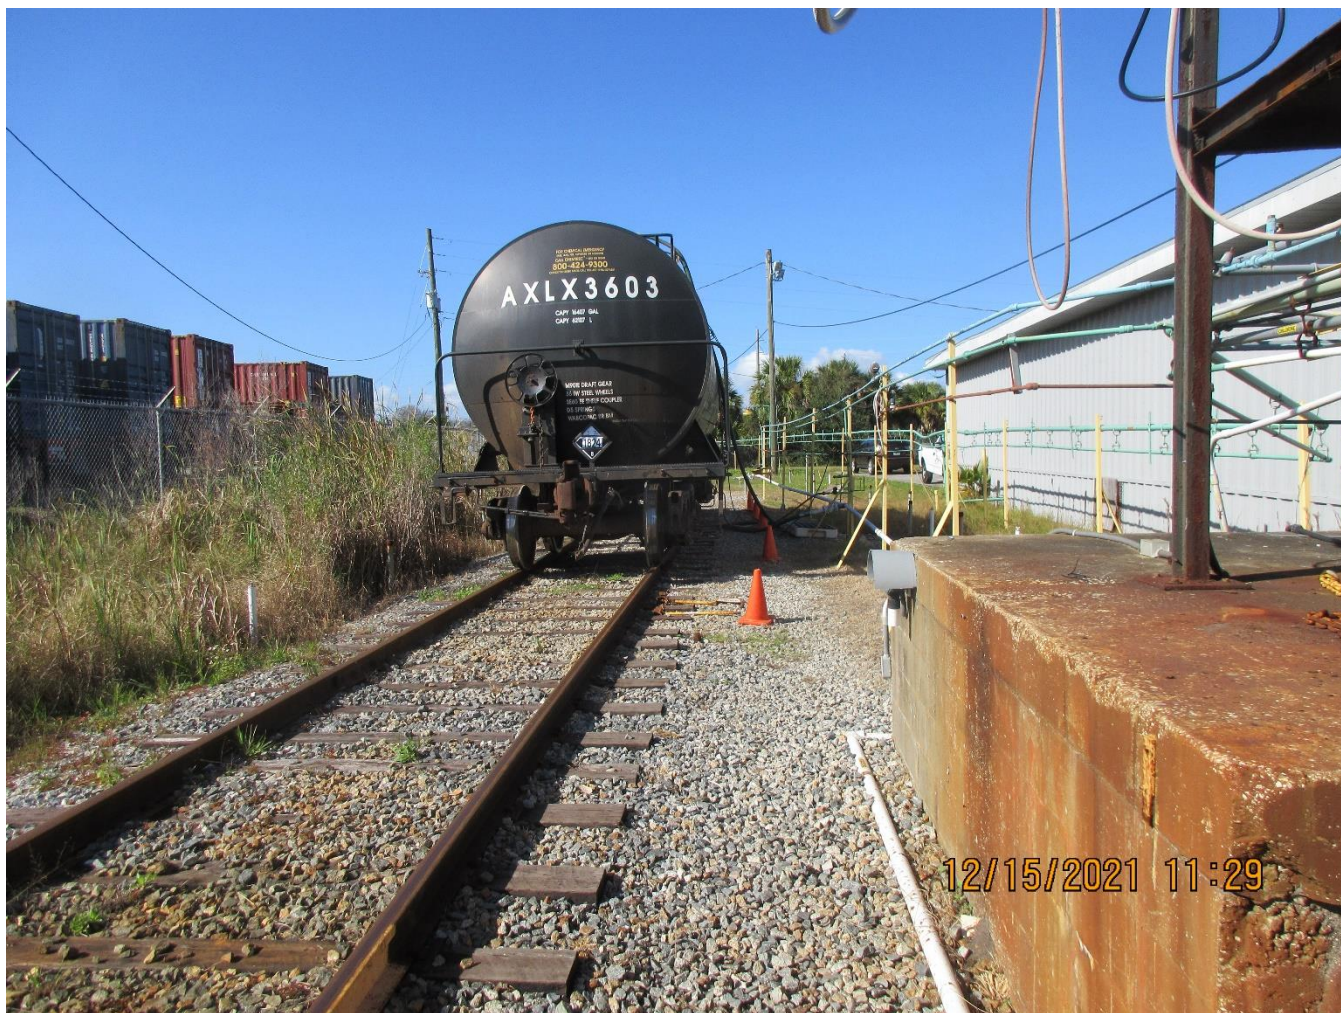
The facility receives chlorine gas and liquid sodium hydroxide that is transported via rail car to a railroad spur that is located on the south side of the manufacturing area. The sodium hydroxide is pumped from a rail car to a pipe on the north side of the unloading area. A spill of sodium hydroxide in this area on March 28, 2012 resulted in ongoing cleanup operations of groundwater in this area. The most recent removal of contaminated soil and groundwater from this area occurred in January of 2019. Thirty-two drums of contaminated soil and fifteen drums of contaminated groundwater were collected at this time and manifested off-site as nonhazardous wastes. Sampling performed on the groundwaters collected were sampled and analyzed. A review of these documents indicated that the liquids collected were nonhazardous by having a pH of less than 12.5. No spills or areas of concern were observed in this area at the time of the inspection.

Photo 18 – Railcar Off-Loading Area

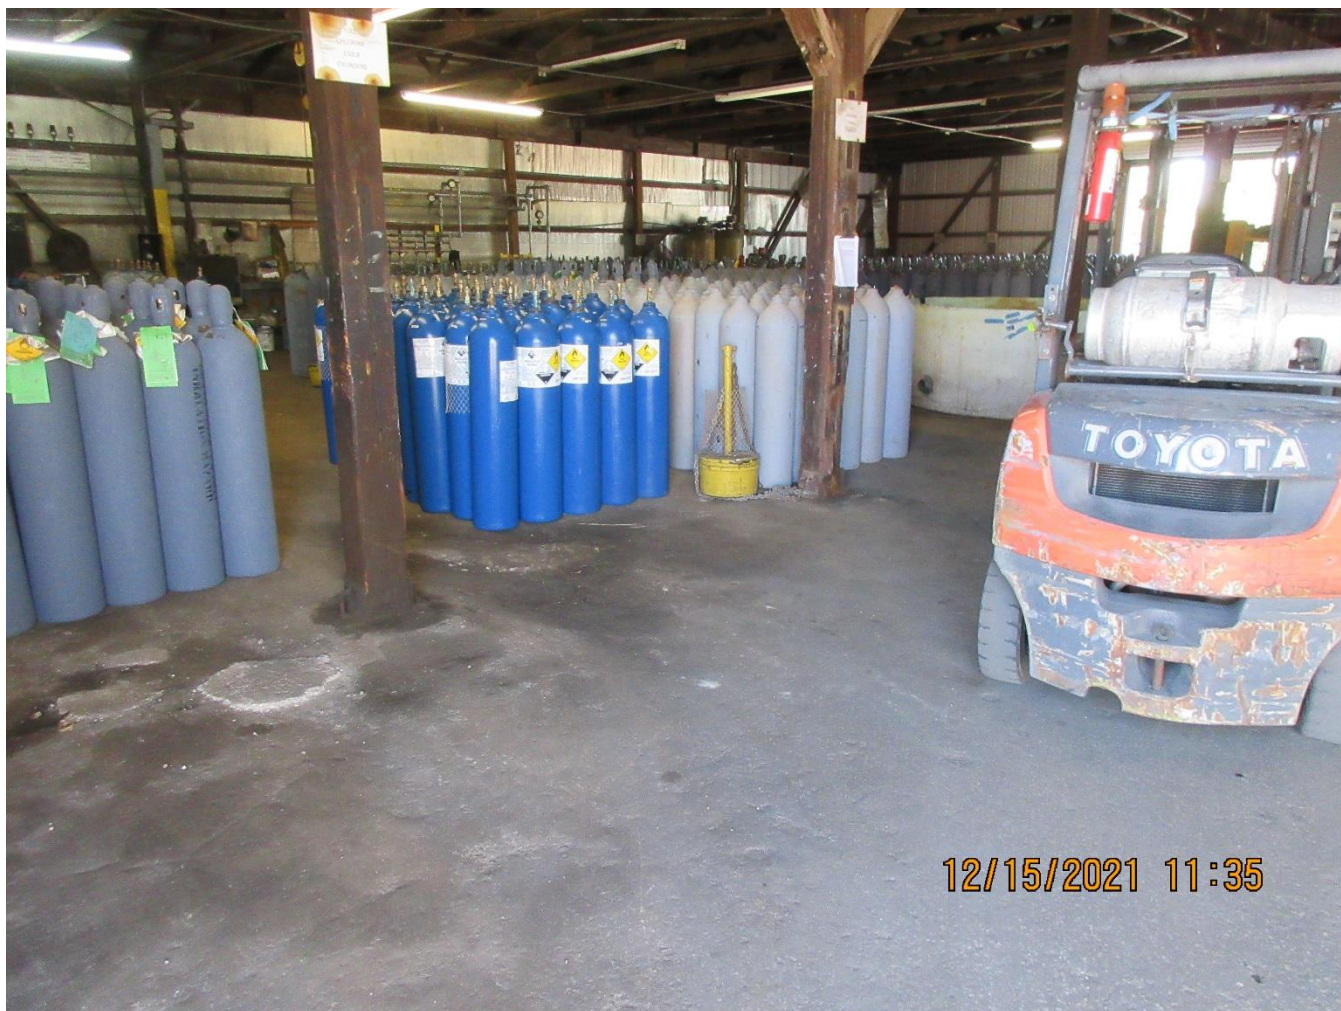
JCI also repackages chlorine into smaller cylinders managing approximately 150 lbs. of chlorine. This process is performed in Building 2 (Photo 19). Once filled in this area, the cylinders are also painted with the gray or blue latex paint (depending on customer specifications) and stenciled with ink. No hazardous waste is generated in this area.

Photo 19 – 150 Pound Chlorine Containers

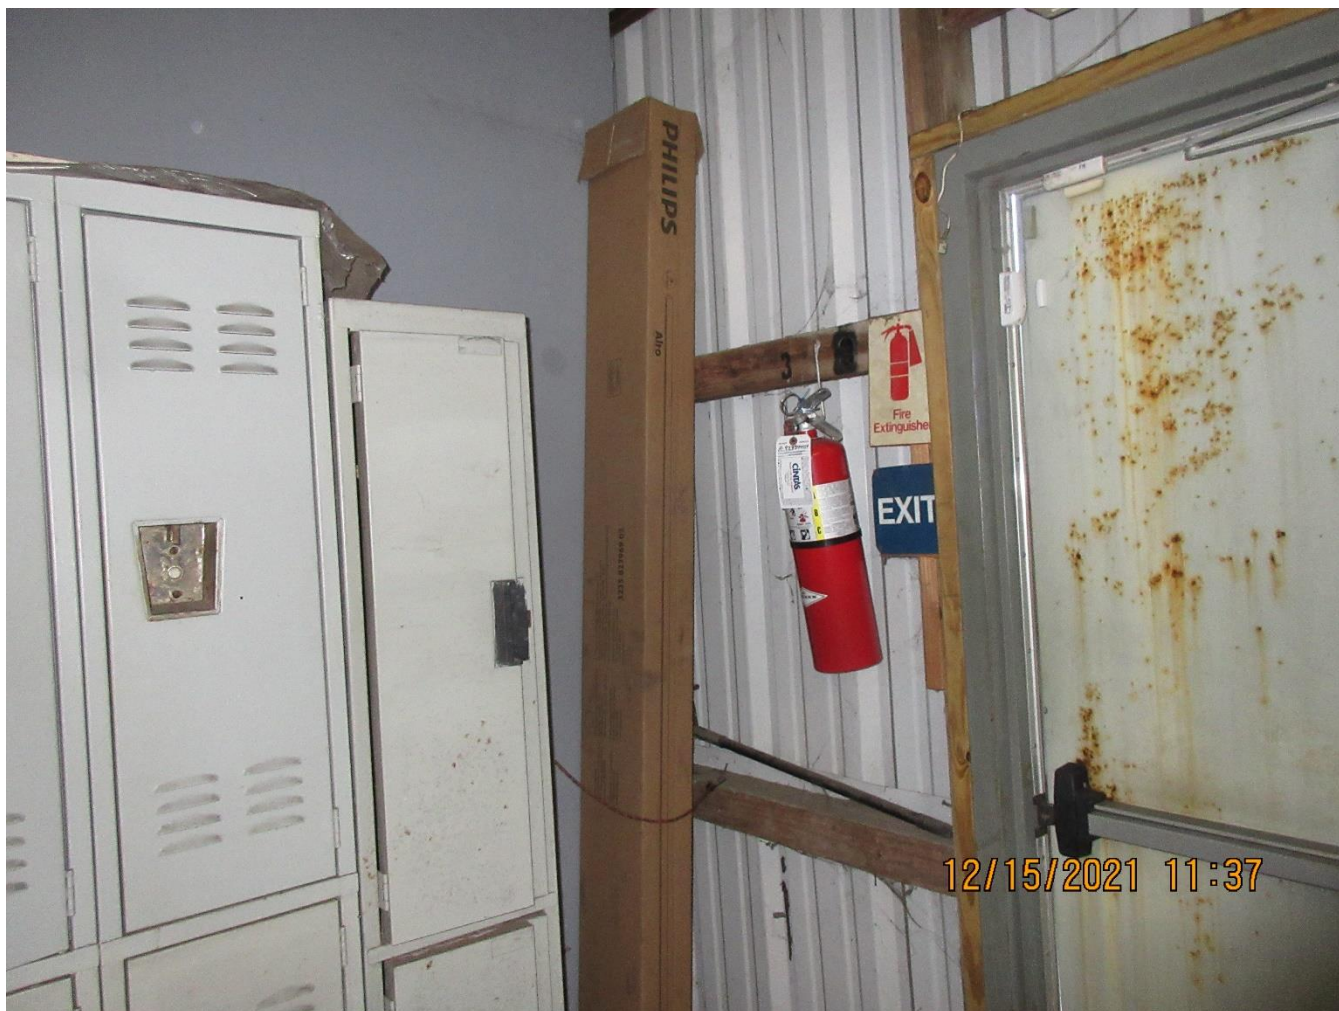
One eight-foot box of spent fluorescent lamps was observed in Building 2 to be open and unlabeled and undated at the time of the inspection (Photo 20).

Photo 20 – Box of Universal Waste Fluorescent Lamps in the Building 2 Universal Waste Area

**Pursuant Fla. Admin. Code Ann. r. 62-730.185(1) [40 C.F.R. § 273.13(d)], a SQHUW must manage universal waste lamps in a way that prevents releases of any universal waste or component of a universal waste to the environment.**

**Pursuant to Fla. Admin. Code Ann. r. 62-730.185(1) [40 C.F.R. § 273.14(e)], a SQHUW must label or mark each lamp or container of lamps clearly with one of the following phrases: “Universal Waste-Lamp(s),” or “Waste Lamp(s),” or “Used Lamps.”**

**Pursuant to Fla. Admin. Code Ann. r. 62-730.185(1) [40 C.F.R. § 273.15(a) and (c)], a SQHUW may accumulate universal waste no longer than one year and must to be able to demonstrate the length of time that the universal waste has accumulated from the date that it became a waste or was received.**
