INSPECTION REPORT

| Type of Inspection | FCI - Focused Compliance Inspection | |
| Permittee Name | Camino Real Regional Utility Authority (CRRUA) | |
| Facility or Site Name | Sunland Park Wastewater Plant | |

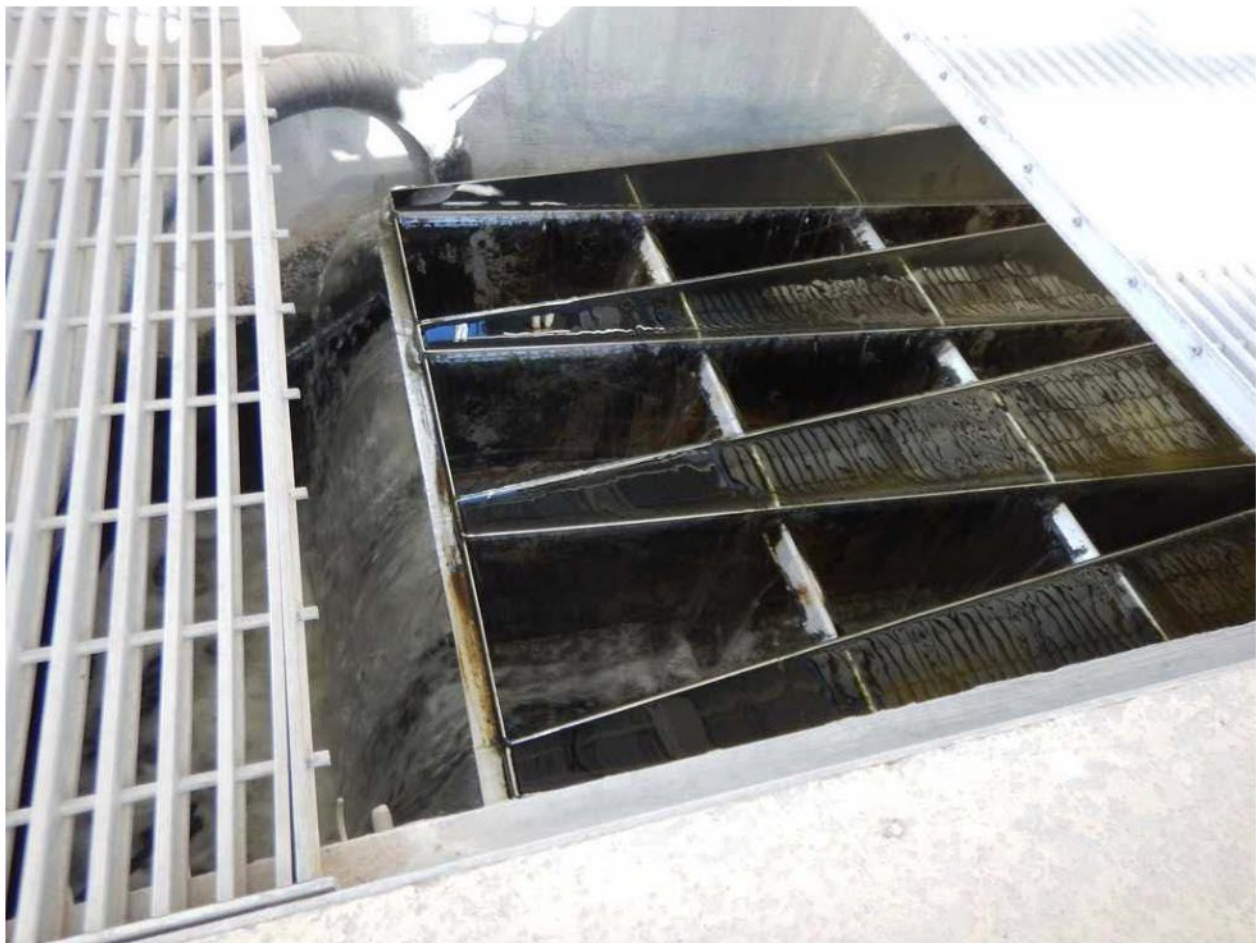
| Photo 1 | DSCN1793.JPG | |

| View of finger weirs just past UV disinfection. Effluent appears clear. | | |

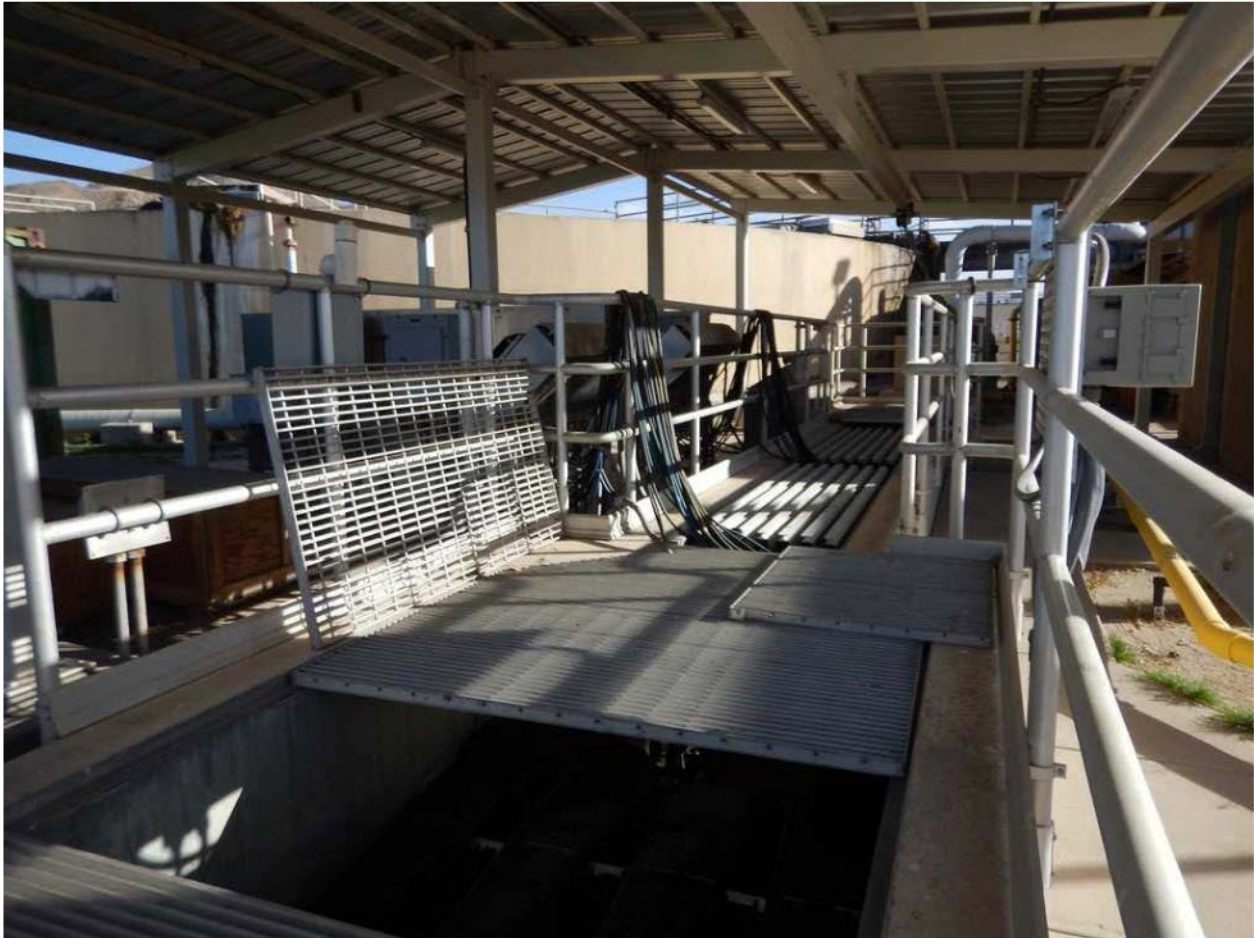
| Photo 2 | DSCN1794.JPG | |

| View of the effluent flow channel showing UV disinfection system. | | |

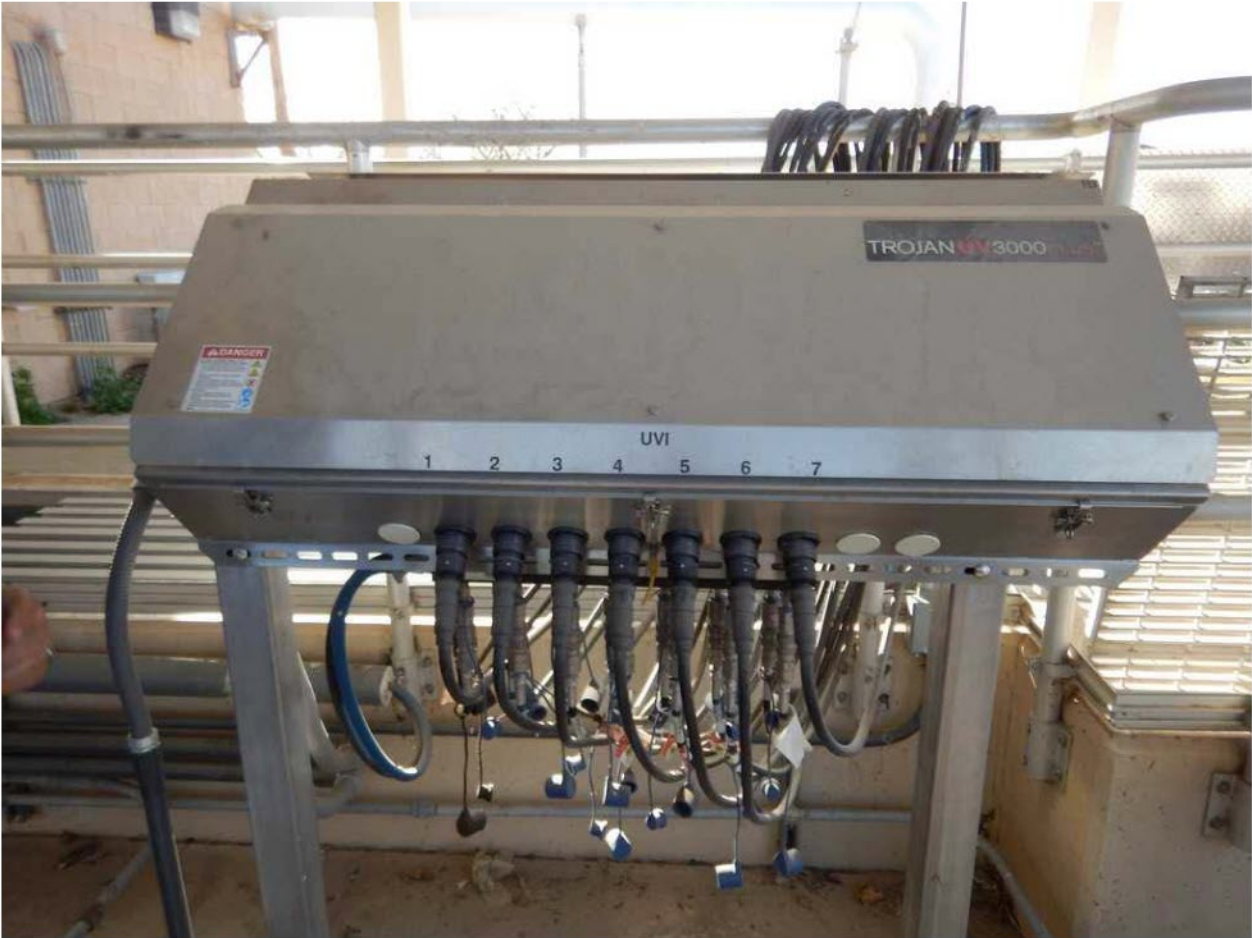
| Photo 3 | DSCN1796.JPG | |

| <p>The UV disinfection system was recently replaced and is running well. The autosampler had also been replaced and a thermometer was present and at the proper temperature.</p> | | |

| UV disinfection system. | | |

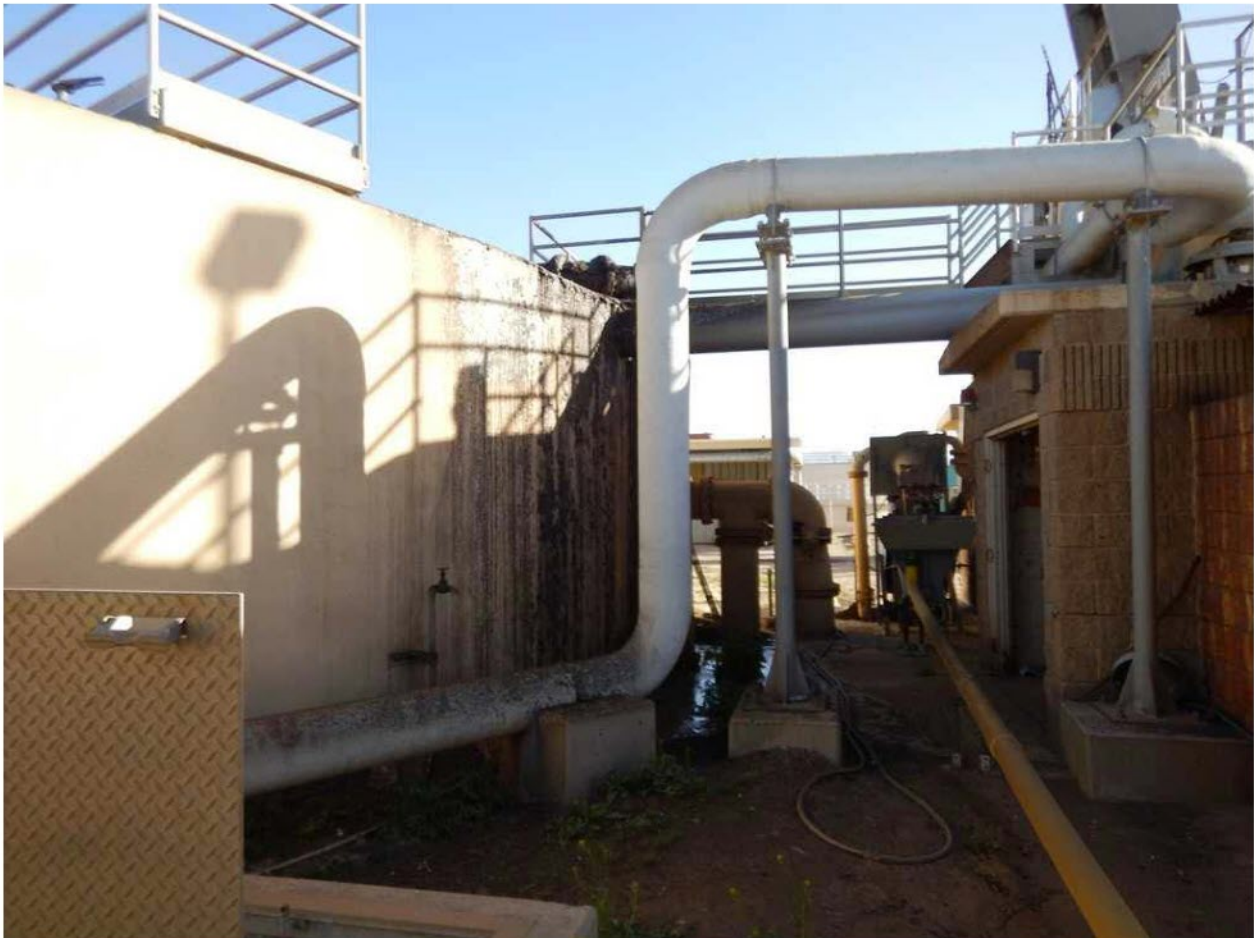
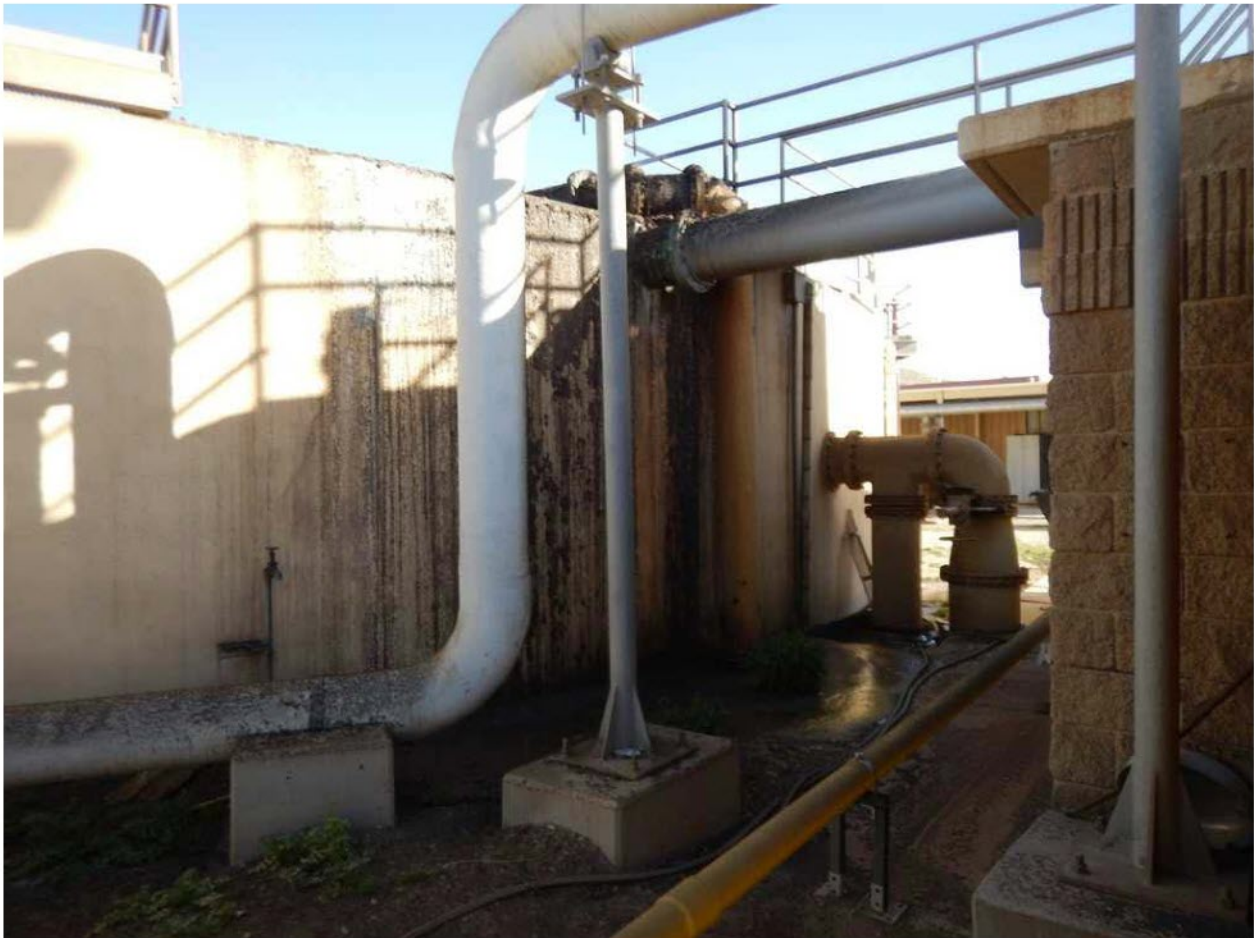
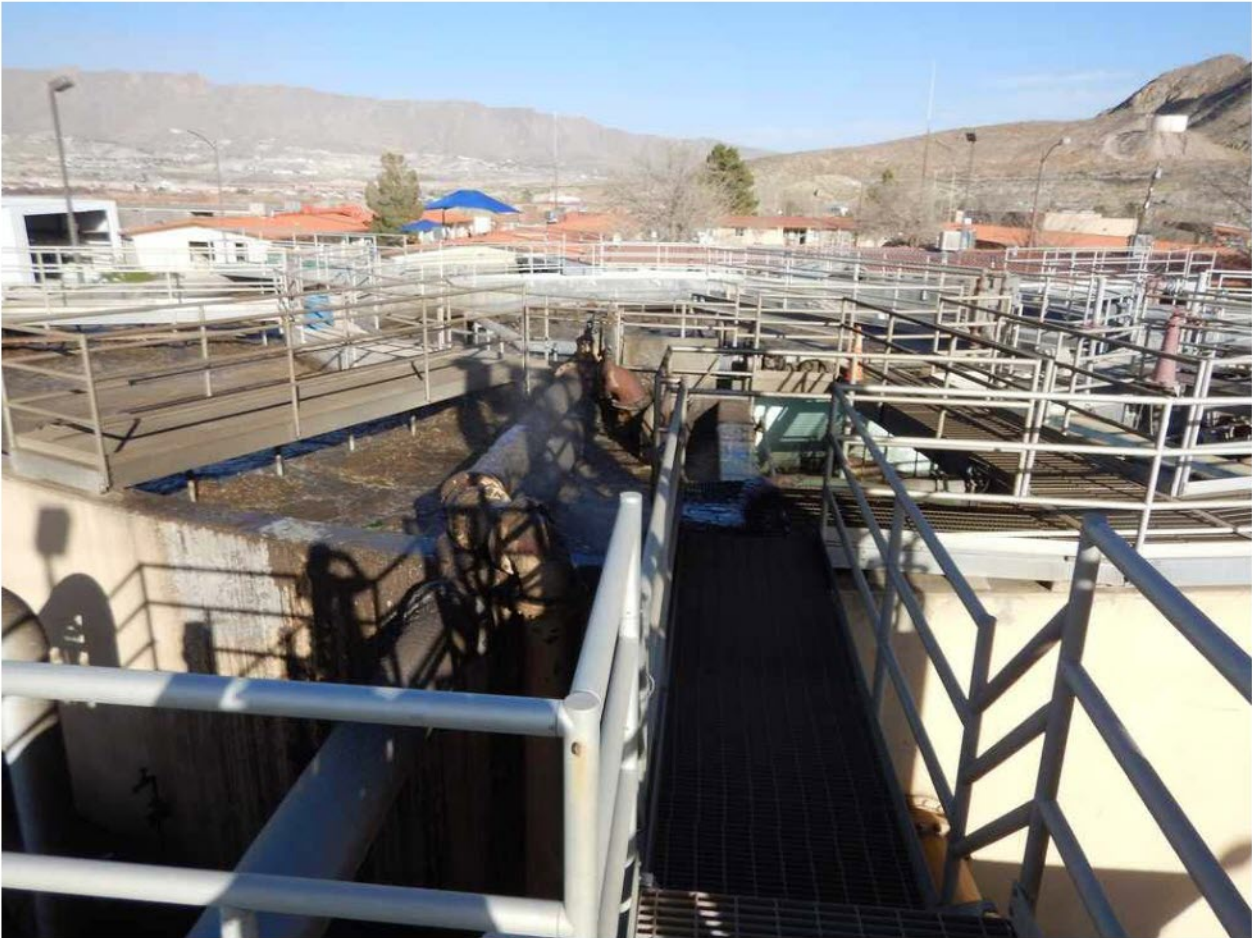
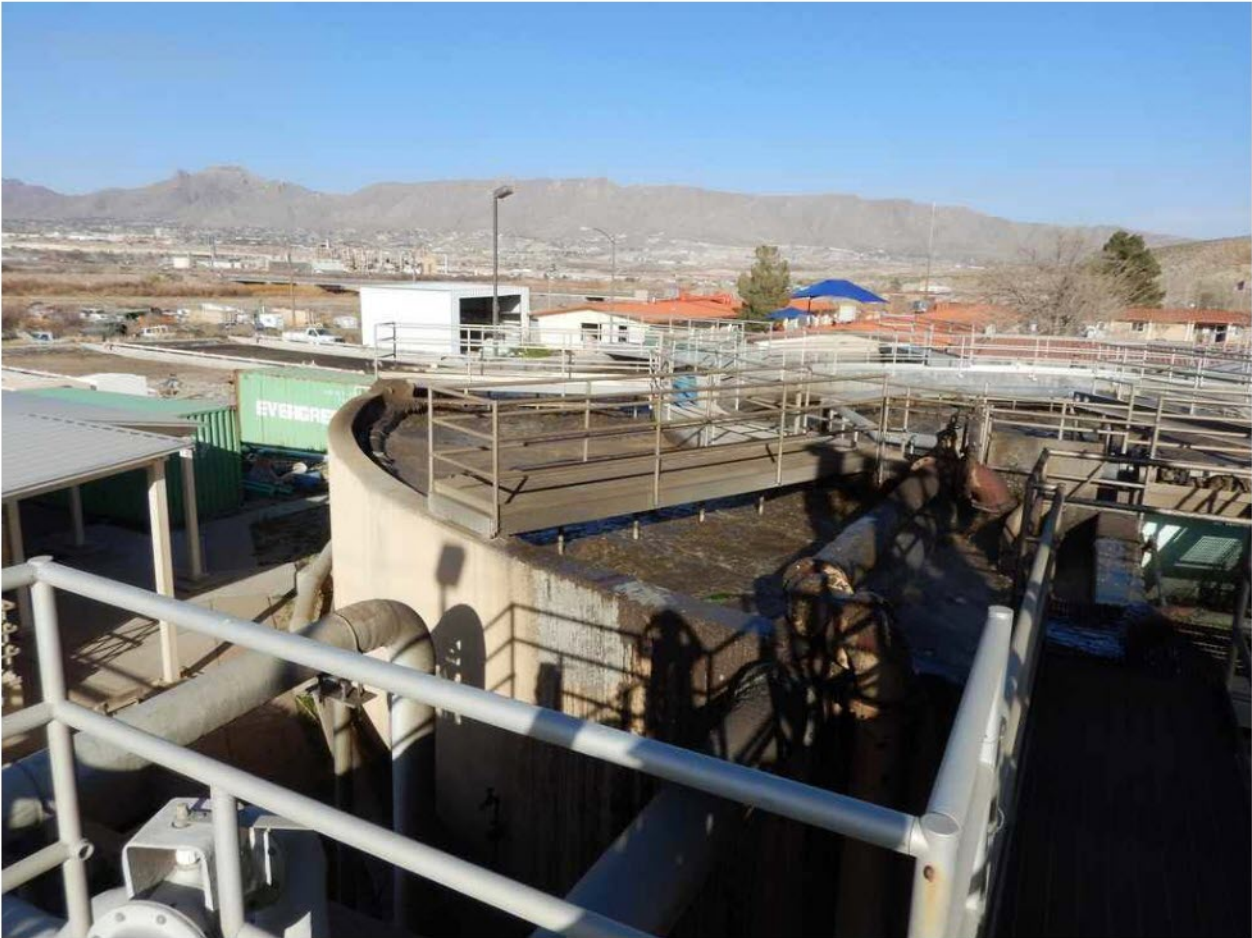
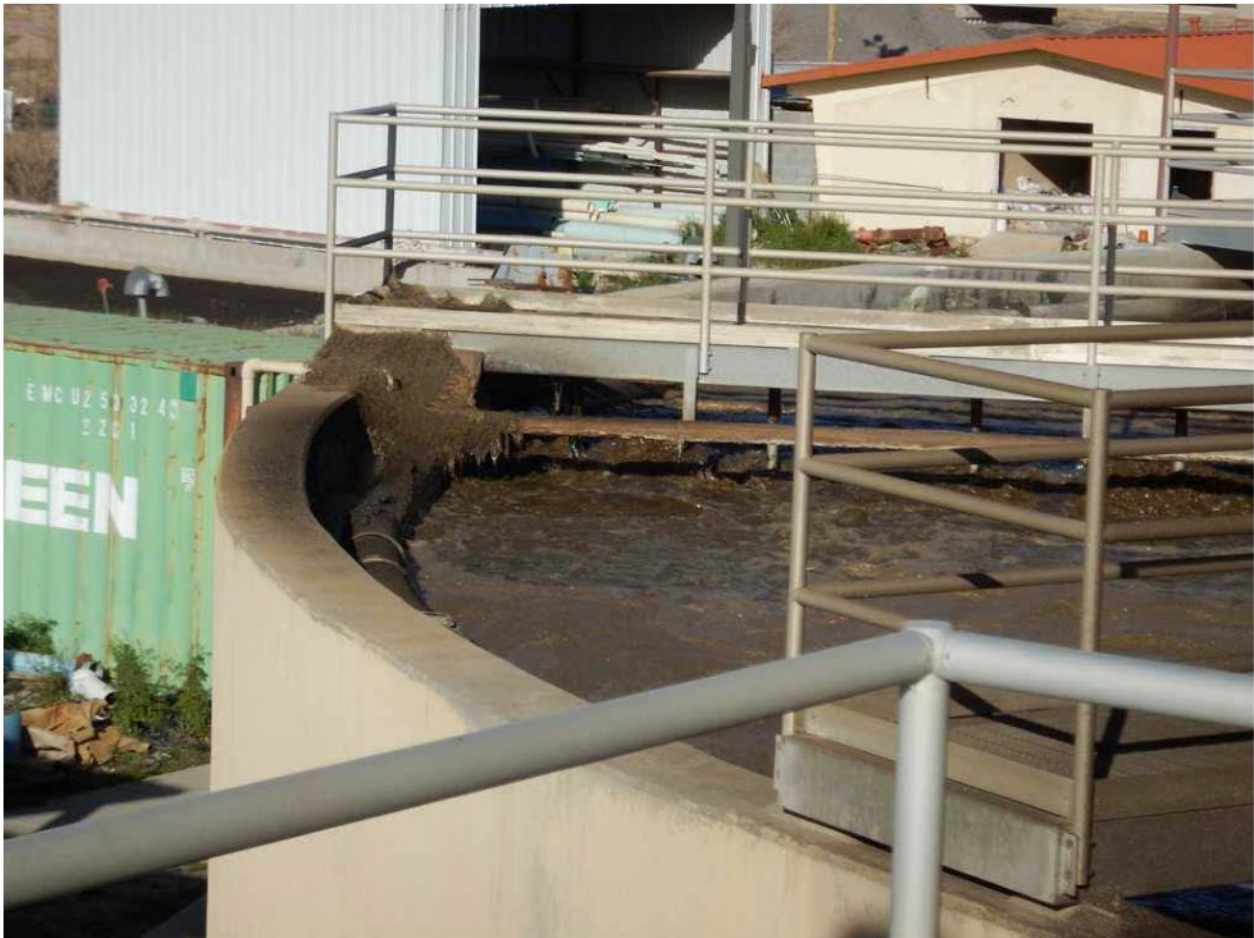
| <p>Aeration lines in the aeration basin are leaking and blowing wastewater out of the basin and onto the ground.</p> | | |

| AOC Reference #: AA2-OB-004 | Location: 2 - Treatment System |
|---|---|
| <b>AOC:</b><br><br>Aeration lines in the aeration basin are leaking and blowing wastewater out of the basin and onto the ground. | |

| Wastewater is being aerosolized and blown out of aeration basin due to leaks in the air lines. Wastewater is coating walkways, the outside of the basin, and the ground around the basin. | | |

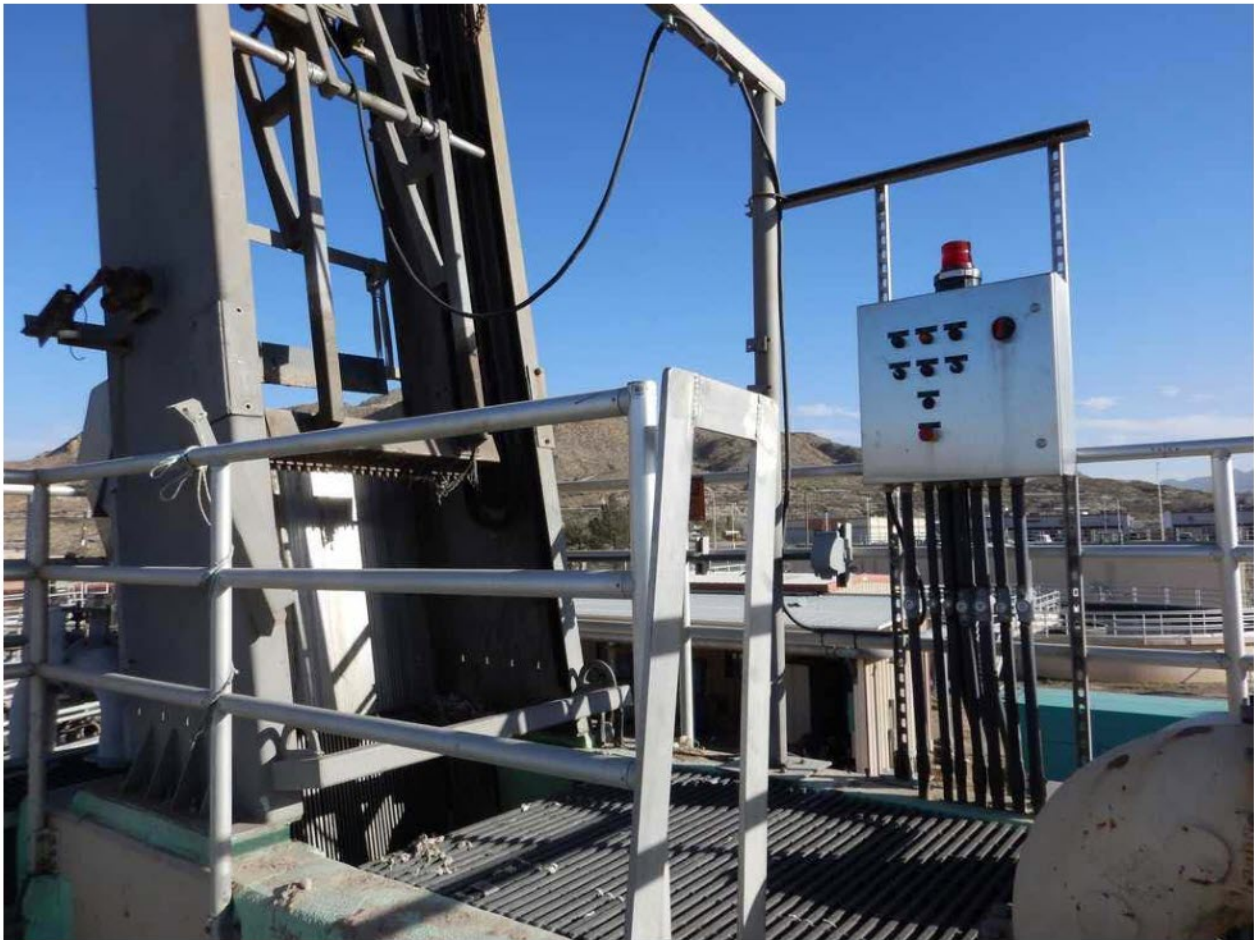
| Location: 2 - Treatment System | | |
|---|---|---|
| <p>Bar screen and grit pumps were rebuilt in late 2022 by C&amp;E. An epoxy coating was used for structural stability. The bar screen is fully automated. The grit drain line has been rerouted and the grit auger runs for 15 minutes out of every hour.</p> | | |

| New bar screen. | | |

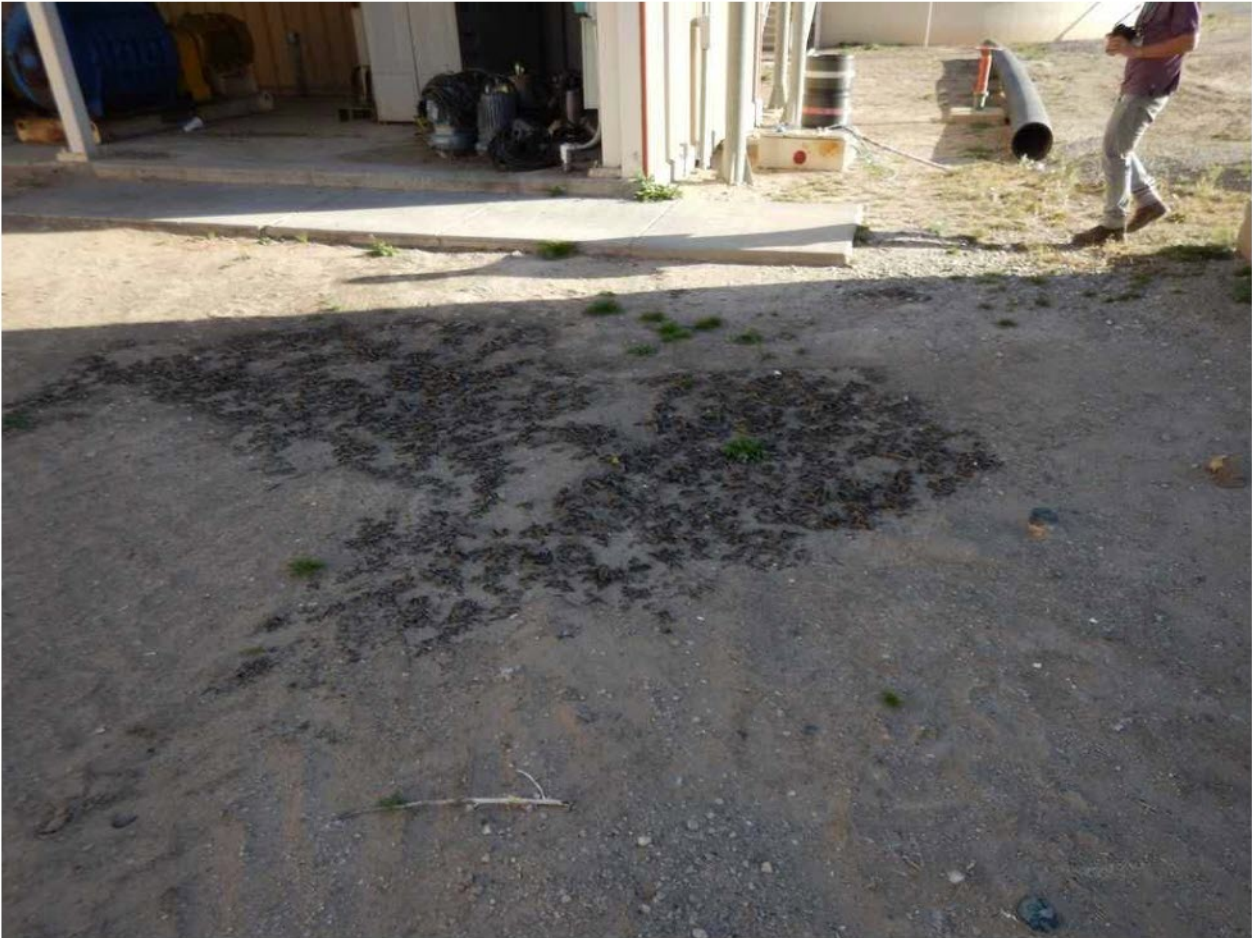
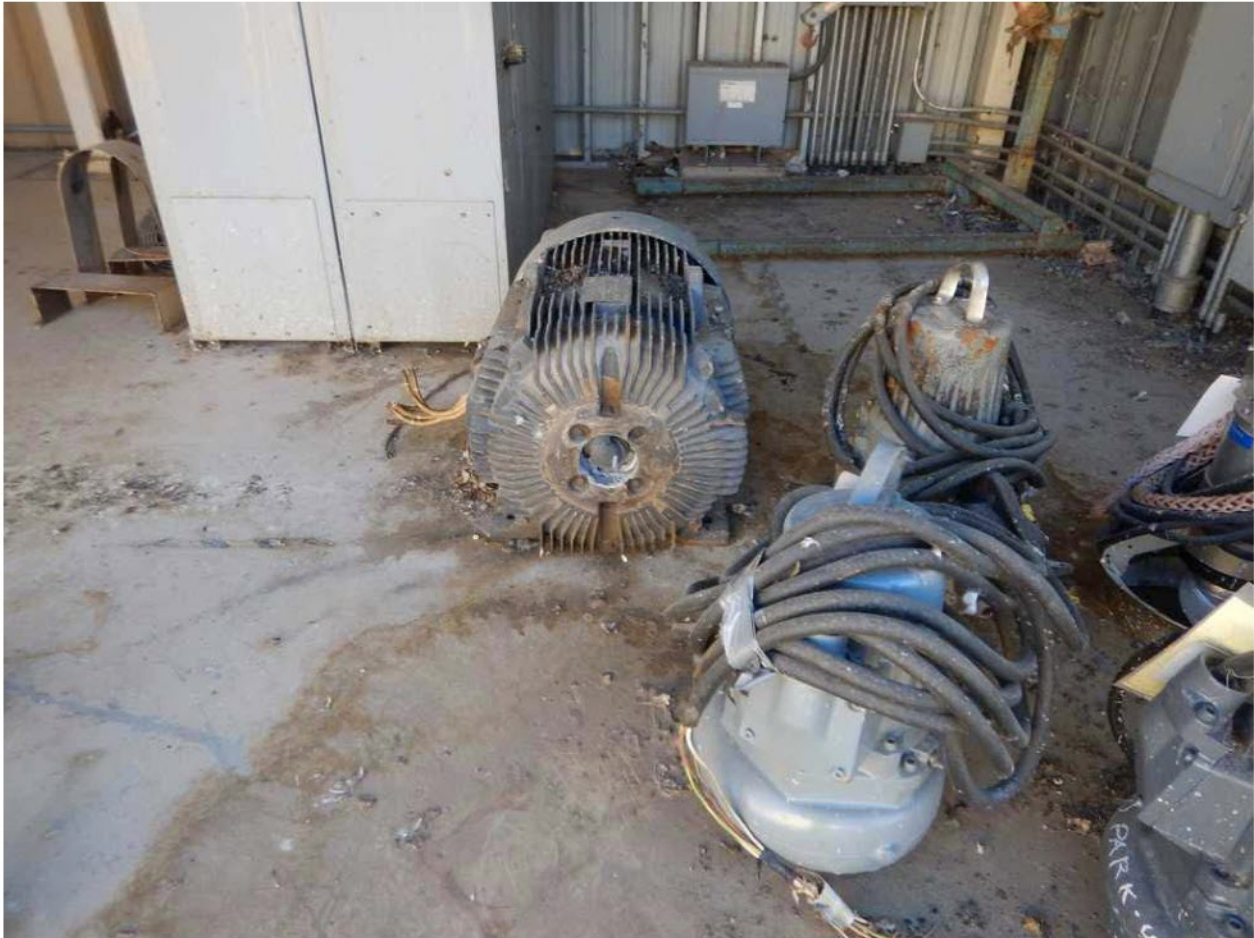
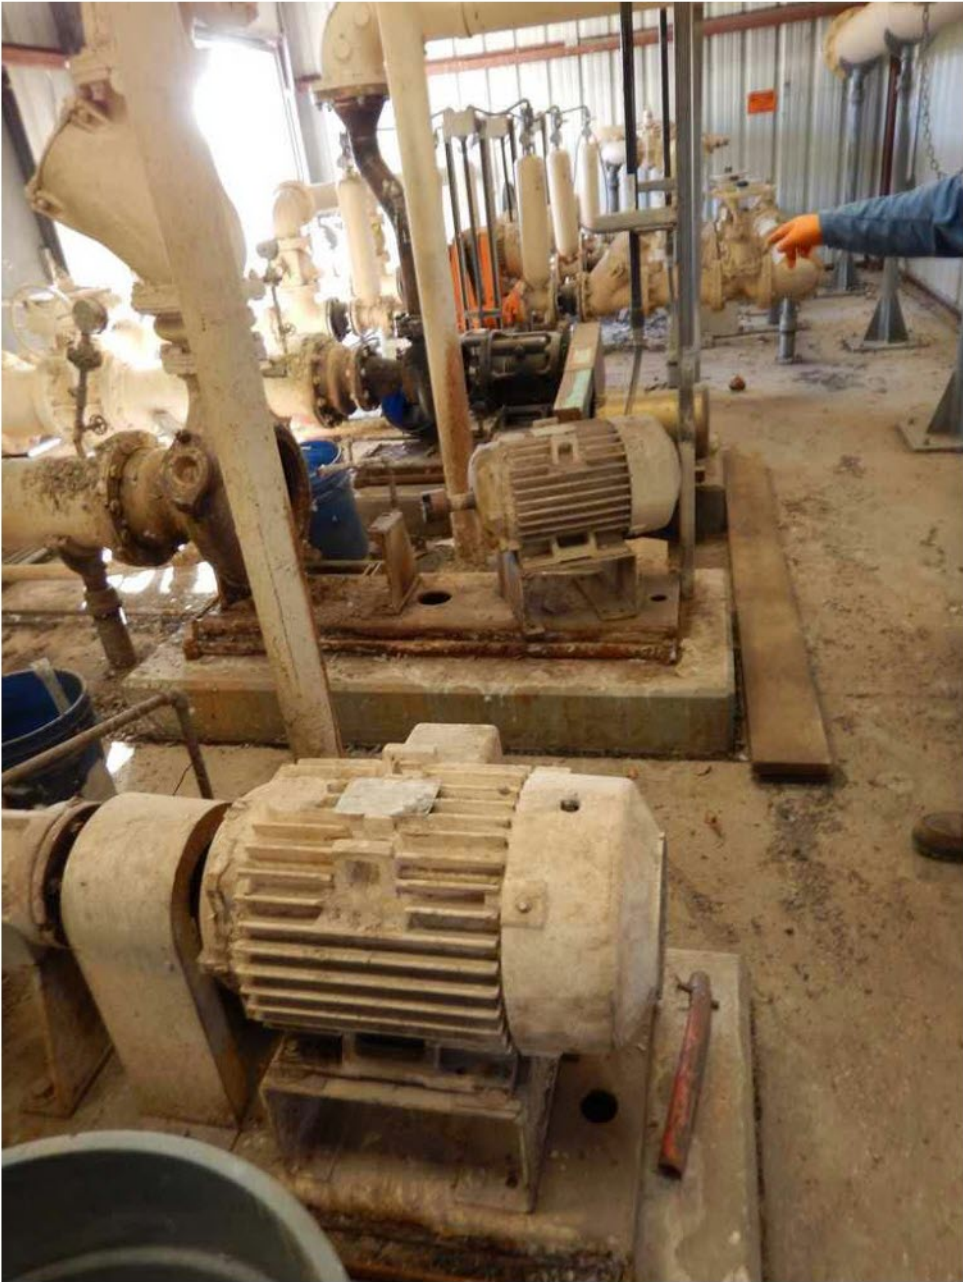
| <p>RAS and WAS pumps are old and are in need of replacement, however as a cost saving measure, they are constantly being rebuilt instead of replaced. Eric stated that CRRUA is getting Asset Management software soon, but he's concerned that they may not have the personnel who have time to learn and run the software.</p> | | |

| AOC Reference #: AA2-OB-002 | Location: 2 - Treatment System |
|---|---|
| <b>AOC:</b><br><br>RAS and WAS pumps are old and are in need of replacement, however as a cost saving measure, they are constantly being rebuilt instead of replaced. Eric stated that CRRUA is getting Asset Management software soon, but he's concerned that they may not have the personnel who have time to learn and run the software. | |

| Pumps and blower motors in various states of being rebuilt. | | |
