**UNITED STATES ENVIRONMENTAL PROTECTION AGENCY  
REGION 8  
RESOURCE CONSERVATION AND RECOVERY ACT**

**Facility Name:** Chemtrade Refinery Services Inc.      **Facility Location:** 140 Goes in Lodge Road, Riverton, Wyoming

**Date of Inspection:** August 17, 2021      **Arrival Time:** 9:00 a.m.  
**Departure Time:** 3:45 p.m.

**Type and Purpose of Inspection:** Compliance Evaluation Inspection

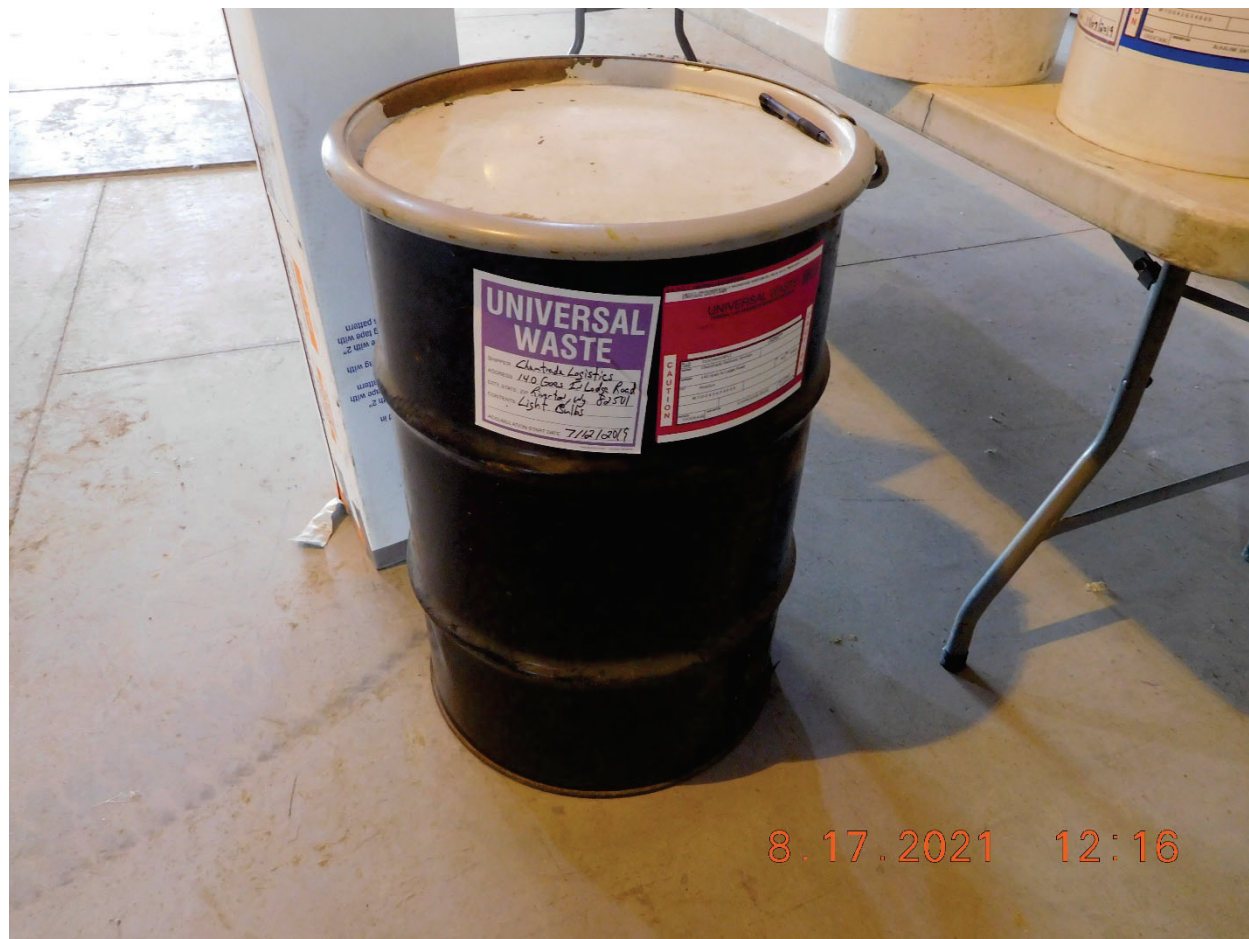
- UPA Warehouse
  - In this area I observed universal waste including:
    - light bulbs, closed metal 55-gallon drum, labeled universal waste light bulbs with accumulation start date 7/12/2019 (see photos 1425 and 1426);

Photo 1425: DSCN1425.jpg, photo of universal waste light bulbs in a closed metal drum labeled with accumulation start date 7/12/2019. The containers in this area, including the two universal waste battery containers visible on the table to right, were staged and prepared for pickup by Clean Harbors.

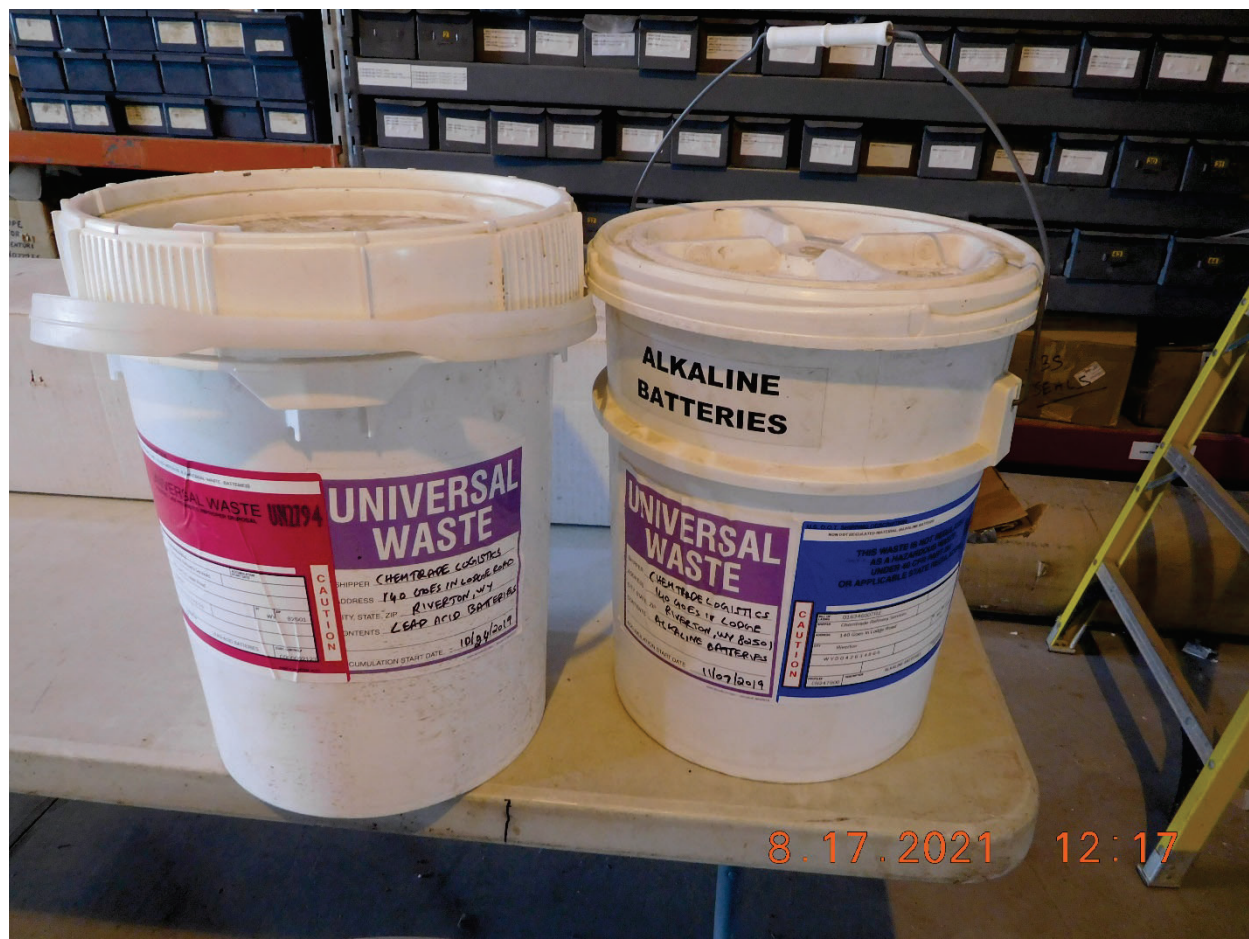
Photo 1427: DSCN1427.jpg: photo of a closed lead acid battery universal waste container labeled with accumulation start date 10/24/2021 and an alkaline battery universal waste container labeled with accumulation start date 11/07/2019.

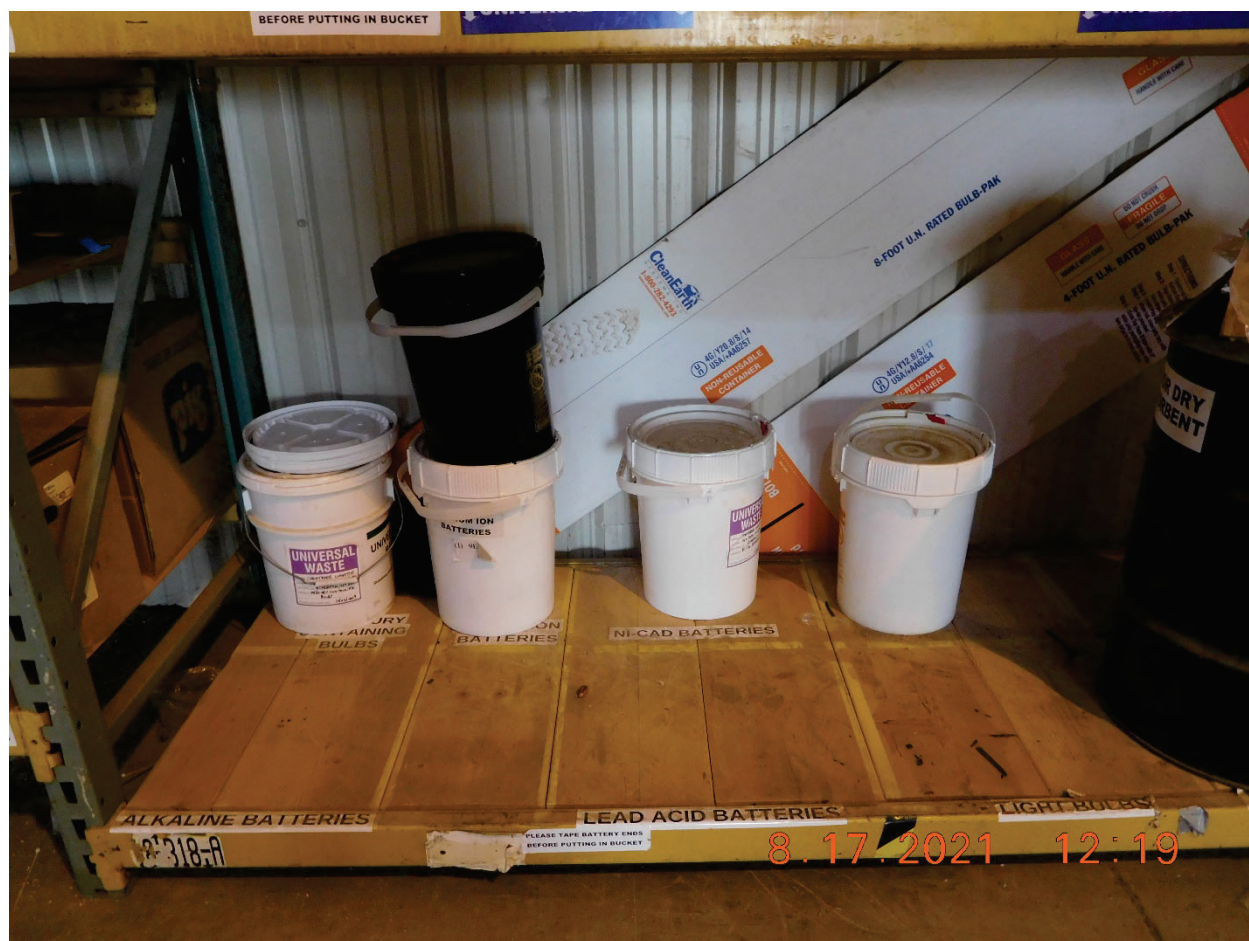
Photo 1430: DSCN1430.jpg: photo of the universal waste accumulation area where universal wastes are accumulated; the containers shown in this picture were empty according to the Facility representatives.

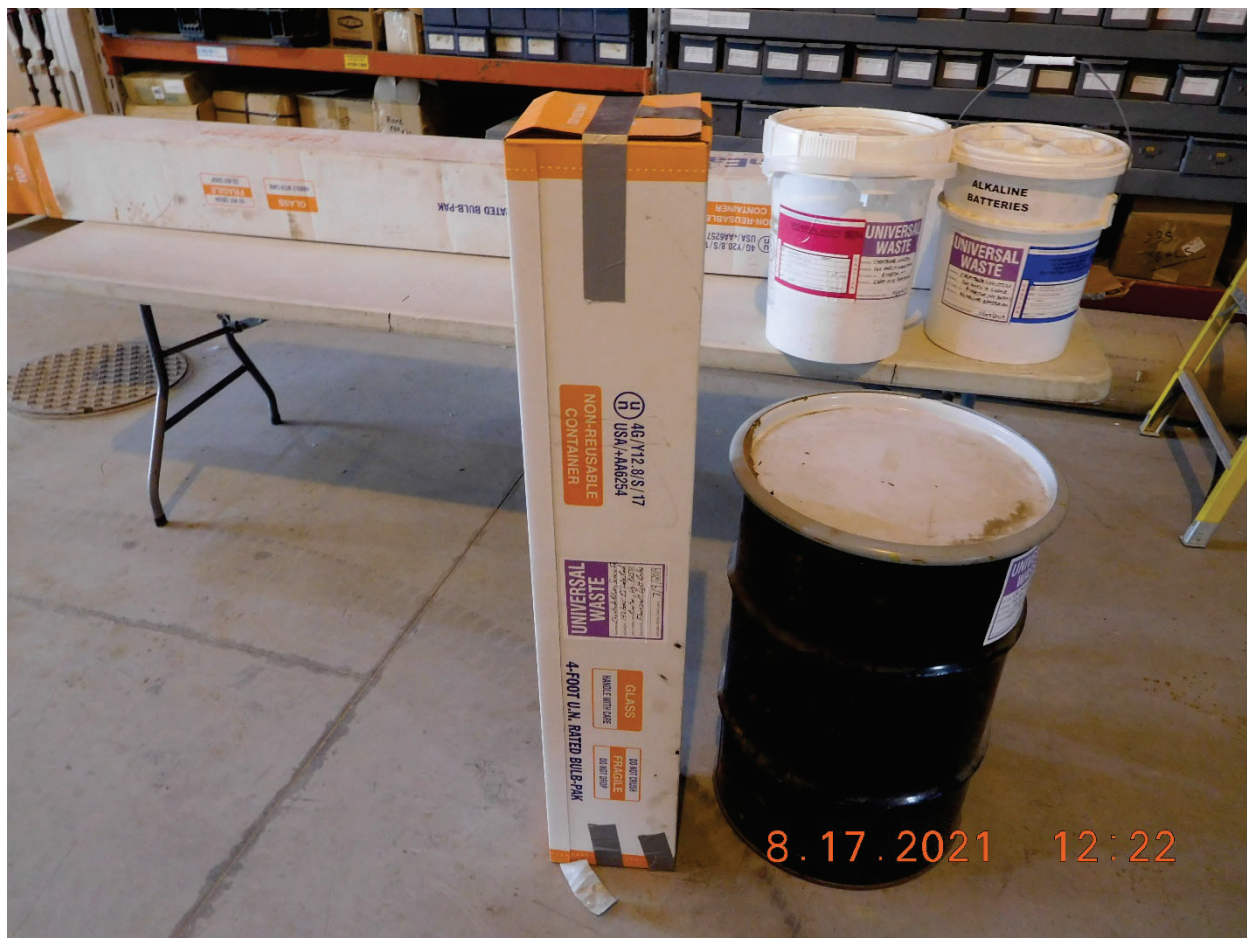
Photo 1431: DSCN1431.jpg: overview photo of the containers shown in photos 1425-1430 and 1432.

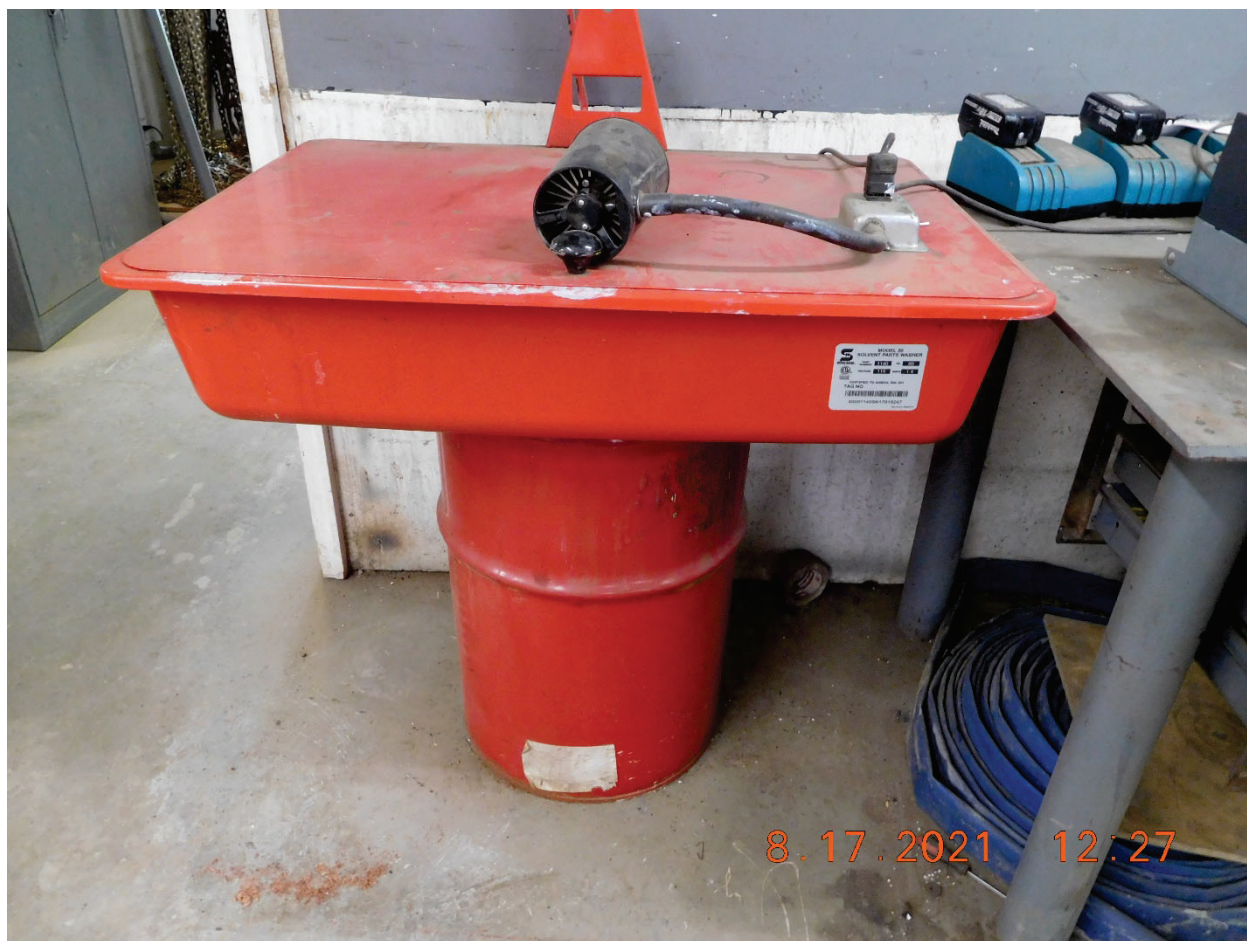
- Maintenance shop
  - In this area, I observed a parts washer labeled "Safety-Kleen Model 30 Solvent Parts Washer" (see photo 1433). I did not observe any concerns related to the parts washer.

Photo 1433: DSCN1433.jpg: photo of parts cleaner located in the maintenance shop and labeled “Model 30 Solvent Parts Washer”.

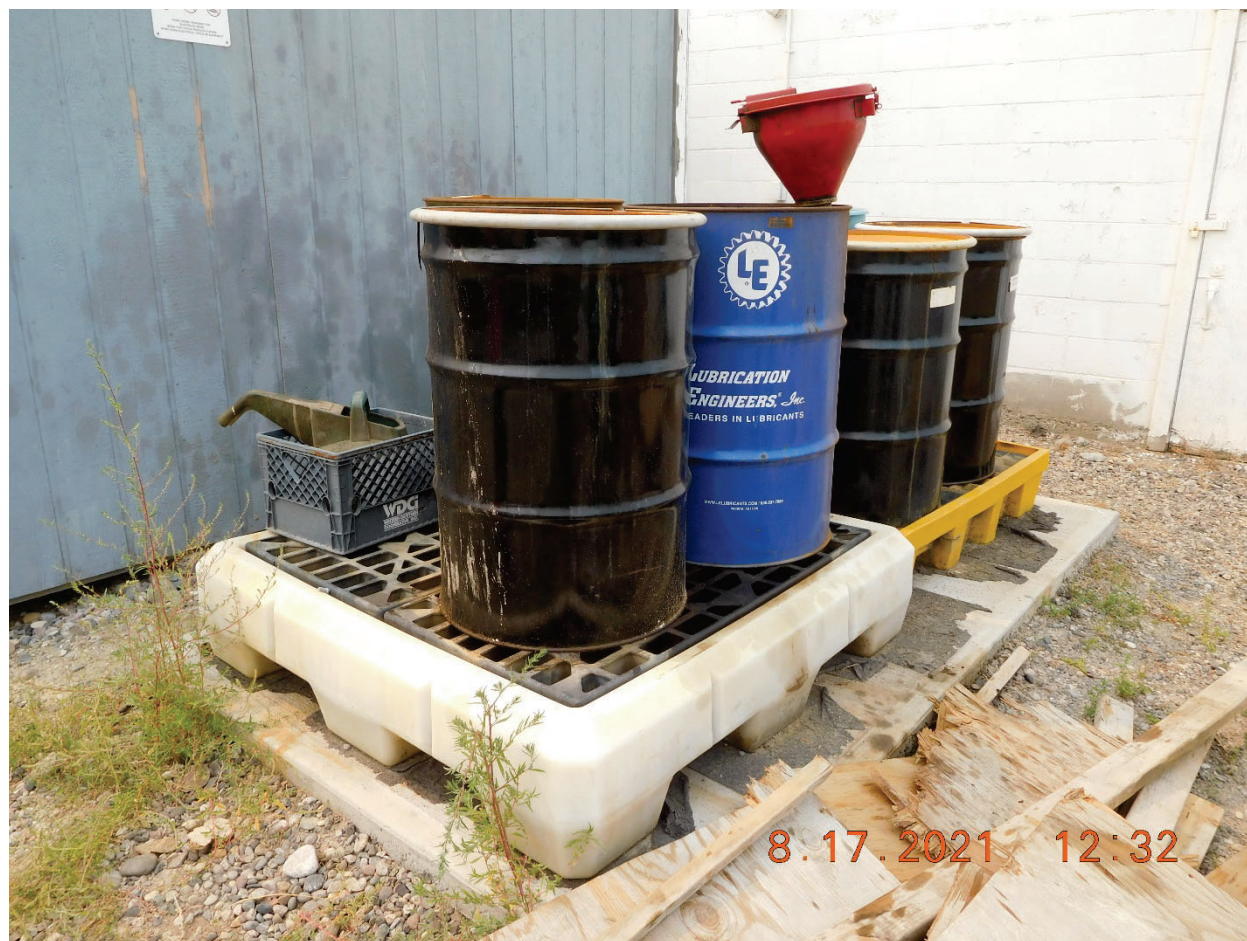
- Used oil storage located outside of maintenance shop
  - In this area, I observed six containers on a secondary/spill containment pallet, all of which appeared to be in good condition and not leaking:

Photo 1434: DSCN1434.jpg: overview photo of the used oil storage area located outside of the maintenance shop. No spills, leaks or other concerns were observed in this area.

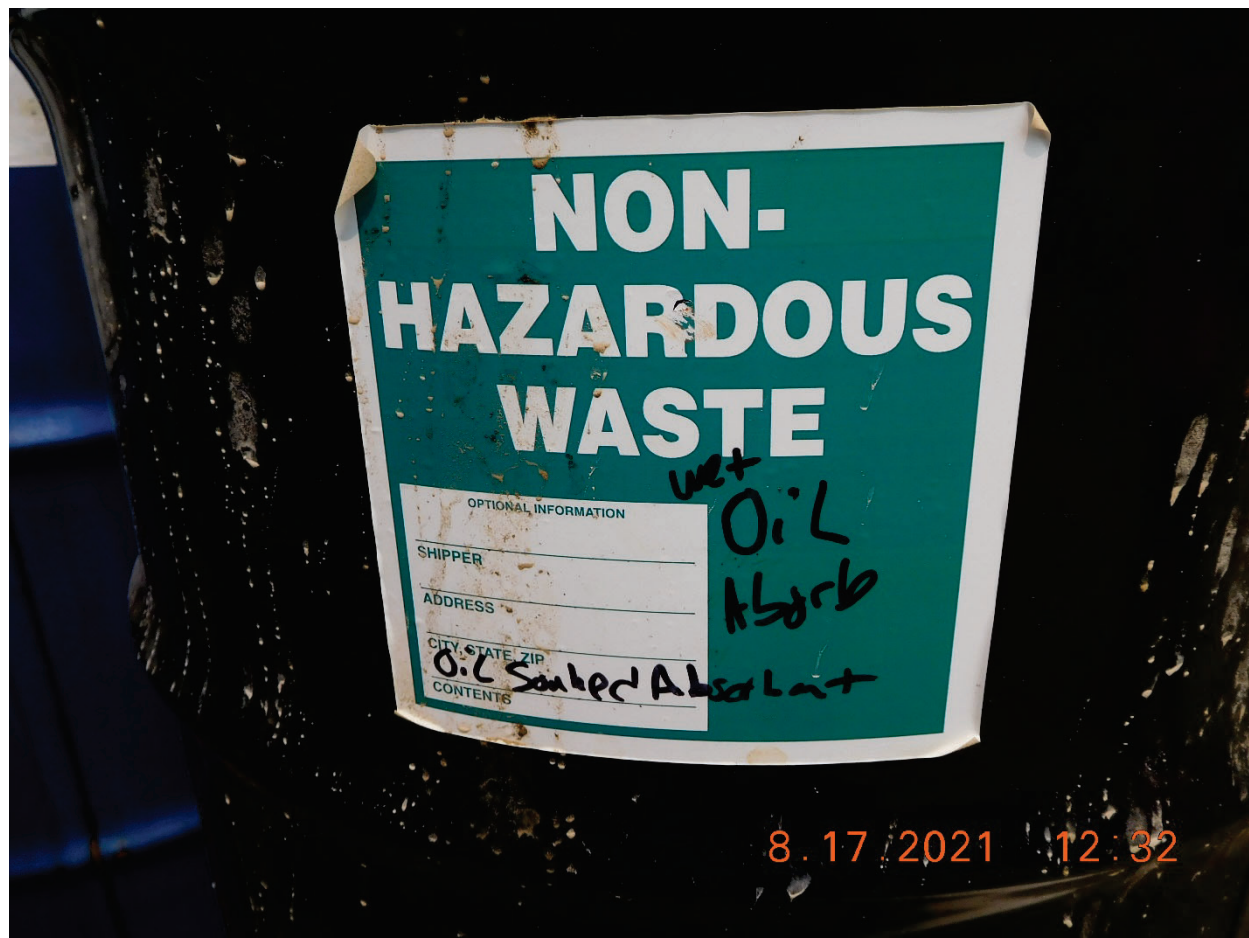
Photo 1435: DSCN1435.jpg: photo of a 55-gallon drum labeled “oil soaked absorbent”.

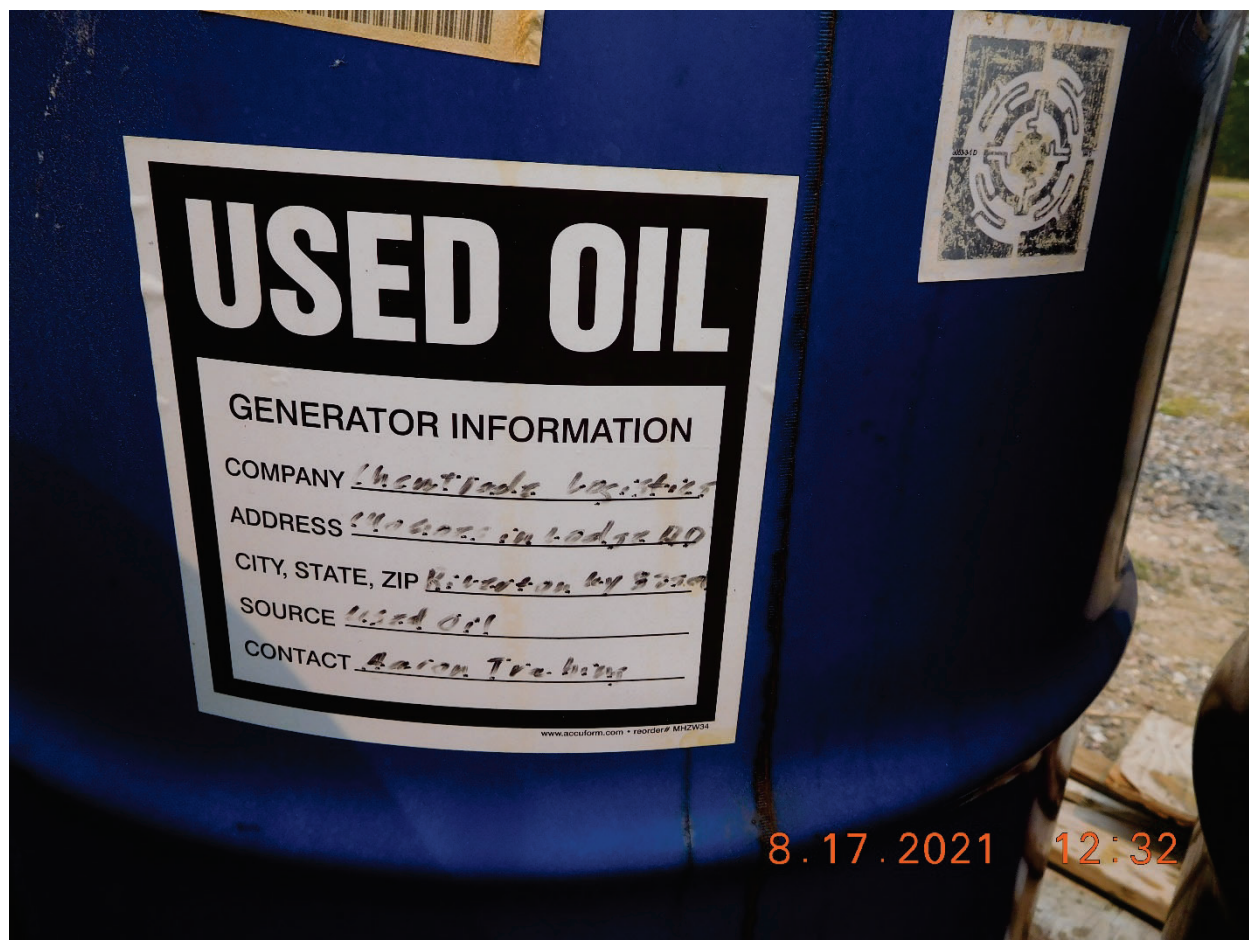
Photo 1436: DSCN1436.jpg: photo of a 55-gallon drum labeled “used oil”.

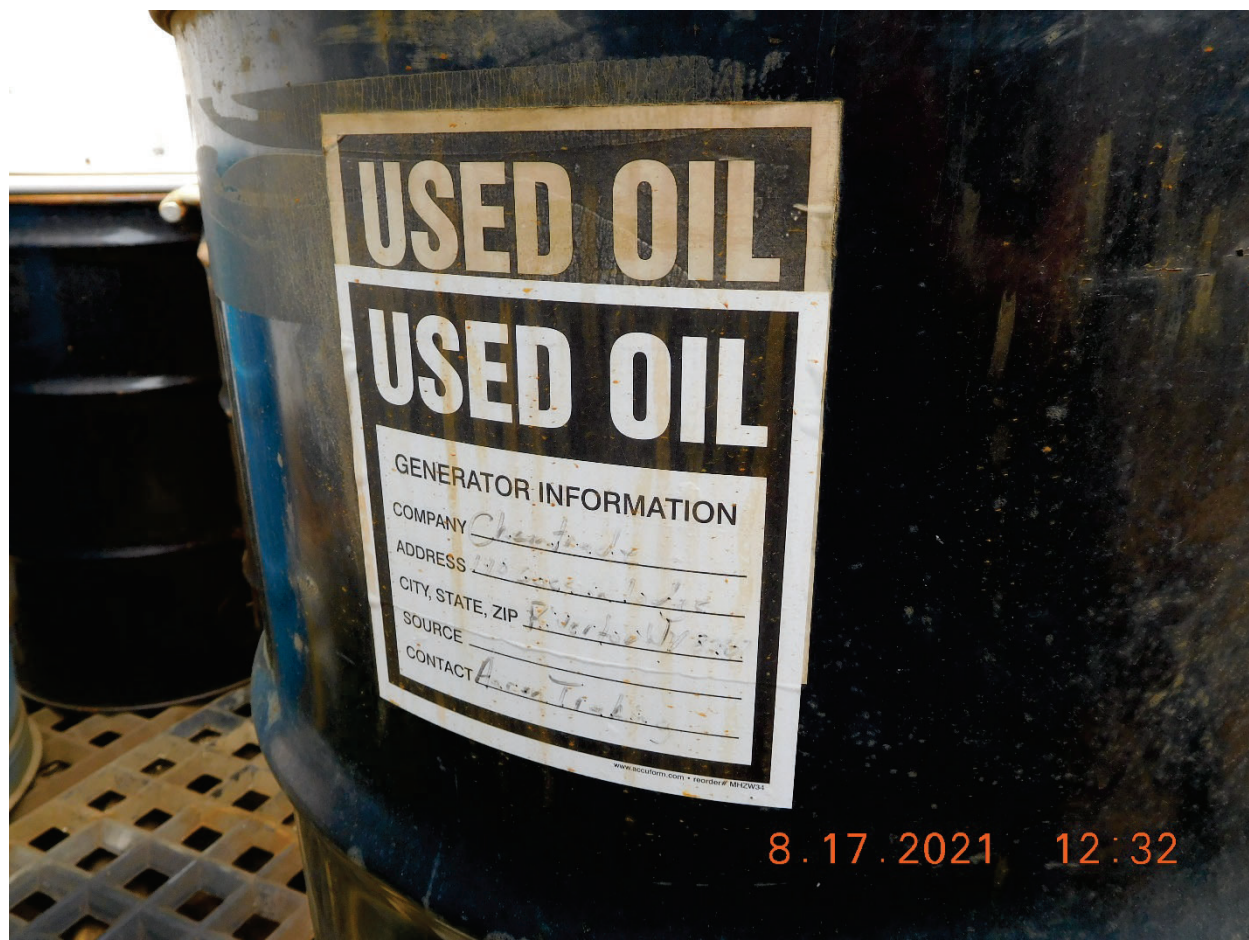
Photo 1437: DSCN1437.jpg: photo of a 55-gallon container labeled “used oil”.

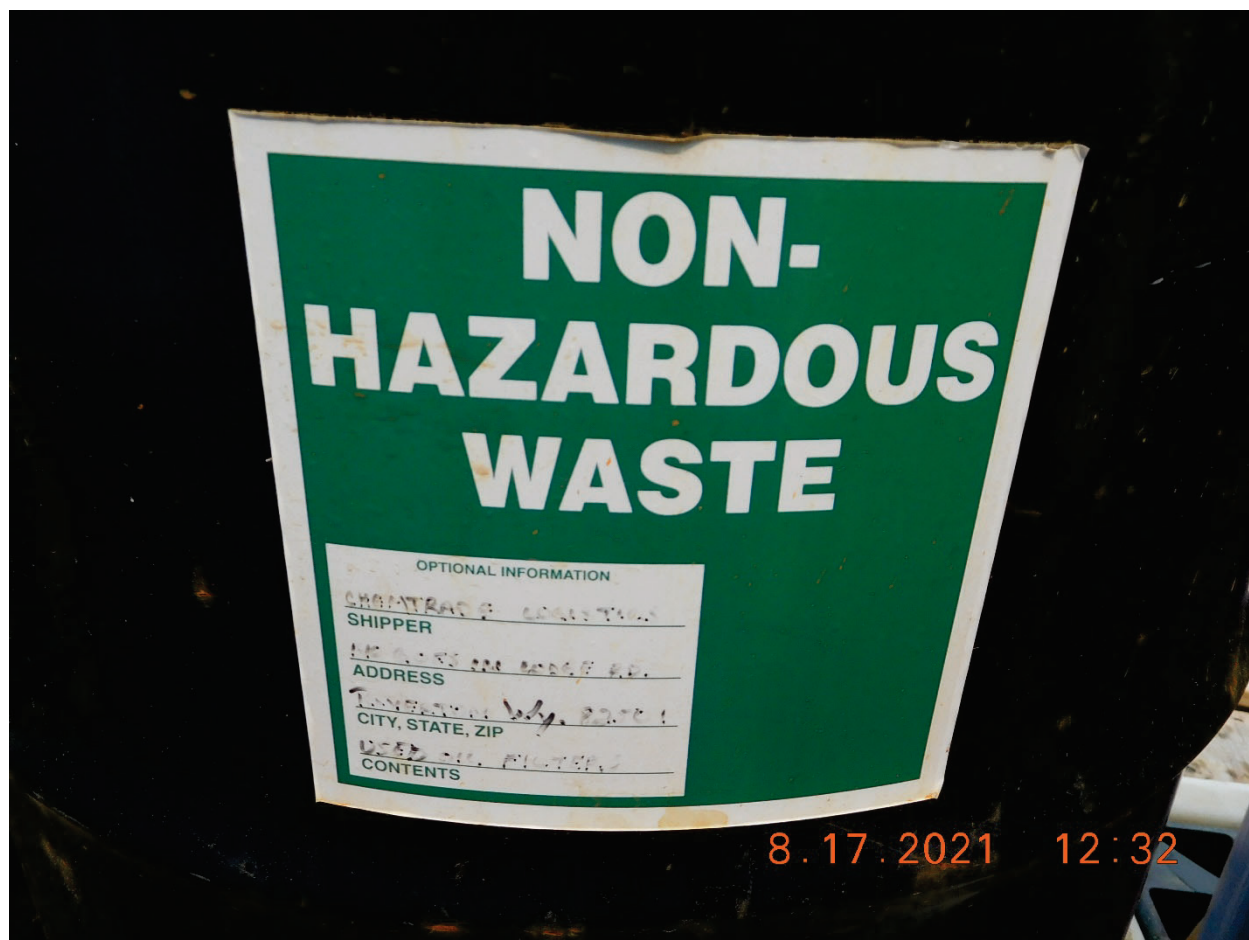
Photo 1438: DSCN1438.jpg: photo of a 55-gallon drum labeled “used oil filters”.

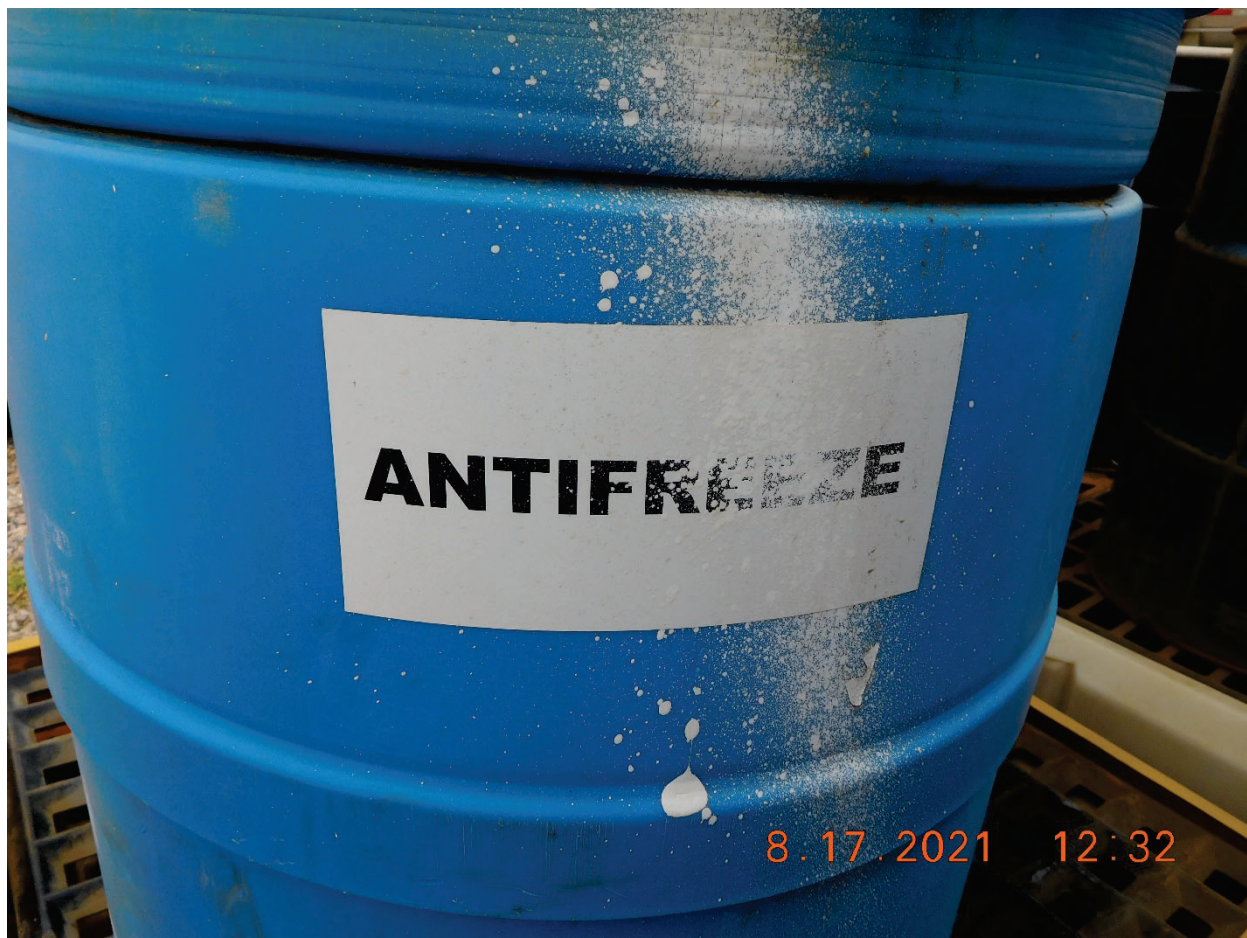
Photo 1439: DSCN1439.jpg: photo of an approximately 55-gallon drum labeled “antifreeze”.

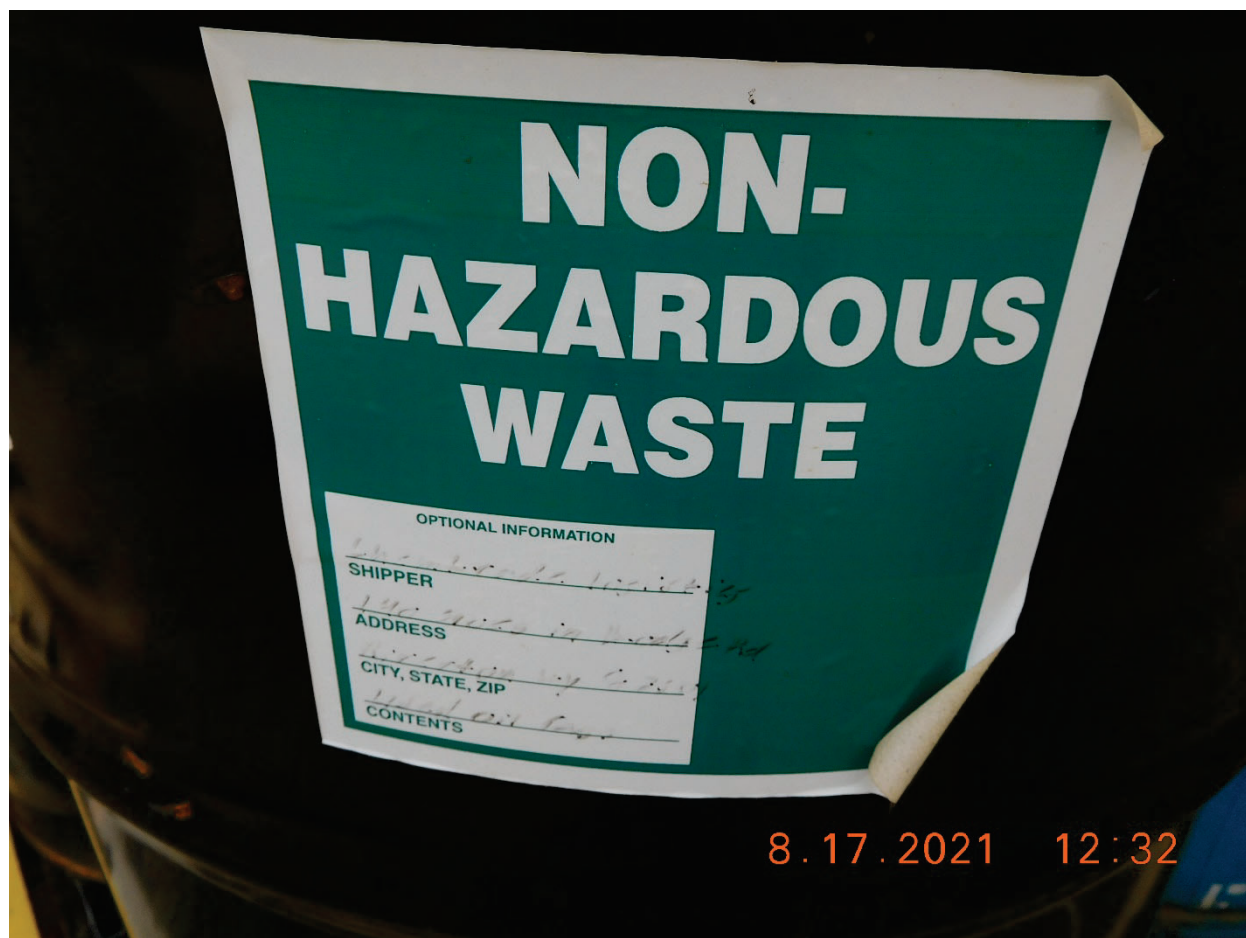
Photo 1440: DSCN1440.jpg: photo of a 55-gallon drum labeled “used oil rags”.

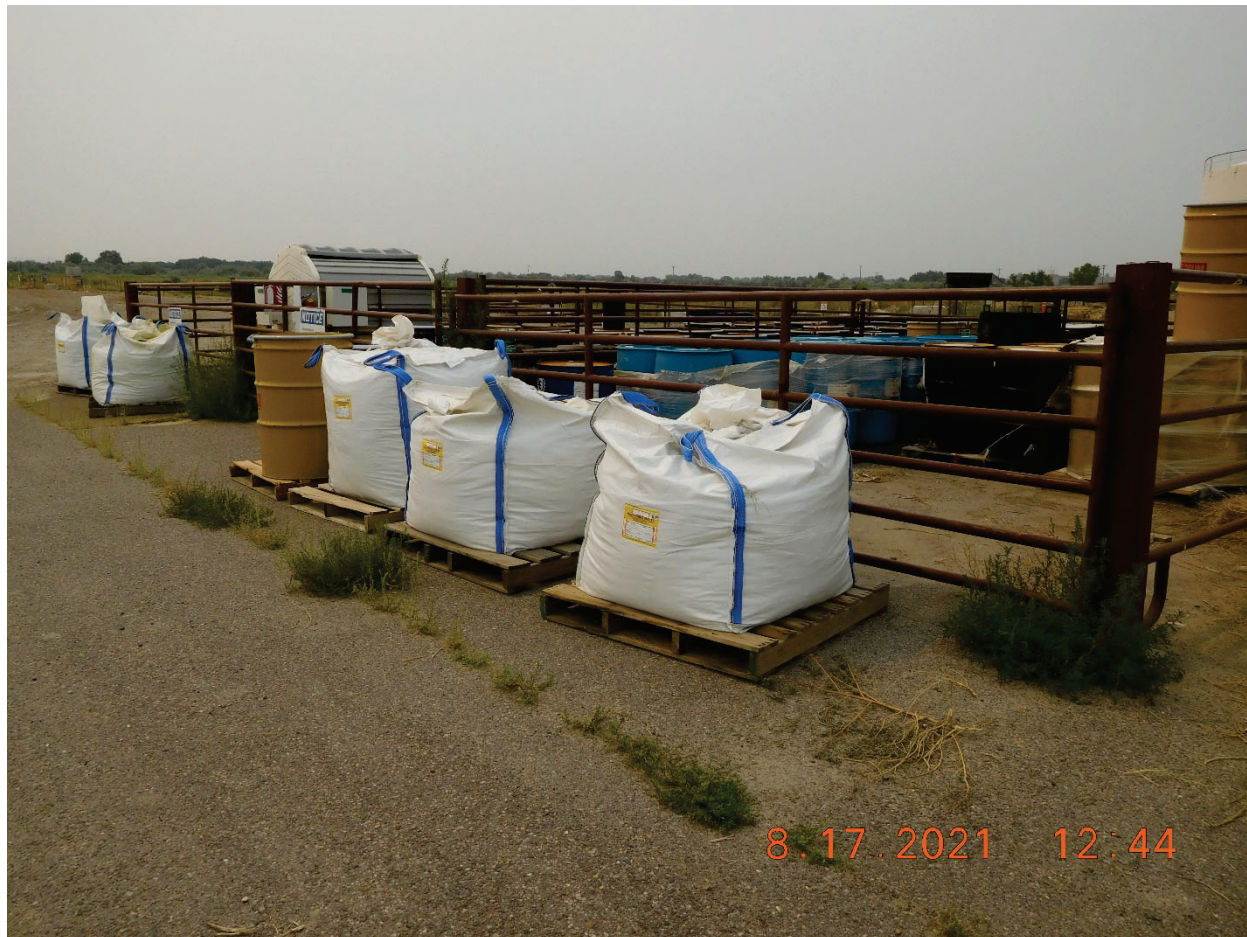
- two 55-gallon drums labeled “used oil”.
- “Waste Corral” 90-day central accumulation area (see photo 1441 for an overview of this area).
    - The area used for central accumulation of hazardous waste is located outdoors in the southeast portion of the Facility, east of the northern end of the wastewater ponds. The majority of waste is stored within fencing and a spill containment drum shed capable of holding a small number of drums is located inside the fencing.

- Outside of the fencing were:
        - Five supersacks set on pallets and awaiting disposal.
          - The five supersacks were labeled “Hazardous Waste”, “waste spent catalyst (chromium)”, and with Hazard Class 9; however, the five containers were not marked with an accumulation start date. (See photos 1441, 1442, 1443, 1444, 1447, 1448, 1449, and 1450.)

Photo 1441: DSCN1441.jpg: overview photo of the waste corral. Visible in the photo are supersacks containing hazardous waste, non-hazardous waste storage inside corral to right behind supersacks, and the hazardous waste pen located within the corral behind supersacks to left. Photo taken facing south/southwest.

- Please provide receiving Facility-signed manifests for the following wastes that were on-site at the time of the inspection:
  - supersacks;
  - drum of boiler ash waste that had been labeled non-hazardous;

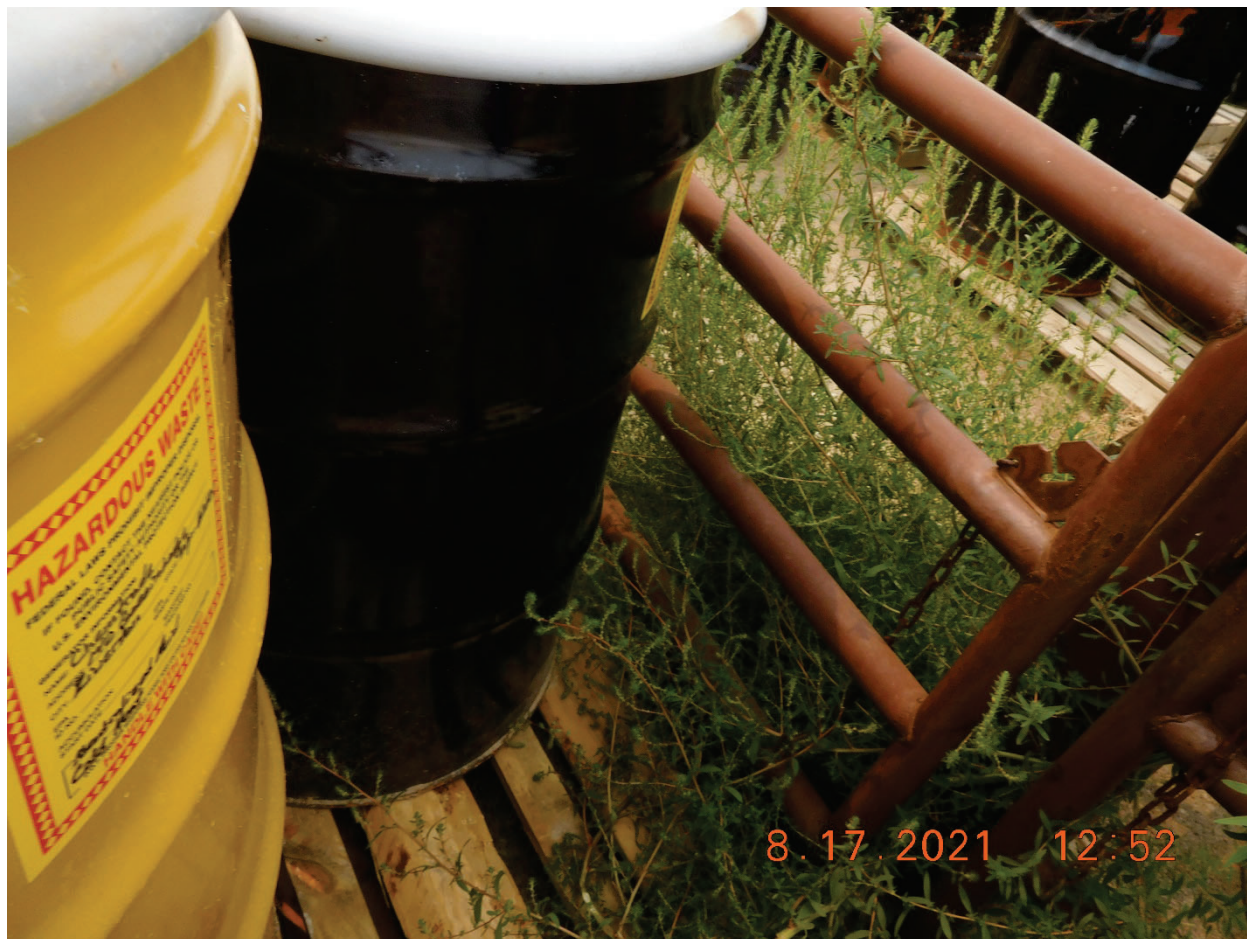
- One yellow salvage drum labeled “Hazardous Waste” and “neutralized acid, cold heat”, but it was not labeled with an indication of the hazards or with an accumulation start date. (See photos 1441, 1445, 1446, and 1447.) The Facility representatives stated that this container was initially labeled “hazardous waste”, but it was subsequently found to be non-hazardous following receipt of analytical data.

Photo 1445: DSCN1445.jpg: photo of one yellow and one black drum (both at left of fence) located in between the five supersacks shown in photo 1441. Both drums were labeled with the words “Hazardous Waste”.

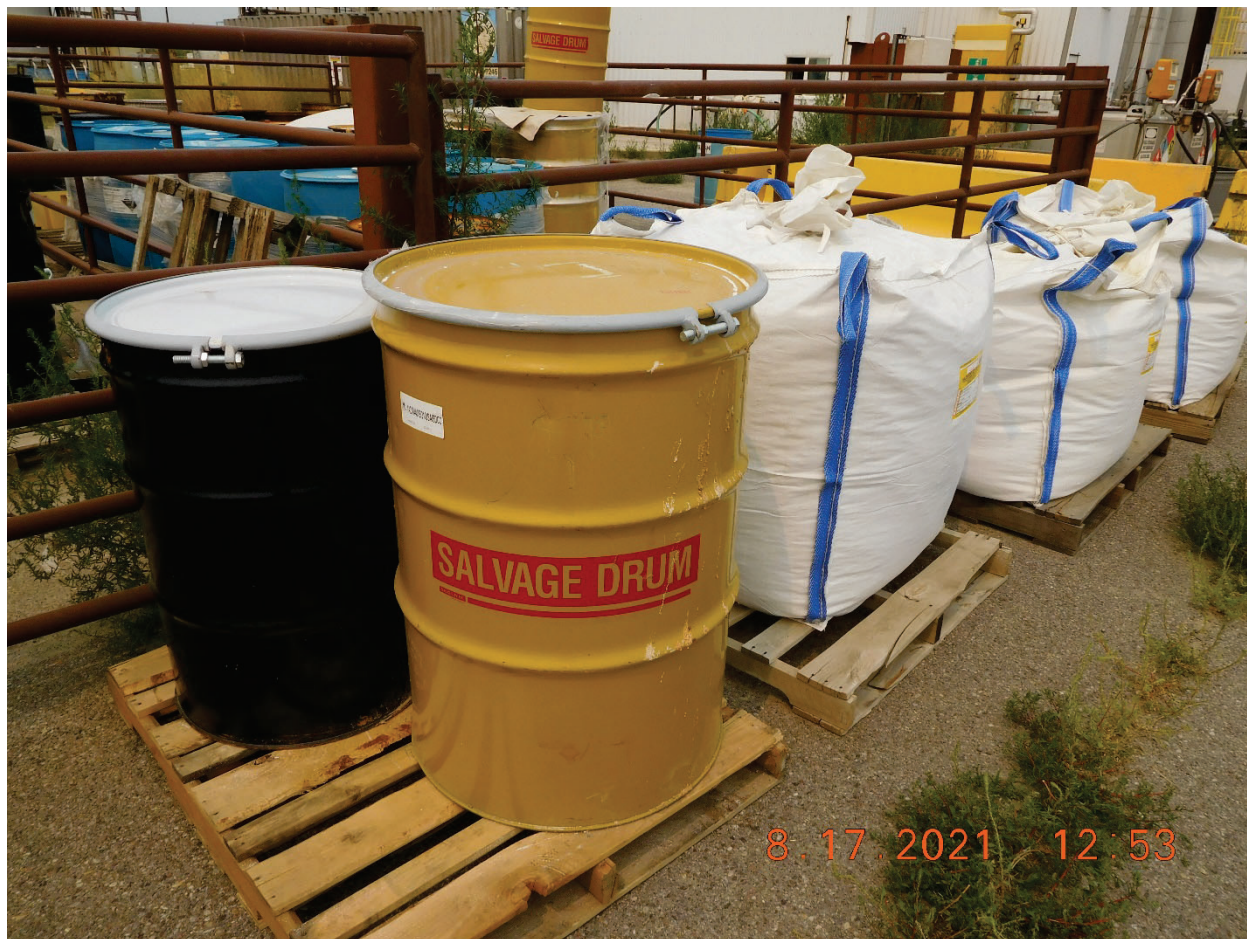
- One black 55-gallon drum with a hazardous waste label; the Facility representatives stated this container had also been determined to be non-hazardous following placement of the hazardous waste label. (See photo 1447.)

Photo 1447: DSCN1447.jpg: overview of drums depicted in photos 1445 and 1446. Photo taken facing northwest.

- Waste determination documentation demonstrating how the determination was made that the wastes in the yellow salvage drum and black 55-gallon drum located outside of the waste corral during the inspection and shown in photos 1447 were non-hazardous.

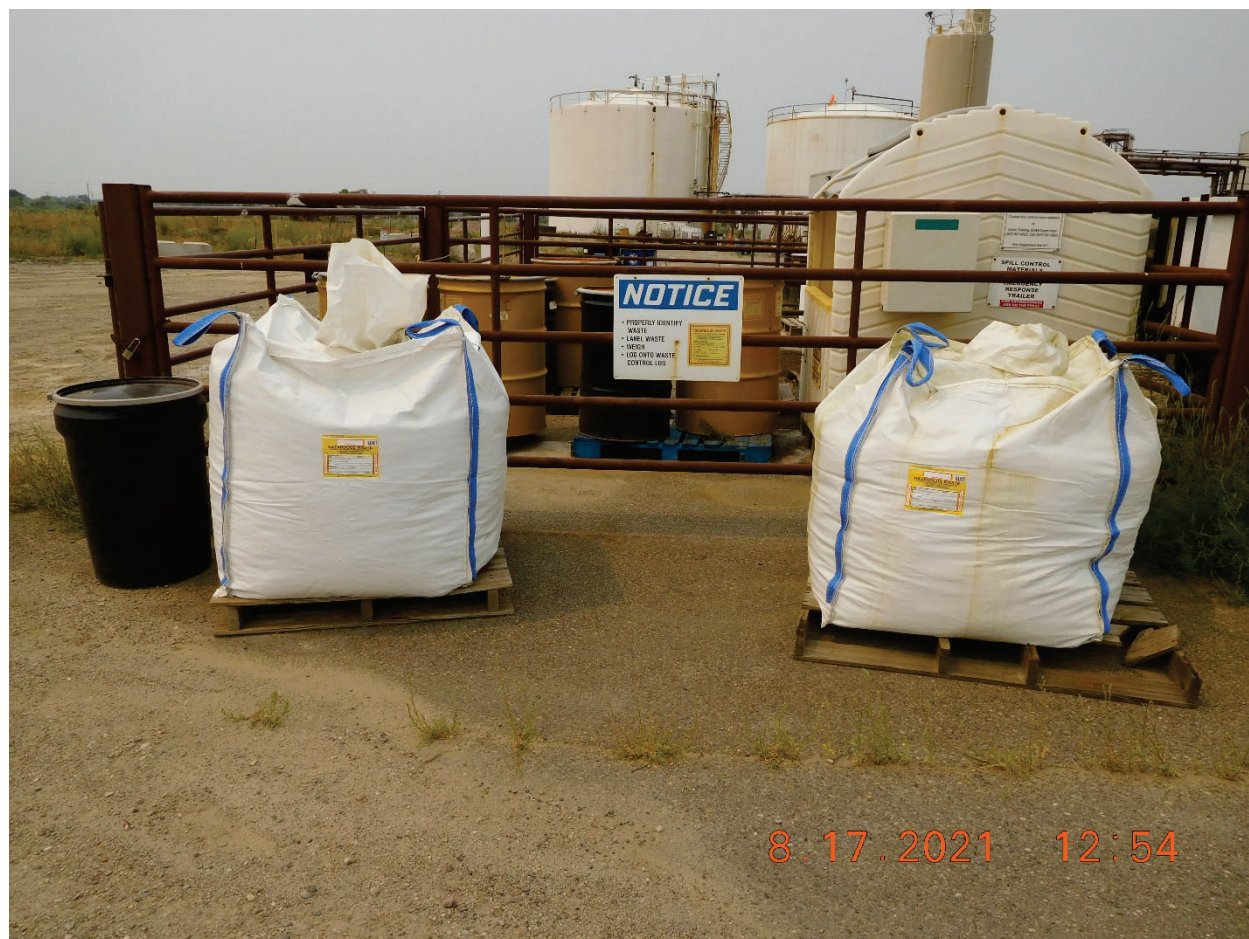
Photo 1448: DSCN1448.jpg: photo of the southernmost two supersacks shown in photo 1441 and a black drum to left, all three located east of the waste corral near the southeast corner. Photo taken facing west.

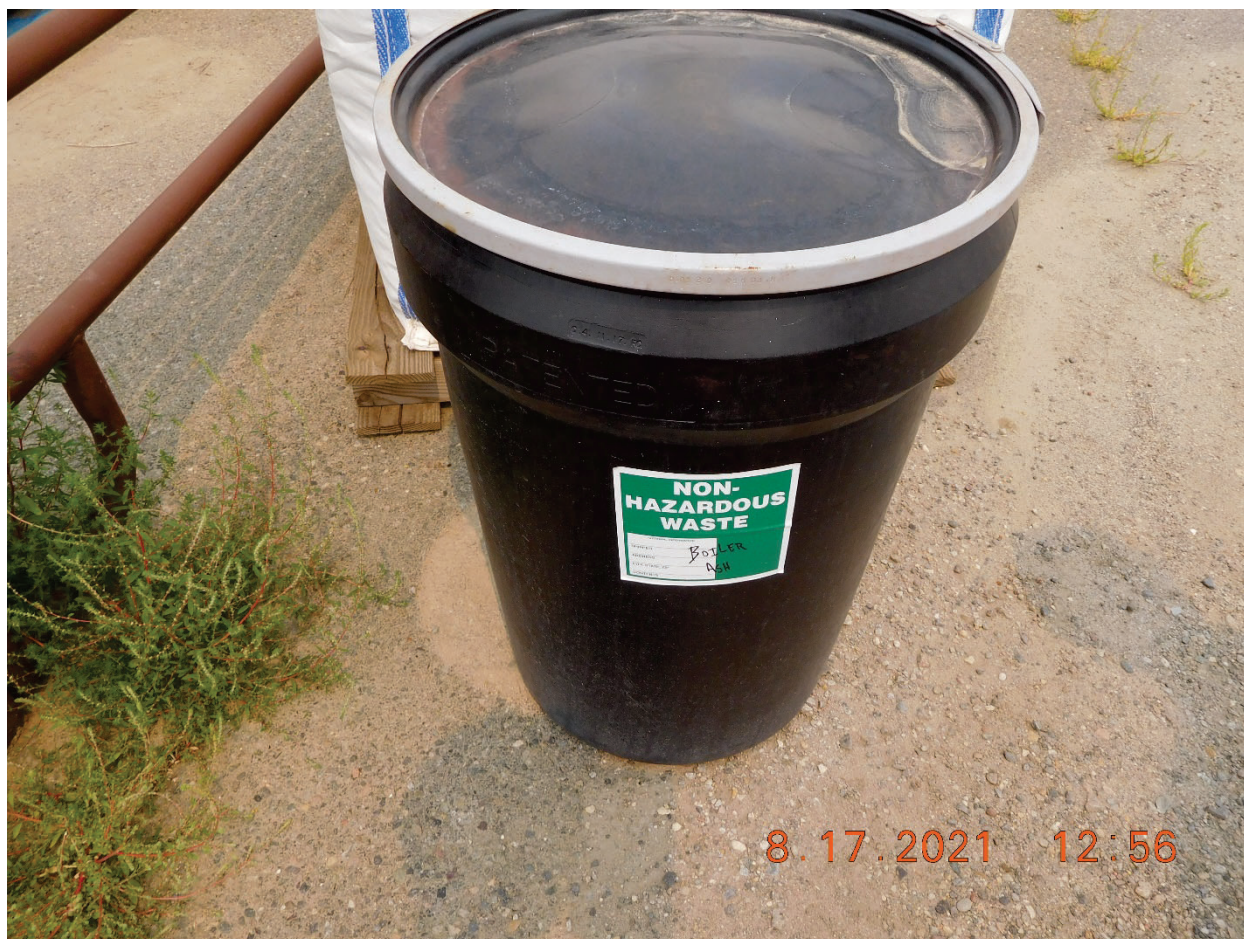
- One black poly drum labeled “non-hazardous waste” and “boiler ash”. This drum was incorrectly labeled, it is hazardous waste. The Facility representatives stated that a new employee had incorrectly labeled this container non-hazardous waste. (See photos 1451 and 1452.) The label was replaced with a hazardous waste label before the inspectors left the site, though the Facility representatives could not mark the label with the accumulation start date because it was not known. (See photo 1467.)

Photo 1451: DSCN1451.jpg: photo of drum shown at left in photo 1448. This drum was labeled “non-hazardous waste”, but it did contain hazardous waste (boiler ash).

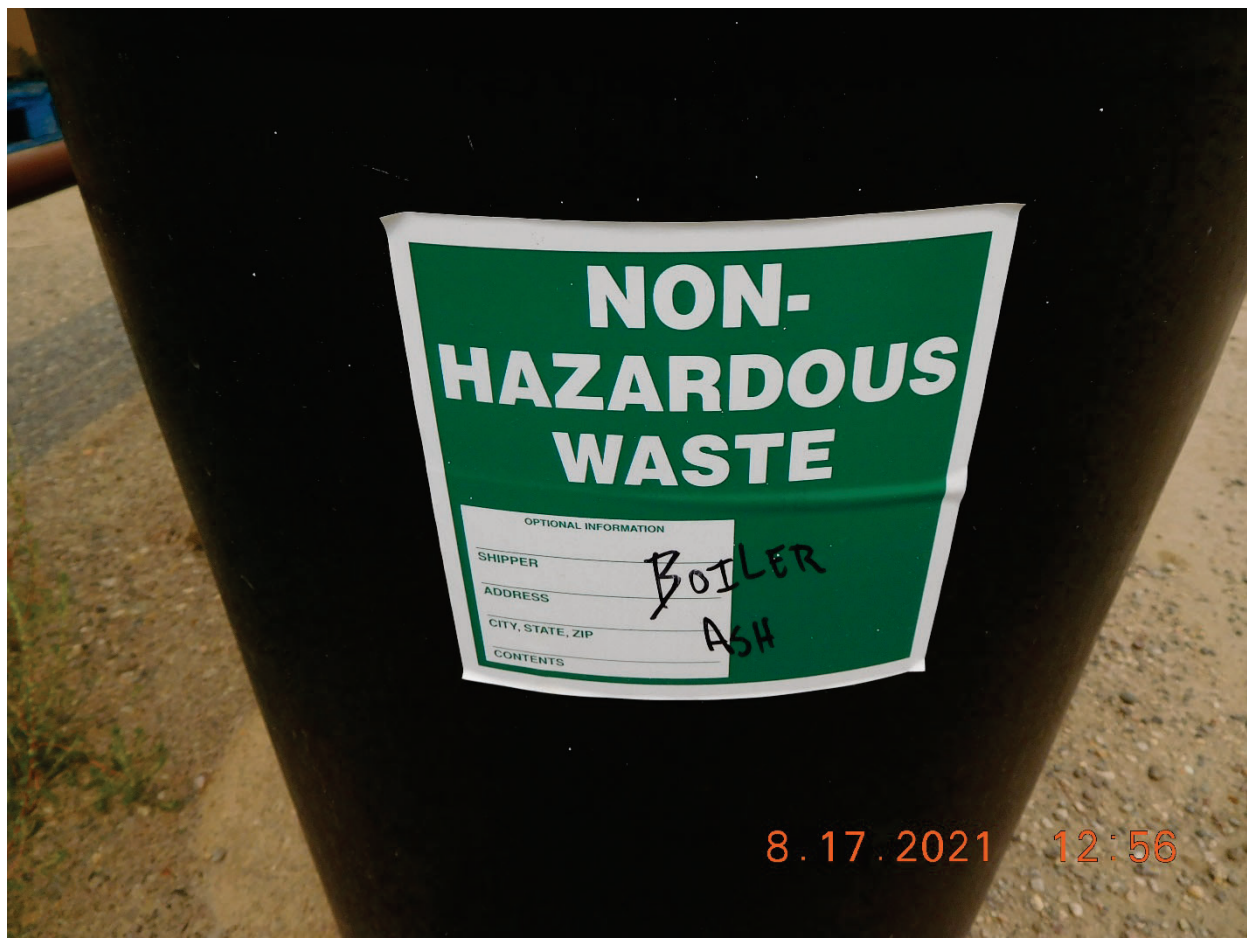
Photo 1452: DSCN1452.jpg: close-up of label on container shown in photo 1451.
