**UNITED STATES ENVIRONMENTAL PROTECTION AGENCY  
REGION 8  
RESOURCE CONSERVATION AND RECOVERY ACT**

**Facility Name:** Chemtrade Refinery Services Inc.      **Facility Location:** 140 Goes in Lodge Road, Riverton, Wyoming

**Date of Inspection:** August 17, 2021      **Arrival Time:** 9:00 a.m.  
**Departure Time:** 3:45 p.m.

**Type and Purpose of Inspection:** Compliance Evaluation Inspection

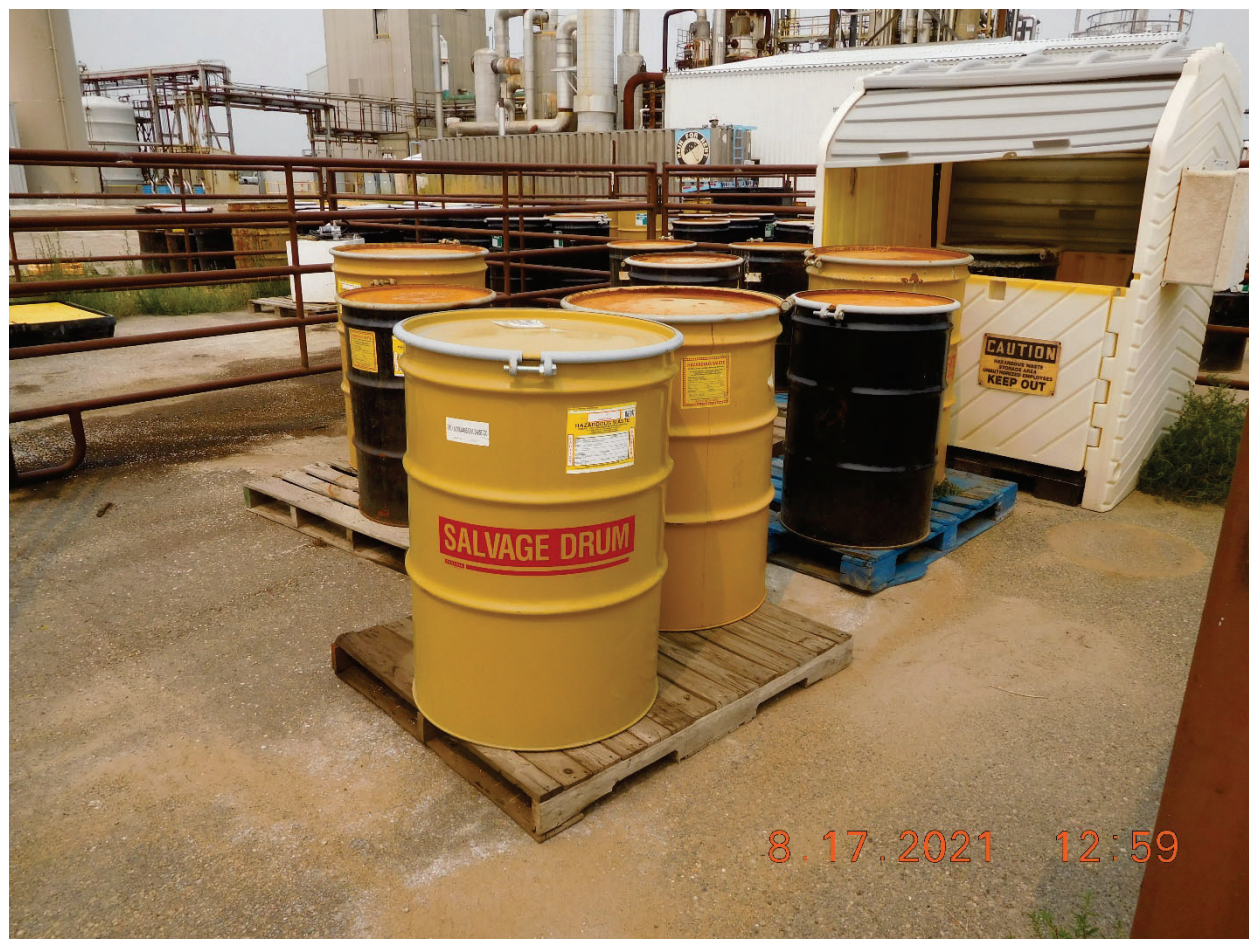
Photo 1453: DSCN1453.jpg: overview of hazardous waste stored inside the southwest pen of the waste corral.

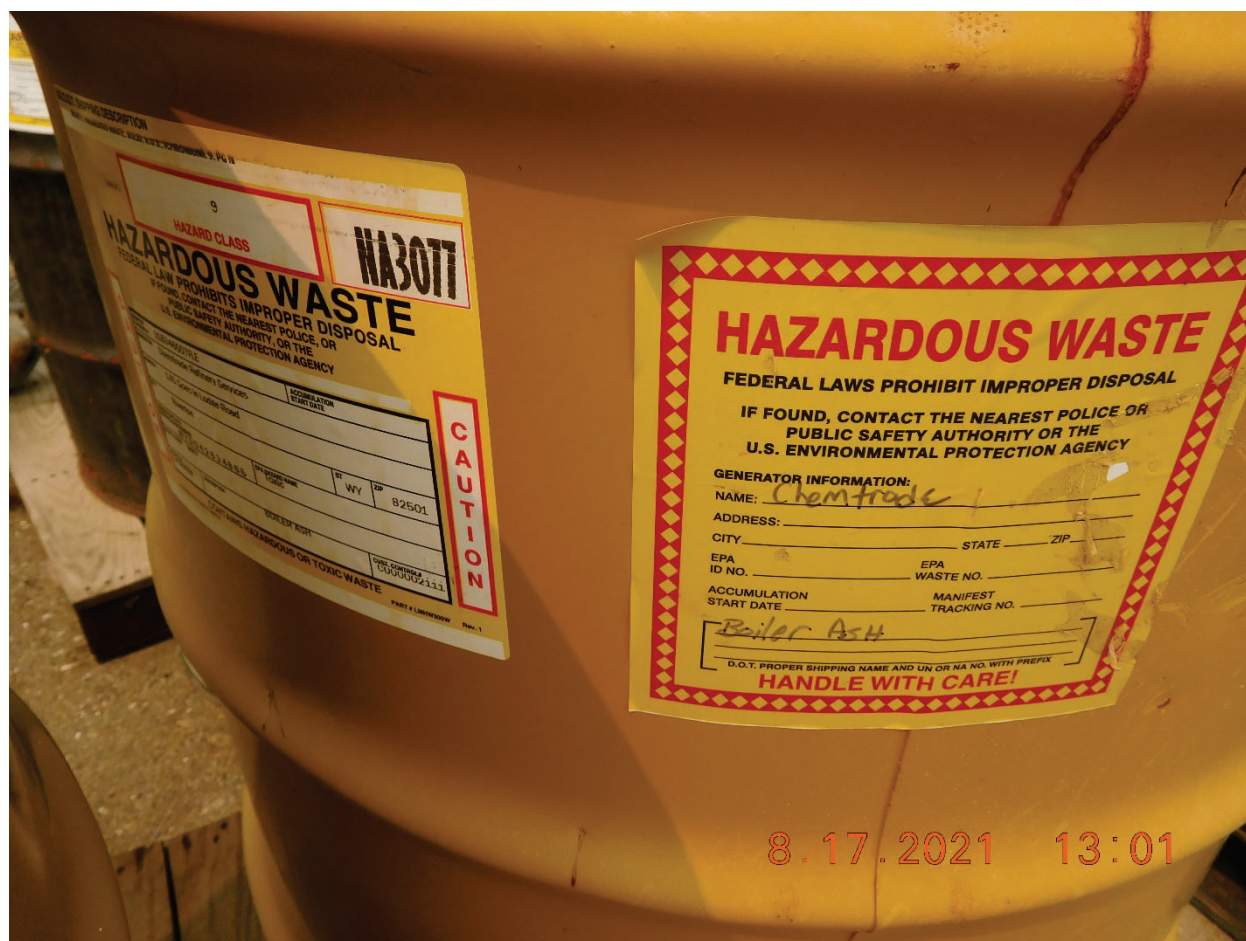
- Inside the fencing located in the southeast corner of the Waste Corral were ten drums labeled “hazardous waste” and with the hazard class, but none of the ten were marked with the accumulation start date. Following the viewing of this area, the Facility representatives stated that these ten containers were removed by Clean Harbors before the end of the inspection, but after the inspectors had left this area.

Photo 1455: DSCN1455.jpg close-up of a label on a second container shown in photo 1454 that includes the words “hazardous waste”, “boiler ash” and “hazard class 9”, but with no accumulation start date.

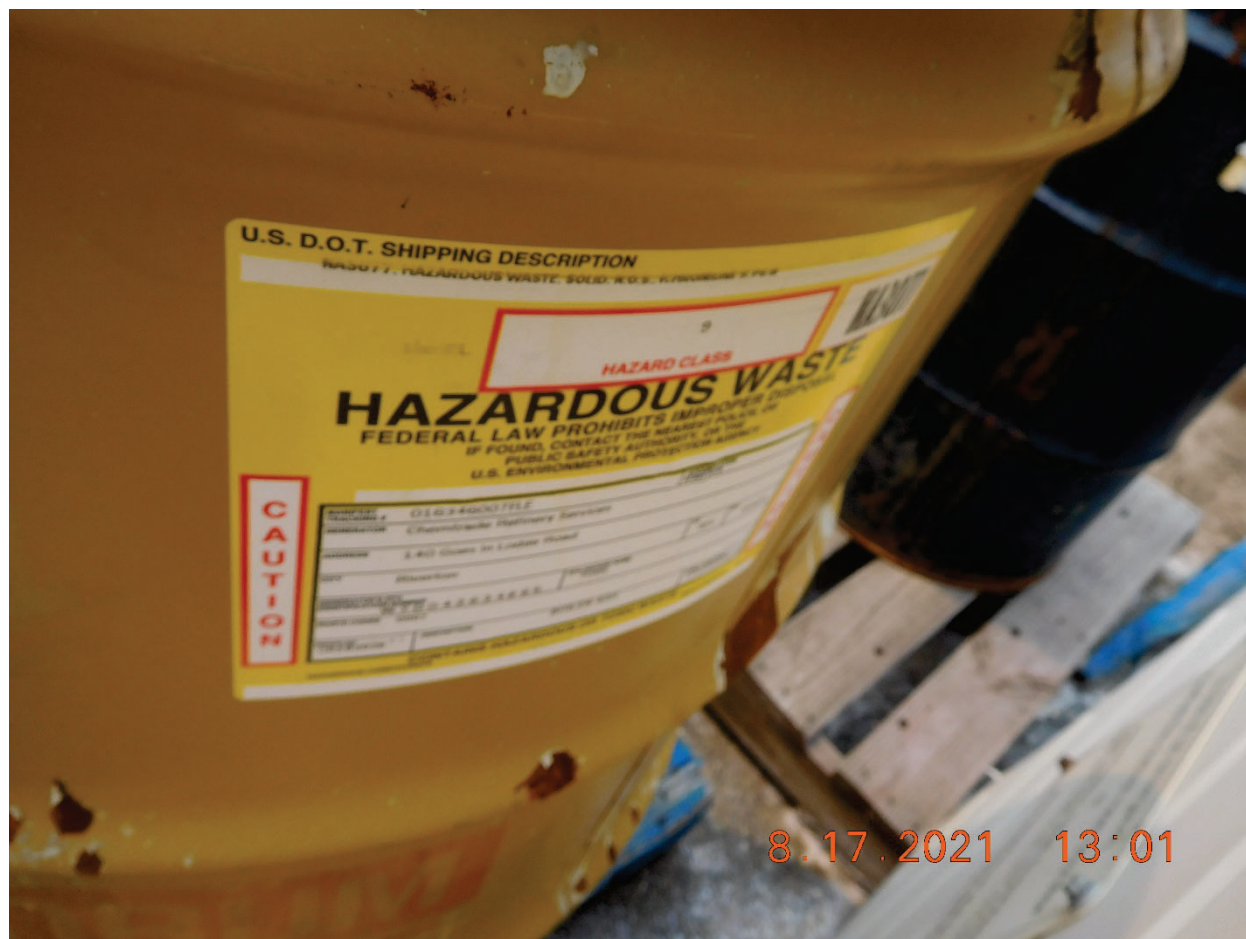
Photo 1456: DSCN1456.jpg: close-up of a label on a third container shown in photo 1454 that includes the words “hazardous waste” and “hazard class 9”, but with no accumulation start date.

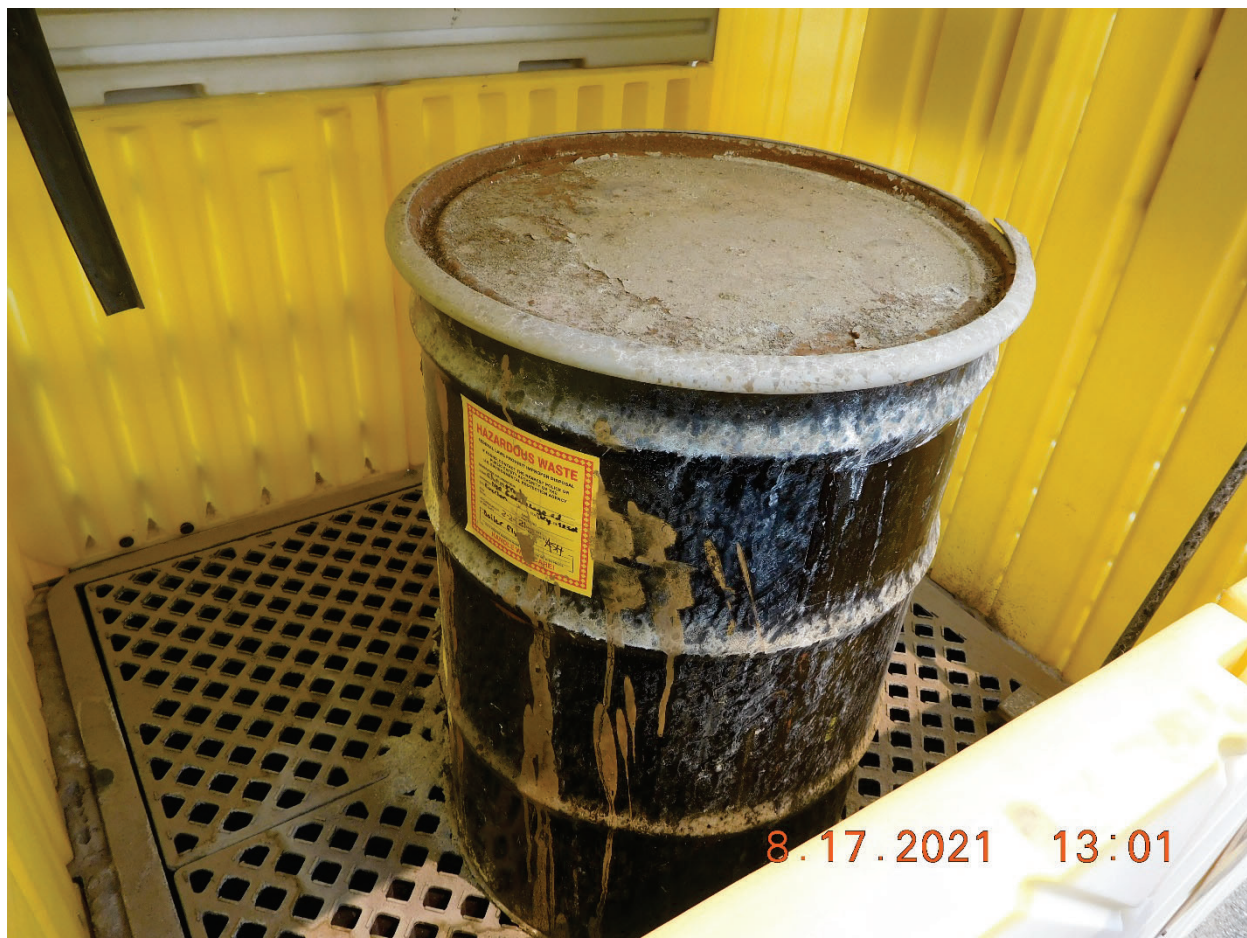
- Inside a drum shelter in this fenced area.
  - One drum was labeled “hazardous waste” and “boiler fly ash” and with an accumulation start date of 2/2/21, which indicates this hazardous waste had been accumulated and stored in this container for longer than the 90-days allowable for a Facility with LQG status based on the LQG conditions for exemption from RCRA permit requirements. In addition, the label was not marked with an indication of the hazards. (See photos 1453, 1459, and 1460.)

Photo 1459: DSCN1459.jpg: photo of a drum located inside a drum shelter within the waste corral.

- drums containing hazardous waste in and near the waste corral with no accumulation start date; and
  - Universal wastes
- Provide documentation of the status of the drum located in the drum shelter inside of the waste corral. If this drum was shipped for disposal, please provide a copy of the hazardous waste manifest. If it is awaiting disposal, provide a description of the steps to be taken for its disposal as well as a description of procedures to be implemented to avoid future exceedance of the LQG 90-day storage time limit.

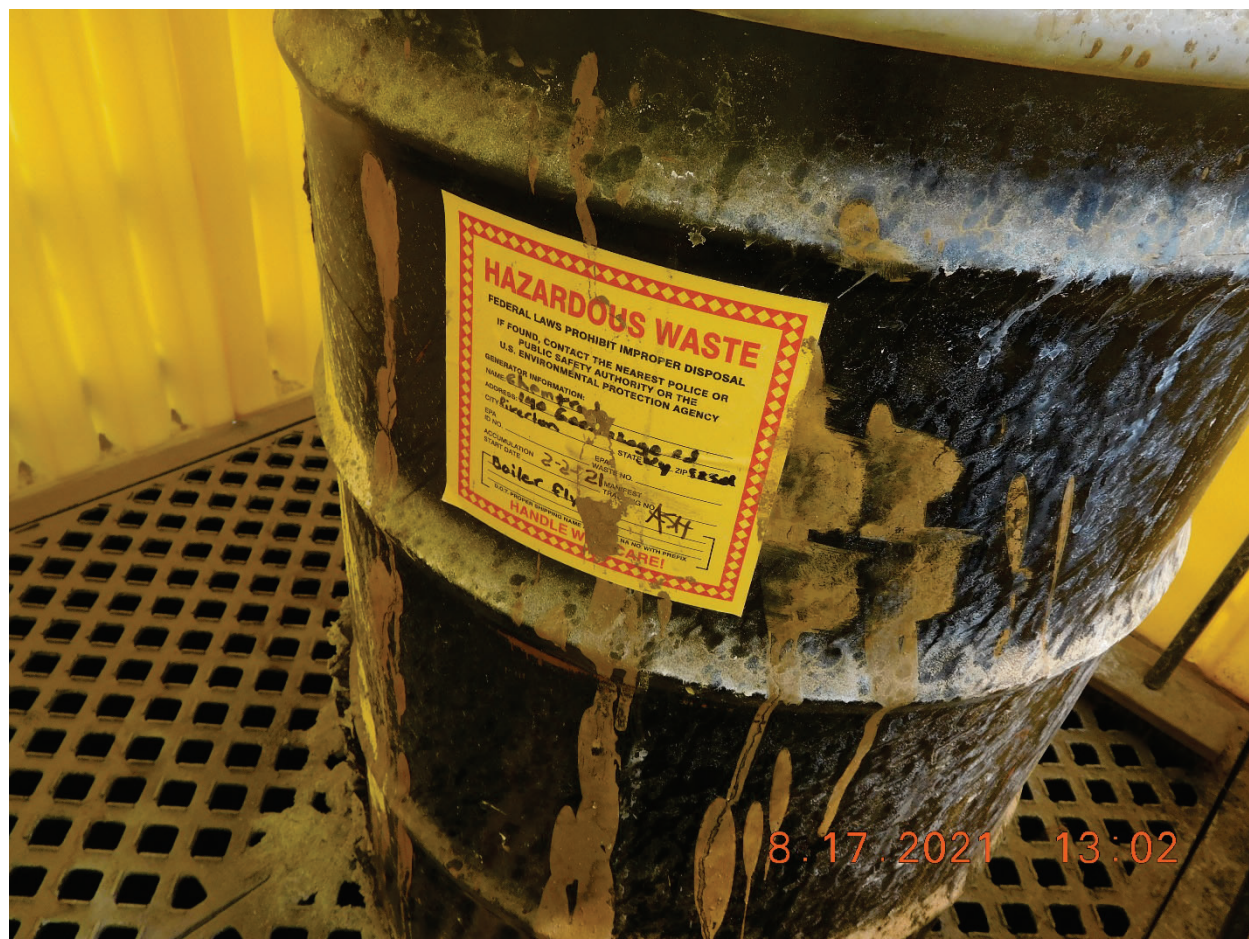
Photo 1460: DSCN1460.jpg: close-up of the label on the drum shown in photo 1459. This drum was labeled with an accumulation start date of February 2, 2021 (marked 2-2-21) indicating that accumulation of hazardous waste in this container had exceeded 90 days.

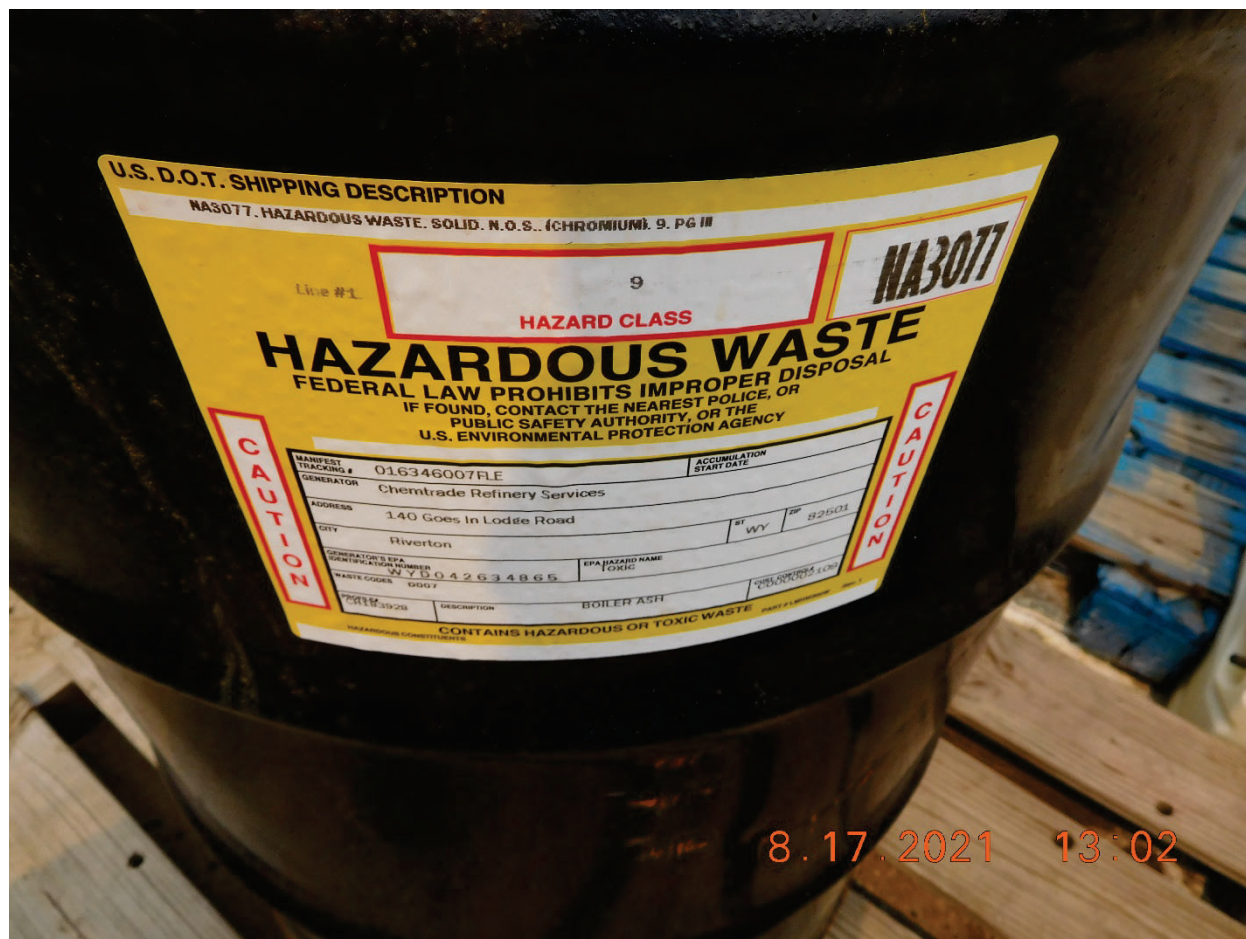
Photo 1461: DSCN1461.jpg: photo of a sixth drum located inside the waste corral that was labeled “hazardous waste”, but it was not labeled with an accumulation start date.

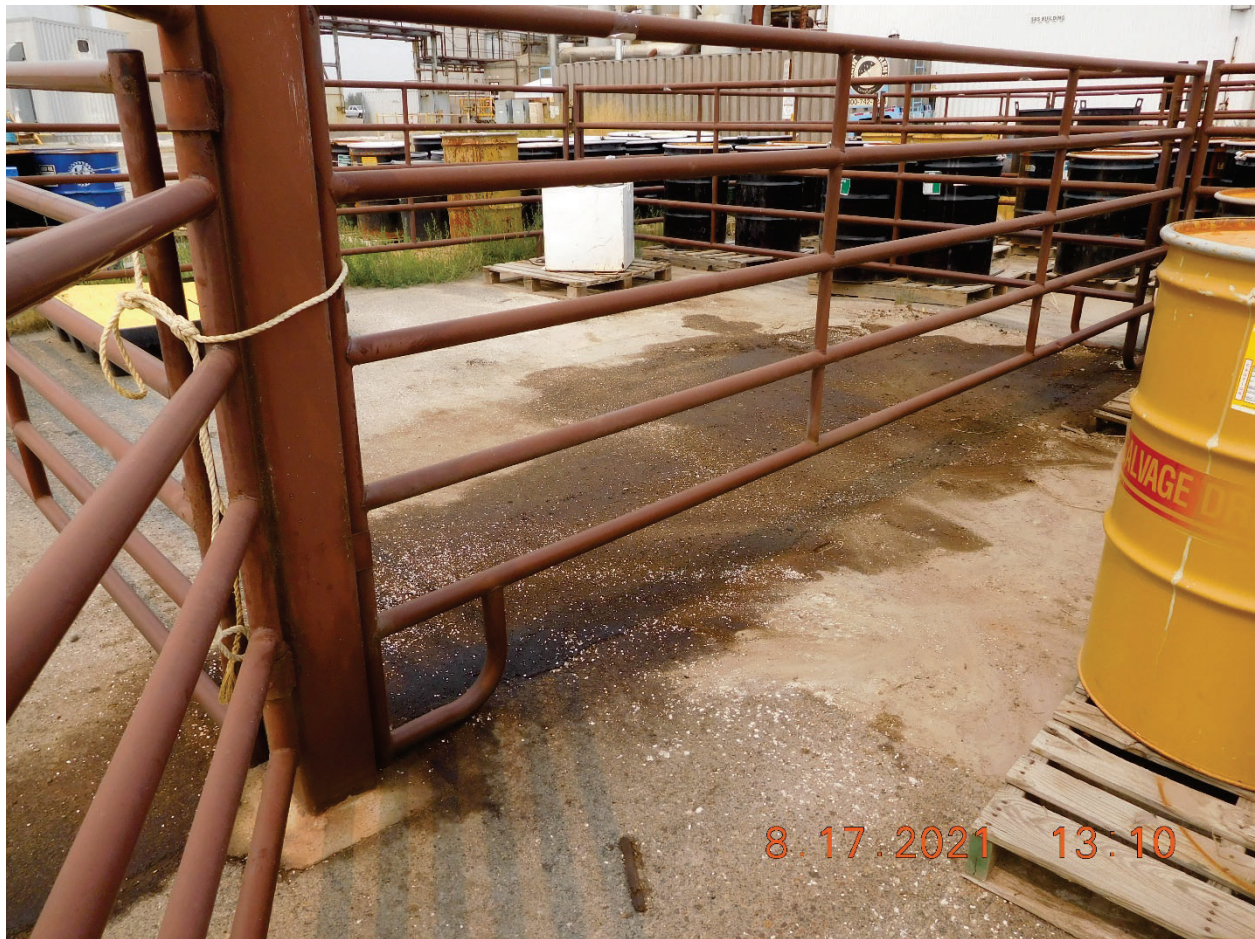
- In the next fenced area to the west within the Waste Corral, I observed stained soil. The Facility representatives stated it was used oil and used oil storage was no longer in this area. I requested a photo of the area showing the spill had been cleaned up.

Photo 1466: DSCN1466.jpg: photo of a spill in the waste corral area. The Facility representatives stated that used oil had previously been stored in this area.

- labeling, specifically in regard to accumulation start dates on 90-day waste containers, and indication of the hazards labeling on SAA containers;
- the spilled used oil in the waste corral (requested a photo post-cleanup and a description of how the contaminated soil would be managed);
- universal waste storage greater than one year, noting that the waste was removed from the site by Clean Harbors prior to the end of the inspection; and
- a drum labeled non-hazardous that did contain hazardous waste, noting that a hazardous waste label had been applied prior to the end of the inspection.

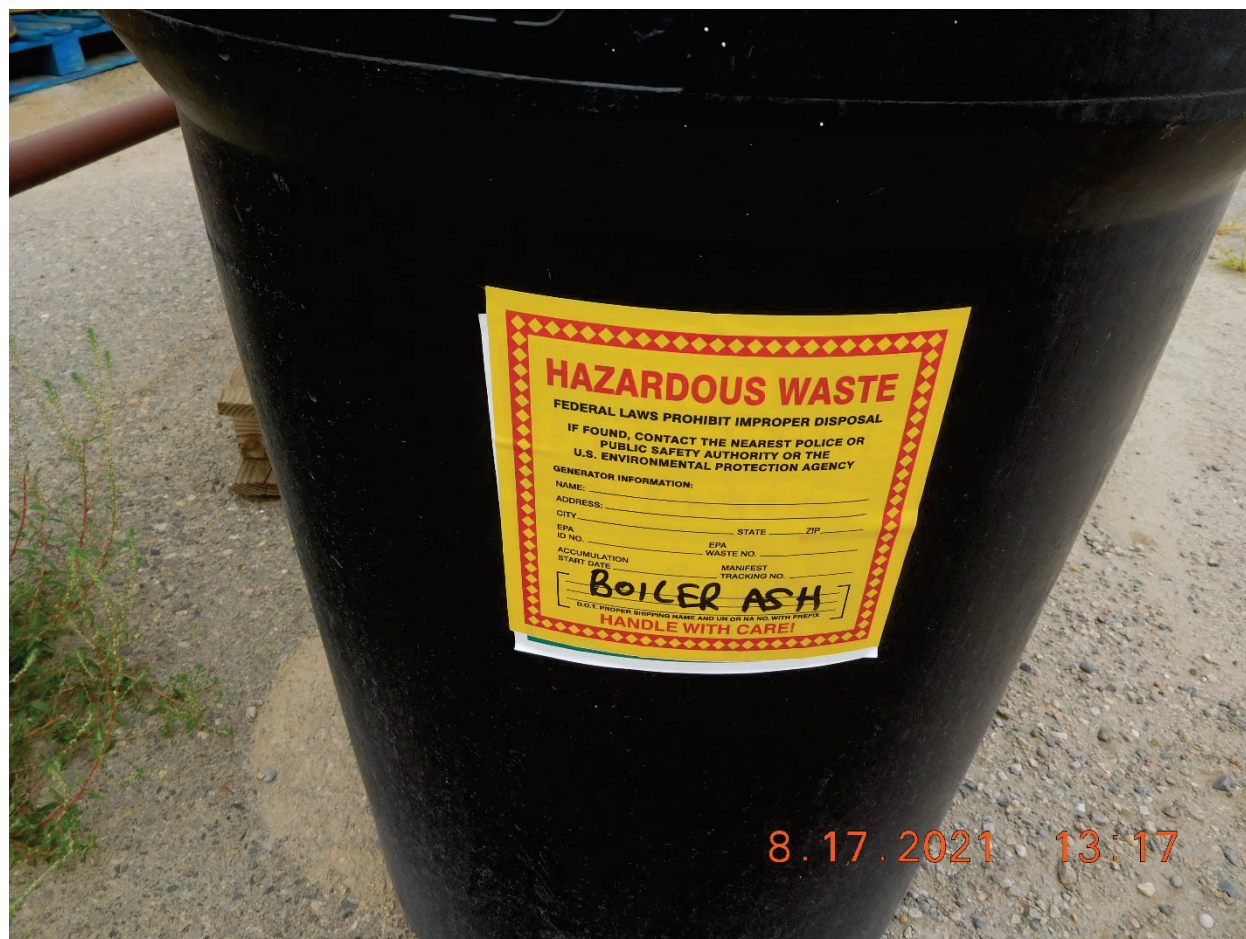
- One black poly drum labeled “non-hazardous waste” and “boiler ash”. This drum was incorrectly labeled, it is hazardous waste. The Facility representatives stated that a new employee had incorrectly labeled this container non-hazardous waste. (See photos 1451 and 1452.) The label was replaced with a hazardous waste label before the inspectors left the site, though the Facility representatives could not mark the label with the accumulation start date because it was not known. (See photo 1467.)

Photo 1467: DSCN1467.jpg: photo of a new hazardous waste label placed onto the container shown in photos 1448, 1451 and 1452 that had been labeled non-hazardous.

- a statement that a hazardous waste label was applied over the non-hazardous label for the improperly labeled drum.
- A copy of a hazardous waste storage area and SAA weekly inspection form for July 1, 6, 14, 21, and 29, 2021 noting the time the inspection was done and the name of the person performing it.

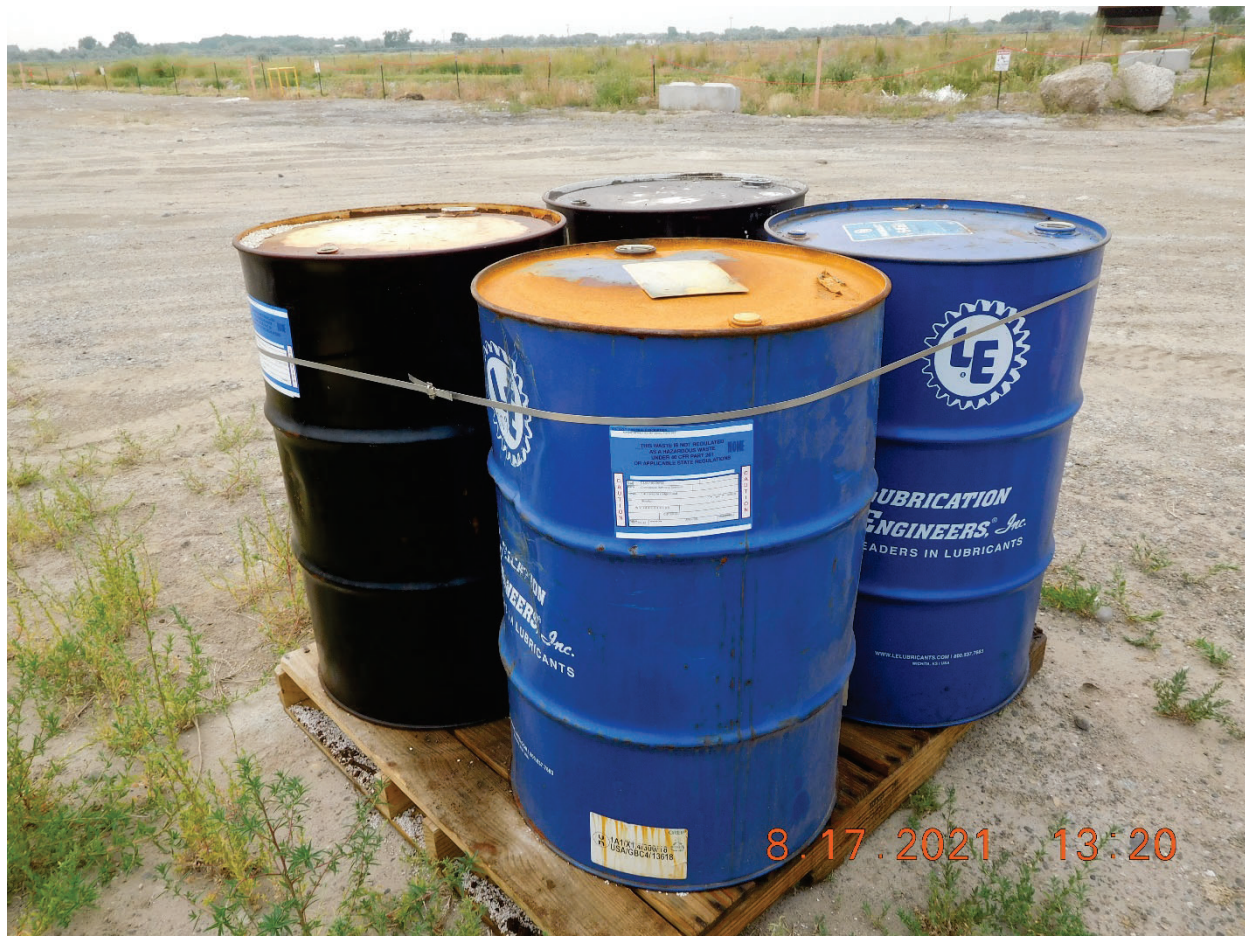
- In other sections of the Waste Corral and outside of the fencing on the west side of Waste Corral, additional drums were stored that the Facility representatives stated were non-hazardous waste. (See photos 1468-1471.) I was not able to view all of the labels on these containers as there was not aisle space, which is not required for non-hazardous waste. I did observe the following:

Photo 1468: DSCN1468.jpg: photo of non-hazardous waste stored to the west of the waste corral.

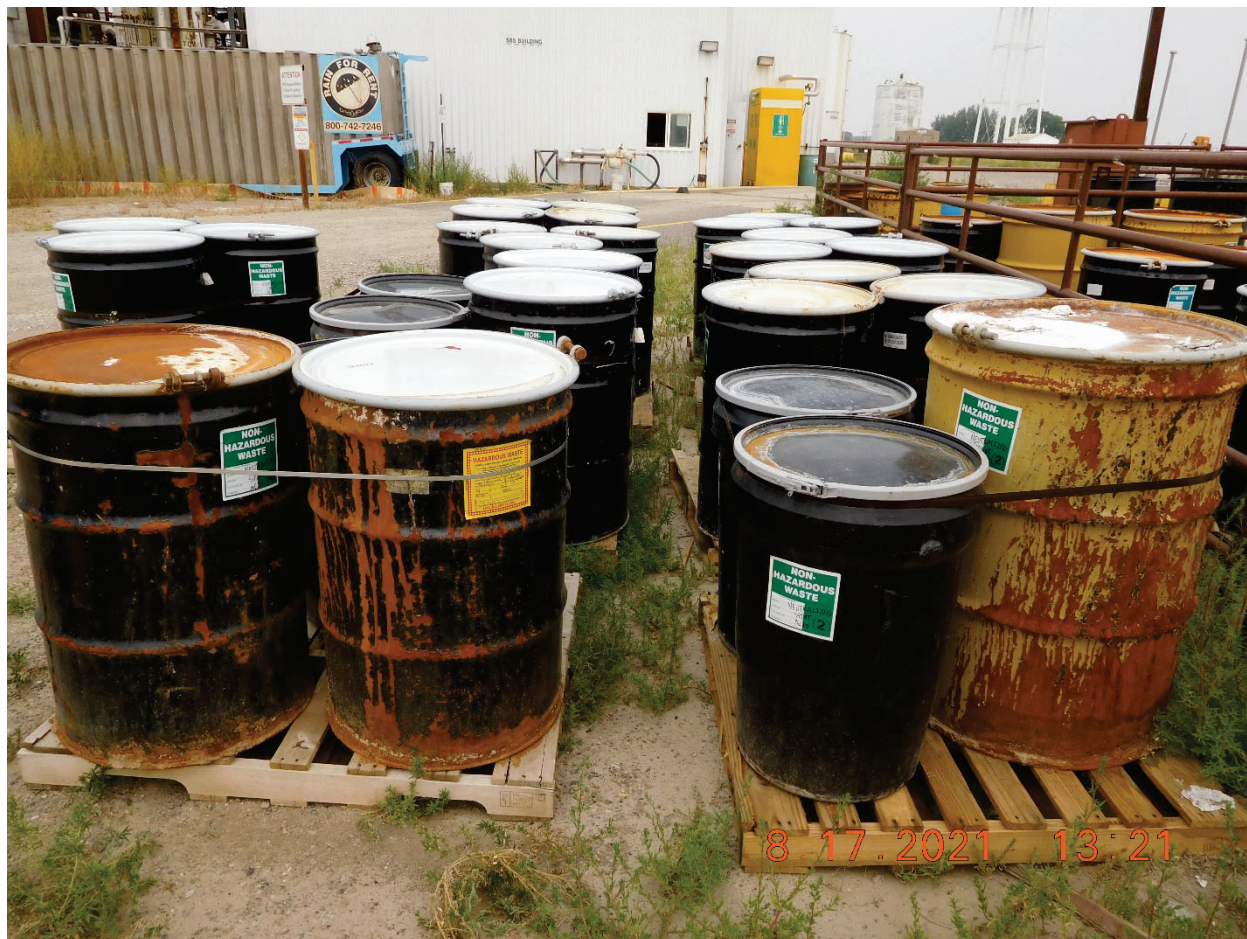
- On one pallet, four drums were labeled used oil (see photos 1468-1469).
  - One drum outside of the fencing was marked with two labels, one with the wording “hazardous waste” and the second label with the wording “non-hazardous waste”. The Facility representatives stated that this was in fact a non-hazardous waste, specifically neutralized spent acid, and the hazardous waste label had been improperly applied. (See photos 1470-1471.)

Photo 1470: DSCN1470.jpg: photo of non-hazardous waste containers stored to the west of the waste corral. One container, center left, was labeled with both a hazardous waste label and also a non-hazardous waste label. The Facility personnel stated that the hazardous waste label had been incorrectly applied, and that the waste was non-hazardous.

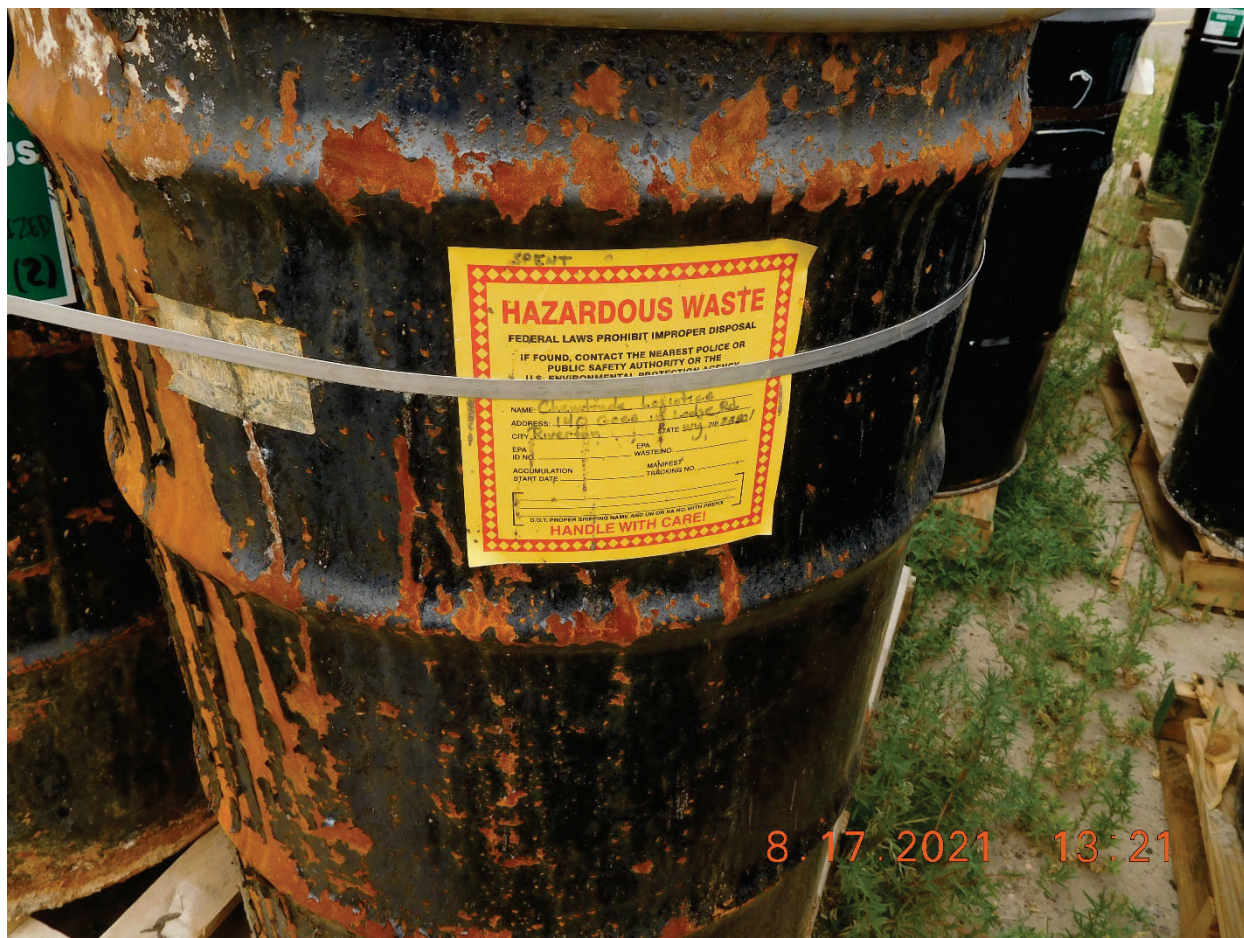
Photo 1471: DSCN1471.jpg: close-up of the hazardous waste label shown in photo 1470.

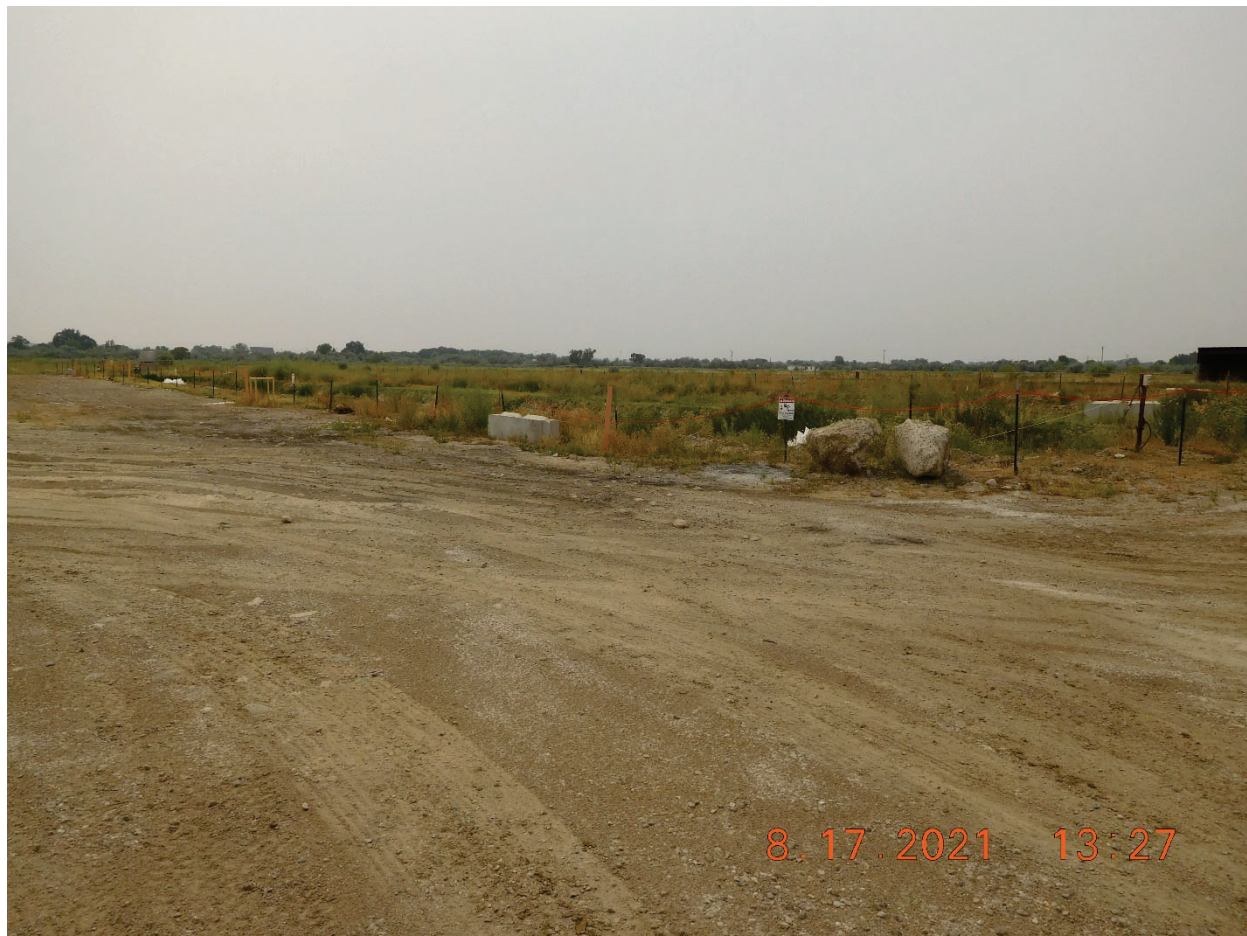
Photo 1472: DSCN1472.jpg: overview of the wastewater pond area. Photo taken facing southwest.

- For the dredged material from the wastewater ponds, please provide a description of how samples were collected to ensure that the samples were representative or provide a sampling plan and schedule for re-sampling. Representative samples are required for hazardous waste determinations made to identify whether the waste is hazardous for any of the hazardous

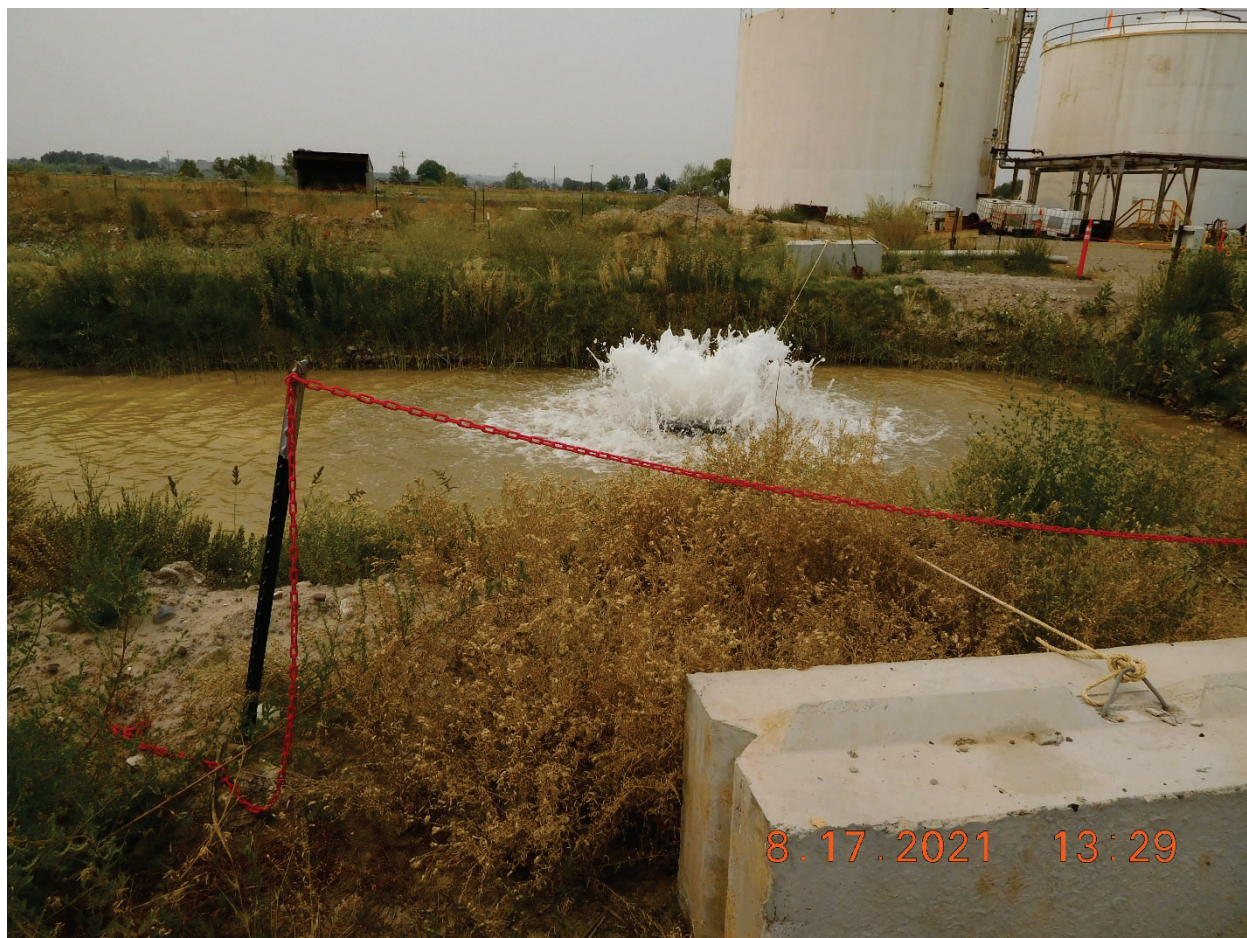
Photo 1473: DSCN1473.jpg: photo of aerator in one of the ponds.

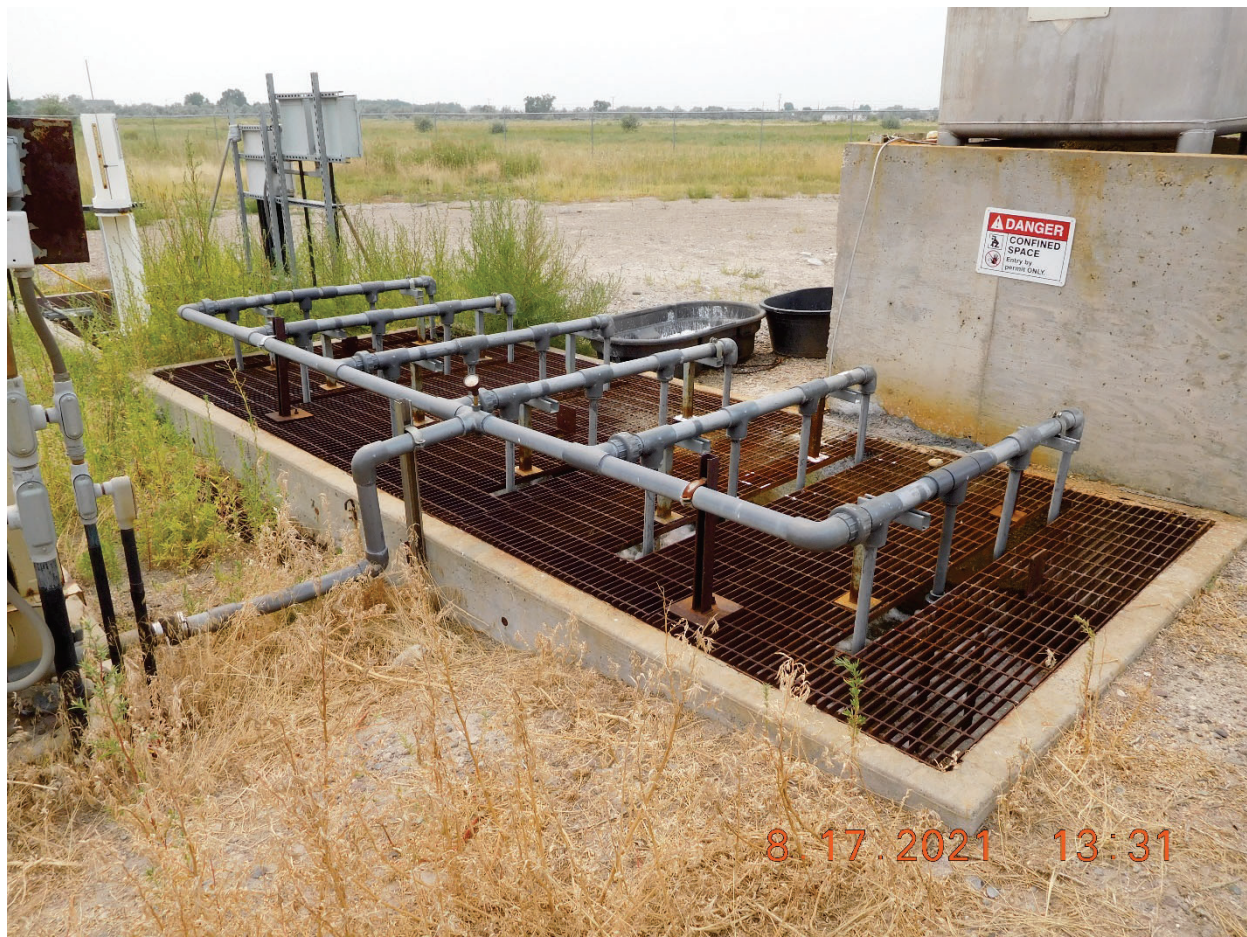
Photo 1474: DSCN1474.jpg: photo of blower used to add dissolved oxygen.

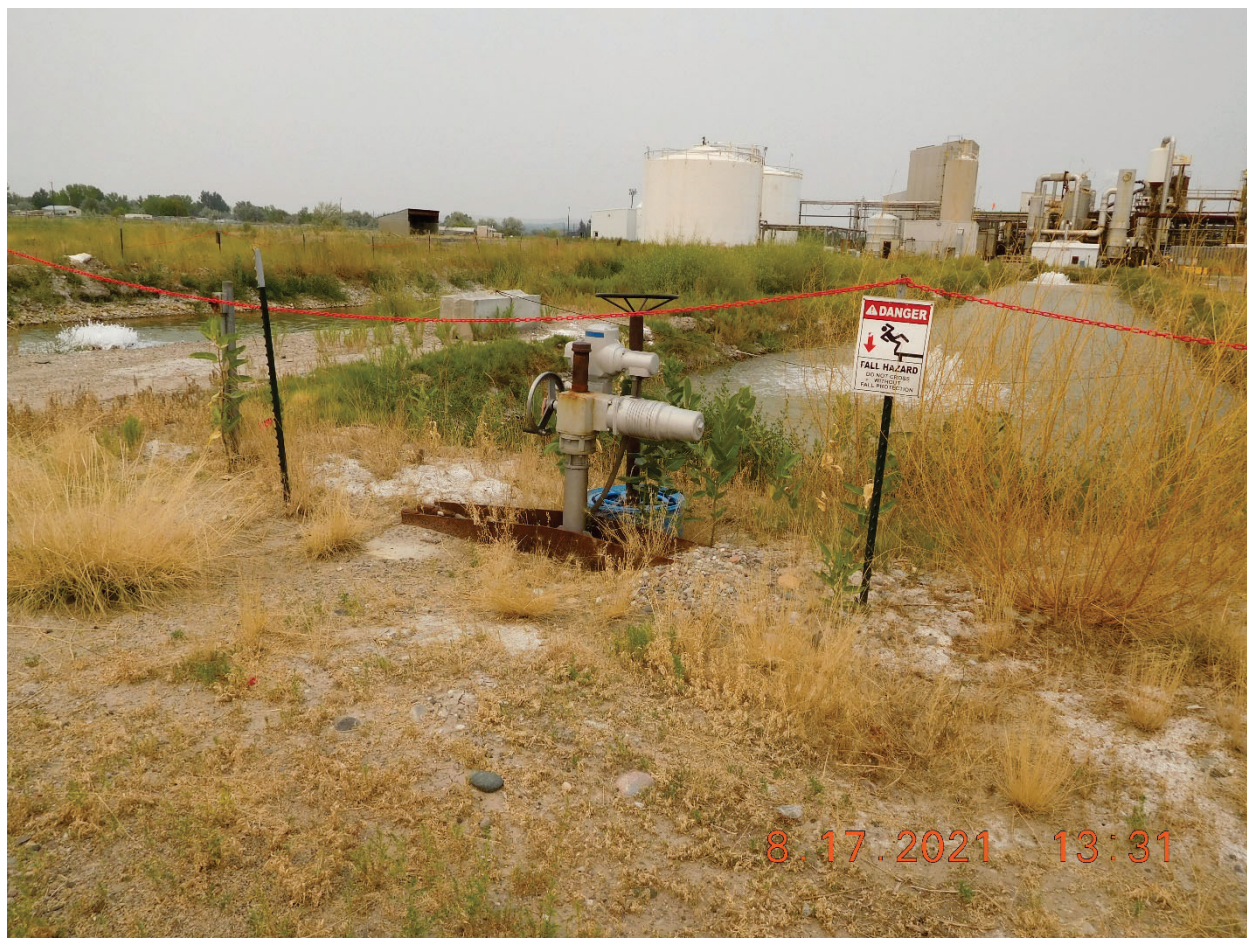
Photo 1475: DSCN1475.jpg: photo of overview of ponds facing back toward the plant.

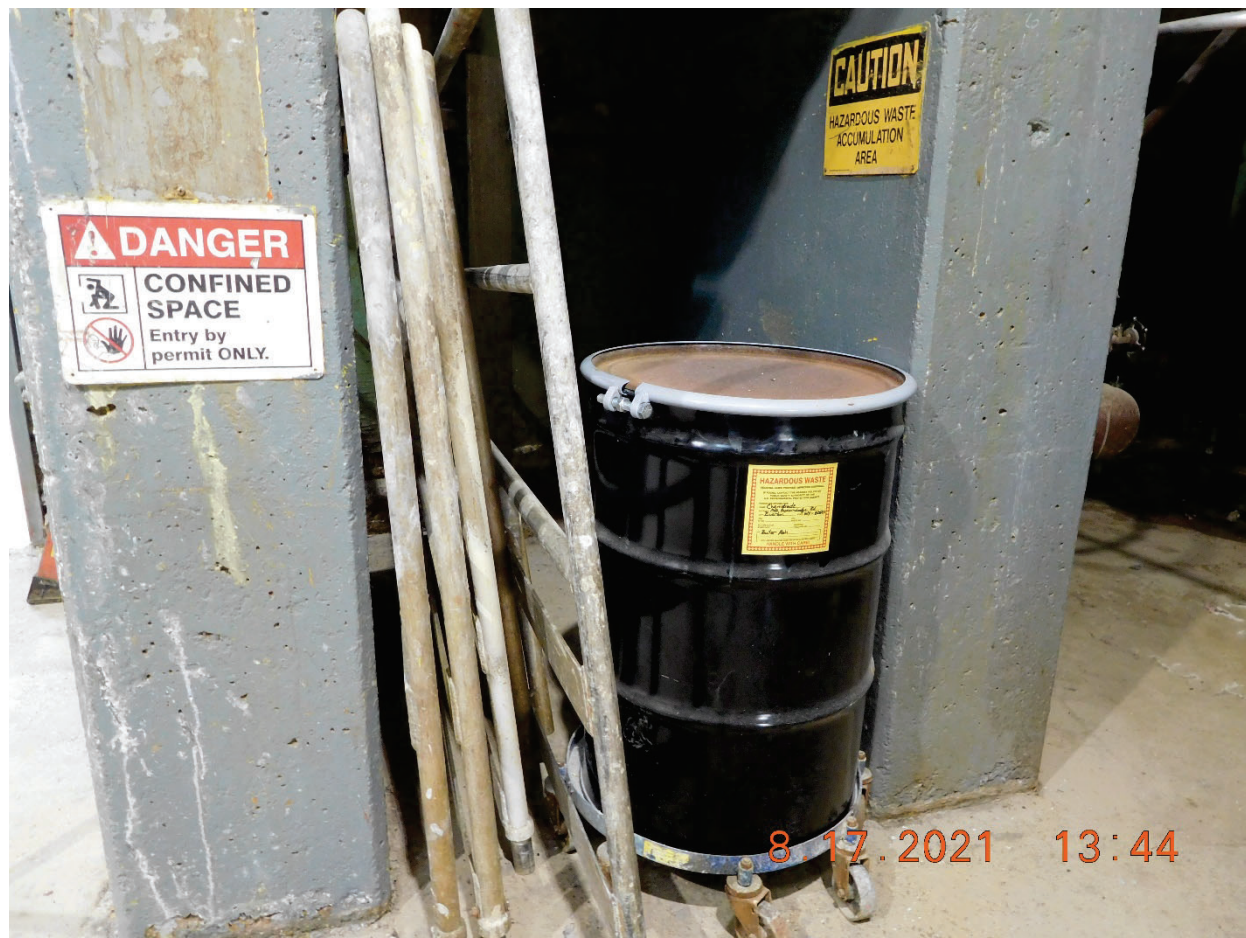
Photo 1477: DSCN1477.jpg: photo of a satellite accumulation container.

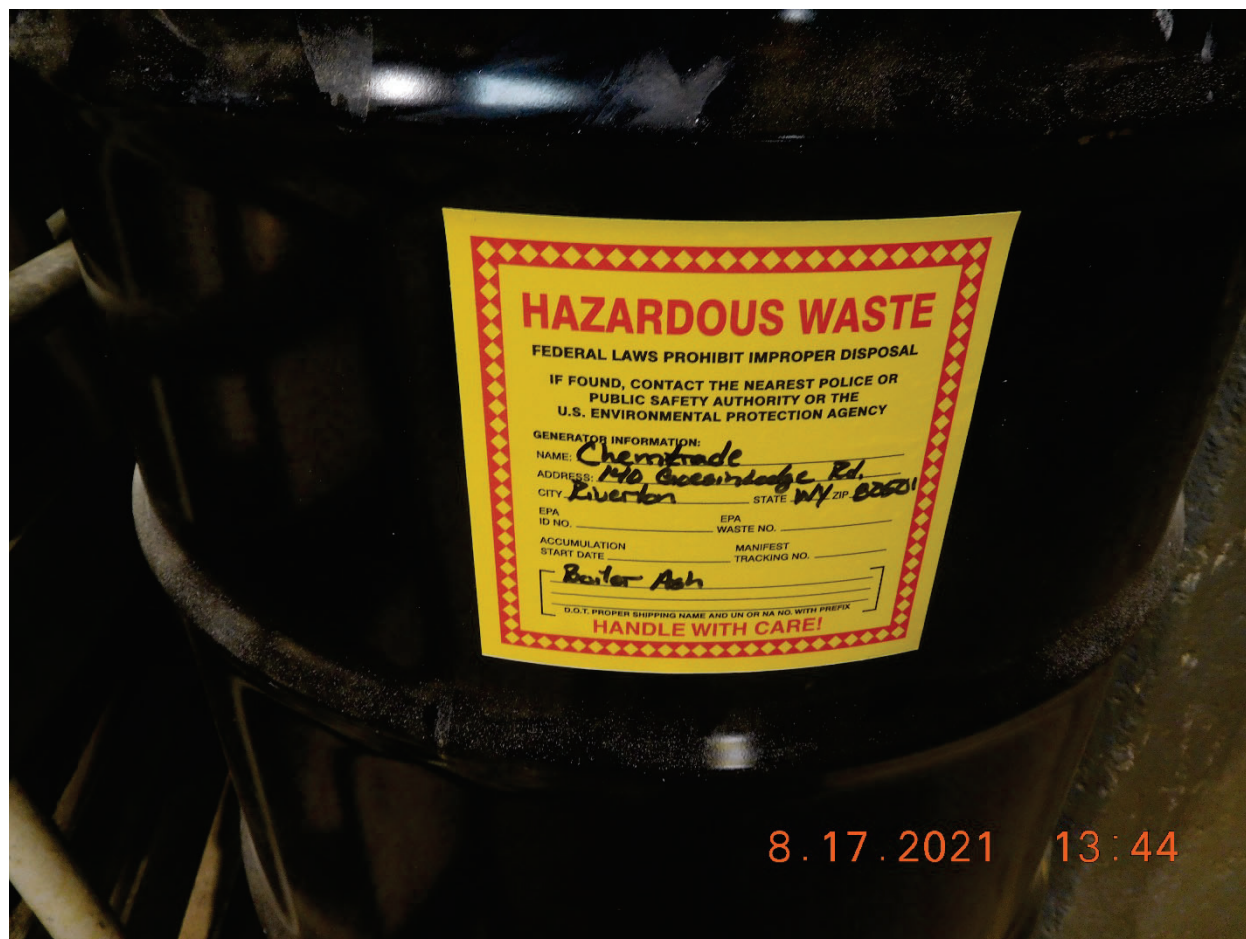
- Dredged material pile from wastewater ponds
- Primary sump
- Non-hazardous sulfur waste drum
- #2 Boiler room satellite accumulation area (SAA)
  - One 55-gallon drum labeled “hazardous waste” and “boiler ash”, but it was not labeled with an indication of the hazards.

Photo 1478: DSCN1478.jpg: close-up of the container shown in photo 1477. The label was not marked with an indication of the hazards.

- a photo of the SAA container showing an indication of the hazards was added, a procedure change description regarding staff training, and a training log sheet;
