## **RCRA Compliance Evaluation Inspection Report**

#### **General Dynamics Ordnance and Tactical Systems (OTS)**

EPA ID Number: ALR000001966

March 17, 2022, 8:30 a.m.

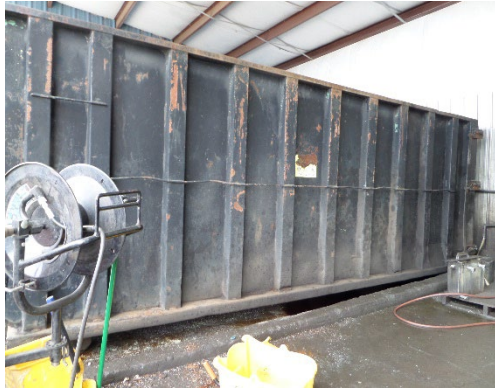
In this area, the metal shavings from the CNC machine area are transported to a large 40-yard roll-off container (Photo-1) staged outside under a canopy adjacent to the manufacturing building. The spent lead (D008) contaminated oil coolant mixture

gravity drains to the bottom of the roll-off container in a catch-basin. The waste D008 oil/coolant mixture is pumped from the catch-basin through underground pipes to three large 1,100-gallon storage tanks located inside the Hazardous Waste Storage Area. Once all the waste D008 oil/coolant mixture is drained from the shavings, the scrap metal is sold to a recycler for recycling purposes. There were no leaks or spills observed near the roll-off container.

Photo-1 40-yard Roll-off Container containing waste metal shavings

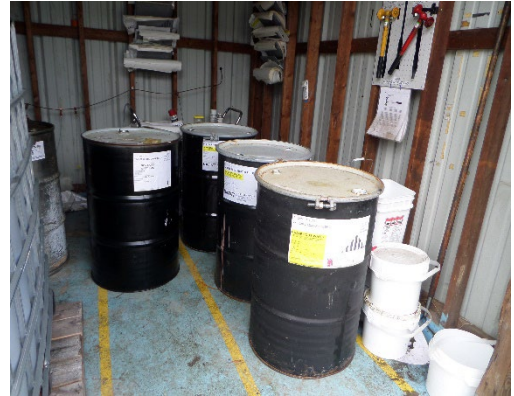
The storage area consisted of a locked corrugated metal shed. The appropriate signage was located on the outside of the shed warning of the hazards. There was proper secondary containment as the floor of the building was chemically coated with a berm surrounding the building's perimeter. The inspectors observed two 55-gallon drums of paint filters (D007, D008), one 55-gallon drum of cadmium debris (D006) being staged inside the building (Photo-4). All the drums were observed to be closed, labeled, and dated. The oldest accumulation start date was observed to be February 11, 2022.

Photo-4 Less than 90-day Storage Area

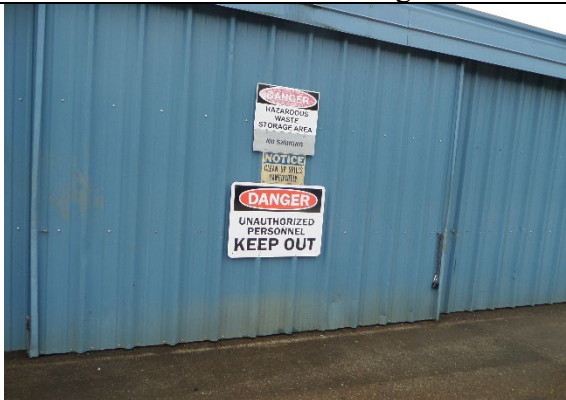
Mr. Kirby escorted us to the hazardous waste storage area located outside the manufacturing building (Photo-2). The storage area consisted of a locked corrugated metal shed. The appropriate signage was located on the outside of the shed warning of the hazards. Mr. Kirby unlocked the shed during the site visit.

Photo-2 Hazardous Waste Storage Area

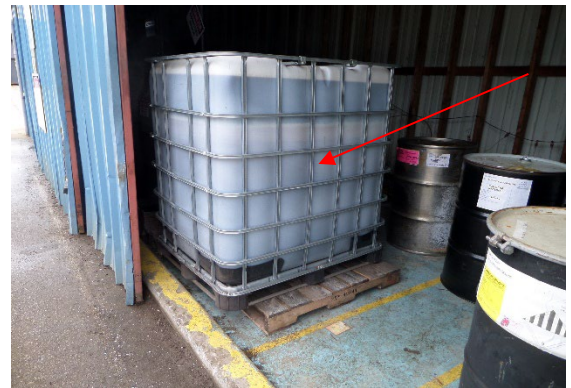
The inspectors observed one 275-gallon tote containing wastewater sludge (Photo-5). The tote was observed to be closed and labeled as "Hazardous Waste" and with a hazard indication label. The accumulation start date on the tote was missing. In response to an inquiry regarding the sludge stored in the tote, Mr. Kirby stated that the spent coolant water (D008) is piped from metal reclamation area and stored in one of three 1,100-gallon tanks located in the hazardous waste storage area. The tanks are directly connected to an evaporator unit located outside of the hazardous waste storage building through the tank management system. Once the evaporator removes the coolant water, the residual sludge is stored in a tote and managed as hazardous waste (D008) for the purpose of storage and disposal. There were no leaks or spills observed in the storage area. The storage area was observed to be equipped with fire extinguisher and spill kits.

Photo-5 275-gallon tote containing waste sludge (D008)

**Pursuant to ADEM Admin. Code r. 335-14-3-.01 (5)(i) [40 C.F.R. § 262.17(a)(5)(i)], which is a condition of the LQG Permit Exemption, a generator must mark or label its containers with the date upon which each period of accumulation begins clearly visible for inspection on each container.**

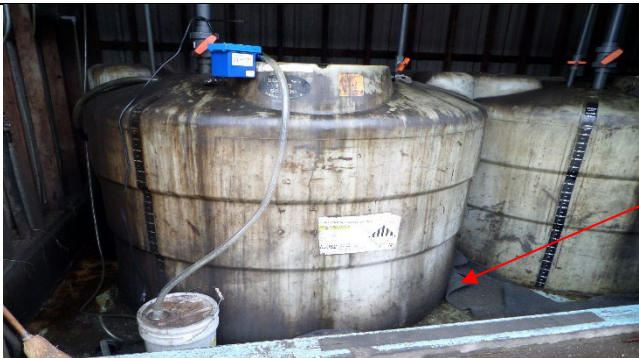
The inspectors observed three 1,100-gallon plastic tanks (Photo-3) labeled as “Coolant Water Sludge” and as “Hazardous Waste”. The tanks also had hazard indication on them. All the tanks were observed inside a diked secondary containment. All the tanks were observed to be open at the top. The inspectors observed absorbent mats placed inside the diked walls with spilled waste material inside the secondary containment system. According to Mr. Kirby, the waste coolant sludge in the tanks is managed as less than 90-day storage. Mr. Kirby did not appear to maintain any inventory logs and/or records demonstrating that the hazardous waste in the tanks were being emptied within ninety days of first entering the tanks readily available for inspection onsite.

Photo-3 1,100-gallon tanks containing coolant water sludge in Secondary Containment System with leaks and spills

**Pursuant to ADEM Admin. Code r. 335-14-3-.01 (7)(a)2. [40 C.F.R. § 262.17(a)(2)], which incorporates ADEM Admin. Code r. 335-14-3-.01 [40 C.F.R. Part 265, Subpart J], and is a condition of the LQG Permit Exemption, a generator accumulating hazardous waste in tank systems is required to comply with the applicable requirements of ADEM Admin. Code r. 335-14-3-.01 [40 C.F.R. Part 265, Subpart J], except ADEM Admin. Code r. 335-14-6-.12(9) [40 C.F.R § 265.197(c)] (closure and post-closure care) and ADEM Admin. Code r. 335-14-6-.11(6) [40 C.F.R § 265.200] (waste analysis and trial tests).**

**Pursuant to ADEM Admin. Code r. 335-14-3-.01(7)(a)6 [40 C.F.R. § 262.17(a)(6)], which incorporates ADEM Admin. Code r. 335-14-3-.01(7)(a)6 [40 C.F.R. § 262.251], and is a condition of the LQG Permit Exemption, a generator is required to maintain and operate its facility to minimize the possibility of a fire, explosion, or any unplanned sudden or non-sudden release of hazardous waste or hazardous waste constituents to air, soil, or surface water**

**Pursuant to ADEM Admin. Code r. 335-14-3-.01 (5)(ii) [40 C.F.R. § 262.17(a)(5)(ii)], which is a condition of the LQG Permit Exemption, a generator must use inventory logs, monitoring equipment or other records to demonstrate that hazardous waste has been emptied within 90 days of first entering the tank; and keep inventory logs or records with the above information on site and readily available for inspection.**
