## **RCRA Inspection Report**

Pinewood Site Custodial Trust  
8430 Camp Macboykin Road  
Pinewood, South Carolina 29125  
Sumter County  
EPA ID No. SCD070375985

June 15, 2022

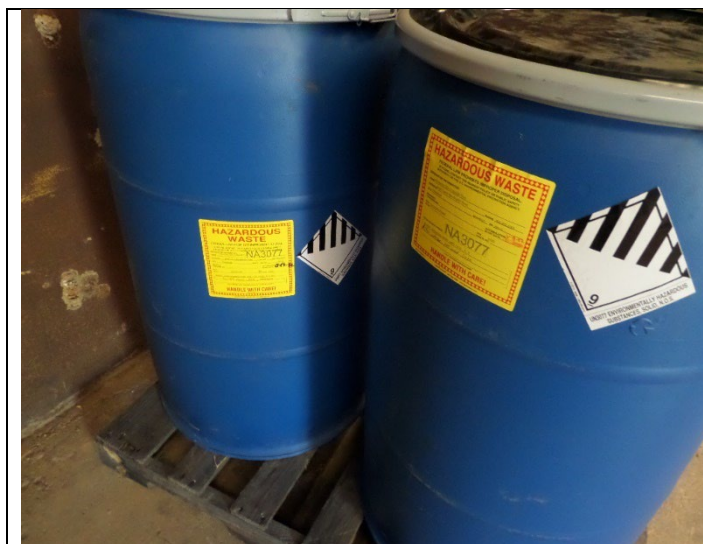
The Waste Pile Building #2 (WP2) was used for storing hazardous waste piles while the landfill was in operation. Currently, PSCT uses the WP2 to store hazardous waste containers for 90-days or less prior to shipping them off-site. The WP2 is not covered by the facility's post-closure care permit. The inspectors observed one SAA container accumulating personal protective equipment (PPE) and debris. The container was closed, labeled with words "hazardous waste", marked with the waste code F039, and labeled with a #9 miscellaneous pictogram. The inspector did not observe a hazard indicator for the characteristic of toxicity on the container (Photograph 1). Mr. Burgess marked the hazardous waste label with the word "toxic", indicating the hazard (Photograph 2). The inspectors also observed two 55-gallon containers storing hazardous waste. The containers were closed, labeled with words "hazardous waste", marked with the waste code F039, marked with the dates May 17, 2022 and June 8, 2022, and labeled with a #9 miscellaneous pictogram. The inspector did not observe a hazard indicator for the characteristic of toxicity on the containers (Photograph 3). Mr. Burgess marked the hazardous waste label on each container with the word "toxic", indicating the hazard (Photograph 4).

Waste Pile Building #2. 90-Day Area. The inspector observed two 55-gallon containers of hazardous waste without a toxic hazard indicator. Photograph 1 taken at 10:18 a.m.

**Pursuant to S.C. Code Ann. Regs. 61-79.262.17(a)(5)(i)(B) [40 C.F.R. § 262.17(a)(5)(i)(B)], which is a condition of the LQG Permit Exemption, a generator must mark or label its containers with the following: an indication of the hazards of the contents.**

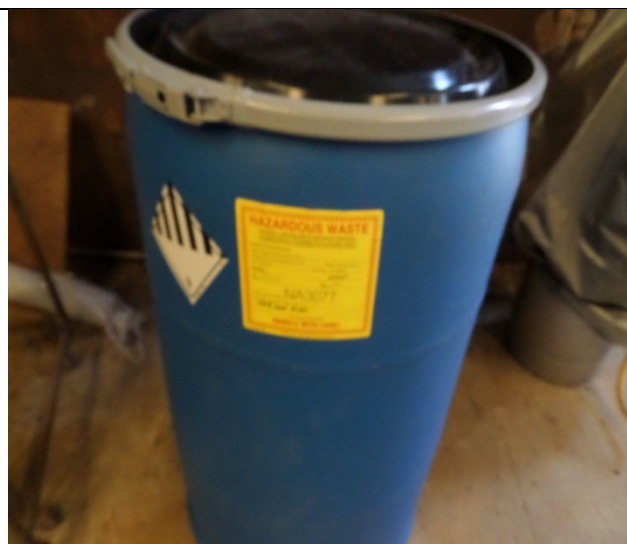
Waste Pile Building #2. The inspector observed one 55-gallon SAA container of hazardous waste without a toxic hazard indicator. Photograph 2 taken at 10:18 a.m.

**Pursuant to S.C. Code Ann. Regs. 61-79.262.15(a)(5)(ii) [40 C.F.R. § 262.15(a)(5)(ii)], which is a condition of the SAA Permit Exemption, mark or label its containers with an indication of the hazards of the contents (examples include, but are not limited to, the applicable hazardous waste characteristic(s) (i.e., ignitable, corrosive, reactive, toxic); hazard communication consistent with the Department of Transportation requirements at 49 CFR part 172 subpart E (labeling) or subpart F (placarding); a hazard statement or pictogram consistent with the Occupational Safety and Health Administration Hazard Communication Standard at 29 CFR 1910.1200; or a chemical hazard label consistent with the National Fire Protection Association code 704).**

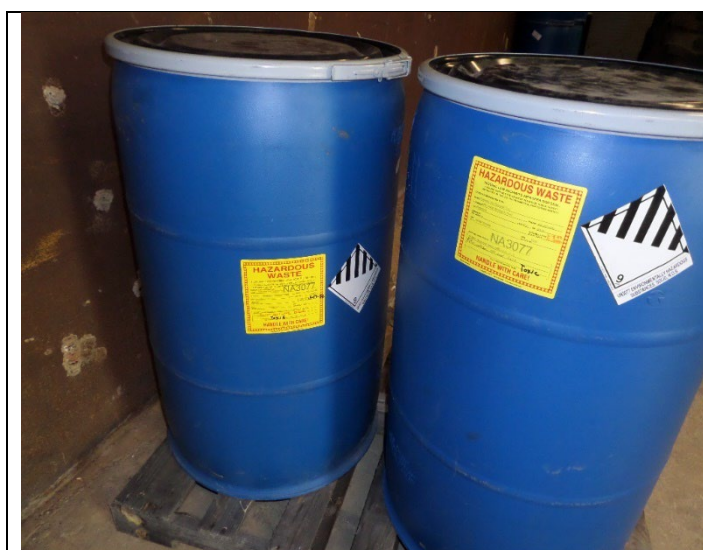
Waste Pile Building #2. 90-Day Area. The inspector observed PSCT mark the two 55-gallon containers of hazardous waste with the word “toxic”. Photograph 3 taken at 10:18 a.m.

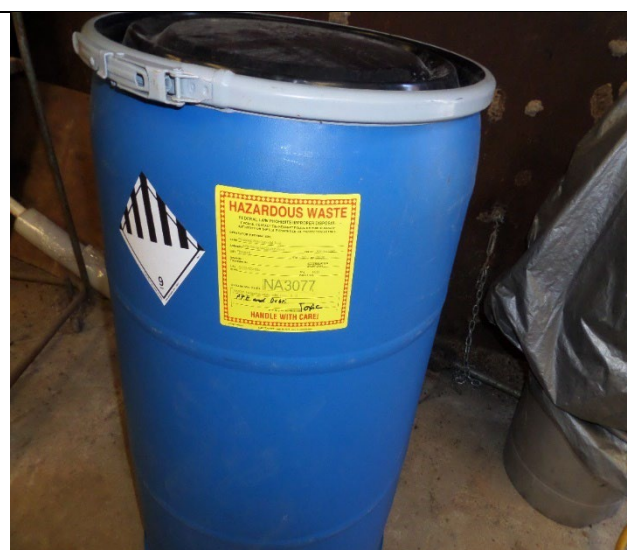
Waste Pile Building #2. The inspector observed PSCT mark the one 55-gallon SAA container of hazardous waste with the word “toxic”. Photograph 4 taken at 10:18 a.m.

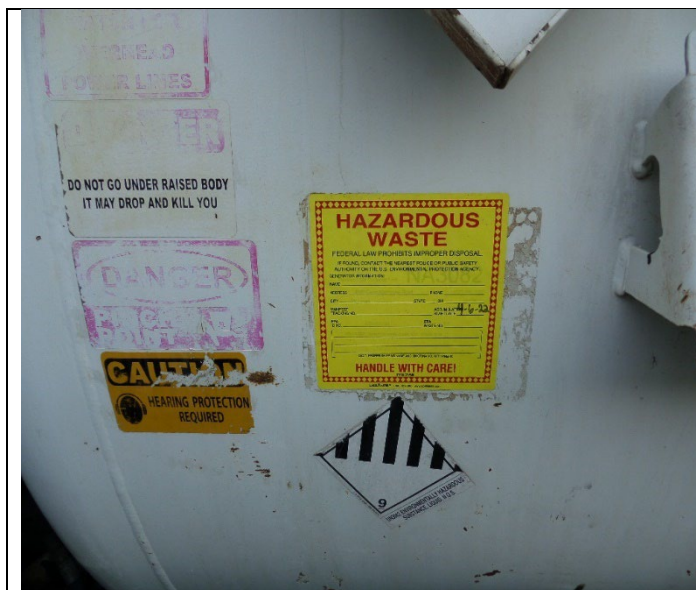
landfill, prior to treatment in the Leachate Treatment System. The inspectors observed a sign posted on a metal beam with the words “central tank farm hazardous waste accumulation area”. The concrete secondary containment system and pad appeared in good condition. The inspectors observed one empty 3,300-gallon capacity vacuum truck that was closed, labeled with the words “hazardous waste”, marked with the date April 16, 2022, and labeled with a #9 miscellaneous pictogram. Mr. Burgess marked the hazardous waste label with the word “toxic”, indicating the hazard (Photographs 5 and 6). The inspectors observed one empty 3,250-gallon capacity vacuum truck that was closed, labeled with the words “hazardous waste”, and labeled with a #9 miscellaneous pictogram. Mr. Burgess marked the hazardous waste label with the word “toxic”, indicating the hazard (Photographs 7 and 8). The inspectors observed one 1,100-gallon capacity polyethylene container on a trailer. The inspectors observed the container was closed, labeled with the words “hazardous waste”, marked with the date May 26, 2022, and labeled with a #9 miscellaneous pictogram. Mr. Burgess marked the hazardous waste label with the word “toxic”, indicating the hazard (Photographs 9 and 10). The inspectors also observed one 55-gallon SAA container accumulating PPE and debris generated on the CTF pad. The container was closed, labeled with the words “hazardous waste”, and labeled with a #9 miscellaneous pictogram. Mr. Burgess marked the hazardous waste label with the word “toxic”, indicating the hazard (Photograph 11).

Central Tank Farm. The inspector observed the 3,300-gallon vacuum truck not marked with a toxic hazard indicator. Photograph 5 taken at 10:27 a.m.

**Pursuant to S.C. Code Ann. Regs. 61-79.262.17(a)(5)(i)(B) [40 C.F.R. § 262.17(a)(5)(i)(B)], which is a condition of the LQG Permit Exemption, a generator must mark or label its containers with the following: an indication of the hazards of the contents.**

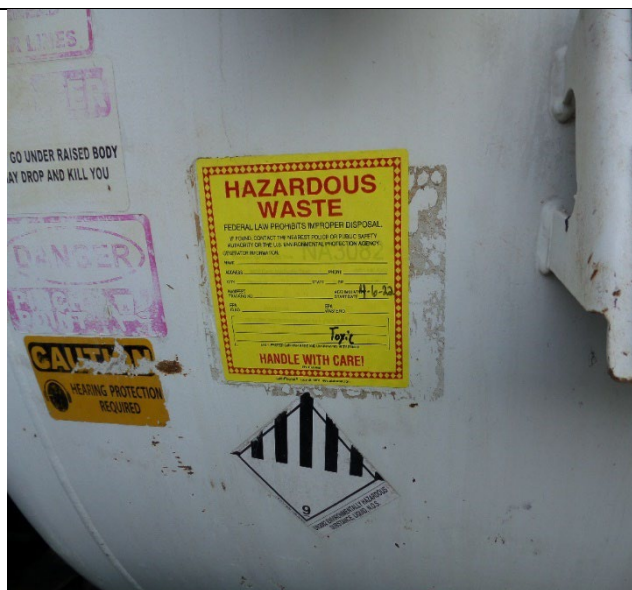
Central Tank Farm. The inspector observed PSCT mark the 3,300-gallon vacuum truck with the word “toxic”. Photograph 6 taken at 10:27 a.m.

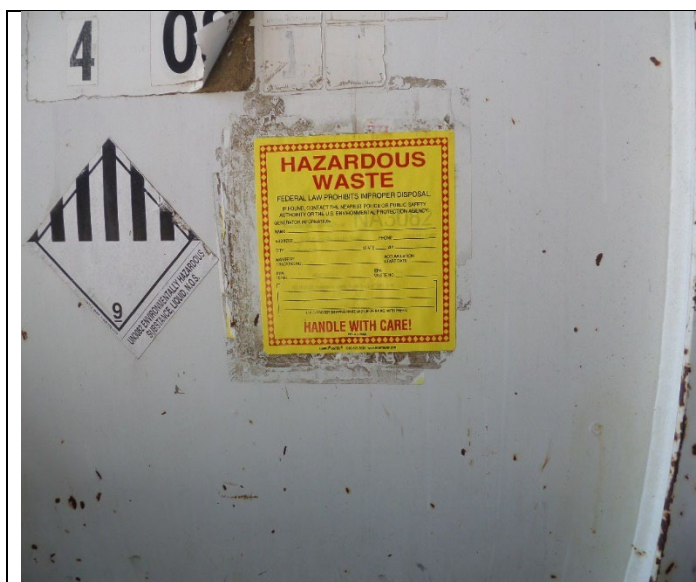
Central Tank Farm. The inspector observed the 3,250-gallon vacuum truck not marked with a toxic hazard indicator. Photograph 7 taken at 10:29 a.m.

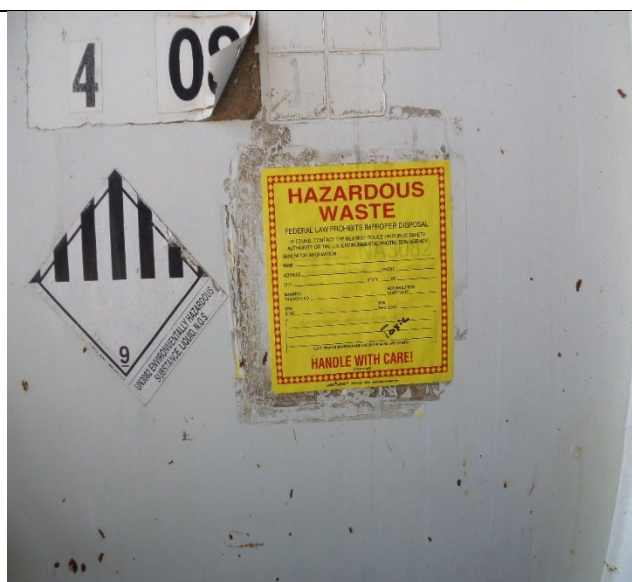
Central Tank Farm. The inspector observed PSCT mark the 3,250-gallon vacuum truck with the word “toxic”. Photograph 8 taken at 10:29 a.m.

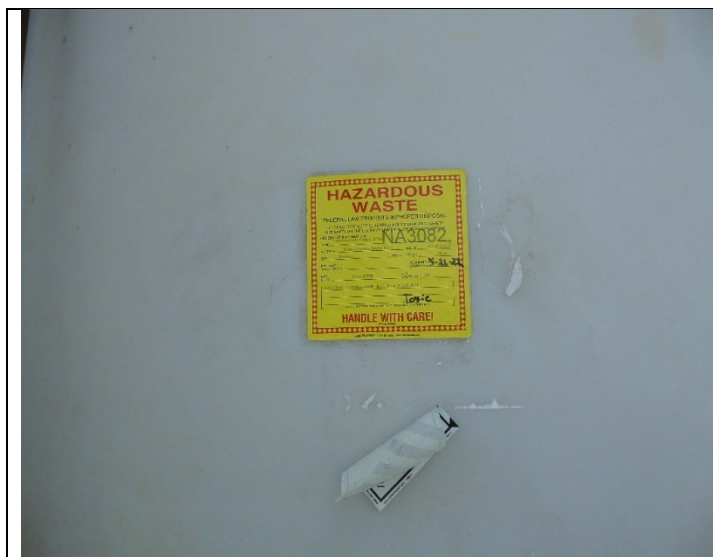
Central Tank Farm. The inspector observed PSCT mark the 1,100-gallon container with the word “toxic”. Photograph 9 taken at 10:32 a.m.

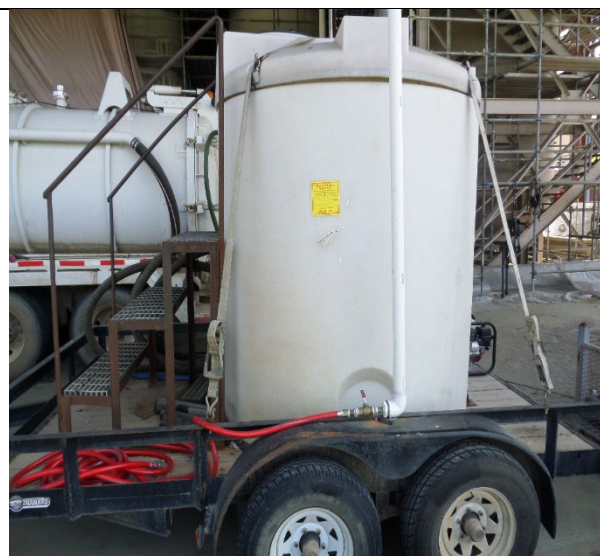
Central Tank Farm. The inspector observed the 1,100-gallon container on a trailer. Photograph 10 taken at 10:32 a.m.

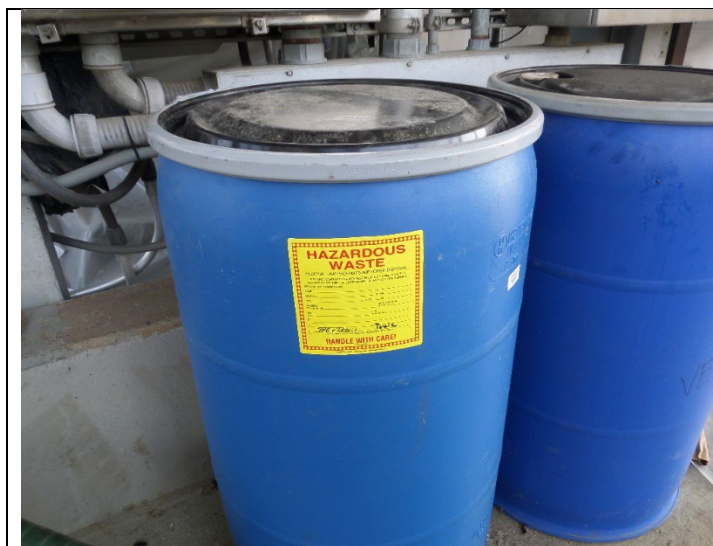
Central Tank Farm. The inspector observed PSCT mark the 55-gallon SAA container with the word “toxic”. Photograph 11 taken at 10:34 a.m.

**Pursuant to S.C. Code Ann. Regs. 61-79.262.15(a)(5)(ii) [40 C.F.R. § 262.15(a)(5)(ii)], which is a condition of the SAA Permit Exemption, mark or label its containers with an indication of the hazards of the contents (examples include, but are not limited to, the applicable hazardous waste characteristic(s) (i.e., ignitable, corrosive, reactive, toxic); hazard communication consistent with the Department of Transportation requirements at 49 CFR part 172 subpart E (labeling) or subpart F (placarding); a hazard statement or pictogram consistent with the Occupational Safety and Health Administration Hazard Communication Standard at 29 CFR 1910.1200; or a chemical hazard label consistent with the National Fire Protection Association code 704).**

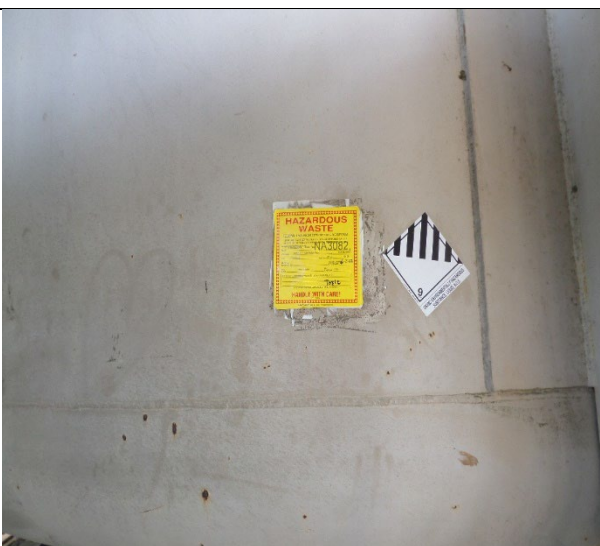
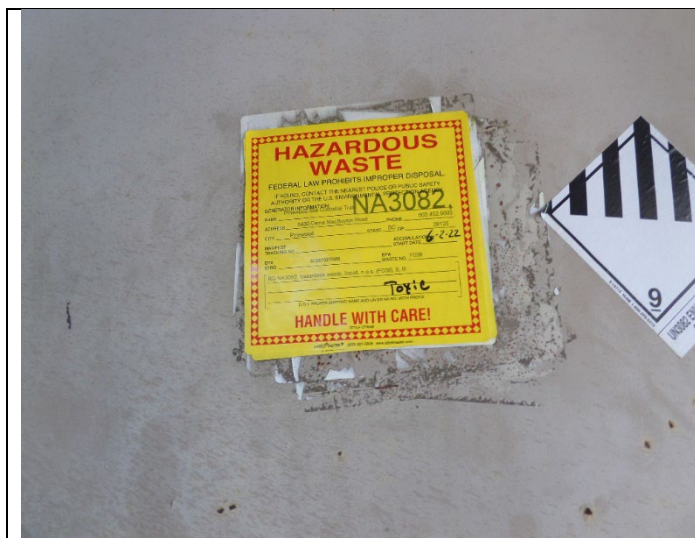
Mr. Burgess indicated that tank #3 was accumulating hazardous waste. Based on the electronic level gauge the inspector read a level of 6,779-gallons in tank #3. The tank was labeled with the words “hazardous waste”, marked with the date June 2, 2022, and labeled with a #9 miscellaneous pictogram. Mr. Burgess marked the hazardous waste label with the word “toxic”, indicating the hazard (Photographs 12 and 13). Mr. Burgess indicated tank #4 was empty.

Central Tank Farm. The inspector observed PSCT mark Tank #3 with the word “toxic”. Photograph 12 taken at 10:38 a.m.

Central Tank Farm. The inspector observed PSCT mark Tank #3 with the word “toxic”. Photograph 13 taken at 10:38 a.m.

**Pursuant to S.C. Code Ann. Regs. 61-79.262.17(a)(5)(ii)(B) [40 C.F.R. § 262.17(a)(5)(ii)(B)], which is a condition of the LQG Permit Exemption, mark or label its tanks with an indication of the hazards of the contents (examples include, but are not limited to, the applicable hazardous waste characteristic(s) (i.e., ignitable, corrosive, reactive, toxic); hazard communication consistent with the Department of Transportation requirements at 49 CFR part 172 subpart E (labeling) or subpart F (placarding); a hazard statement or pictogram consistent with the Occupational Safety and Health Administration Hazard Communication Standard at 29 CFR 1910.1200; or a chemical hazard label consistent with**

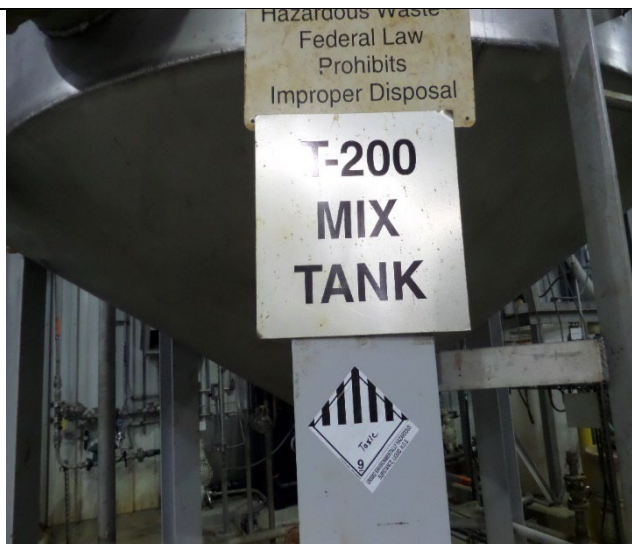
The inspector observed the T-200 Mix Tank identified with a sign with the words “hazardous waste” and labeled with a #9 miscellaneous pictogram (Photograph 14).

Leachate Treatment System. The inspector observed PSCT mark the T-200 Mix Tank with the word “toxic”. Photograph 14 taken at 10:59 a.m.

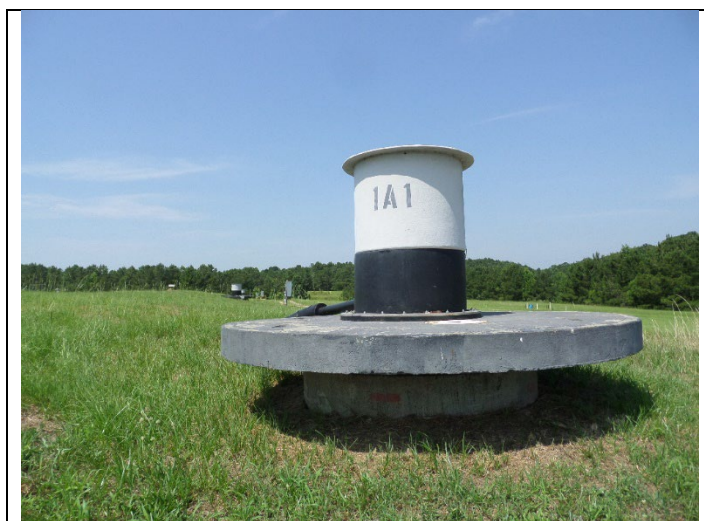
The inspectors observed pump enclosure 1A1 which pumps landfill leachate to the CTF (Photograph 15). The inspectors observed the landfill cover appeared in good condition.

Landfill Section 1. The inspector observed pump enclosure 1A1. Photograph 15 taken at 11:24 a.m.
