**UNITED STATES ENVIRONMENTAL PROTECTION AGENCY  
REGION 8  
RESOURCE CONSERVATION AND RECOVERY ACT**

**Facility Name:** Specialty Chemicals and Systems **RCRA ID:** CO0000195180

**Date of Inspection:** May 16, 2023  
**Arrival Time:** 9:15 a.m.  
**Departure Time:** 10:45 a.m.

**Type and Purpose of Inspection:** Compliance Evaluation Inspection  
Compliance with RCRA Subtitle C

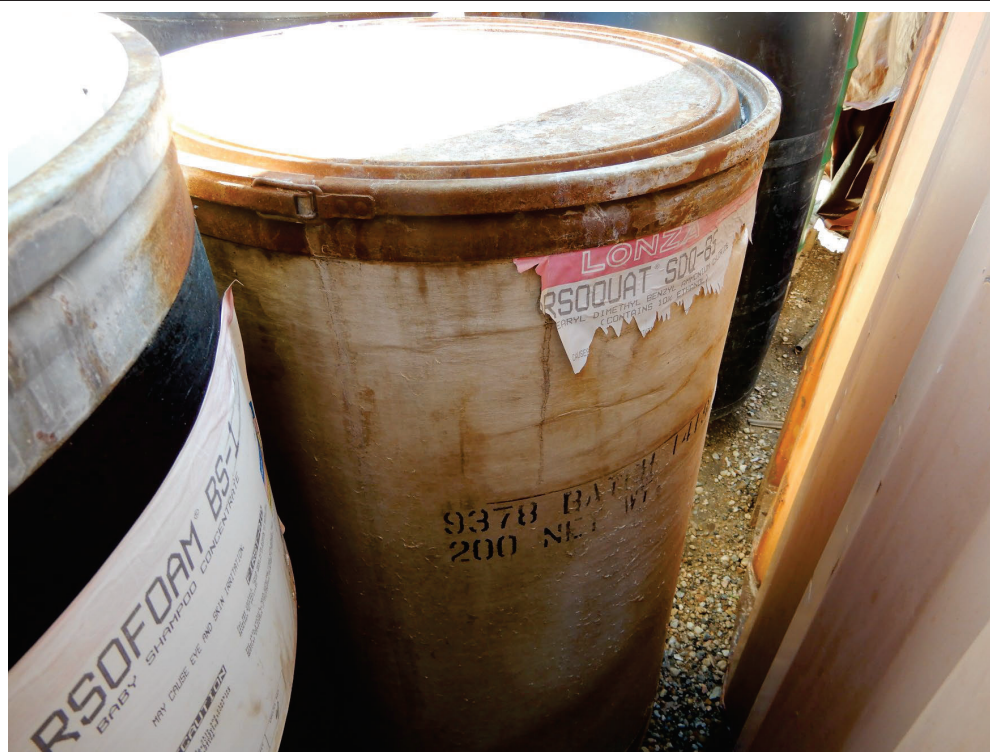
Photo 2.  
Label on fiber  
drum in outside  
yard originally  
read:  
“CARSOQUAT  
SDQ-85; stearyl  
dimethylbenzyl  
ammonium  
chloride”  
(DSCN0096.JPG)

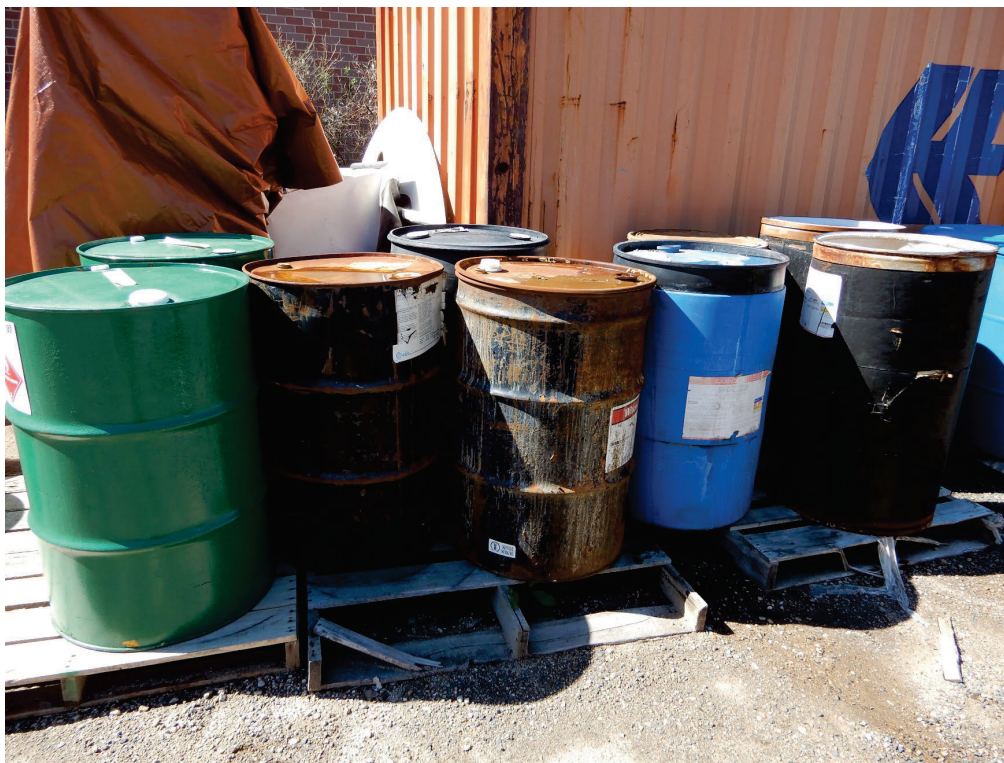
Photo 3.

Next to the containers of hand sanitizer, I observed approximately 13 drums that appeared to have been outside for a long period of time. Mr. Martin said that when they closed the previous location, some materials were moved to this location, and that to his knowledge, none of the products were out of date and none of the raw materials were past their expiration dates. There were two green 55-gallon drums labeled as isopropyl alcohol, which Mr. Martin said were product, along with eleven other metal and poly 55-gallon drums (photos 3 & 4). I observed that the metal drums were rusted and at least one of them was not closed (center drum in photo 3). I observed two drums labeled as Carsofoam BS-1 baby shampoo concentrate, one with a plastic lid that was cracked in half, exposing the material to the elements, and the other which was not closed. I noted that some drums had labels, although some of the labels were old and not able to be read, and other drums were unlabeled (photos 1 & 2). Some of the labels that I could decipher were Carsofoam BS-1 baby shampoo concentrate, Carsoquat SDQ-85 and Bardac 208M. After the inspection, I reviewed the information in the Safety Data Sheets for these three compounds, and Carsofoam and Carsoquat do not appear to be considered hazardous waste. However, the flash point for Bardac 208M is 46°C, therefore it would be an ignitable hazardous waste, which is defined as a liquid with a flash point of less than 60°C.

Two green drums of product isopropyl alcohol and nine drums moved from previous location (DSCN0097.JPG)

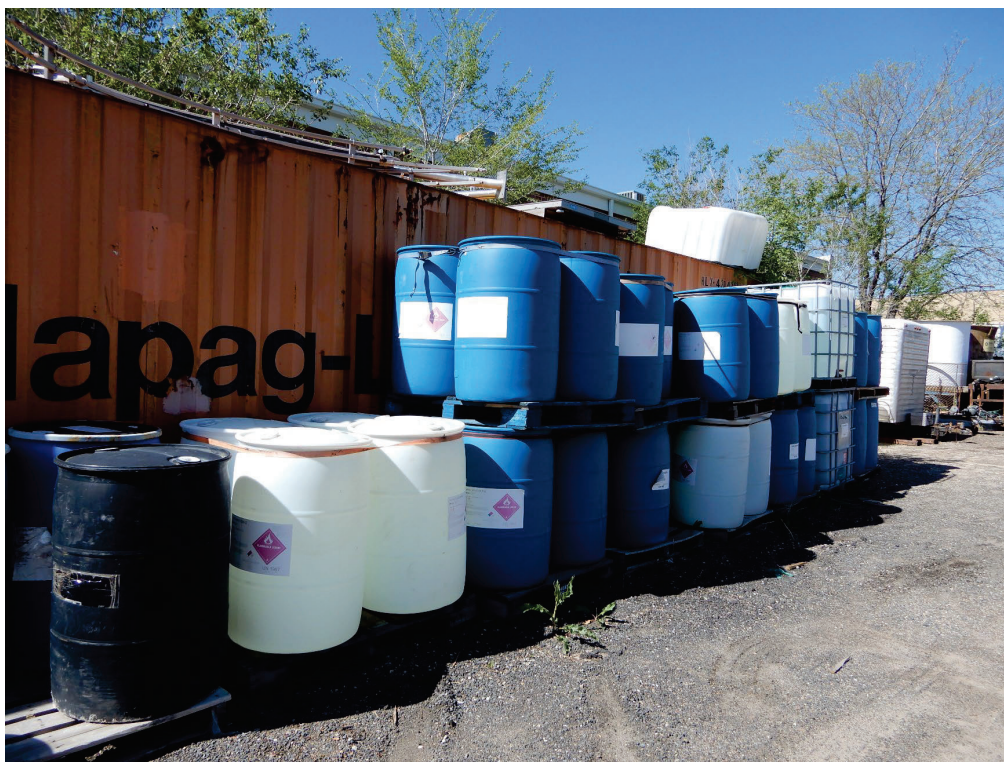
Photo 4.

In the outdoor area of the facility, I observed 34 55-gallon drums and two 250-gallon totes labeled as hand sanitizer (photo 4), as well as eight 55-gallon drums labeled as denatured ethyl alcohol. Mr. Martin explained that they belonged to the previous owner of the facility, Joe Janecky. He said that the facility allowed Mr. Janecky to store the containers of alcohol and hand sanitizer, and that they did not manufacture or distribute the hand sanitizer. Mr. Martin was not sure how long the containers had been there but estimated that it had been about two years. Because this product is being stored at Specialty Chemicals and Systems, it is the responsibility of the facility to ensure that it is properly managed and disposed of. There is a total of approximately 2,400 gallons of hand sanitizer, along with approximately 450 gallons of denatured ethyl alcohol. Alcohol-based hand sanitizer and denatured ethyl alcohol are ignitable hazardous wastes (waste code D001) when disposed of.

Two 250-gallon totes and 34 55-gallon poly drums of hand sanitizer product with eight drums of denatured ethyl alcohol and two drums moved from previous location (blue and black drums on far left) (DSCN0098.JPG)

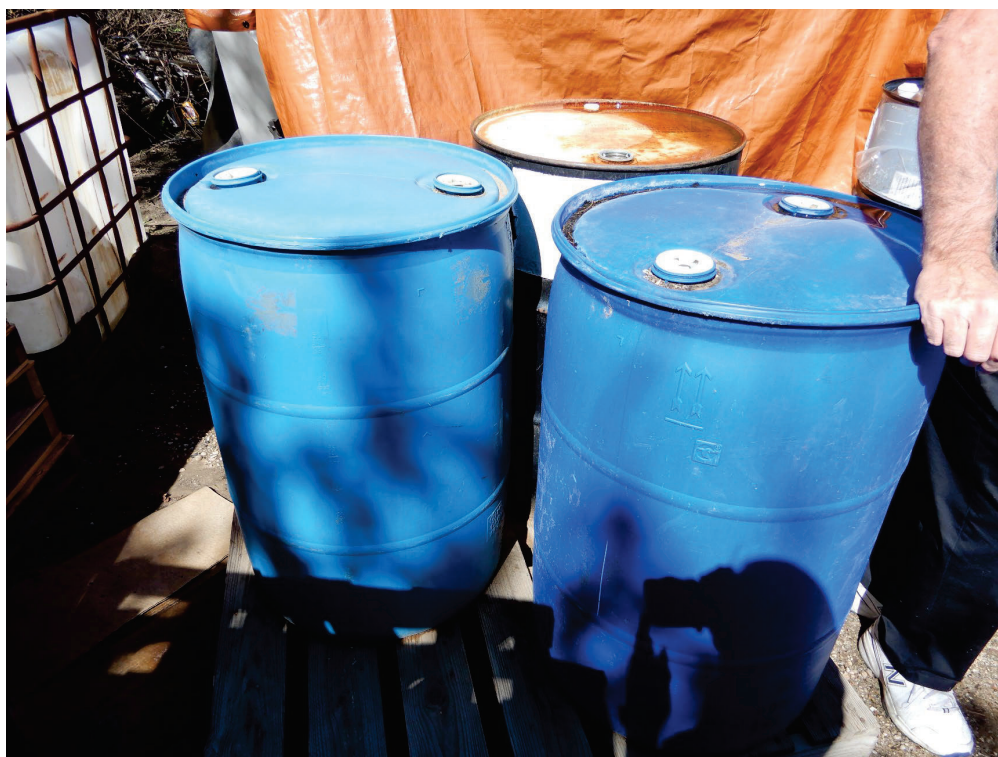
To the east of the first set of drums, I observed an area with approximately 39 additional 55-gallon drums. There were two blue poly drums on a pallet with one black metal drum labeled as windshield washer fluid (photo 5). I looked at all sides of the blue poly drums and did not observe any labels. I observed that some of the drums in this area were labeled and some were not (photos 6 – 9). Pallets and other material blocked my access to the area of these drums, so I was not able to read any of the labels. I

Photo 5.  
Two unlabeled  
55-gallon blue  
poly drums of  
product and one  
black 55-gallon  
drum labeled as  
windshield  
washer fluid  
(DSCN0099.JPG)

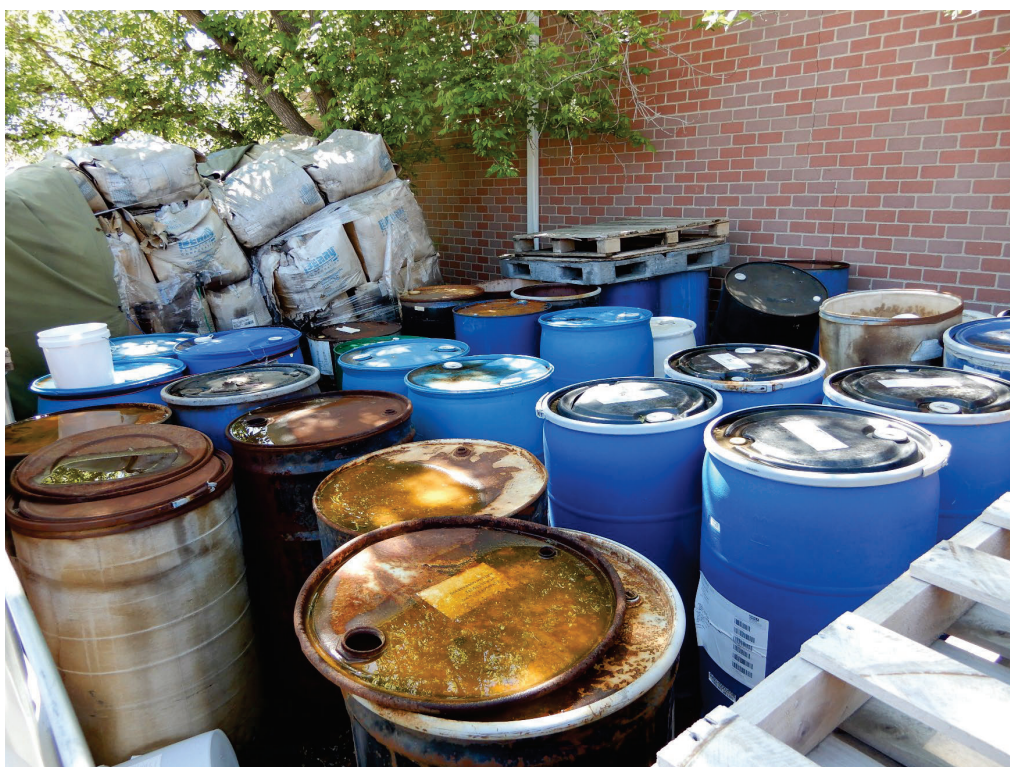
observed that at least two of the drums in this area were open. Behind the drums, Mr. Martin said that there were supersacks of cardboard (in the background of photos 6 and 7).

Photo 6.  
Drums with  
unknown  
contents in the  
outside yard  
(DSCN0100.JPG)

During the closing conference with Mr. Martin, I stated that they should determine if the drums in the outside yard hold material that will be used or if they are waste. For all drums determined to be waste, a hazardous waste determination must be made. Any materials determined to be waste or hazardous waste must be disposed of in an appropriate manner. I explained that the facility can use laboratory analysis or process knowledge to make the hazardous waste determinations.

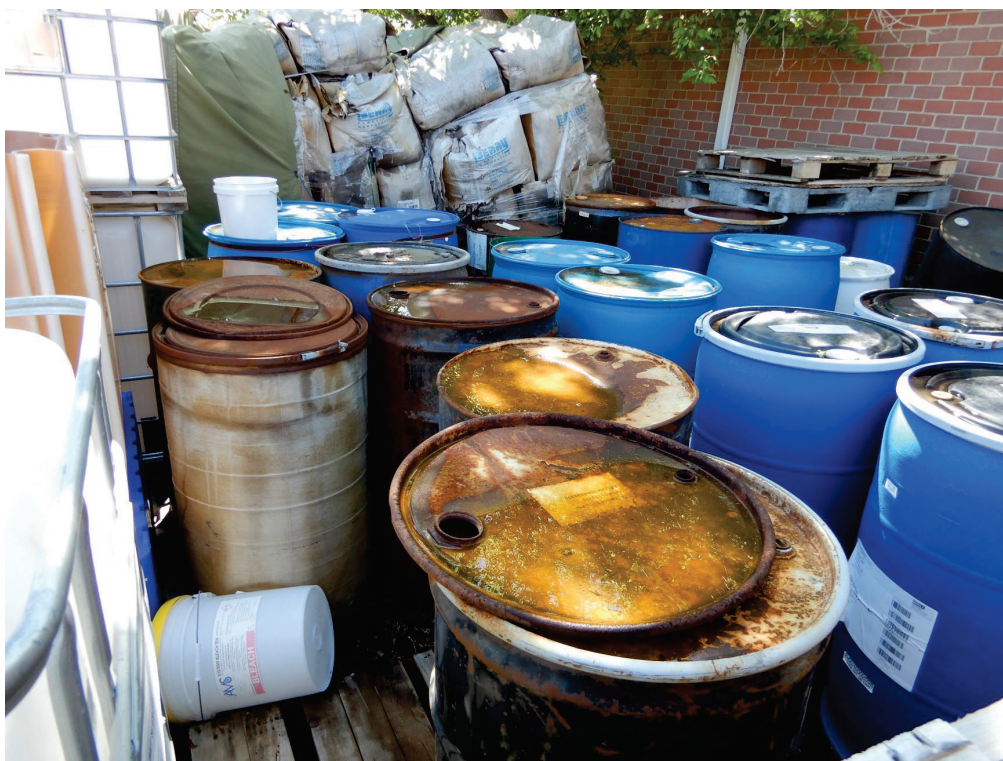
Photo 7.  
Left side of photo  
6  
(DSCN0101.JPG)

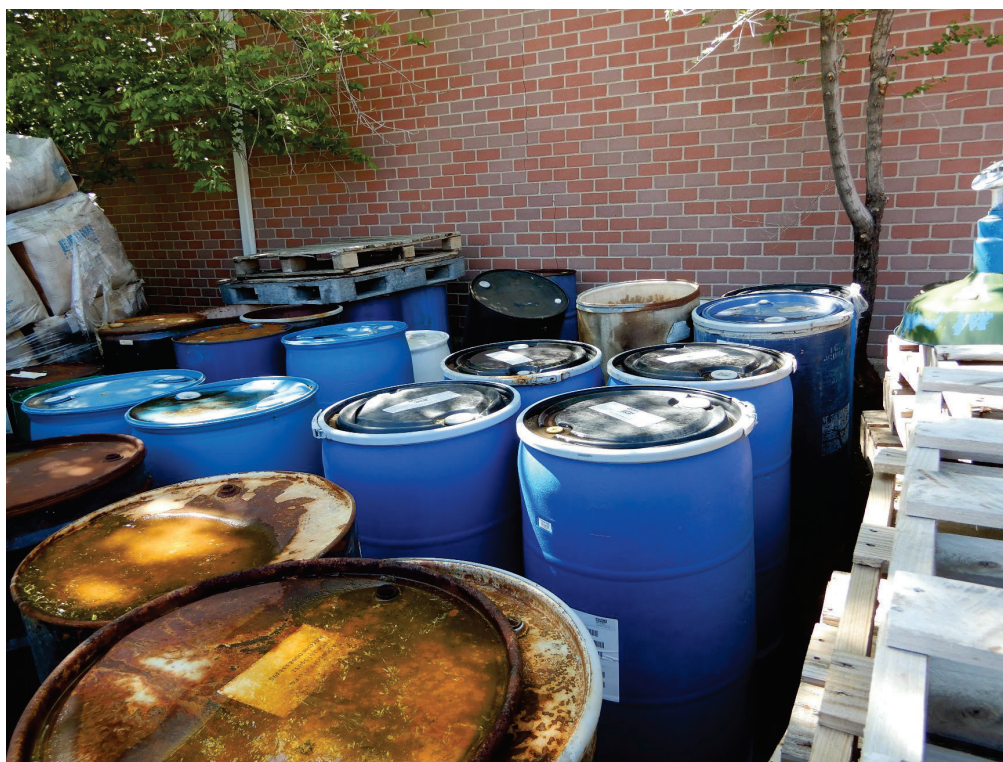
Photo 8.  
Right side of  
photo 6  
(DSCN0102.JPG)

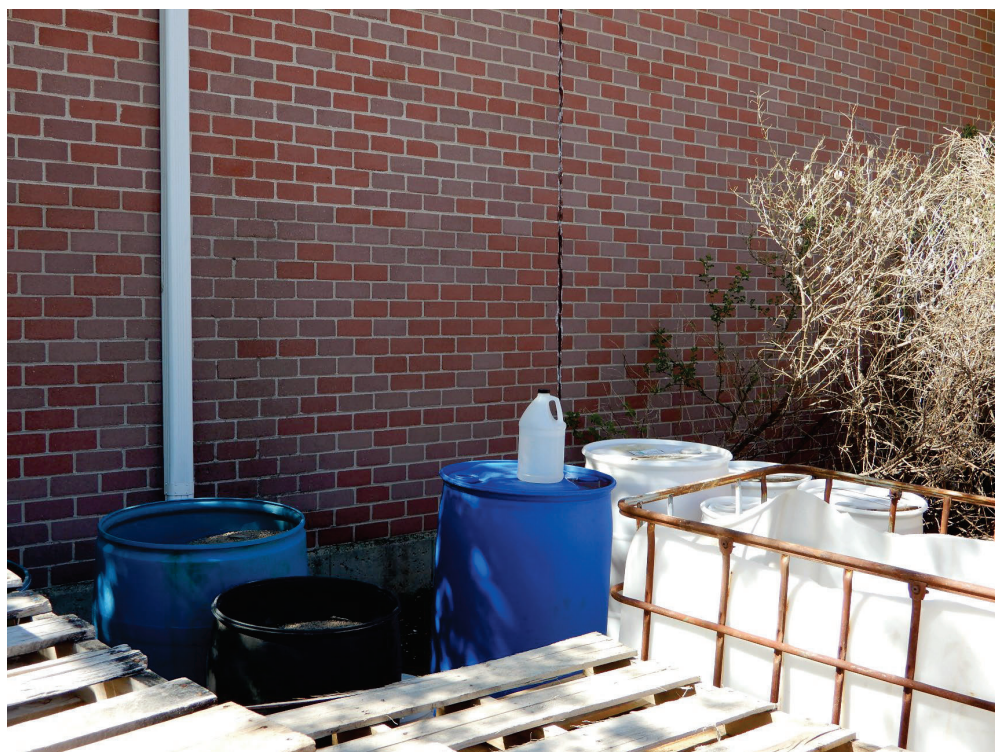
Photo 9.  
Additional  
unknown poly  
drums in outside  
yard  
(DSCN0103.JPG)
