**Region 6 - Enforcement & Compliance Assurance Division**  
**INSPECTION REPORT**

| Company Name: | <b>Capstone Oilfield Disposal of Arkansas, LLC</b> | |
| Facility Name: | <b>Bohannon No. 4 SWDS Tank Battery</b> | |

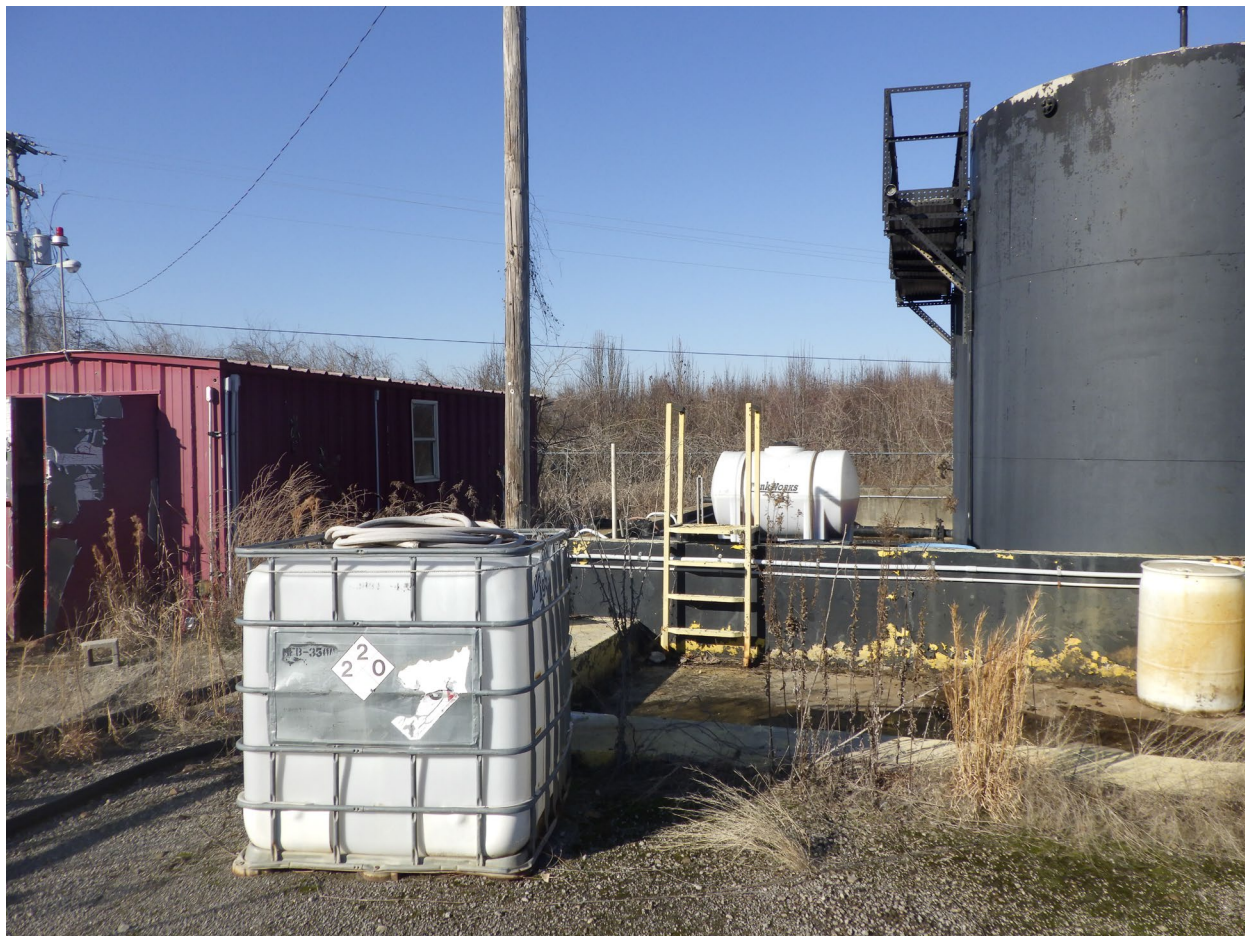
Photo No. 1

I observed one (1) tank outside secondary containment with miscellaneous hosing stored on top; see Appendix 1 (Photograph Log), Photo No. 1. For additional GPS location and photo metadata, see Appendix 1.

**Description:** Looking NNE, this photo shows miscellaneous materials outside secondary containment.

- Miscellaneous materials stored outside secondary containment, see Part 1, 1.7 of the general permit.
- A residual spill of hydrocarbons that has not been properly cleaned up, see Part 1, 1.7 of the general permit.
- A barrel outside secondary containment with an open bung hole, see Part 1, 1.7 of the general permit.

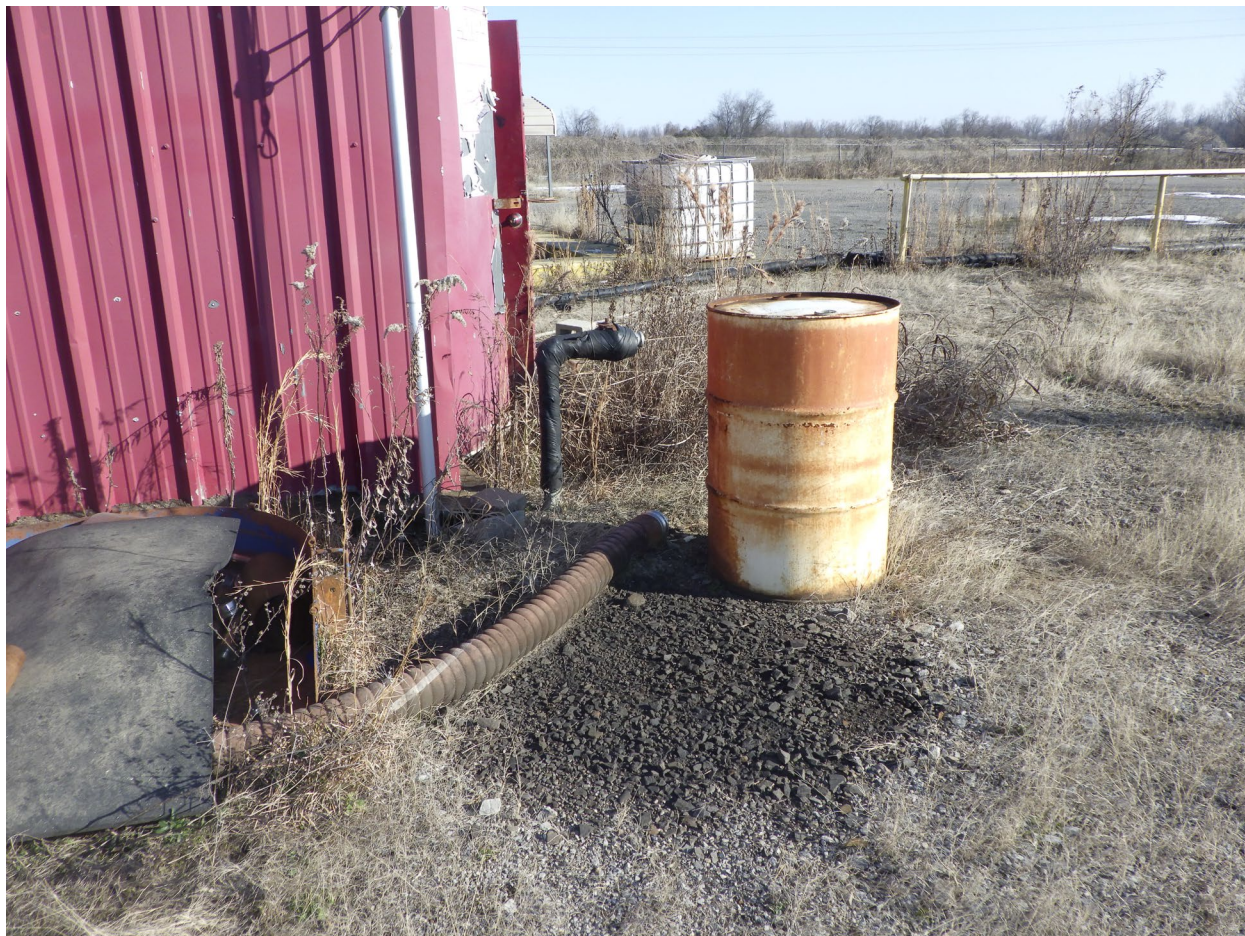
Photo No. 2

I observed a residual hydrocarbon spill on the ground, see Photo No. 2.

**Description:** Looking E, this photo shows a residual spill of hydrocarbons that has not been properly cleaned up.

| No-Exposure Exclusion Verification | | |
|---|---|---|
| Comments: <u>Old hydrocarbon spill from a barrel onsite.</u> | | |

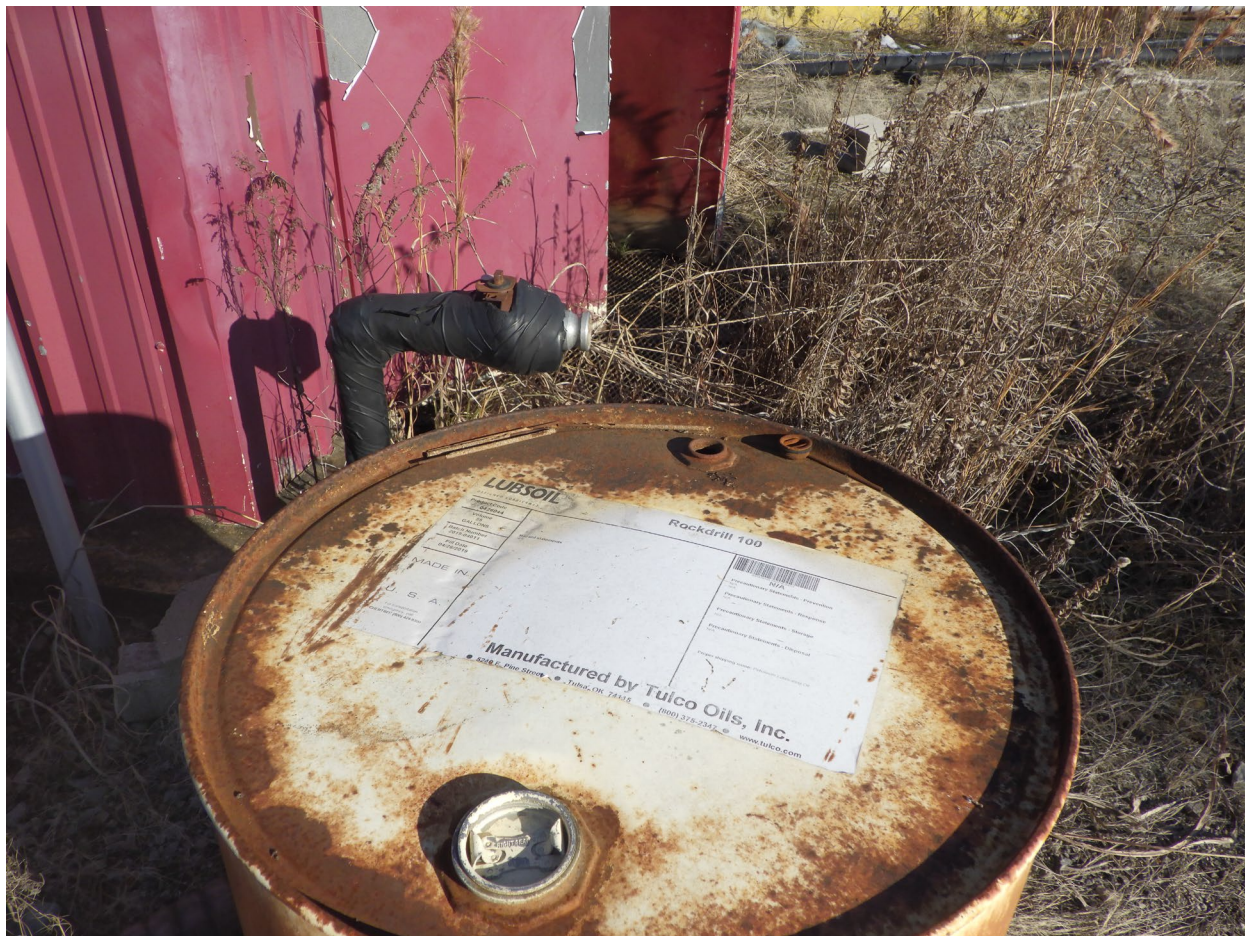
Photo No. 3

I observed a barrel outside secondary containment with an open bung hole, see Photo No. 3.

**Description:** Looking ENE, this photo shows a barrel outside secondary containment with an open bung hole.

| No-Exposure Exclusion Verification | | |
|---|---|---|
| Comments: <u>Barrel with open bunghole; miscellaneous totes/tanks outside secondary containment</u> | | |
