**Compliance Evaluation Inspection Report**

Grenada Publicly Owned Treatment Works

NPDES Permit No. MS0020397

**Project No. CV-MS0020397-10252023**

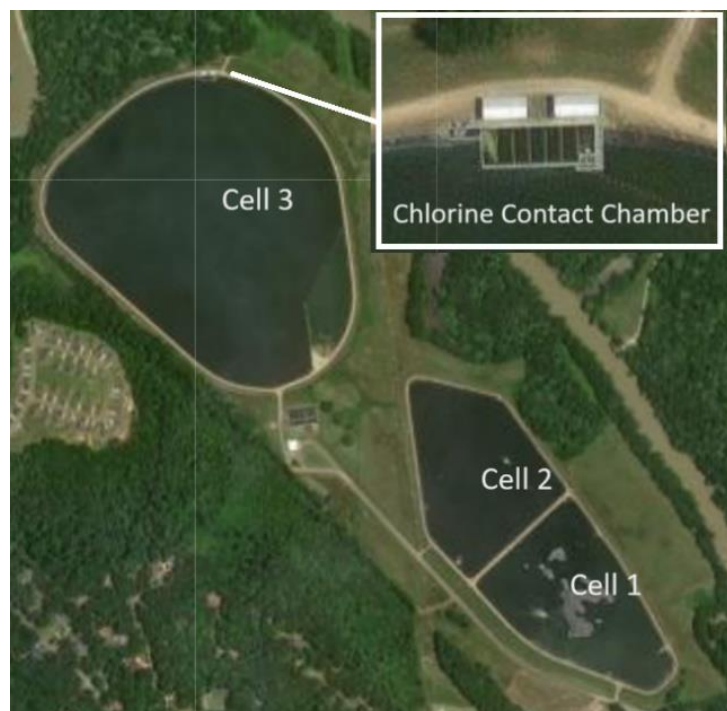
**Figure 1.** Grenada POTW

The Lagoon is a three-cell wastewater treatment lagoon that treats domestic and industrial wastewater from the City of Grenada. Figure 1 shows an aerial view of the Lagoon. Cell 1 consists of six aerators along the Lagoon banks. Cell 2 consists of five aerators along the banks of the Lagoon. Cell 3 is a facultative lagoon. Chlorine gas is used to disinfect and sulfur dioxide gas is used to dechlorinate prior to discharge. All three cells are lined with a geosynthetic material to prevent seepage.

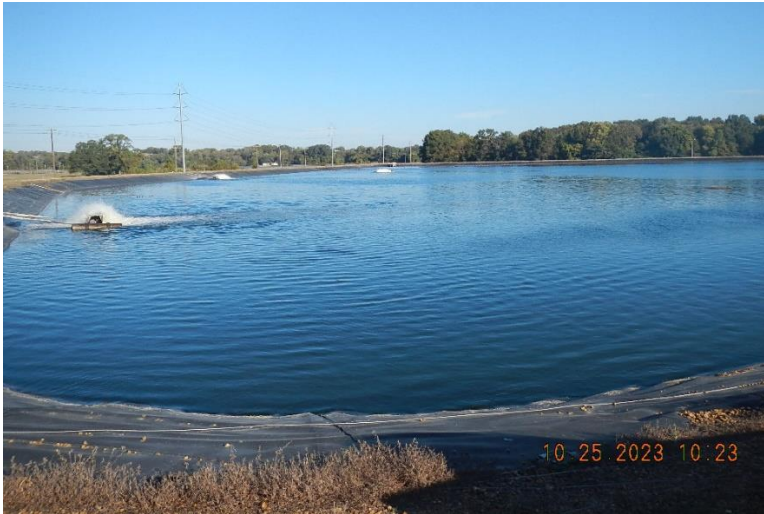
- i. All aerators were operational in Cells 1 and 2 (See Photo 1).
- ii. The Lagoon liner appeared to be in good condition.
- iii. The chlorine contact chamber was in good condition.
- iv. The wastewater flow in the chlorine contact chamber was notably green in color due to excessive green algae growth, which was also noted in Cell 3 (See Photo 2).

Photo 1. Cell 2, operational aerators.

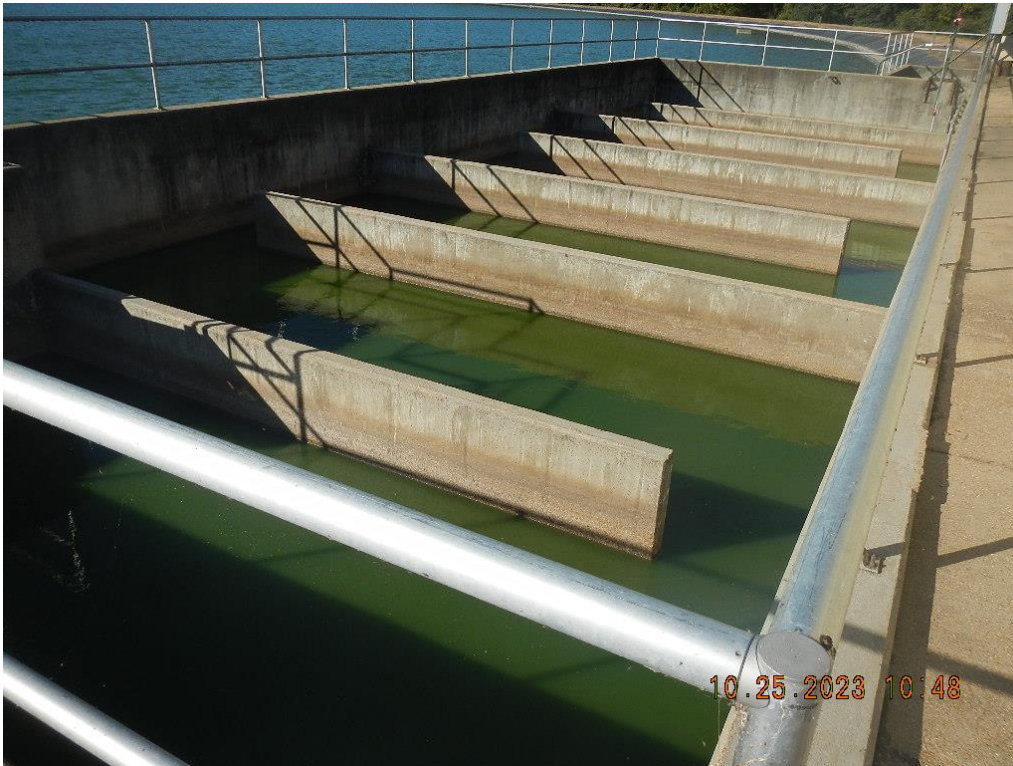
High BOD and TSS in the Lagoon can cause excessive green algae growth. Increasing mixing/aeration is one technique to control green algae growth. Excessive solids, to include algae, can also interfere with disinfection in the chlorine contact chamber, which may account for the *E.coli* exceedances noted in Table 1. Other operational tips and best practices for small lagoons can be found in EPA’s Compliance Advisory referenced in the footnotes of this page.

Photo 2. Green algae observed in the chlorine contact chamber.

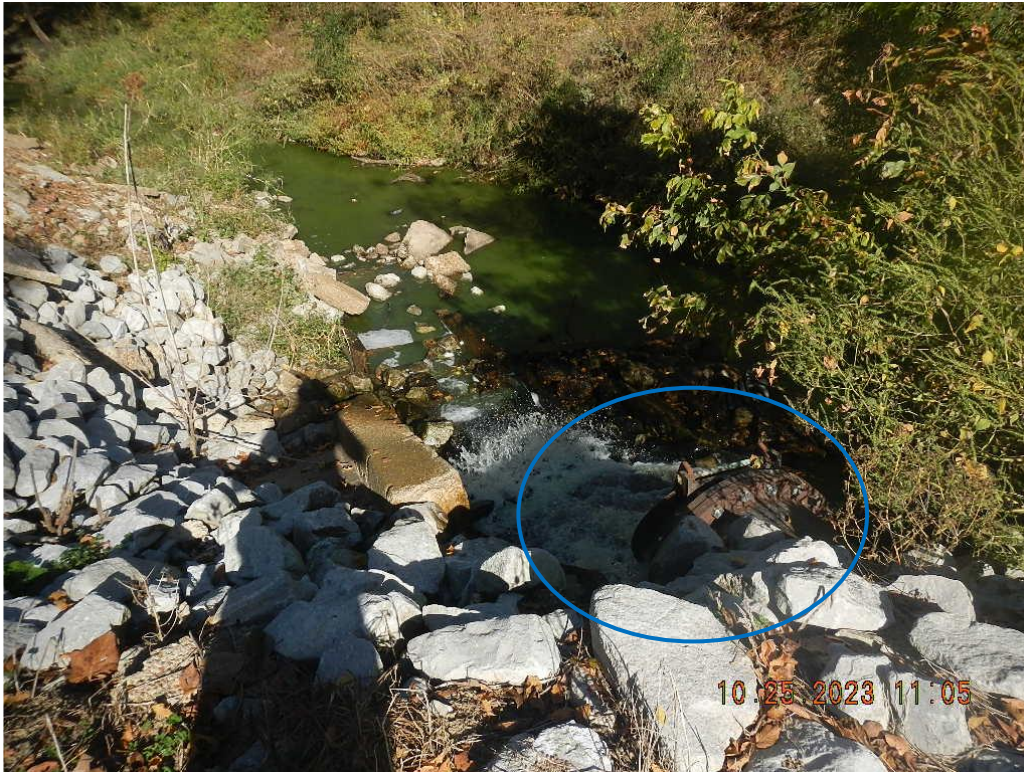
Photo 3. Outfall 001.

The Lagoon discharges at Outfall 001 into a ditch that discharges into the Yalobusha River. Suspended green algae growth was observed in the stream water in ditch. The effluent looked clear with exception of the suspended algae in the stream (See Photo 3).
