**Region 6 - Enforcement & Compliance Assurance Division**  
**INSPECTION REPORT**

| Regulatory Program(s) | NESHAP | |
| Company Name: | LyondellBasell Industries | |
| Facility Name: | Houston Refining LP | |

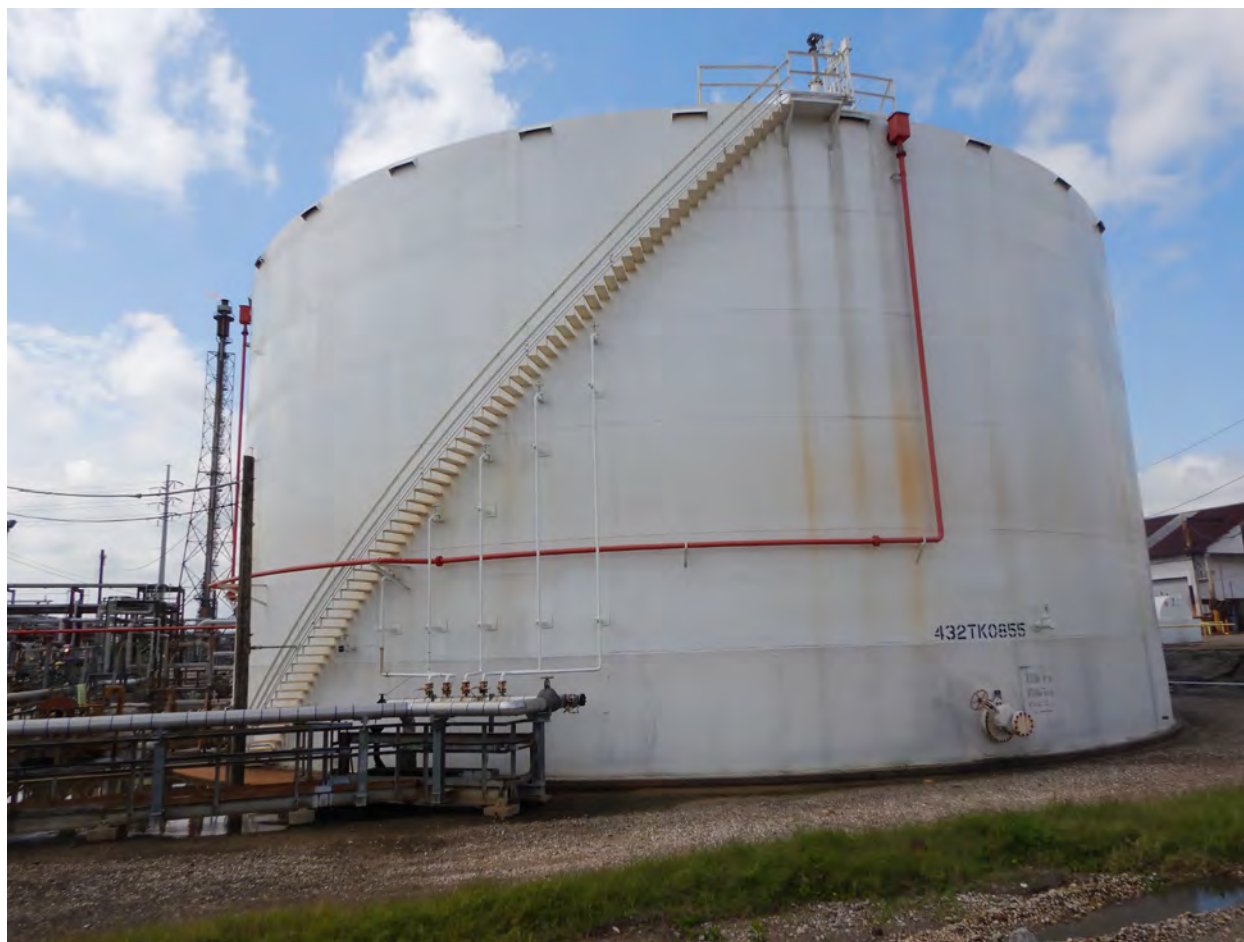
Photo No. 1

Description: Photograph of Tank 855, containing benzene wastewater. Concentrations of up to 10 ppm benzene were detected with a PID.

Mr. Bobbs climbed Tank 855 and detected up to 10 parts per million ("ppm") benzene emitting from the tank's perimeter vent. Mr. Bobbs climbed Tank 854 and detected up to 59 ppm benzene emitting from the tank's perimeter vent. [AOC 5]

- 5) Inspectors observed emissions of VOC and benzene from Tanks 854 and 855 via OGI and PID. Concentrations of up to 59 ppm benzene were detected at the vents of Tank 854. The eGC EPA 2 had concentrations of up to 6.1 ppb benzene when the wind was from the direction of Tanks 854 and 855. The emissions from these tanks could be impacting the fenceline during specific wind conditions.

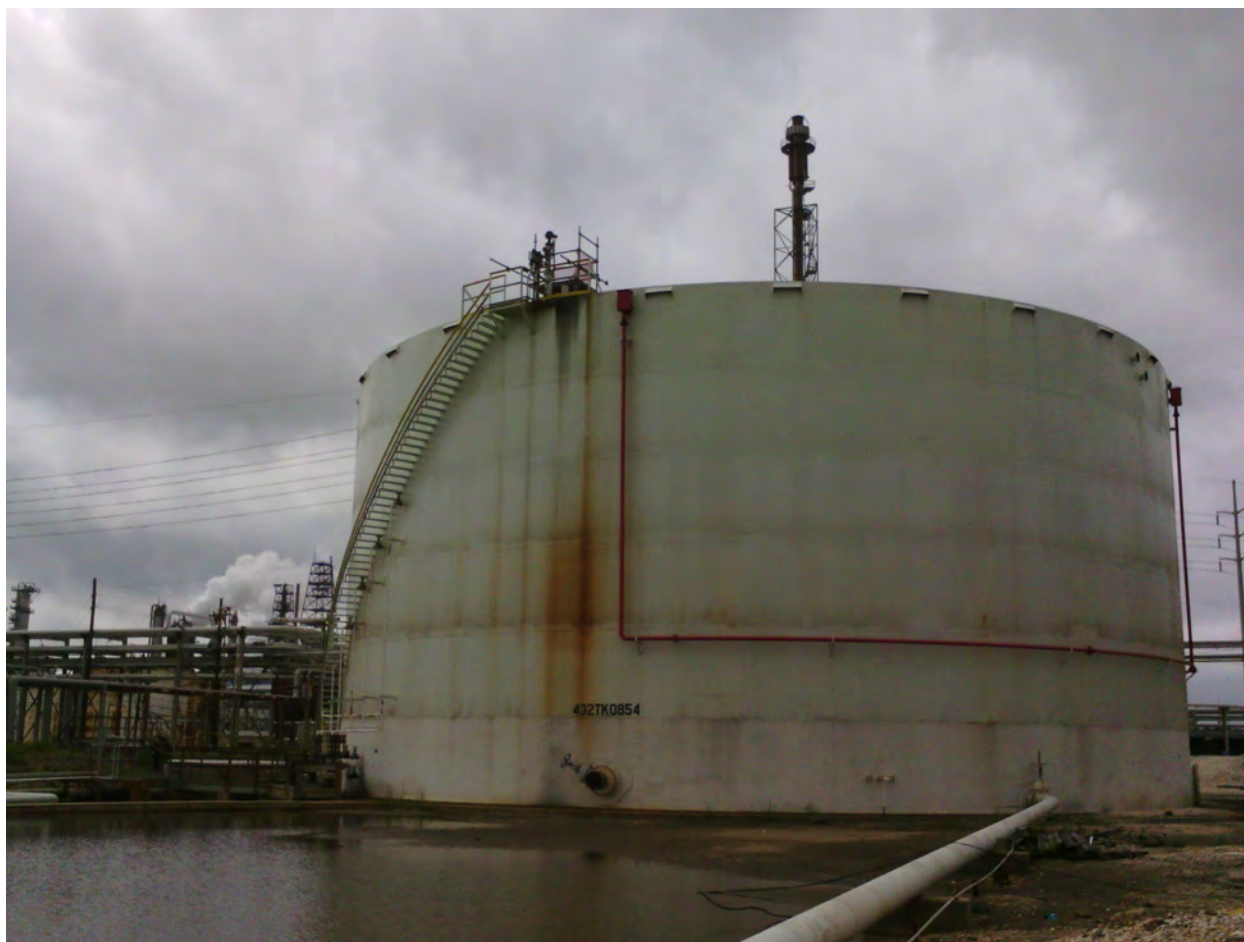
Photo No. 2

Description: Photograph of Tank 854, containing benzene wastewater. Concentrations of up to 59 ppm benzene were detected with a PID.

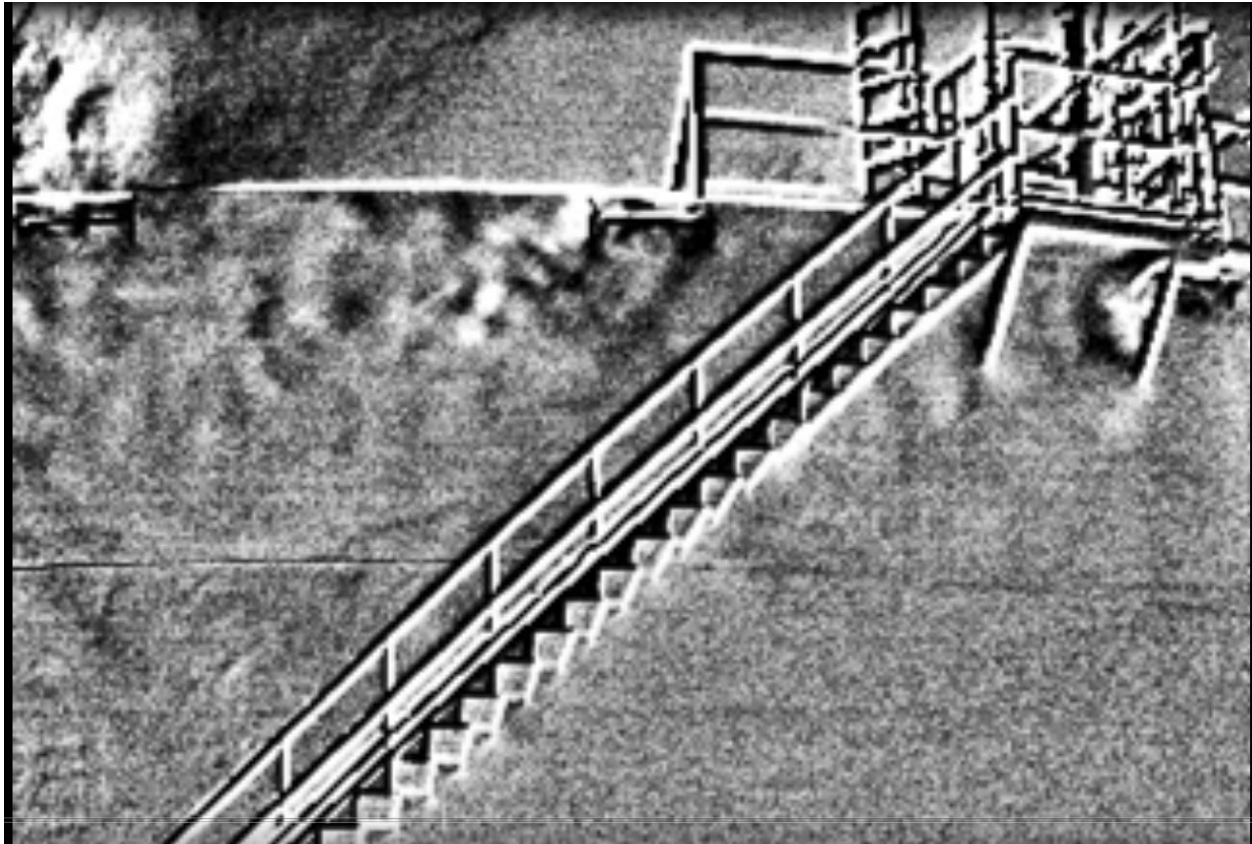
Photo No. 3

Description: Hydrocarbon emissions emitting from vents on Tank 854. The tank contains benzene wastewater.

The inspection team observed Tanks 855 (Photo 1) and 854 (Photo 2). Mr. Miller observed hydrocarbon emissions from both tanks (Video 3). [AOC 5] The tanks contain benzene wastewater and are equipped with internal floating roofs. The contents of the tank settle and are routed to the steam stripper. Oil is manually skimmed off the top layer and sent to Tank 412 (slop oil), according to Mr. Muñoz. The inspection team observed the area around Tank 412 and detected up to 232 ppb VOC, but the source was not located. No hydrocarbons were observed with the OGI camera.

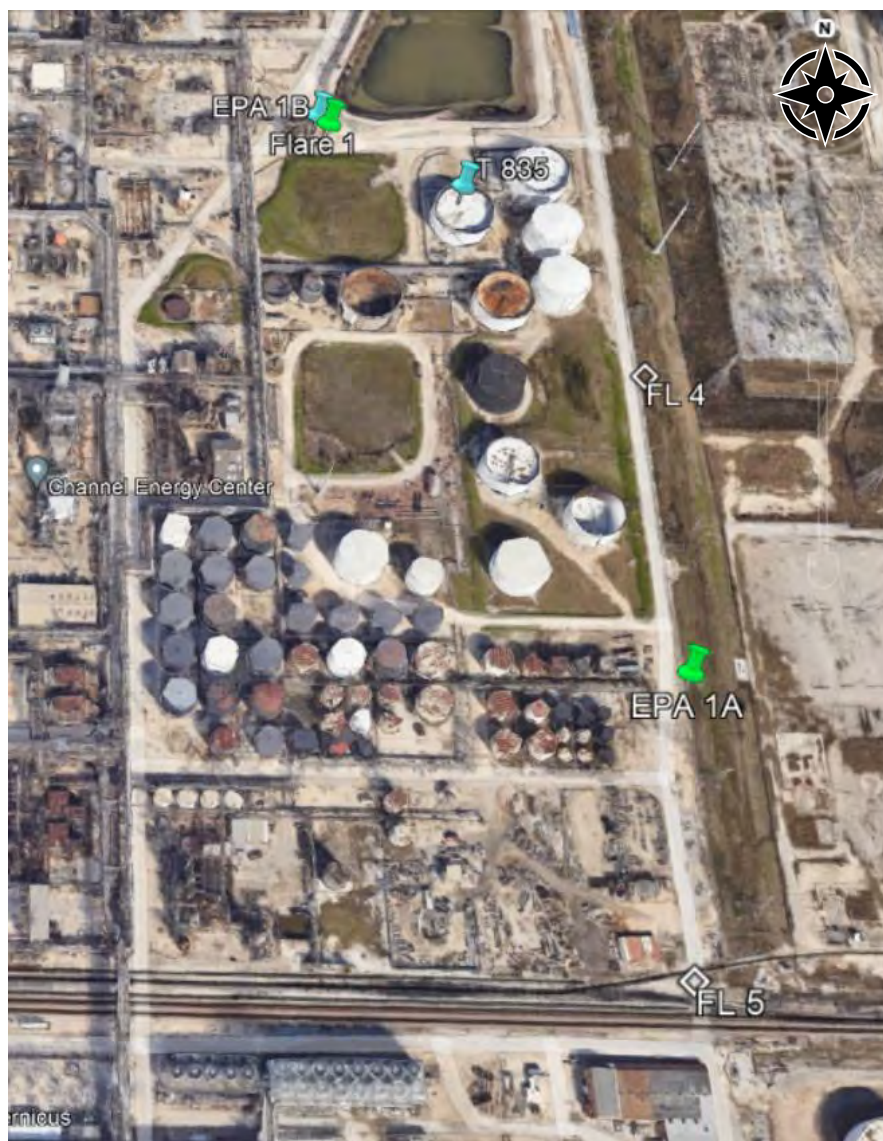
Figure 2. EPA 1 eGC Site Overview

Site EPA 1A was the first site that EPA 1 was positioned at; the site was located on the Eastern fence line of Houston Refining between fence line monitors 4 and 5. EPA 1 was set up at approximately 10:56 AM on April 25, 2023 and ran at site EPA 1A until 9:16 AM on April 26, 2023. The wind during this time frame came predominantly from the southeast and east and varied from 1 mph to 4 mph.

Site EPA 1B was the second site of EPA 1, this site was northeast of EPA 1A and at the base of Flare 1. EPA 1 was set up at this site at approximately 9:56 AM on April 26, 2023 and stayed there until 9:34 am on April 27, 2023. During the first half of this time period the wind was very erratic and there was no clear wind direction trend overall, wind speed averaged at around 1.0 – 3.0 mph.

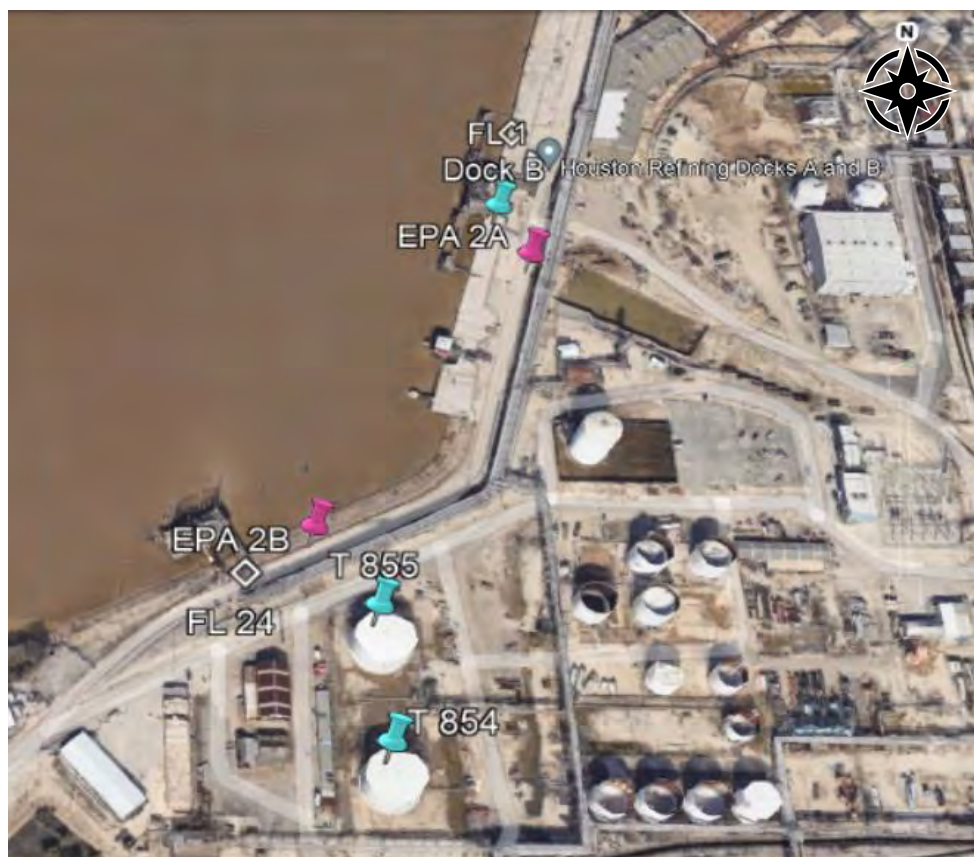
Figure 5. EPA 2 eGC Site Overview

Site EPA 2A was the first location EPA 2 was deployed at during the inspection. The site was located next to Dock B and southeast of fence line monitor 1. EPA 2 was set up at approximately 12:16 PM on April 25, 2023 and stayed at this site until approximately 11:36AM on April 26, 2023. The wind was coming from the east at a speed of approximately 2.0 – 5.0 mph.

Site EPA 2B was located southwest of EPA 2A and North of T855 and T854. EPA 2 was set up at this site at approximately 11:56 AM on April 26, 2023 and stayed at this site until approximately 3:16 PM on April 27, 2023. The wind shifted a lot during this time frame and had a speed of 1.5 – 4.0 mph.

- A significant benzene reading of 6.07 ppb occurred at 3:26 pm on April 26, 2023.
- A significant benzene reading of 7.29 ppb occurred at 2:26 am on April 27, 2023.
