**Region 6 - Enforcement & Compliance Assurance Division**  
**INSPECTION REPORT**

| Media Program: | Water | |
| Regulatory Program(s) | CWA | |

The unpermitted facility is a broiler operation and has [REDACTED] barns. The facility can typically grow the birds to 37 days. The farm stocks 20,000 chickens per house for a total of 200,000 birds. The chickens are fed a corn-soy based diet. After the flock reaches maturity, they are removed and sold. The operator will windrow, de-cake then remove the composted cake material 2-3 times a year. Waste litter is transferred offsite to a 3<sup>rd</sup> party. Mortalities are composted in a litter barn. Mortalities occur at a rate of 7,500 per month and are composted in the litter barn within 24 hours. The facility has a Natural Resource Conservation Service (NRCS) approved Nutrient Management Plan (NMP). The facility was within the [REDACTED] Watershed. The inspector exited the facility at 11:30 am.

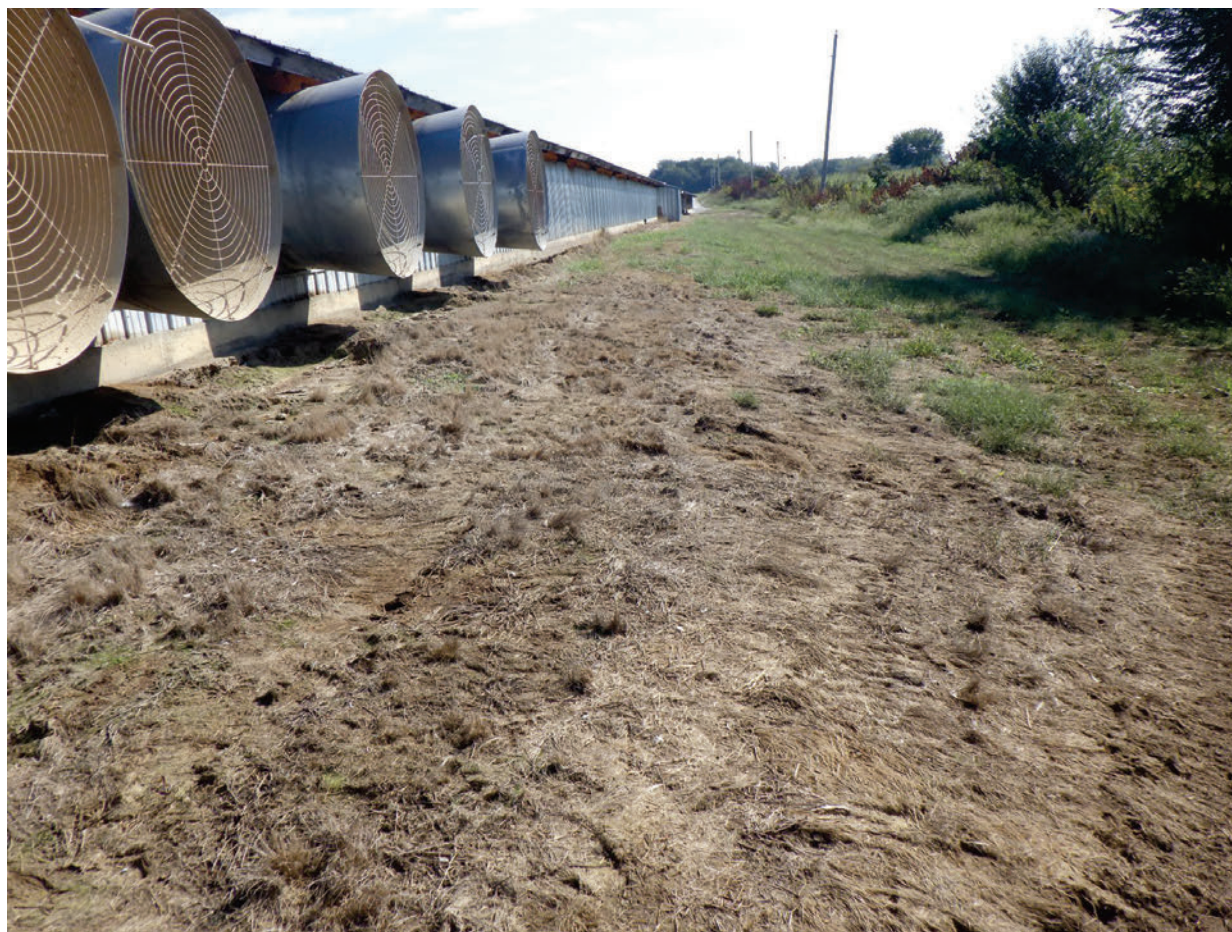
Photo No. 1

- The facility demonstrates good housekeeping practices (Photo 1, Appendix 1).
- No cracks or run-off were observed from the litter barn.
- Ineffective vegetated buffers were observed next to chicken houses 1 on the south side of the property (Photo 1, Appendix 1).
- There were no signs of track-out at the entrance of any of the chicken houses.
- Chicken parts were observed outside containment (Photo 2, Appendix 1).

| Description: | The vegetated buffer next to chicken house 1 on the south side of the facility needs to be regrown. | | |

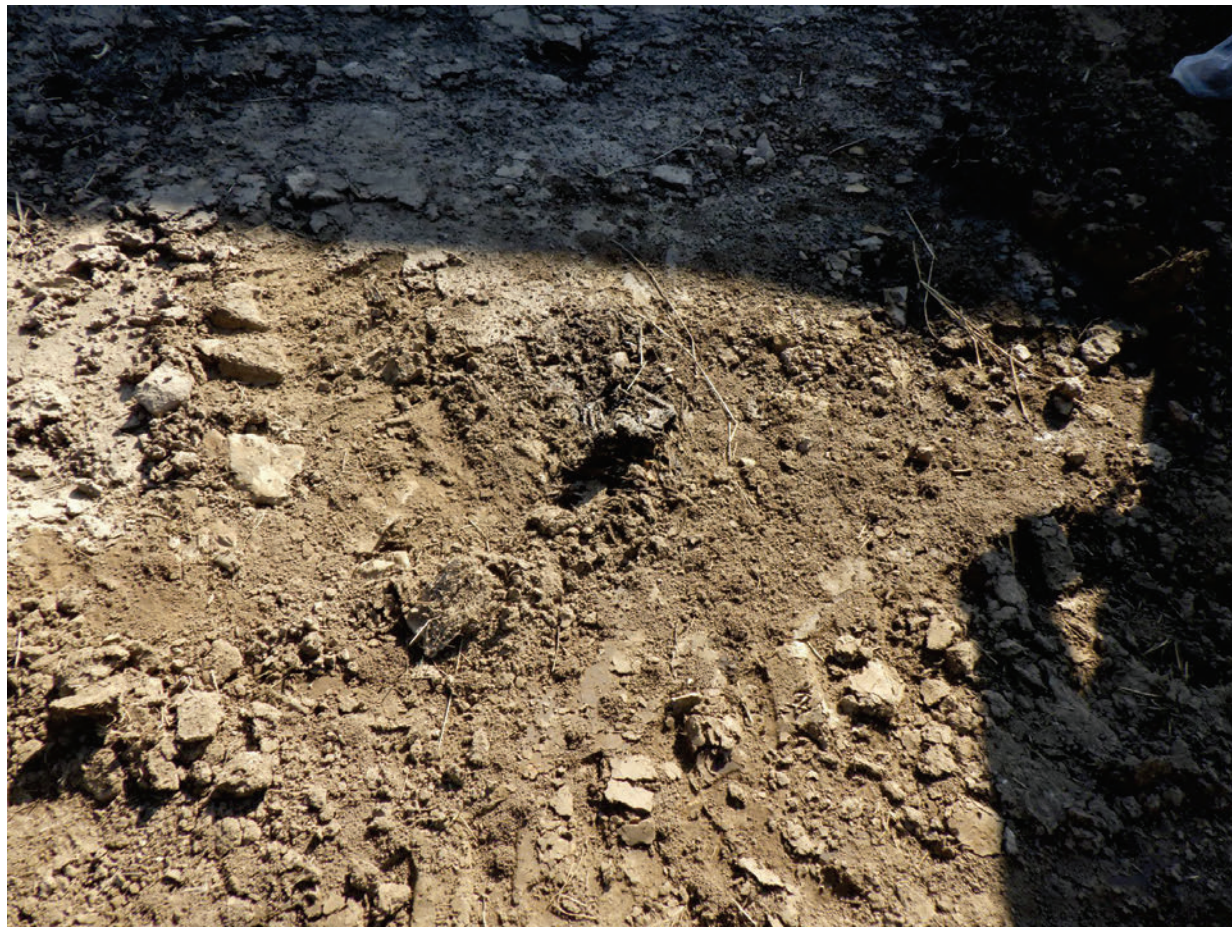
Photo No. 2

The exposed mortality outside the litter barn is at risk of being washed away by rainfall, potentially contaminating nearby water bodies such as [REDACTED], which is currently impaired for Benthic Macroinvertebrates Bioassessments & Dissolved Oxygen (DO) (Photo 2, Appendix 1) (40 CFR §122.23(b)(7)).

| Description: | A dead chicken was observed west of chicken house 3. | | |
