## **RCRA Inspection Report**

Loveland Products  
917 Platte Road  
Clarksdale, Mississippi 38703

**COMPLIANCE EVALUATION Inspection**

**October 26, 2021**

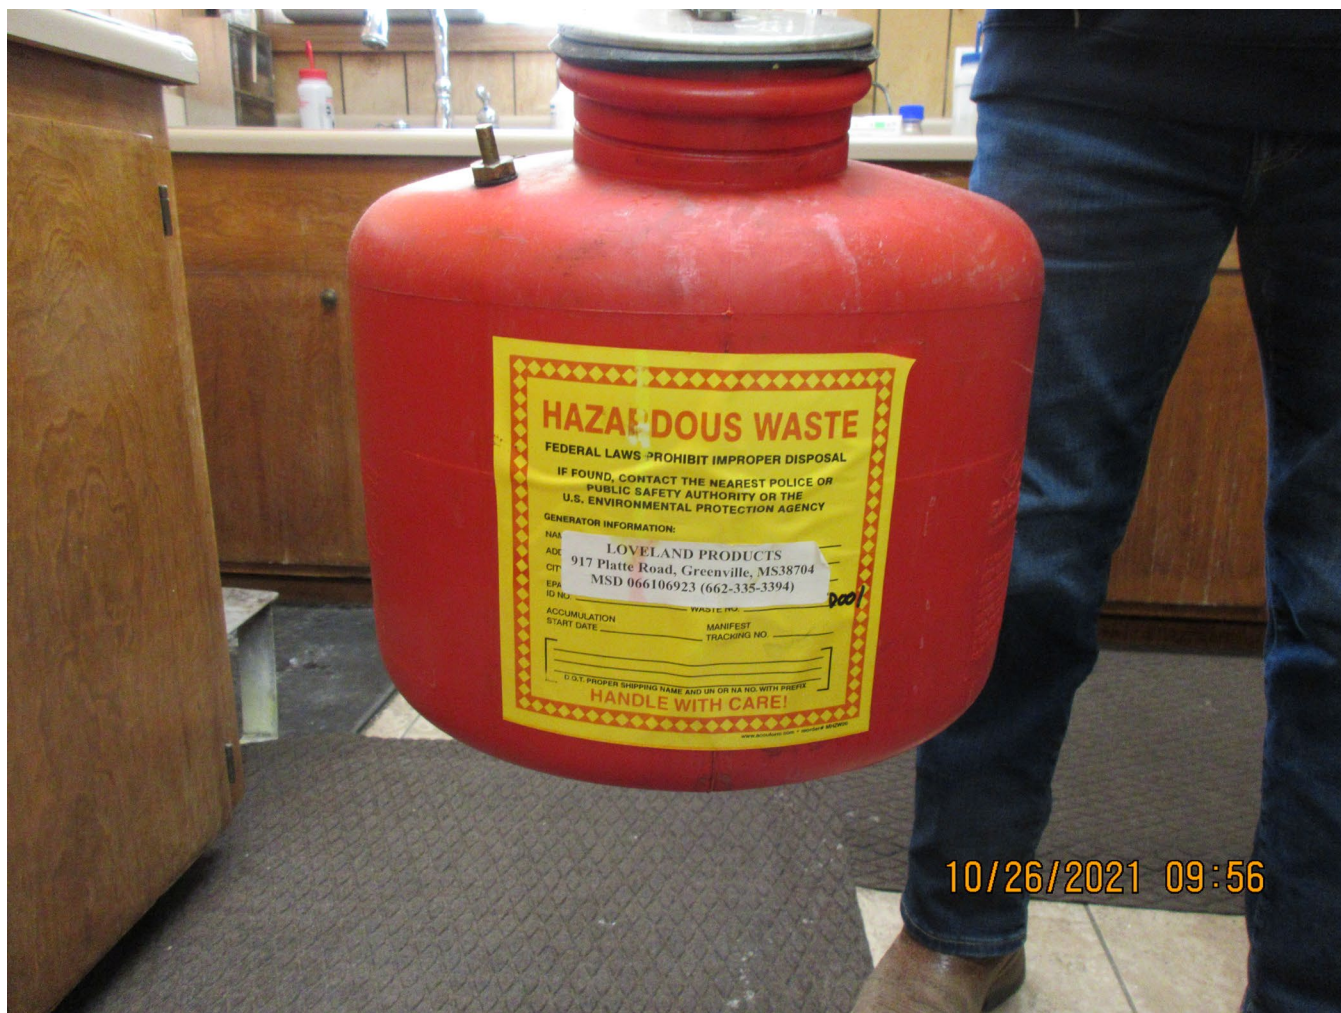
Within a "Wet Lab Area," ignitable hazardous wastes were generated in a three-gallon container (Photos 1 & 2) in a satellite accumulation area (SAA). At the time of the inspection, the container was closed and labeled with the words "Hazardous Waste." The container was not labeled with an indication of the hazard contents of the container.

Photo 1 – Label on 3-gallon container in Wet Lab Area

**Pursuant to 11 Miss. Admin. Code Pt. 3, R. 1.3 [40 C.F.R. § 262.15(a)(5)(ii)], which is a condition of the SAA Permit Exemption, a generator is required to mark or label its containers (ii) with an indication of the hazards of the contents.**
