INSPECTION REPORT

| <b>Type of Inspection</b> | Focused Compliance Evaluation Inspection (CEI) | | |
| <b>Company Name</b> | Port Houston Authority and Related Facilities | | |

The Port Houston Authority and its tenants were selected for inspection based on an Environmental Justice and Regional initiative to evaluate facilities at ports receiving or transporting Resource Conservation and Recovery Act (RCRA)-regulated hazardous wastes. On 11/08/23, Dedriel Gardner contacted Port Houston Authority to announce the inspection, but asked that it be unannounced to the tenants. A list of tenants that had an International Convention for the Prevention of Pollution from Ships (MARPOL) Annex V Certificate of Adequacy (COA) issued by the U.S. Coast Guard (USCG) was provided to Port Houston Authority. MARPOL Annex V's contains regulations designed to prevent garbage pollution from ships. "Garbage" is broadly defined and may include RCRA-regulated wastes.

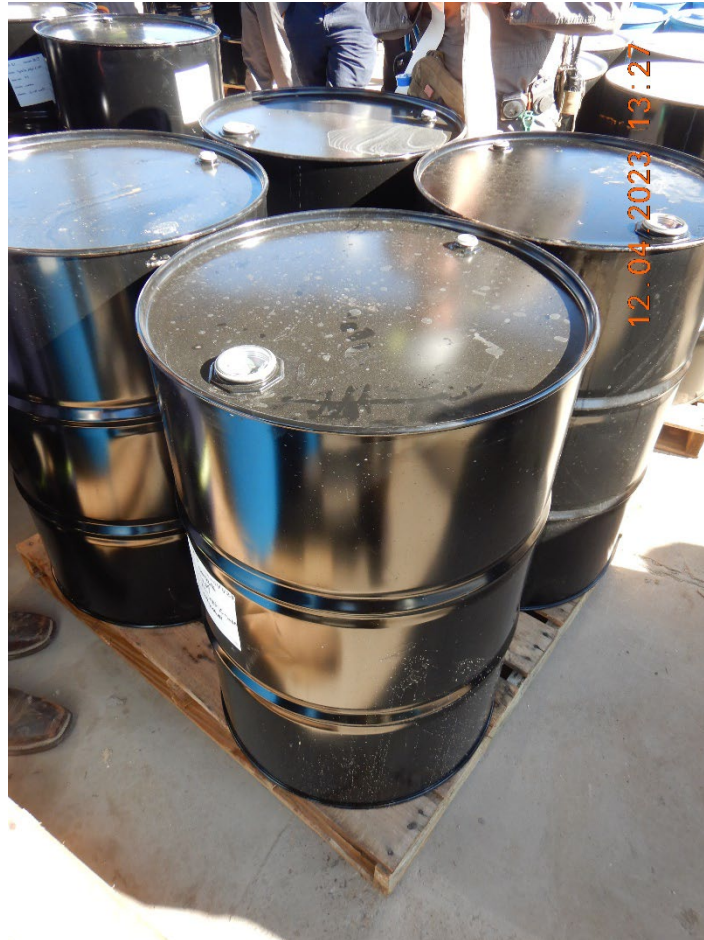
Photo File Name: DSCN6918

Description: Four 55-gallon drums of benzene not properly labeled as "Hazardous Waste" in the CAA.

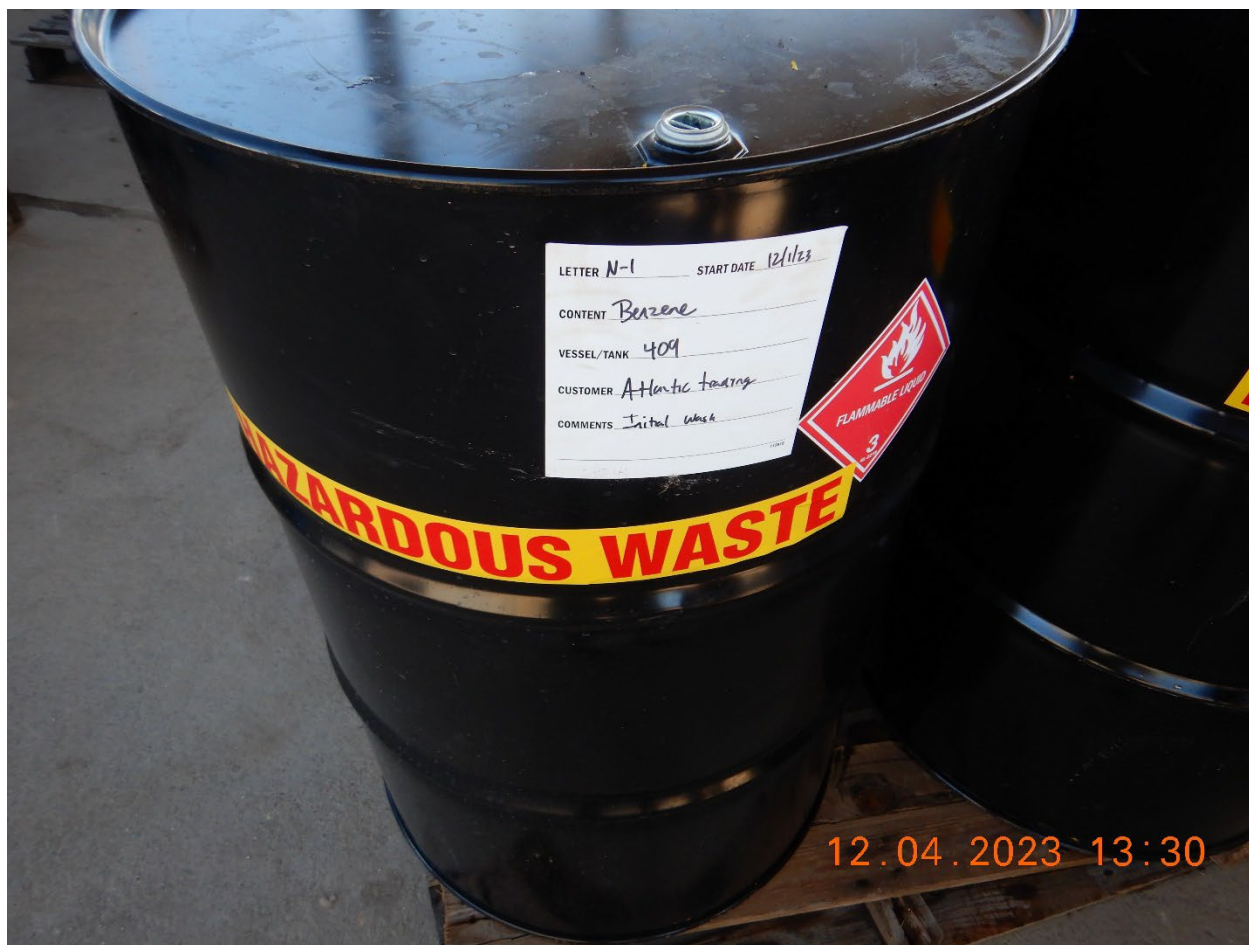
Photo File Name: DSCN6919

Description: A 55-gallon drum of hazardous waste containing benzene in the CAA. This drum was stored in the same secondary containment as hazardous a 55-gallon drum of waste acids which are incompatible (see Photo 4).

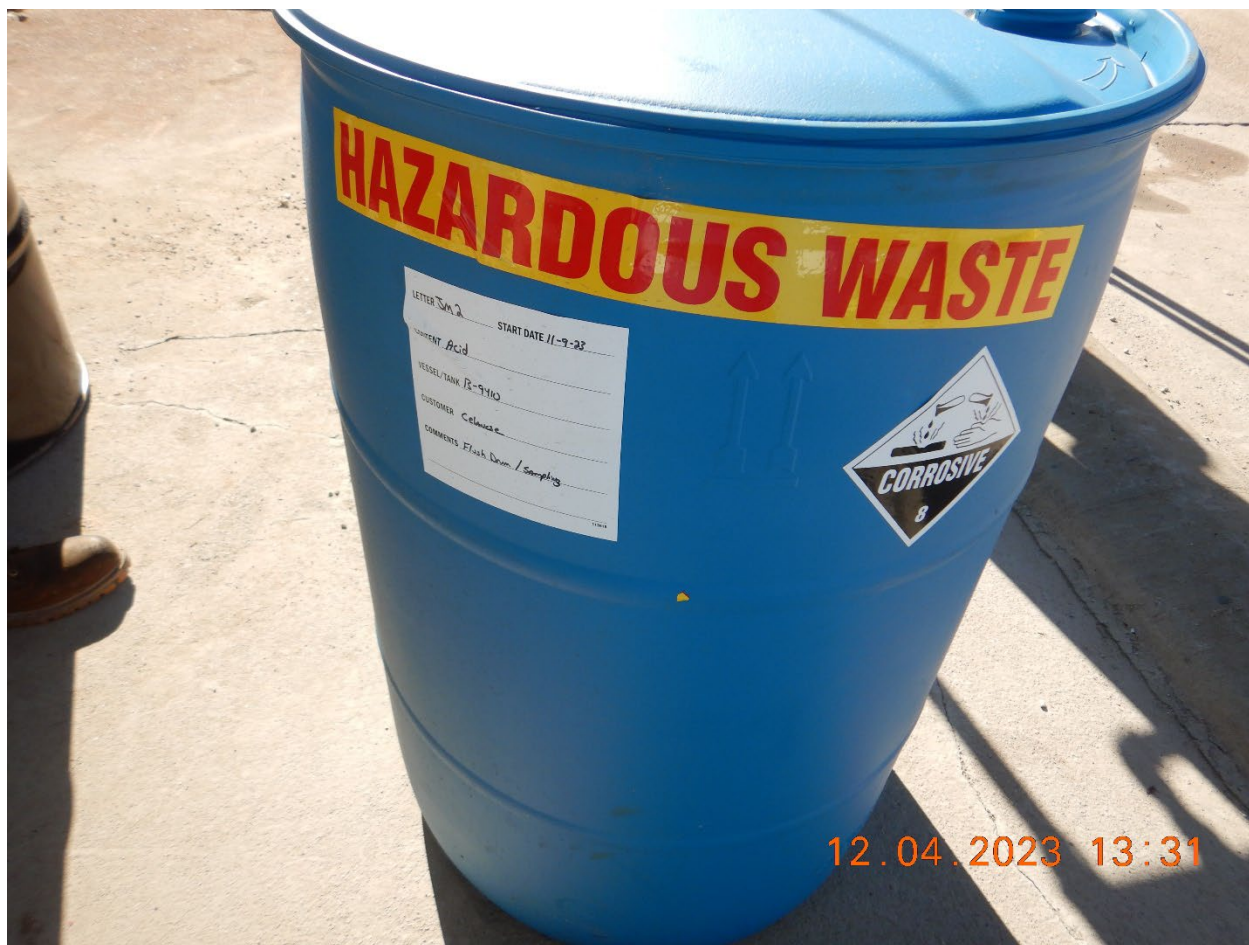
Photo File Name: DSCN6920

Description: A 55-gallon drum of hazardous waste containing acids in the CAA. This drum was stored in the same secondary containment as a 55-gallon hazardous waste drum containing benzene which are incompatible (see Photo 3).

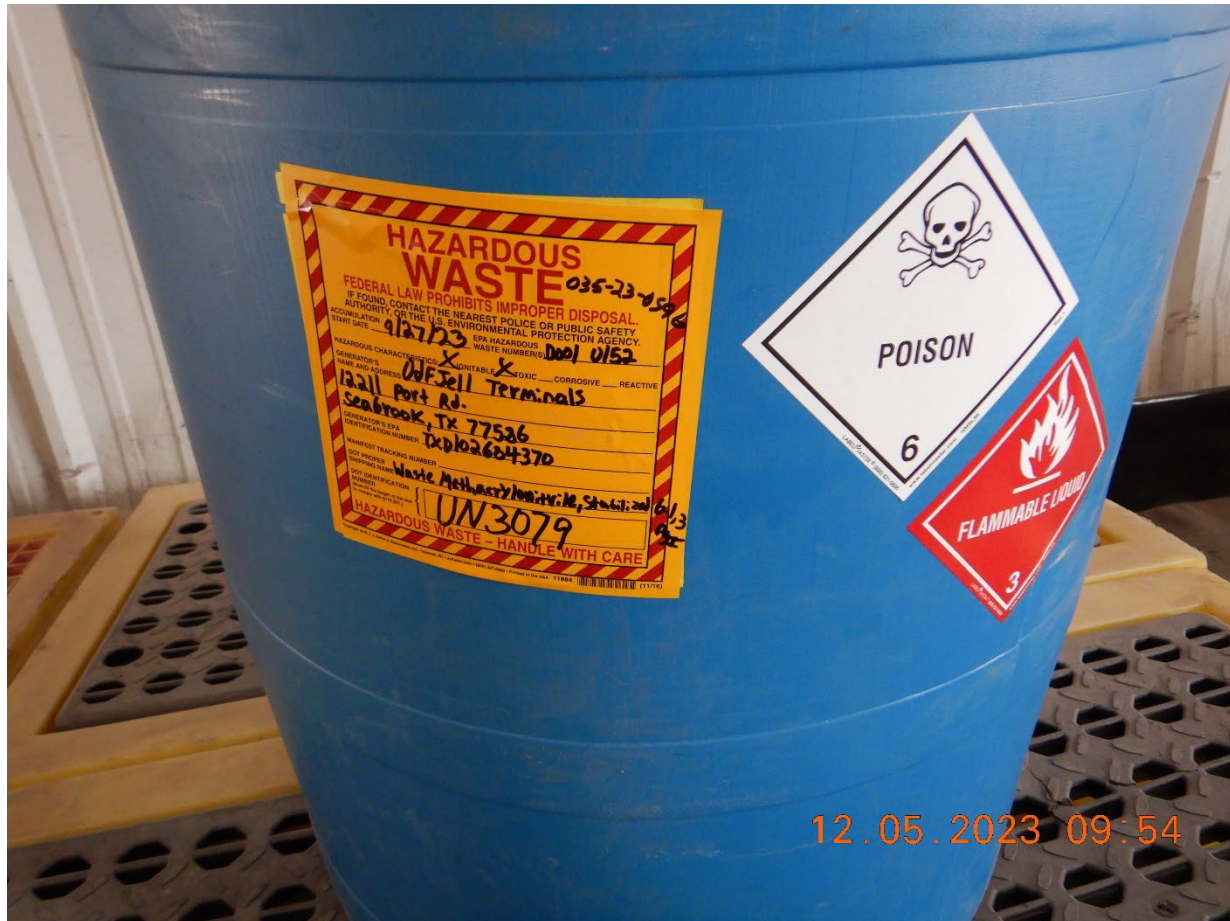
Photo File Name: DSCN6921

Description: Labels on a 55-gallon drum of hazardous waste containing methacrylonitrile from a spill cleanup for Odjfell Terminals in the CAA.

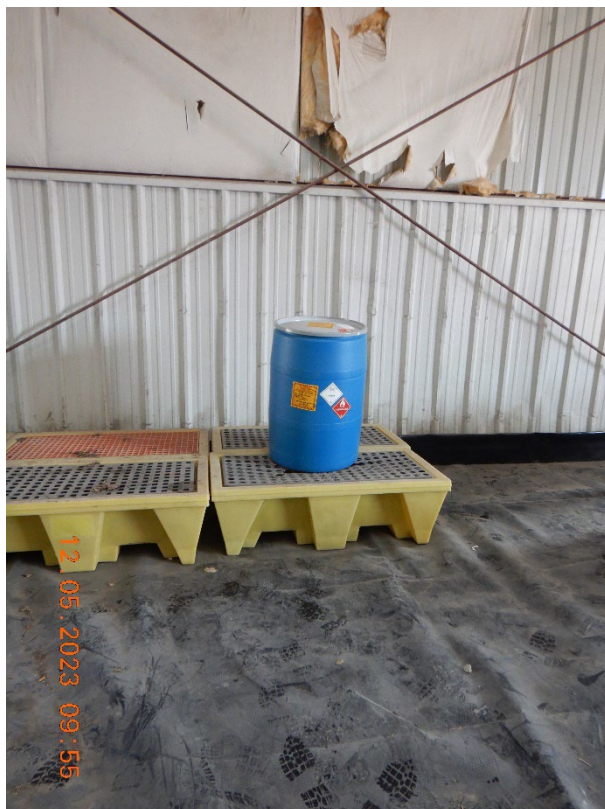
Photo File Name: DSCN6922

Description: A 55-gallon drum of hazardous waste containing methacrylonitrile from a spill cleanup for Odjfell Terminals in the CAA. The drum was being managed in a fenced area designated for hazardous waste.

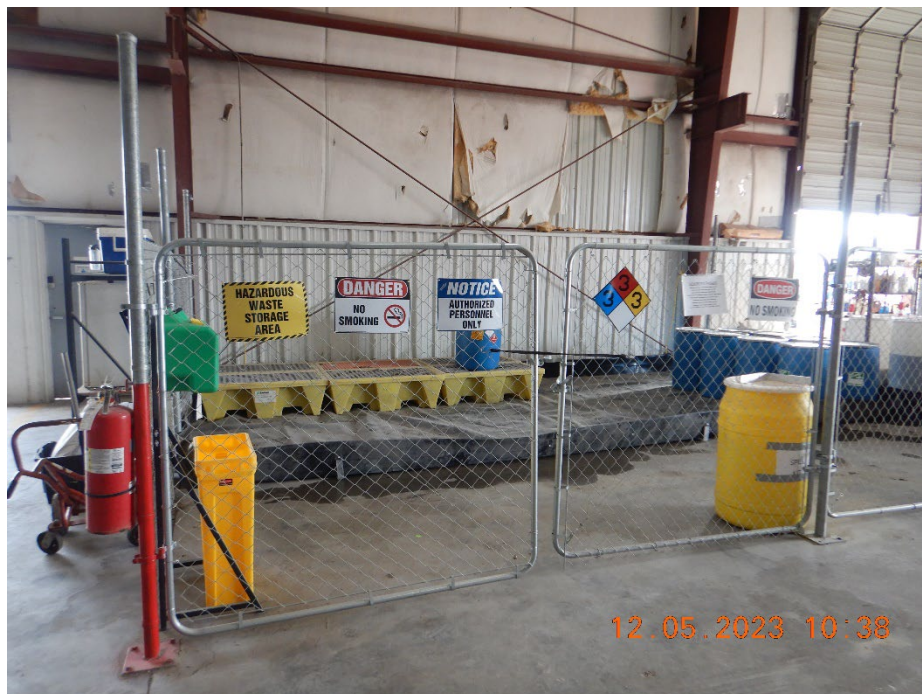
Photo File Name: DSCN6923

Description: Picture showing hazardous waste management area and signage.

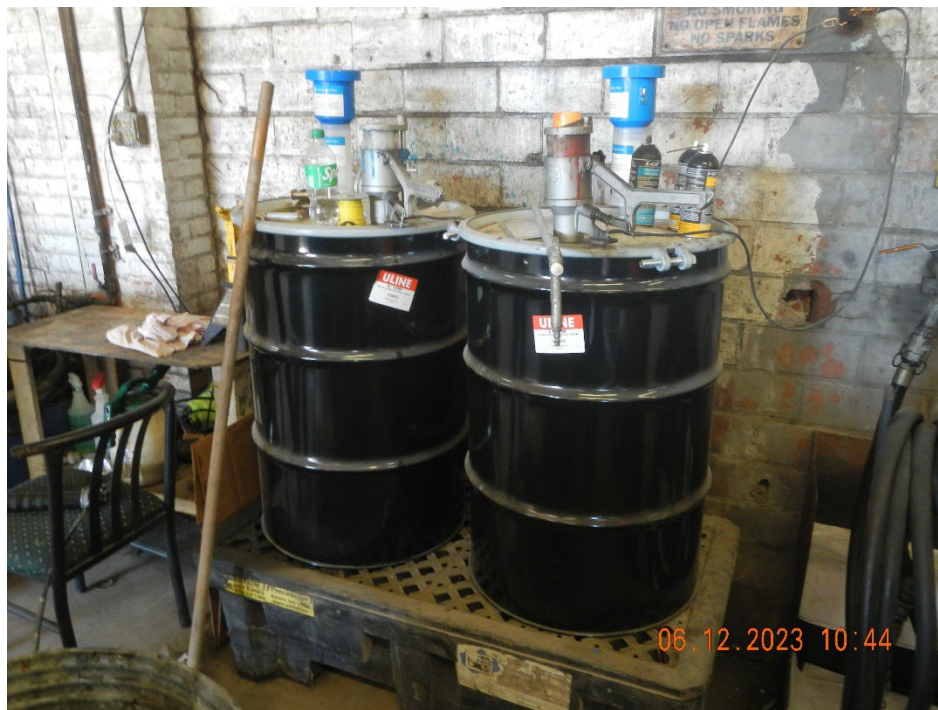
Photo File Name: DSCN6498

Description: Maintenance shop aerosol can area. Jacintoport indicated that they puncture their cans here and collect the residuals. The residuals are sent off as universal paint waste, but they were also collecting residuals from non-paint waste that could include hazardous waste, meaning the drums shown here should be shipped off as hazardous waste.

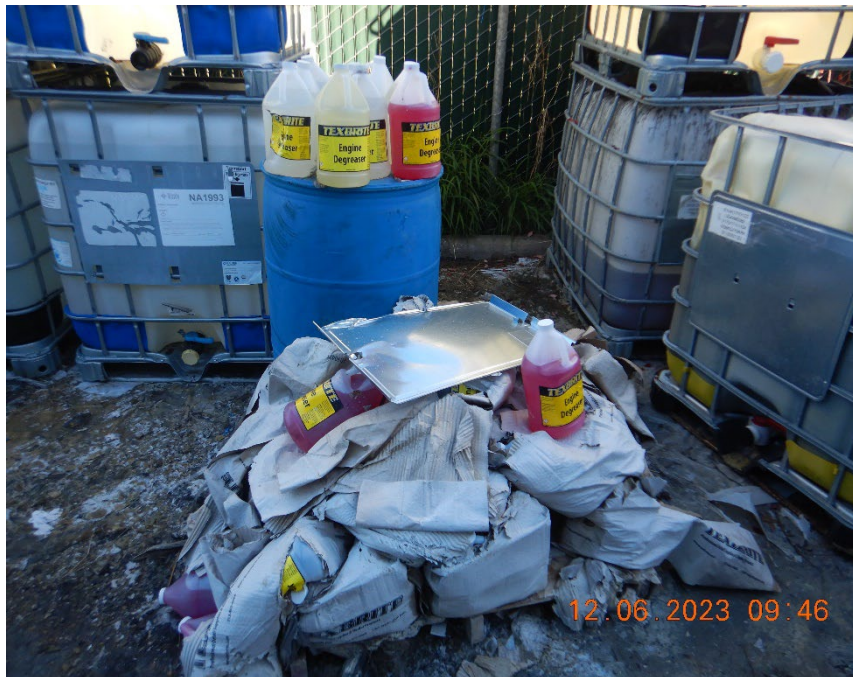
Photo File Name: DSCN6927

Description: Containers of engine degreaser that are used on site, with exterior packaging damaged in the drum storage area. Some of the containers were empty while others contained liquid.

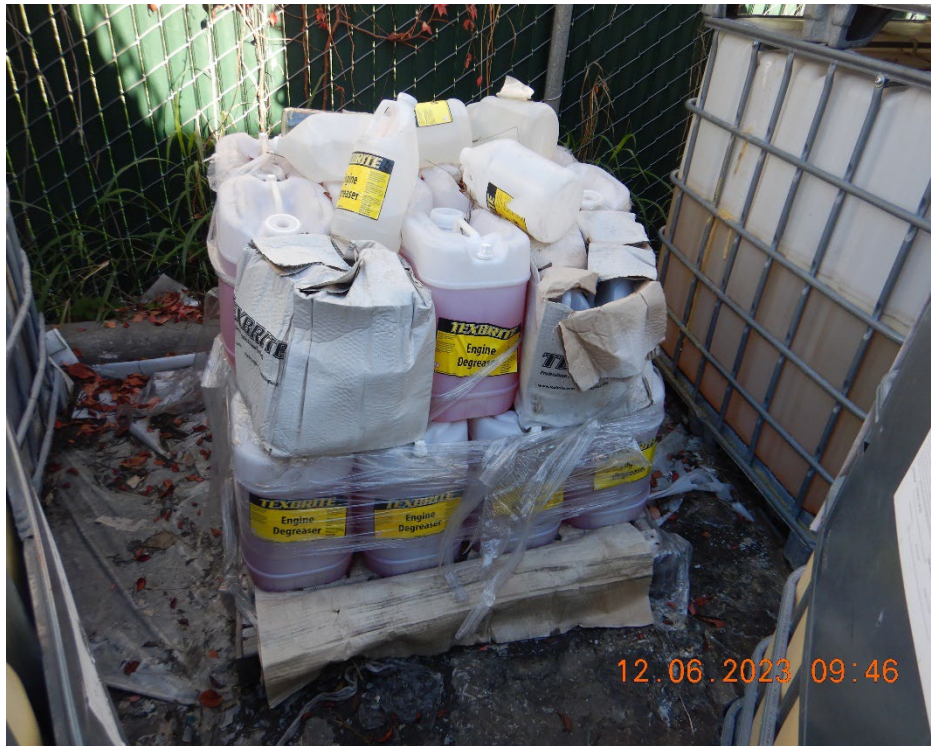
Photo File Name: DSCN6928

Description: Containers of engine degreaser found in the drum storage area that are used on site. Some of the containers were empty while others contained liquid.

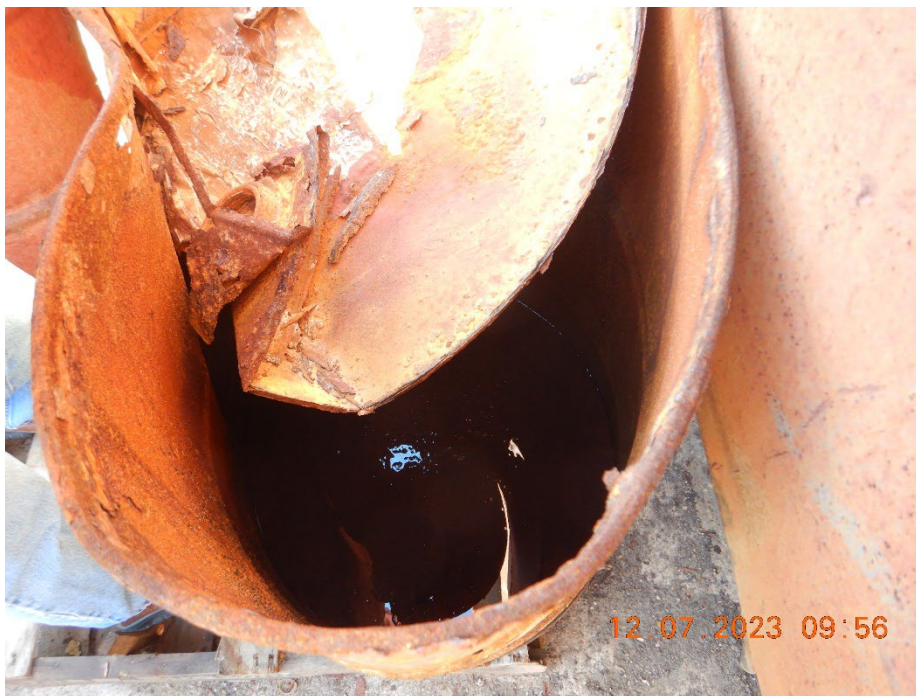
Photo File Name: DSCN6934

Description: A 55-gallon drum that was corroded and contained residuals of unidentified liquids in the drum storage area.

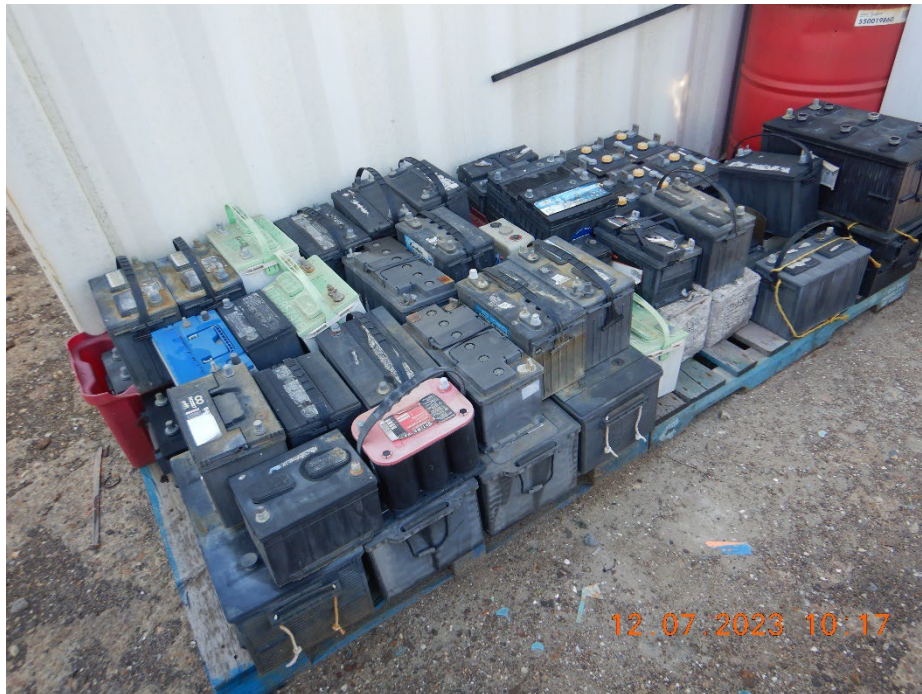
Photo File Name: DSCN6940

Description: Used batteries on pallets that came from ACCP Dickinson boats and vehicles/equipment found near the drum storage area. The batteries were not labeled as universal waste and did not have an accumulation start date.

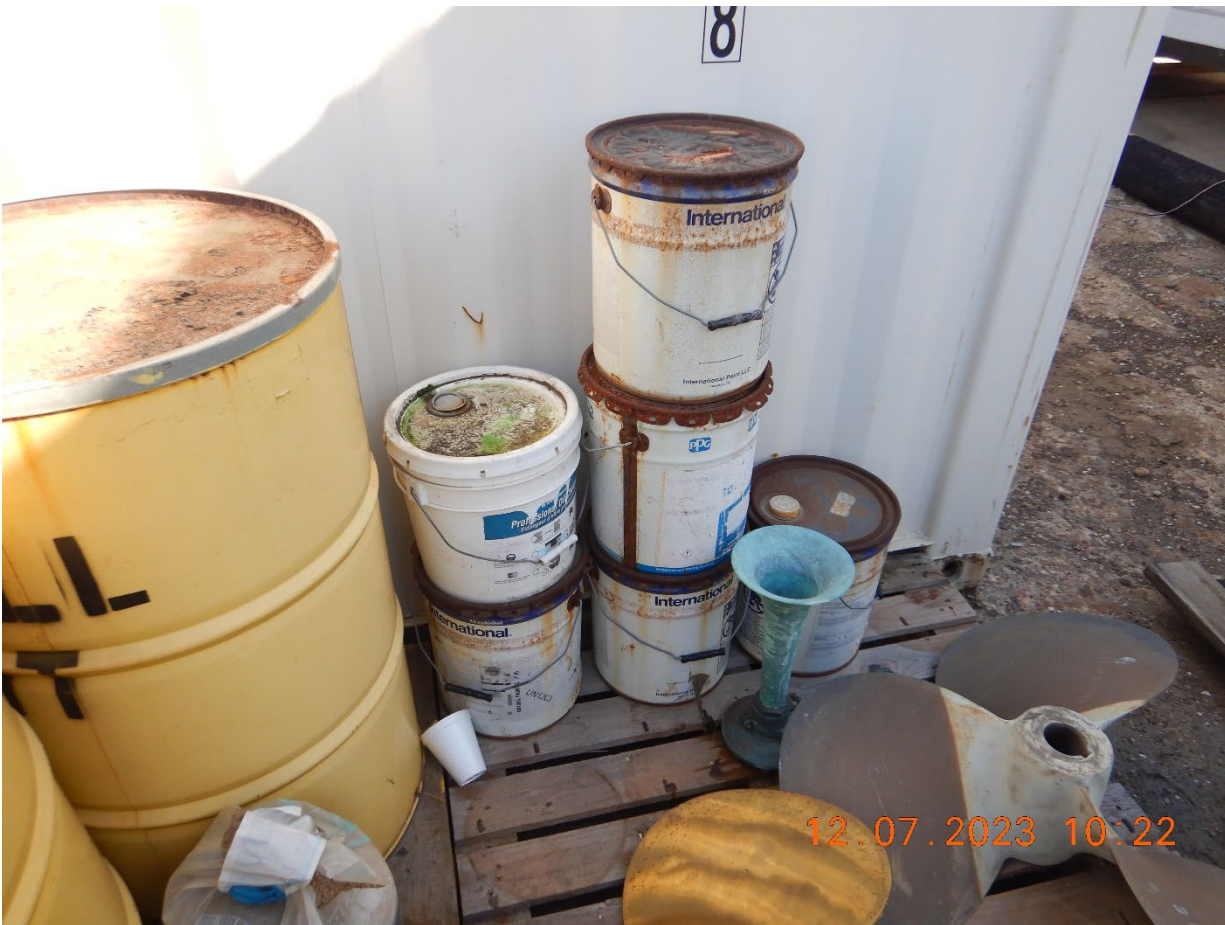
Photo File Name: DSCN6941

Description: Six 5-gallon buckets of used paints received from ships as waste found near the drum storage area. The containers were not labeled as universal waste and did not have an accumulation start date.

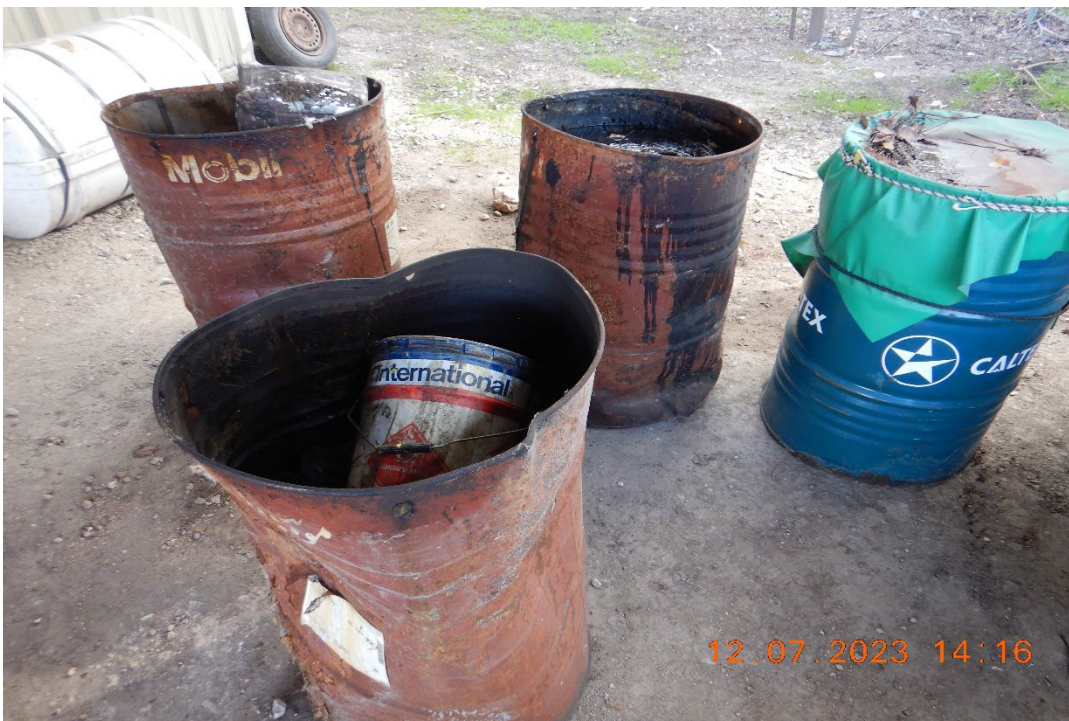
Photo File Name: DSCN6944

Description: Four 55-gallon drums received from ships containing used oil or used oil sludge material found in the drum storage area. The drums were not clearly labeled, were not fully closed, and some were corroded and/or had holes in them.

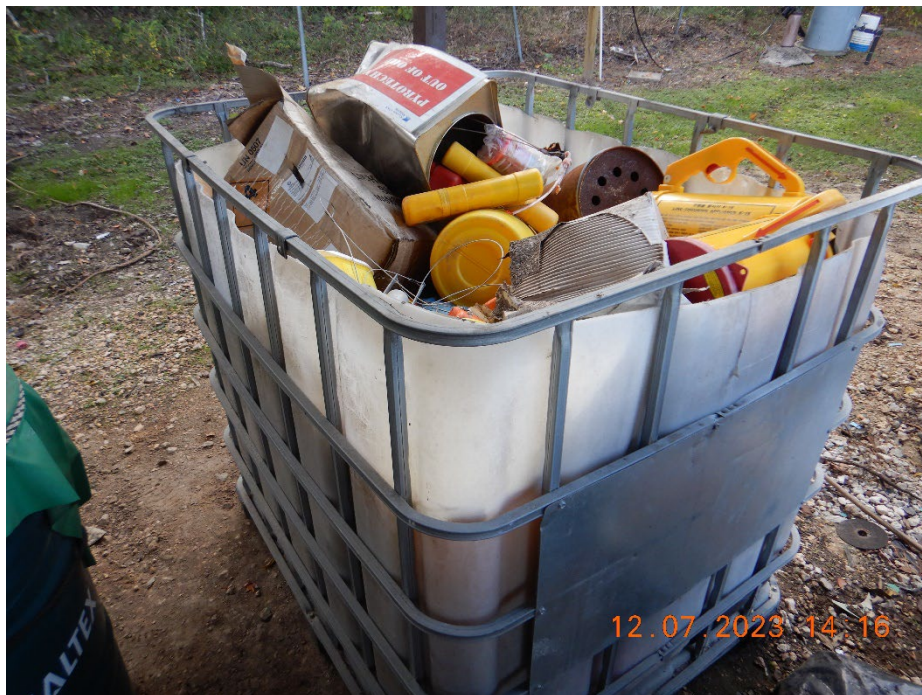
Photo File Name: DSCN6945

Description: An open tote used to accumulate expired flares or pyros received from ships found in the drum storage area.
