Re: U.S. EPA-Region 1 Inspection Report of Naval Submarine Base New London, September 25 - 26, 2024

### RCRA Compliance Inspection of:

Naval Submarine Base New London  
RTE 12 Crystal Lake Road  
Groton, CT 06340

## RCRA HAZARDOUS WASTE INSPECTION REPORT

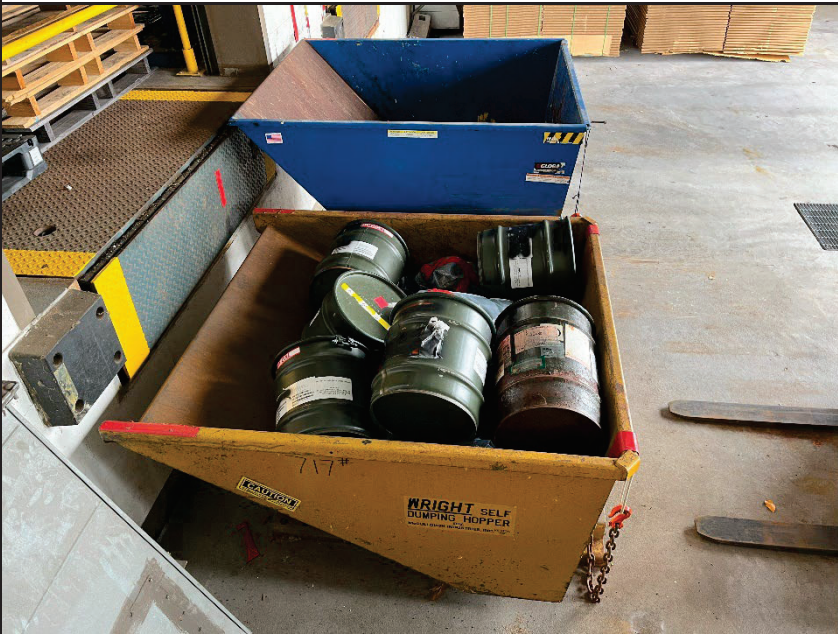
| <b>TAKEN BY:</b> Bryan Gonzalez | <b>SITE LOCATION:</b> TSDF – TSDF (B-562) Staging Area |

| <b>PHOTO #:</b> 1<br><br><b>COMMENTS:</b><br>View of loading bay at TSDF with hopper containing state regulated waste. | |

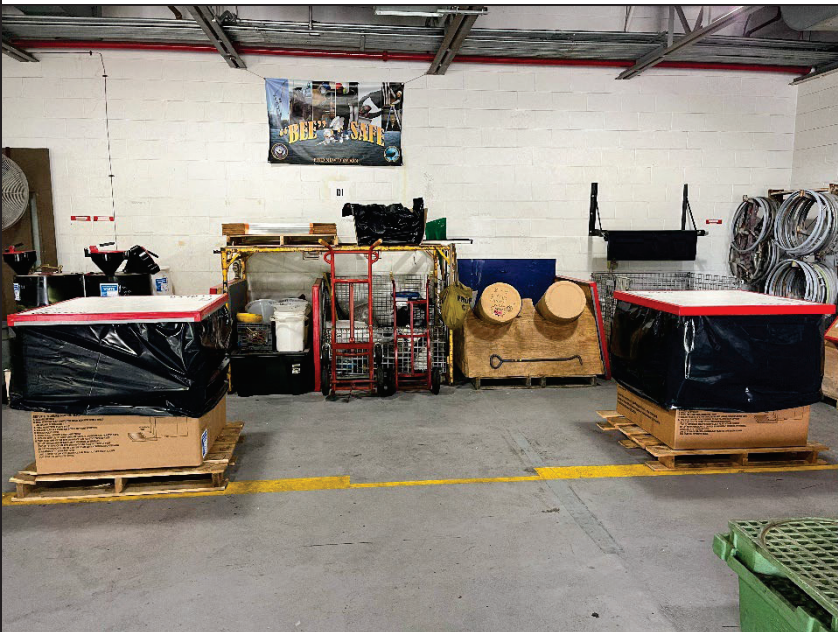
| <b>TAKEN BY:</b> Bryan Gonzalez | <b>SITE LOCATION:</b> TSDF (B-562) Staging Area |

| <b>PHOTO #:</b> 2<br><br><b>COMMENTS:</b><br>View of staging area at the TSDF - Building 562. | |

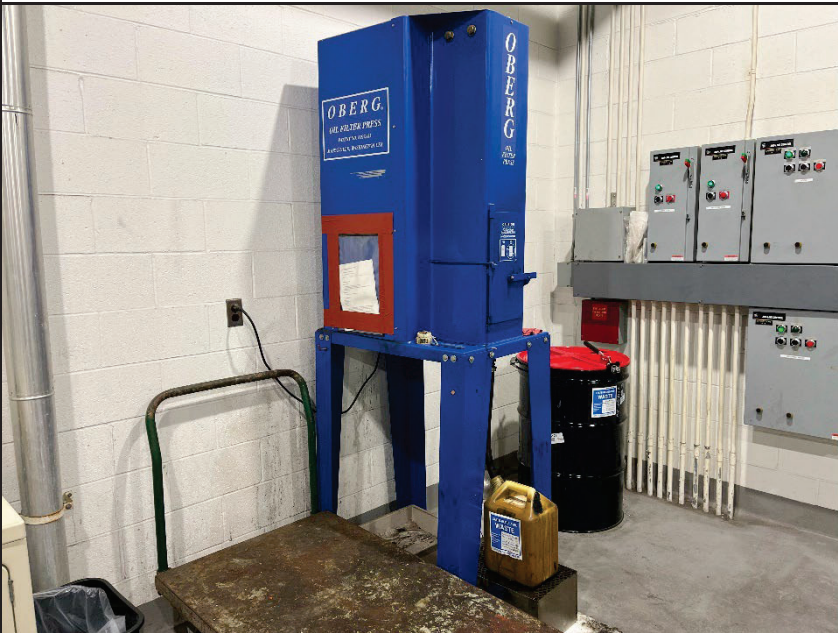
| <b>TAKEN BY:</b> Bryan Gonzalez | <b>SITE LOCATION:</b> TSDF (B-562) Process Room |

1. **Oil Filter Crushing** – A process used to reduce the size and volume of used oil filters which are classified as hazardous waste due to the residual oil they contain. The process extracts the remaining oil for proper recycling and disposal. There was oil waste stored in a 5-gallon container and crushed filters stored in a 55-gallon container in the area at

| <b>PHOTO #:</b> 3<br><br><b>COMMENTS:</b><br>View of Oil Filter Crusher and 50-gallon drum for storage of crushed filters. | |

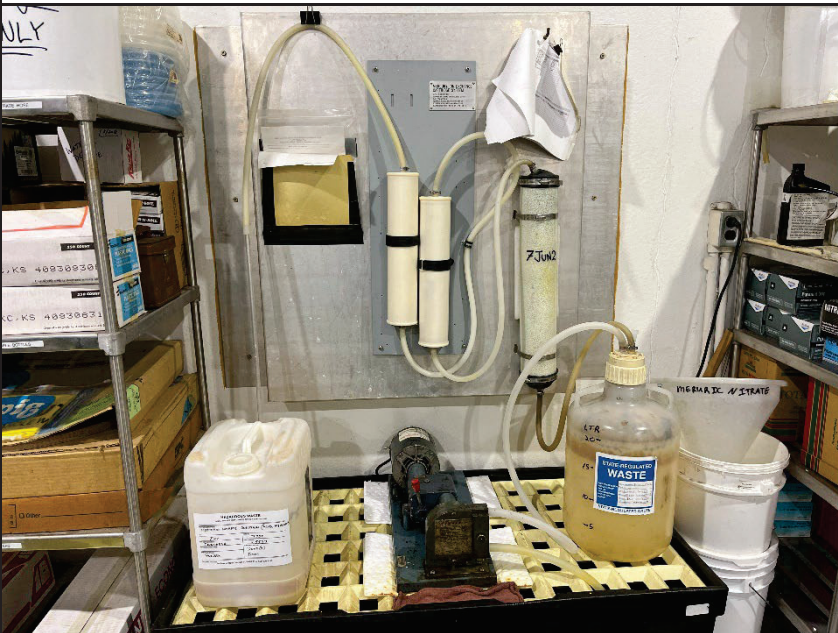
| <b>TAKEN BY:</b> Bryan Gonzalez | <b>SITE LOCATION:</b> TSDF (B-562) Process Room |

| <b>PHOTO #:</b> 4<br><br><b>COMMENTS:</b><br>View of Mercuric Nitrate Reclamation area with 5-gallon waste container. | |

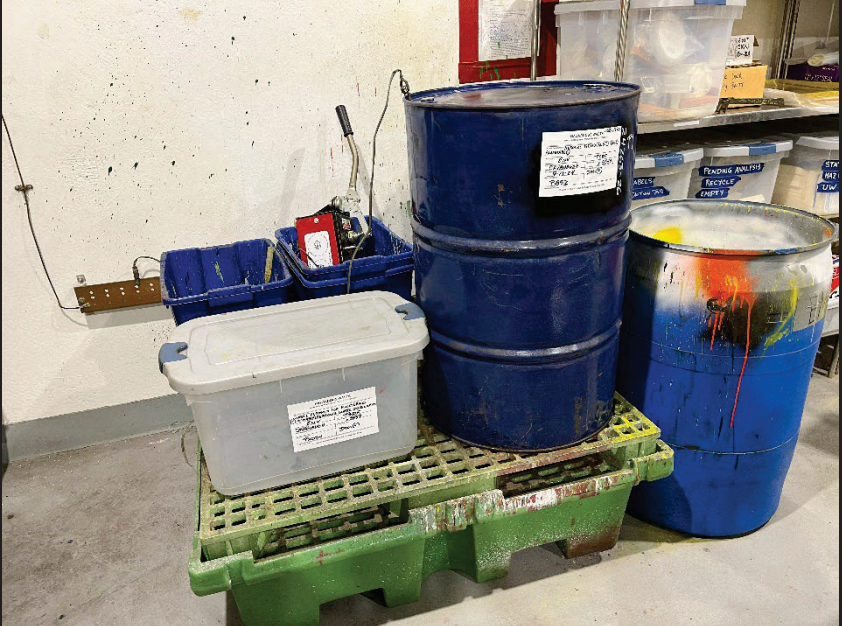
3. **Aerosol Can Puncturing** – A process used to manage and dispose of aerosol cans which are considered hazardous waste when not completely emptied. Brian Hendrickson explained that the process involves puncturing the cans to release any remaining contents and propellants making the cans easier to recycle as scrap metal. A 55-gallon drum is being used to store the aerosol residuals, labeled as HW liquid/flammable. A 55-gallon plastic drum is used to store empty/punctured aerosol cans, labeled “empty aerosol cans”.

| <b>PHOTO #: 5</b><br><br><b>COMMENTS:</b><br>View of Aerosol Can Puncturing area. 55-gallon drum used to store aerosol residual and plastic drum used to store empty/punctured aerosol cans. | A photograph of a storage area in a process room. In the foreground, a green plastic pallet holds a white plastic drum with a label and a blue 55-gallon drum. To the right, another blue 55-gallon drum is visible, partially covered in paint splatters. In the background, there are shelves with various containers and a wall with some equipment. |

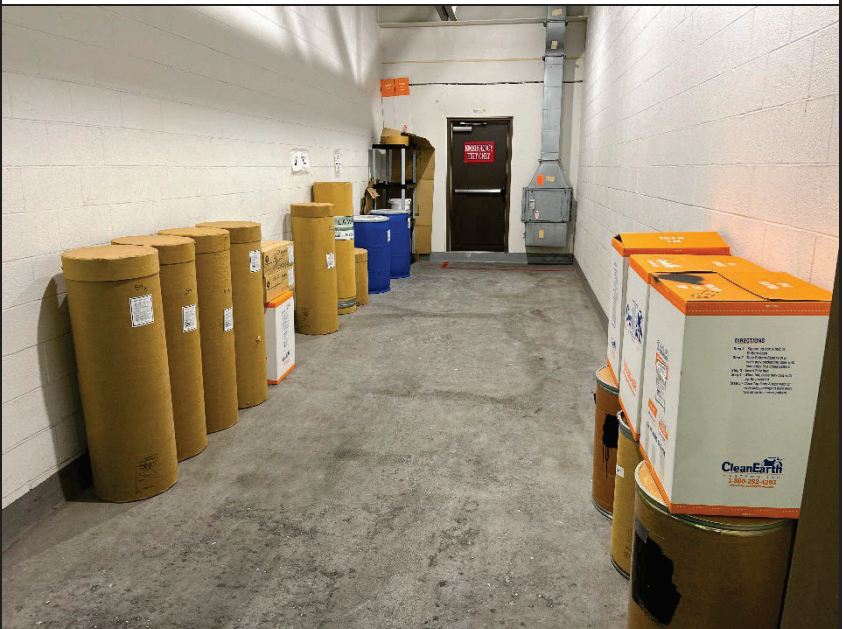
| <b>PHOTO #: 6</b><br><br><b>COMMENTS:</b><br>View of inside Universal Waste storage room. | A photograph of the interior of a Universal Waste storage room. The room has white cinder block walls and a concrete floor. On the left side, there are several rows of yellow drums. On the right side, there are orange and white boxes, some of which are labeled 'CleanEarth'. In the background, there is a dark door and some equipment. |

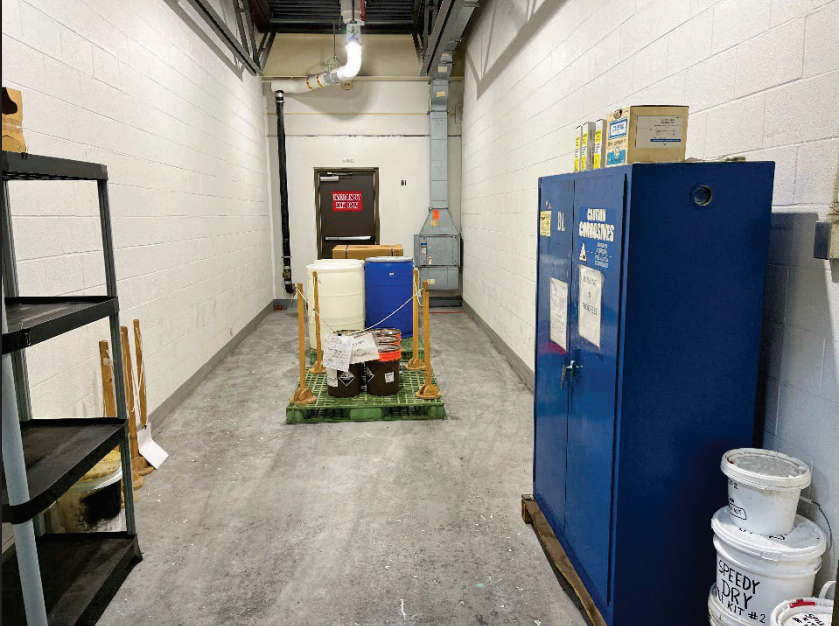
| <b>TAKEN BY:</b> Bryan Gonzalez | <b>SITE LOCATION:</b> TSDF (B-562) Alkaline Waste Bay |

**Alkaline Bay** – Contained six (6) 3-gallon buckets labeled monoethanolamine and water, on one pallet, three (3) 55-gallon plastic drums each labeled Monoethanolamine and water, Ammonium hydroxide/zinc oxide, bulked alkaline waste. All drums were on a plastic pallet in the middle of the room. One (1) cubic yard box labeled HW bulked alkaline waste. One (1) corrosive locker that was closed, contained 50+ quart size bottles all labeled ammonium oxide, zinc oxide, bottles all closed. All boxes and containers were closed inside the bay.

| <b>PHOTO #:</b> 7<br><br><b>COMMENTS:</b><br>View of inside Alkaline Waste storage room. | |

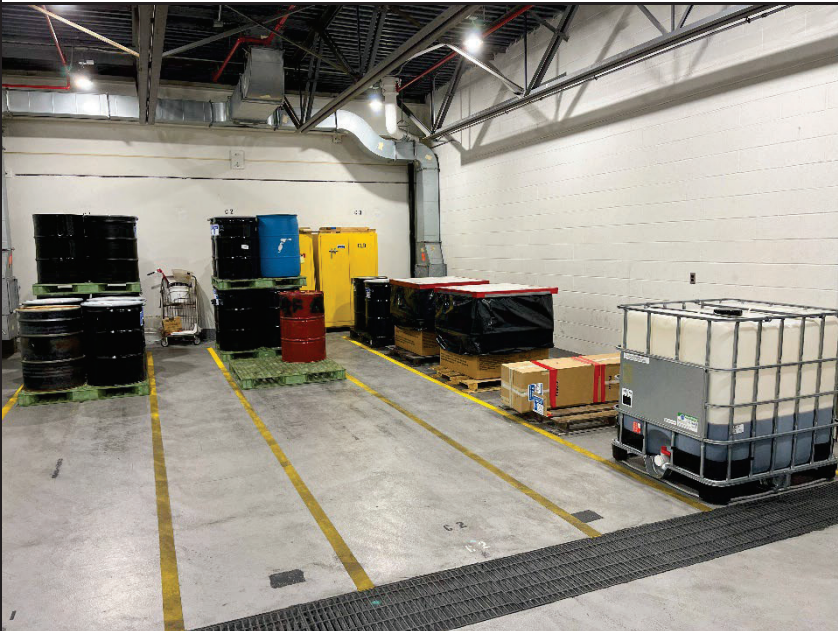
| <b>TAKEN BY:</b> Bryan Gonzalez | <b>SITE LOCATION:</b> TSDF (B-562) PCB Waste Bay |

| <b>PHOTO #:</b> 10<br><br><b>COMMENTS:</b><br>View of inside the PCB waste storage room facing right. | |

| <b>PHOTO #:</b> 11<br><br><b>COMMENTS:</b><br>View of inside the PCB waste storage room facing left. | |

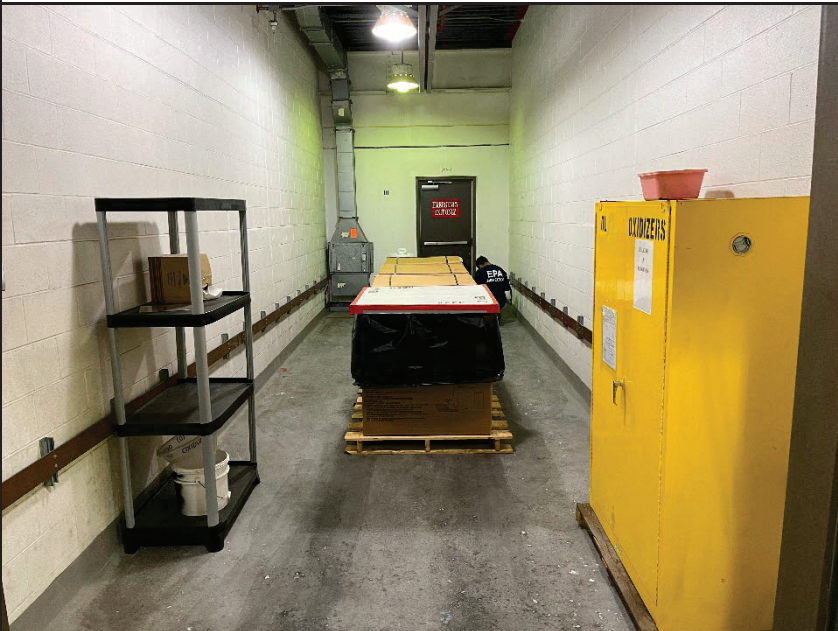
| <b>TAKEN BY:</b> Bryan Gonzalez | <b>SITE LOCATION:</b> TSDF (B-562) Oxidizer Waste Bay |

| <b>PHOTO #:</b> 13<br><br><b>COMMENTS:</b><br>View of inside the Oxidizer Waste storage room. | |

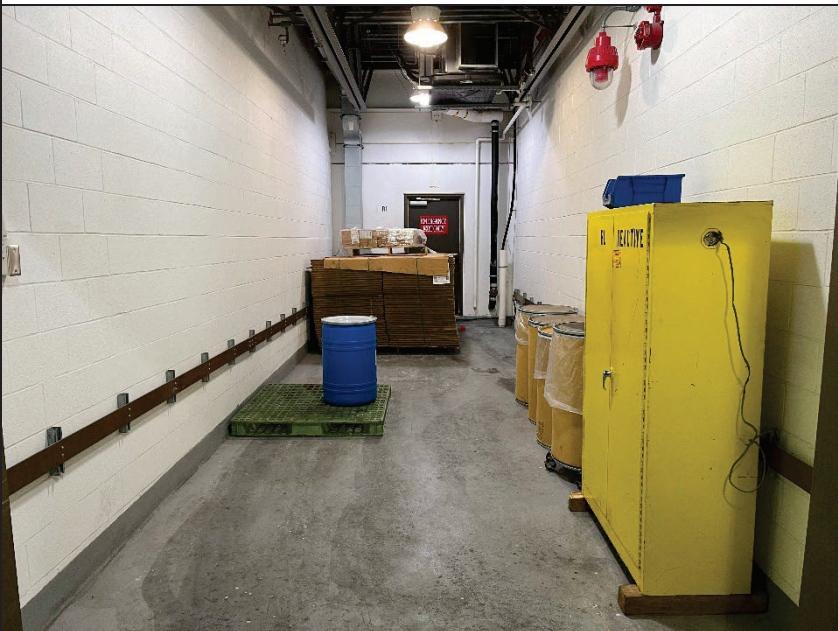
| <b>TAKEN BY:</b> Bryan Gonzalez | <b>SITE LOCATION:</b> TSDF (B-562) Reactive Waste Bay |

| <b>PHOTO #:</b> 14<br><br><b>COMMENTS:</b><br>View of inside the Reactive Waste storage room. | |

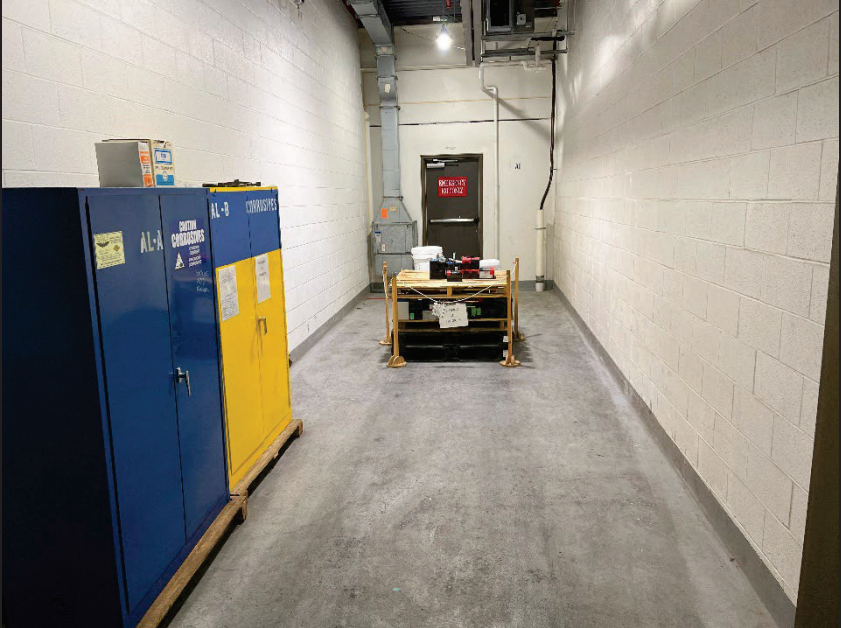
| <b>TAKEN BY:</b> Bryan Gonzalez | <b>SITE LOCATION:</b> TSDF (B-562) Acid Waste Bay |

| <b>PHOTO #:</b> 15<br><br><b>COMMENTS:</b><br>View of inside the Acid Waste storage room. | |

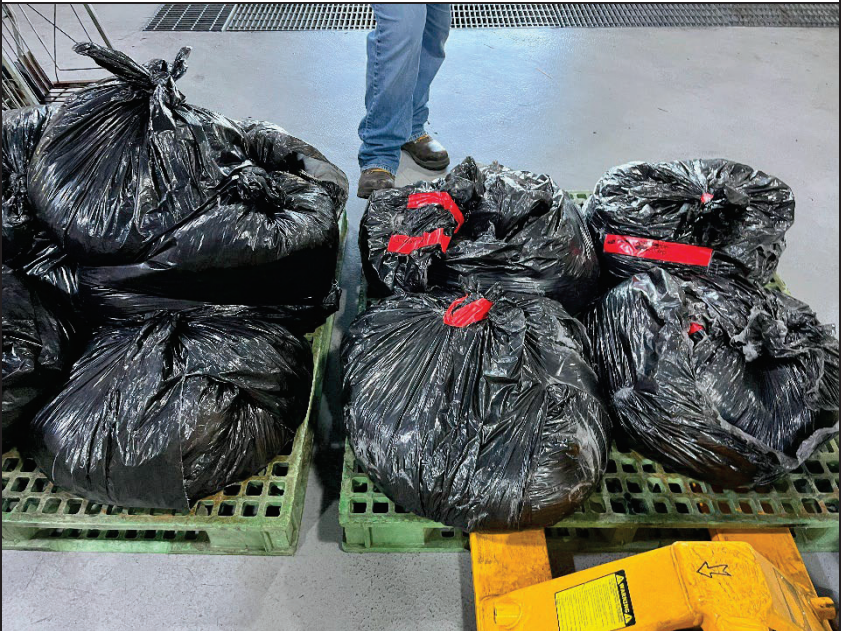
| <b>TAKEN BY:</b> Bryan Gonzalez | <b>SITE LOCATION:</b> TSDF (B-562) Staging Area |

| <b>PHOTO #:</b> 16<br><br><b>COMMENTS:</b><br>Pallet of waste received during inspection of TSDF. Waste had come off a submarine. | |

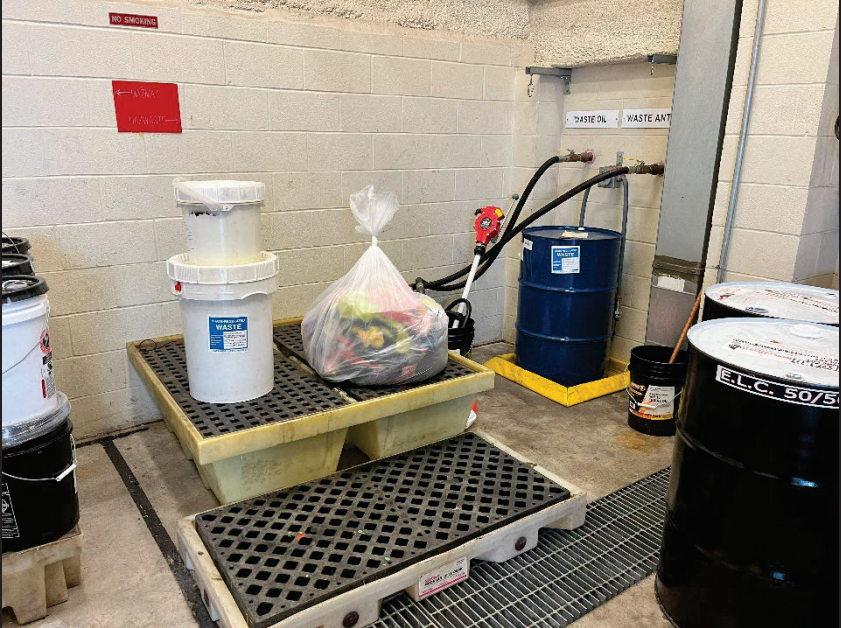
| <b>TAKEN BY:</b> Bryan Gonzalez | <b>SITE LOCATION:</b> A13, Port Services (B-1) |

| <b>PHOTO #:</b> 17<br><br><b>COMMENTS:</b><br>View of inside CAA A13, Port Services. | |

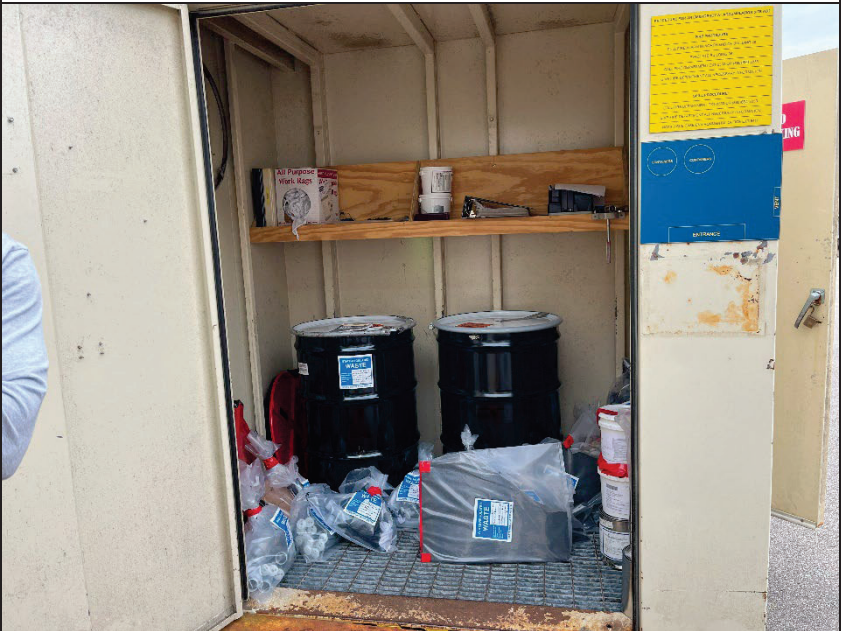
| <b>TAKEN BY:</b> Bryan Gonzalez | <b>SITE LOCATION:</b> A02, Carpenter Shop (B-38) |

| <b>PHOTO #:</b> 18<br><br><b>COMMENTS:</b><br>View of inside CAA A02, Carpenter Shop. | |

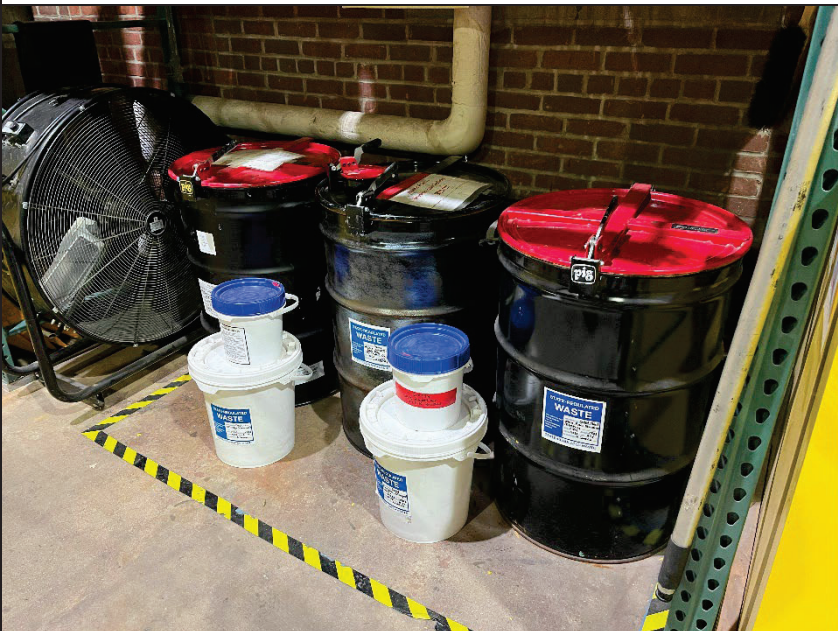
| <b>TAKEN BY:</b> Bryan Gonzalez | <b>SITE LOCATION:</b> A44, Powdercoating (B-174) |

| <b>PHOTO #:</b> 20<br><br><b>COMMENTS:</b><br>View of CAA for the Powder Coating Building. | |

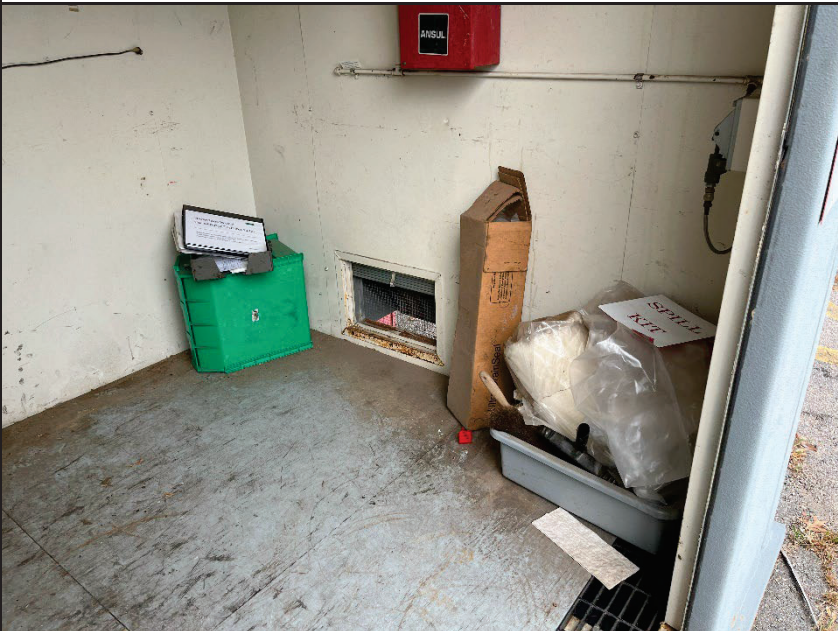
| <b>TAKEN BY:</b> Bryan Gonzalez | <b>SITE LOCATION:</b> A04, Outside Machine Shop |

| <b>PHOTO #:</b> 21<br><br><b>COMMENTS:</b><br>View of CAA R9 Outside Machine Shop. | |

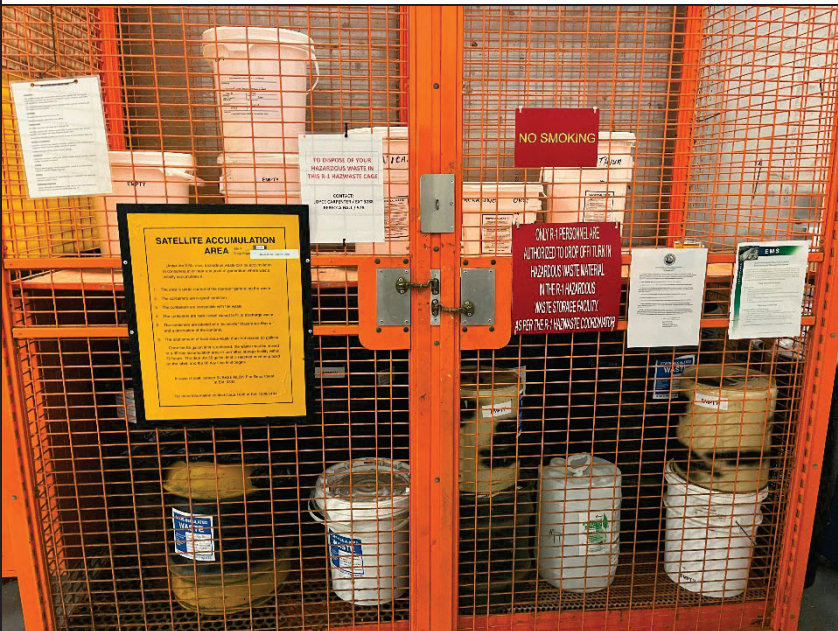
| <b>TAKEN BY:</b> Bryan Gonzalez | <b>SITE LOCATION:</b> S45, Hull Division (B-478) |

| <b>PHOTO #:</b> 22<br><br><b>COMMENTS:</b><br>View of SAA S45 Hull Division. Site will be converted to a CAA after review of process and point of generation. | |

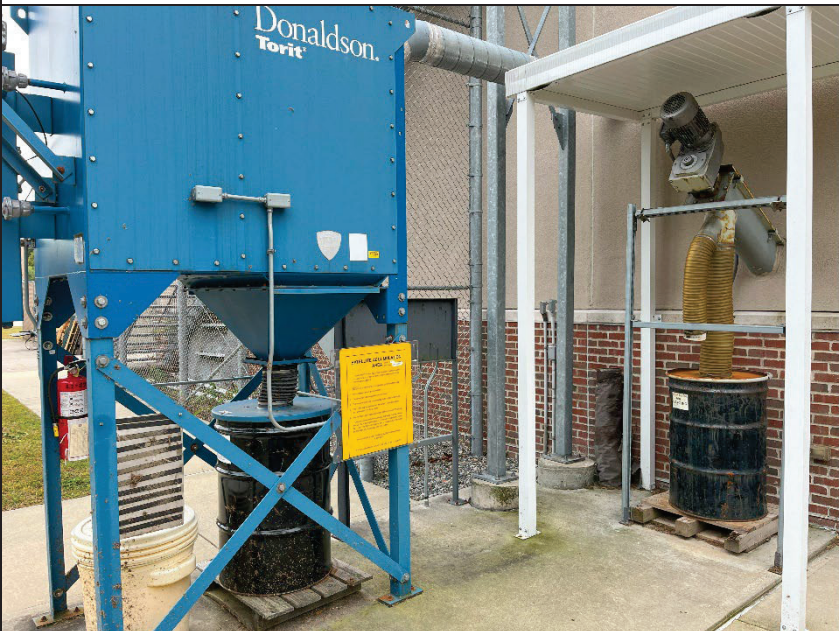
| <b>TAKEN BY:</b> Bryan Gonzalez | <b>SITE LOCATION:</b> S125, Firing Range (Hopper) |

| <b>PHOTO #:</b> 24<br><br><b>COMMENTS:</b><br>View of SAA Firing Range located outside of building B-612 | |

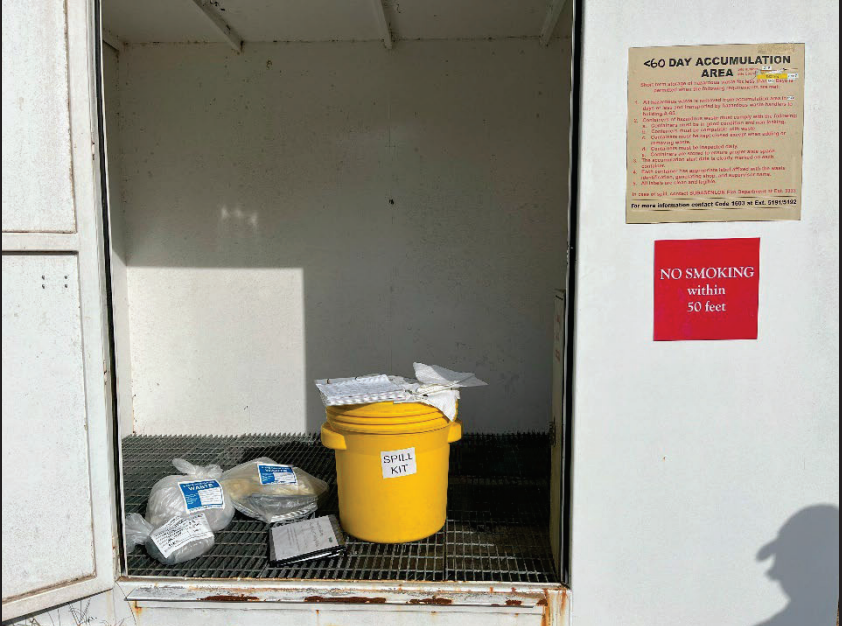
| <b>TAKEN BY:</b> Bryan Gonzalez | <b>SITE LOCATION:</b> A18, Weapons 91E (B-325) |

| <b>PHOTO #:</b> 25<br><br><b>COMMENTS:</b><br>View of inside CAA Weapons 91E. | |

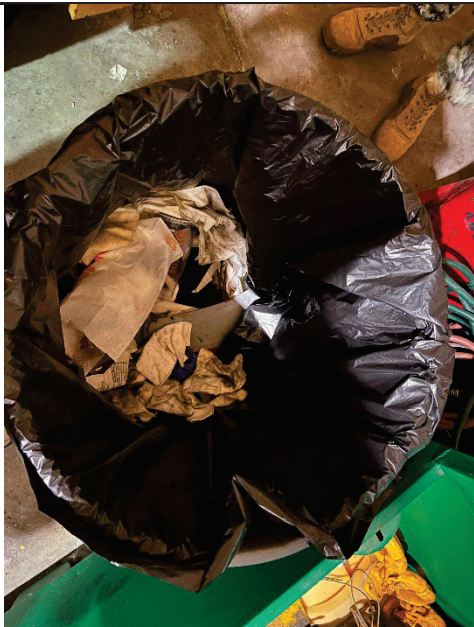
| <b>TAKEN BY:</b> Bryan Gonzalez | <b>SITE LOCATION:</b> B-325 Vehicle Maintenance Area |

training slides, weekly inspections logs, and training certificates. The site had a fire extinguisher and spill kit at the time of the inspection. CAA and no smoking signage were present. The inspection team proceeded to the vehicle maintenance area of Building - 325. Inspector Gonzalez noticed used rags with unknown residue on them inside one of the trash bins. The inspection team also observed a puddle of oily fluid on the floor underneath one of the vehicles. Brian Hendrickson explained that the maintenance of the vehicles is performed by contractors. No secondary containment was present in the building where the vehicles were being worked. Photos were taken of the oily fluid on the ground and the rags inside of the trash can (Attachment 1, Photo 26 and 27).

| <b>PHOTO #:</b> 26<br><br><b>COMMENTS:</b><br>Spent rags with unknown solvent observed inside a mix garbage bag. | |

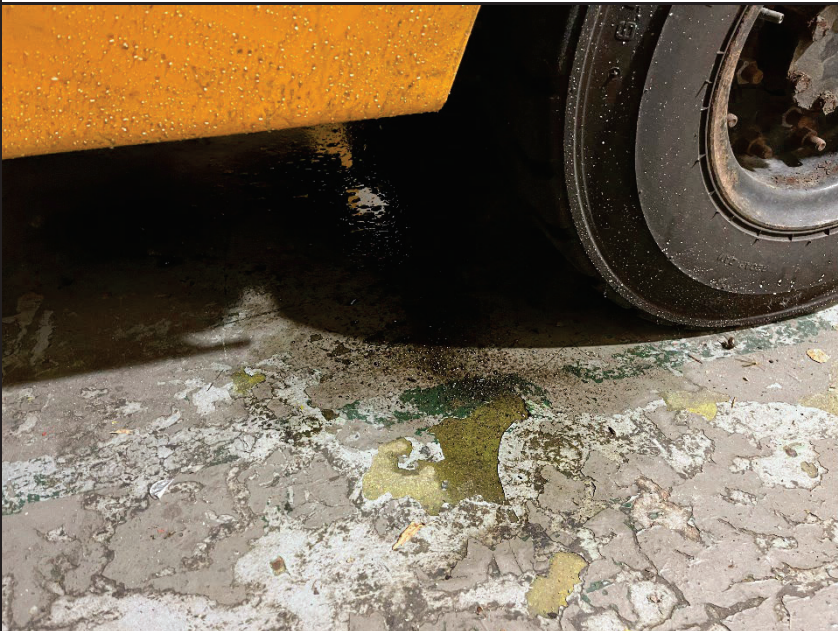
| <b>TAKEN BY:</b> Bryan Gonzalez | <b>SITE LOCATION:</b> B-325 Vehicle Maintenance Area |

| <b>PHOTO #:</b> 27<br><br><b>COMMENTS:</b><br>Oily residue dripping from vehicle parked in the Vehicle Maintenance Area. No drip pan being used. | |

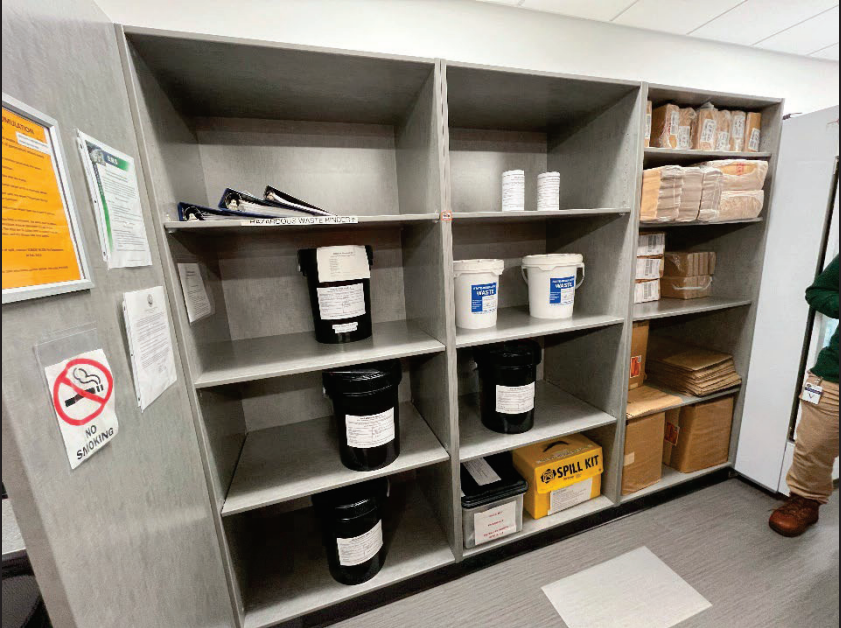
| <b>TAKEN BY:</b> Bryan Gonzalez | <b>SITE LOCATION:</b> S131, Pharmacy (B-449) |

| <b>PHOTO #:</b> 29<br><br><b>COMMENTS:</b><br>View of SAA at the Naval Health Clinic Pharmacy. | |

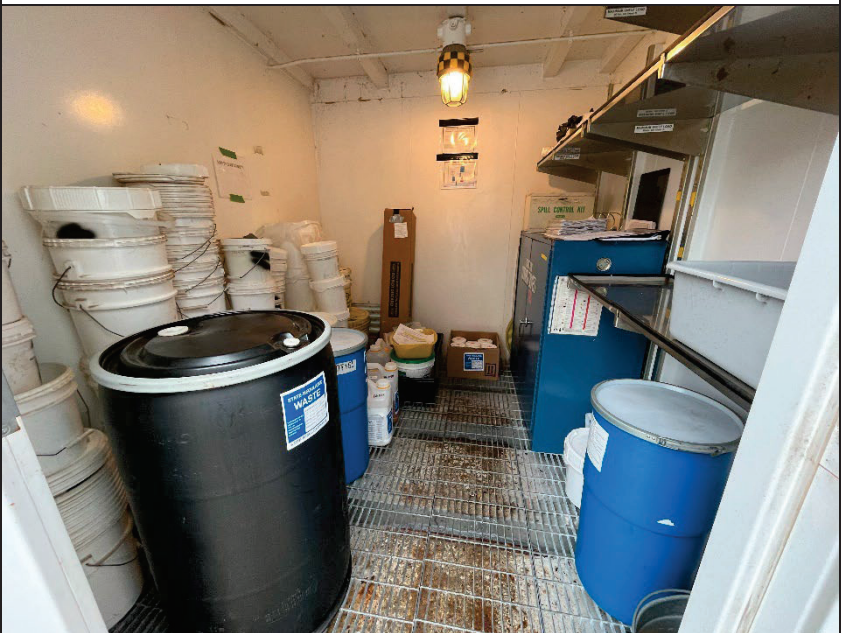
| <b>TAKEN BY:</b> Bryan Gonzalez | <b>SITE LOCATION:</b> A17, Naval Branch Health Clinic (B-449) |

| <b>PHOTO #:</b> 30<br><br><b>COMMENTS:</b><br>View of inside SAA A17 Naval Branch Health Clinic. | |

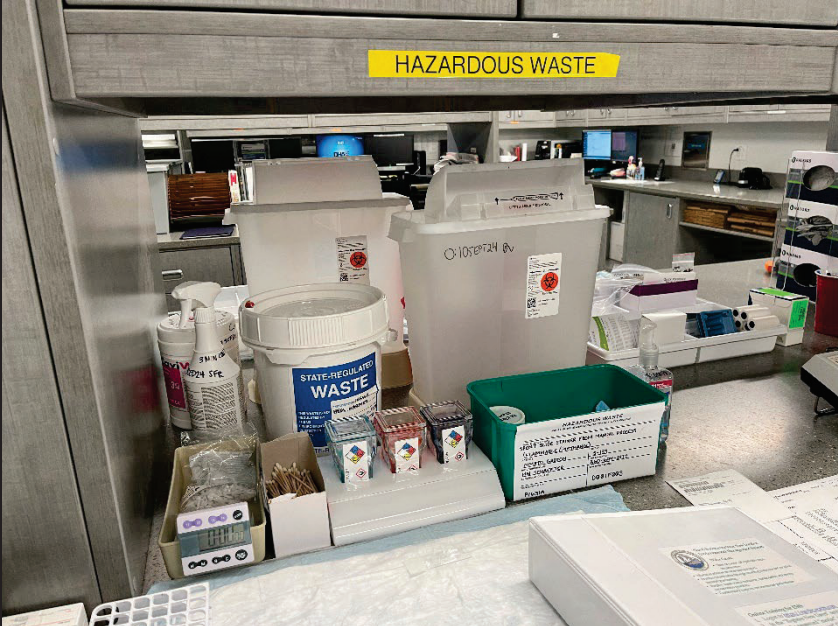
| <b>TAKEN BY:</b> Bryan Gonzalez | <b>SITE LOCATION:</b> S133, Laboratory (B-449) |

| <b>PHOTO #:</b> 31<br><br><b>COMMENTS:</b><br>View of the SAA at the Naval Health Clinic Laboratory. | |

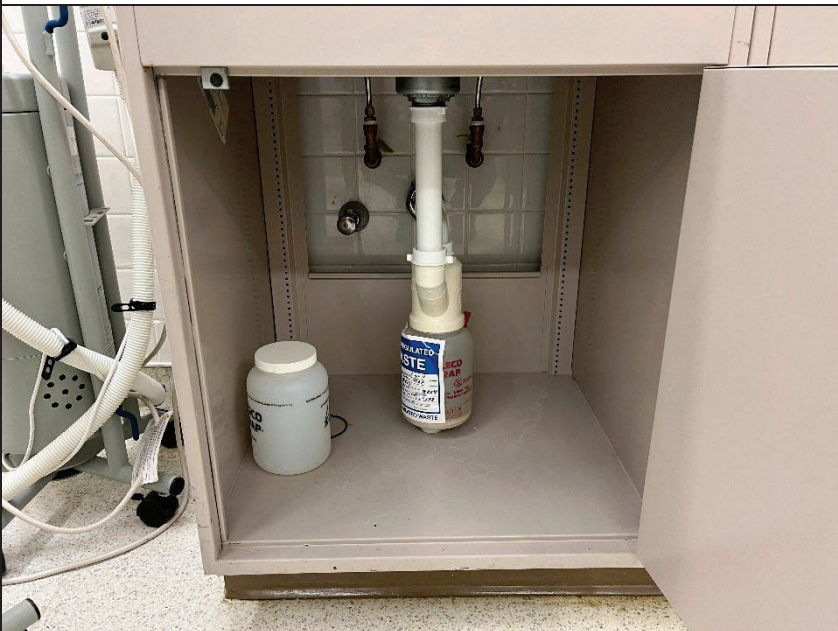
| <b>TAKEN BY:</b> Bryan Gonzalez | <b>SITE LOCATION:</b> S138, Orthopedics (B-449) |

| <b>PHOTO #:</b> 32<br><br><b>COMMENTS:</b><br>View of the SAA at the Naval Health Clinic Orthopedics Area. | |

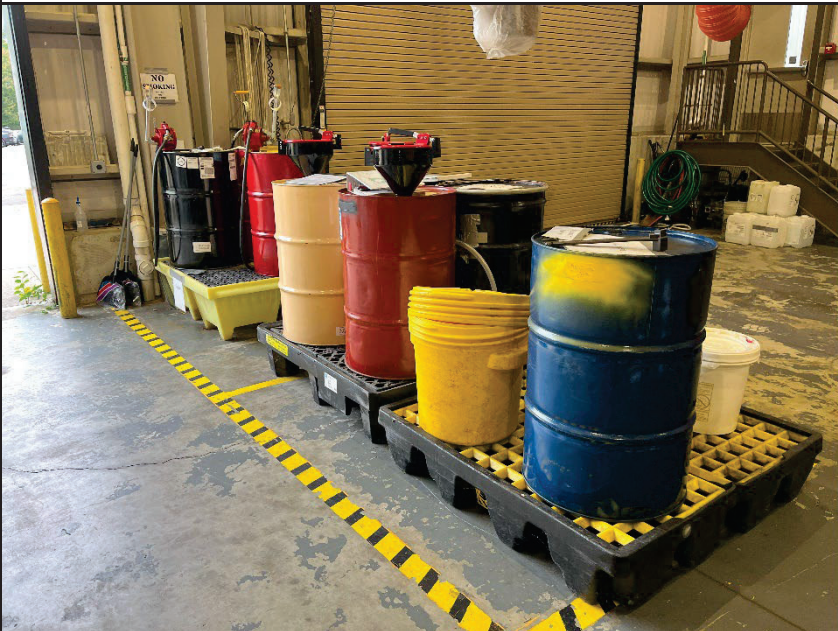
| <b>TAKEN BY:</b> Bryan Gonzalez | <b>SITE LOCATION:</b> S96, Coastal Riverine (B-574) |

| <b>PHOTO #:</b> 33<br><br><b>COMMENTS:</b><br>View of SAA at the Coastal Riverine Building. | |

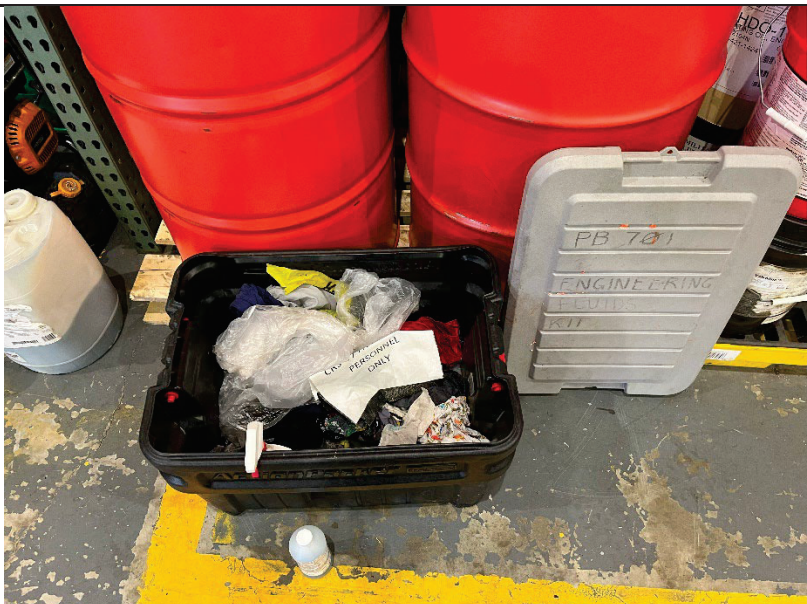
| <b>TAKEN BY:</b> Bryan Gonzalez | <b>SITE LOCATION:</b> S96, Coastal Riverine (B-574) |

| <b>PHOTO #:</b> 34<br><br><b>COMMENTS:</b><br>View of bin containing spent rags and used chemicals outside of SAA area. | |

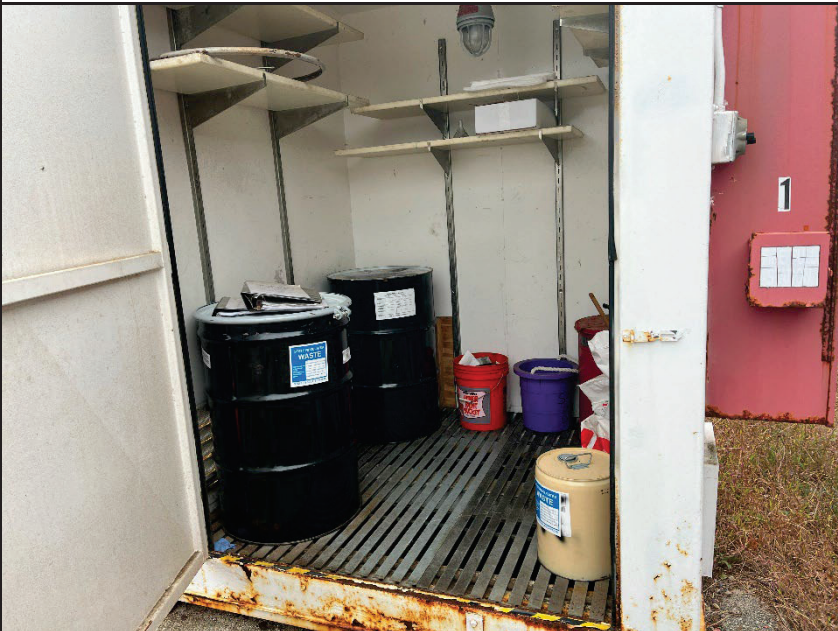
| <b>TAKEN BY:</b> Bryan Gonzalez | <b>SITE LOCATION:</b> S75, Marina (B-535) |

| <b>PHOTO #:</b> 35<br><br><b>COMMENTS:</b><br>View of SAA at the Marina. | |

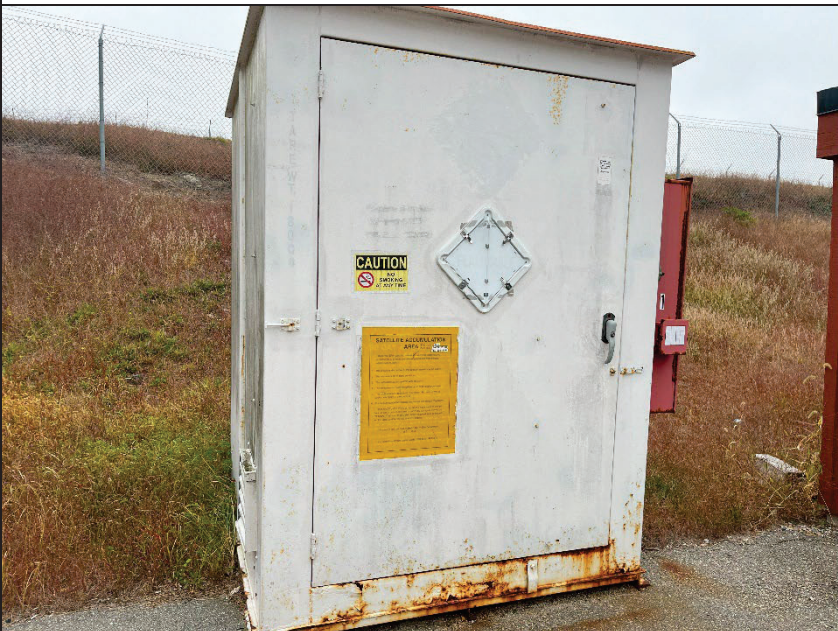
| <b>TAKEN BY:</b> Bryan Gonzalez | <b>SITE LOCATION:</b> S75, Marina (B-535) |

| <b>PHOTO #:</b> 36<br><br><b>COMMENTS:</b><br>View of outside SAA. Site is located across the street from the actual Marina. | |

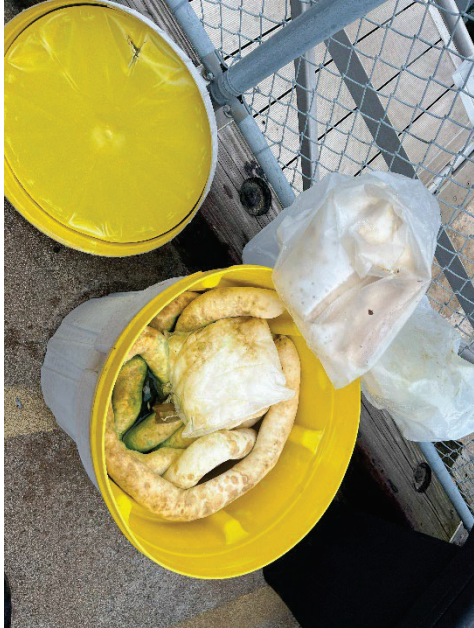
| <b>TAKEN BY:</b> Bryan Gonzalez | <b>SITE LOCATION:</b> S75, Marina (B-535) |

| <b>PHOTO #:</b> 37<br><br><b>COMMENTS:</b><br>Spill kit located at the marina dock. Spill kit was in disrepair and had water inside due to a crack in the cover. All contents had water damage and were unusable. | |

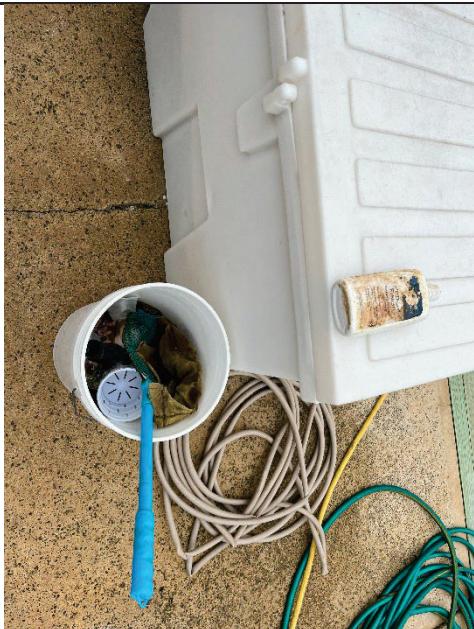
| <b>TAKEN BY:</b> Bryan Gonzalez | <b>SITE LOCATION:</b> S75, Marina (B-535) |

| <b>PHOTO #:</b> 38<br><br><b>COMMENTS:</b><br>5-gallon bucket observed on the dock at the marina. Contents were spent rags, lubricants, and trash. | |
