| <b>System Name:</b> | Oklahoma City Public Water System | |
| <b>PWS ID:</b> | OK1020902 | |

## Section I - INTRODUCTION

## Oklahoma City Public Water System (OK1020902)

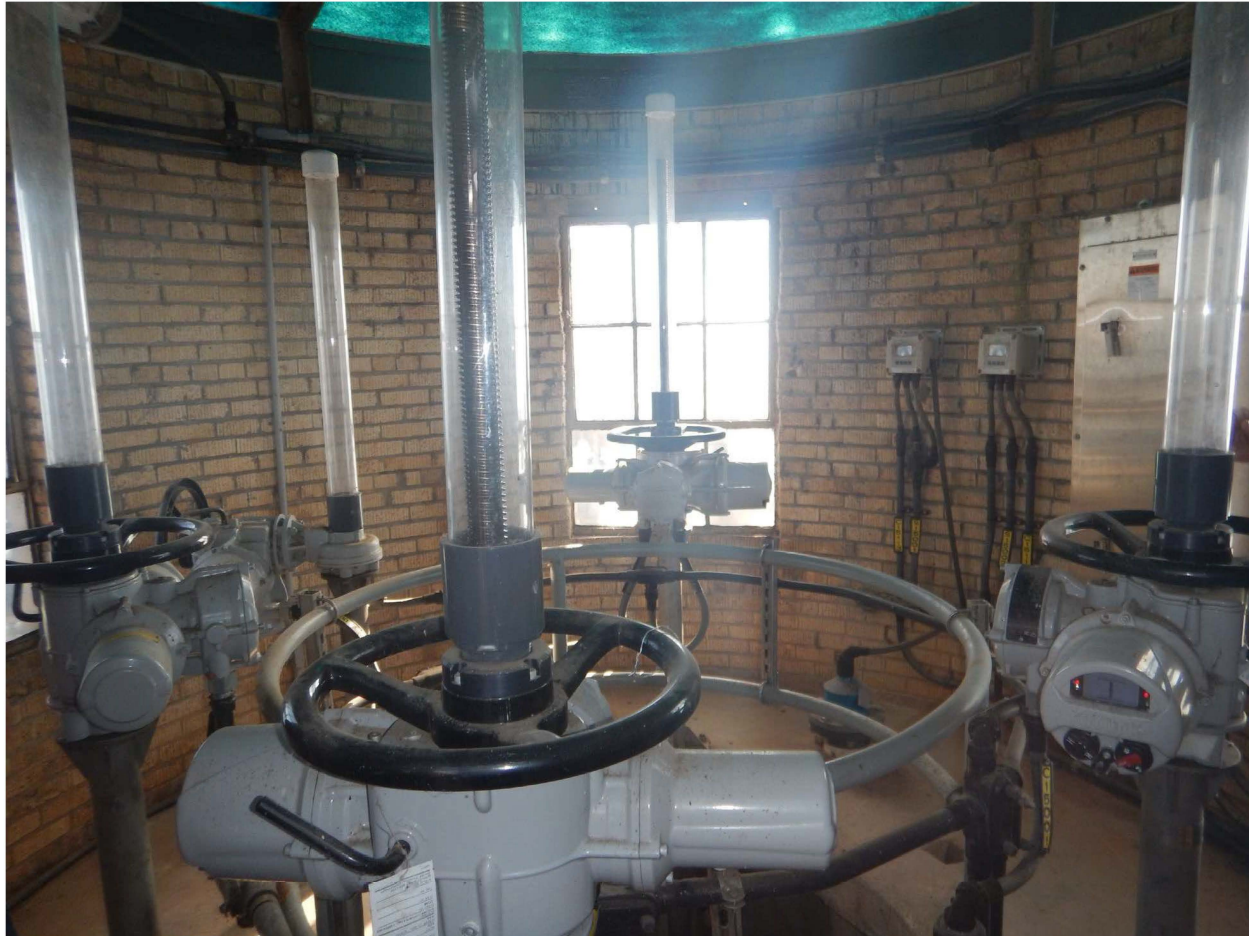
Photograph No. 2

Description: The water intake structure has five gates. At the time of inspection, two of these gates were open.

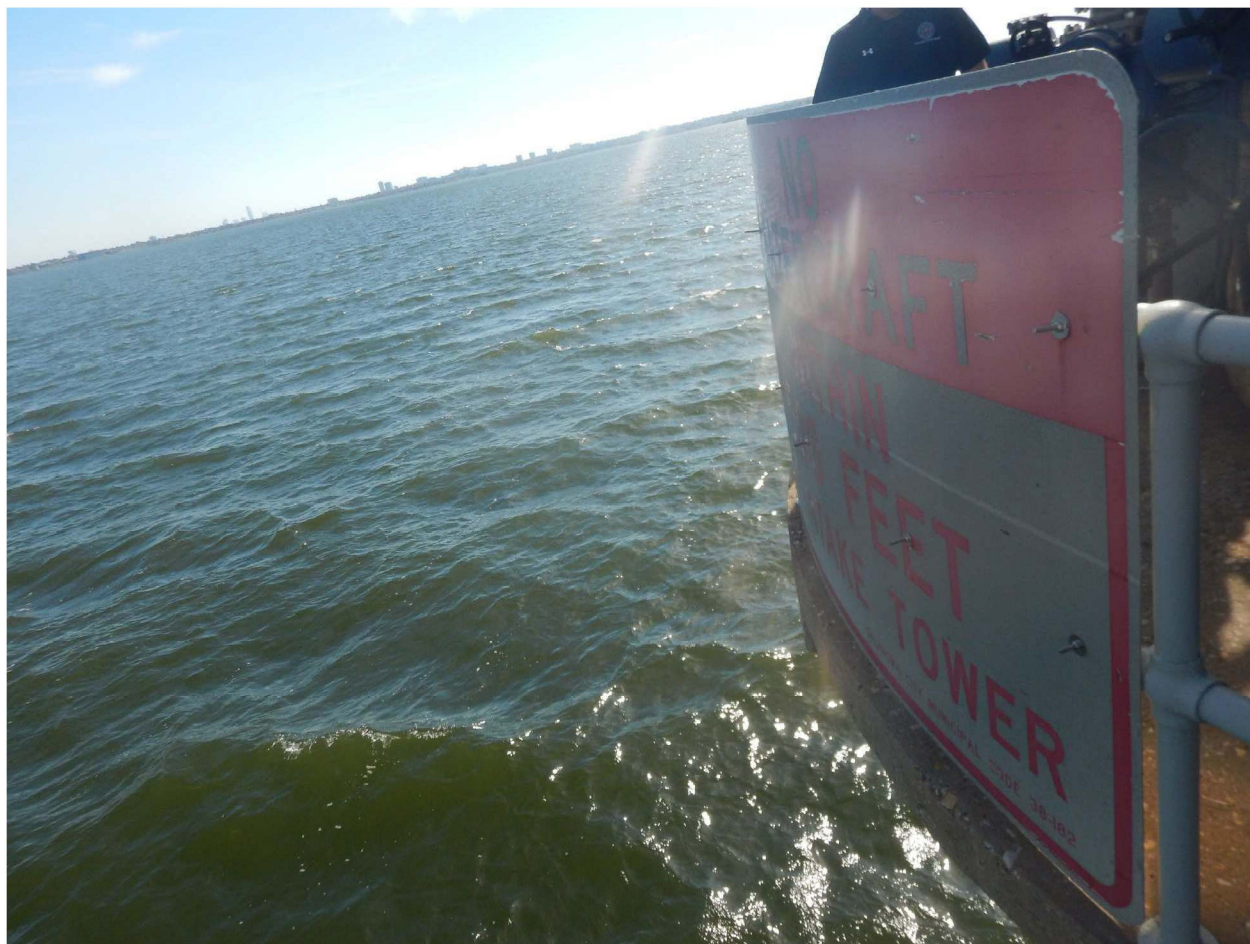
Photograph No. 3

Description: The intake structure has A warning sign indicating that it is a water intake structure, and that watercraft are prohibited from approaching within 500 feet.

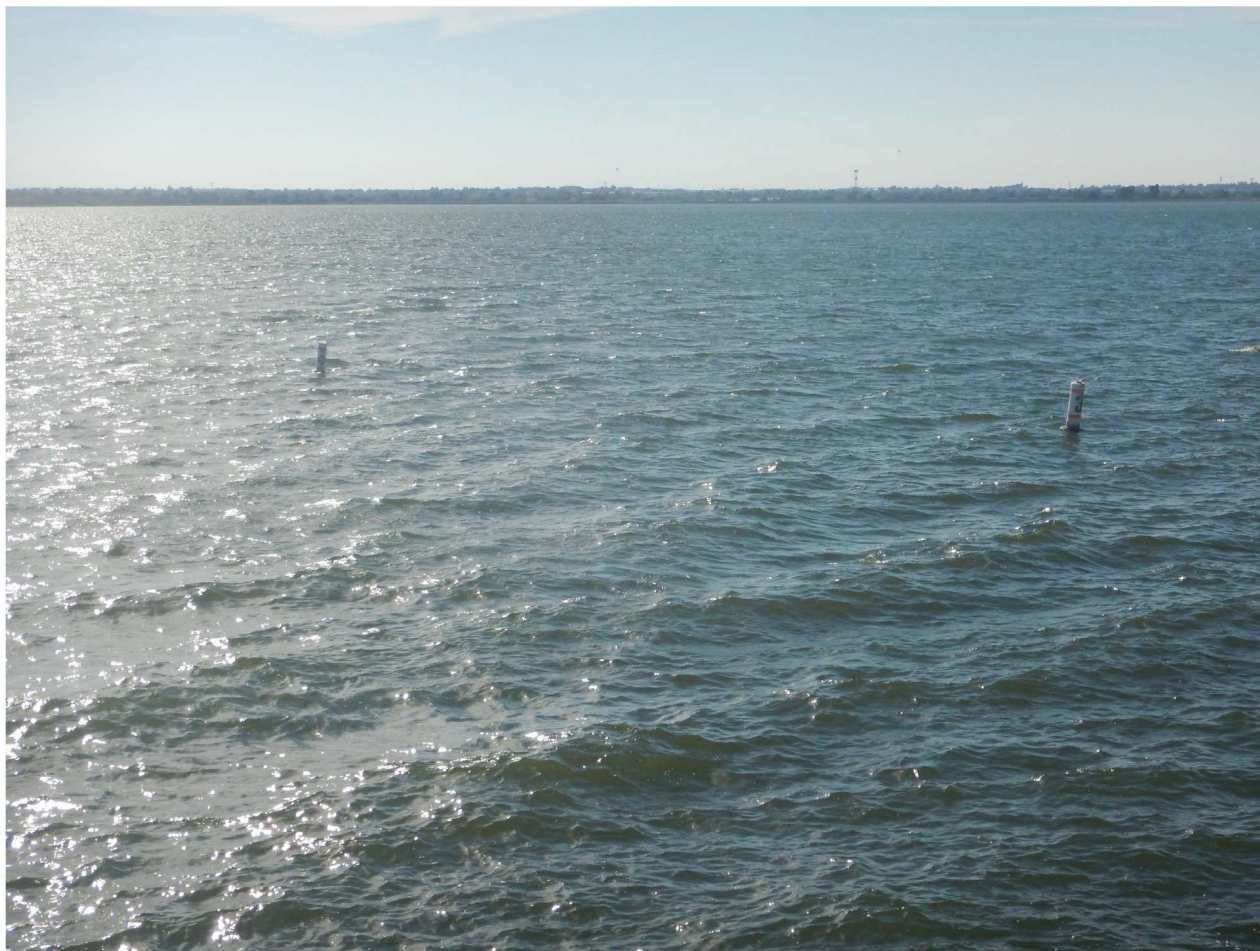
Photograph No. 4

Description: Several buoyant are placed near the intake structure to provide protection.

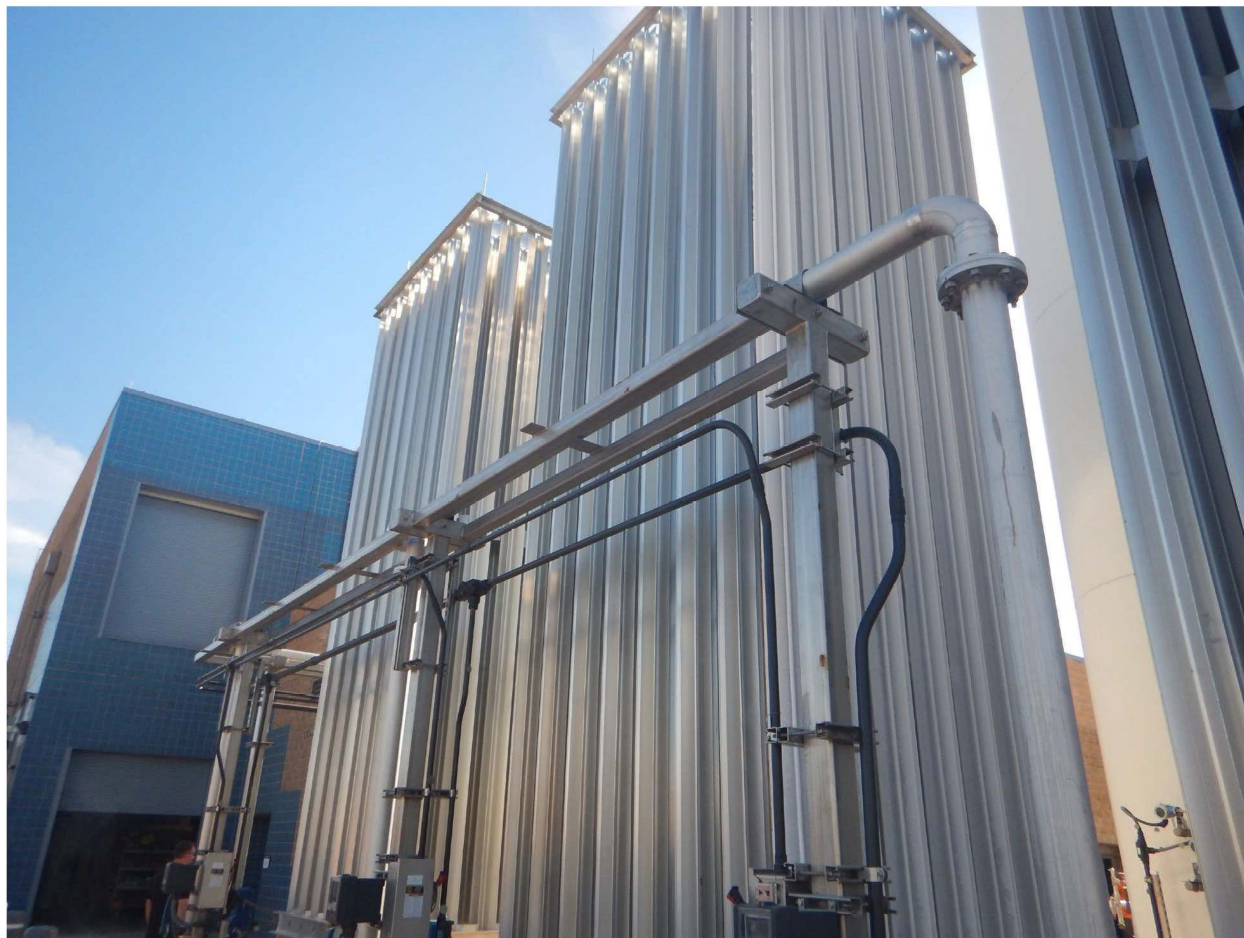
Photograph No. 5

Description: Ozone disinfection system and building in Lake Hefner WTP

Water from intakes flows into two ozone contact basins for disinfection ([Appendix 2, Photograph 5](#)). After the disinfection process, ferric sulfate for coagulation, Lime for softening, and polymer for flocculation are injected. Then, water move to 5 clarifiers. Sludge generated from the clarifiers is treated to reduce its water content ([Appendix 2, Photograph 6](#)). The sludge is converted into lime sludge with a water content of 45 percent and then transported off-site for disposal or other purposes ([Appendix 2, Photograph 7](#)). Water goes two recarbonation basins, and it treated with carbon dioxide and fluoride for pH adjustment and dental health. After this process, water proceeds to filters. System representative stated that Lake Hefner WTP is equipped with 22 granular activated carbon (GAC) filters. According to system representative, if turbidity exceeds 0.25 Nephelometric Turbidity Units (NTU), the system automatically ceases operation. After filtration, zinc orthophosphate is added for corrosion control, and gas chlorine along with liquid ammonia is injected for disinfection. The treated water is stored in three clearwells. One clearwell has a storage capacity of 10 million gallons, while the other two can each store 5 million gallons. System representative stated that tank inspection for clearwells is conducted once a year. All treated water in Lake Hefner is pumped to the distribution system with five finished water pumps.

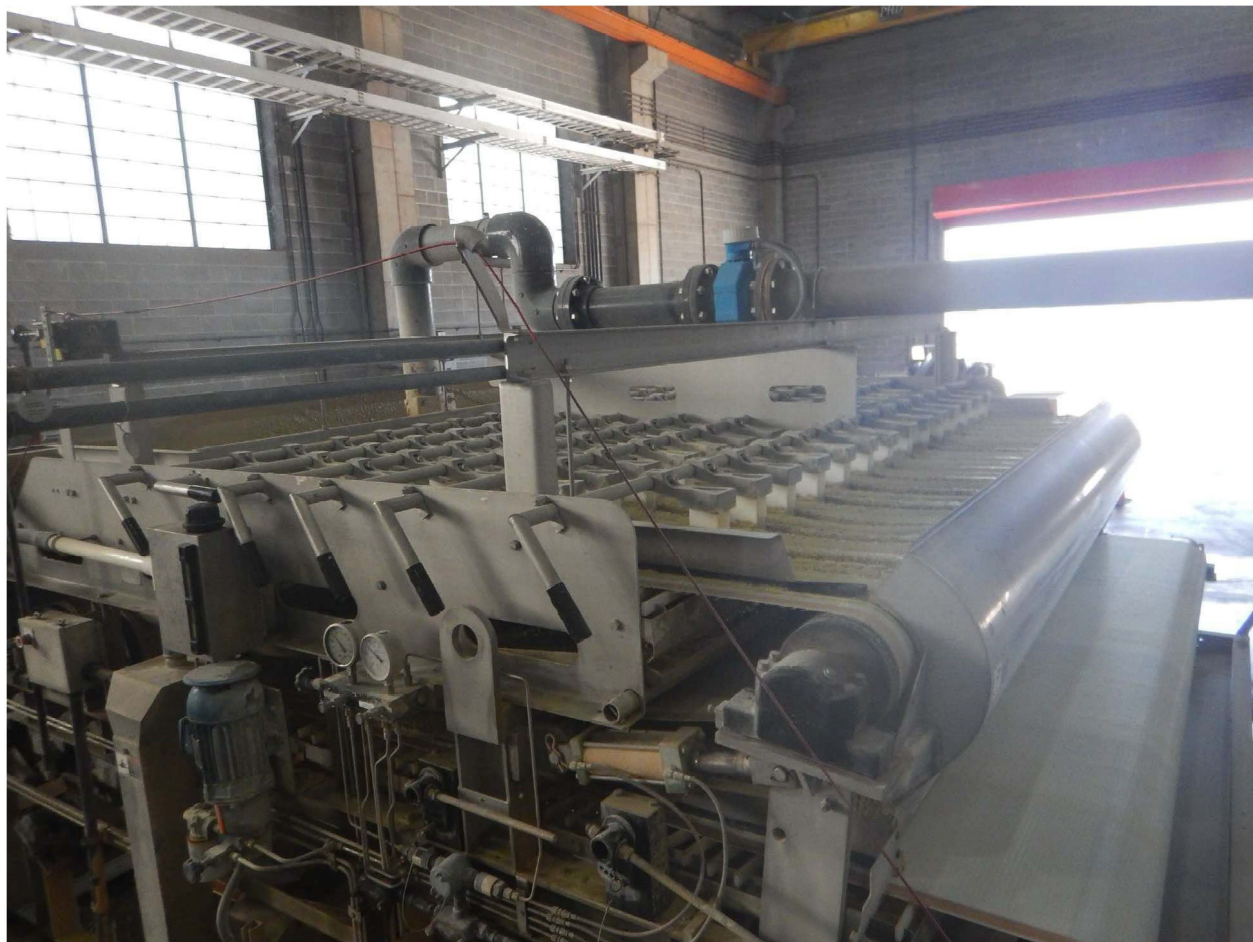
Photograph No. 6

Description: Sludge generated from the clarifiers

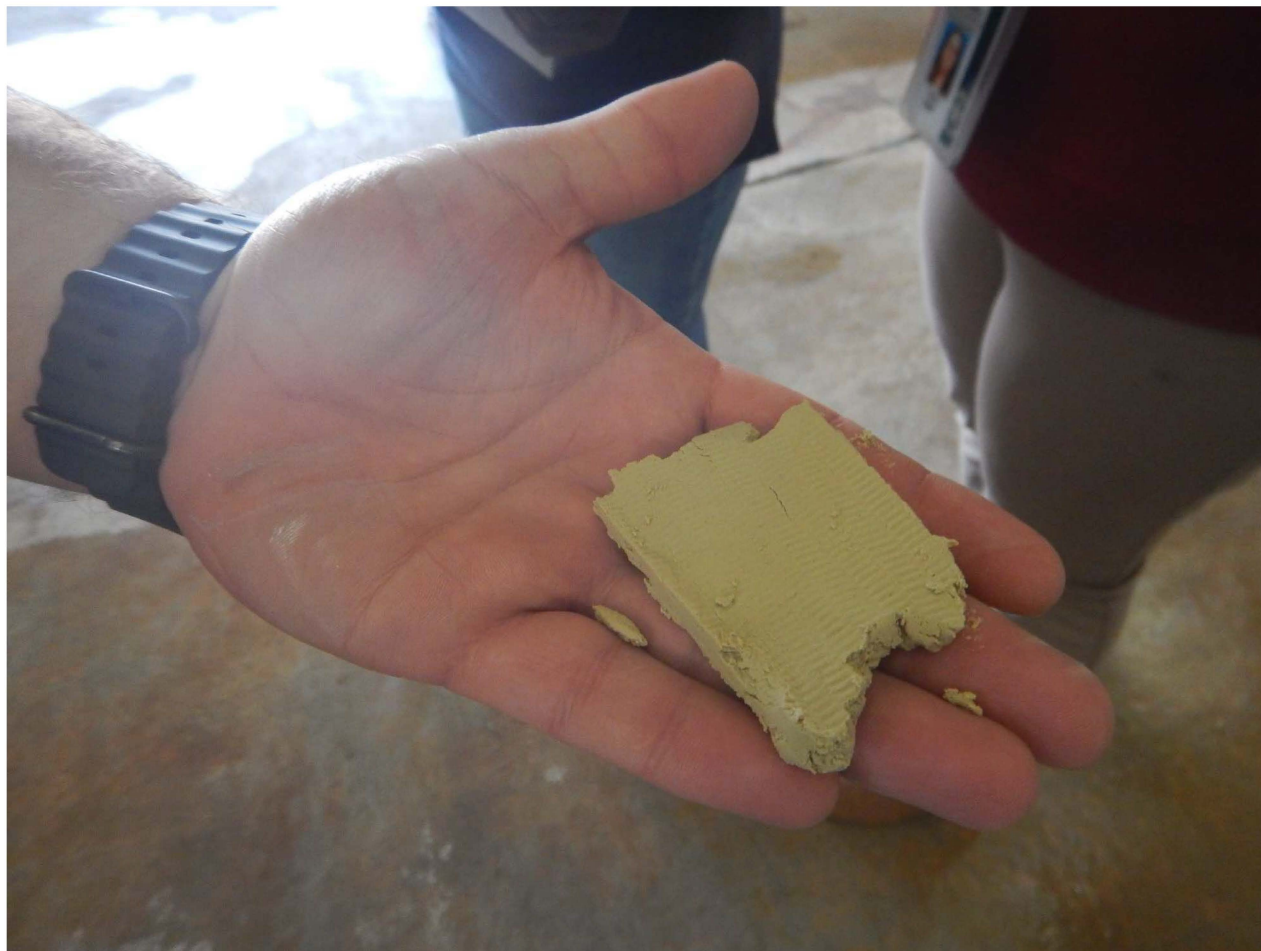
Photograph No. 7

Description: The sludge is converted into lime sludge with a water content of 45 percent.

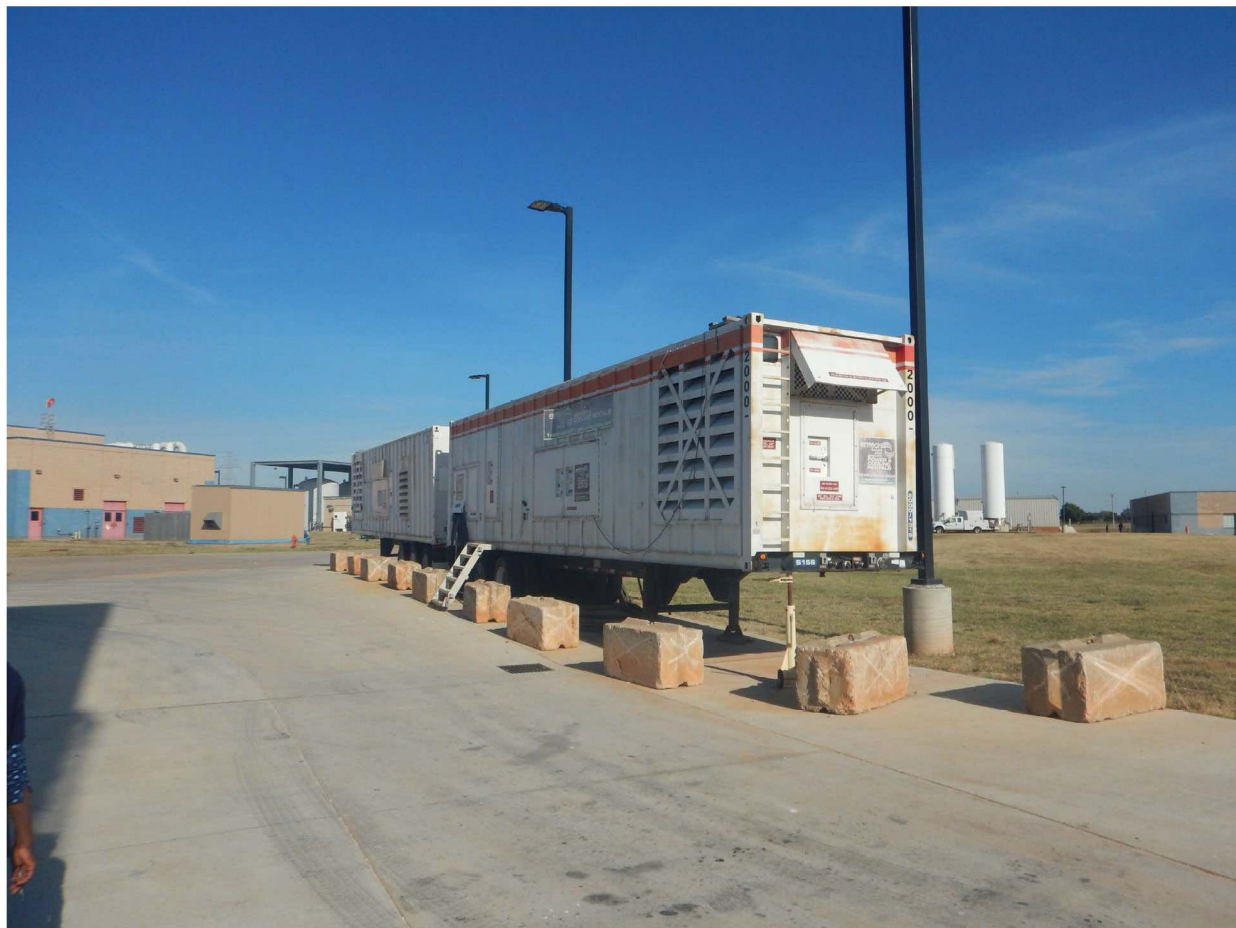
Photograph No. 8

Description: Backup generators are available at Lake Hefner WTP. According to the system representative, there are a total of five portable backup generators on-site for Lake Hefner WTP.

System is equipped with backup generators sufficiently sized to run all water treatment plant equipment and finished water pumps ([Appendix 2, Photograph 8](#)). The backup generators at Lake Hefner can operate for up to 2 days with on-site fuel, while the Lake Draper WTP backup generator can provide power for up to 7 days without refueling. Additional fuel requirements can be met by the fleet department, based on their agreement. Lake Hefner WTP utilizes trailer-mounted backup generators, and once a backup generator is connected to one of their docking locations, the entire system can be operated using the backup generator ([Appendix 2, Photograph 9](#)). System representative stated that Lake Draper WTP uses permanently mounted backup generators.

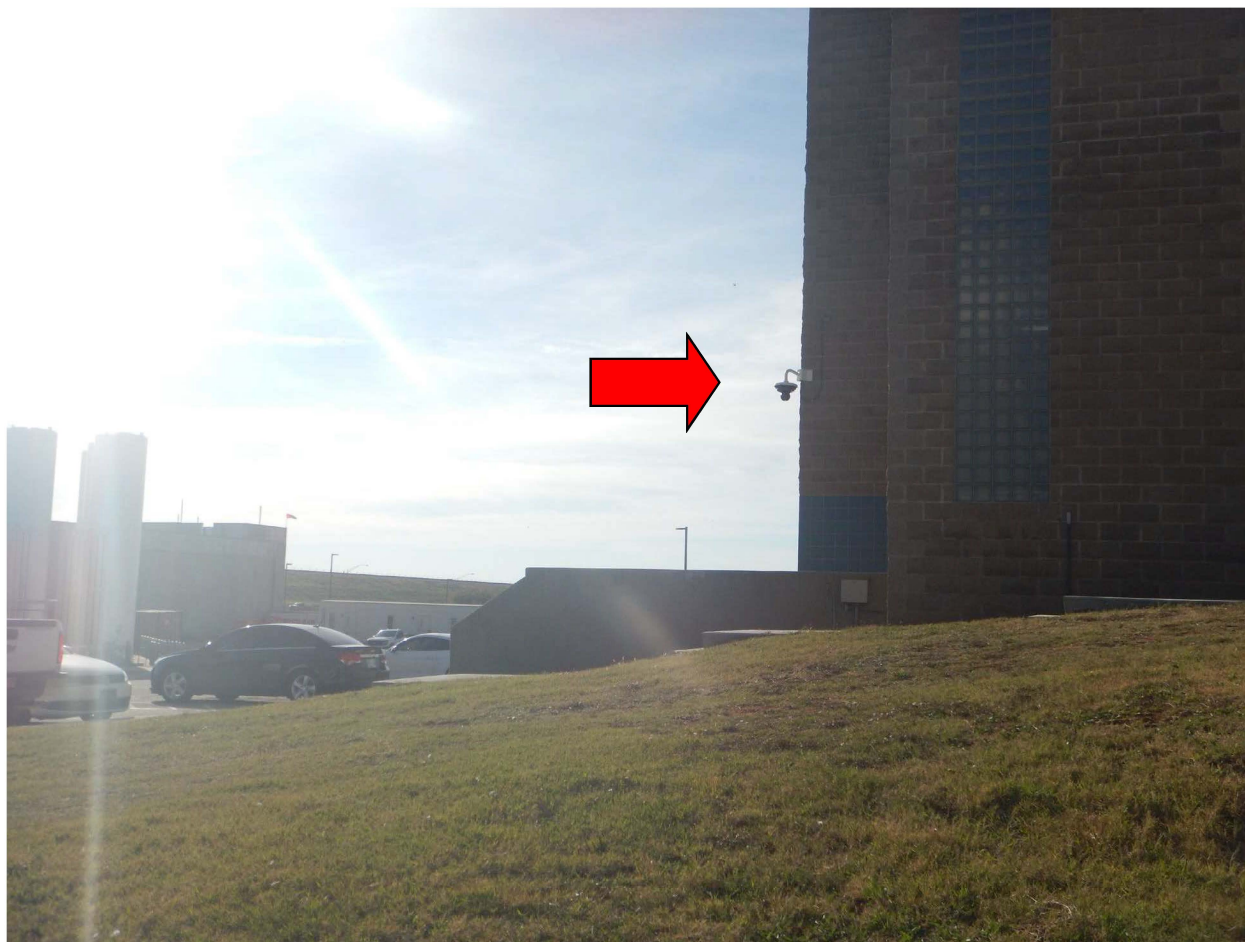
Photograph No. 11

Description: System is in the process of installing video cameras at their facilities to enhance security measures. The camera was installed for laboratory and SCADA building.

The water treatment plant is secured with fencing and a locked gate ([Appendix 2, Photograph 1](#)). System is in the process of installing video cameras at their facilities to enhance security measures ([Appendix 2, Photograph 11](#)). Once the project is completed, water treatment plant operators will be able to view the video feed from inside the SCADA room. The water treatment plant is staffed 24 hours a day. Additionally, the SCADA room can be accessed by authorized staff using login credentials to make necessary changes measures ([Appendix 2, Photograph 12](#)). Oklahoma City staff stated that all water system buildings are equipped with intrusion alarms. According to the system's safety sign, Lake Hefner WTP has worked for 2,520 days without an OSHA recordable injury on the job measures ([Appendix 2, Photograph 13](#)).

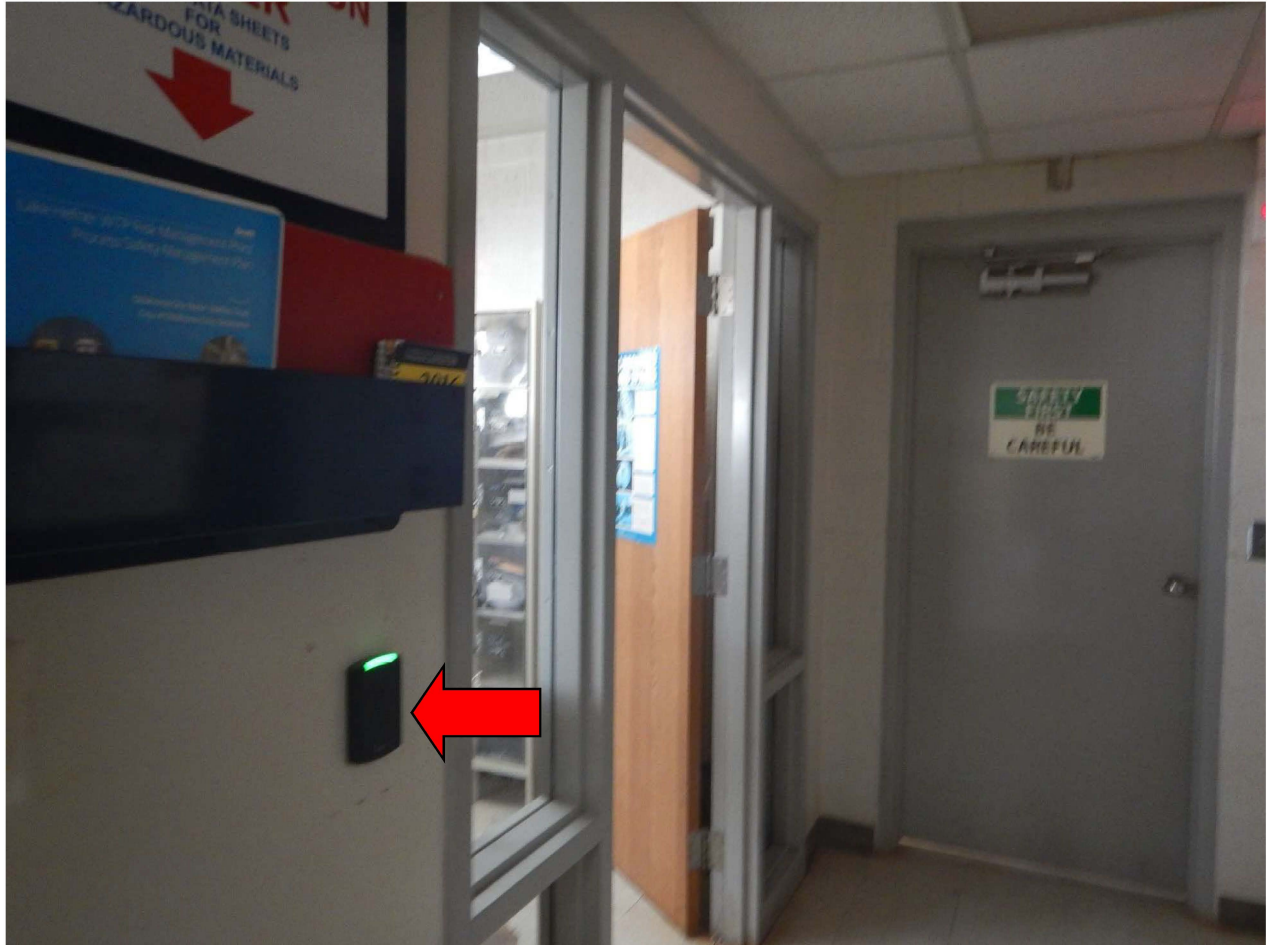
Photograph No. 12

Description: the SCADA room can be accessed by authorized staff using login credentials

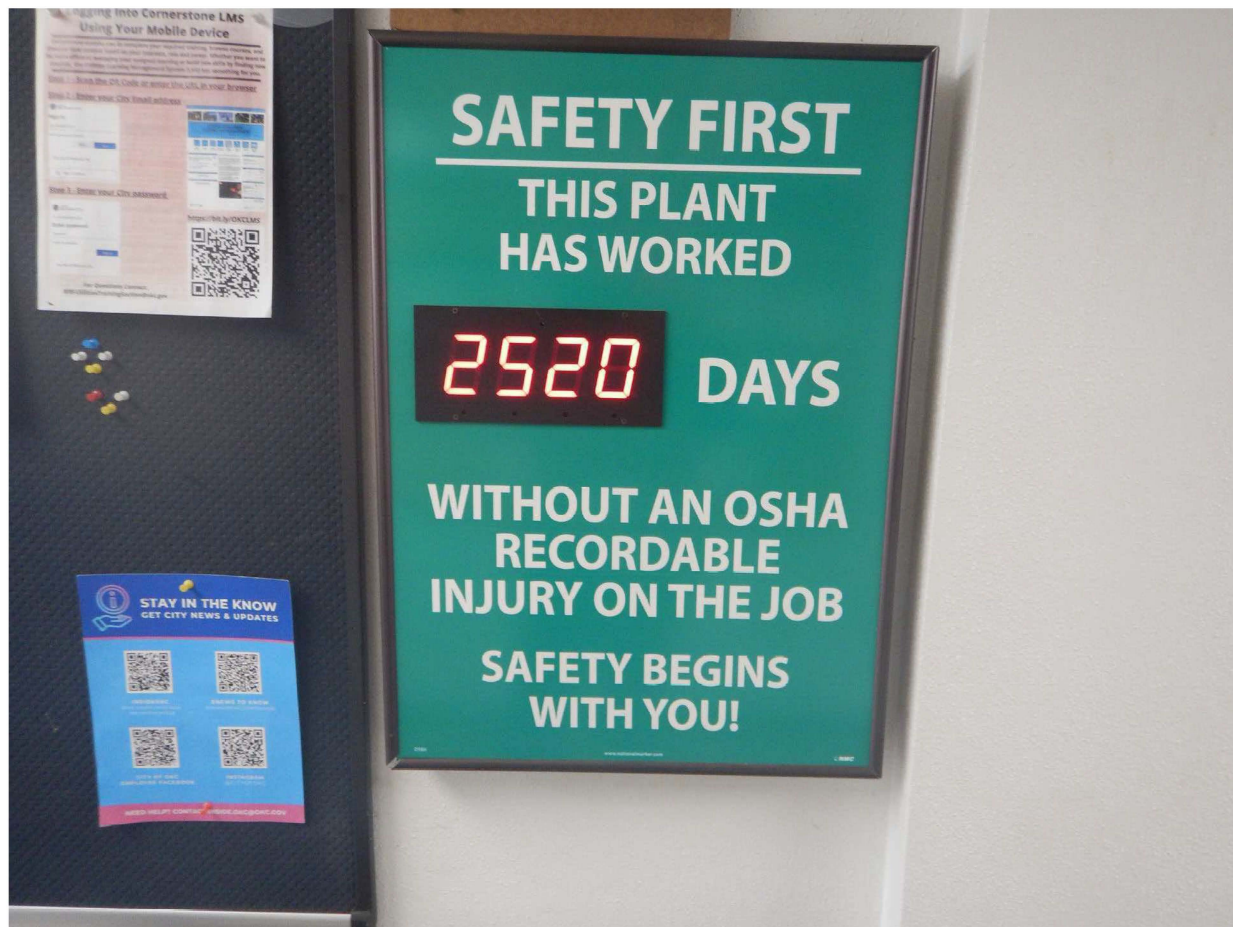
Photograph No. 13

Description: The system's safety sign indicated that the laboratory has operated for 2,520 days without an OSHA recordable injury on the job.
