**Region 6 - Enforcement & Compliance Assurance Division**  
**INSPECTION REPORT**

| Media Program: | Water | |
| Regulatory Program(s) | CAFO | |

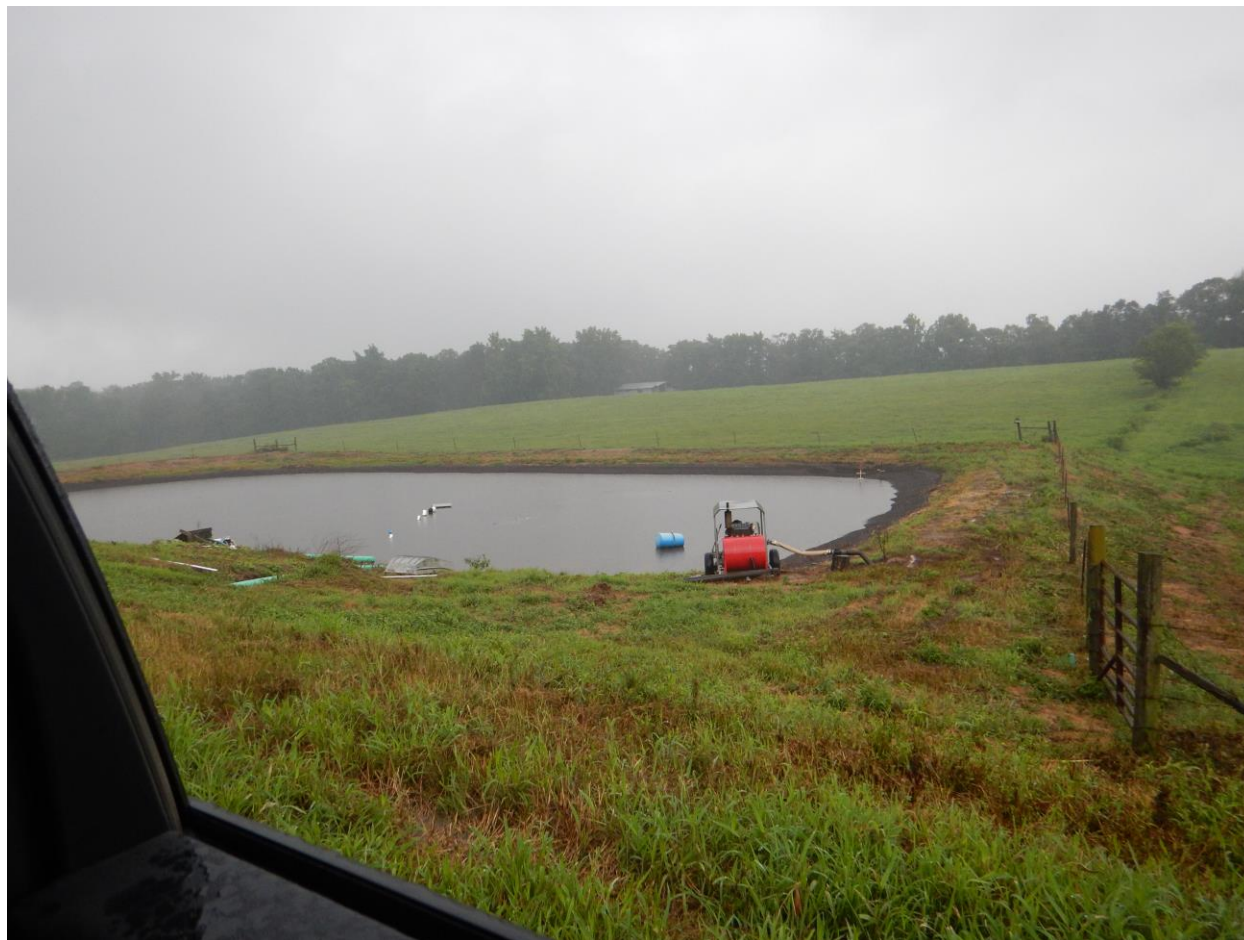
Photo No. 1

The lagoon (see Photo 1) has a pole marker, and the level was below the 25-yr/24-hr event mark. The embankment appears well vegetated, and there was no evidence of a discharge. The available freeboard is estimated to be approximately four feet. Mortalities are managed using an incinerator and the ash is land applied.

Description: The farm's single wastewater lagoon which has approximately 4' of freeboard. The unit has a pole marker at the northeast corner of the unit where the long bar represents the 25-year/24-hour pump out mark. There is a wastewater pump which is connected to the riser that sends the wastewater to the risers located in the land application fields which are equipped with a traveling reel gun. The view is toward the northwest.

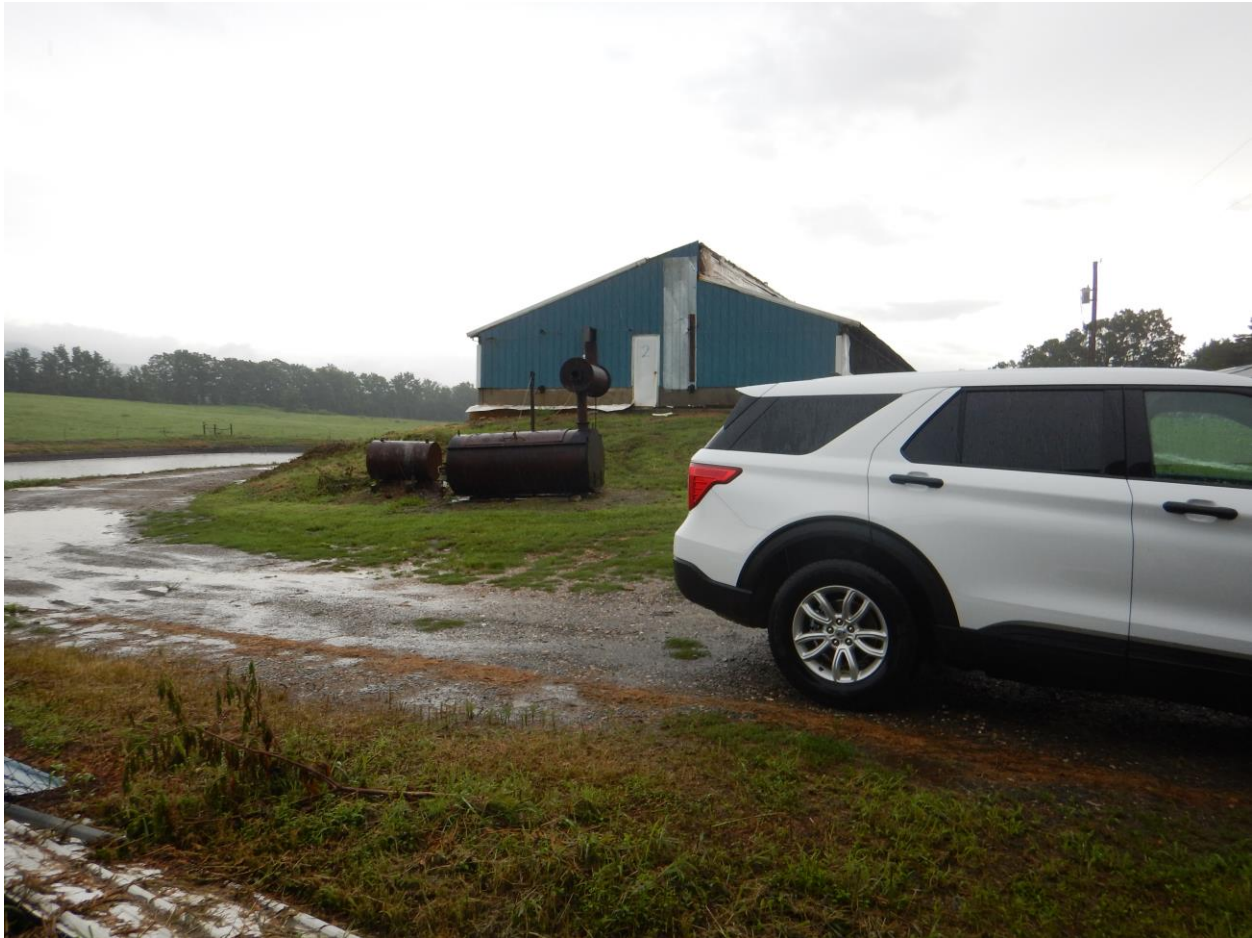
Photo No. 2

Description: One of the farm's four swine barns, with the incinerator that is used for mortality management in the foreground. The view is toward the northeast.

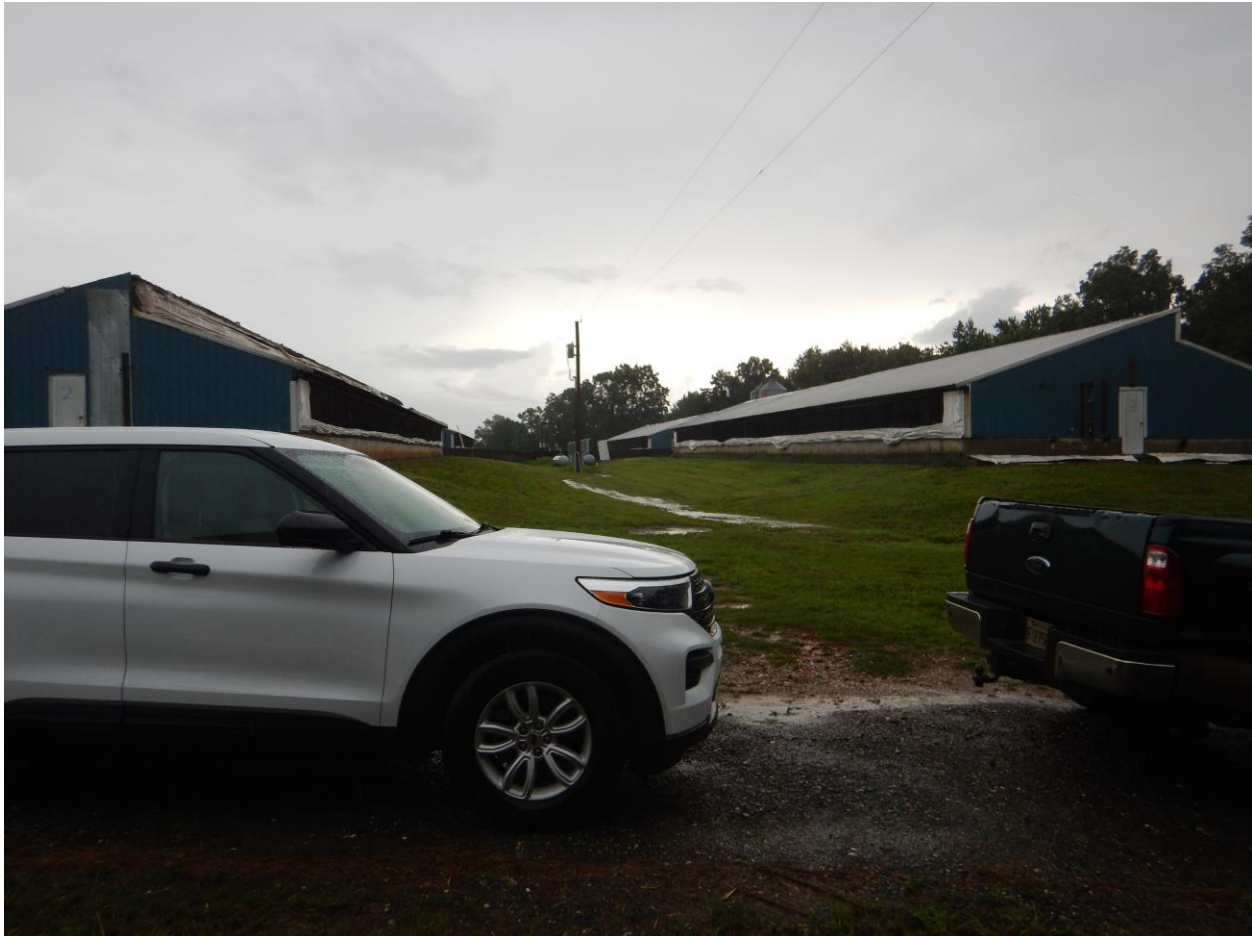
Photo No. 3

Description: Looking east between the barns. The grounds are well maintained and neat. Silver covers can be seen covering the flush water drain pit at the barn to the right of the photo that direct wastewater to the lagoon.

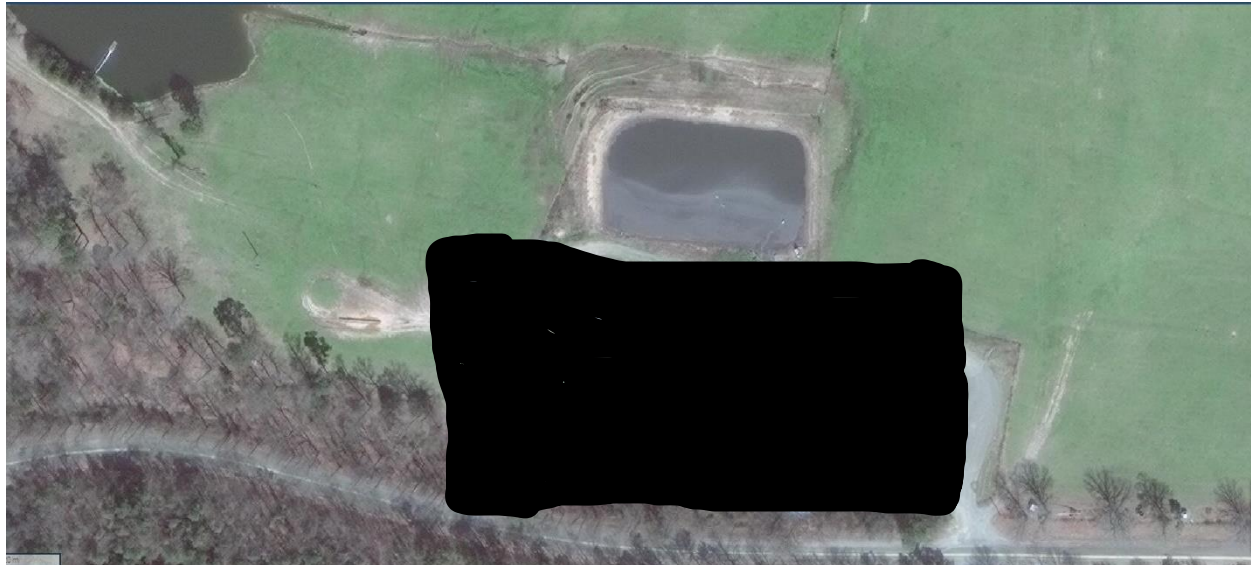
Photo No. 7

[REDACTED] DigitalGlobe Aerial View from 3/19/2023

Four swine barns and one lagoon. An unimpacted freshwater stock tank is located to the west of the lagoon:
