## **RCRA Inspection Report**

Ardagh Metal Beverage USA  
4000 Old Milwaukee Lane  
Winston-Salem, NC 27107

EPA ID#: NCD000827493  
NAICS #: 332431 - METAL CAN  
MANUFACTURING

December 6, 2023 9:15 AM

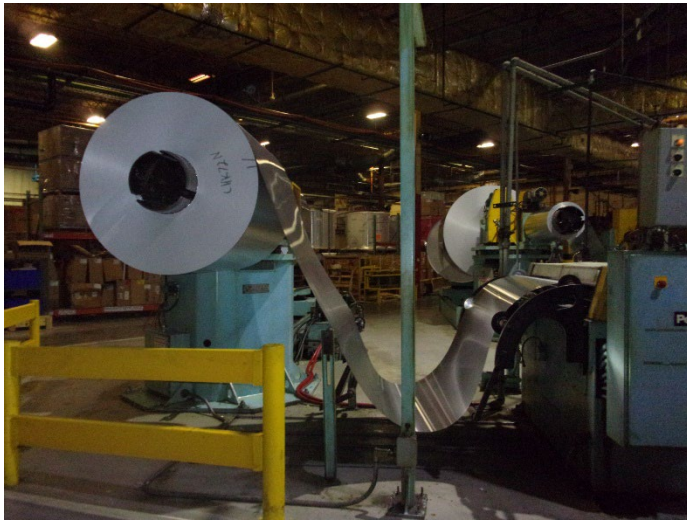
The facility process begins at the front end, where the aluminum sheets are cut and shaped into cans (Photo 1). Ardagh operates a large conveyor belt that cuts open ended cylinders from the sheet. The aluminum cylinders are oily after the shaping and are then moved to the washer stage. Ardagh maintains seven washers on site which spray the open cylinders with nozzles. The cans are then flipped and put on another conveyor belt to be sprayed with the inside varnish and dried in a high temperature oven. Excess inside varnish is accumulated in a tray underneath the spray area as nonhazardous waste. The tray is emptied into a 10-gallon drum near the point of generation which is then brought consolidated in a 55-gallon drum outside the equipment area. Finally, cans are brought to the printing area where they are printed with the appropriate product label and dried again. The printer on-site first prints a blanket white image onto the metal can and a second layer on top displays the full image. The cans are then brought on the conveyor belt to be palletized and loaded onto a truck via forklift. The final product is shipped as aluminum cylinders with one open end and product labels on the outside. The can will be filled with product, closed, and tabbed when it reaches the customer. With all 10 production lines running, Ardagh can produce up to 18 million cans a day.

Photo 1 – Aluminum sheet used to cut cylinders for can production.

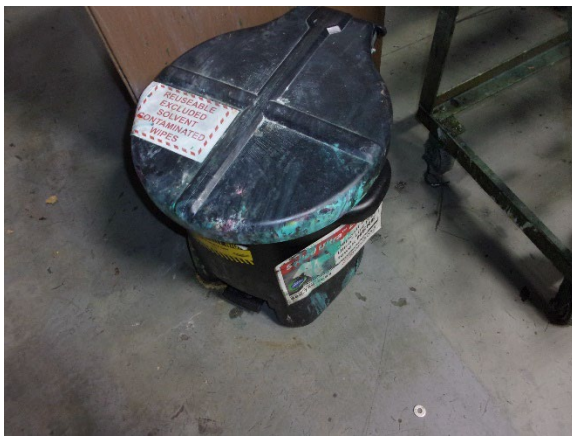
Inspectors observed several 5-gallon containers labeled “reusable excluded solvent contaminated wipes” (Photo 2). Malcolm Edwards informed inspectors that isopropyl alcohol is used in spray bottles to clean the machinery throughout the production area. Empty spray bottles are put in red 5-gallon containers observed throughout the process area to be rinsed and refilled. Solvent contaminated wipes are wrung out before disposing to prevent free liquids in the wipes container. The wipes are wrung out into a 200-gallon portable box container labeled, “isopropyl alcohol – keep closed when not in use” (Photo 3). Facility representatives informed inspectors that the isopropyl alcohol in this container is used to fill the empty spray bottles and is not a waste. The container holds product isopropyl alcohol as well as alcohol wrung out from used wipes.

Photo 2 – Container of excluded solvent contaminated wipes in the production area.

Inspectors reviewed documentation for the laundering and returning of excluded solvent contaminated wipes by Absorb Tech. Facility representatives informed inspectors that Absorb Tech picks up rags weekly. Inspectors requested the facility maintain a log for their excluded wipes to better demonstrate compliance with the 180-day accumulation time limit for excluded wipes.

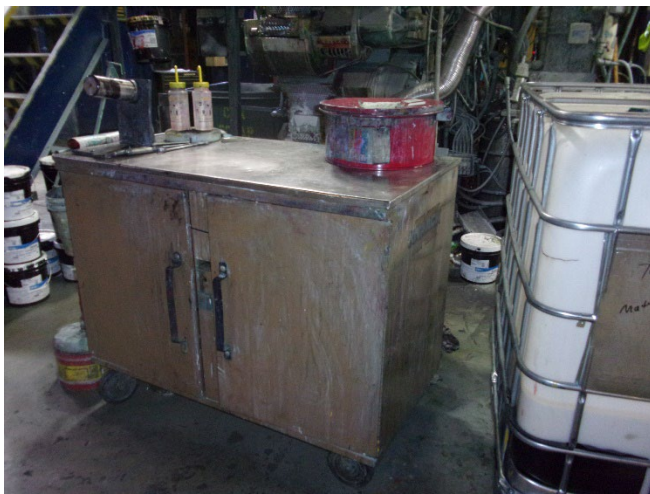
Photo 3 – Container of isopropyl alcohol used for equipment cleaning in process area.

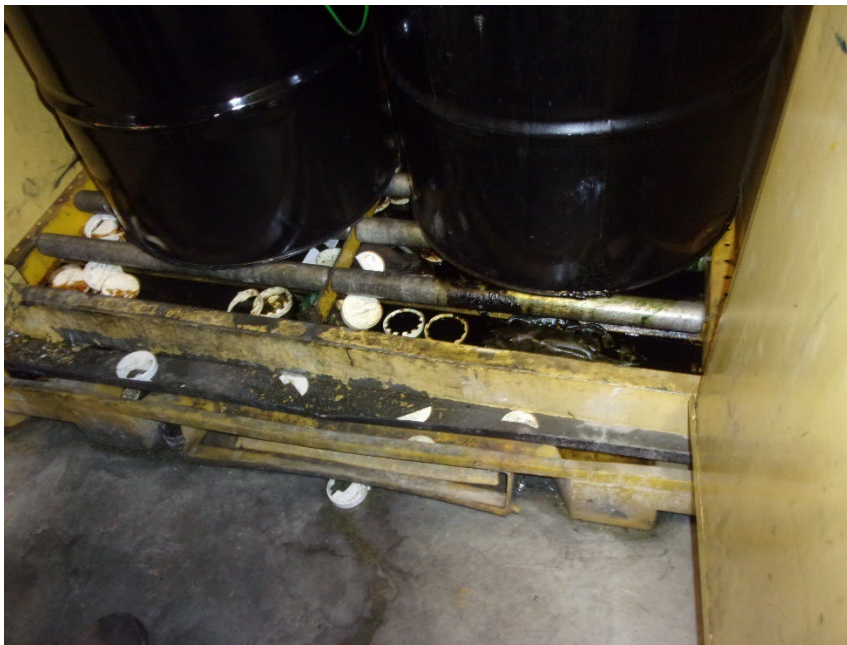
Inspectors observed liquid at the bottom of the secondary containment and liquid on the lid of the waste container (Photo 4). Inspectors requested the facility improve housekeeping in this area and to be able to attend to spills of hazardous waste immediately.

**Pursuant to [15A NCAC 13A .0107(a)] [40 C.F.R. § 262.17(a)(6)], which incorporates [15A NCAC 13A .0107(i)] [40 C.F.R. § 262.251], and is a condition of the LQG Permit Exemption, a generator is required to maintain and operate its facility to minimize the possibility of a fire, explosion, or any unplanned sudden or non-sudden release of hazardous waste or hazardous waste constituents to air, soil, or surface water which could threaten human health or the environment.**

Photo 4 – Spills observed in secondary containment of flammable cabinet storing drums of hazardous waste.

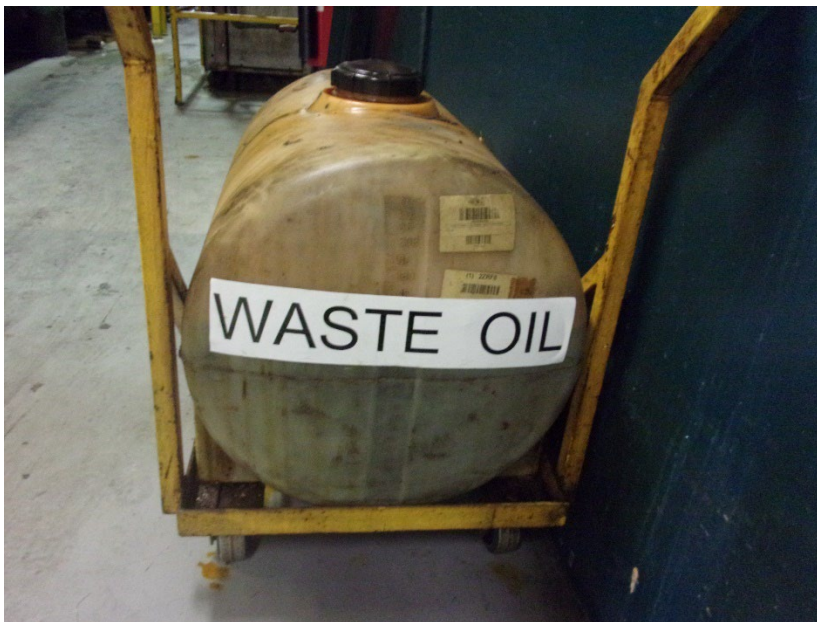
Inspectors observed a horizontal 30-gallon container labeled “Waste Oil” with Deminimus oil spills underneath the container (Photo 5-6). Inspectors requested that facility representatives clean the oil around this area and relabel the container with the words “Used Oil.” Facility representatives submitted a photo of the corrected container via email on December 27, 2023.

**Pursuant to [15A NCAC 13A .0118(c)] [40 C.F.R. § 279.22(c)(1)], containers and aboveground tanks used to store used oil at generator facilities must be labeled or marked clearly with the words “Used Oil.”**

Photo 5 – Container labeled "waste oil" in production area.

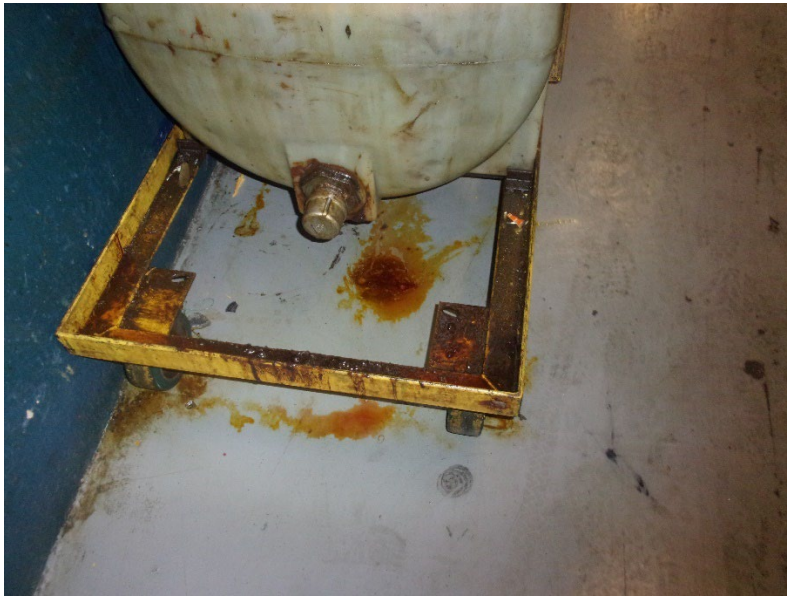
**Pursuant to [15A NCAC 13A .0118(c)] [40 C.F.R. § 279.22(d)], upon detection of a release of used oil to the environment, the facility must clean up and manage properly the released used oil and other materials.**

Photo 6 - Oil spills observed underneath the used oil container in the production area.

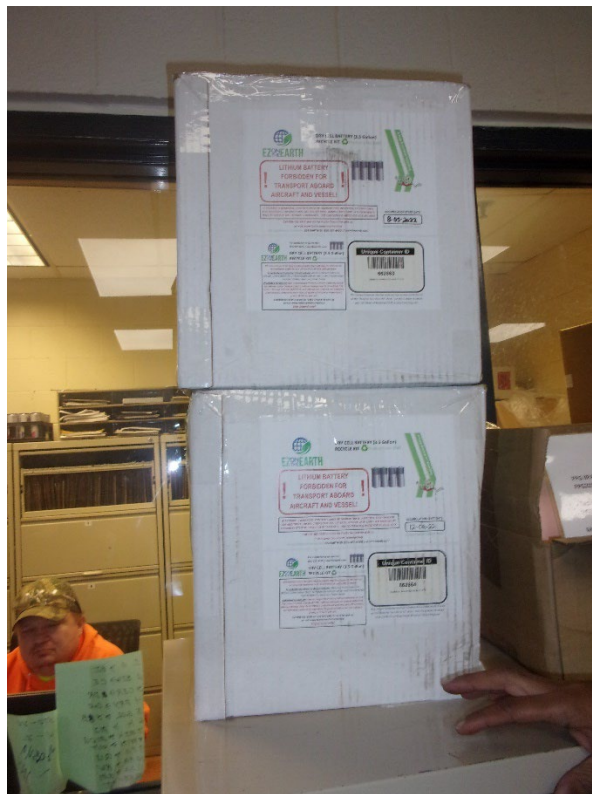
- One 5-gallon drum labeled "universal waste, lithium batteries, 5/9/23."
- One 2-foot cylinder container labeled "universal waste, dry cell batteries, 10/12/2023."
- Two cardboard boxes of batteries labeled "lithium batteries, dry cell battery Recycle." These containers were dated 8/5/2022 and 12/8/2022 (Photo 7). One of these containers had exceeded the one-year accumulation time limit for universal waste and one container was two days from the one year time limit (Photo 6).

**Pursuant to [15A NCAC 13A .0119(b)] [40 C.F.R. § 273.15(a) and (c)], a SQHUW may accumulate universal waste no longer than one year and must to be able to demonstrate the length of time that the universal waste has accumulated from the date that it became a waste or was received.**

Photo 7 – two boxes of universal waste lithium batteries in the QC laboratory. One of these boxes was past the one-year accumulation time limit for universal waste and one was within days of the one year mark.

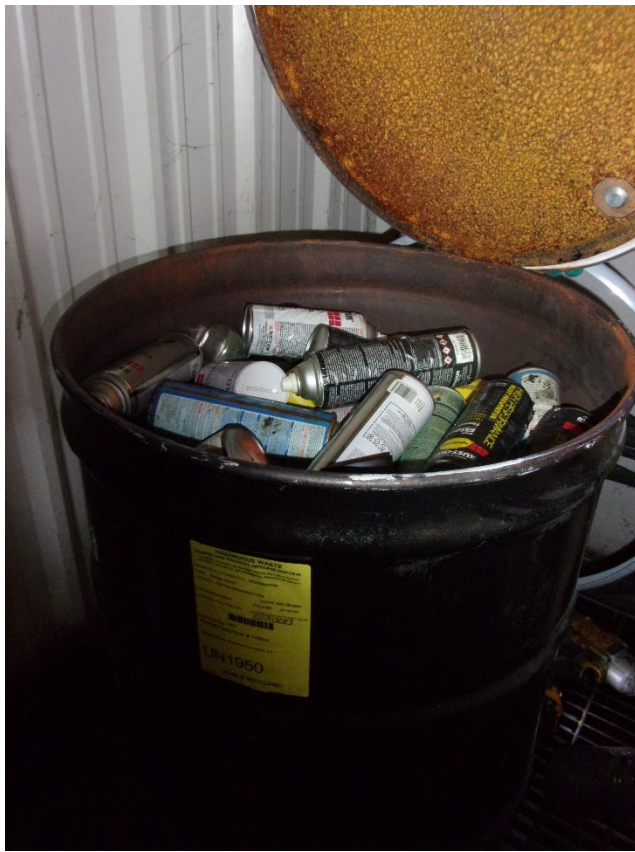
- One 55-gallon drum labeled “UN1950, hazardous waste, aerosols, flammables, 10/19/2023.” This drum contained spray paint aerosol cans. Other aerosol cans generated at the facility are managed as universal waste.

Photo 8 – Hazardous waste aerosol container holding used spray paint cans in Ardagh CAA.
