**UNITED STATES ENVIRONMENTAL PROTECTION AGENCY  
REGION 8  
RESOURCE CONSERVATION AND RECOVERY ACT**

**Facility Name:** Sweetwater Disposal

**Type and Purpose of Inspection:** Compliance Evaluation Inspection

**Facility Type:** Commercial Oilfield Waste Disposal Facility

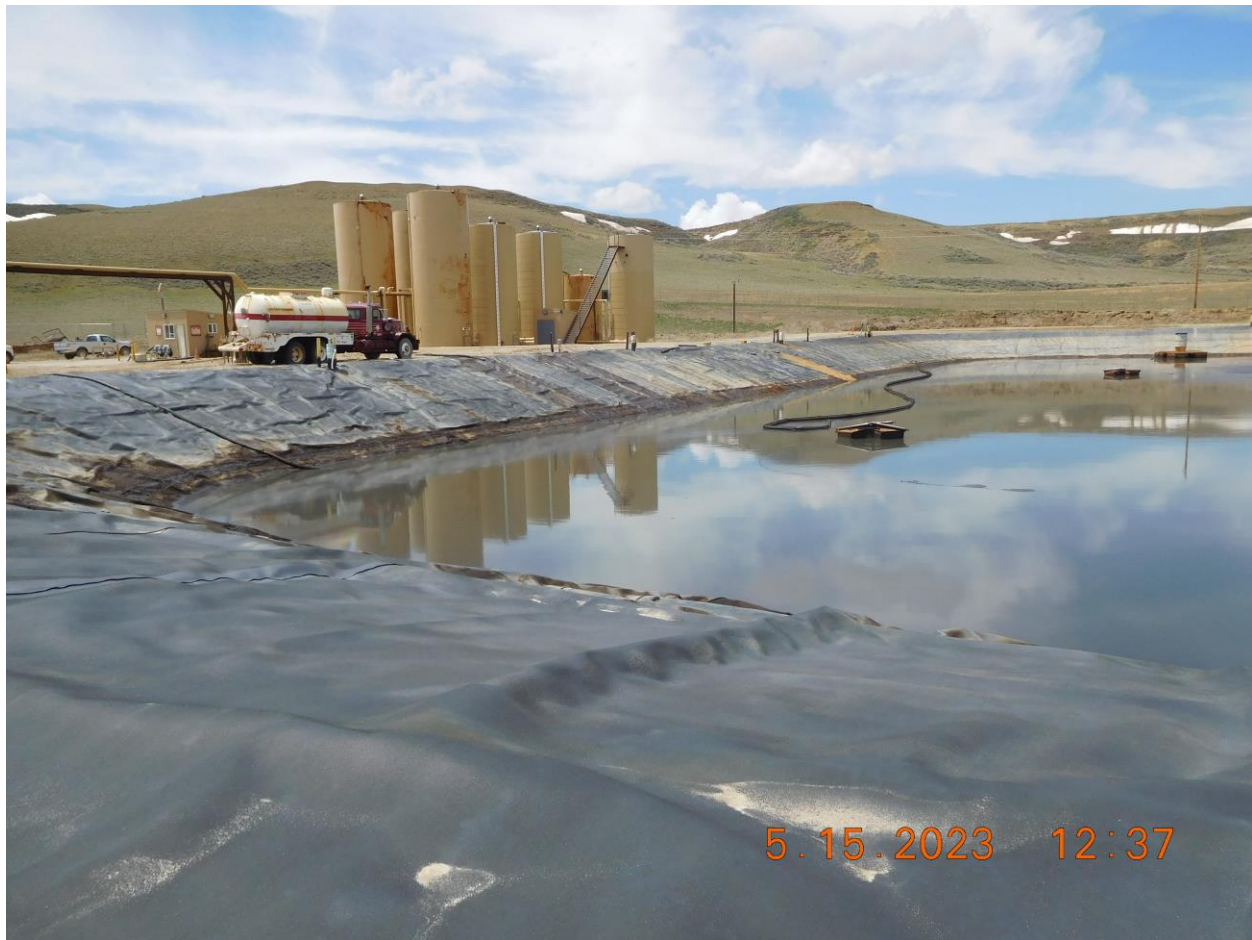
**Data Collected and Observations:** During the inspection, I observed that oil was visible on approximately 40% of the surface of pond 1 located north of the tank battery (see Attachment 1 – Photo Log). No oil was observed on the other evaporation ponds, and no spills were observed in the tank battery area. No bird or other wildlife mortalities were observed in any areas of the facility that were inspected.

Photo 1997: DSCN1997.jpg – photo of pond 1 facing southwest.

A closing conference was conducted with Mr. Maestas indicating concern regarding the oil on the surface of pond 1. Mr. Maestas stated that he would work on getting the oil removed.

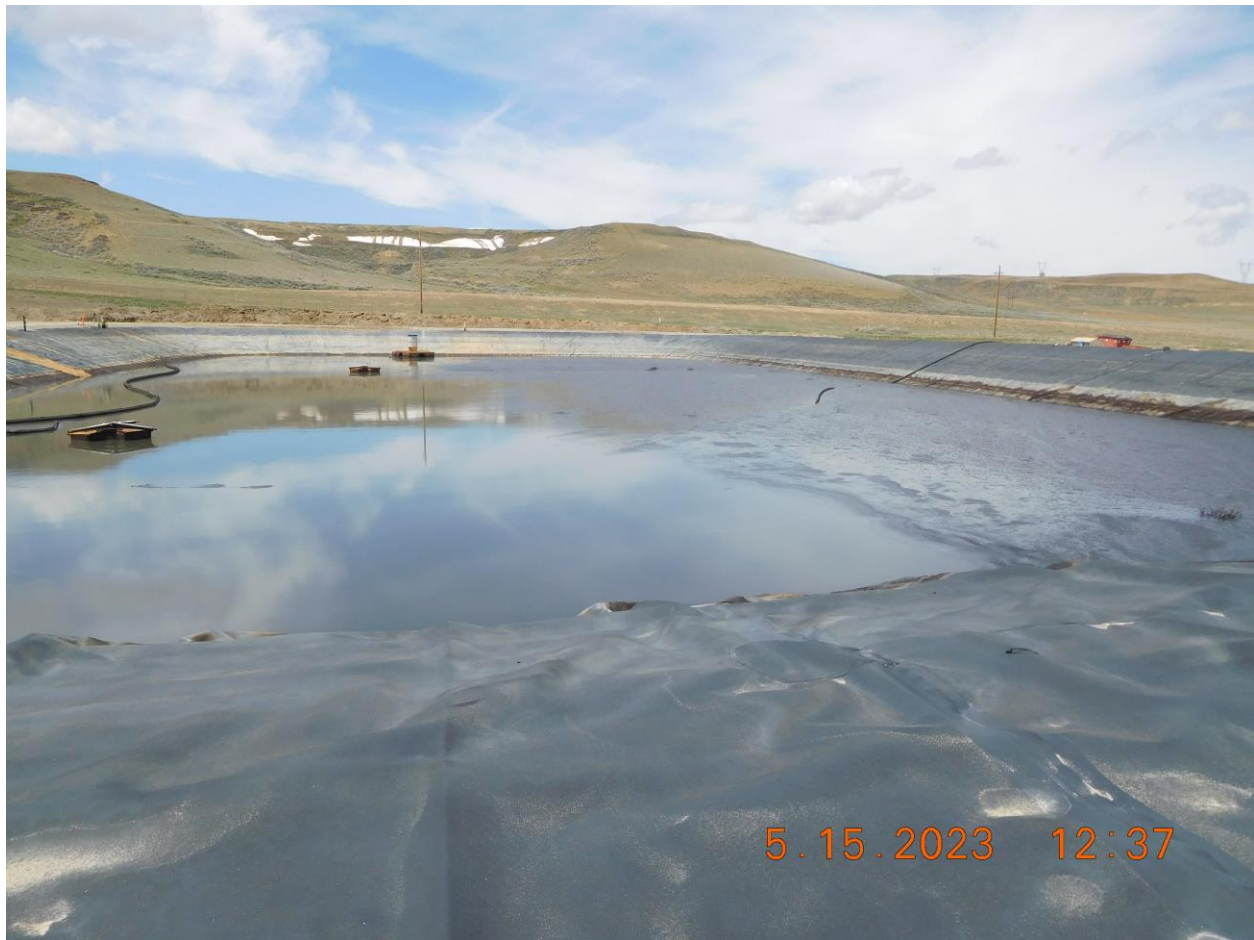
Photo 1998: DSCN1998.jpg – photo of the same area as that shown in photo 1997, panned right. Oil on the surface of the pond is visible to the right in the photo.

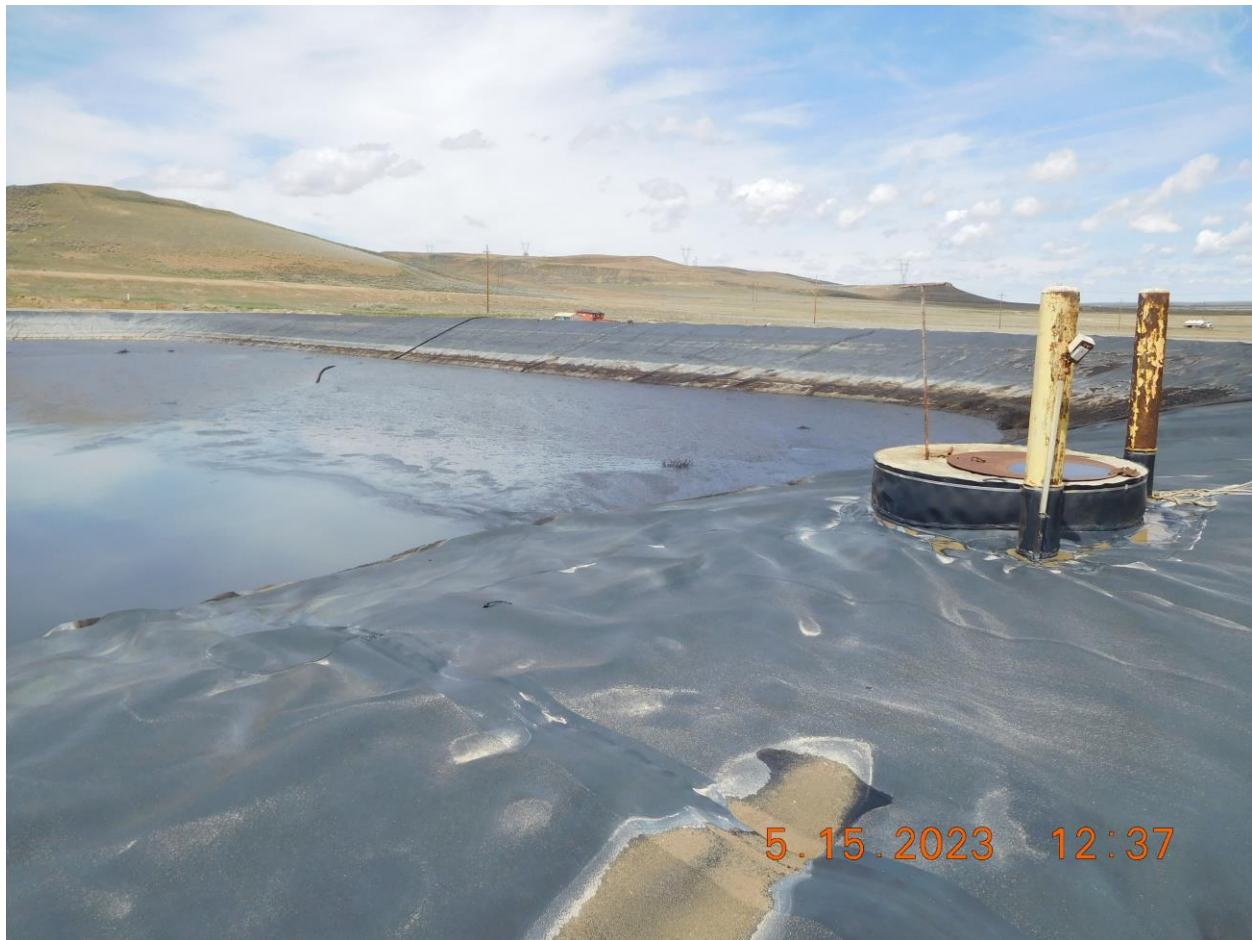
Photo 1999: DSCN1999.jpg – photo of the same area as that shown in photos 1997 and 1996, panned right.
