## RCRA Compliance Evaluation Inspection Report

Inteplast Engineered Films Corp.  
7549 Brokerage Drive  
Orlando, Florida 32809-5625  
County: Orange  
Latitude: 28.453796  
Longitude: -84.418123  
EPA ID Number: FLD984201251  
Primary NAIC: 323111 – Commercial Gravure Printing  
Other NAICS: 326111 – Plastics Bag and Pouch Manufacturing

RCRA CEI Photographs for  
Inteplast Engineered Films Corp.  
7549 Brokerage Drive  
Orlando, Florida 32809-5625  
Taken by: David Champagne, U.S. EPA  
April 8, 2021  
Camera Model: Google Pixel XL

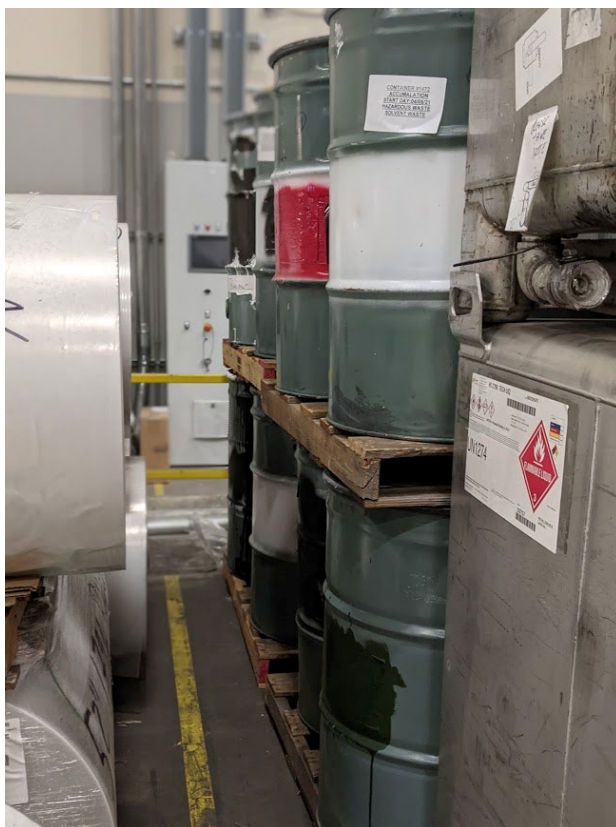
Photograph 1 of 21: Plate Mounting, Film Production Floor - Hazardous Waste CAA

At the time of the inspection, there were sixteen (16) 55-gallon hazardous waste containers in the CAA. The containers were double stacked in two rows of 4 containers. This area lacked aisle space and was difficult for the inspection team to conduct the CEI of the Plate Mounting Room and Film Production Floor's CAA (Photographs 1 and 2 of 21).

Hazardous waste labels, containing the accumulation dates and significant information containing the contents of the container, were not clearly visible at the time of the inspection (Photographs 1, 3, and 4 of 21).

**Pursuant to Fla. Admin. Code Ann. r. 62-730.160(1) [40 C.F.R. § 262.17(a)(6)], which incorporates Fla. Admin. Code Ann. R. 62-730.160(1) [40 C.F.R. § 262.255], and is a condition of the LQG Permit Exemption, a generator is required to maintain aisle space to allow the unobstructed movement of personnel, fire protection equipment, spill control equipment, and decontamination equipment to any area of facility operation in an emergency, unless aisle space is not needed for any of these purposes.**

**Pursuant to Fla. Admin. Code Ann. r. 62-730.160(1) [40 C.F.R. § 262.17(a)(5)(i)(C)], which is a condition of the LQG Permit Exemption, the date upon which each period of accumulation begins, must be clearly visible for inspection on each container.**

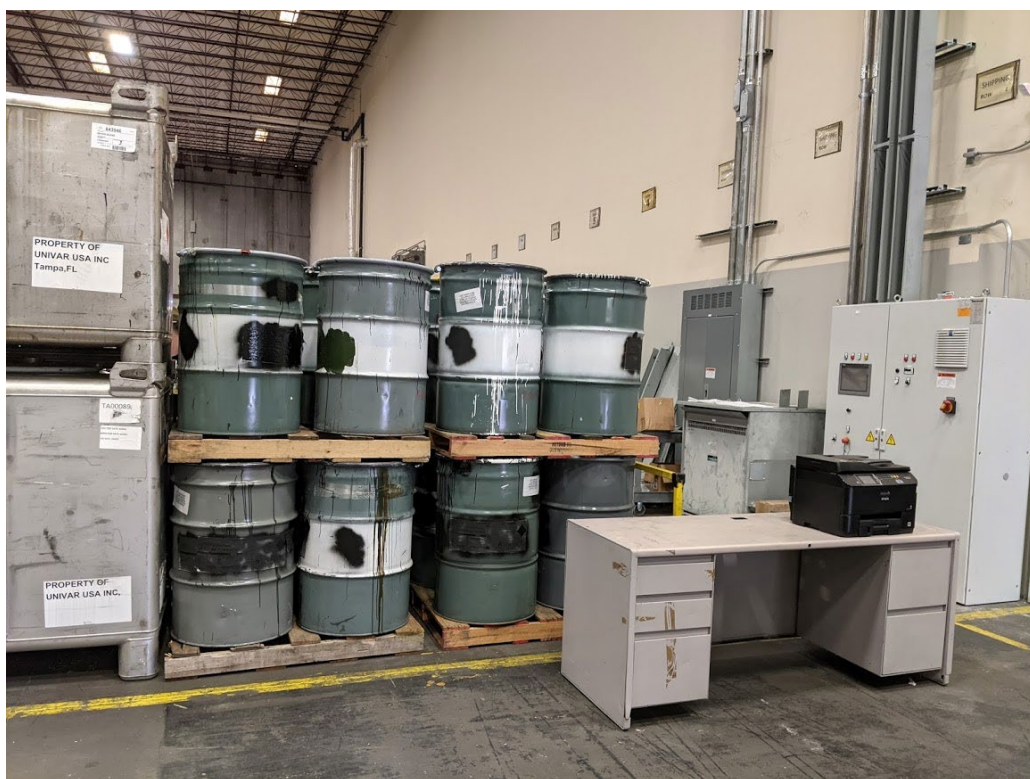
Photograph 3 of 21: Plate Mounting, Film Production Floor - Hazardous Waste CAA

At the time of the inspection, the facility was storing hazardous waste in a CAA and did not take precautions to prevent an accidental ignition of ignitable waste by posting “No Smoking” signs (Photograph 3 of 21).

At the time of the inspection, within the immediate location of the CAA, there was no decontamination eye-wash station present (Photograph 3 of 21).

**Pursuant to Fla. Admin. Code Ann. r. 62-730.160(1) [40 C.F.R. § 262.17(a)(1)(vi)(B)], which is a condition of the LQG Permit Exemption, special conditions for accumulation of ignitable/reactive waste require LQGs to take precautions to prevent accidental ignition or reaction of ignitable or reactive waste and “No Smoking” signs must be conspicuously placed wherever there is a hazard from ignitable or reactive waste.**

**Pursuant to Fla. Admin. Code Ann. r. 62-730.160(1) [40 C.F.R. § 262.17(a)(6)], which incorporates Fla. Admin. Code Ann. R. 62-730.160(1) [40 C.F.R. § 262.252(c)] and is a condition of the LQG Permit Exemption, all areas deemed applicable by Fla. Admin. Code Ann. R. 62-730.160(1) [40 C.F.R. § 262.250] must be equipped with decontamination equipment.**

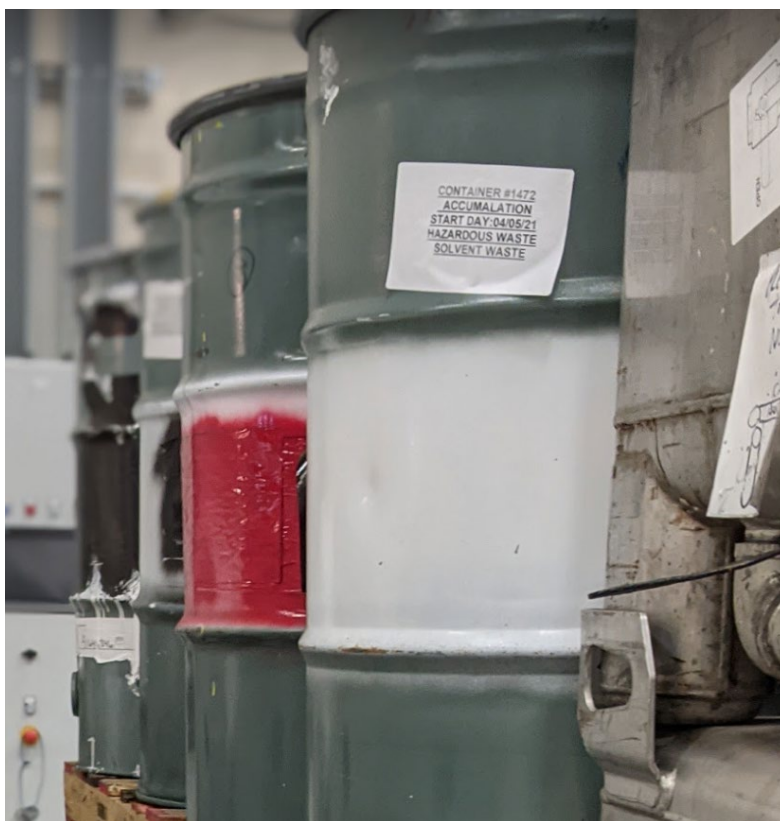
Photograph 4 of 21: Plate Mounting, Film Production Floor - Hazardous Waste CAA

At the time of the inspection, the sixteen (16) hazardous waste containers stored in the CAA were not labeled with the indication of the hazards of the contents (Photograph 4 of 21).

**Pursuant to Fla. Admin. Code Ann. r. 62-730.160(1) [40 C.F.R. § 262.17(a)(5)(i)], which is a condition of the LQG Permit Exemption, a generator must mark or label its containers with an indication of the hazards of the contents.**

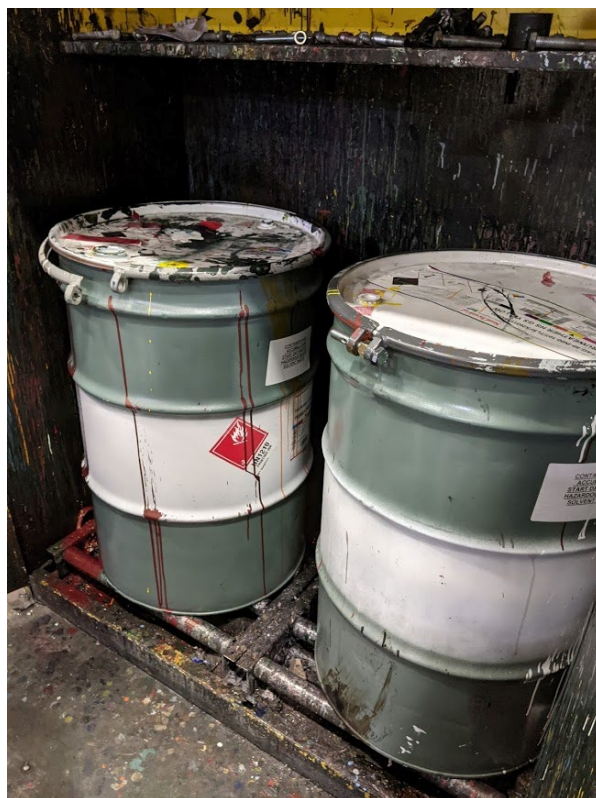
Photograph 5 of 21: Printing Department - Hazardous Waste CAA

Waste generated in the Ink Dispensing Room and the Printing Department, are collected, and stored in a CAA within this designated area. At the time of the inspection there were three (3) 55-gallon hazardous waste containers in this CAA. All containers were labeled and dated. One container was not closed during accumulation at the time of the inspection (Photograph 5 of 21).

**Pursuant to Fla. Admin. Code Ann. r. 62-730.160(1) 262.17(a)(1)(iv)(A), which is a condition of the LQG Permit Exemption, a container holding hazardous waste must always be closed during accumulation, except when it is necessary to add or remove waste.**

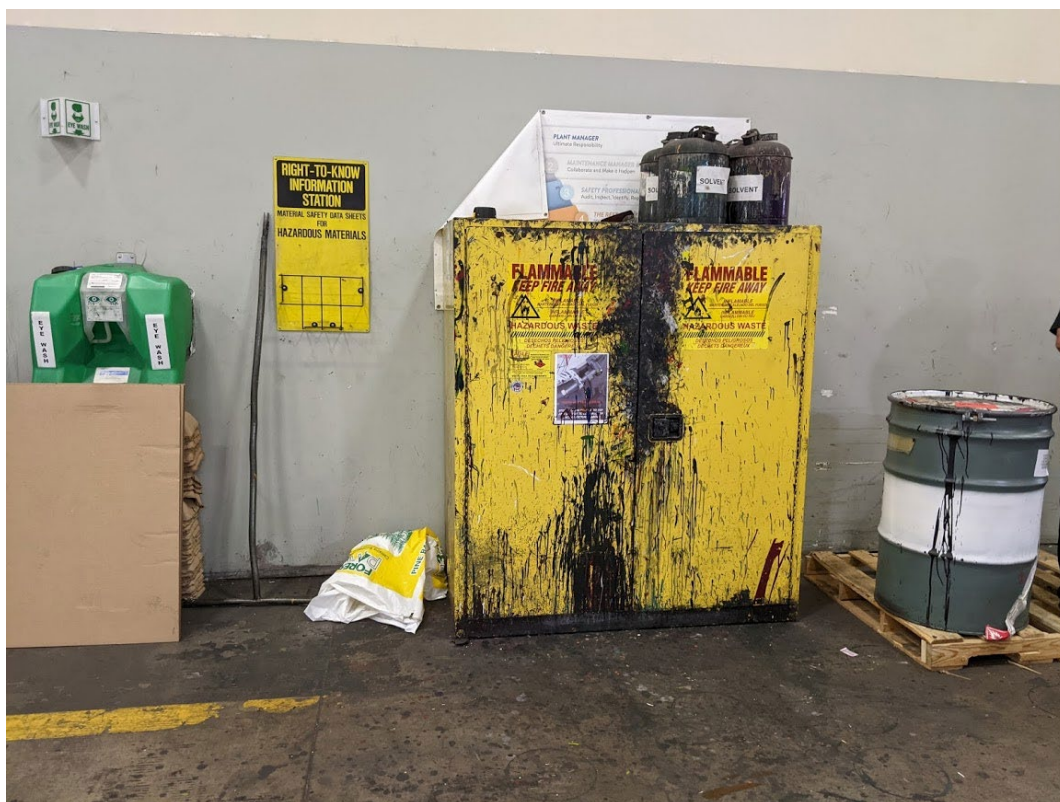
Photograph 6 of 21: Printing Department - Hazardous Waste CAA

At the time of the inspection, the facility was storing hazardous waste in a CAA and did not take precautions to prevent an accidental ignition of ignitable waste by posting “No Smoking” signs (Photograph 6 of 21).

**Pursuant to Fla. Admin. Code Ann. r. 62-730.160(1) [40 C.F.R § 262.17(a)(1)(vi)(B)], which is a condition of the LQG Permit Exemption, special conditions for accumulation of ignitable/reactive waste require LQGs to take precautions to prevent accidental ignition or reaction of ignitable or reactive waste and “No Smoking” signs must be conspicuously placed wherever there is a hazard from ignitable or reactive waste.**

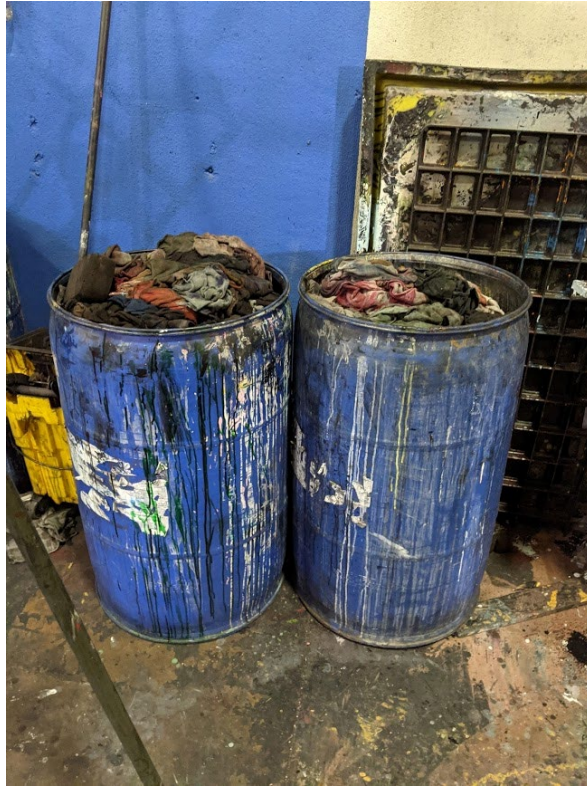
Photograph 7 of 21: Spent Rag Collection Area

Located in the Worker Station of the Printing Department, the facility was managing six (6) 55-gallon containers, two (2) 10-gallon containers, and a 5-gallon container of spent solvent-contaminated rags. The inspection team asked the facility to make a hazardous waste determination on the spent solvent-contaminated rags prior to disposal (Photographs 7-9 of 21).

**Pursuant to Fla. Admin. Code Ann. r. 62-730.160(1) [40 C.F.R. § 262.11], a person who generates a solid waste, as defined in Fla. Admin. Code Ann. r. 62-730.030(1) [40 C.F.R. § 261.2], must make an accurate determination as to whether that waste is a hazardous waste in order to ensure wastes are properly managed according to applicable RCRA regulations articulated in Fla. Admin. Code Ann. r. 62-730.160(1) [40 C.F.R. § 262.11].**

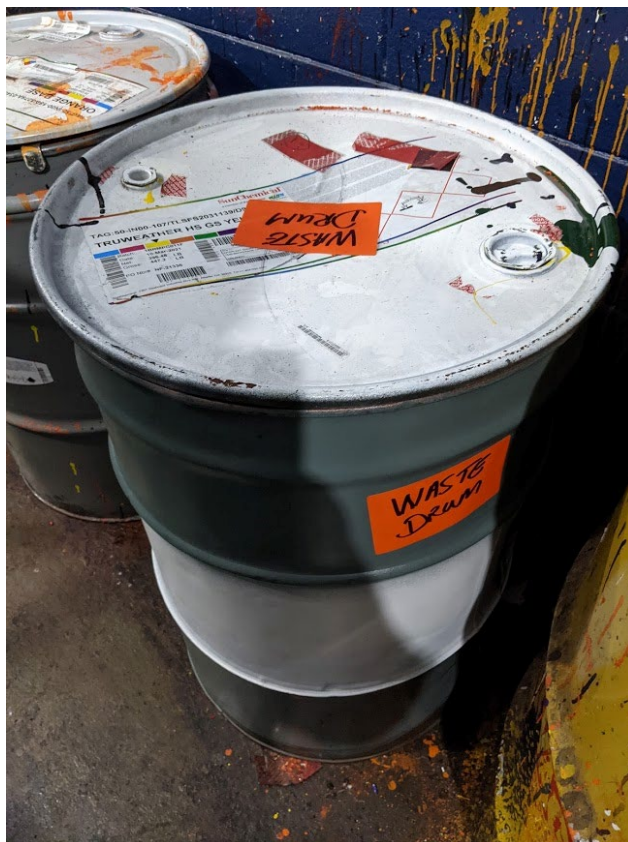
Photograph 10 of 21: Ink Dispensing Room – Hazardous Waste SAA

Paint is formulated and mixed in this area. At the time of the inspection, there was D001 paint-related hazardous waste in a 55-gallon container in a SAA that was not closed, not labeled with the words “Hazardous Waste” nor an indication of the hazard of the contents (Photographs 10 and 11 of 21).

**Pursuant to Fla. Admin. Code Ann. r. 62-730.160(1) [40 C.F.R. § 262.15(a)(4)], which is a condition of the SAA Permit Exemption, a generator is required to keep containers of hazardous waste closed at all times during accumulation, except when adding, removing, or consolidating waste; or when temporary venting of a container is necessary for the proper operation of equipment, or to prevent dangerous situations, such as build-up of extreme pressure.**

**Pursuant to Fla. Admin. Code Ann. r. 62-730.160(1) [40 C.F.R. § 262.15(a)(5)(i) and (ii)], which is a condition of the SAA Permit Exemption, a generator is required to mark or label its containers (i) with the words “Hazardous Waste” and (ii) with an indication of the hazards of the contents.**

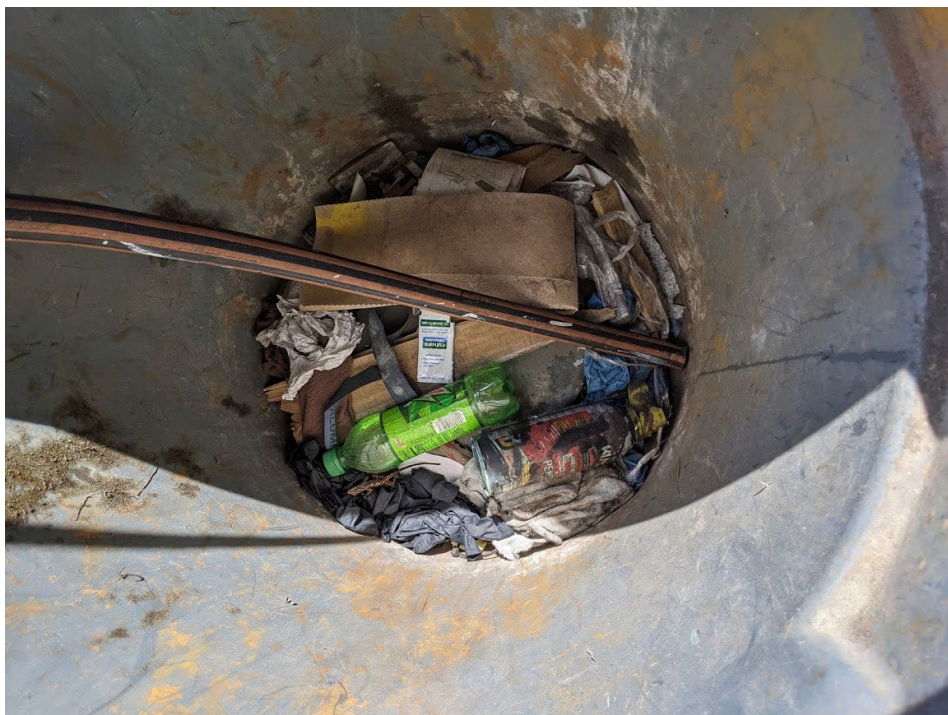
Photograph 12 of 21: Maintenance Department – Aerosol Can Disposal

Aerosol cans are used for various touch-ups and general maintenance on parts or machines and are thrown in the regular trash. The inspection team requested a hazardous waste determination for the municipal disposal of unpunctured aerosol cans (Photograph 12 of 21).

**Pursuant to Fla. Admin. Code Ann. r. 62-730.160(1) [40 C.F.R. § 262.11], a person who generates a solid waste, as defined in Fla. Admin. Code Ann. r. 62-730.030(1) [40 C.F.R. § 261.2], must make an accurate determination as to whether that waste is a hazardous waste in order to ensure wastes are properly managed according to applicable RCRA regulations articulated in Fla. Admin. Code Ann. r. 62-730.160(1) [40 C.F.R. § 262.11].**

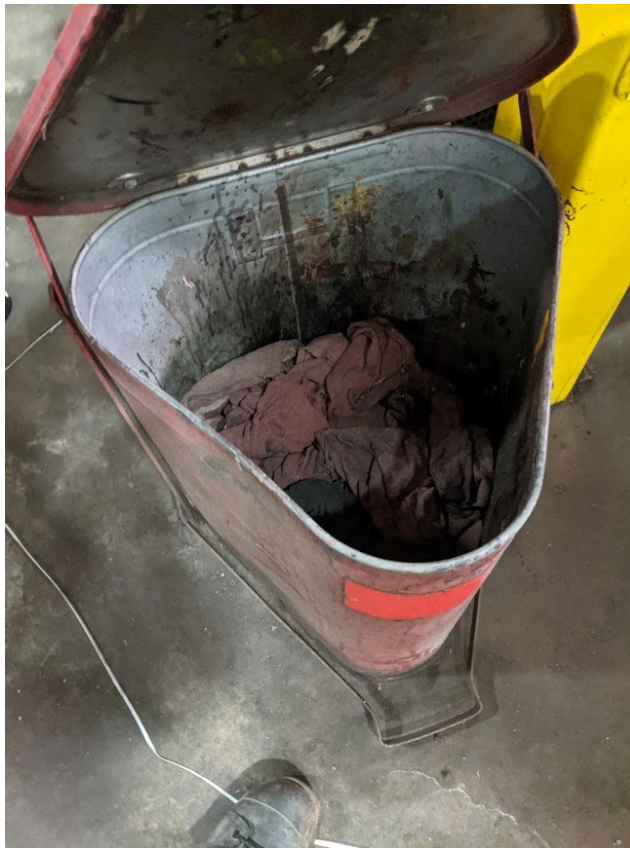
Photograph 13 of 21: Maintenance Department – Spent Rag Collection Container

The maintenance department generates spent rags. At the time of the inspection, it was unclear how the facility was managing two (2) 10-gallon containers storing spent rags. A hazardous waste determination was requested (Photographs 13 and 14 of 21).

**Pursuant to Fla. Admin. Code Ann. r. 62-730.160(1) [40 C.F.R. § 262.11], a person who generates a solid waste, as defined in Fla. Admin. Code Ann. r. 62-730.030(1) [40 C.F.R. § 261.2], must make an accurate determination as to whether that waste is a hazardous waste in order to ensure wastes are properly managed according to applicable RCRA regulations articulated in Fla. Admin. Code Ann. r. 62-730.160(1) [40 C.F.R. § 262.11].**

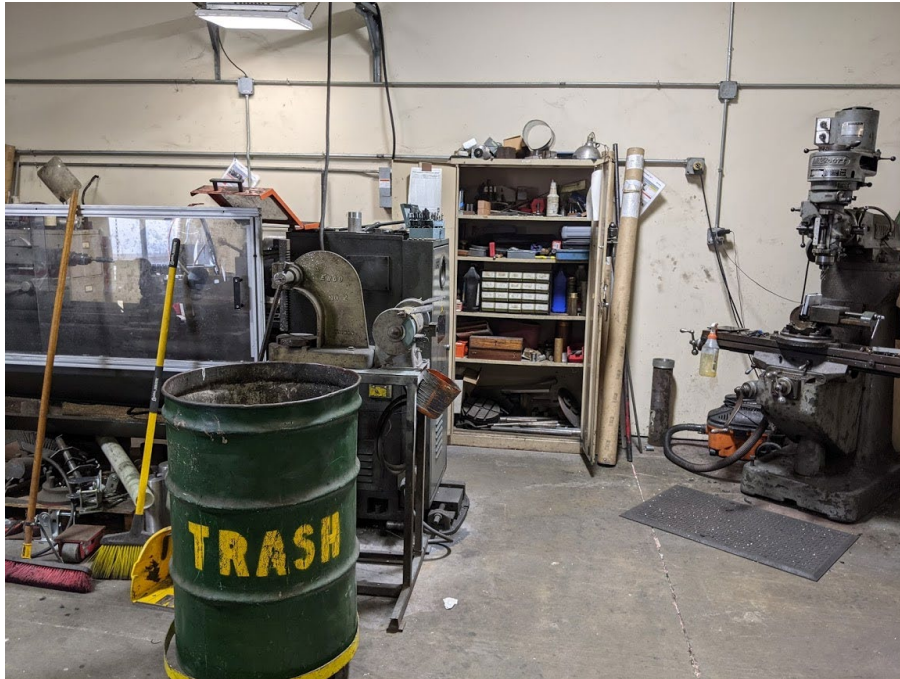
Photograph 15 of 21: Maintenance Department – Scrap Metal Generation Area

The maintenance department has a two milling machines. At the time of the inspection, a waste determination was requested for the scrap metal and documentation indicating where the metal is shipped for disposal or recycling (Photographs 15 and 16 of 21).

**Pursuant to Fla. Admin. Code Ann. r. 62-730.160(1) [40 C.F.R. § 262.11], a person who generates a solid waste, as defined in Fla. Admin. Code Ann. r. 62-730.030(1) [40 C.F.R. § 261.2], must make an accurate determination as to whether that waste is a hazardous waste in order to ensure wastes are properly managed according to applicable RCRA regulations articulated in Fla. Admin. Code Ann. r. 62-730.160(1) [40 C.F.R. § 262.11].**

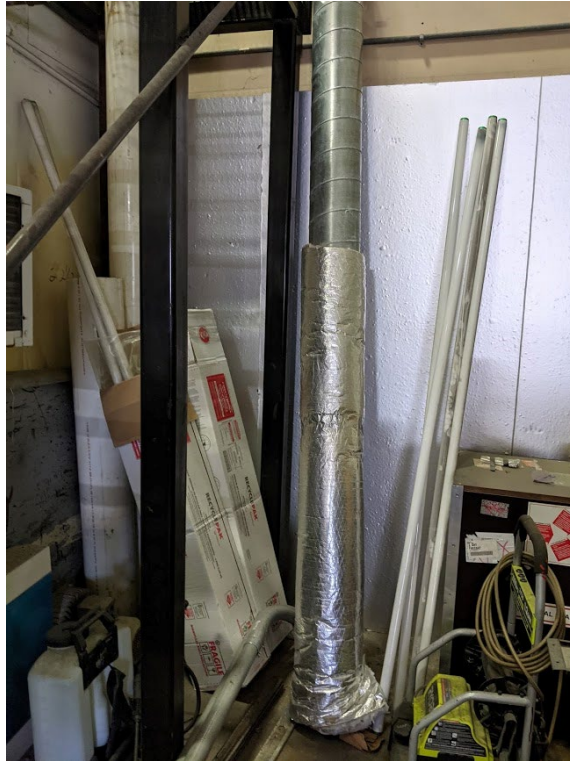
Photograph 17 of 21: Maintenance Parts Room – Universal Waste Storage Area

Located in the Maintenance Parts Room was storage for universal waste. At the time of the inspection, there was a 4-foot container of universal waste lamps that was not labeled, dated, or closed. There were two (2) additional 4-foot containers of universal waste lamps that were labeled, but not dated, or closed. There were also four (4) 8-foot universal waste lamps that were not in containers, labeled or dated

(Photographs 17-21 of 21).

**Pursuant Fla. Admin. Code Ann. r. 62-730.185(1) and Fla. Admin. Code Ann. r. 62-737.400(5) [40 C.F.R. § 273.13(d)], a SQHUW must manage universal waste lamps in a way that prevents releases of any universal waste or component of a universal waste to the environment.**

**Pursuant to Fla. Admin. Code Ann. r. 62-730.185(1)[40 C.F.R. § 273.14(e)], a SQHUW must label or mark each lamp or container of lamps clearly with one of the following phrases: “Universal Waste-Lamp(s),” or “Waste Lamp(s),” or “Used Lamps.”**

**Pursuant to Fla. Admin. Code Ann. r. 62-730.185(1) and Fla. Admin. Code Ann. r. 62-737.400(7) [40 C.F.R. § 273.15(a) and (c)], a SQHUW may accumulate universal waste no longer than one year and must be able to demonstrate the length of time that the universal waste has accumulated from the date that it became a waste or was received.**
