**Well Inspection**  
**Osage DNR / Environmental Protection Agency**  
**1201 Elm Street, Suite 500**  
**Dallas, Texas 75270**

| <b>Operator Info</b> | Contango Resources, LLC<br>1717 South Boulder, Suite 900<br>Tulsa, OK 74119<br>Phone: 918-392-3396 | <b>Inventory ID</b> | OS2880000 | | |
| | | <b>Well ID</b> | 20W3 | | |
| <b>Location</b> | SE 21 24N 07E | <b>Status</b> | Active | <b>Well Type</b> | Enhanced Recovery |

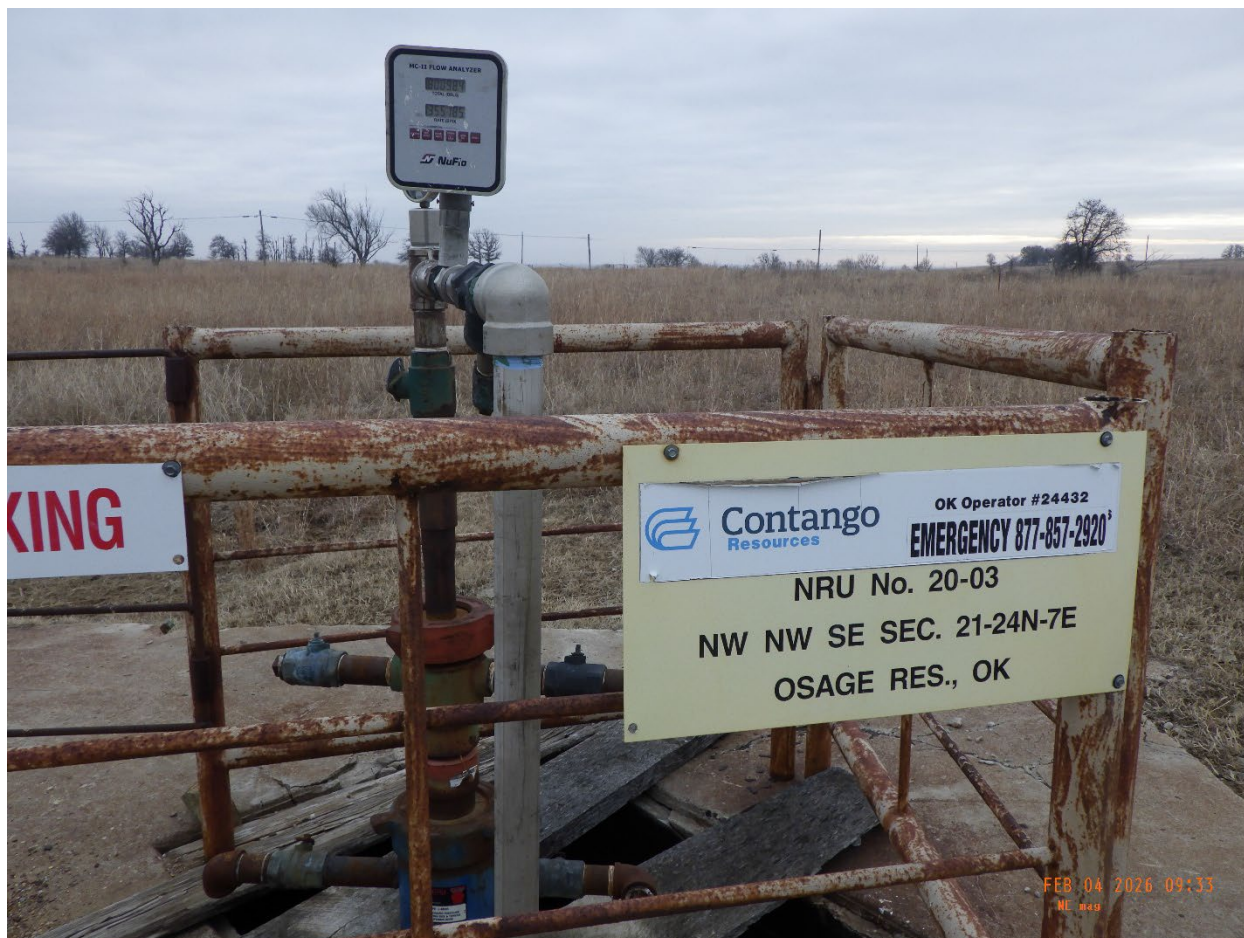
Photo No. 1

| <b>Inspection Comments</b> | Inspector observed well OS2880000. The well was connected and injecting at 355bbls/day. Well was overdue for MIT at the time of the inspection. Great Horned Owls was the new owner/operator at the time of the inspection but the ownership transfer was not completed with EPA. | | | | |

**Description:** This was well, OS288000, connected and injecting with a rate of 355 barrels per day. The company pressure gauge displayed 0psi on the tubing.
