*Resource Conservation and Recovery Act (RCRA)*

Compliance Evaluation Inspection

| Facility Name: | Boehringer Ingelheim Animal Health Puerto Rico LLC | | |
| Date of Inspection: | July 19, 2023 | | |

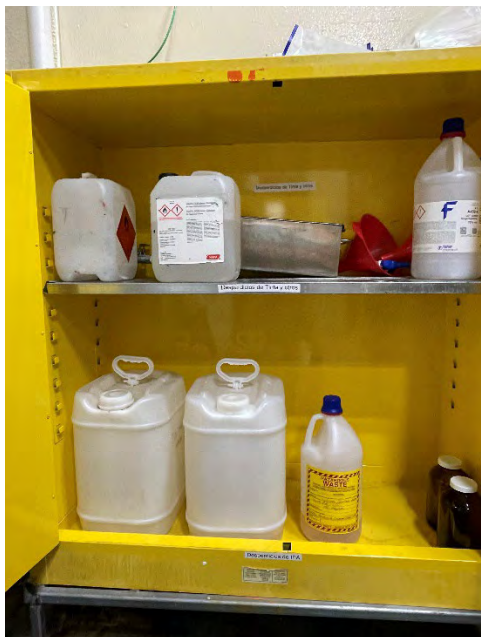
At the time of the inspection, the F6 SAA had a 5-gallon container of contaminated isopropyl alcohol (IPA) that was not marked and/or labeled with the words "hazardous waste" nor with an indication of the hazards of the contents (See Appendix A, Photograph 1).

Photograph 1: F6 SAA; 5-gallon container of isopropyl alcohol not marked and/or labeled with the words “hazardous waste” nor with an indication of the hazards of the contents.

| REGULATORY, STATUTORY OR PERMIT REFERENCE | FIELD OBSERVATION |
|---|---|
| | Corrective action: The Facility corrected the regulatory concerns the same day of the inspection and provided evidence proving the words “hazardous waste” were marked and/or labeled on the drums. (See Appendix A, Photographs 5 and 6) |

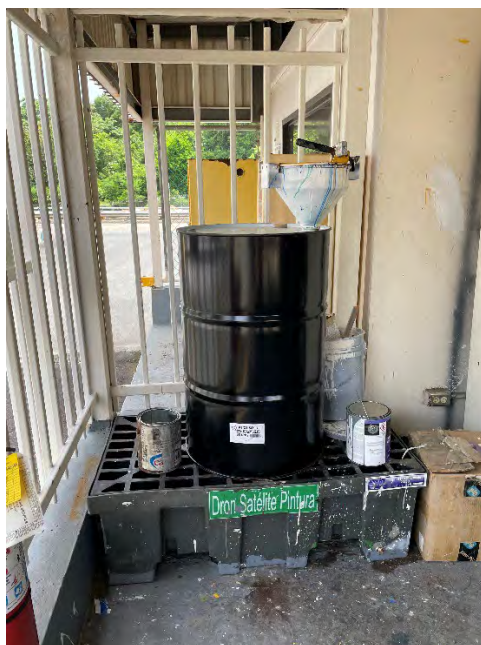
The Paint Shop SAA had a 55-gallon drum of waste paint that was not marked and/or labeled with the words "hazardous waste" nor with an indication of the hazards of the contents (See Appendix A, Photograph 2).

Photograph 2: Paint Shop SAA; 55-gallon drum of waste paint not marked and/or labeled with the words “hazardous waste” nor with an indication of the hazards of the contents.

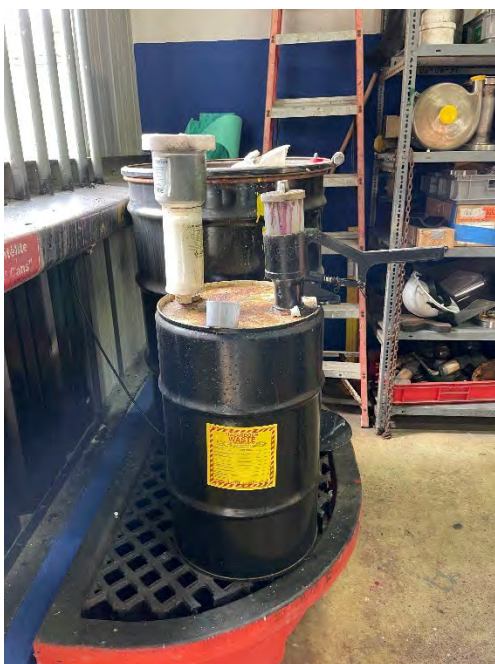
The Aerosol and Welding Shop SAA had a 30-gallon drum of aerosol cans (See Appendix A, Photograph 3).

Photograph 3: Aerosol and Welding Shop SAA; 30-gallon drum of aerosol cans waste.

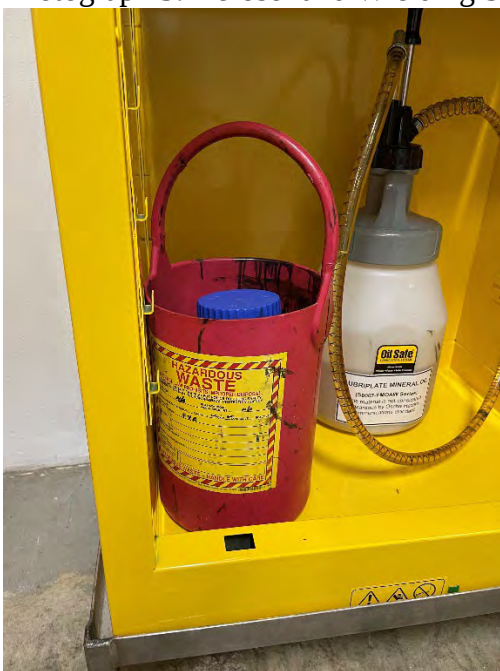
At the F4A SAA, there was a container of corrosive and toxic hazardous waste (See Appendix A, Photograph 4).

Photograph 4: F4A SAA; a container of toxic and corrosive ink waste.

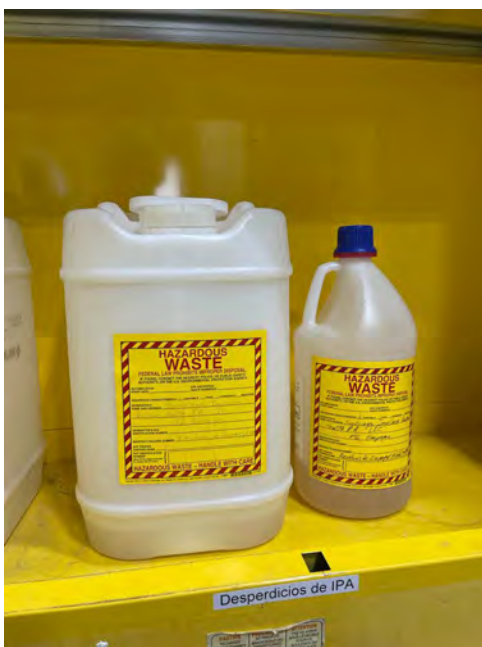
Photograph 5: Facility's corrective action – F6 SAA with a 5-gallon container of isopropyl alcohol marked and/or labeled with the words “hazardous waste” and with an indication of the hazards of the contents.

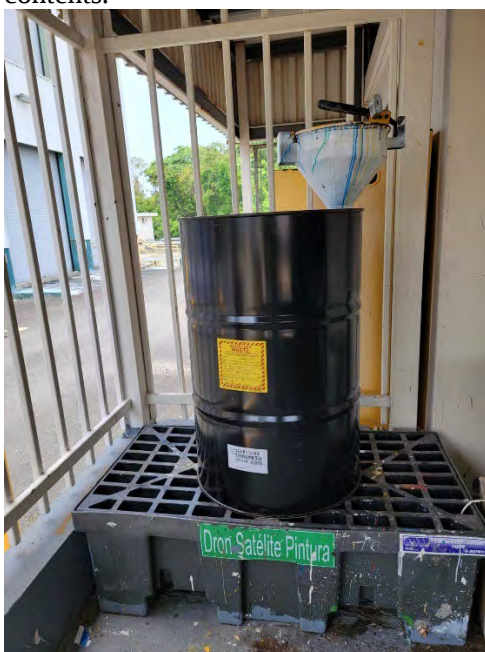
Photograph 6: Facility's corrective action – Paint Shop SAA with a 55-gallon drum of waste paint marked and/or labeled with the words “hazardous waste” and with an indication of the hazards of the contents.
