Report of Results: MVA0491

Asbestos Fiber Release During the Removal  
of Valve Packing and Repacking

**ASBESTOS FIBER RELEASE DURING  
THE REMOVAL OF VALVE PACKING**

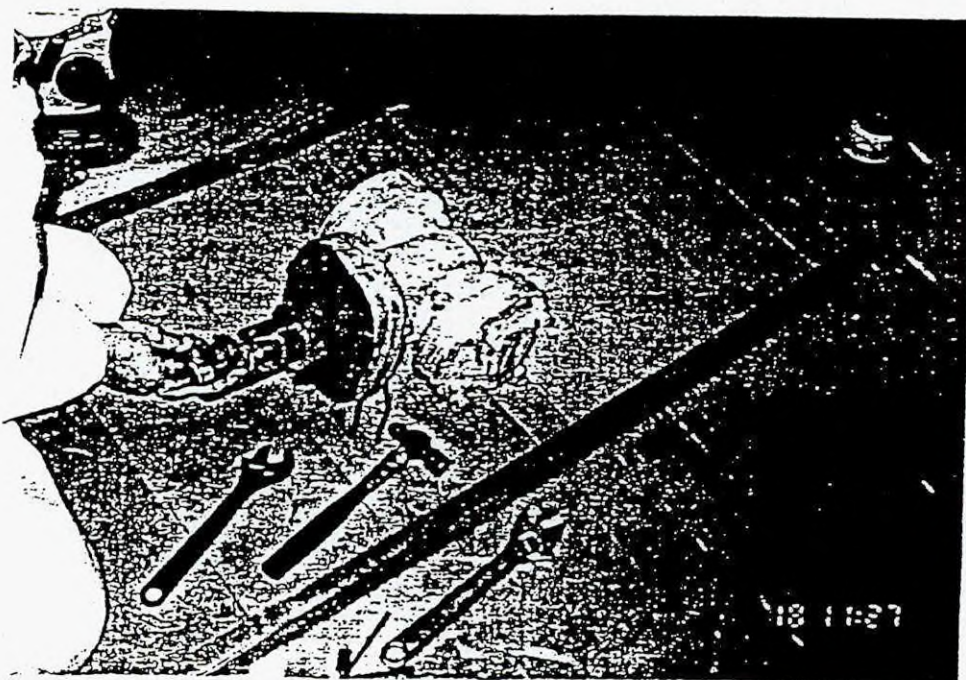
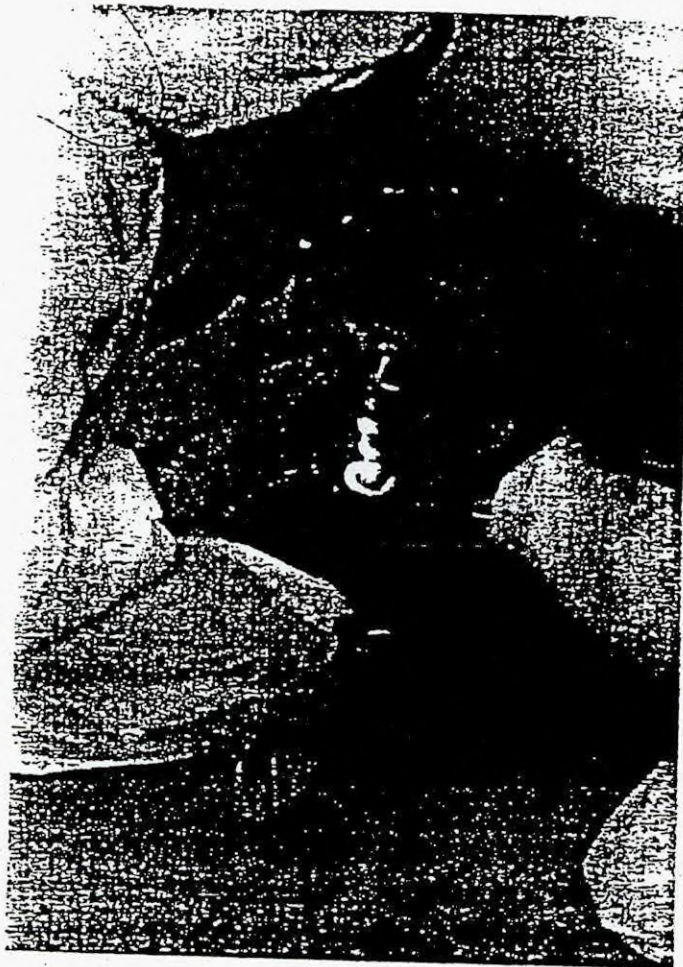
Figure 4. Removing packing.

Figure 5. Removing packing.

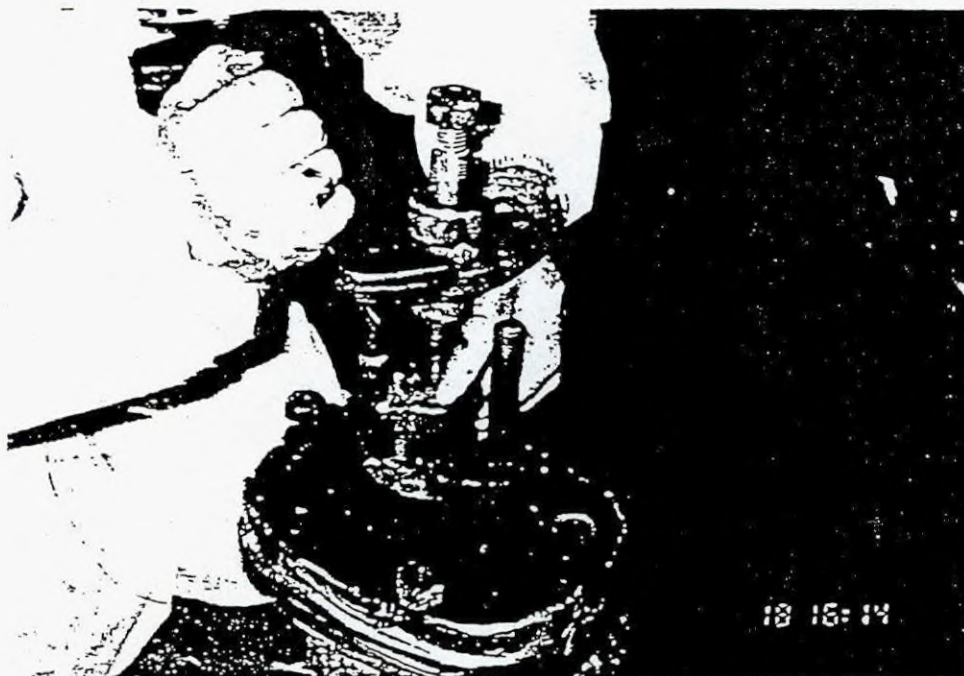
Figure 6. Repacking.

pipefitter using his own tools (Figure 1) and performing the removal of packing in the same way that he had in his previous years of work on valves. Although some lubricating oil was used to loosen the bolts on the valve, the work was generally done in a dry manner. One packing removal test was performed (Figures 2 through 5). Pieces of the removed packing were placed in plastic bags and stored for analysis. The packing removed from the valve appeared to be graphite impregnated packing material with a wire insert. It had a shiny gray-black appearance. The packing removal activity occurred for approximately 62 minutes. The study site was cleaned after the work. After the valve stuffing box had been cleaned thoroughly and vacuumed with a HEPA vacuum, the valve was repacked with an asbestos-containing packing (Figures 6 and 7). The repacking test period was 7 minutes.

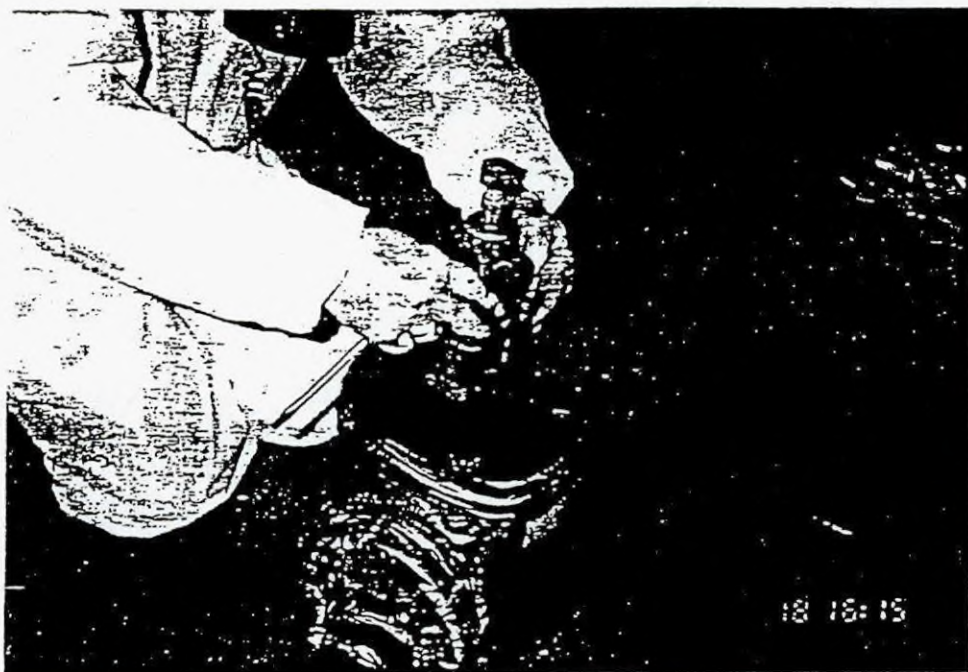
Figure 7. Pushing down gland during repacking.
