## **RCRA Inspection Report**

SAATI Americas, Inc.  
201 Fairview Street, Ext  
Fountain Inn, Greenville County, South Carolina 29644

EPA ID No. SCD980841944

SAATI Americas, Inc.  
SCD980841944  
RCRA CEI Report  
June 17, 2021

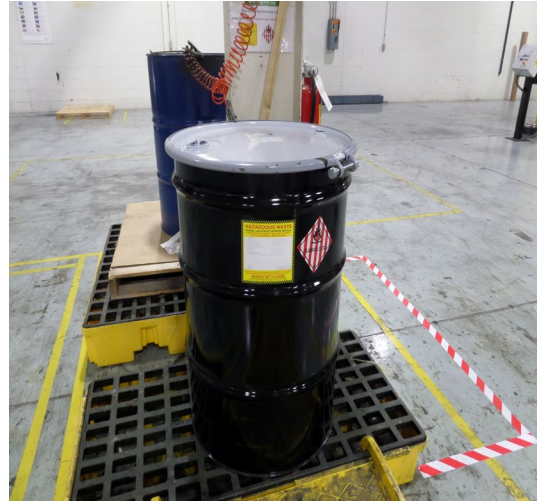
inspectors observed the container was closed, labeled with the words hazardous waste (waste flammable solids D001, D035), and labeled with a flammable hazard indicator (Photograph 2). The profile number for this waste stream is 193221580.

SAATI. Coating Line. Inspectors observed a second 55-gallon container accumulating hazardous waste next to the column. Photograph 2 taken at 10:47 a.m.

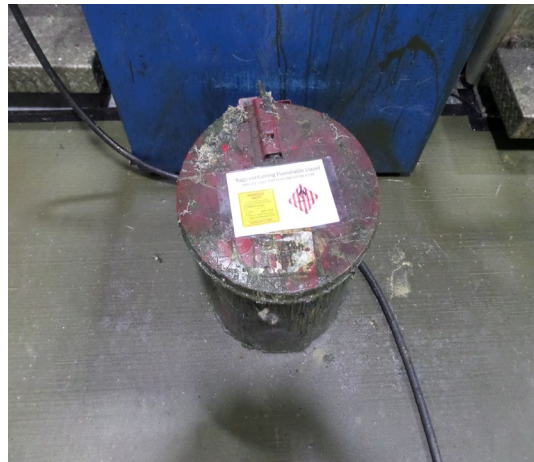
Located next to the Isotex machine inspectors observed an empty 5-gallon red safety container to accumulate hazardous waste rags during the day and transferred to a 55-gallon container in the SAA at the end of the shift. The container was labeled with the words hazardous waste (waste flammable solids D001, D035) and labeled with a flammable hazard indicator. The container's lid did not appear to be in good condition to keep the container closed when accumulating hazardous waste. The inspectors suggested the container not be used to accumulate hazardous waste (Photographs 4 and 5).

SAATI. Coating Line. Inspectors observed one 5-gallon empty container. The cover was not in good condition. Photograph 4 taken at 10:52 a.m.

On July 12, 2021, Ms. Kowalske emailed the EPA a photograph showing the facility replaced the 5-gallon container with a new container on June 23, 2021.

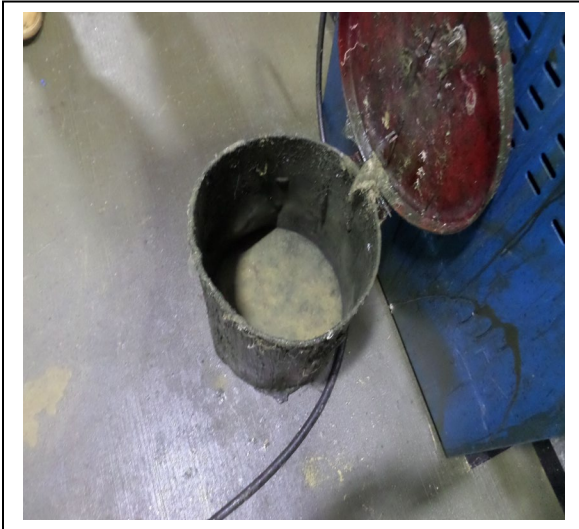
SAATI. Coating Line. Inspectors observed one 5-gallon empty container. Cover was not in good condition. Photograph 5 taken at 10:52 a.m.

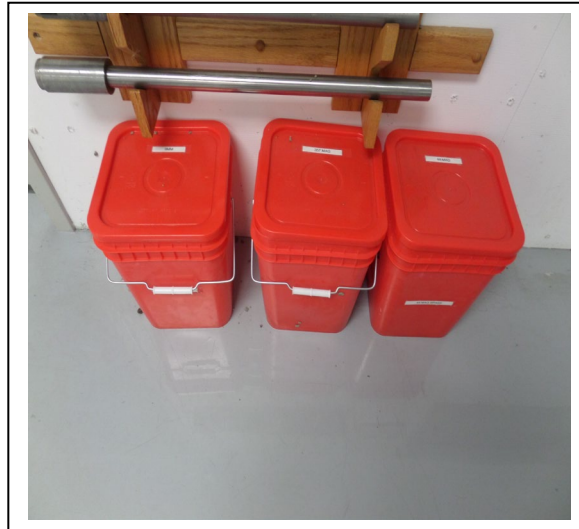
Bullets that miss the box form or deflect off the bullet trap are removed off the floor and accumulated with the casings as scrap metal. Bullets removed from the box form and from the bullet trap are also accumulated as scrap metal. The inspectors observed three 2-gallon containers accumulating nine-millimeter, 357 and 44 magnum bullets and brass casings (Photograph 6). According to the facility the rubber material in the bullet trap has not been replaced.

SAATI. Ballistics Laboratory. Inspectors observed three 5-gallon containers accumulating spent bullets. Photograph 6 taken at 11:08 a.m.

On July 12, 2021, Ms. Kowalske emailed the EPA a photograph showing the facility added a new container for scrap metal in the Firing Range on June 23, 2021. The photograph showed the container was labeled with the words "lead for recycling scrap metal".

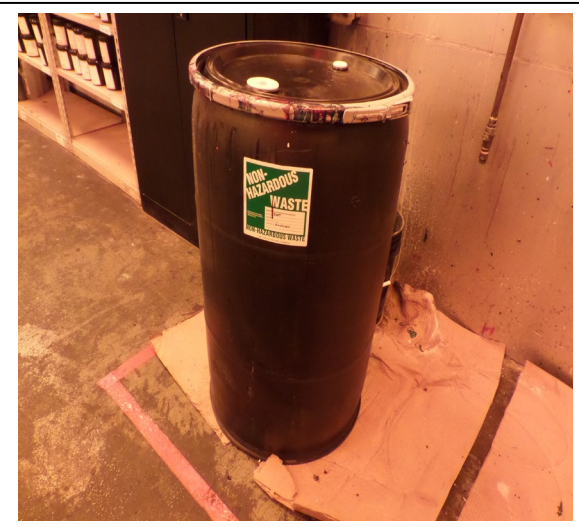
Ann Goodreaux is the QC Laboratory Technician in this area. After mixing the emulsion is transferred to this room to cool. Samples of the emulsion products are retained in this room for customer quality control. The samples are removed from their specified shelf space, based on a date procedure, and accumulated in a 55-gallon container as non-hazardous waste. The inspectors observed one 55-gallon container in this area accumulating waste emulsion samples. The container was closed and labeled with the words non-hazardous waste (Photograph 7).

SAATI. Cool Room (Emulsions). The inspectors observed waste samples are accumulated in a 55-gallon container labeled with the words non-hazardous waste. Photograph 7 taken at 11:36 a.m.

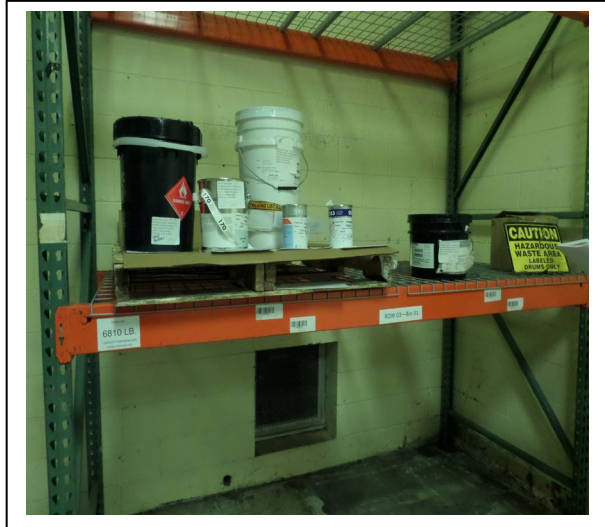
The inspectors observed a 0.5-gallon container of expired chemical (silver ink 191) labeled with the words hazardous waste. The hazard indicator (pictogram) was covered with other labeling partially concealing the hazard indicator (Photograph 8).

**Pursuant to 25 S.C. Code Ann. Regs. 61-79.262.17(a)(5)(i) [40 C.F.R. § 262.17(a)(5)(i)], which is a condition of the LQG Permit Exemption, a large quantity generator must mark or label its containers with the following: an indication of the hazards of the contents (examples include, but are not limited to, the applicable hazardous waste characteristic(s) (i.e., ignitable, corrosive, reactive, toxic); hazard communication consistent with the Department of Transportation requirements at 49 CFR part 172 subpart E (labeling) or subpart F (placarding); a hazard statement or pictogram consistent with the Occupational Safety and Health Administration Hazard Communication Standard at 29 CFR 1910.1200; or a chemical hazard label consistent with the National Fire Protection Association code 704).**

SAATI. 90-Day or Less Accumulation Area. The inspectors observed the hazardous waste label on a one-quart bottle appeared to cover the hazard indicator. Photograph 8 taken at 11:49 a.m.

On July 12, 2021, Ms. Kowalske emailed the EPA a photograph showing the facility re-labeled the container with a flammable hazard indicator on June 17, 2021.

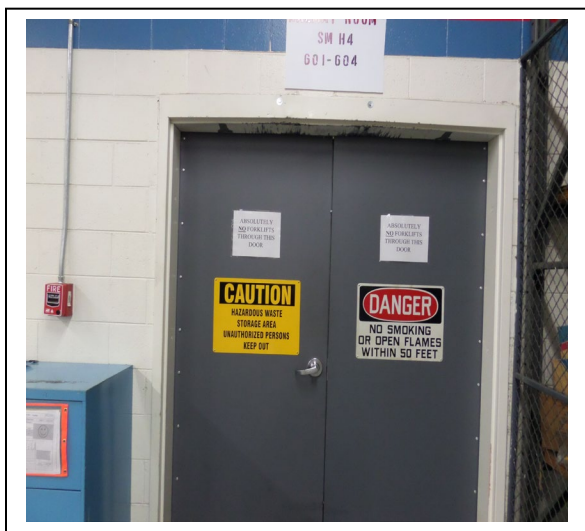
The 90-Day or Less Accumulation Area (90-Day) is constructed of cinder block walls, a concrete floor and secured by locked double metal doors. The inspectors observed signs posted on the exterior doors with the words “Caution Hazardous Waste Storage Area Unauthorized Persons Keep Out” and “Danger No Smoking or Open Flames Within 50 Feet” (Photograph 9). Chemical products and hazardous wastes are stored in the room. The accumulation area for hazardous waste is separated from the chemical products. The inspectors observed hazardous waste is accumulated on a shelf system constructed of metal scaffolding. The inspectors observed a sign on the shelf with the words “Caution Hazardous Waste Area”. Located on a wooden pallet the inspectors observed a five-gallon container accumulating waste acetone (D001, F003), a one-gallon container of ignitable waste (D001), a five-gallon container of ignitable waste (D001), two one-quart containers of ignitable waste (D001) and a 5-gallon container of corrosive waste (D002). The containers were closed, in good condition, accumulating with aisle space, labeled with the words hazardous waste, and labeled with a hazard indicator. The containers were marked with a date. The earliest date observed on a container was May 3, 2021.

SAATI. 90-Day or Less Accumulation Area. Inspectors observed signs identifying the storage area. Photograph 9 taken at 11:49 a.m.

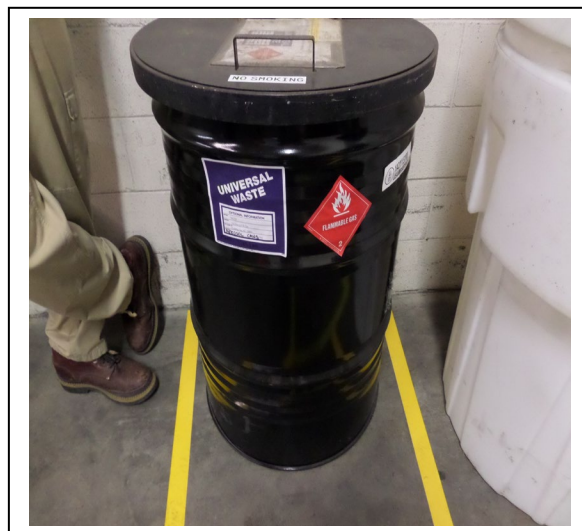
Spent aerosol cans are accumulated in this area as universal waste. The inspectors observed a 55-gallon container accumulating spent aerosol cans. The container was closed labeled with the words universal waste, marked with the date July 29, 2020, and marked with the word aerosol cans. The inspectors explained the effective date the universal waste aerosol rule was adopted by SCDHEC was May 28, 2021. The facility marked the container with the date May 28, 2021 (Photograph 10).

SAATI. Loading Dock Area. The inspectors observed a 55-gallon container accumulating aerosol cans not at atmospheric pressure. The facility corrected accumulation date on the container. Photograph 10 taken at 11:59 a.m.
