## RCRA Compliance Evaluation Inspection Report

Jones Chemical, Incorporated (JCI)  
1433 Talleyrand Avenue  
Jacksonville, Florida 33206-5435  
Latitude: 30.341440  
Longitude: -81.627370  
EPA ID Number: FLD004071890

December 15, 2021, 9:00 a.m.

**COMPLIANCE EVALUATION INSPECTION**

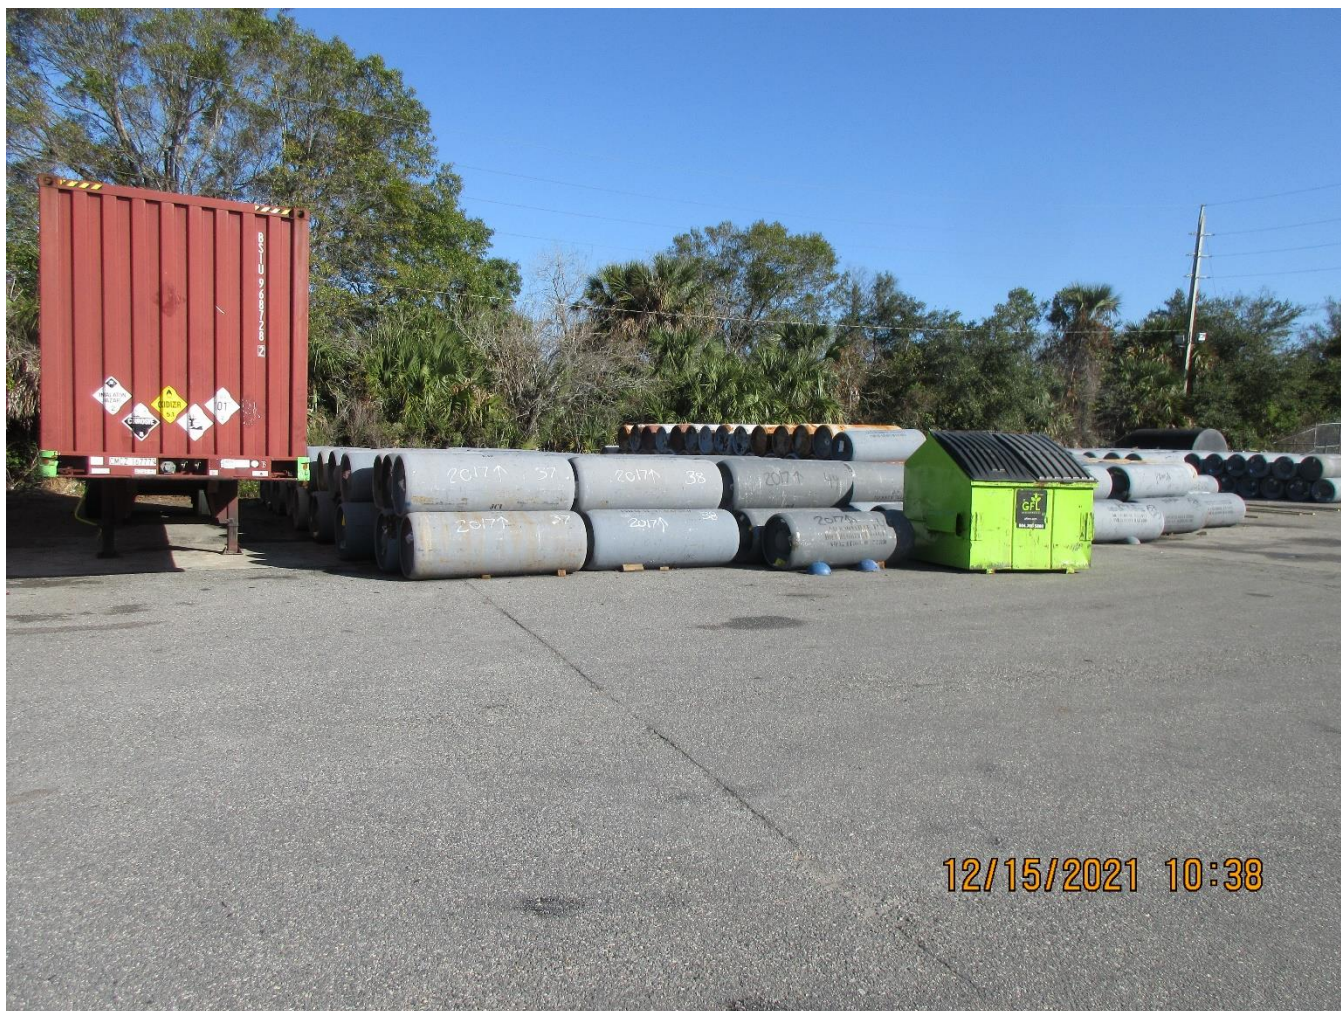
Cylinders (chlorine containers which manage 150-lbs of gas), Tons (chlorine containers which manage one ton of chlorine gas), and other equipment are stored in the outside area of the facility buildings. No wastes were observed in this area (Photos 1-4)

Photo 1 – Outside Area

Photo 2 - Outside Area with ton container storage

Photo 3 - Outside Area with Ton and 150-pound container storage

Photo 4 – One Ton Container observed in the Outside Area
