## Clean Water Act Section 404: Site Visit/Case Development

| Site Name | Sharon Shields, Smith Creek | | | | |

| Inspection Purpose | Initial site visit | | |

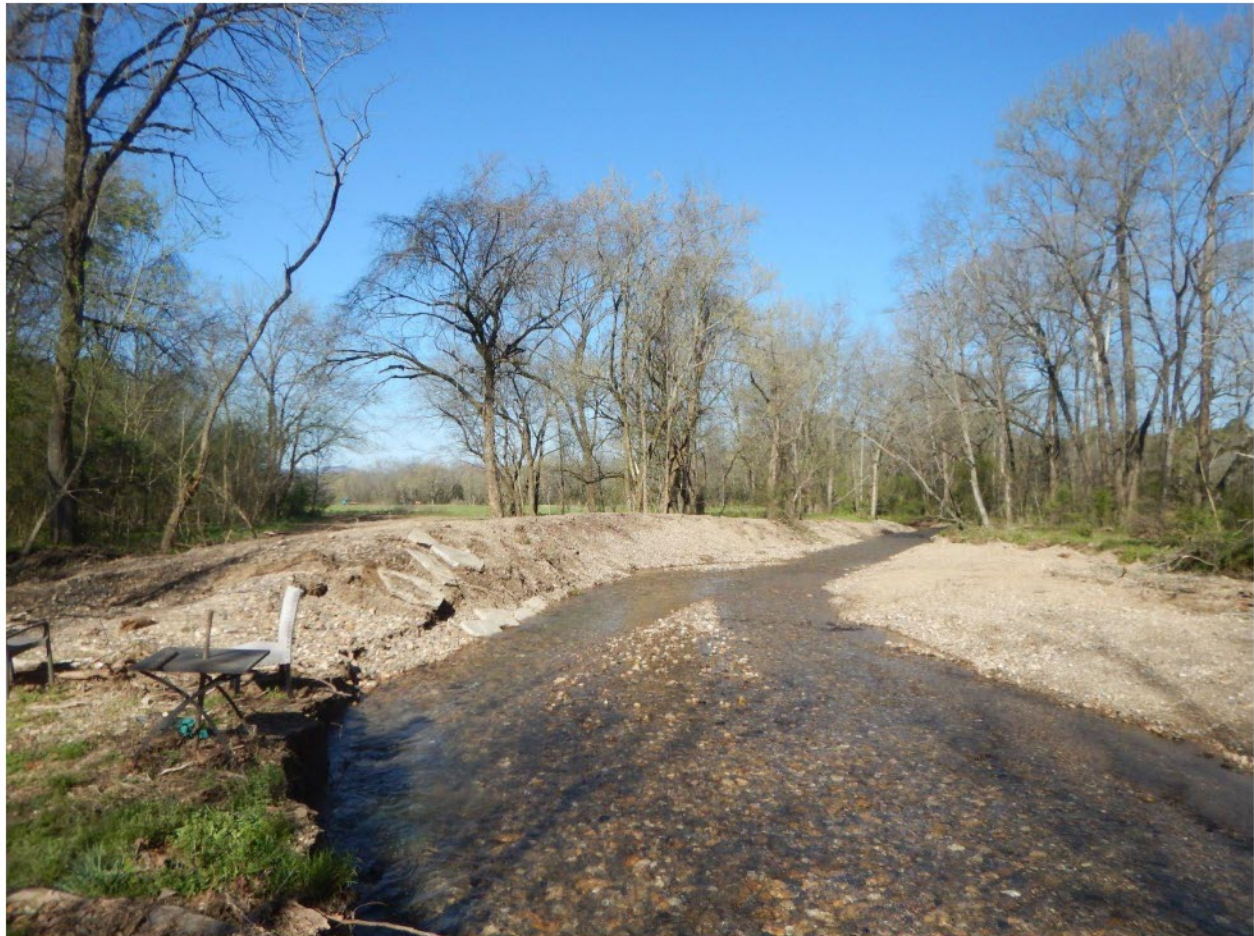
Photo No. 1

| Photo File Name | Date and Time of Photo | Photographer | Description |
|---|---|---|---|
| DSCN6390 | 03/28/2024, 10:02 AM | Chelsey Sherwood | Showing stream channelization and fill material consisting of broken concrete below the Ordinary High Water Mark to build an embankment. Picture taken facing downstream, east. |

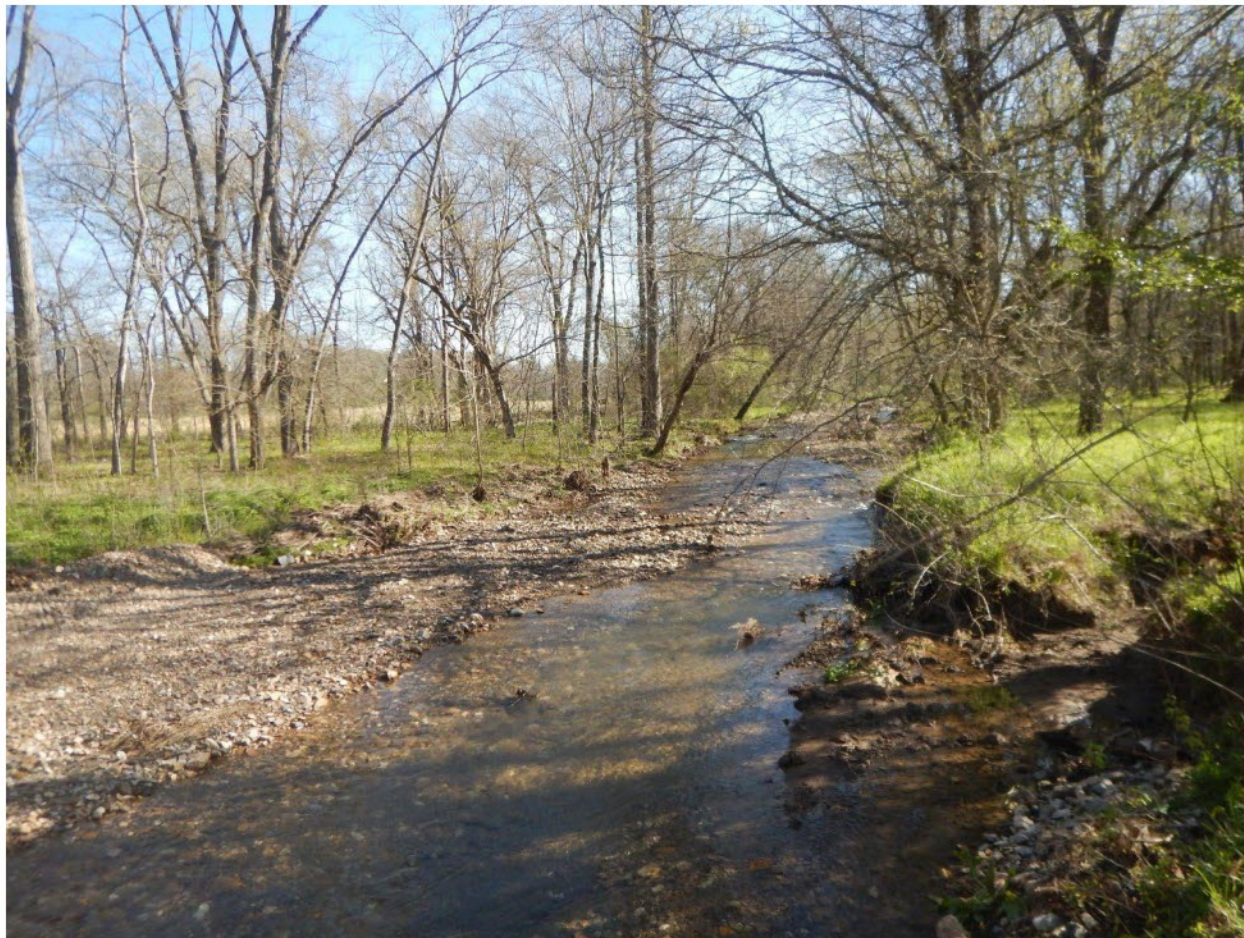
Photo No. 2

| Photo File Name | Date and Time of Photo | Photographer | Description |
|---|---|---|---|
| DSCN6391 | 03/28/2024, 10:02 AM | Chelsey Sherwood | Showing Smith Creek upstream from work conducted. Picture taken facing upstream, west. |

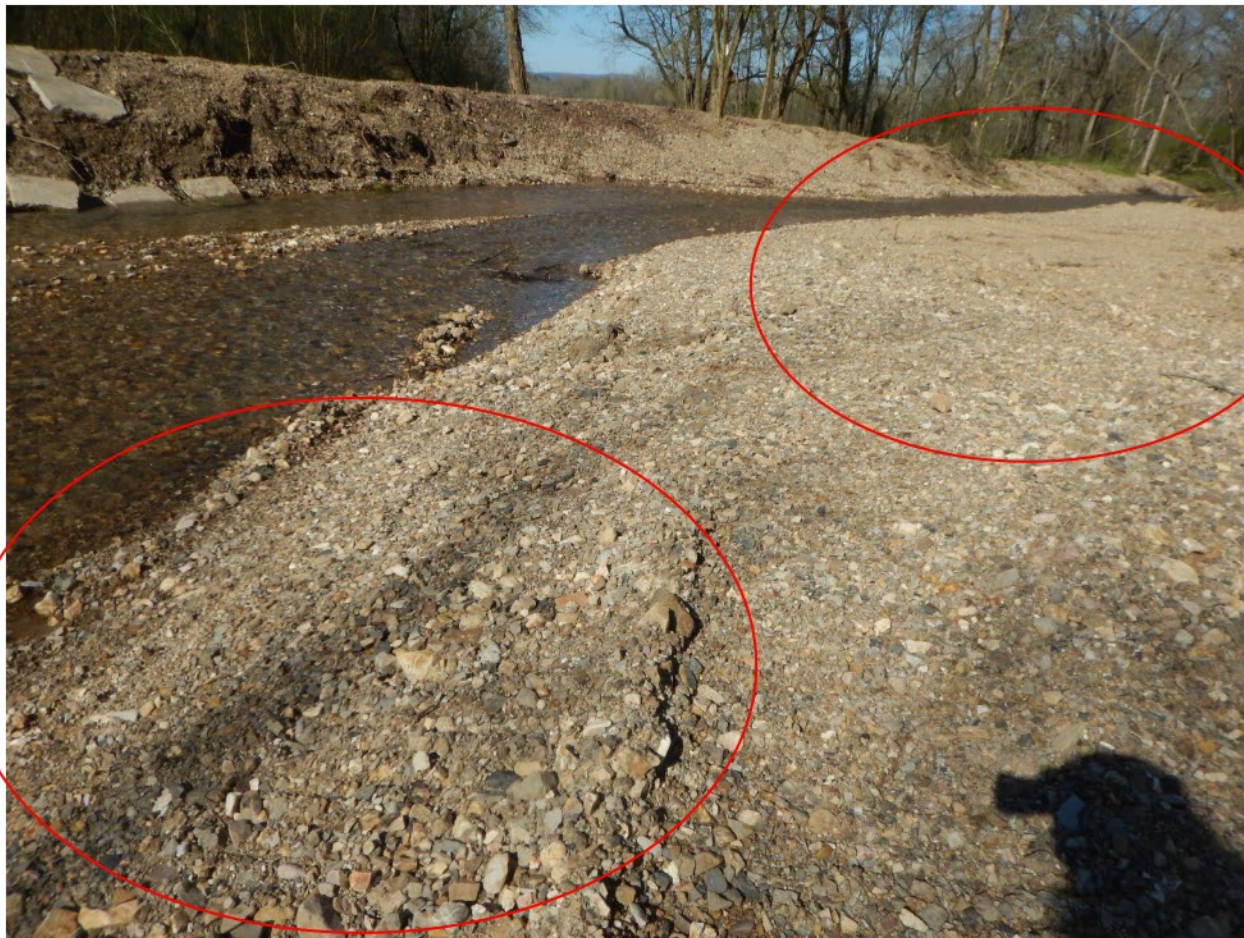
Photo No. 3

| Photo File Name | Date and Time of Photo | Photographer | Description |
|---|---|---|---|
| DSCN6392 | 03/28/2024, 10:06 AM | Chelsey Sherwood | Showing heavy equipment tracks in stream channel. Picture taken facing downstream, southwest. |

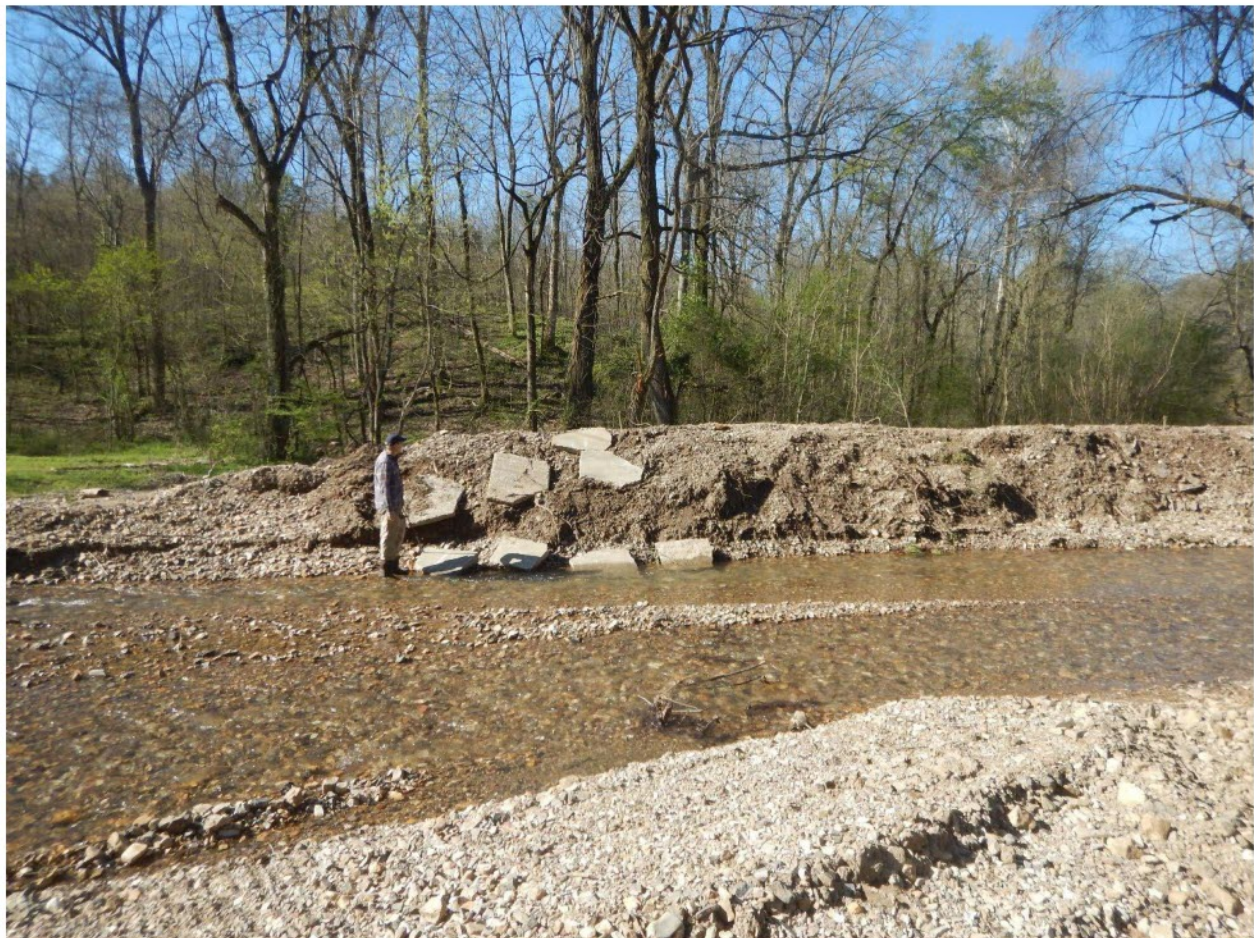
Photo No. 4

| Photo File Name | Date and Time of Photo | Photographer | Description |
|---|---|---|---|
| DSCN6393 | 03/28/2024, 10:07 AM | Chelsey Sherwood | Showing embankment built that is approximately 6 feet high from stream bed and 120 linear feet. Note tire tracks in bottom of picture. Picture taken facing river left, south. |

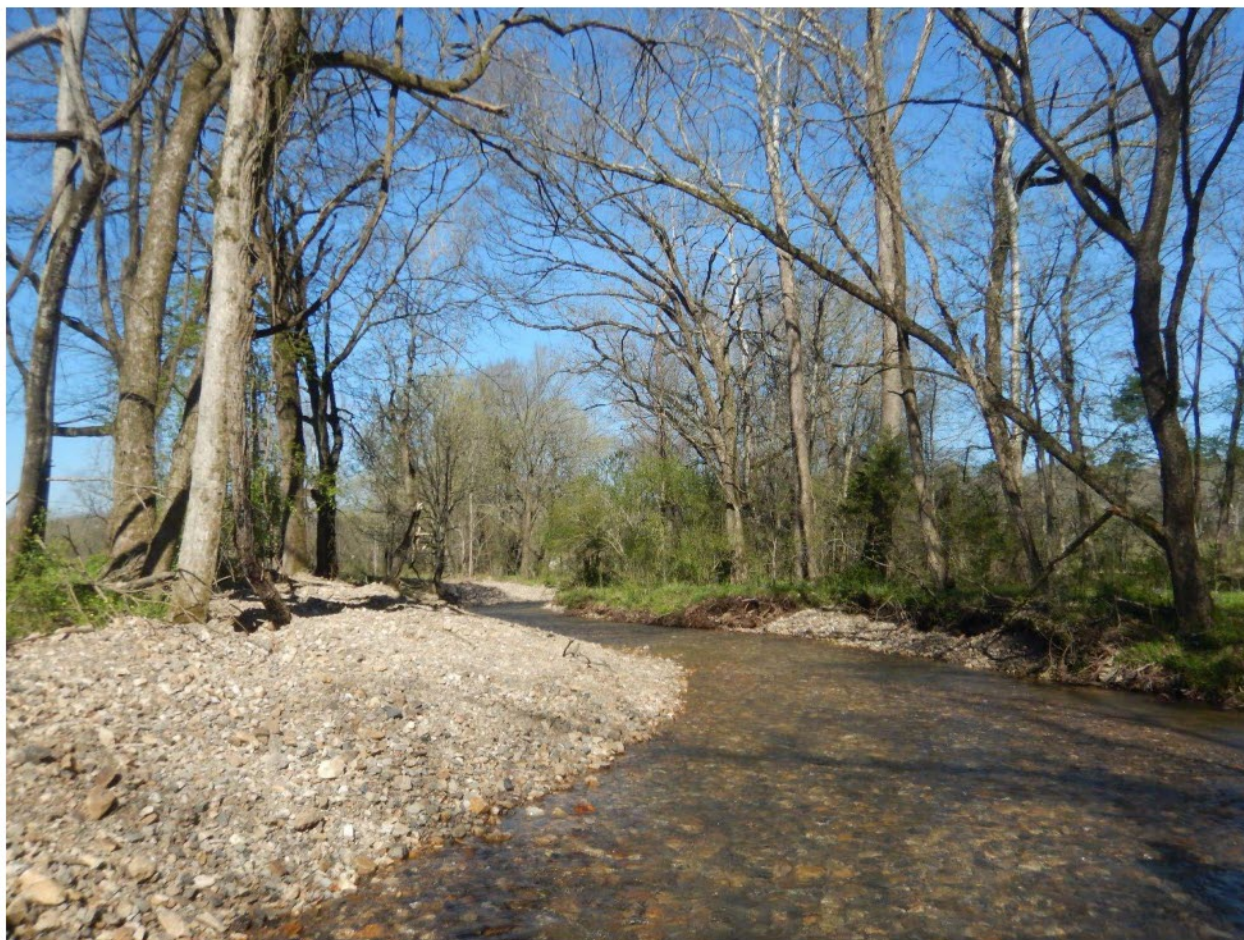
Photo No. 5

| Photo File Name | Date and Time of Photo | Photographer | Description |
|---|---|---|---|
| DSCN6394 | 03/28/2024, 10:11 AM | Chelsey Sherwood | Showing fill material placed below Ordinary High Water Mark built up along river left bank. Picture taken facing downstream, west. |

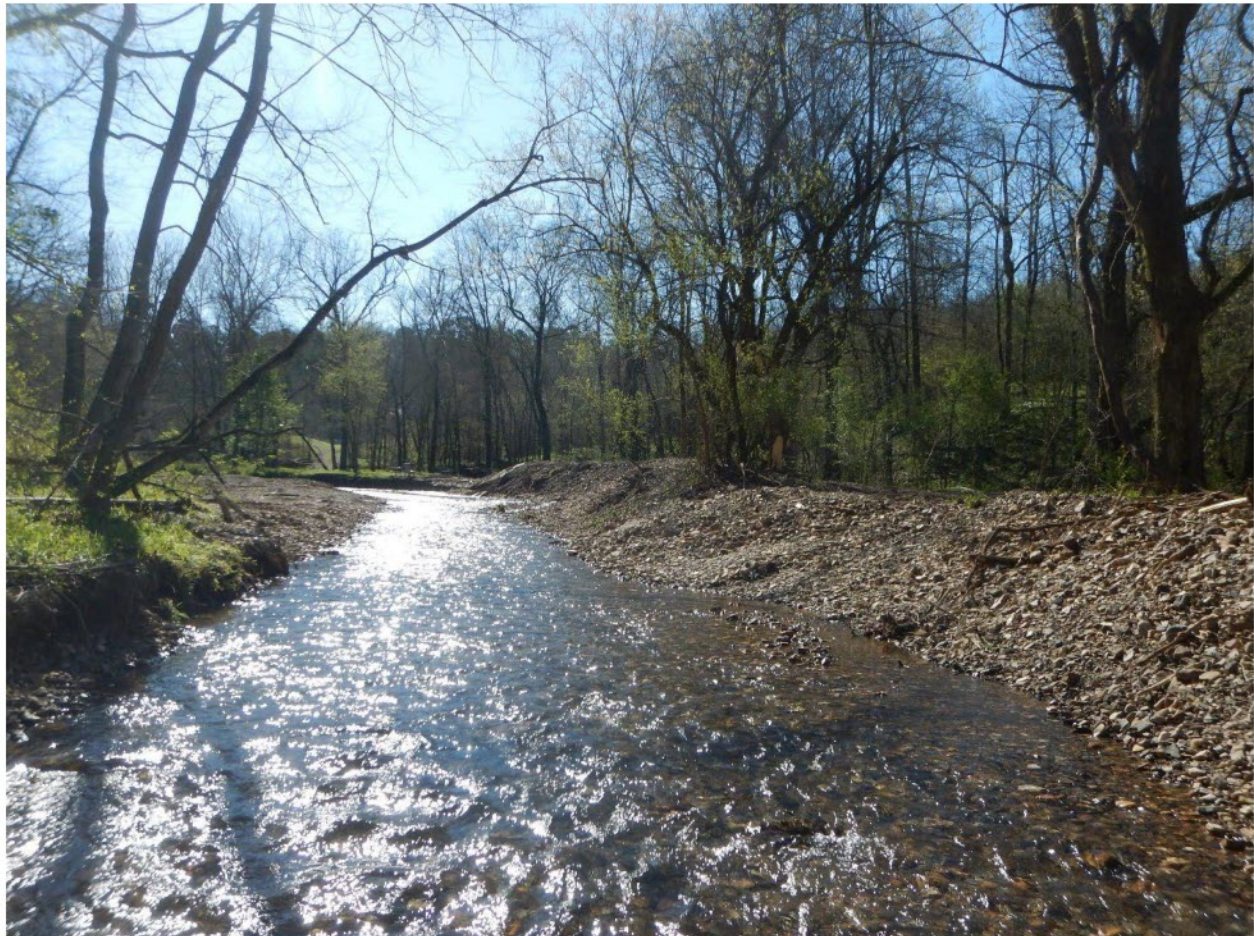
Photo No. 6

| Photo File Name | Date and Time of Photo | Photographer | Description |
|---|---|---|---|
| DSCN6395 | 03/28/2024, 10:11 AM | Chelsey Sherwood | Showing fill material placed below Ordinary High Water Mark and embankment built up along river left bank, which is approximately 350 linear feet. Note the stream appears to be channelized in this area. Picture taken facing upstream, east. |

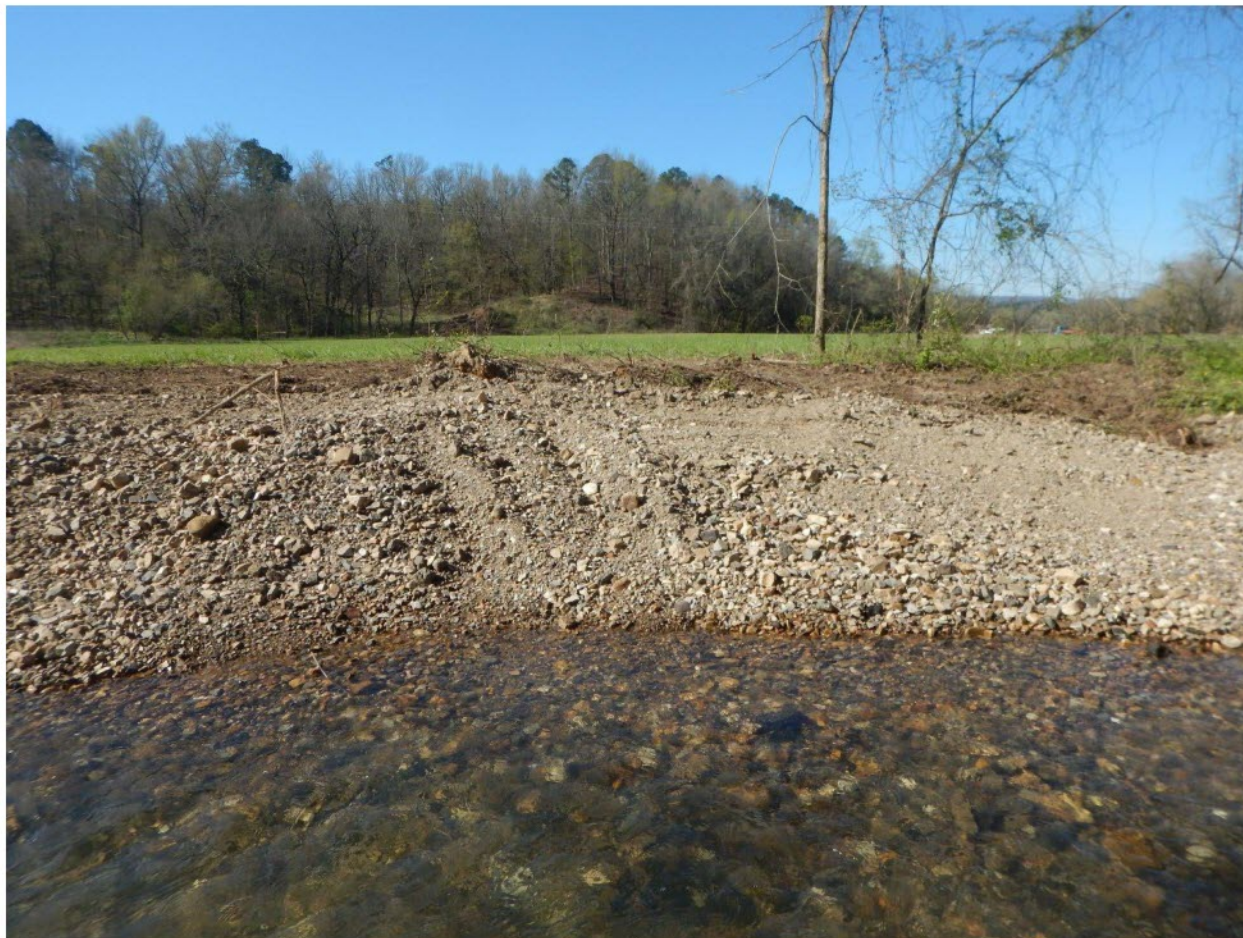
Photo No. 7

| Photo File Name | Date and Time of Photo | Photographer | Description |
|---|---|---|---|
| DSCN6396 | 03/28/2024, 10:14 AM | Chelsey Sherwood | Showing equipment tracks on left bank into stream channel. Picture taken facing river left bank, southwest. |

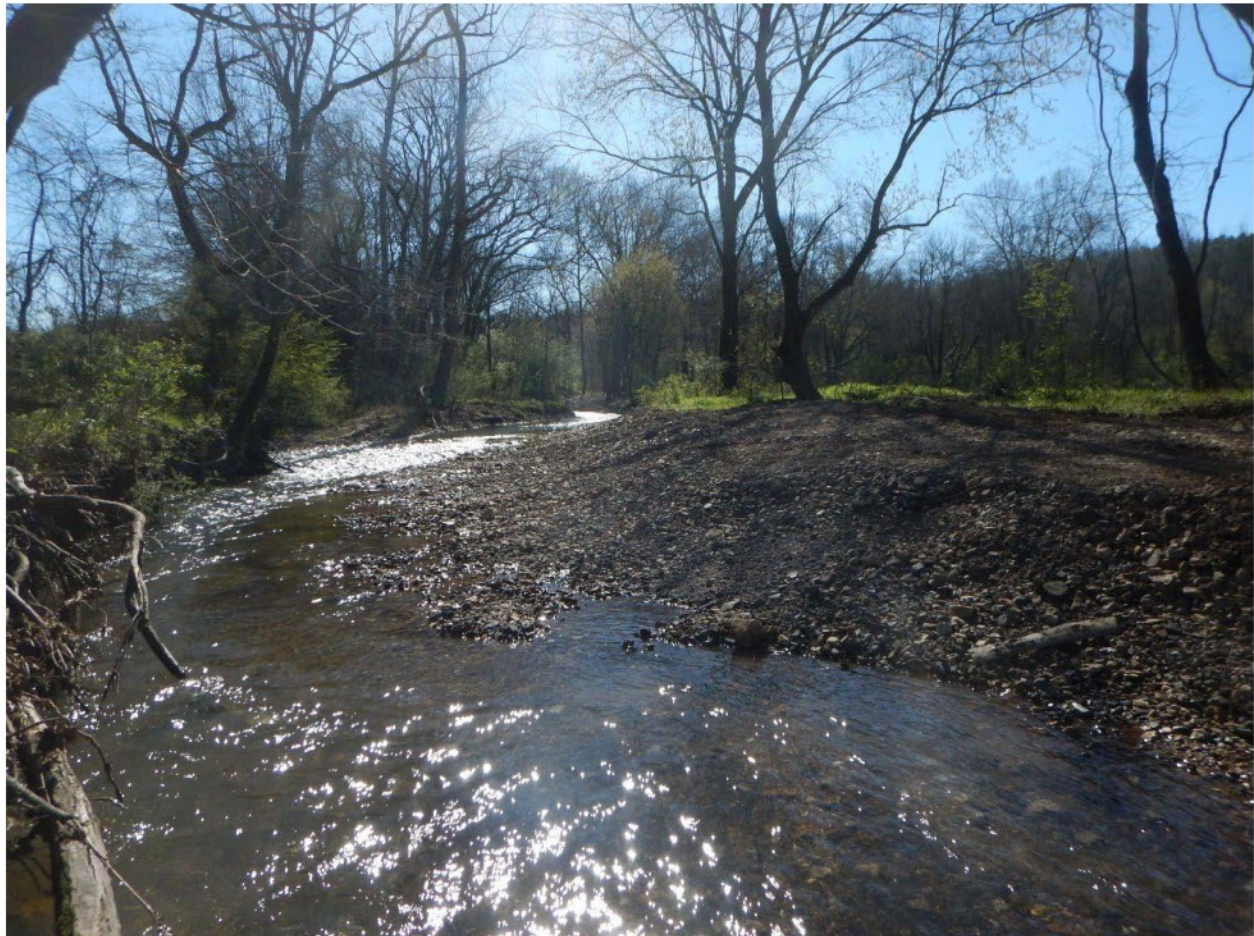
Photo No. 8

| Photo File Name | Date and Time of Photo | Photographer | Description |
|---|---|---|---|
| DSCN6397 | 03/28/2024, 10:18 AM | Chelsey Sherwood | Showing embankment built on river left and equipment scars. Picture taken facing upstream, east. |

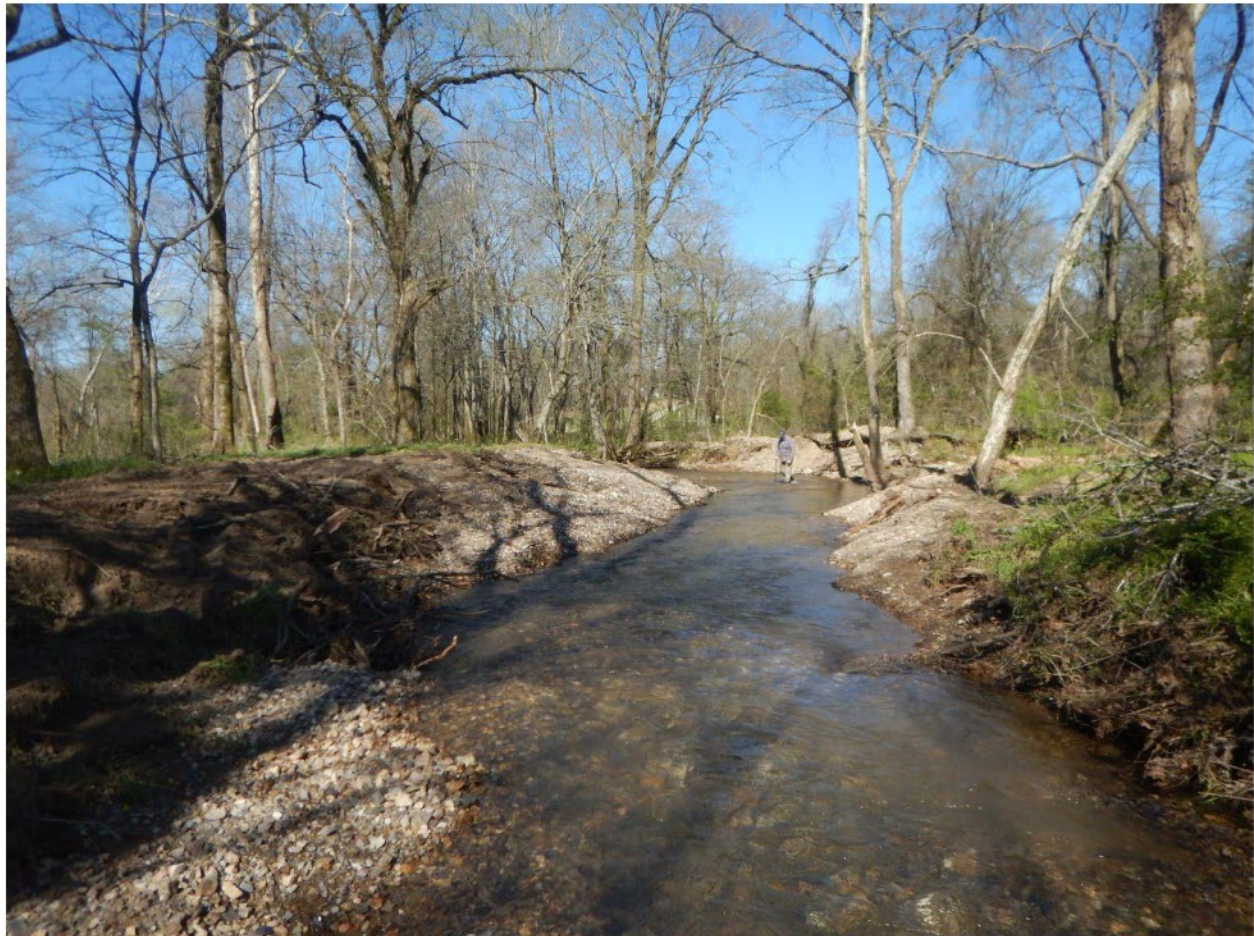
Photo No. 9

| Photo File Name | Date and Time of Photo | Photographer | Description |
|---|---|---|---|
| DSCN6398 | 03/28/2024, 10:19 AM | Chelsey Sherwood | Showing fill material below Ordinary High Water Mark on river left and right. Note stream appears to be channelized. Picture taken facing downstream, west. |

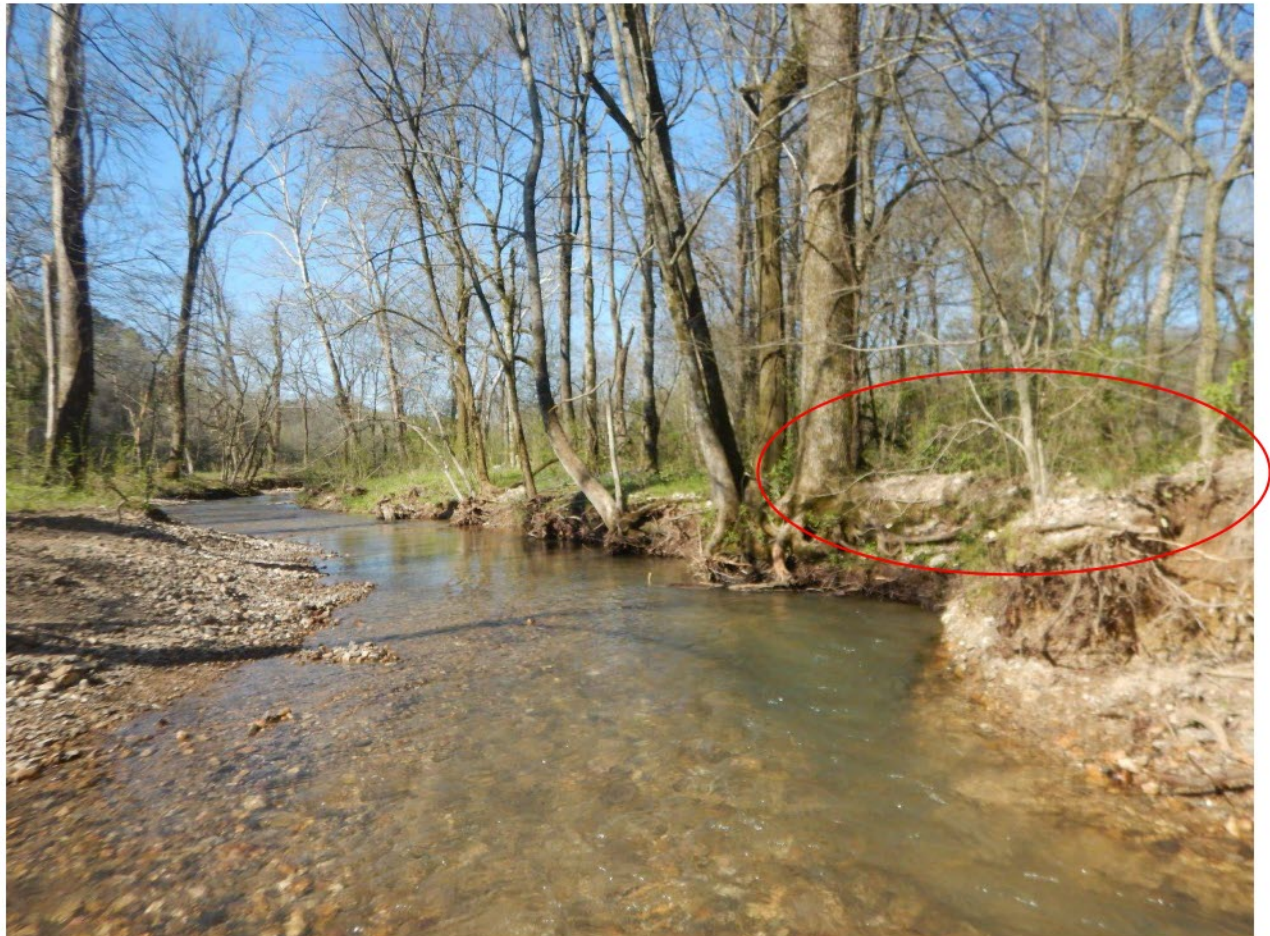
Photo No. 10

| Photo File Name | Date and Time of Photo | Photographer | Description |
|---|---|---|---|
| DSCN6399 | 03/28/2024, 10:21 AM | Chelsey Sherwood | Showing channel disruption and stream bank alteration. There was approximately 1.5 feet of fill material piled up on right bank (circled in red). Also, note the natural bank downstream on river left and right. Picture taken facing downstream, west. |

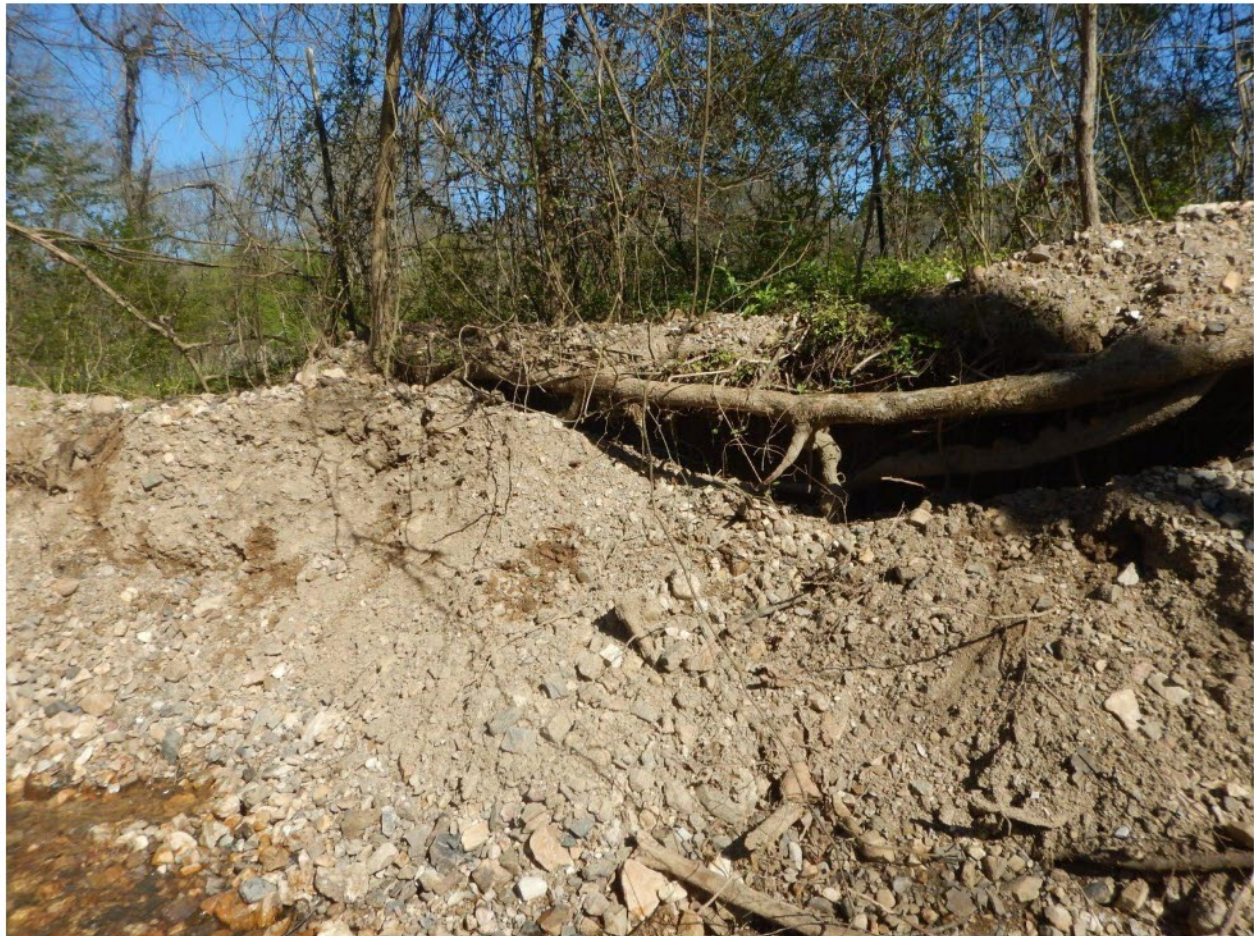
Photo No. 11

| Photo File Name | Date and Time of Photo | Photographer | Description |
|---|---|---|---|
| DSCN6400 | 03/28/2024, 10:21 AM | Chelsey Sherwood | Showing where stream bed material piled up on top of bank and sloughing off into stream. Picture taken facing river right bank, north. |

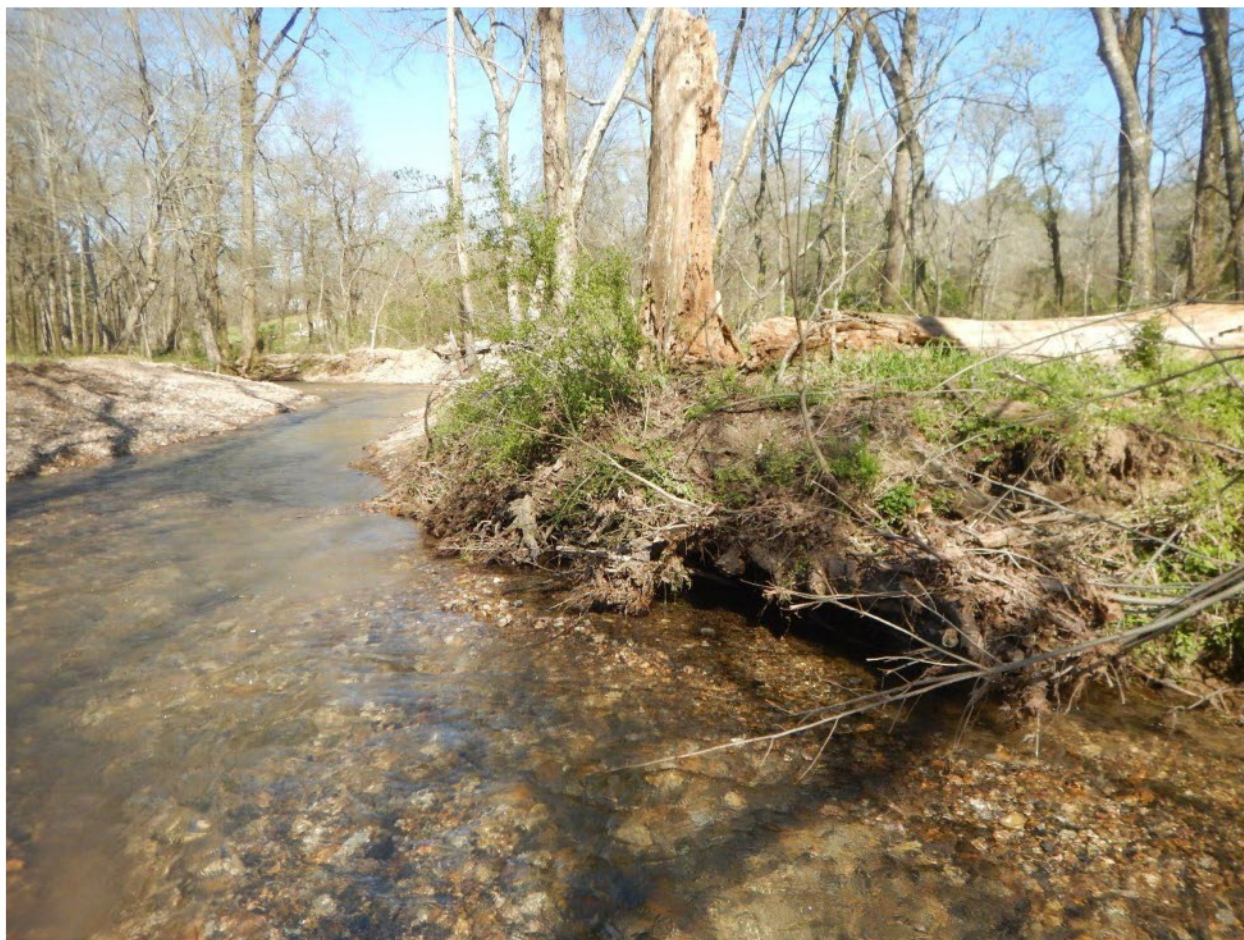
Photo No. 12

| Photo File Name | Date and Time of Photo | Photographer | Description |
|---|---|---|---|
| DSCN6401 | 03/28/2024, 10:28 AM | Chelsey Sherwood | Showing wrack lines on river right and deposition indicators of Ordinary High Water Mark. Note: observed <i>Fundulus sp.</i> in area. Picture taken facing downstream, west. |

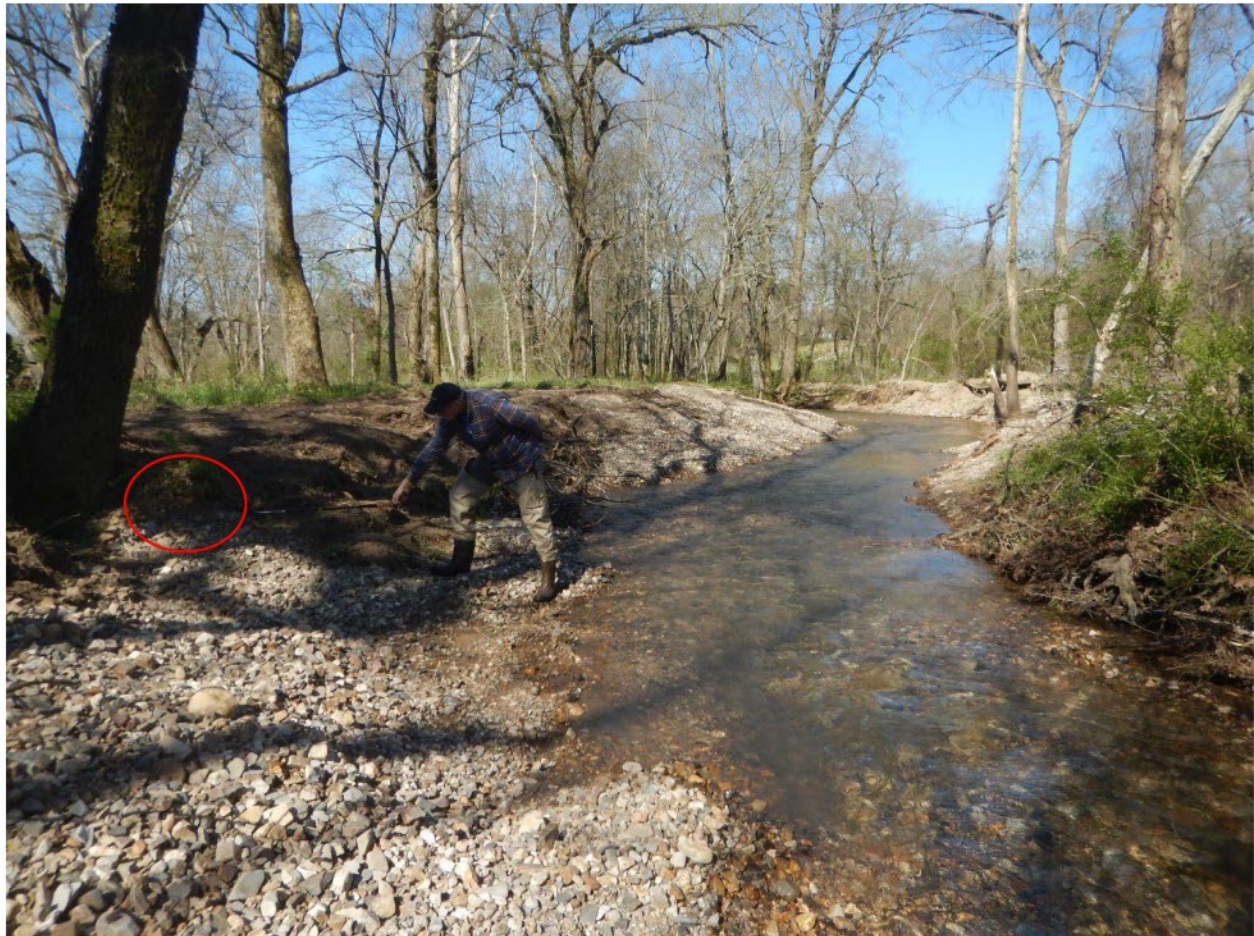
Photo No. 13

| Photo File Name | Date and Time of Photo | Photographer | Description |
|---|---|---|---|
| DSCN6402 | 03/28/2024, 10:28 AM | Chelsey Sherwood | Pointing at Ordinary High Water Mark on river left (circled in red). Picture taken facing downstream, west. |

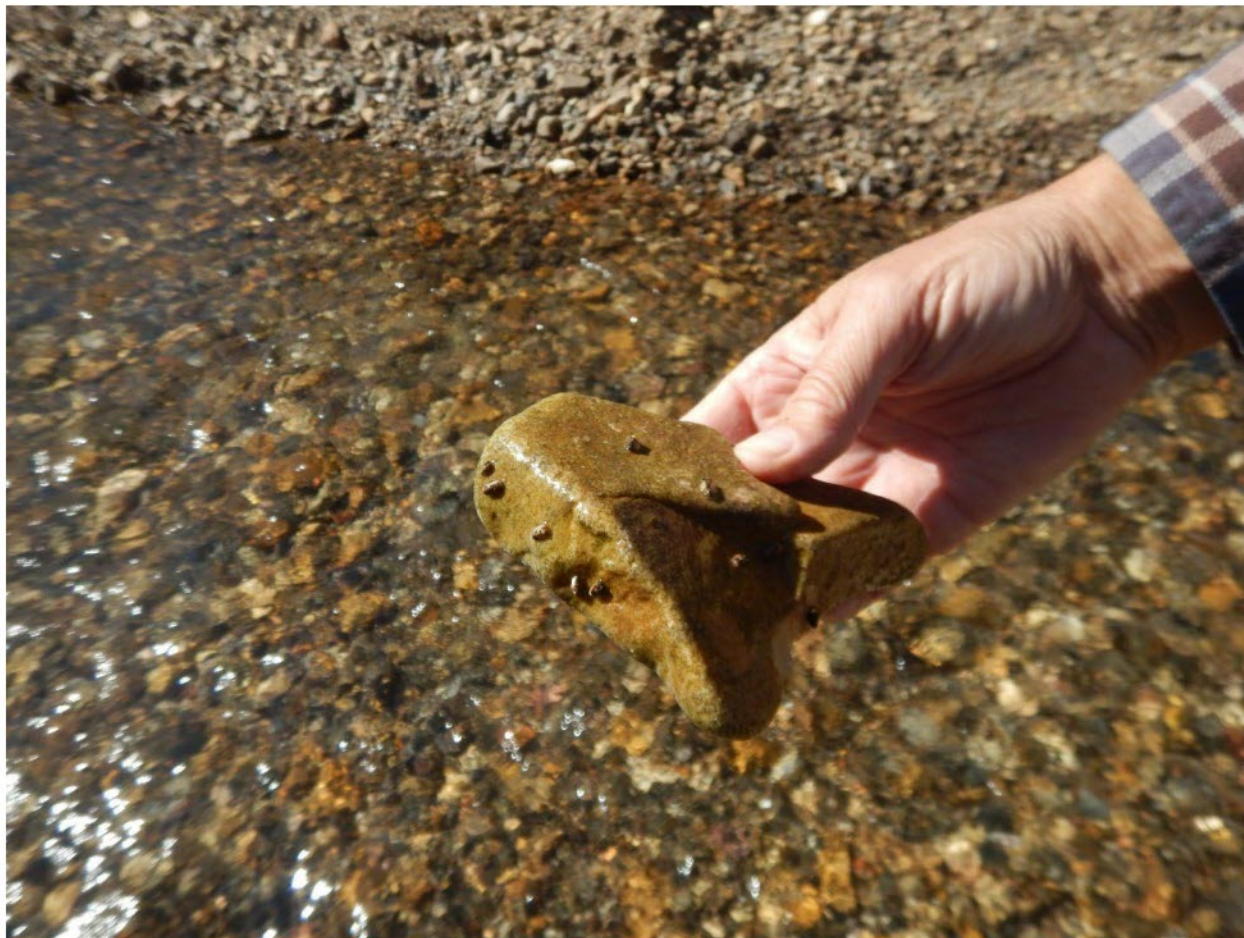
Photo No. 14

| Photo File Name | Date and Time of Photo | Photographer | Description |
|---|---|---|---|
| DSCN6403 | 03/28/2024, 10:33 AM | Chelsey Sherwood | Showing Trichoptera casings on rock. |

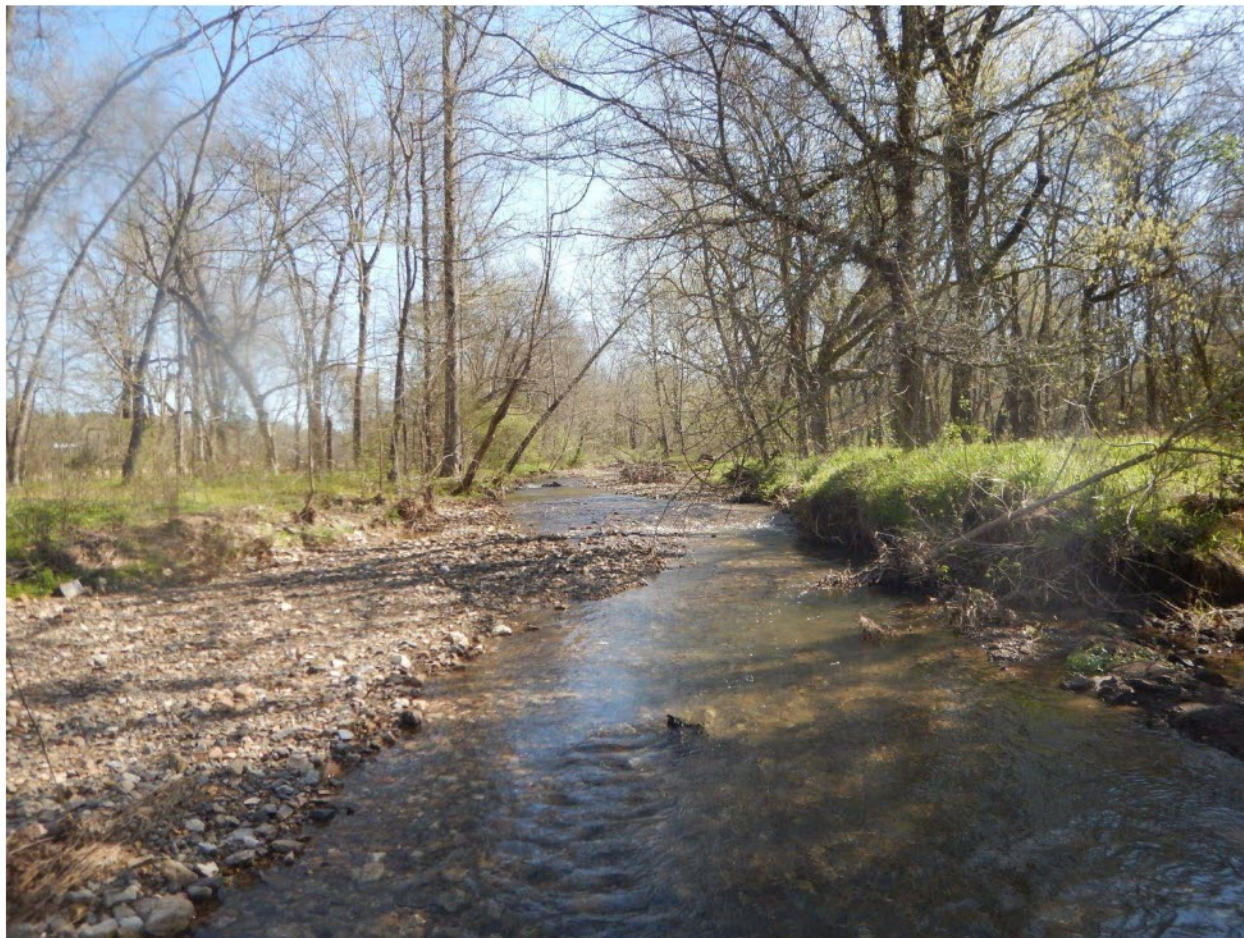
Photo No. 15

| Photo File Name | Date and Time of Photo | Photographer | Description |
|---|---|---|---|
| DSCN6404 | 03/28/2024, 10:39 AM | Chelsey Sherwood | Showing top of site and undisturbed stream channel. Note the banks on river left and right. Picture taken facing upstream, east. |
