**Region 6 - Enforcement & Compliance Assurance Division**  
**INSPECTION REPORT**

| Company Name: | LBOC, LLC | |
| Facility Name: | Reynolds C-3 SWD Tank Battery | |

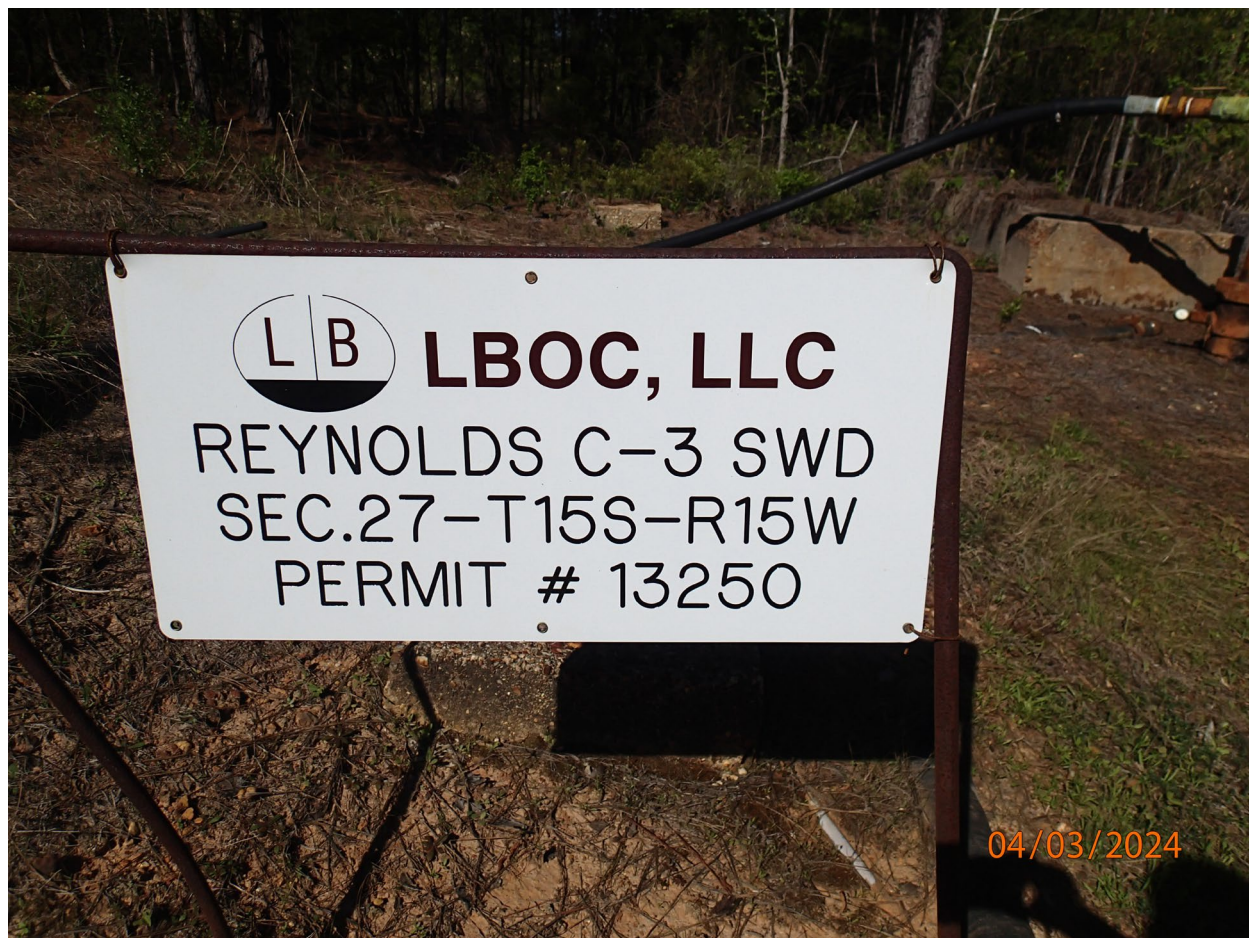
Photo No. 1

Description: Looking NW, this photo showed the signage at the facility.

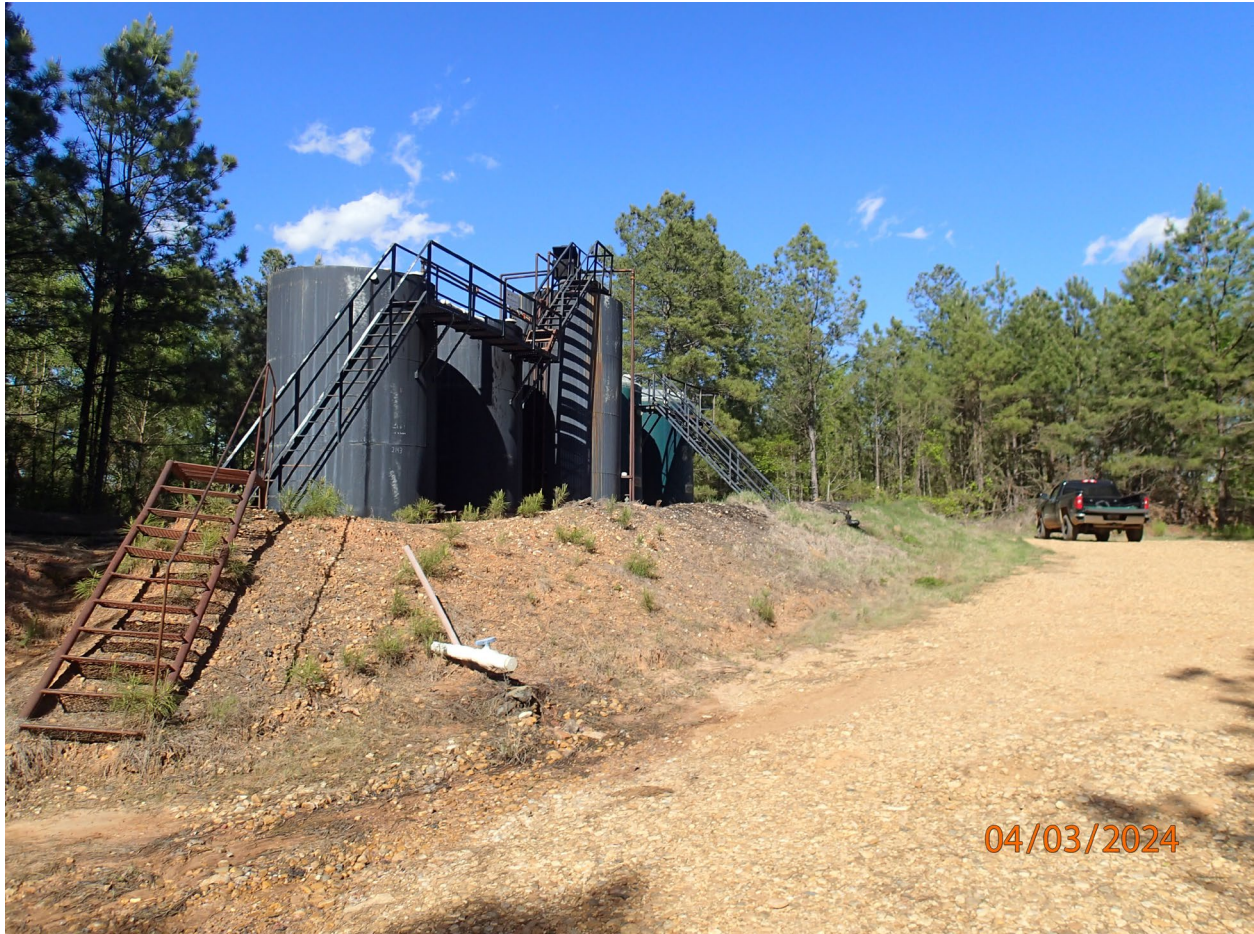
Photo No. 2

I observed the facility sign, secondary containment, pipes and valves, and storage tanks located at the facility; see Appendix 1 (Photographs Log), Photo No. 1 through No. 2. For additional GPS location and photo metadata, see Appendix 1.

**Description:** Looking W, this photo showed an overview of the facility.

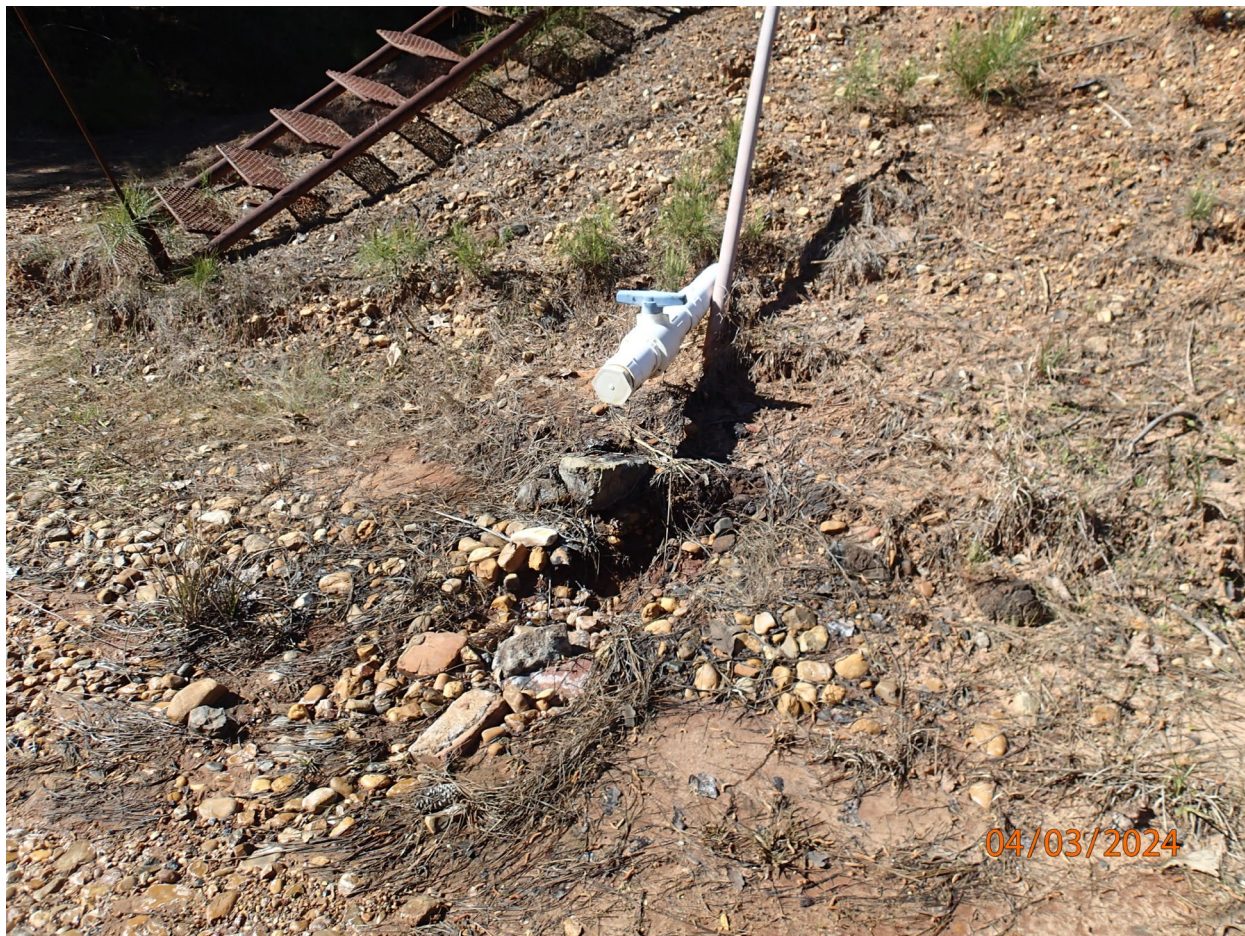
I observed the drainpipe for secondary containment with a closed valve and a cap (partially threaded); salt crystals were observed on the ground around the drainpipe; see Photo No. 3 through No. 5.

**Description:** Looking NE, this photo showed the drainpipe for the secondary containment; I noted the valve was closed and the pipe had a cap.

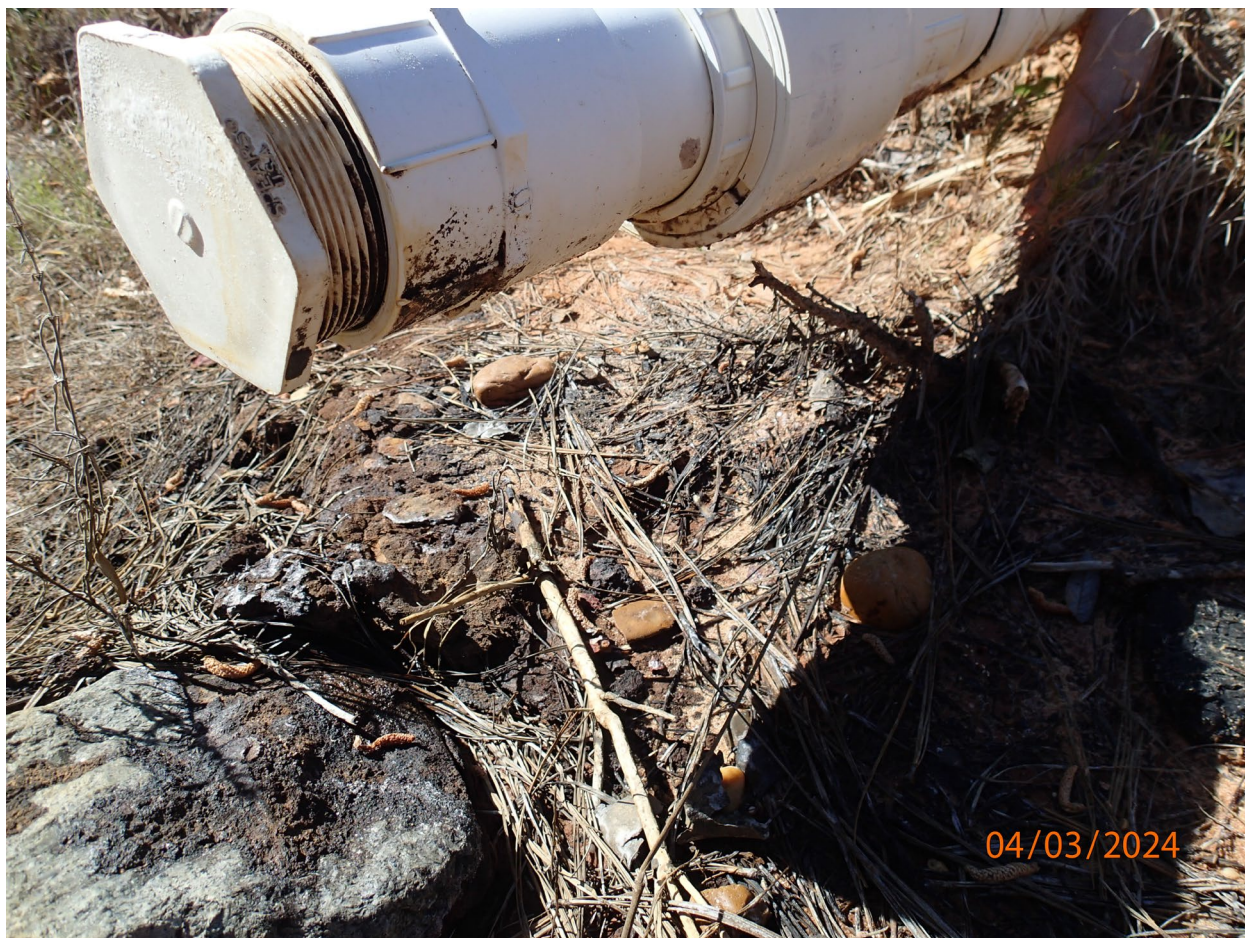
Photo No. 4

**Description:** Looking NE, this photo showed a closeup of the drainpipe from Photo No. 3; an active leak was noted at the drainpipe cap.

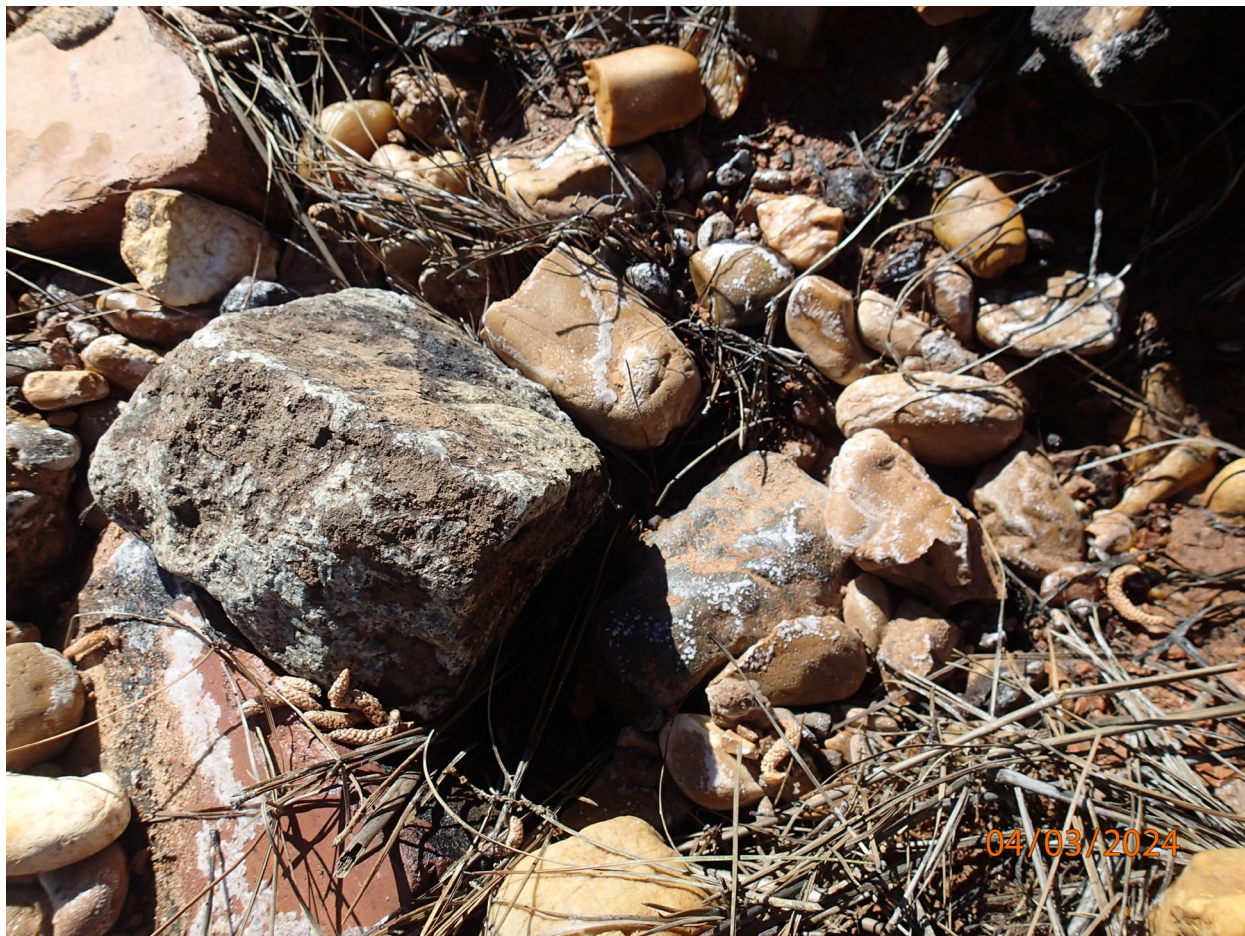
Photo No. 5

**Description:** Looking E-SE, this photo showed a closeup of salt crystals under the drainpipe from Photo No. 3.

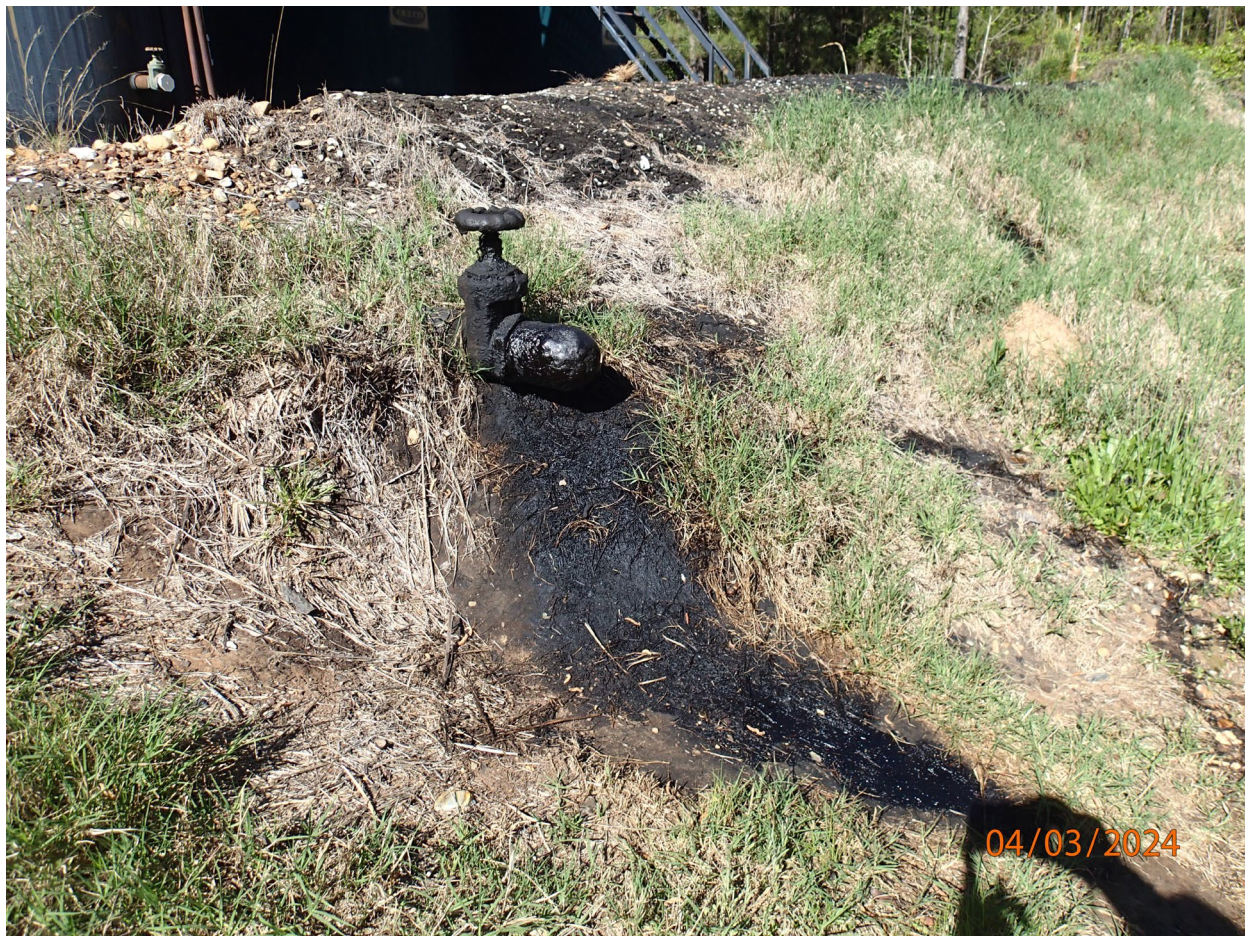
Photo No. 6

I observed the transfer pipe through secondary containment without a catch bucket and loose oil on the ground, see Photo No. 6.

**Description:** Looking W-NW, this photo showed a transfer pipe through secondary containment without a catch bucket and loose oil on the ground.

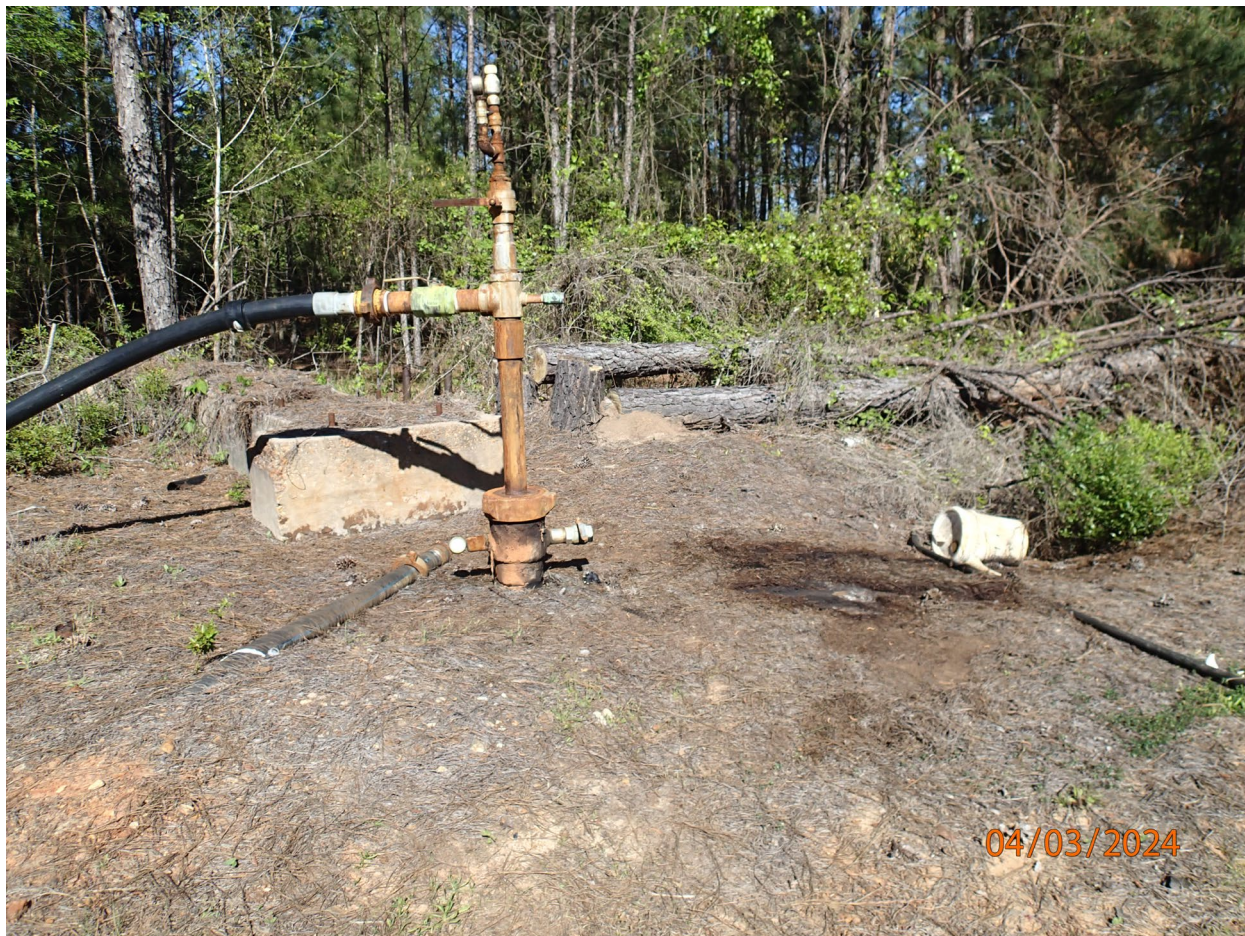
Photo No. 7

I observed the SWD well to have loose oil and solid waste around the area, see Photo No. 7.

**Description:** Looking W, this photo showed the saltwater disposal (SWD) well with loose oil and solid waste on the ground.

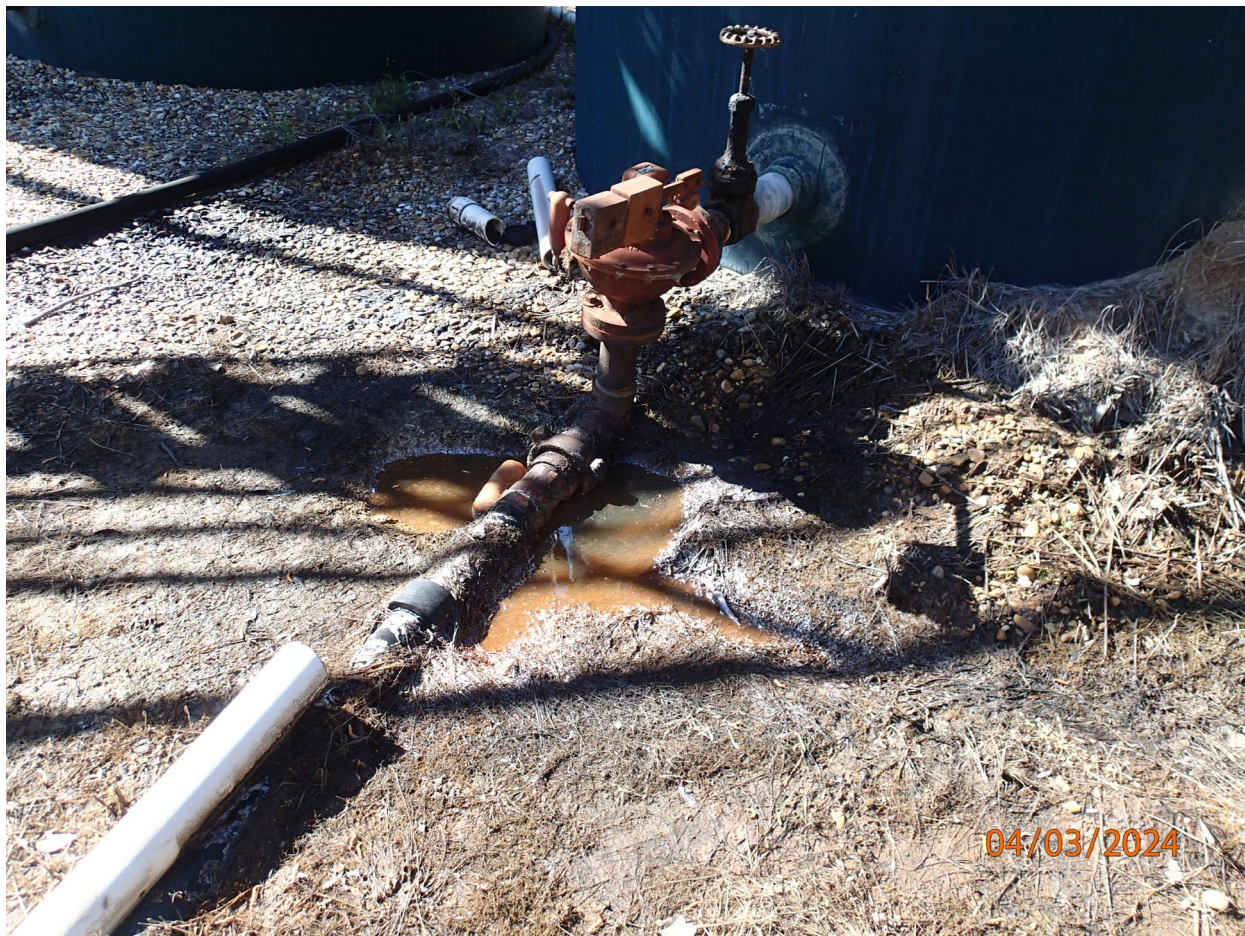
Photo No. 8

I observed active leaks of crude oil and saltwater inside secondary containment, see Photo No. 8, No. 10 through No. 11.

**Description:** Looking E, this photo showed an active saltwater leak into secondary containment.

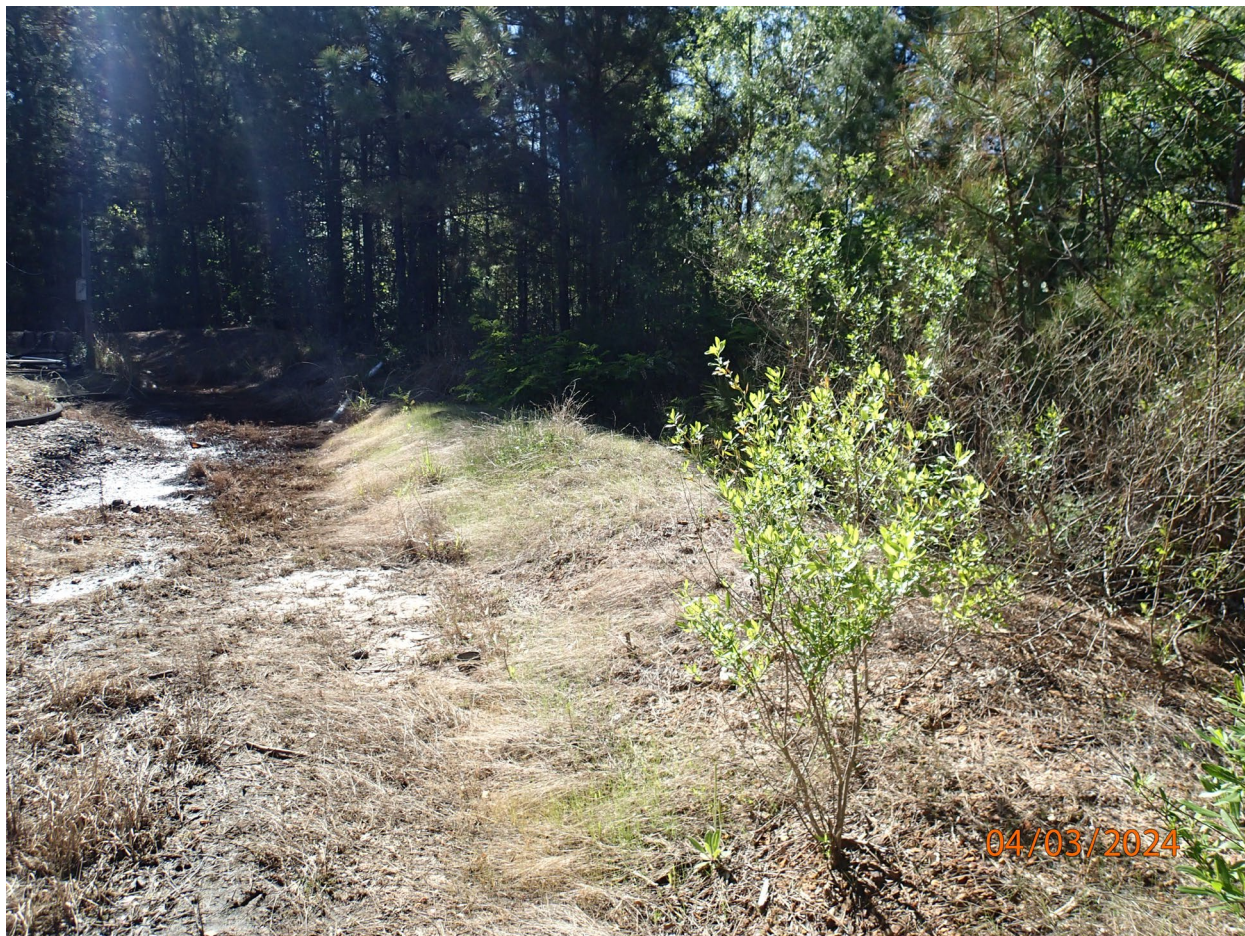
Photo No. 9

I observed woody vegetation within the firewall berm, see Photo No. 9.

**Description:** Looking E-SE, this photo showed woody vegetation growing in the firewall.

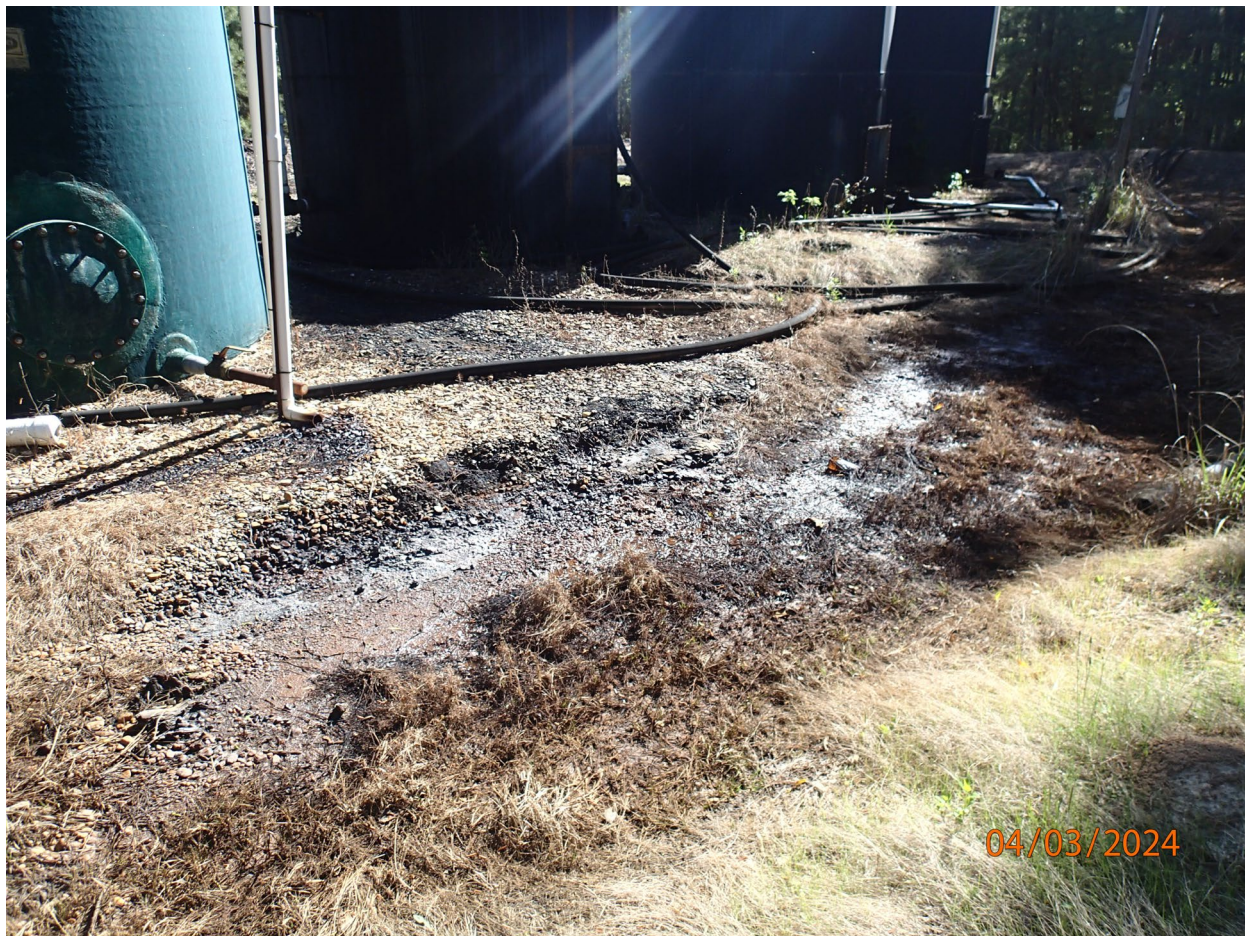
Photo No. 10

**Description:** Looking S-SE, this photo showed a saltwater release inside secondary containment with staining, salt crystals, and dead vegetation.

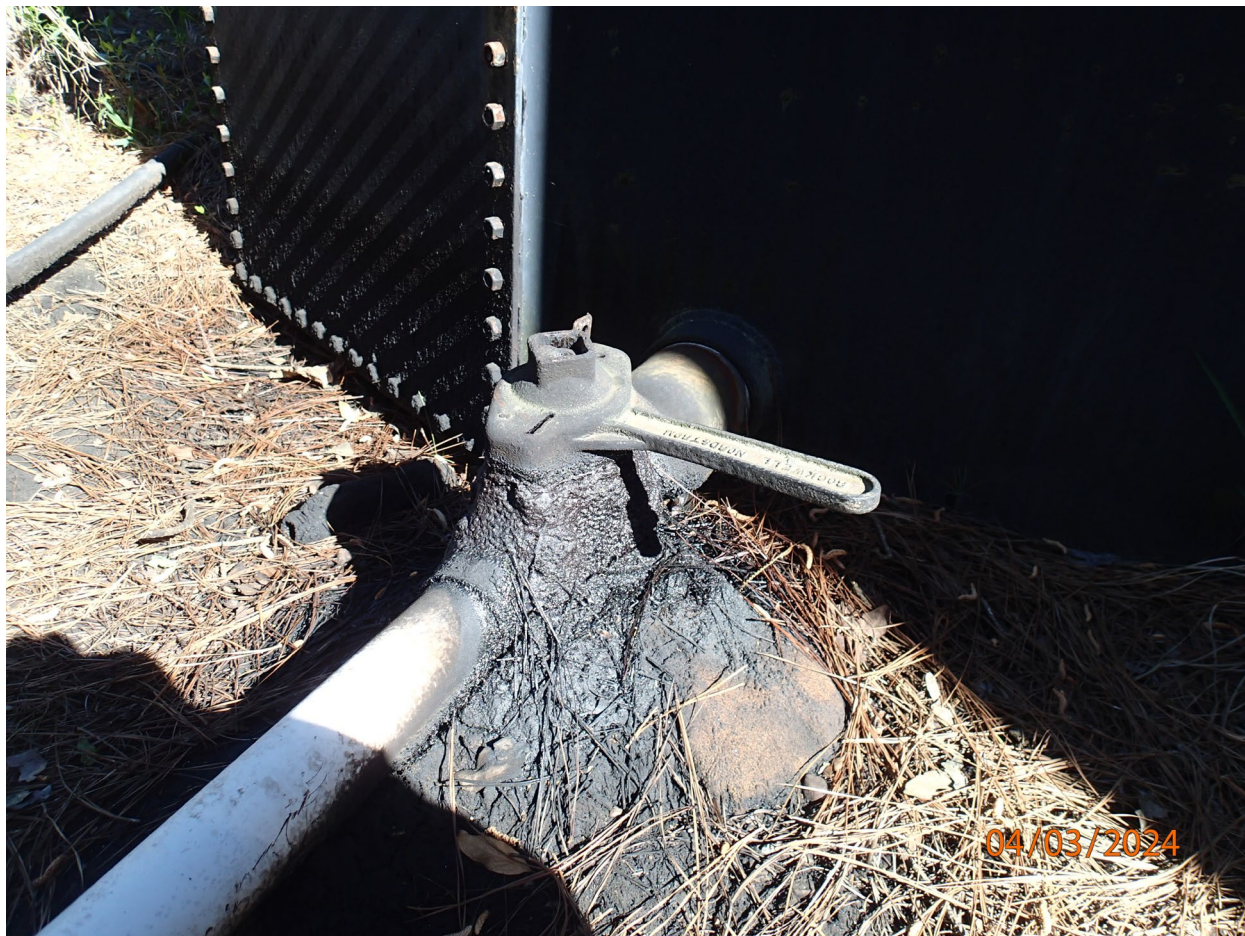
Photo No. 11

**Description:** Looking SW, this photo showed a valve for a storage tank with loose oil inside secondary containment.
