**U.S. Environmental Protection Agency  
Region 5**

**Purpose:** Clean Water Act National Pollutant Discharge Elimination System Inspection

**Facility:** Duluth Seaway Port Authority  
802 Garfield Avenue  
Duluth, Minnesota 55802

**Inspection Date:** May 30, 2025

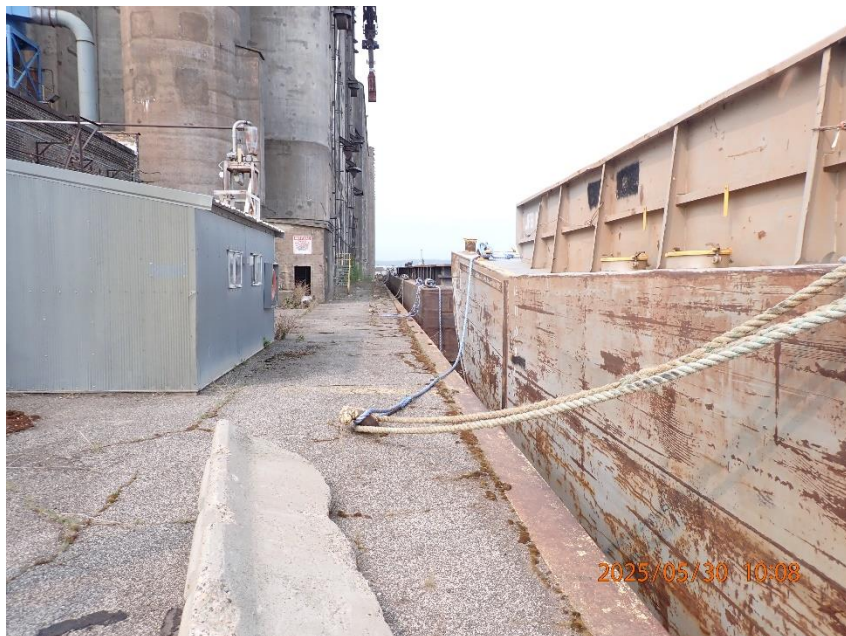
1: P5300001

Description: Drainage Area 7

Location: Duluth Lake Port

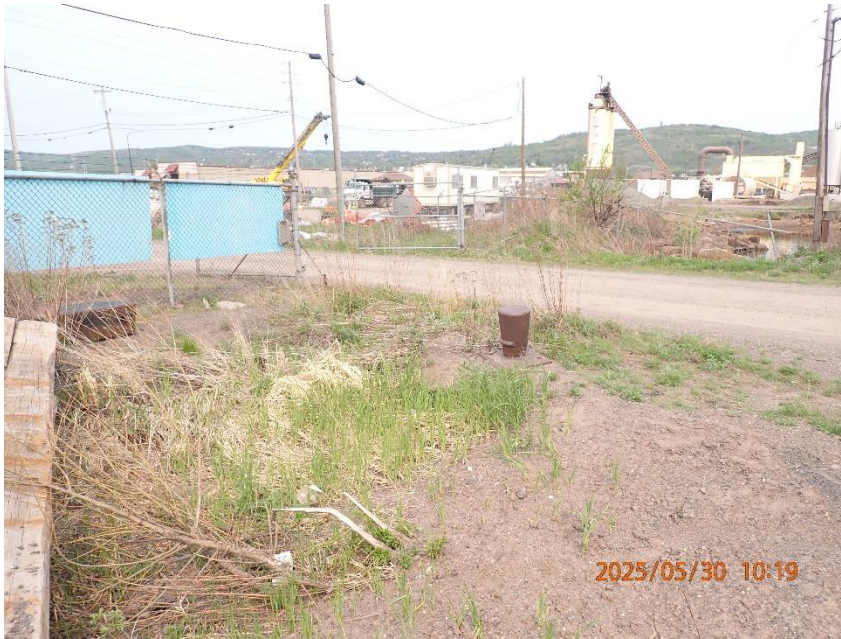
2: P5300002

Description: Drainage Area 7, drainage ditch

Location: Duluth Lake Port

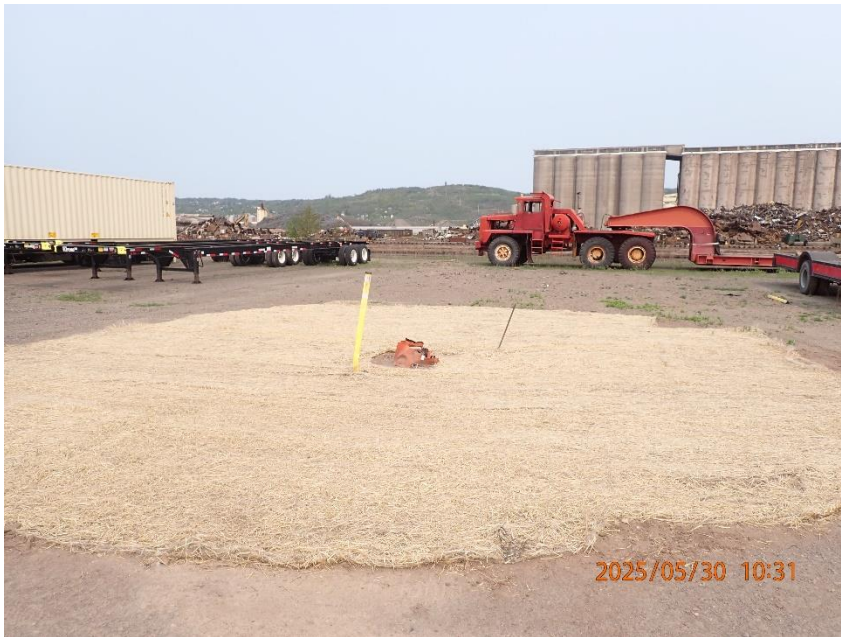
3: P5300003

Description: Benchmark Monitoring Location (BML) 04 (West), reseeded the surrounding area in April 2025.

Location: Dock C and D

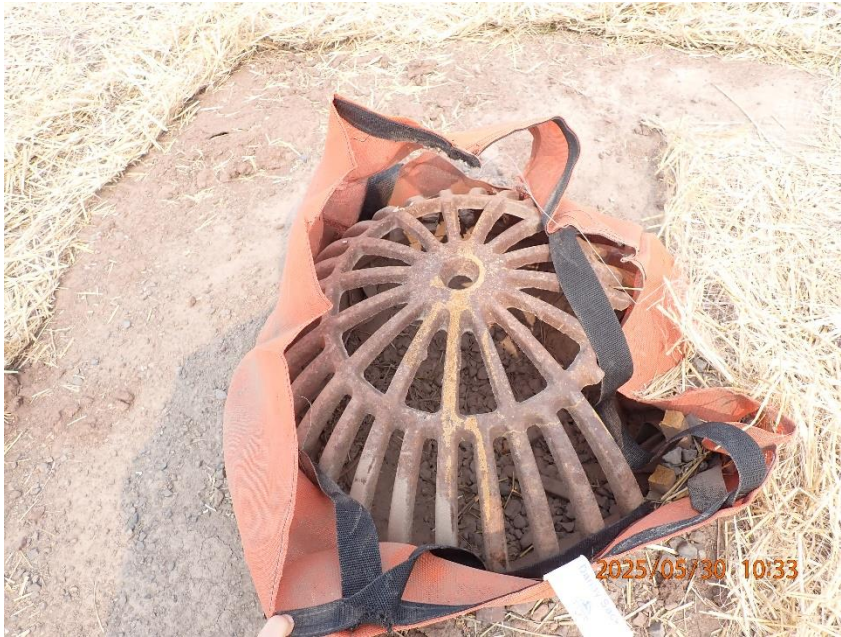
4: P5300004

Description: BML04 (West, same as depicted in Photo 3), dandy bag full of dirt and debris

Location: Dock C and D

- Dandy bags in the storm drains at BML04 (West) and BML04 (East) contain dirt and debris (Photos 4 and 6).
- The pile of golf course bunker sand at Dock C and D is too large for the containment walls. Sand is spilling over the southern containment wall. The southern containment wall has several gaps which is allowing sand to escape. This escaped sand is piled up to the top of the sea wall south of the pile and is several inches deep in some locations (Photos 7 – 10).

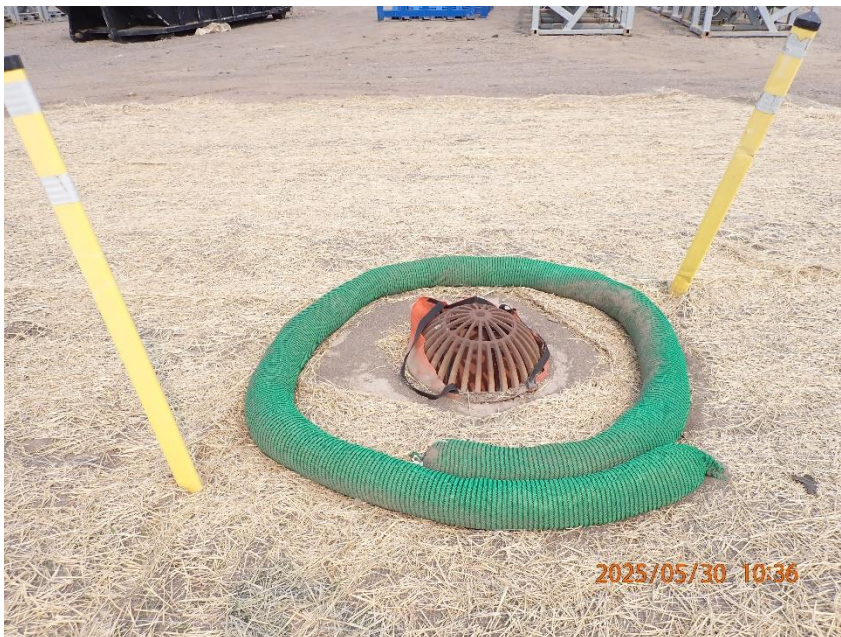
5: P5300005

Description: BML04 (East). Stormwater through this manhole combines with stormwater from BML04 (West) prior to entering the receiving water.

Location: Dock C and D

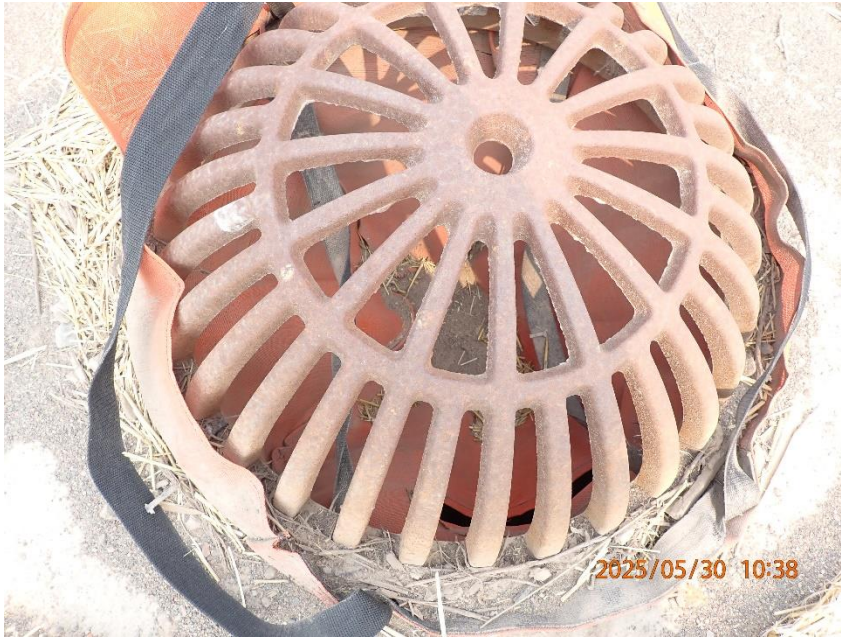
6: P5300006

Description: BML04 (East) dandy bag contains some dirt and debris.

Location: Dock C and D

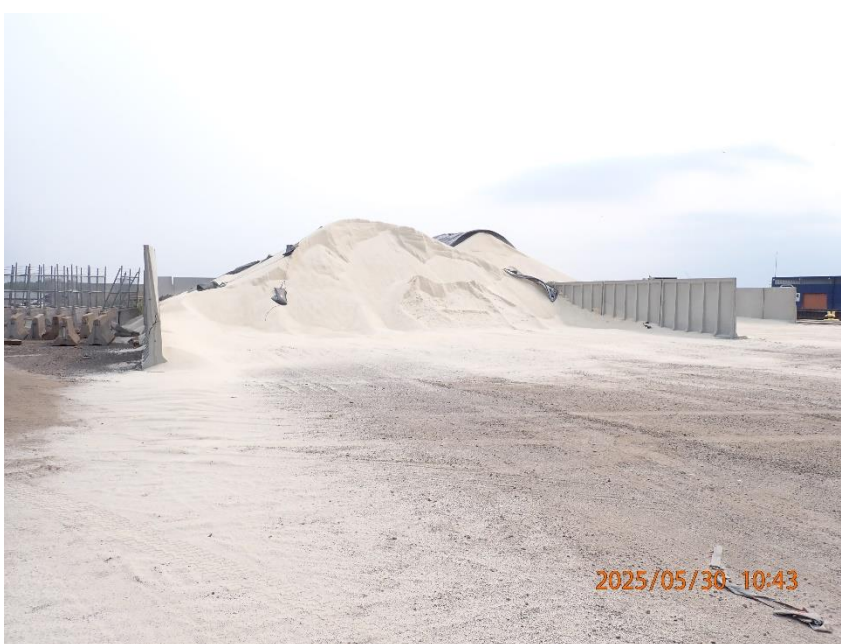
7: P5300007

Description: Golf course sand pile; partially tarped and accessed daily.

Location: Dock C and D

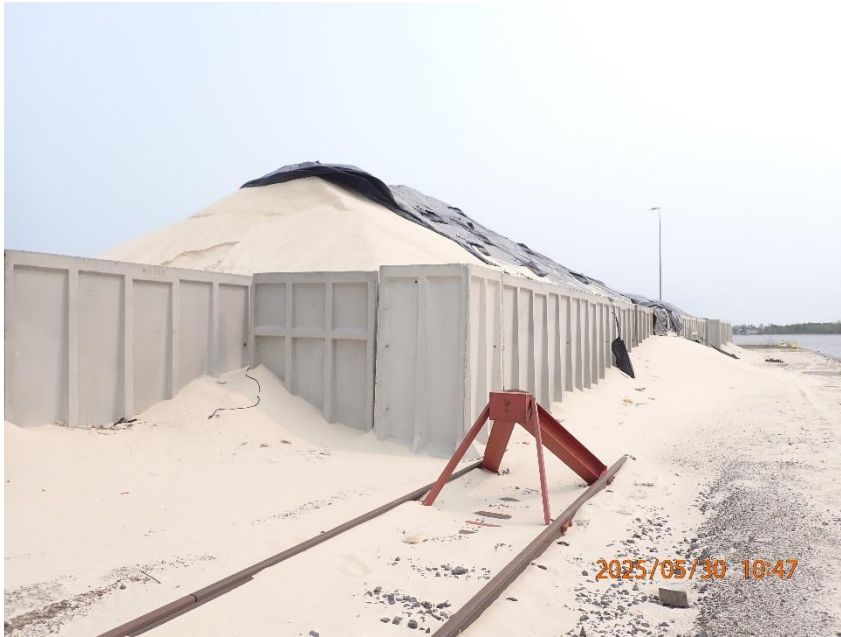
8: P5300008

Description: Golf sand pile, southern wall. Wall is undersized and lacking maintenance; sand piles accumulated south of the wall.

Location: Dock C and D

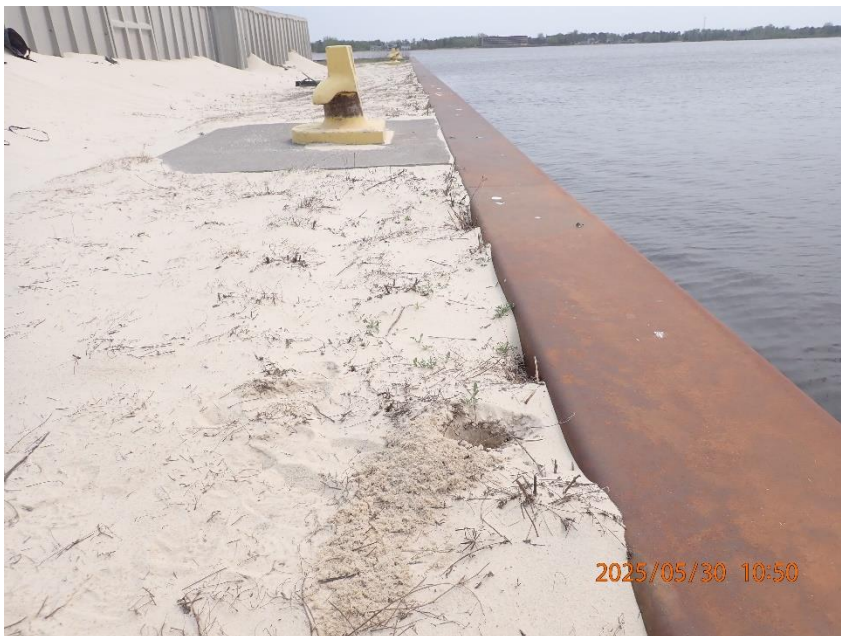
9: P5300009

Description: Golf sand accumulated up to the top of the dock sea wall. Sand is several inches deep in some locations.

Location: Dock C and D

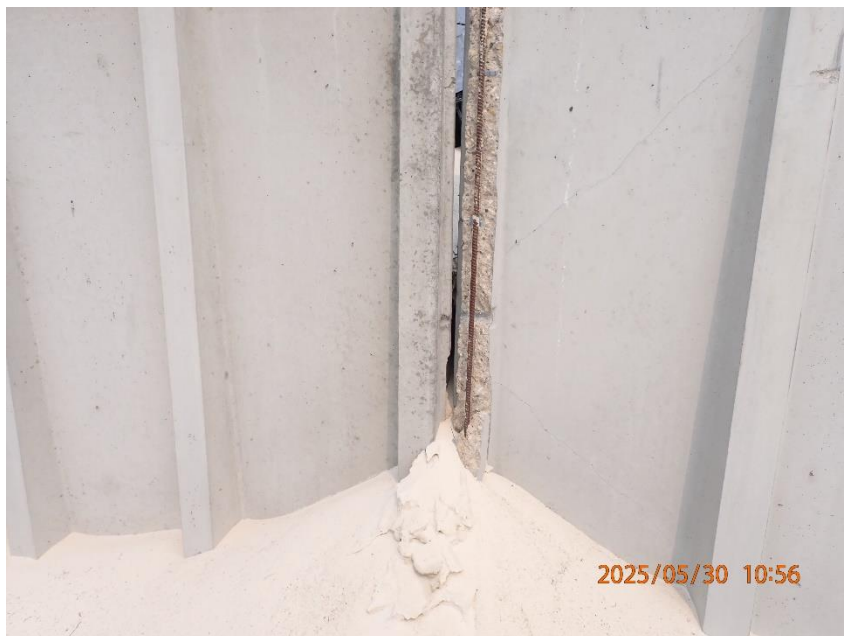
10: P5300010

Description: Golf sand; gaps in the southern wall causing the sand piles in Photos 8 and 9.

Location: Dock C and D

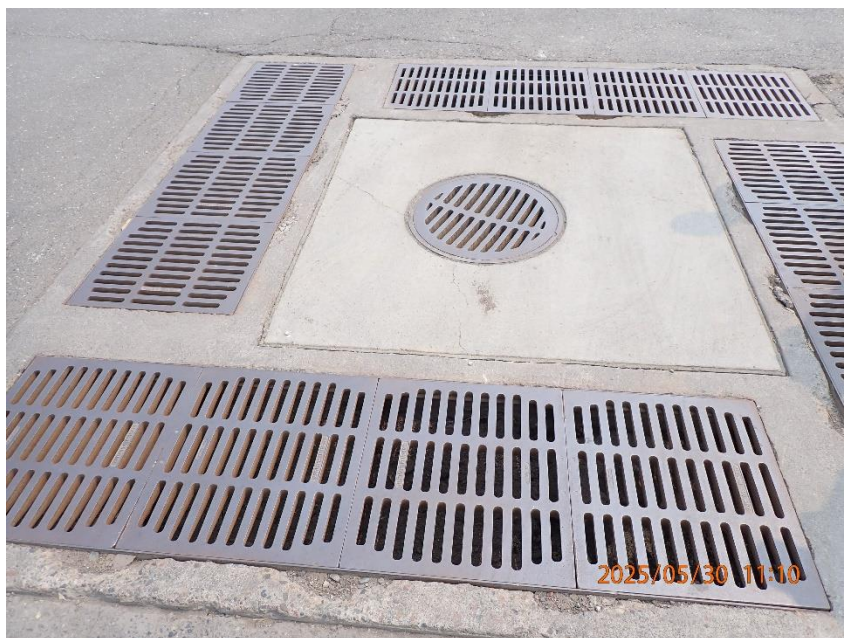
11: P5300011

Description: BML01, Drainage Area 1. Surrounded by spent lime to aid in pollution prevention underneath the rectangular grates. Spent lime last replaced in 2023.

Location: Clure Public Marine Terminal

- From August 2020 to October 2024 at BML01 (Outfall SD 004), the 4-quarter rolling average concentrations for the Total Aluminum and Total Iron benchmark monitoring samples always exceeded the benchmark values.

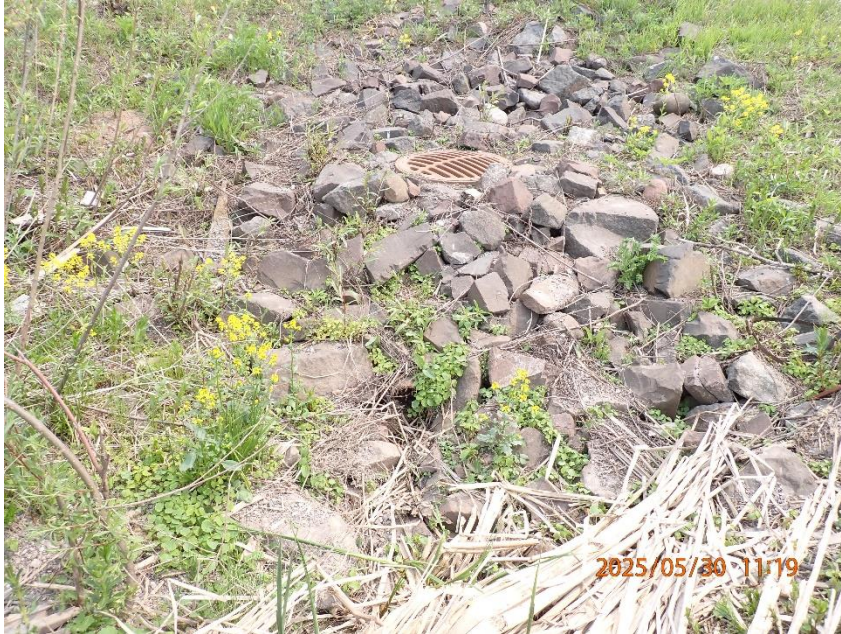
12: P5300012

Description: BML02, Drainage Area 2

Location: Clure Public Marine Terminal

- From August 2020 to November 2024 at BML02 (Outfall SD 005), the 4-quarter rolling average concentration for the Total Iron benchmark monitoring samples always exceeded the benchmark value.

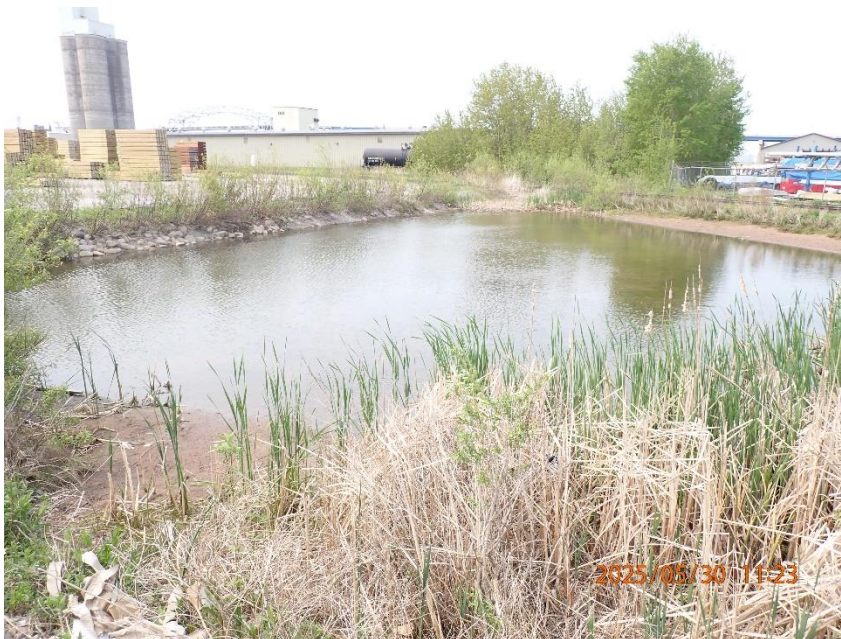
13: P5300013

Description: Stormwater pond, flows to BML02.

Location: Clure Public Marine Terminal

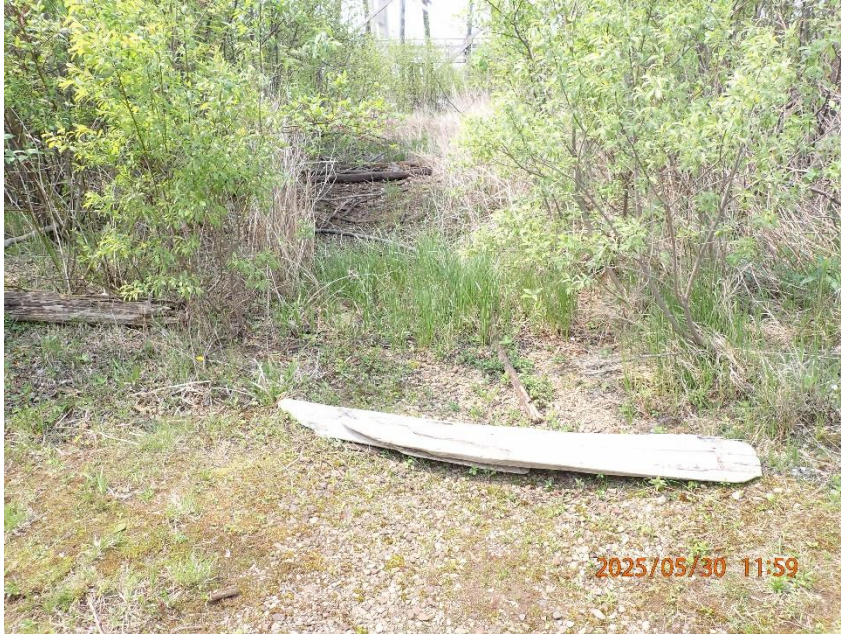
14: P5300014

Description: BML03 and stormwater trench, Drainage Area 3.

Location: Clure Public Marine Terminal

- From August 2020 to November 2024 at BML03 (Outfall SD 001), the 4-quarter rolling average concentration for the Total Iron benchmark monitoring samples always exceeded the benchmark value.
