## **RCRA Inspection Report**

BEKO Technologies, Corp.  
900 Great Southwest PKWY SW  
Atlanta, GA 30336  
Fulton County

May 11, 2023, at 9:00 am

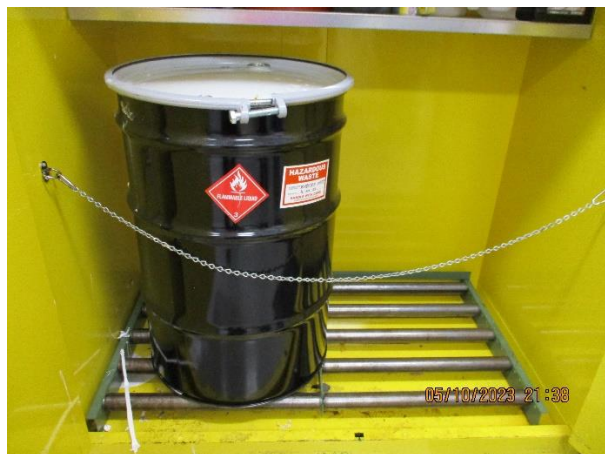
During production of the filament, polymer waste is generated. The facility keeps a satellite accumulation area (SAA) near the generation of the polymer waste. The inspector's observed one 55-gallon drum of polymer waste (Photo #1) in this SAA. The drum was properly closed, labeled with the words "Hazardous Waste", and contained a flammable hazard indication. Although not required for SAAs, the drum was dated with a start accumulation date.

**Photo 1:** 55-gallon drum of polymer waste (Photo #1). The drum was properly closed, labeled with the words “Hazardous Waste”, and contained a flammable hazard indication.

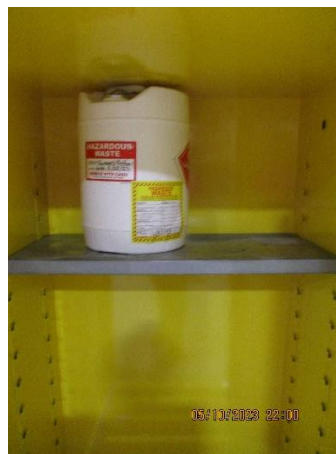
- Two 5-gallon closed containers of hexane and methanol waste. One container was dated March 28, 2023, and the other was dated May 1, 2023. Both containers had a hazard indication for flammability.
- One 55-gallon closed drum of hexane waste. The container was dated April 26, 2023, and it had a hazard indication for flammability.

**Photo 2:** One 5-gallon closed container of hexane and methanol waste dated March 28, 2023, with a hazard indication for flammability.

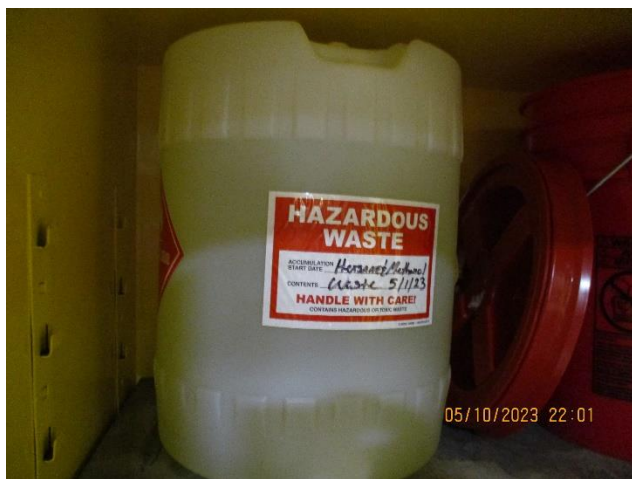
**Photo 3:** One 5-gallon closed container of hexane and methanol waste dated May 01, 2023, with a hazard indication for flammability.

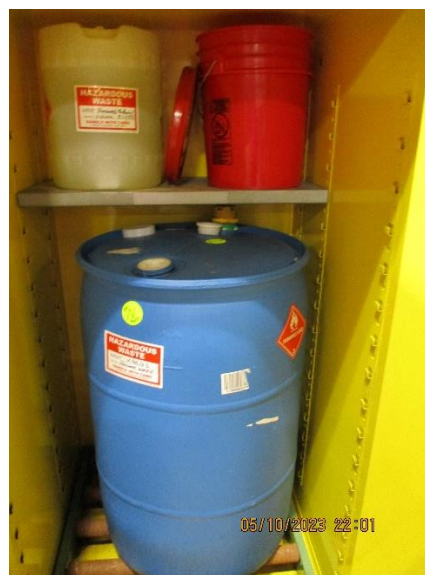
**Photo 4:** One 55-gallon closed drum of hexane waste. The container was dated April 26, 2023, with a hazard indication for flammability.
