INSPECTION REPORT

| Type of Inspection | Focused Compliance Inspection (FCI) | | | |
| Facility or Site Name | Gulf Stream Marine LLC | | | |
| Facility/Site Physical Address | 575 Pete Schaff Blvd | | | |

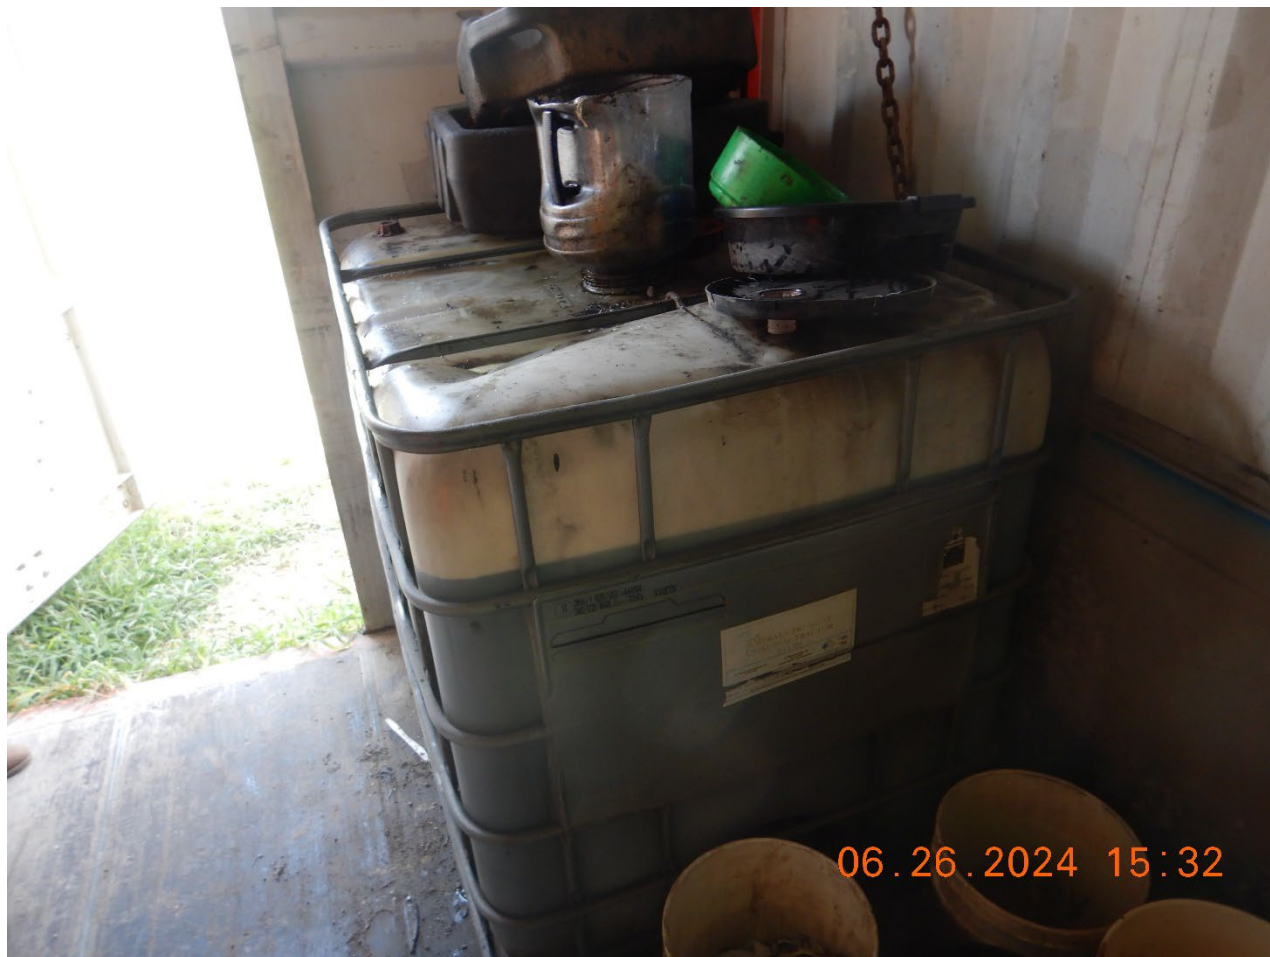
Photo No. 1

| <b>Tenant:</b> Gulf Stream Marine LLC | | |
|---|---|---|
| <b>AOC #1</b> – GSM did not clearly label containers used to store used oil with the words “Used Oil.” | <b>Citation:</b> 40 CFR 279.22 (c)(1) | Section: 2.1 |

Description: A 275-gallon tote of used oil inside a Conex that was approximately  $\frac{3}{4}$  full and unlabeled.

- Unlabeled containers (i.e., tote, 5-gallon buckets) of used oil (**Labels being ordered, will send pictures upon completion. Please note that hydraulic fluid in 5 gallon buckets were pulled from a machine and is going back in machine upon completion of repairs**)
- Potentially unlabeled used batteries – **Not used batteries**
- Oil stains on the ground in the maintenance area – **As a corrective measure we have contacted a local environmental firm to address the small spots. As a preventative measure we have ordered steel plates under work**

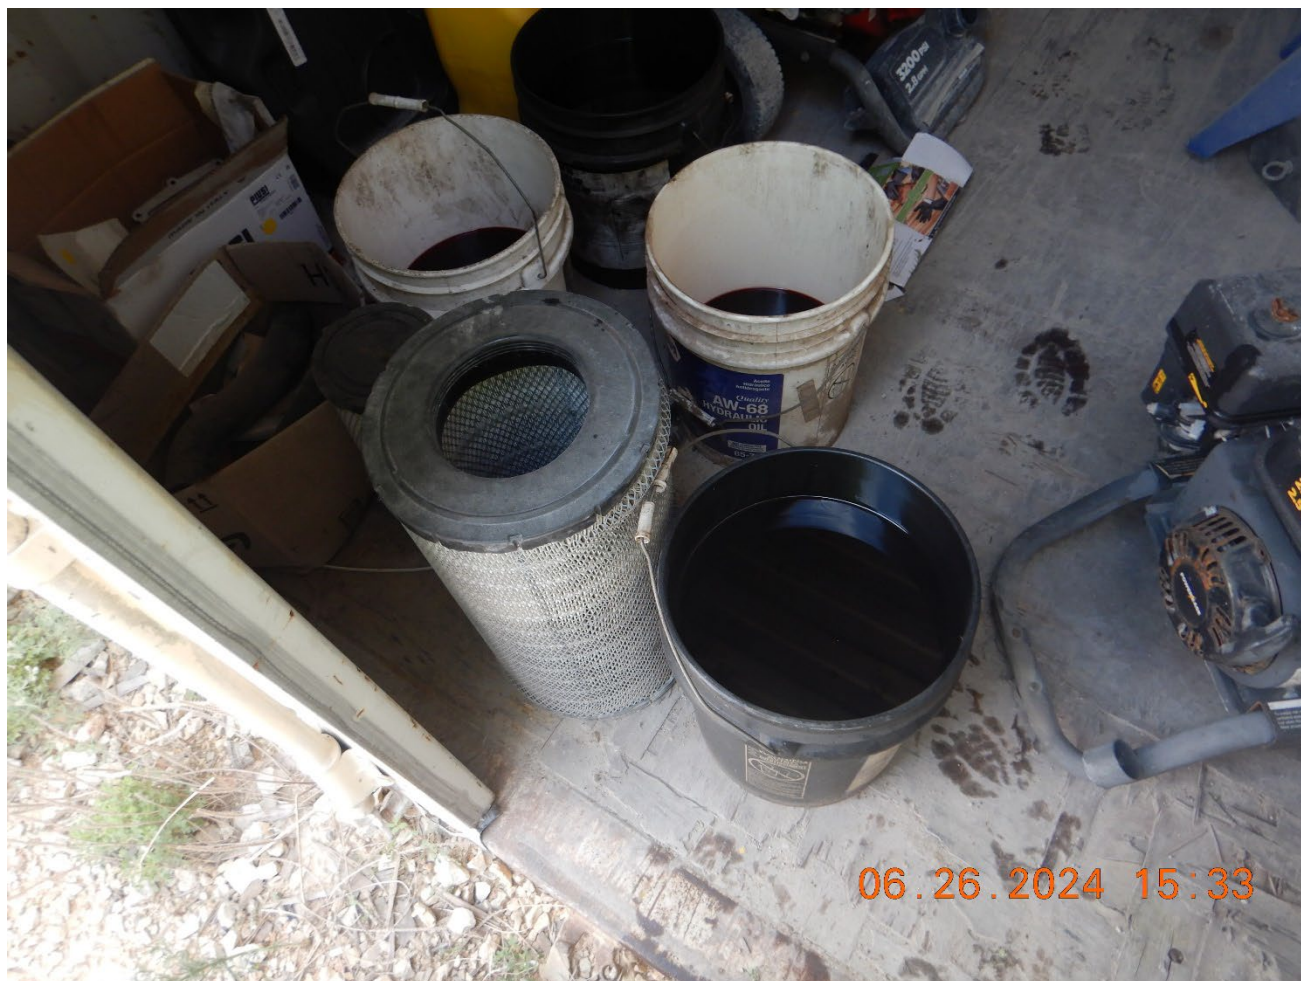
Photo No. 2

Description: Three 5-gallon buckets containing hydraulic oil that GSM said was removed from equipment that was under repair and would be reused.

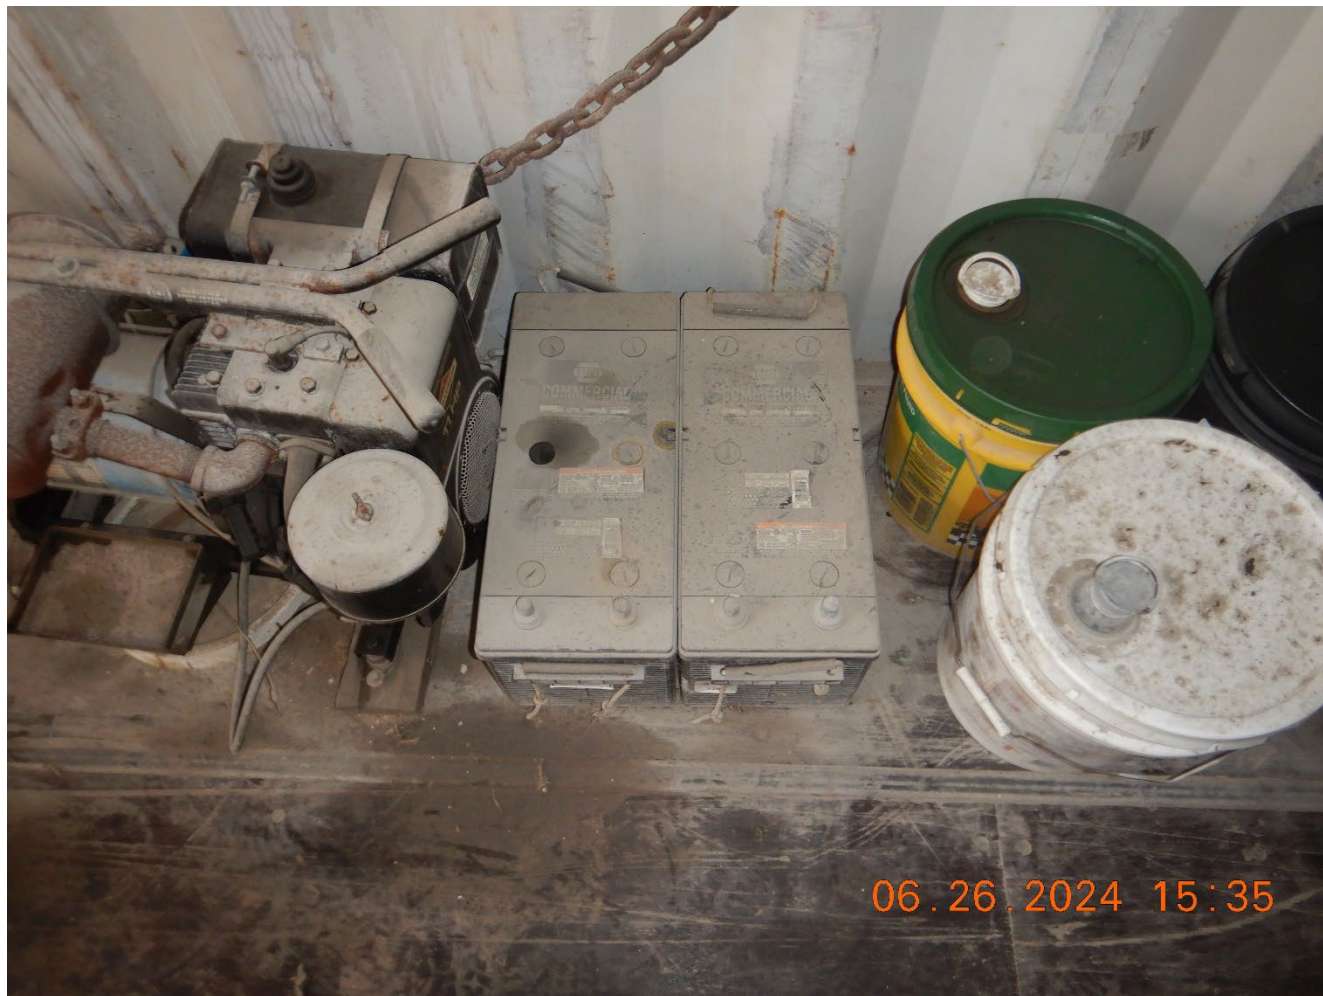
Photo No. 3

Description: Two lead-acid batteries that GMS stated were new and had been set aside for later use.
