INSPECTION REPORT

| Type of Inspection | Compliance Evaluation Inspection (CEI) | | |
| Permittee Name | Grand Traverse Band of Ottawa and Chippewa Indians | | |
| Facility or Site Name | Peshawbestown Wastewater Treatment Plant | | |

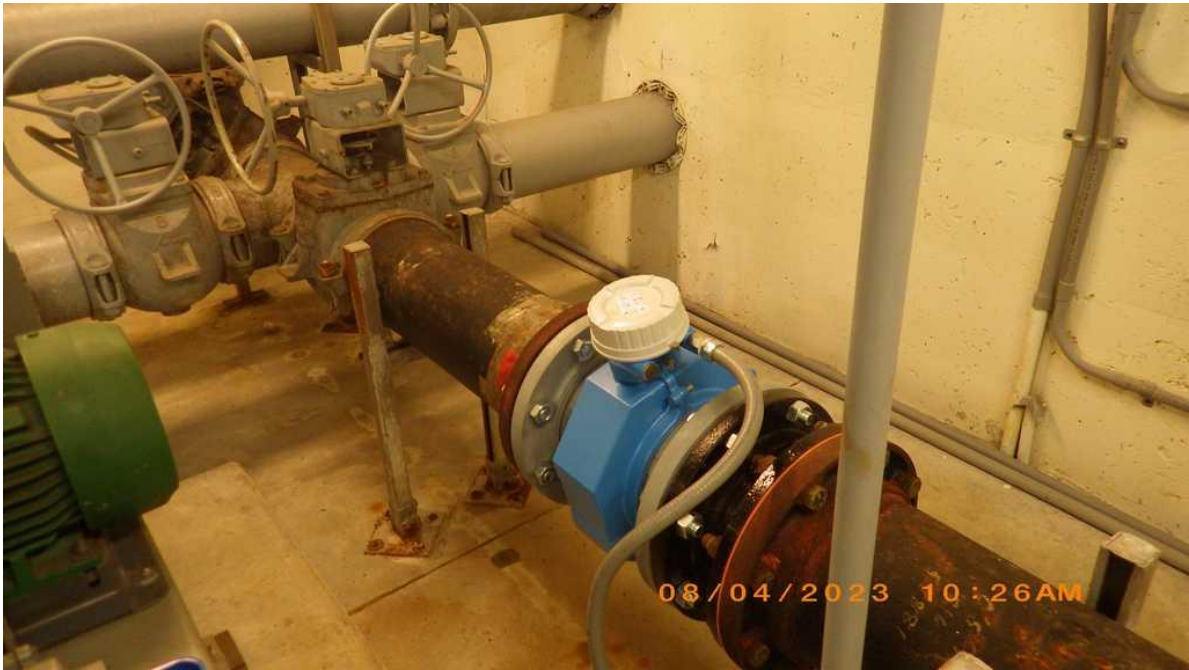
| Influent flow meter and tap location | | | GTBP0269.JPG |

| Located in treatment building. | | | |

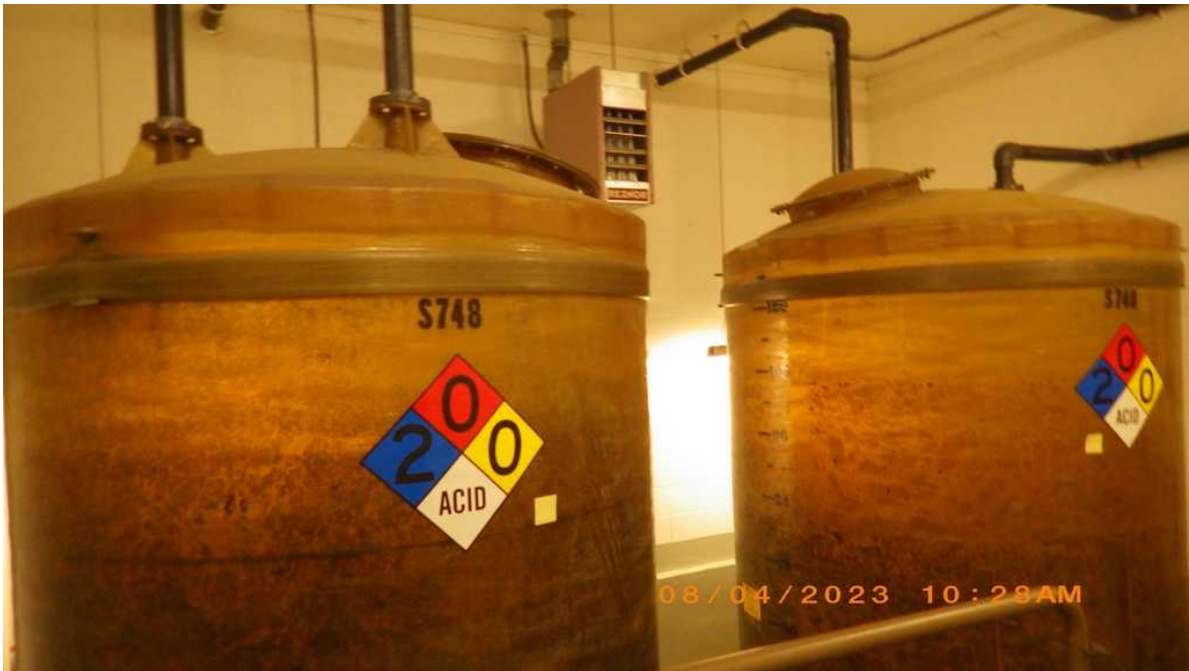
| Ferric room | | | GTBP0270.JPG |

| Location of Ferric tanks (2). | | | |

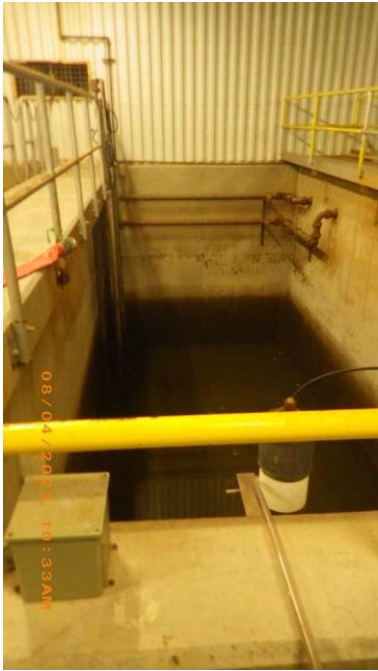
| Pre-EQ Basin | | | GTBP0273.JPG |

| SBR Pre-EQ Basin, located in Tank Room. | | | |

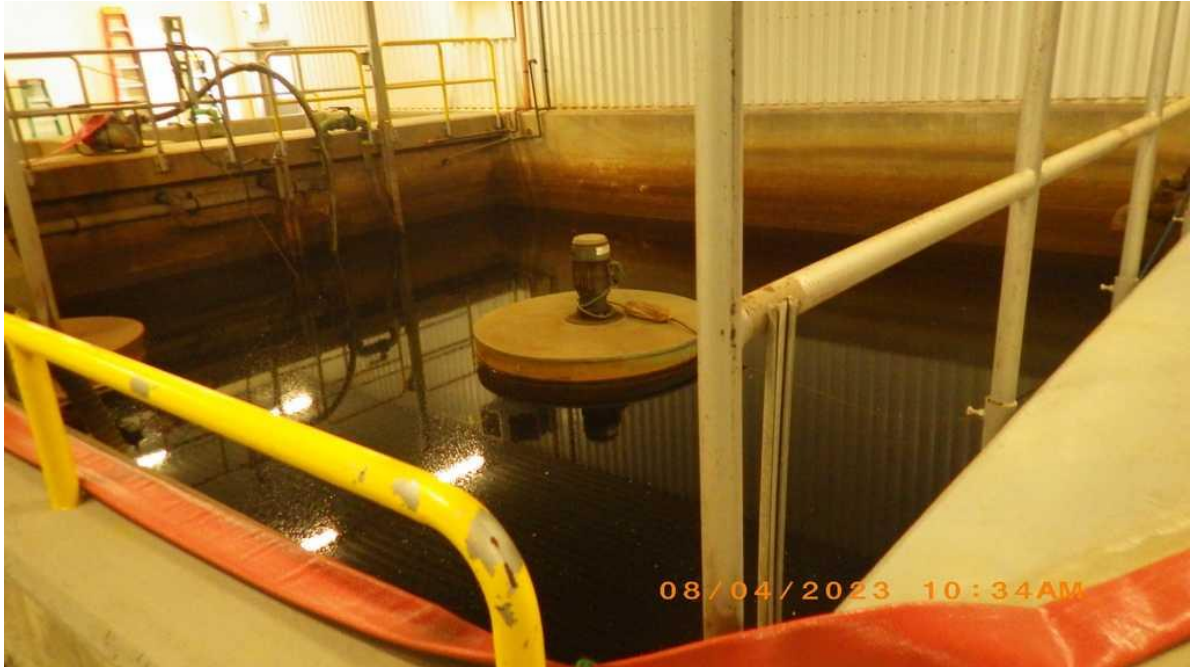
| SBR Basin #1 | | | GTBP0274.JPG |

| SBR Basin #1 currently offline and used for additional storage as needed. | | | |

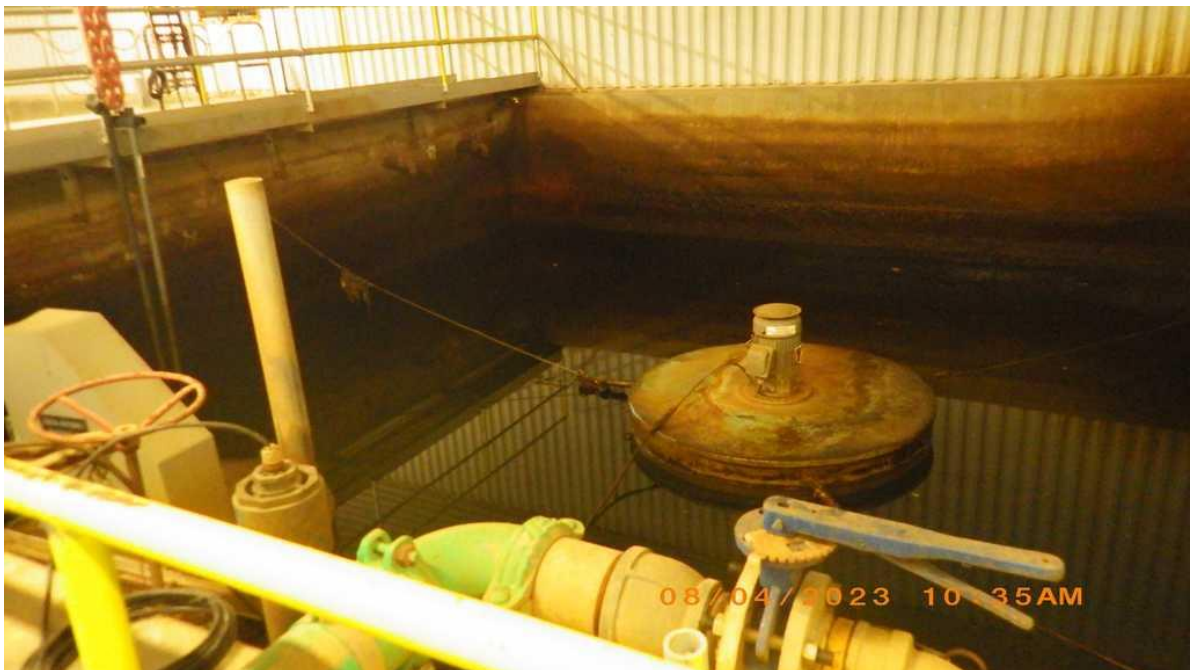
| SBR Basin #2 | | | GTBP0275.JPG |

| SBR Basin #2 currently in use. | | | |

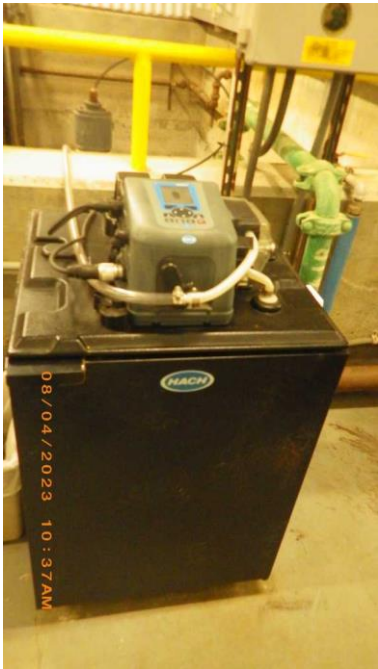
| Influent Autosampler | | | GTBP0276.JPG |

| Located at Pre-EQ basin. Refrigerated unit with heat-sink thermometer. | | | |

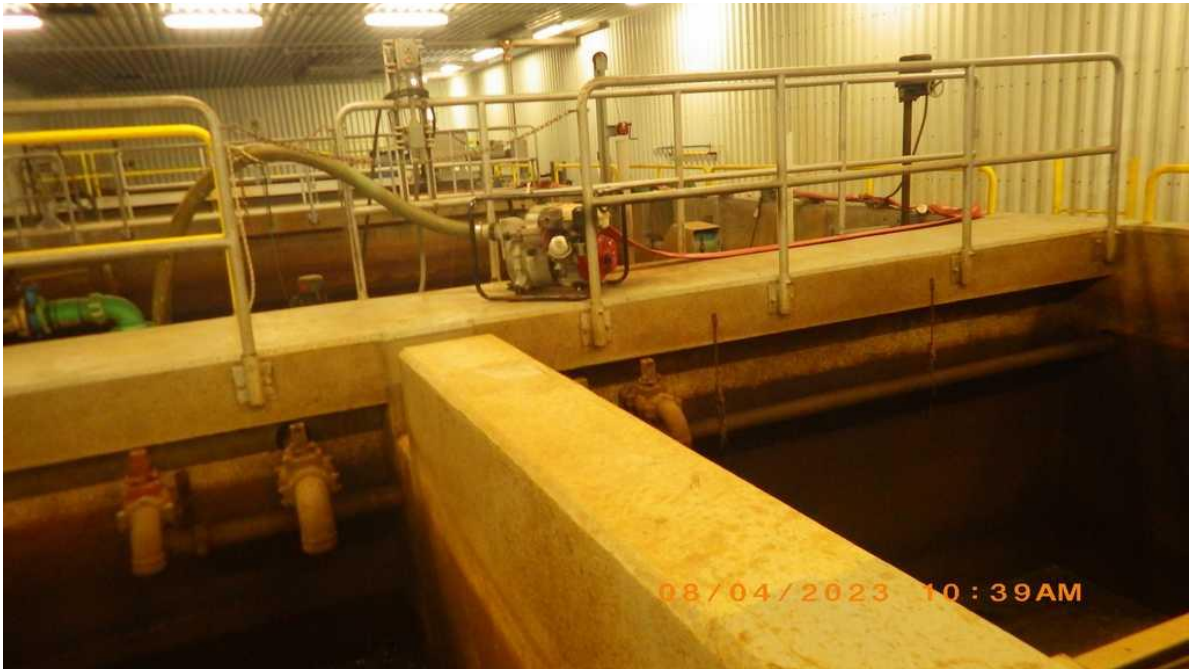
| Digestors (2) | | | GTBP0278.JPG |

| <b>AOC:</b> During the last inspection, I observed that the digester decant process relied on a portable trash pump. The Band intended on installing a permanent decant system. Mr. Burfield confirmed that they still use the trash pump. | |

| Note trash pump used to decant to Basin 1 (storage), usually once per day. | | | |

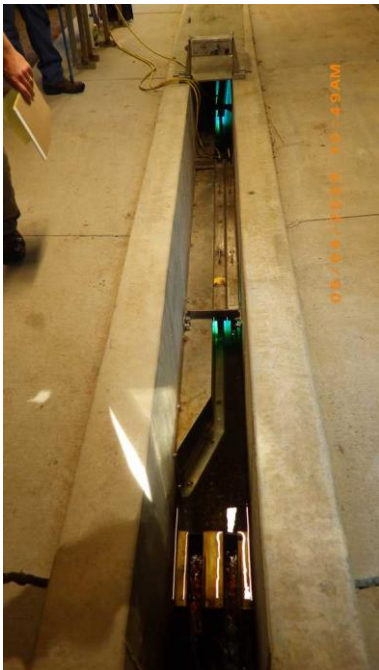
| Ultraviolet (UV) Treatment | | | GTBP0279.JPG |

| UV system contains four banks. Three banks operational, fourth is offline and used as needed. | | | |

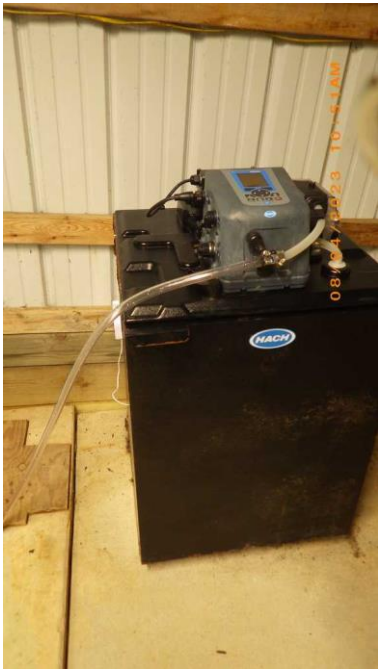
| Effluent autosampler | | | GTBP0280.JPG |

| Effluent auto sampler before UV. Noted clean tubing. | | | |

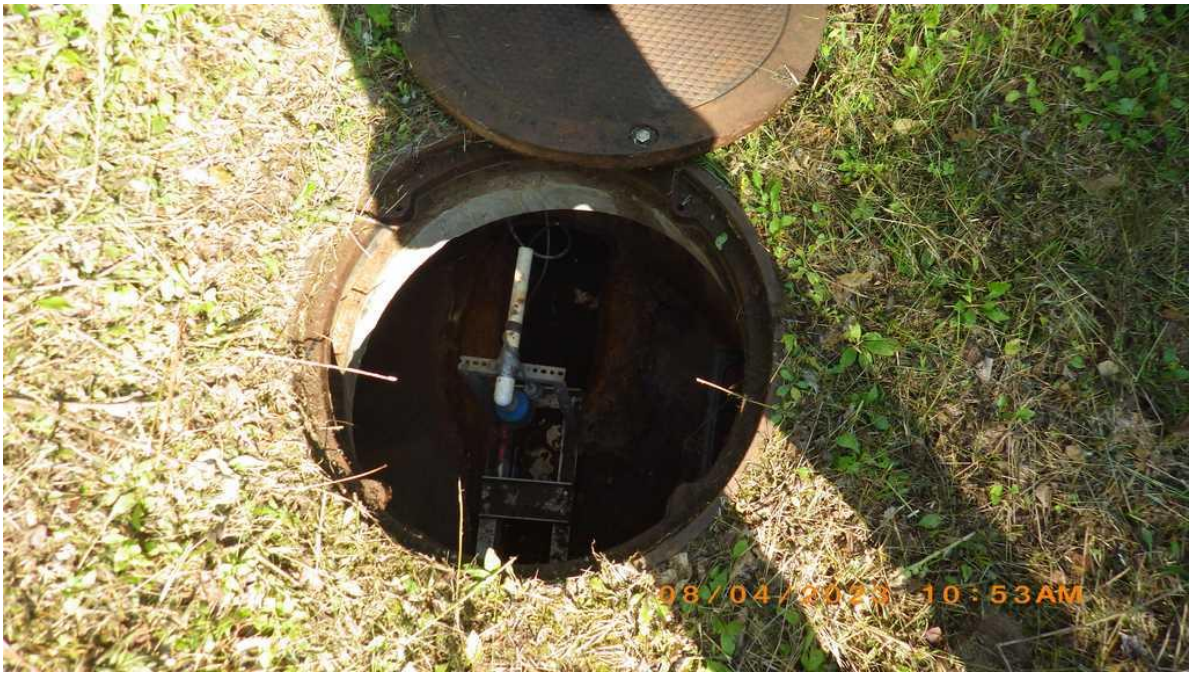
| Effluent manhole | | | GTBP0281.JPG |

| Noted flow sensor in manhole above flume. From here flow travels about 1/2 mile to the bay. | | | |

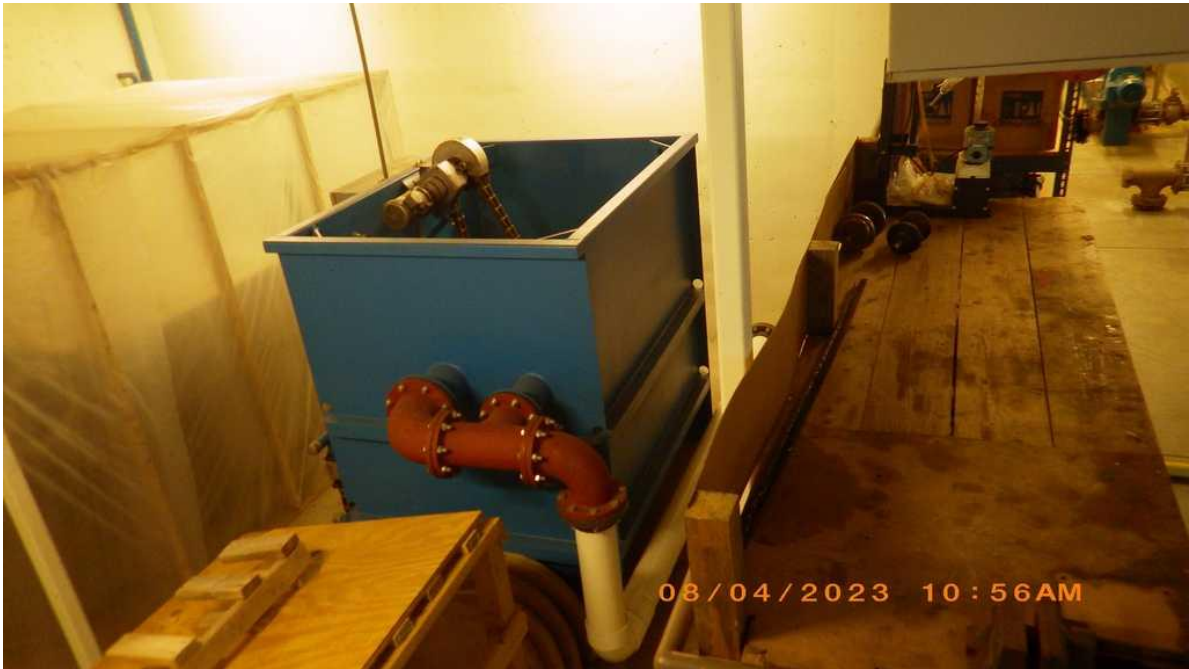
| <b>AOC:</b> The abandoned Aqua Disc tertiary filter is no longer in use and not included in process description in the current Permit but included in process flow diagram for the new proposed Permit. Mr. Huhn said he would contact the EPA permitting program to see if diagram can be corrected prior to issuance of the new Permit. | |

| Abandoned Aqua Disc tertiary filter. No longer in use and not included in process description in the current Permit but included in process flow diagram for the new proposed Permit (See Appendix 2 for copy of the flow diagram). Mr. Huhn said he would contact the EPA permitting program to see if diagram can be corrected prior to issuance of the new Permit. | | | |

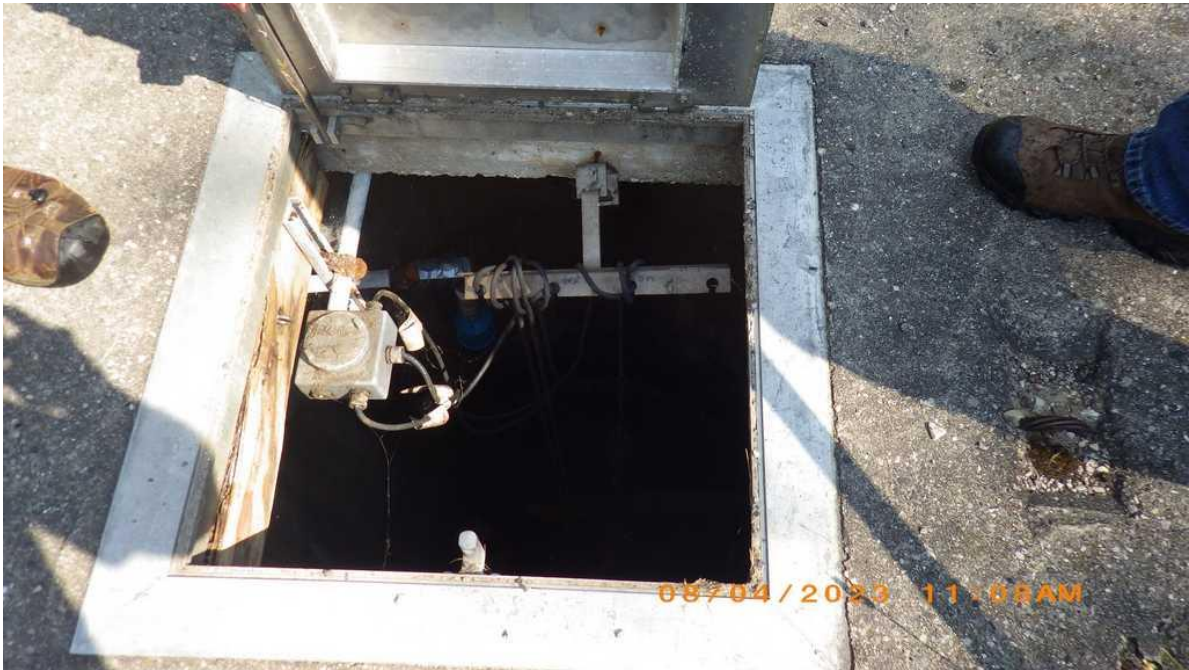
| Lift Station 4 | | | GTBP0283.JPG |

| Lift station 4 wet well. Pumps sewage to Lift Station 3 (last station before plant). | | | |

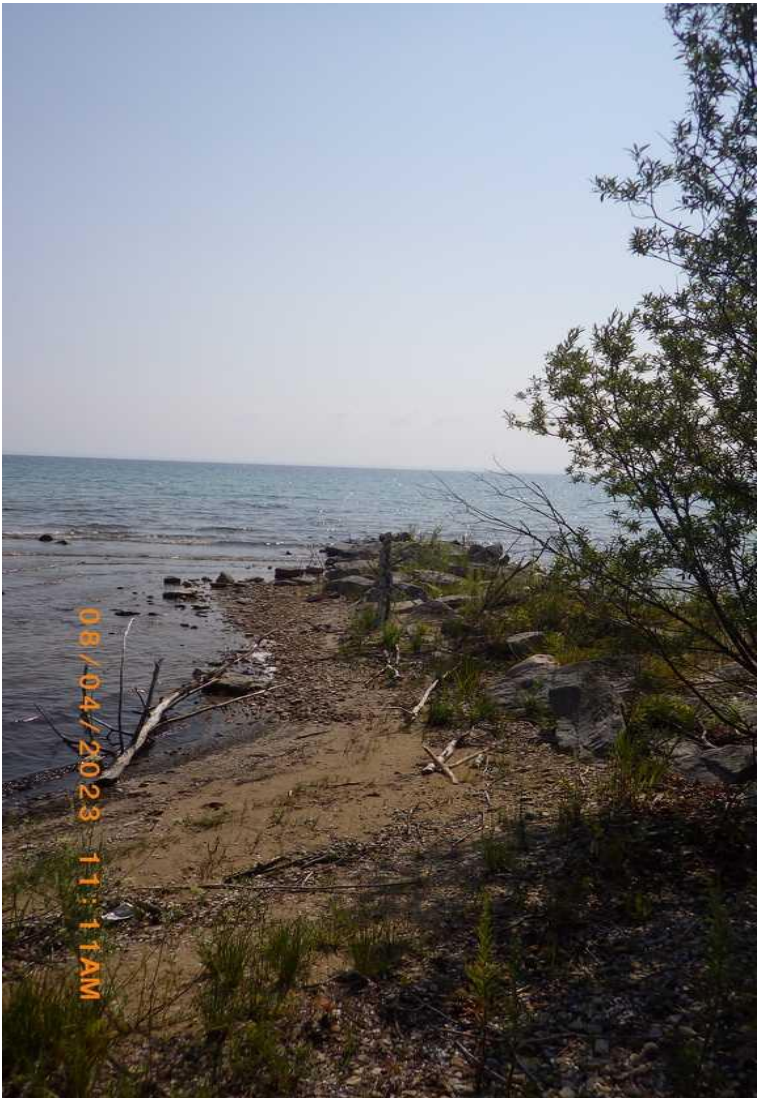
| Outfall #001 | | | GTBP0284.JPG |

| Location of Outfall #001 (buried), which runs about 600 feet into West Grand Traverse Bay. | | | |

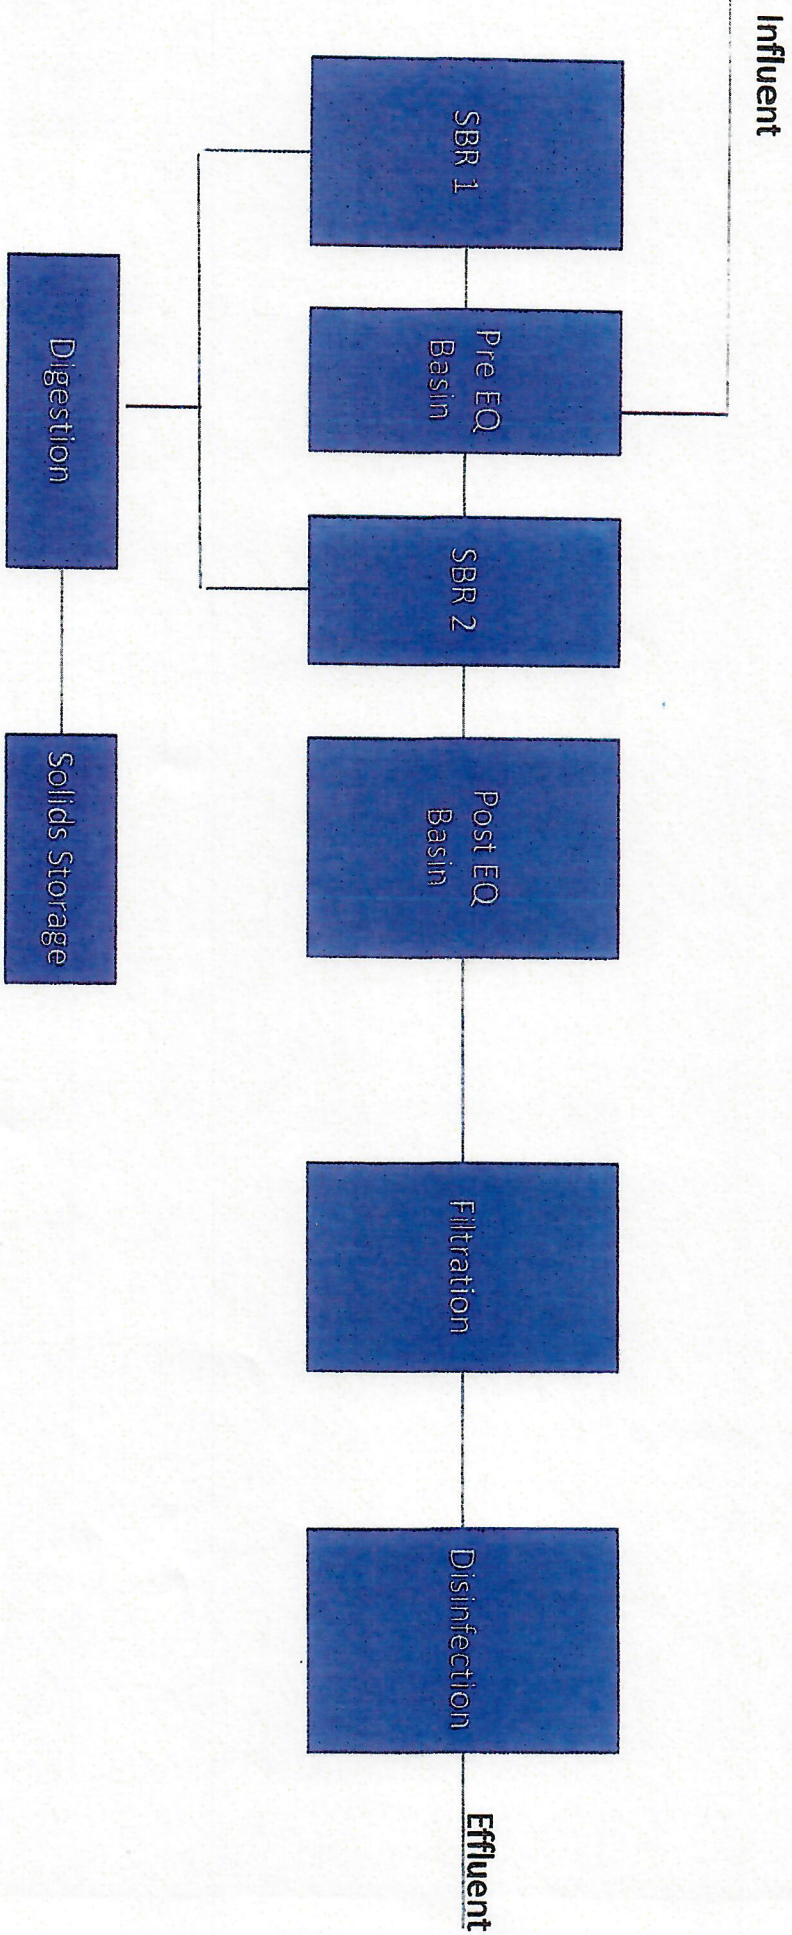
# Flow Diagram

| Document Name | Contains<br>CBI or<br>PII | Date Received | Pages |
|---|---|---|---|
| Process Flow Diagram, including abandoned filtration system | No | 8/4/2023 | 1 |
