**Class I and II Well Inspection Form**  
**US Environmental Protection Agency – Region 4**  
**Underground Injection Control Program**  
61 Forsyth Street SW, MC 9T25, Atlanta, Georgia, 30303  
Phone: (404)562-9424

Well Name & #: *J.H. Wells #23* \_\_\_\_\_  
Well Type (see table): *Enhanced Recovery (EOR)* \_\_\_\_\_ State Permit: *API # 0911320130* \_\_\_\_\_  
Latitude (°N): *30.848734 °N* \_\_\_\_\_ Longitude (°W): *-87.120376 °W* \_\_\_\_\_ Elevation (ft): *NA* \_\_\_\_\_  
Injection Method (check applicable): ☐ Casing Injector; ☒ Tubing & Packer; ☐ Cemented Injection Tubing

Site Photographs  
J.H. Wells #23  
September 13, 2022

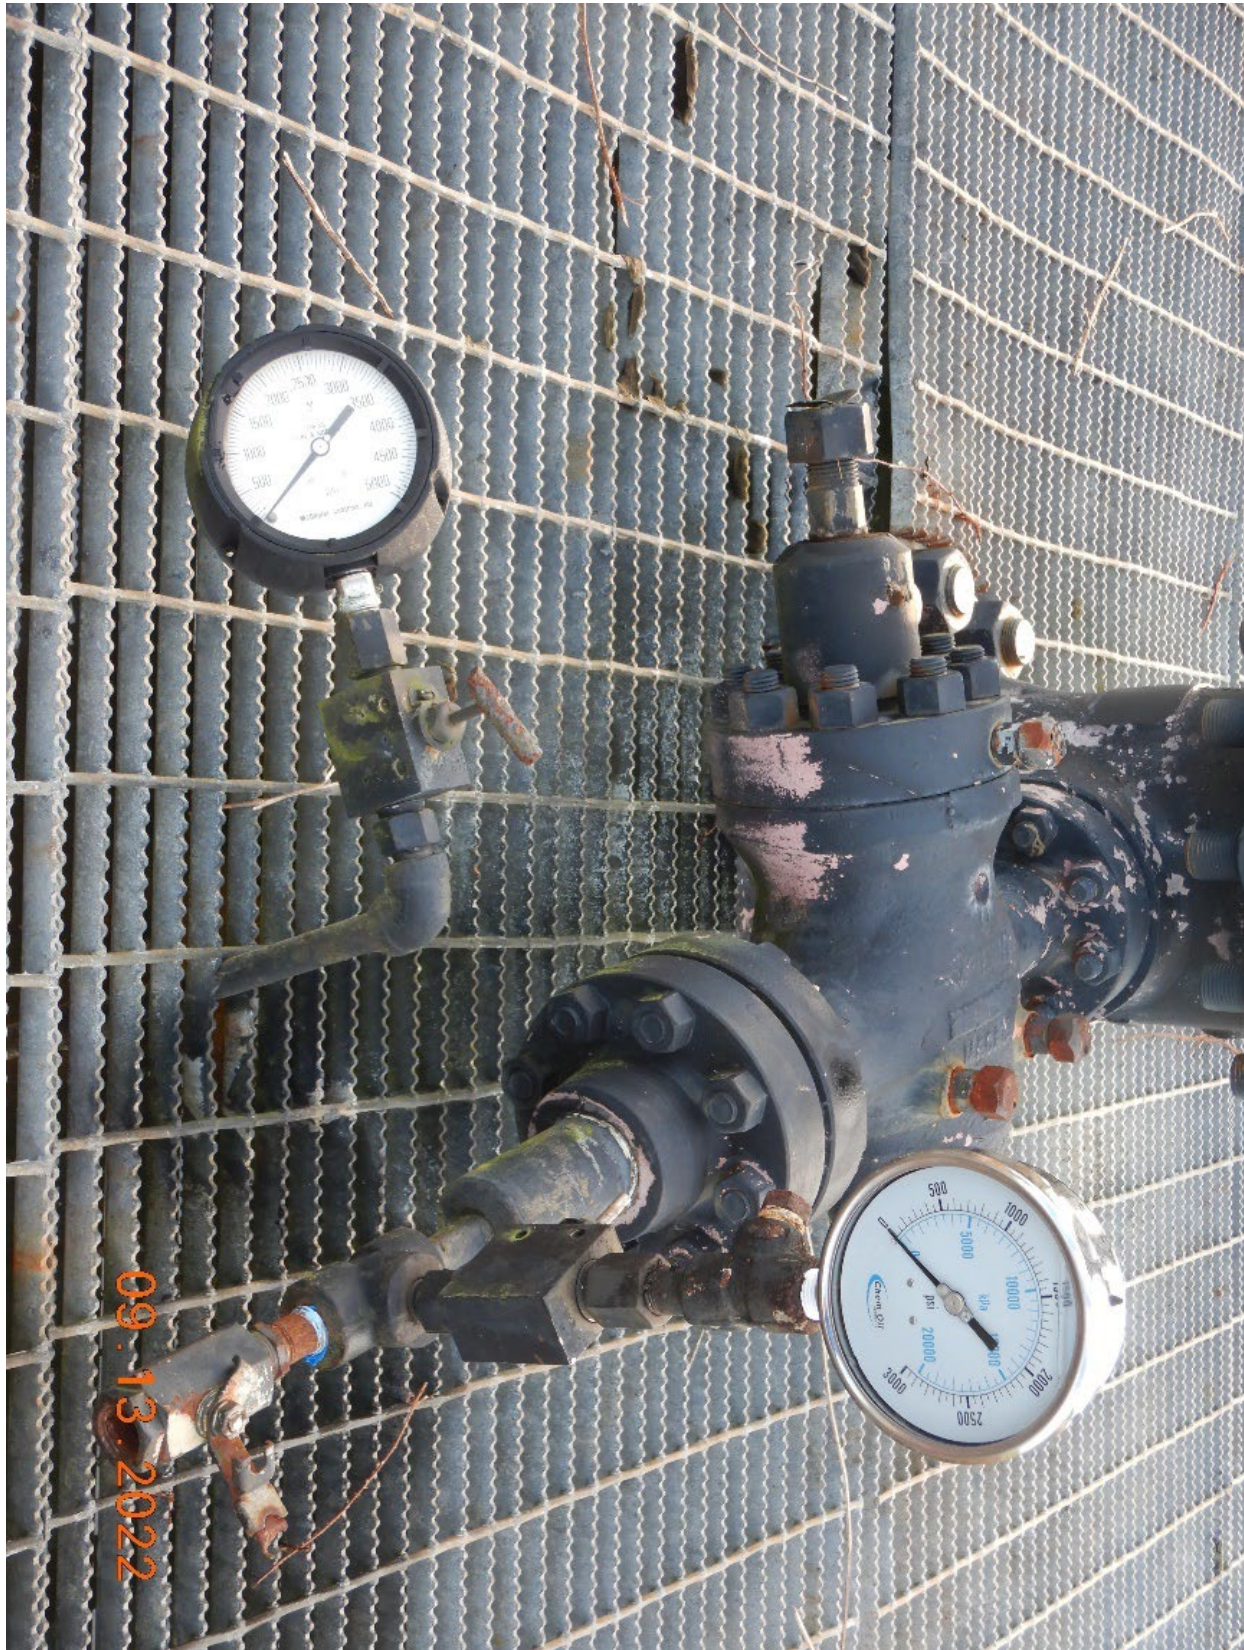
Description: *Looking east, closeup view of surface casing pressure gauge (left, reading 0 psi) and production casing pressure gauge (right, reading 0 psi).* \_\_\_\_\_

**Photograph 2:** Looking east, closeup view of surface casing pressure gauge (left, reading 0 psi) and production casing pressure gauge (right, reading 0 psi).

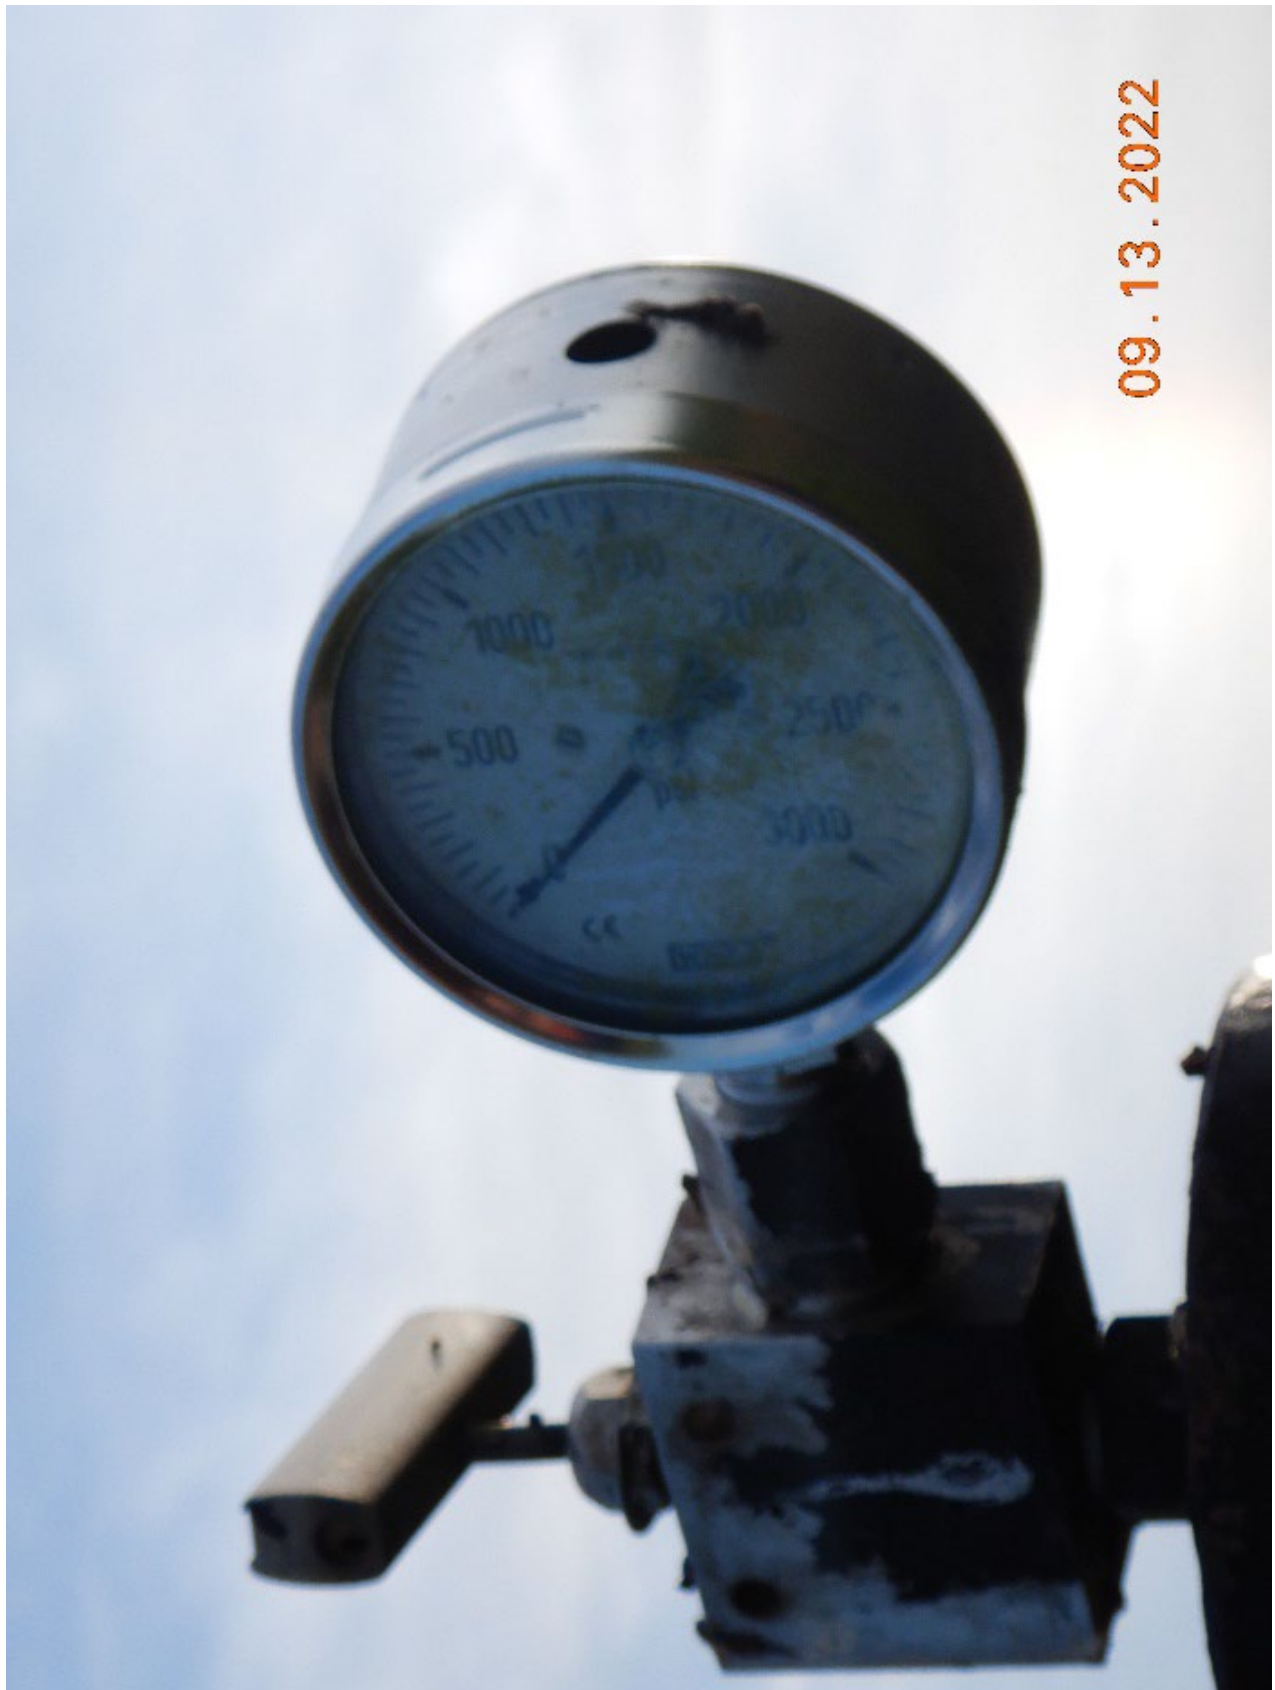
Description: *Looking northeast, closeup view of internal pressure gauge reading 0 psi.* \_\_\_\_\_

**Photograph 3:** Looking northeast, closeup view of internal pressure gauge reading 0 psi.
