**Region 6 - Enforcement & Compliance Assurance Division**  
**INSPECTION REPORT**

| Company Name: | Nevada Oil, LLC | |
| Facility Name: | Irma Nacatoch (Sand) Unit 26-A1 EOR Tank Battery | |

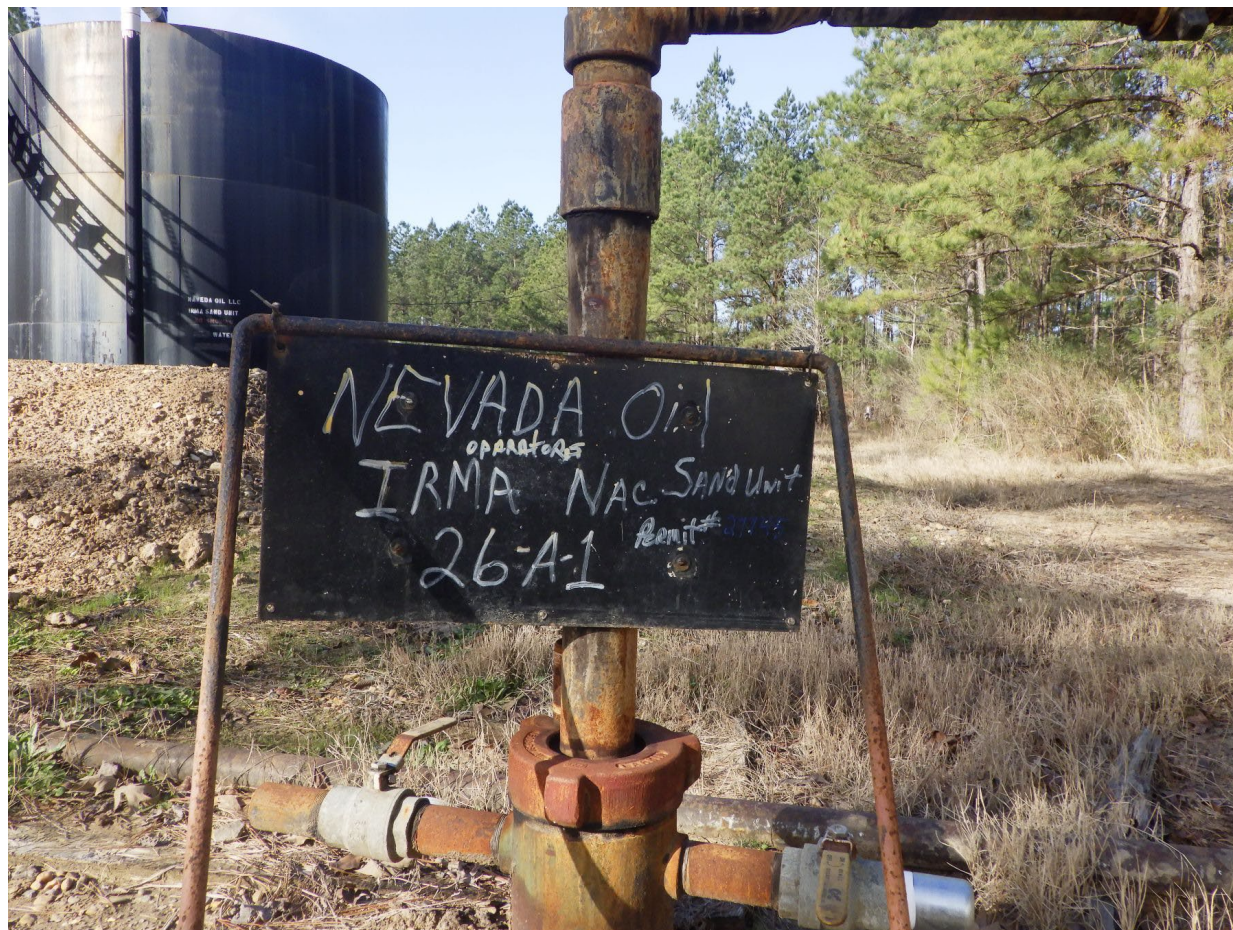
Photo No. 1

I observed the facility signage, tank battery, pipes and valves, storage tanks, and separators/treaters; see Appendix 1 (Photographs Log), see Photos No. 1 and No. 2. For additional GPS location and photo metadata, see Appendix 1.

| Description: | Looking WSW, this photo shows the signage at the Irma Nacatoch Sand Unit 26-A1 EOR Tank Battery ("facility"). | | |

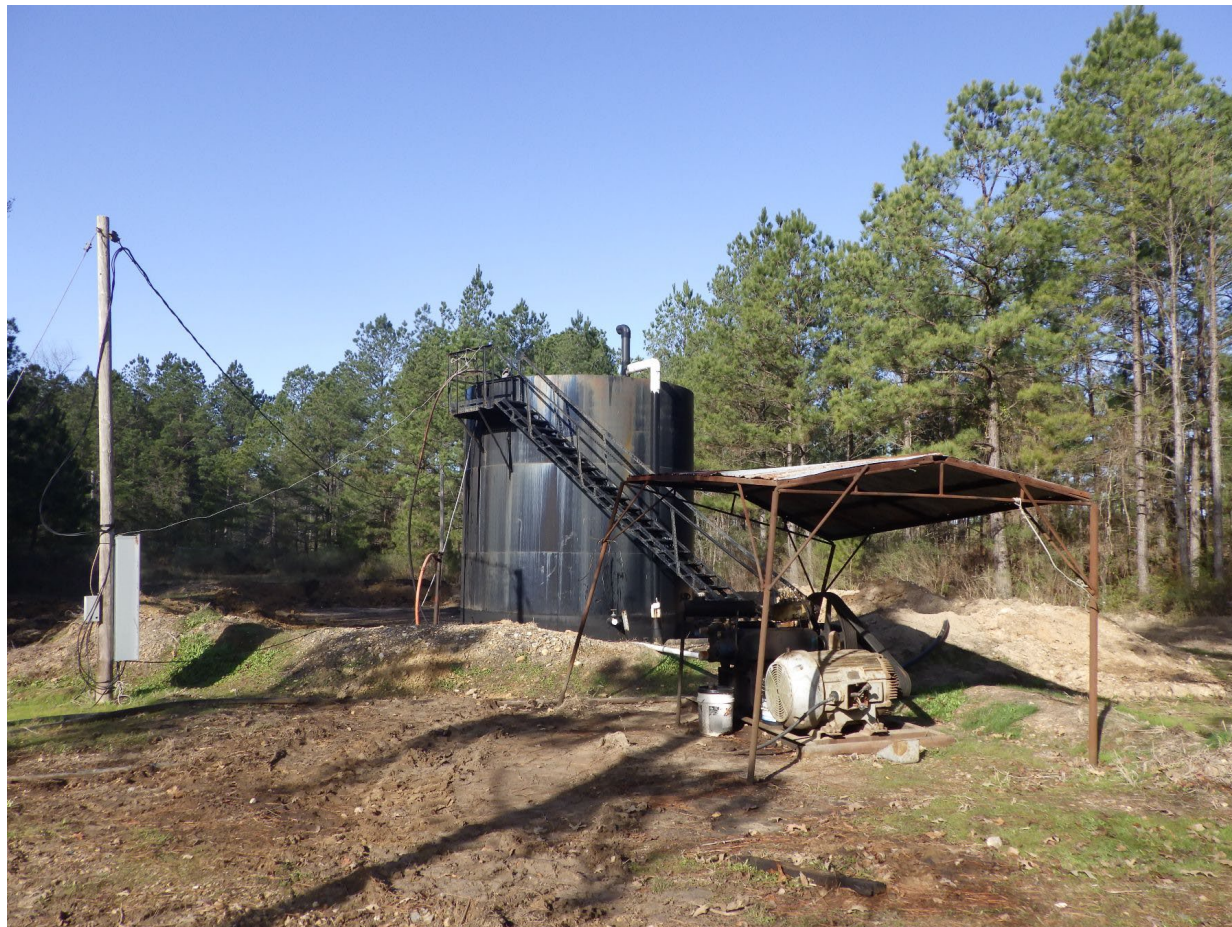
Photo No. 2

| Description: | Looking SW, this photo shows an overview of the facility. | | |

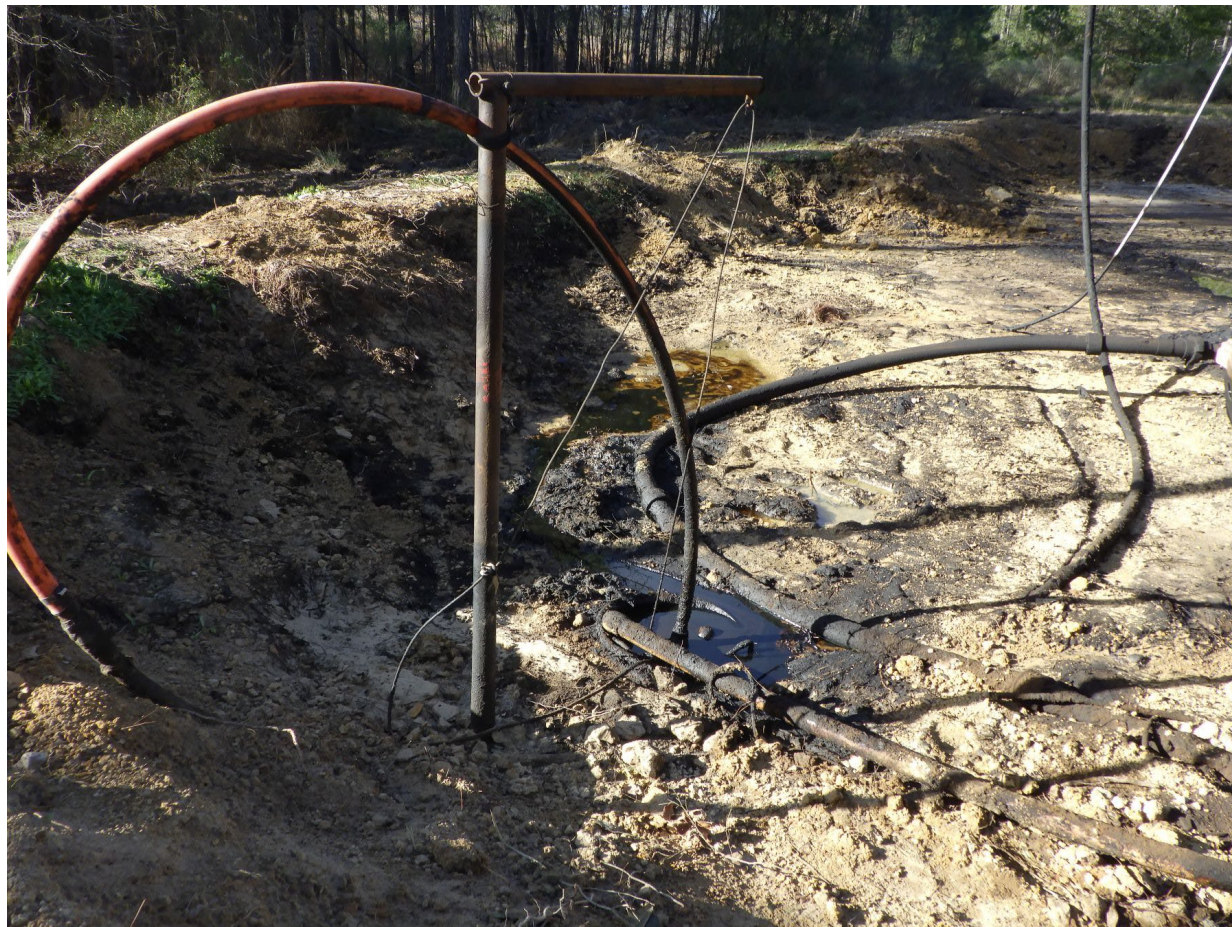
Photo No. 3

I observed the sump area and sump pump inside secondary containment with loose crude oil, Photo No. 3.

- Loose crude oil and saltwater inside secondary containment, 40 CFR 112.9(b)(1) (Photo No. 3).

| Description: | Looking SW, this photo shows the sump area with the sump pump. | | |

Inspector will conduct follow-up phone calls with the company representative(s) over the coming weeks and months to ensure areas of concern are properly addressed. SEE Inspector Tom McKay will address SPCC rule concerns.

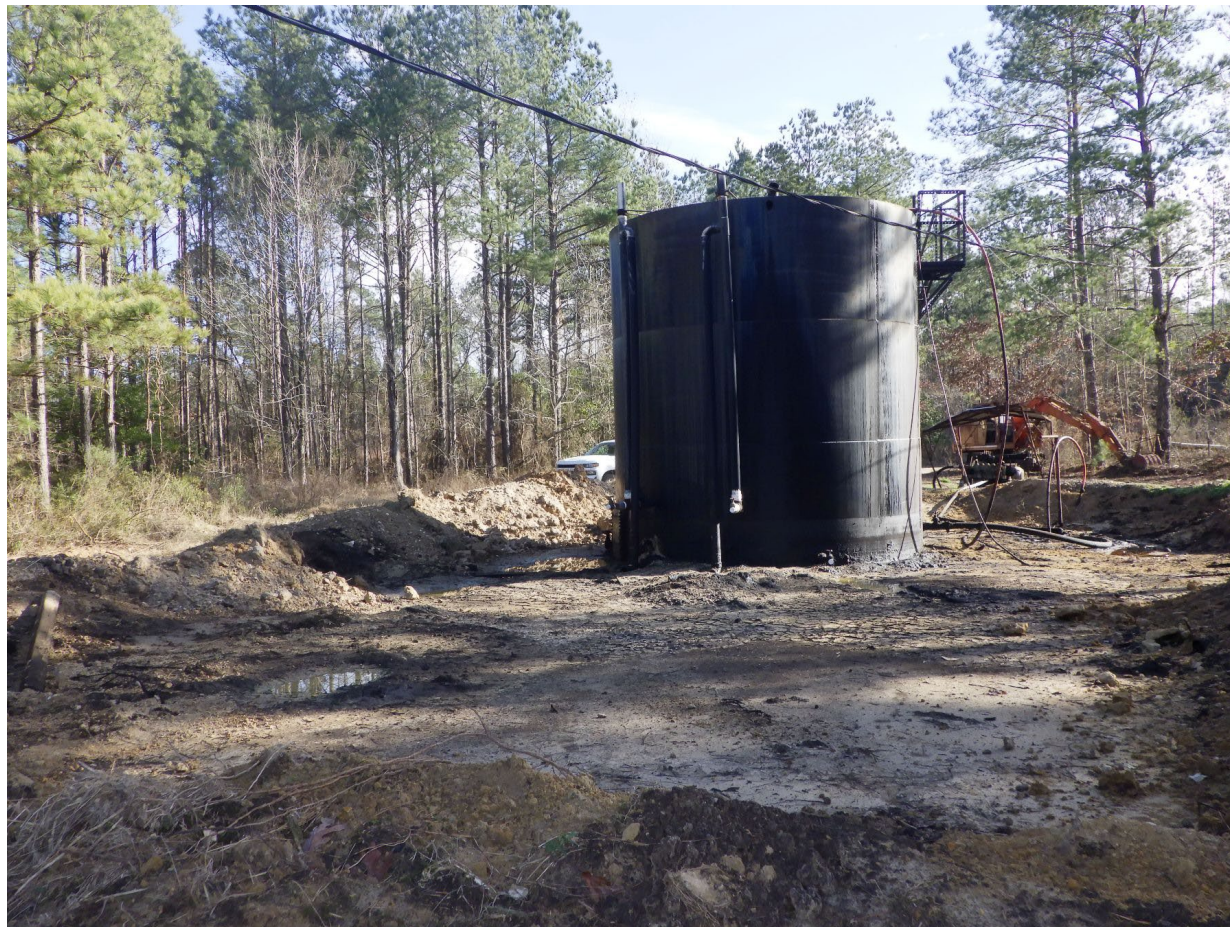
Photo No. 4

I observed the containment berm that Nevada Oil, LLC personnel extended since the 03/05/2025 inspection to contain the total volume of the saltwater tank, see Photo No. 4.

| Description: | Looking S, this photo shows the containment berm that Nevada Oil, LLC personnel extended to accommodate the volume of the saltwater storage tank. | | |
