**Region 6 Compliance Assurance and Enforcement Division**  
**INSPECTION REPORT**

| Company Name: | <b>Mora Independent School District</b> | | |
| Facility Name: | <b>Mora High School – Athletic Field Project</b> | | |

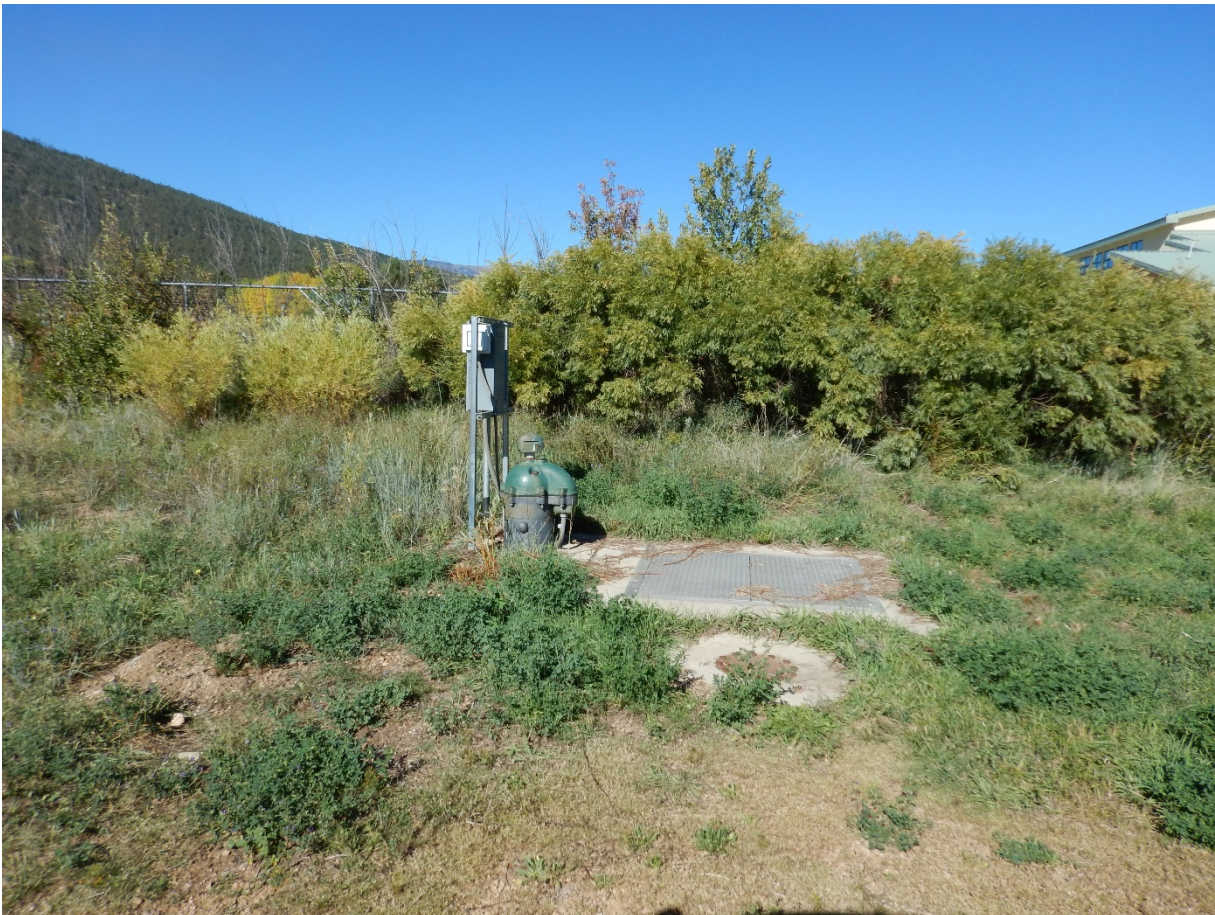
Photo No. 1

Description: Groundwater extraction well, with pump and flow meter, located at the Athletic Field.

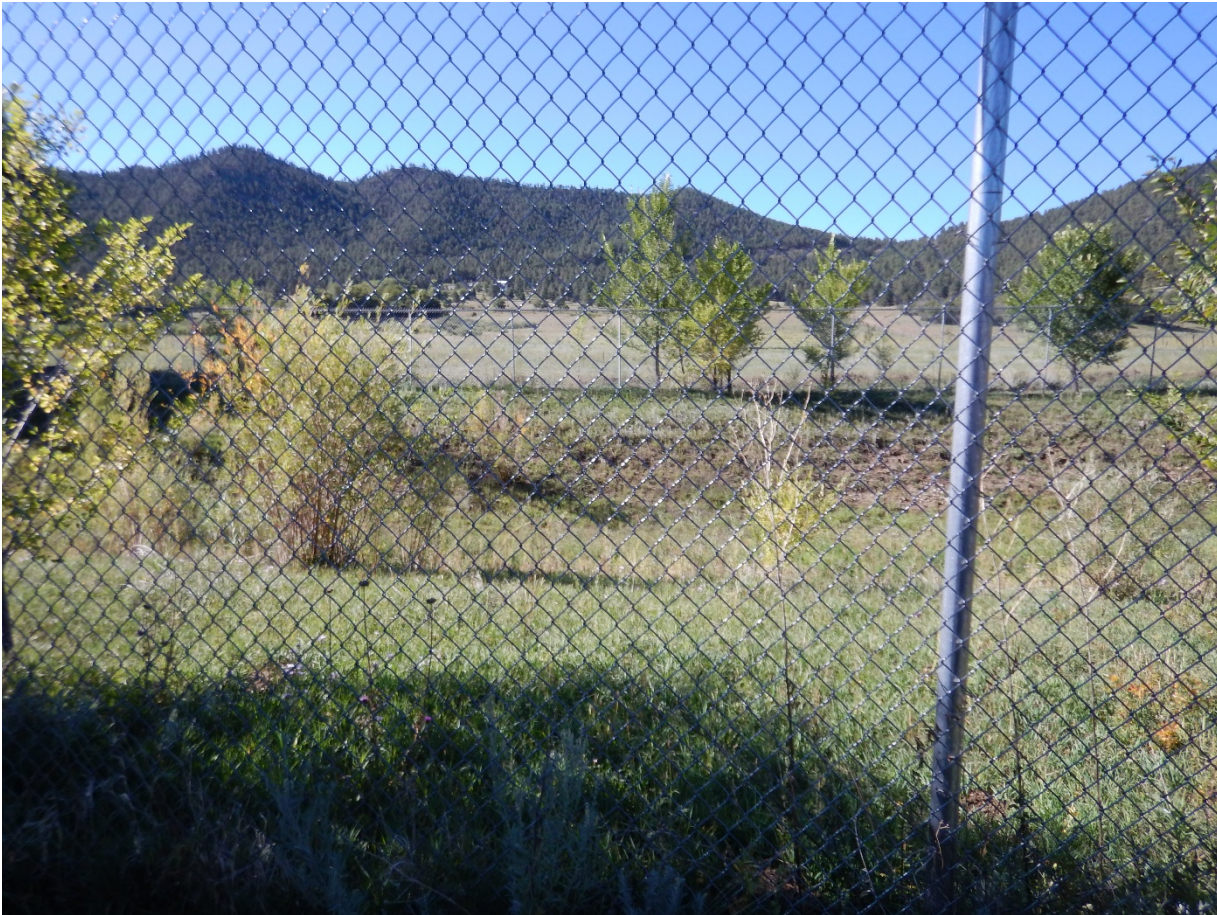
Photo No. 2

Description: Unlined reservoir where the groundwater is stored prior to being discharged to the river through Outfall 001.

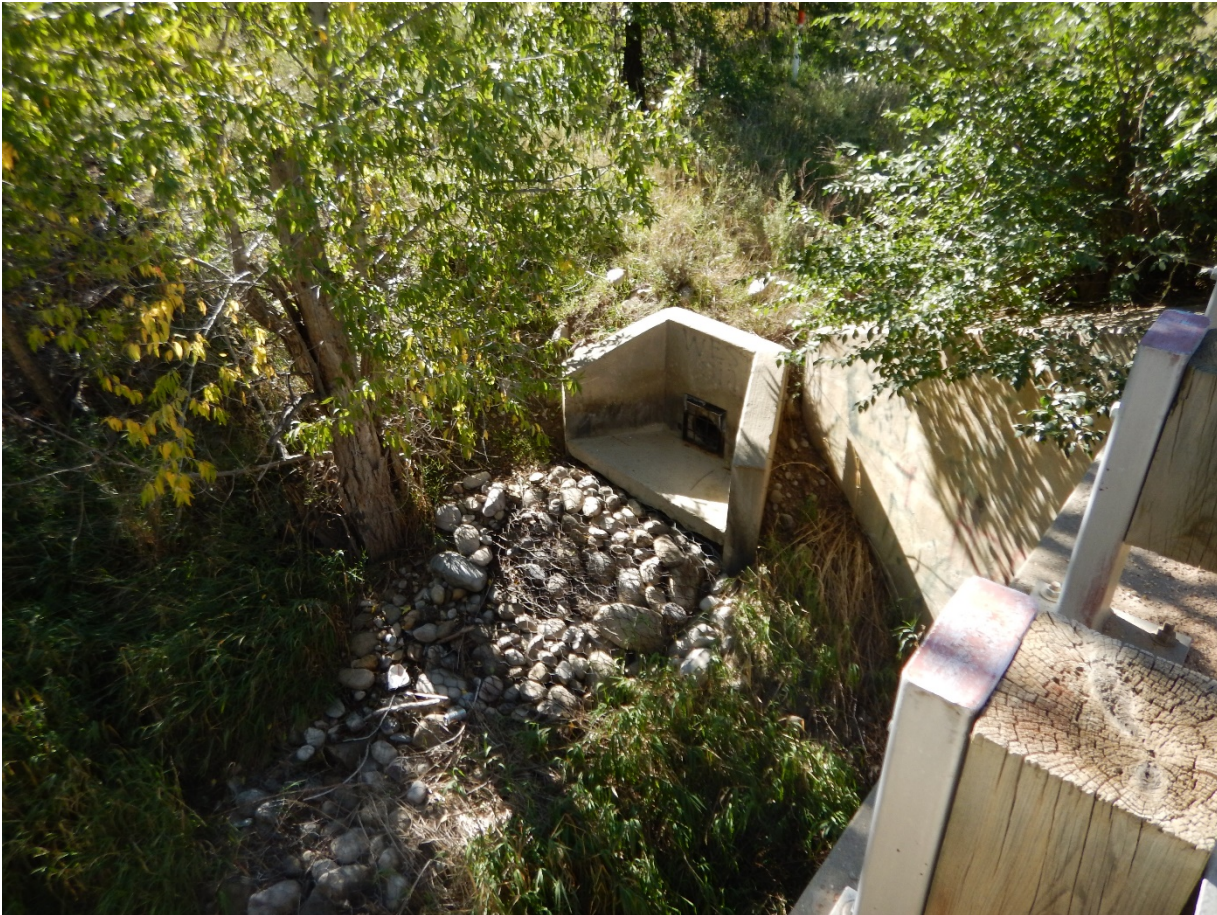
Photo No. 3

There is no flow meter on the discharge amount that flows through Outfall 001. Although each individual flow meter on each of the groundwater extraction wells qualifies as an appropriate flow measurement device in accordance with the above requirement, the summation of the flows recorded by the three well flow meters is not equal to the amount of water that is actually discharged to the Mora River, due to the presence of the reservoirs located between the wells and the discharge. Total flow amounts are recorded once a month from the groundwater wells. The original NPDES permit was issued September 2012, and the permittee has not reported on their DMRs that they have ever had a discharge (there are, however, a significant number of DMRs that were not received). Flow pumped out of the groundwater wells between 7/5/2017 and 8/4/2017 was recorded at 49,000 gallons total, however the permittee reported "NODI-4" on their DMRs, which stands for "no discharge, Discharge to Lagoon/Groundwater." Permittee verbally stated that the water was pumped out of the wells and into the reservoirs, but a once per day visual check confirmed that no water was discharged to the river out of Outfall 001. Flow pumped out of the groundwater wells between 8/4/2017 and 9/6/2017 was recorded at 19,000 gallons, and "NODI-C" was reported on the DMRs, which would mean that there was no discharge at all.

Description: Outfall 001, which discharges to the Mora River.
