**Region 6 - Enforcement & Compliance Assurance Division**  
**INSPECTION REPORT**

| Company Name: | <b>Bonds Company Production, LLC</b> | |
| Facility Name: | <b>Curry Lease Tank Battery</b> | |

Appendix 1 – Facility Photograph Log – 41 photos taken 03/05/2025.

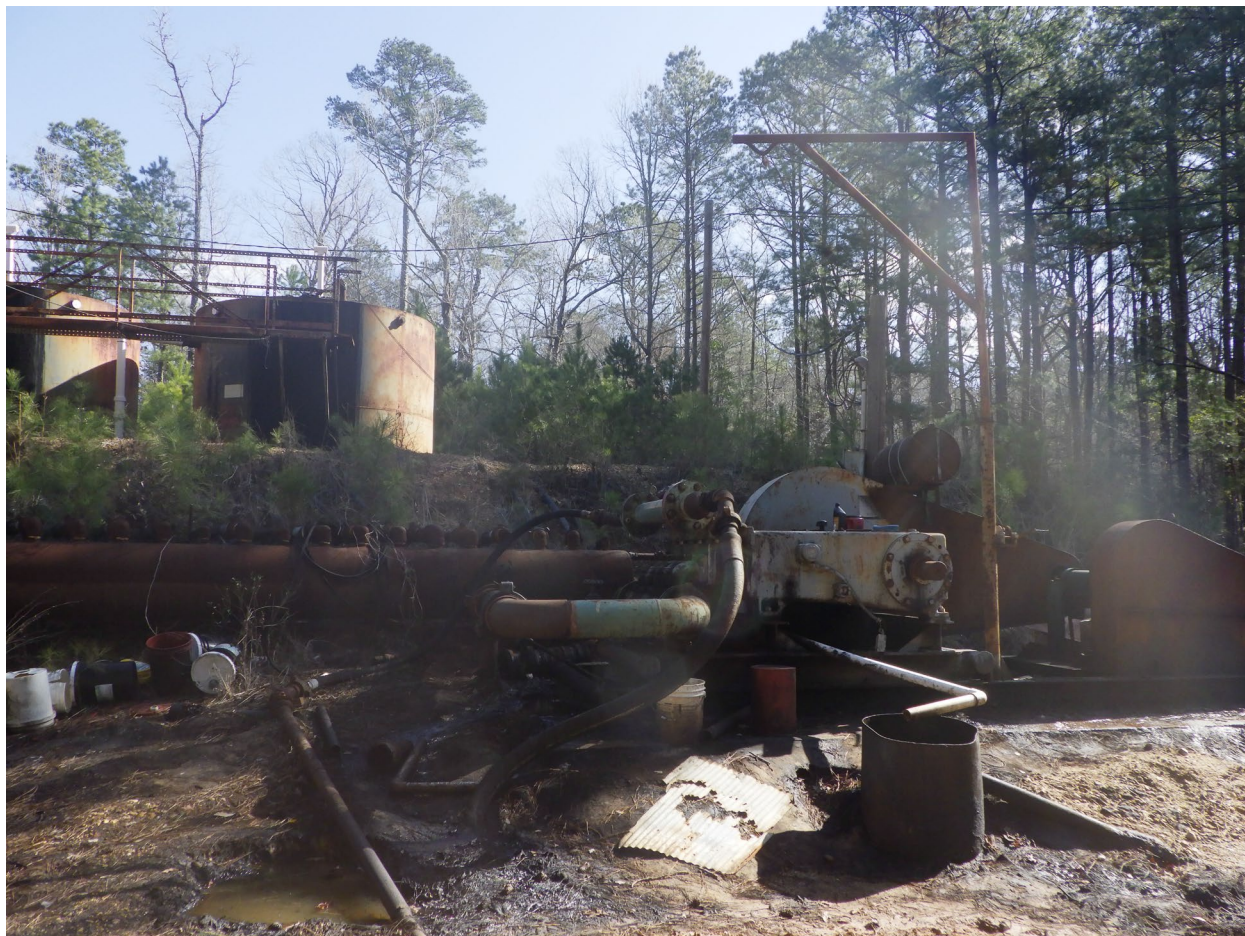
Photo No. 3

**Description:** Looking E, this photo shows the saltwater disposal (SWD) pump outside secondary containment with loose crude oil and saltwater observed on the ground.

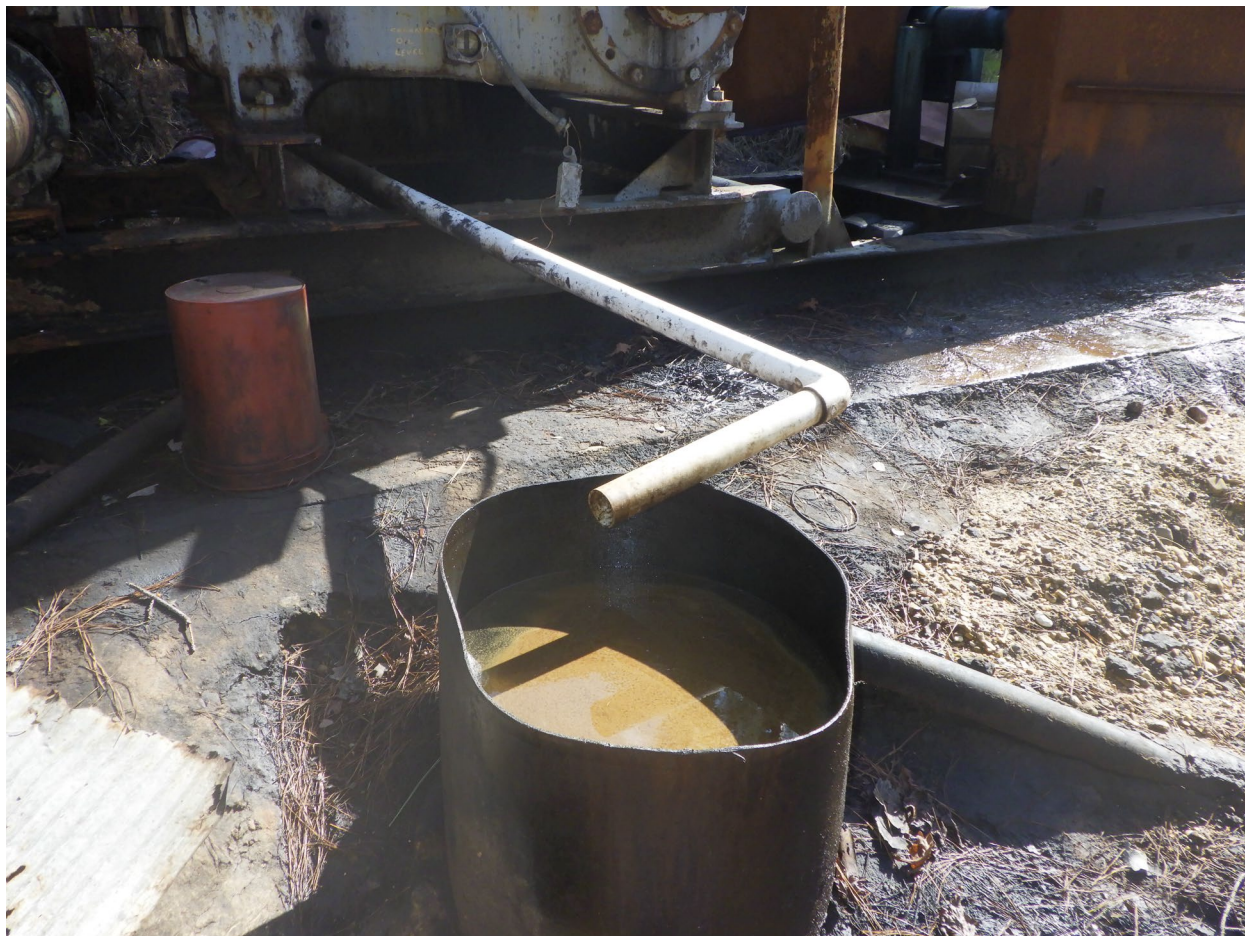
Photo No. 4

**Description:** Looking ENE, this photo shows an open-top catch bucket for the SWD pump outside secondary containment.

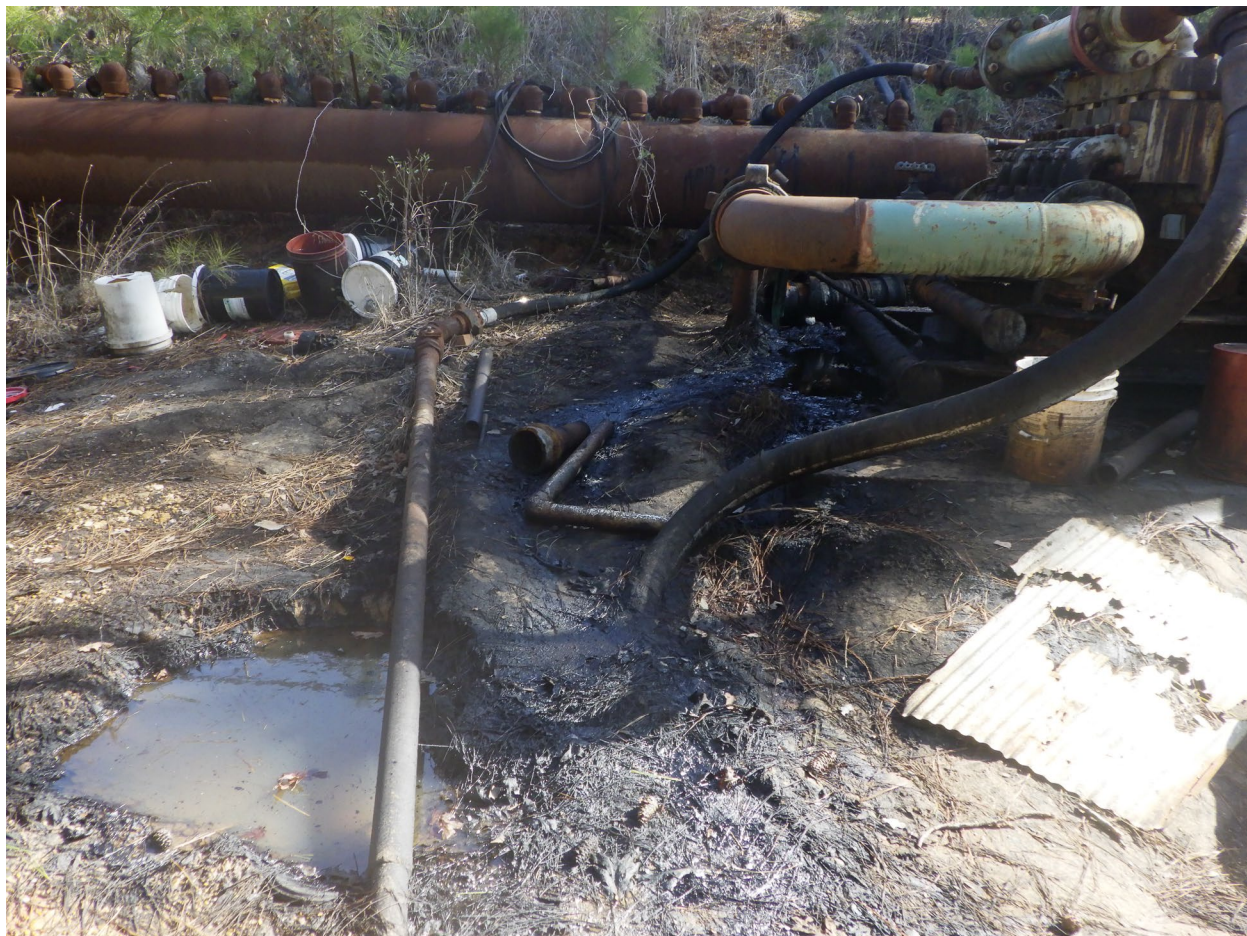
Photo No. 5

**Description:** Looking ENE, this photo shows loose crude oil and saltwater on the ground around the SWD pump.

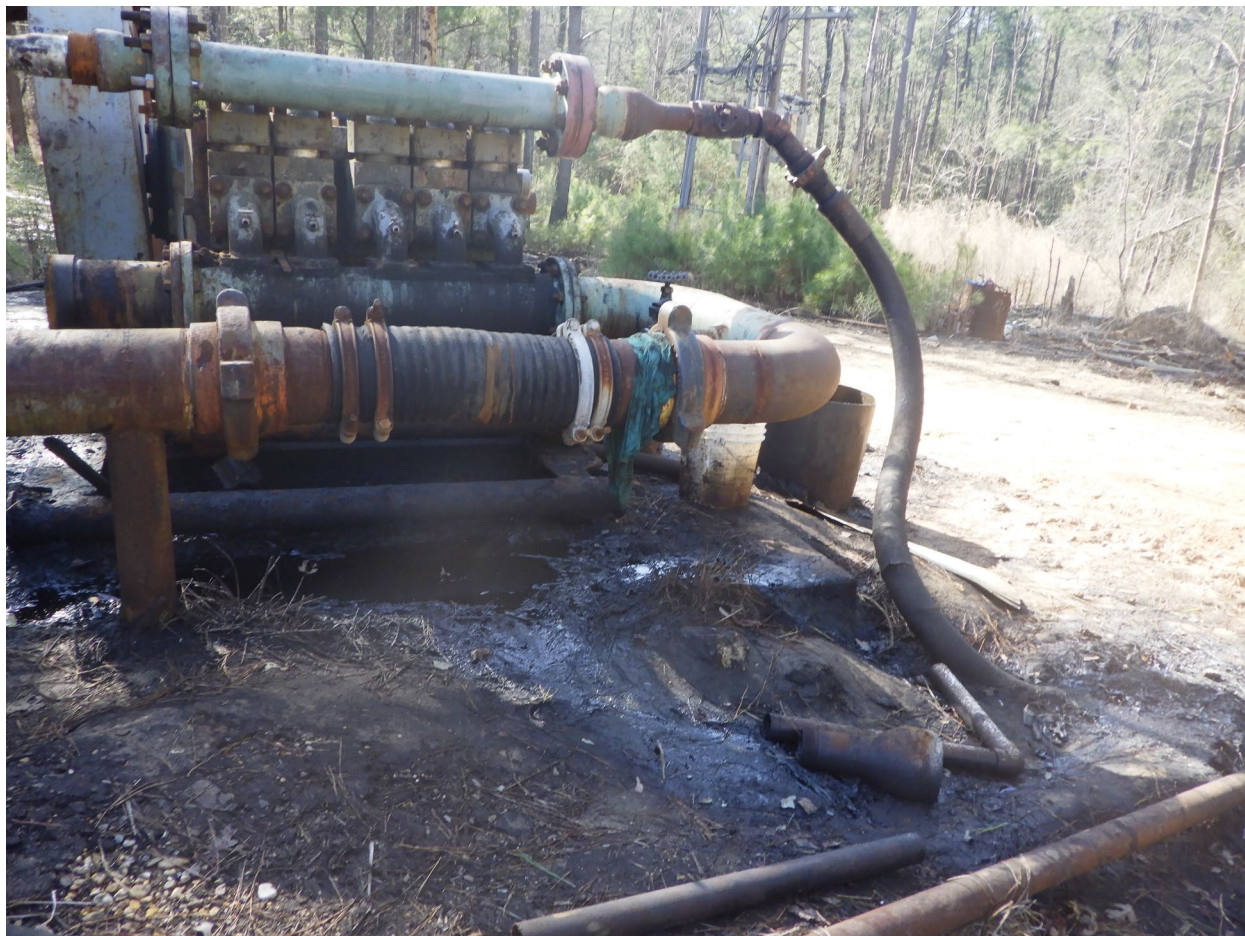
Photo No. 6

**Description:** Looking ESE, this photo shows an additional view of the loose crude oil and saltwater on the ground from the SWD pump.

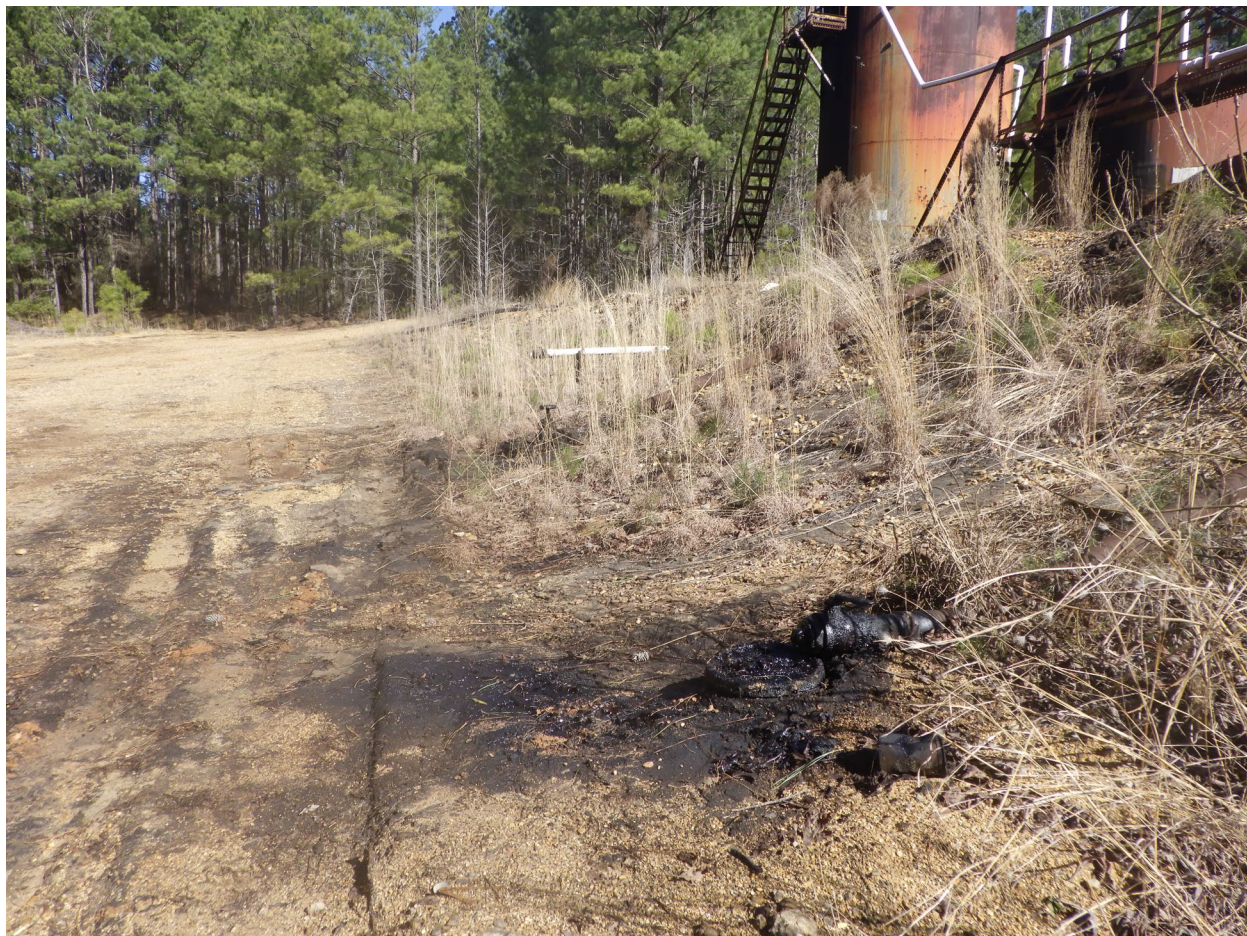
Photo No. 7

**Description:** Looking NNE, this photo shows the transfer lines for the crude oil tanks with subsurface catchment buckets for two of the three pipes.

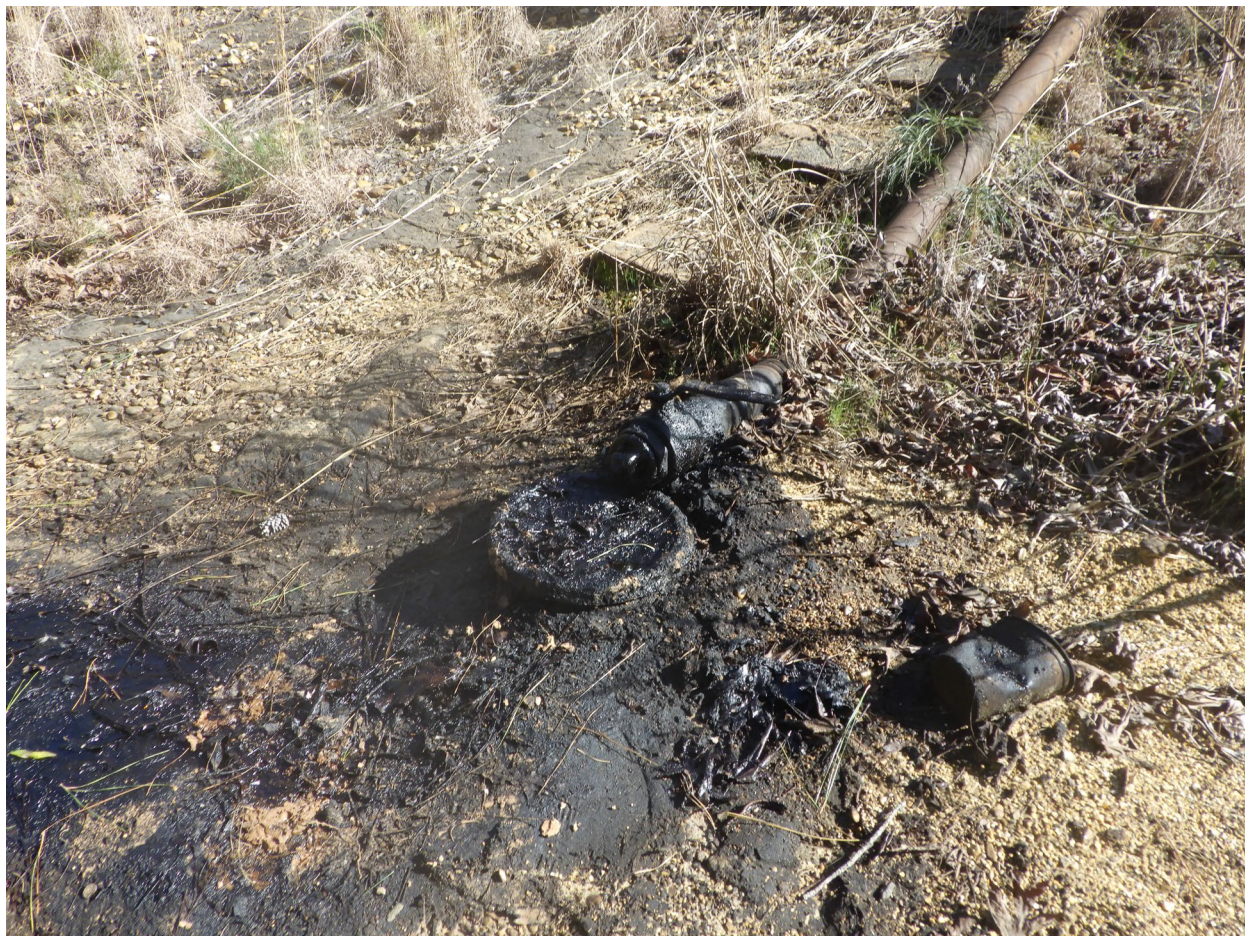
Photo No. 8

**Description:** Looking NE, this photo shows one transfer pipe with a subsurface catchment bucket with loose crude oil on the ground.

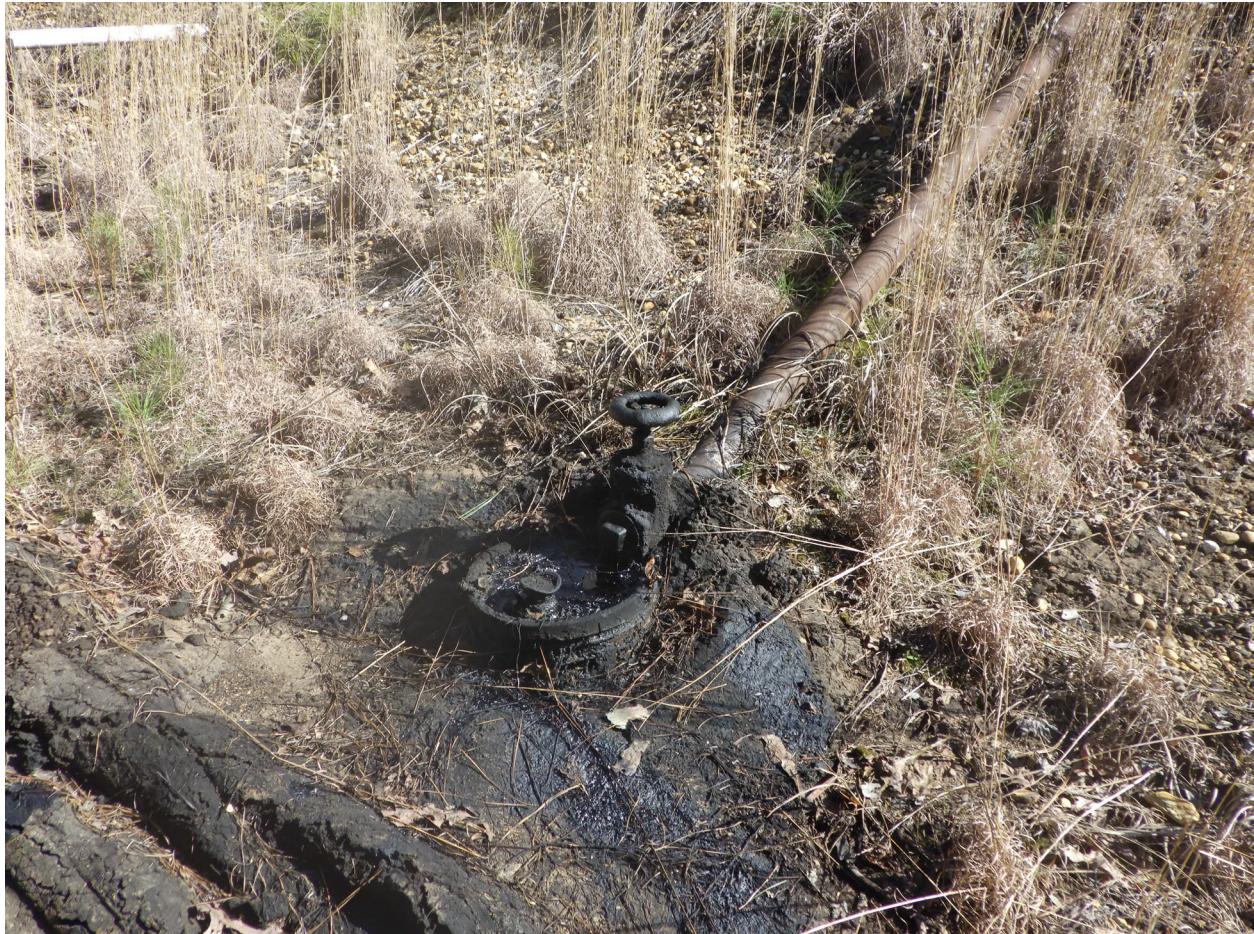
Photo No. 9

**Description:** Looking NE, this photo shows an additional transfer pipe with a subsurface catchment bucket with loose crude oil on the ground.

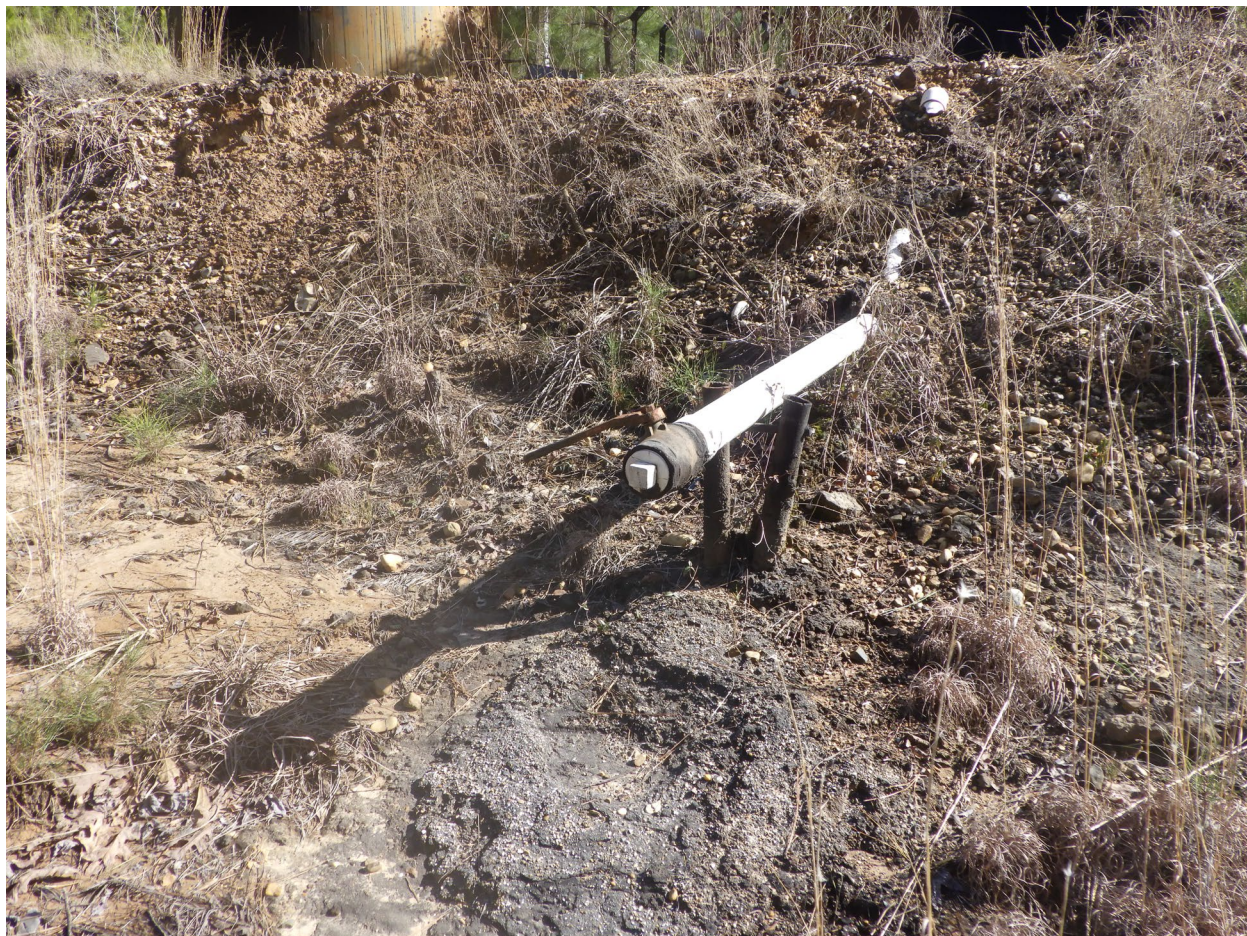
Photo No. 10

**Description:** Looking ENE, this photo shows an additional transfer pipe without a catchment bucket.

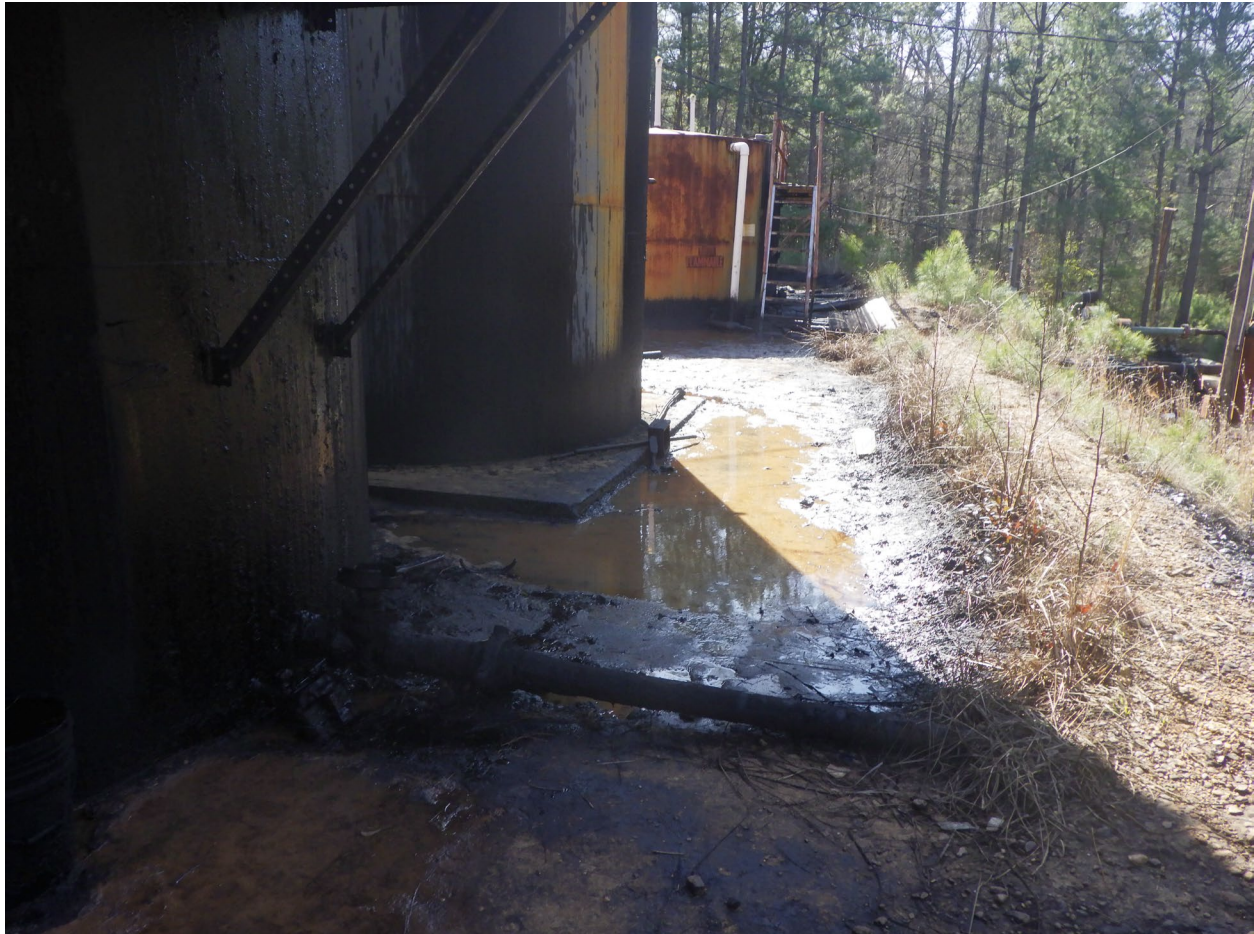
Photo No. 11

**Description:** Looking ESE, this photo shows the inside of the secondary containment (front view; right) with loose crude oil and saltwater.

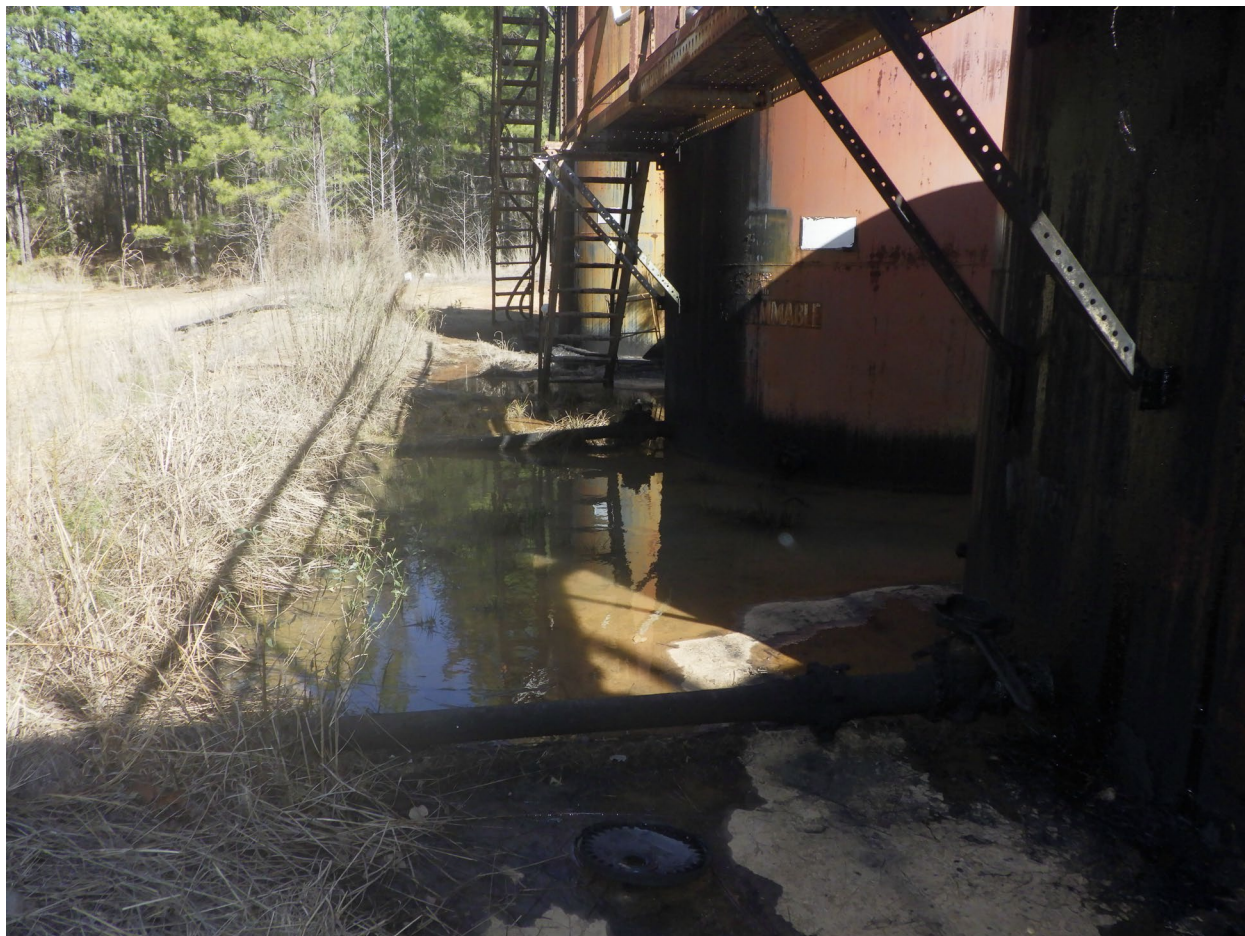
Photo No. 12

**Description:** Looking NNE, this photo shows the inside of the secondary containment (front view; left) with loose crude oil and saltwater.

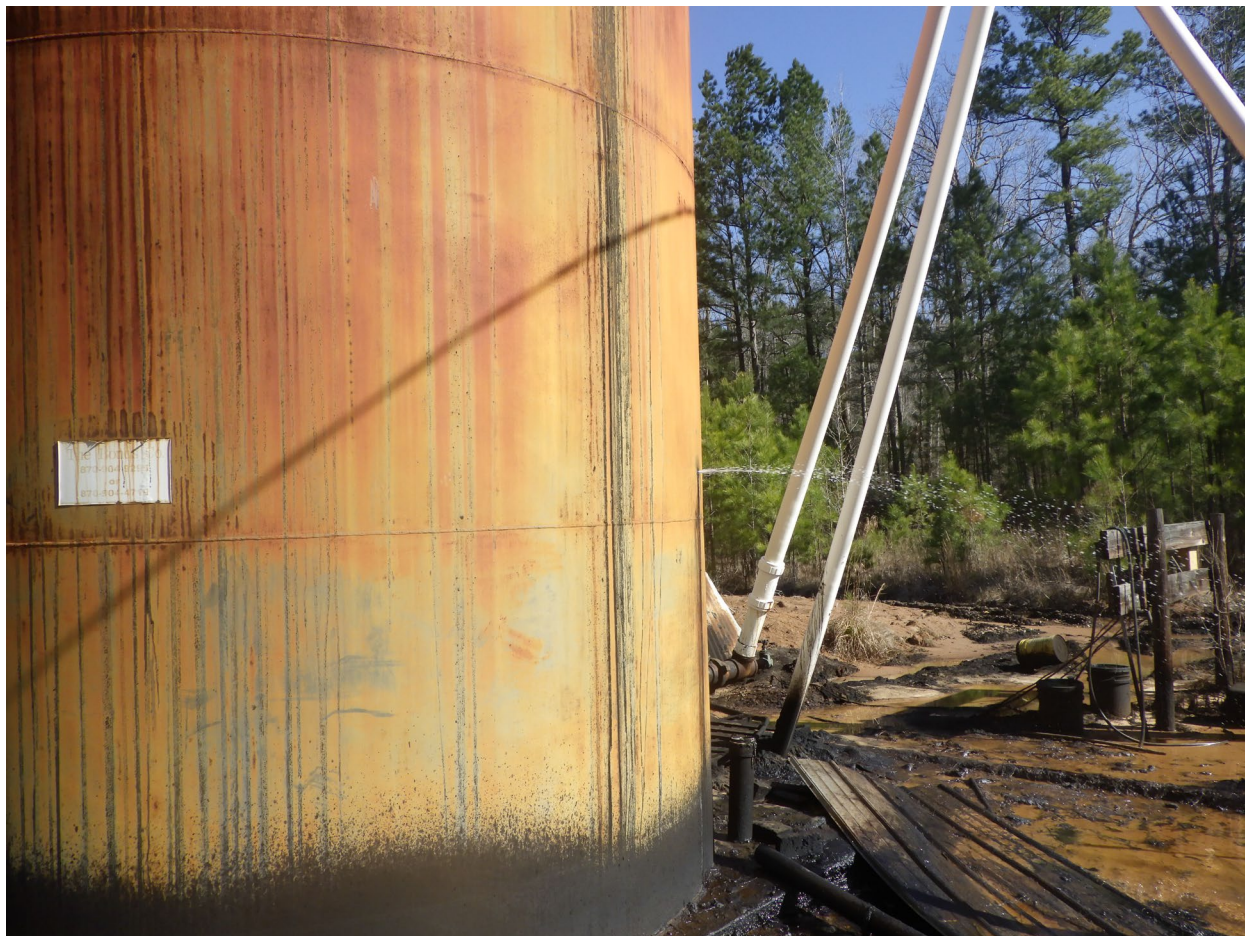
I observed a saltwater storage tank with a hole that was actively leaking, see Photos No. 13 and No. 14. I observed a flowpath caused by the discharge of saltwater from the secondary containment drainpipe to the point of entry into the unnamed tributary of Cypress Creek, see Appendix 2.

**Description:** Looking ENE, this photo shows a saltwater storage tank that was actively leaking inside secondary containment.

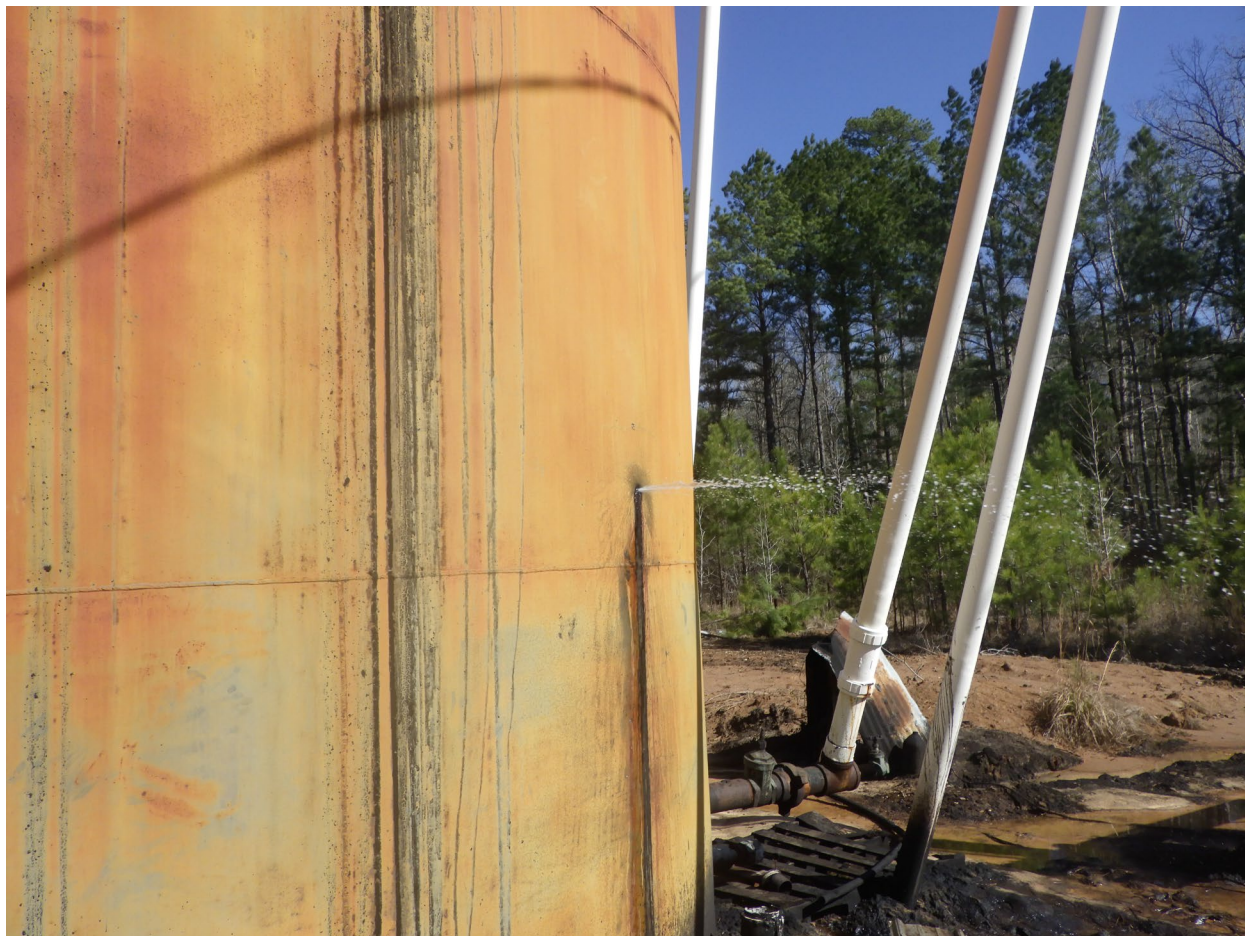
**Description:** Looking NE, this photo shows an additional view of the saltwater storage tank from Photo No. 13 that was actively leaking inside secondary containment.

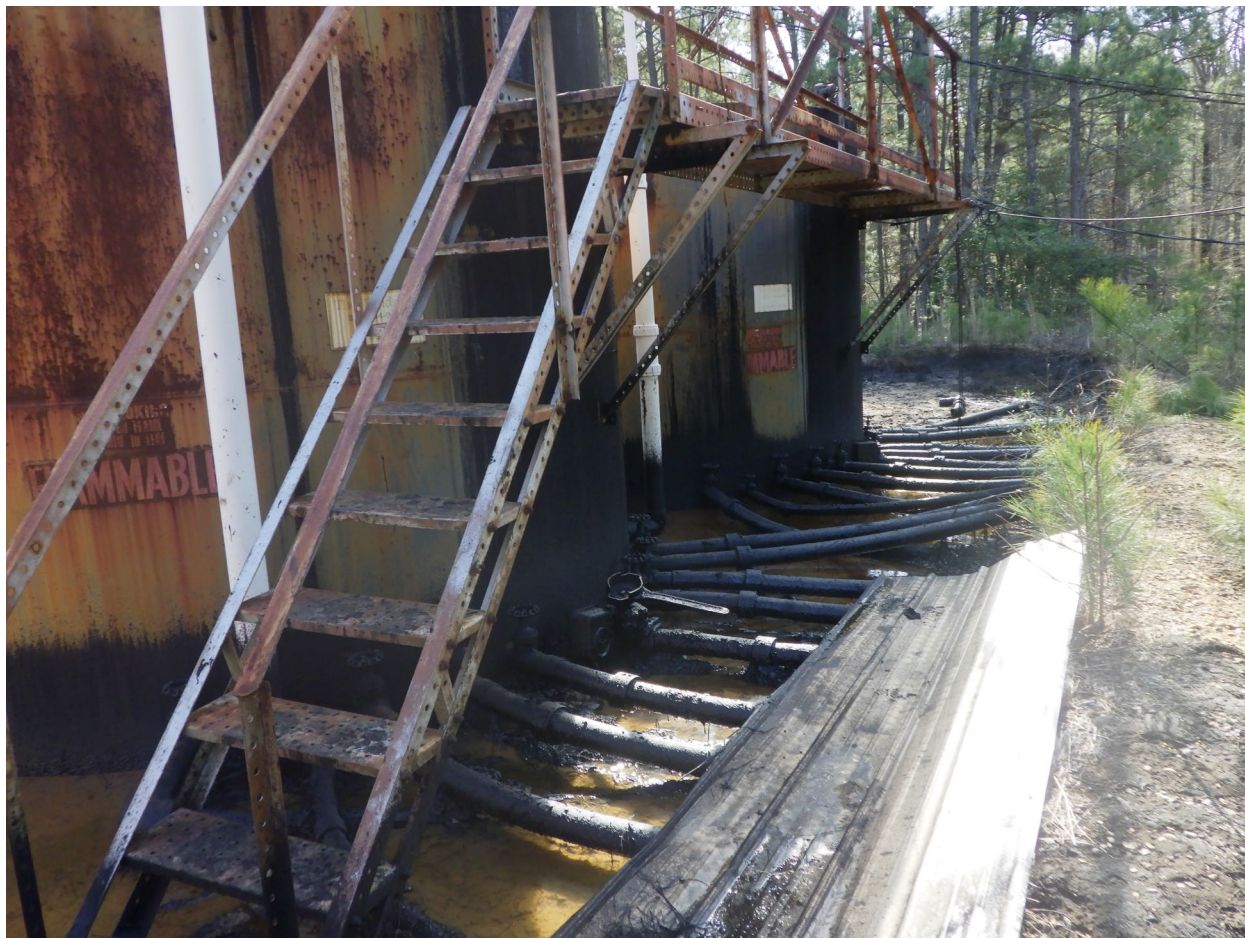
**Description:** Looking ESE, this photo shows the inside of the secondary containment (front view; right) with loose crude oil and saltwater.

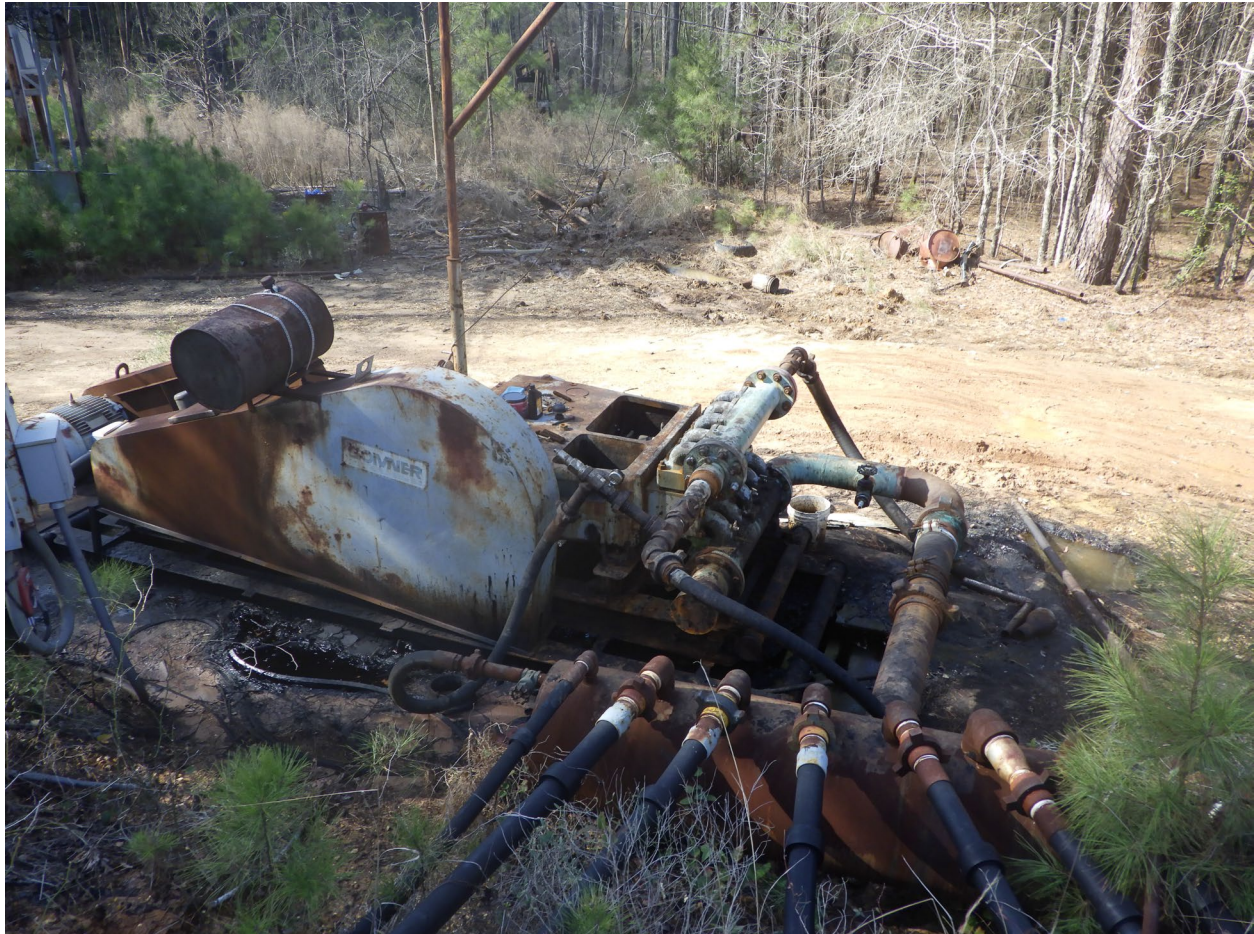
**Description:** Looking SSE, this photo shows an additional (top view) of the SWD pump outside secondary containment with loose crude oil and saltwater.

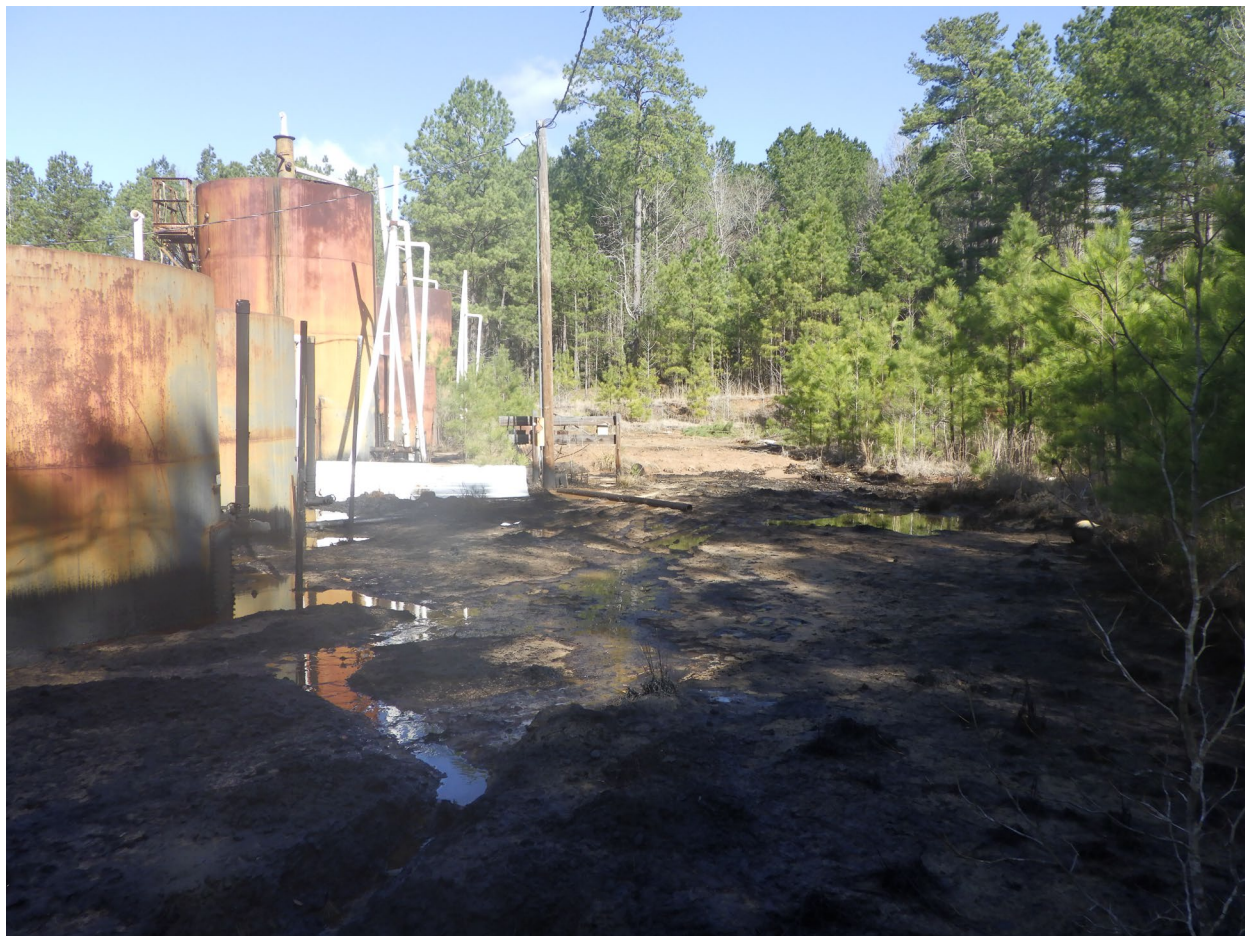
**Description:** Looking NNE, this photo shows an overview of the backside of the secondary containment with loose crude oil and saltwater.

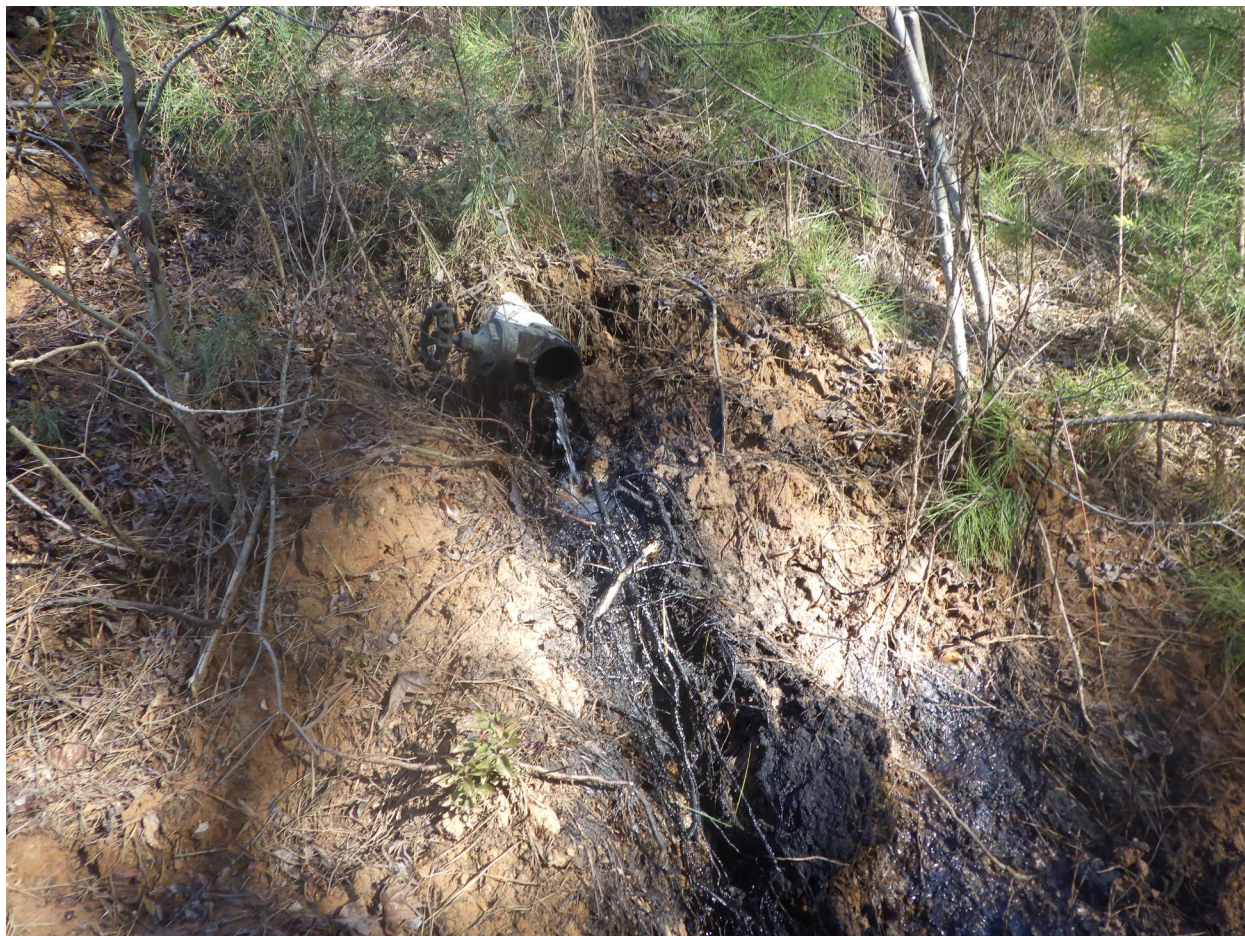
**Description:** Looking NNE, this photo shows the drainpipe for secondary containment that was open and actively releasing loose saltwater. Note residual loose crude oil at drainpipe.

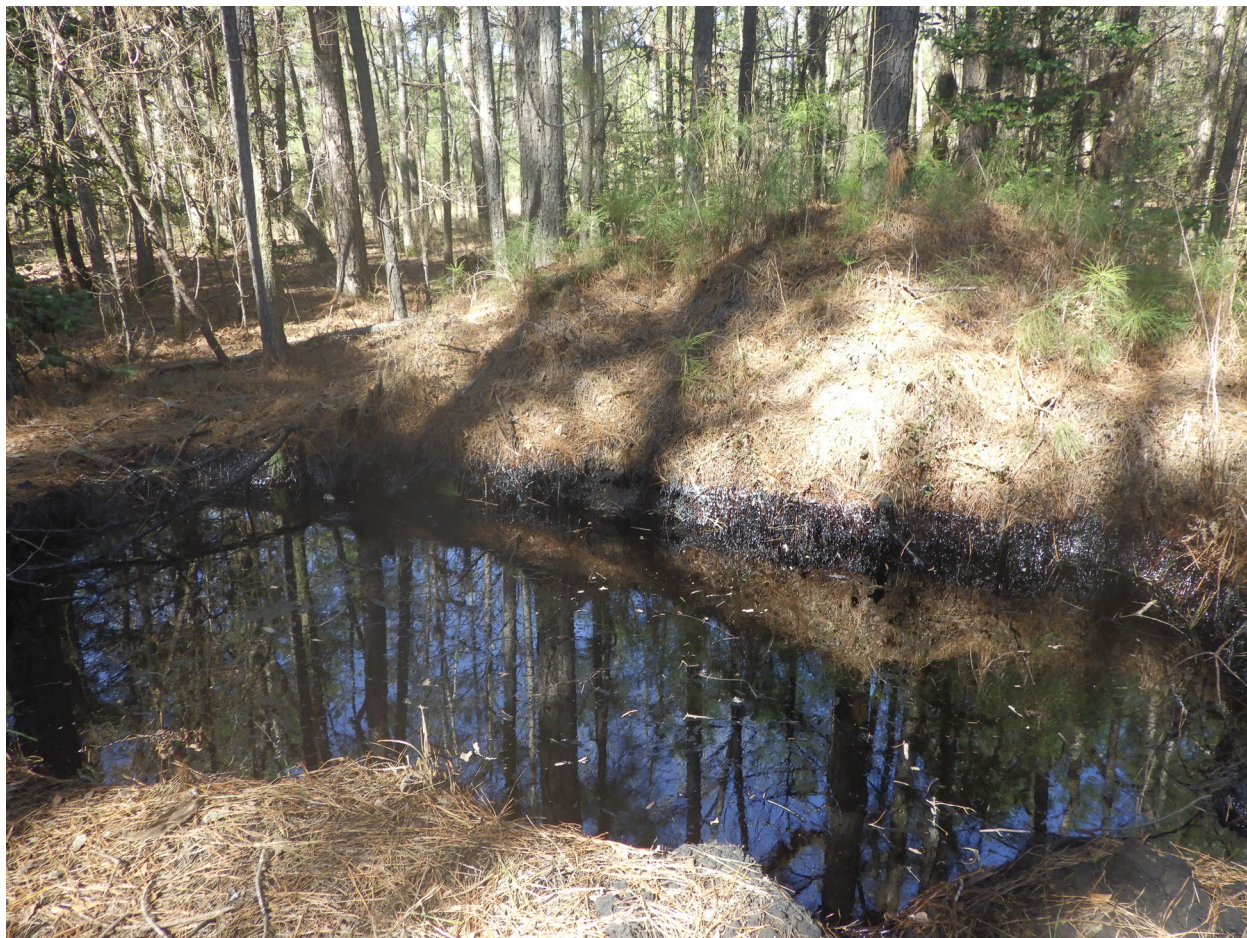
**Description:** Looking WNW, this photo shows a pit next to the production well from Photo No. 24 that contained loose crude oil.

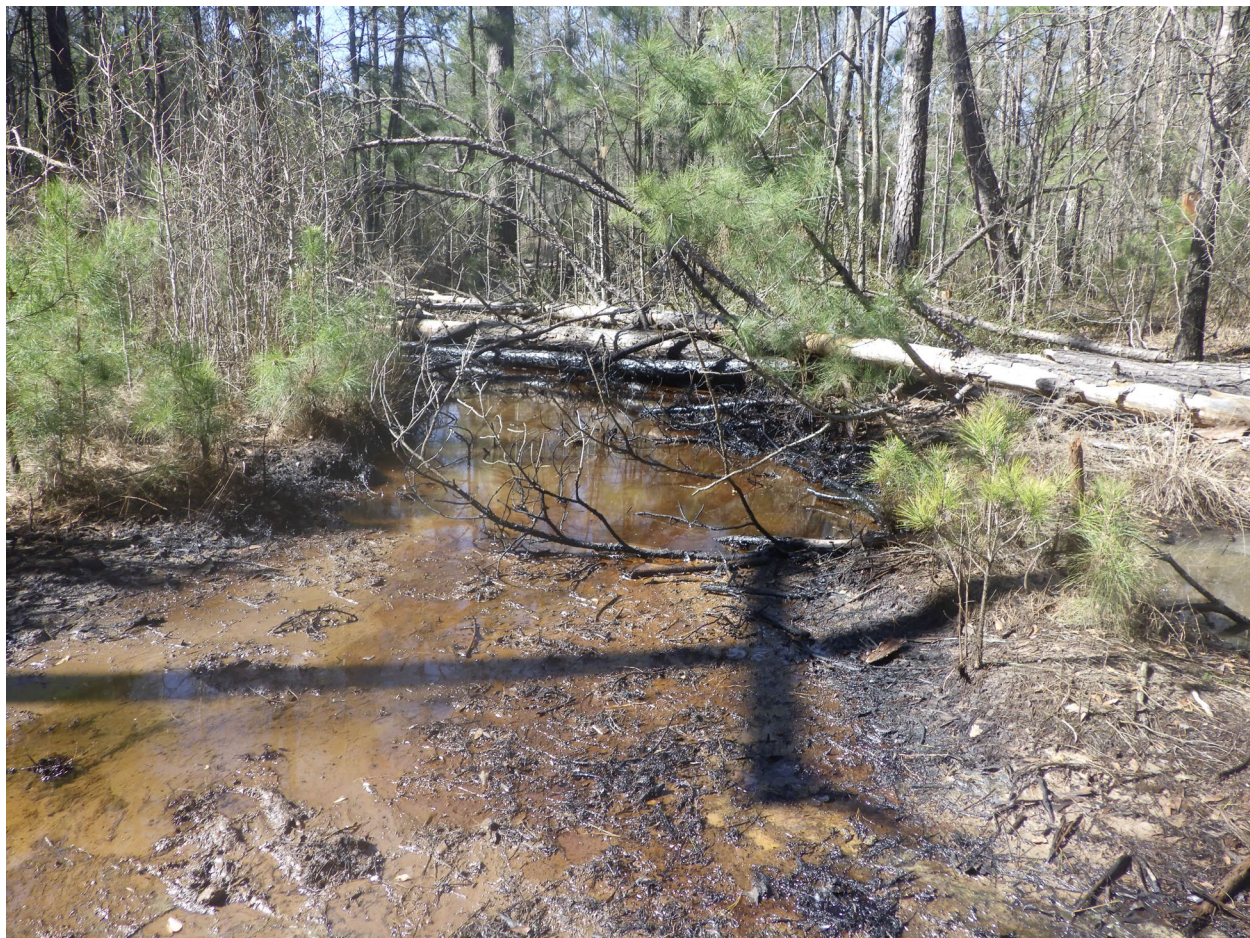
**Description:** Looking WSW, this photo shows loose crude oil and saltwater adjacent to the facility (see Photo No. 16 for frame of reference).

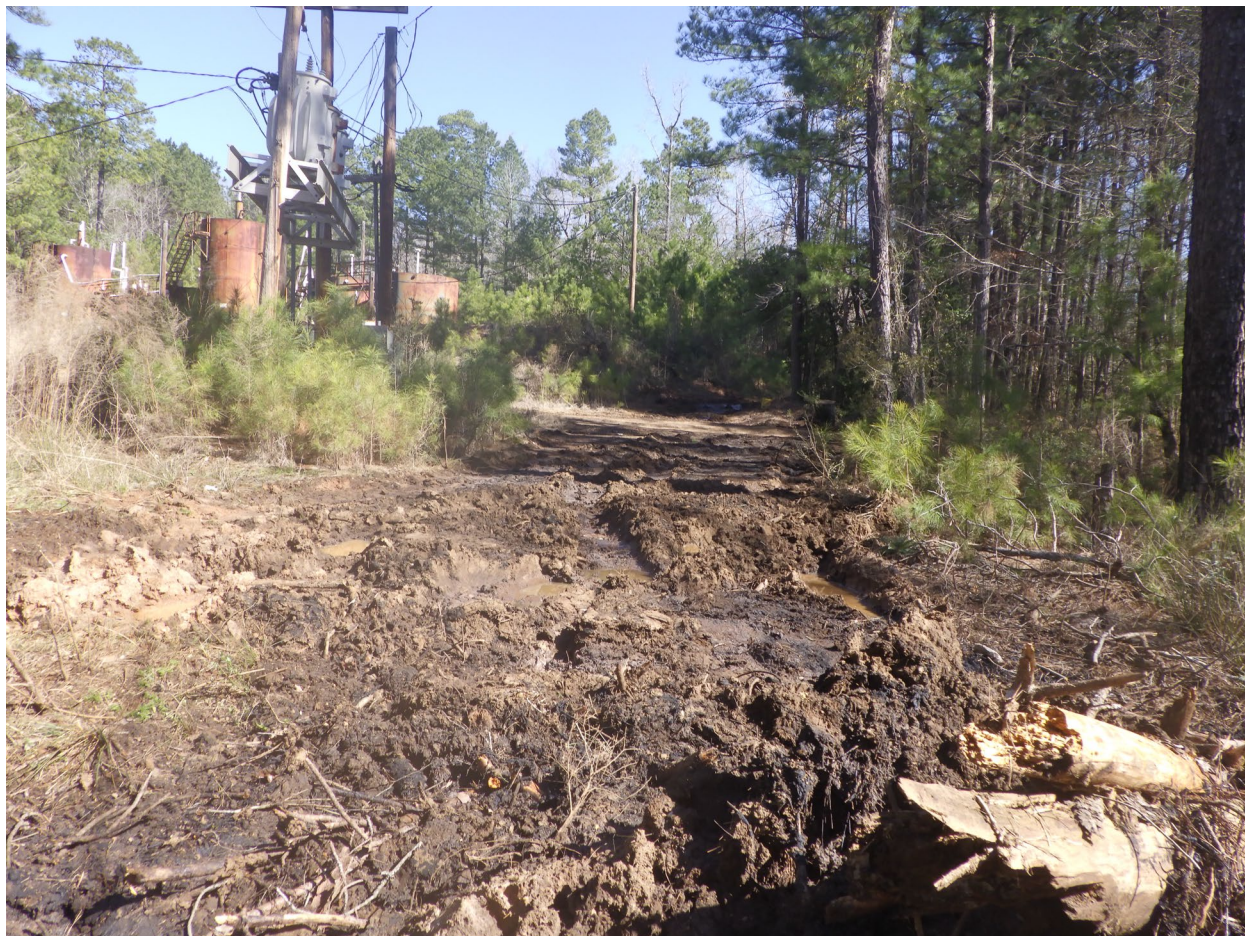
**Description:** Looking NE, this photo shows the proximity of the loose crude oil and saltwater from Photo No. 26 to the facility.
