**Region 6 - Enforcement & Compliance Assurance Division**  
**INSPECTION REPORT**

| Company Name: | <b>Bonds Company Production, LLC</b> | |
| Facility Name: | <b>Curry Lease Tank Battery</b> | |

Appendix 1 – Facility Photograph Log – 41 photos taken 03/05/2025.

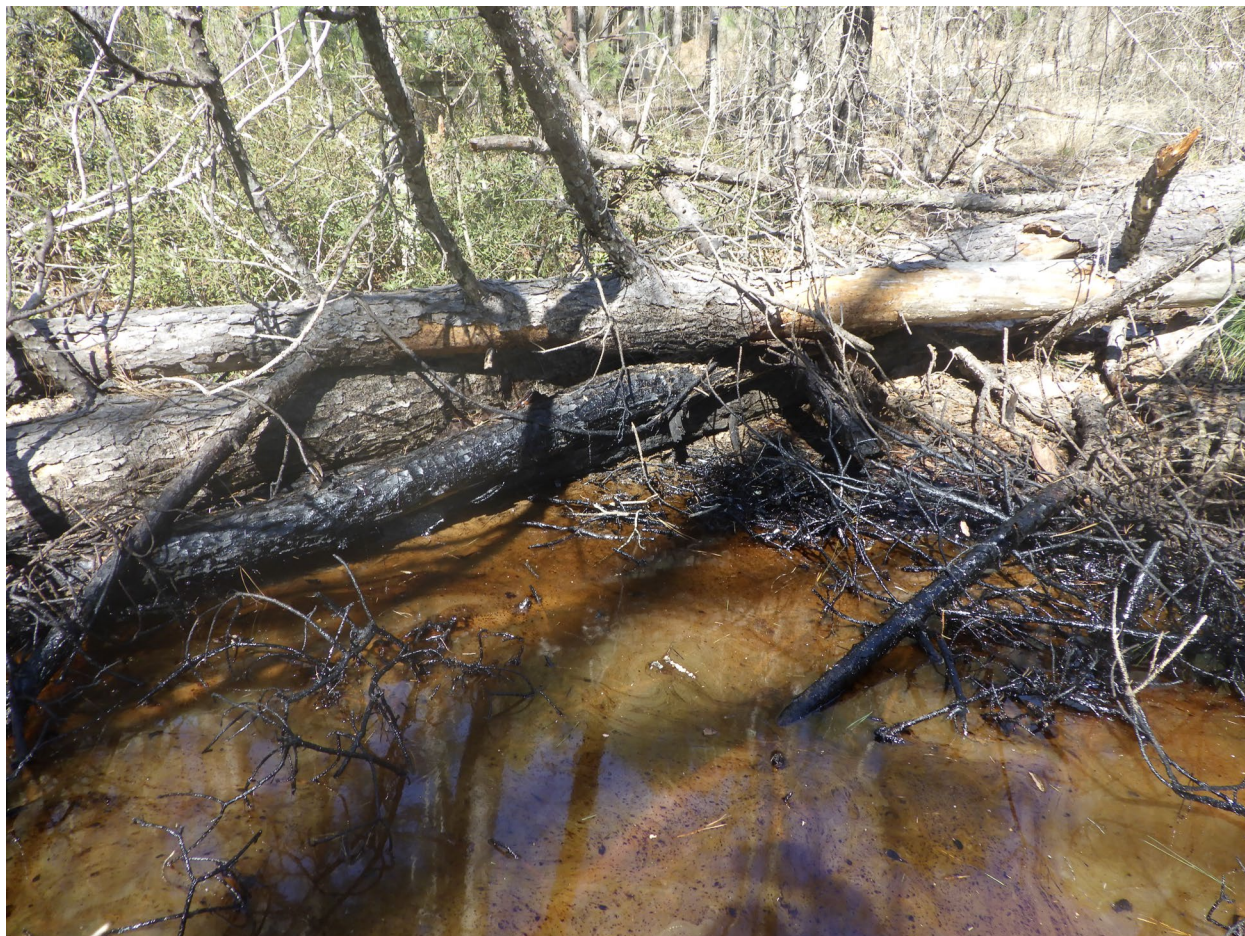
**Description:** Looking N, this photo shows a closeup of the loose crude oil and saltwater from Photo No. 26.

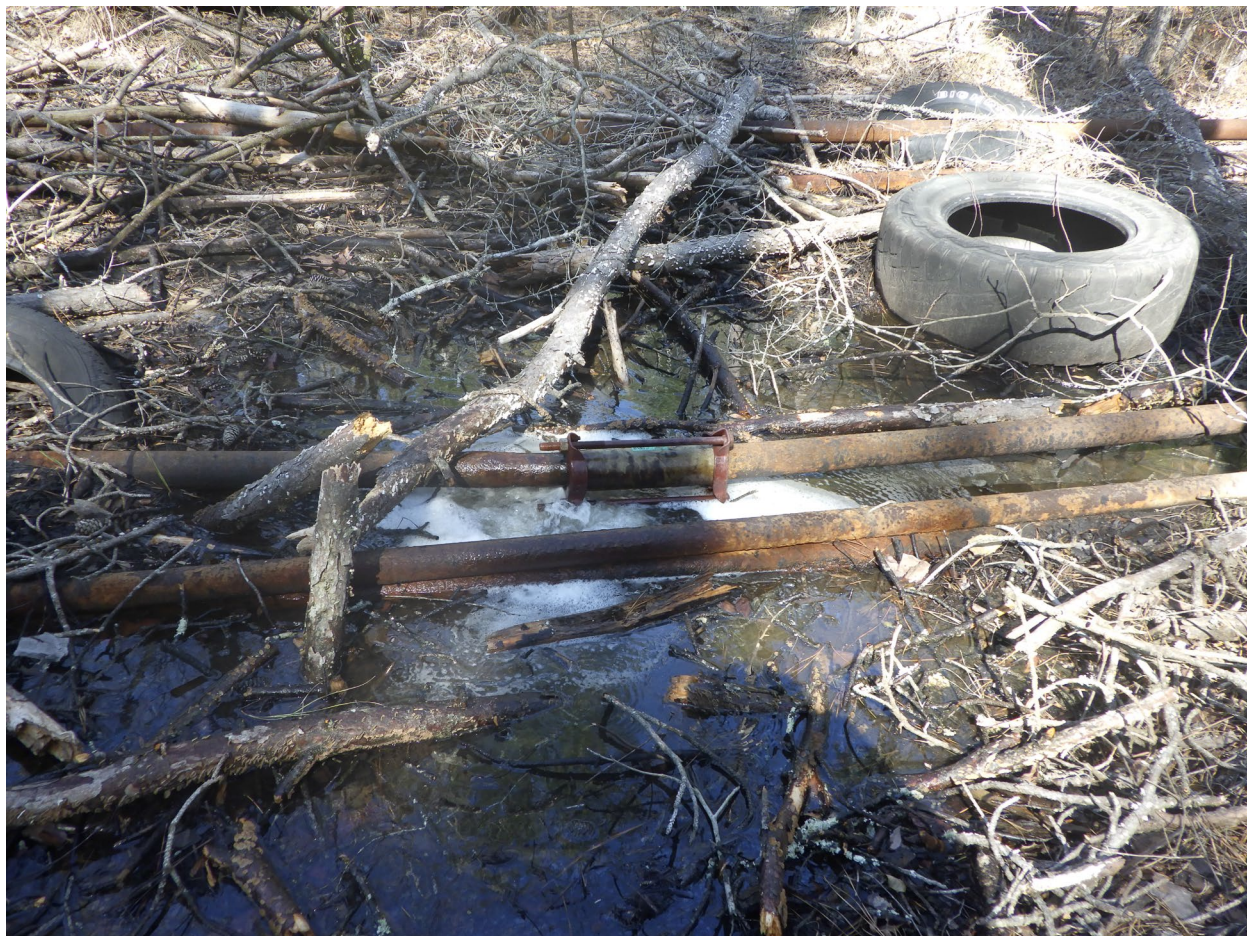
**Description:** Looking N, this photo shows a metal flowline from the facility to the SWD injection well actively leaking.

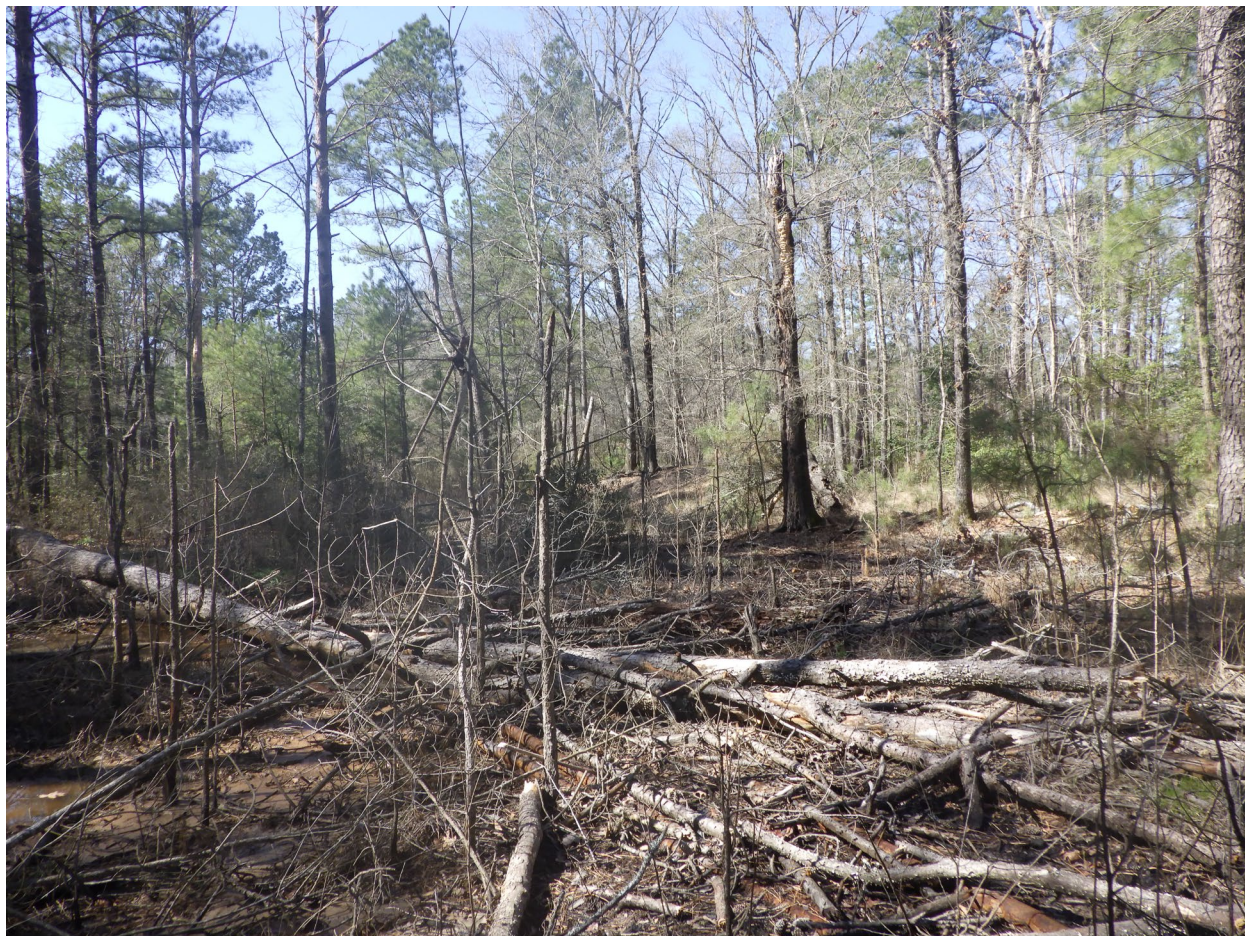
**Description:** Looking SW, this photo shows saltwater staining and dead vegetation around the flowline in Photo No. 29.

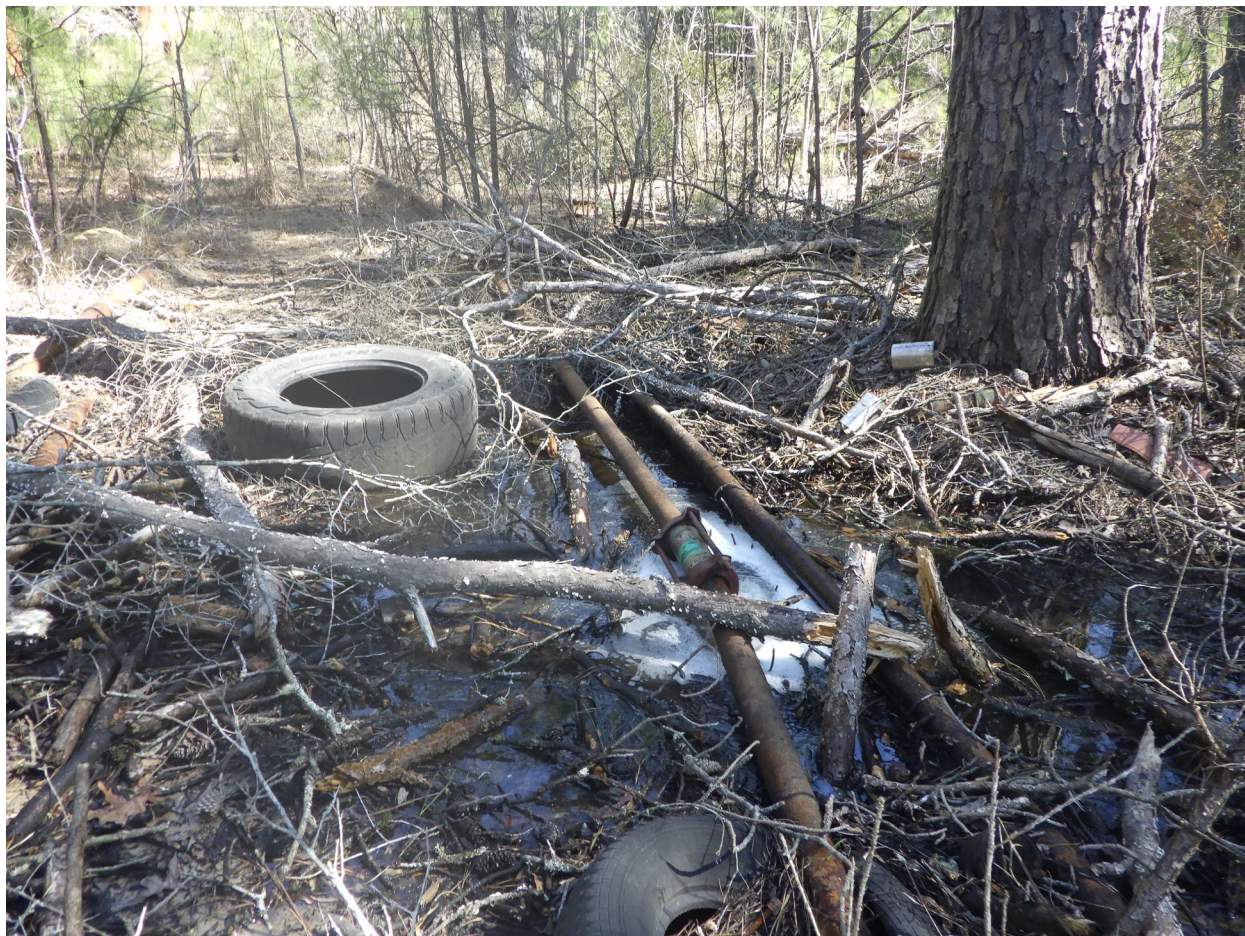
**Description:** Looking NE, this photo shows an additional view of the actively leaking flowline from Photo No. 29.

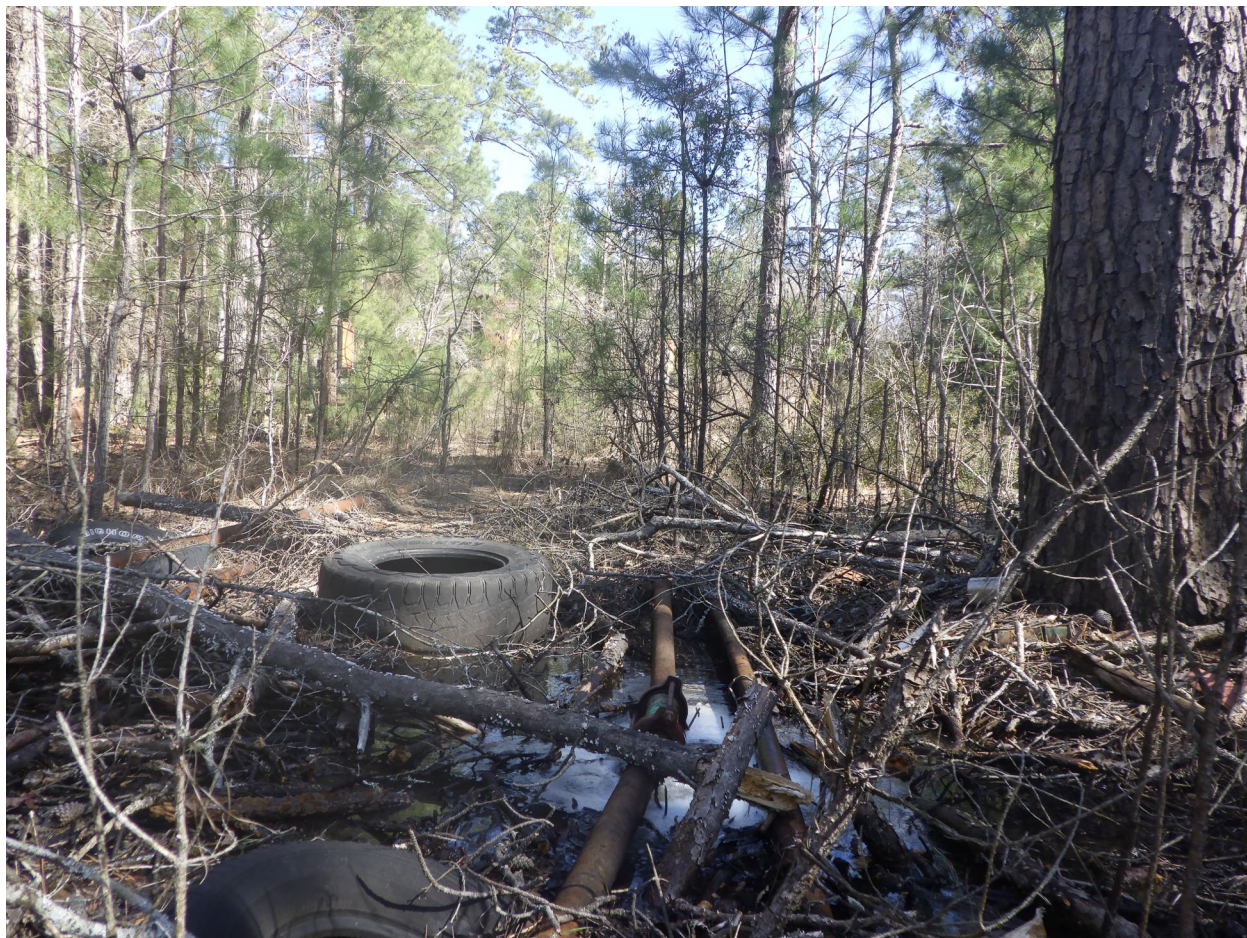
**Description:** Looking NNE, this photo shows an additional view of the actively leaking flowline from Photo No. 29.

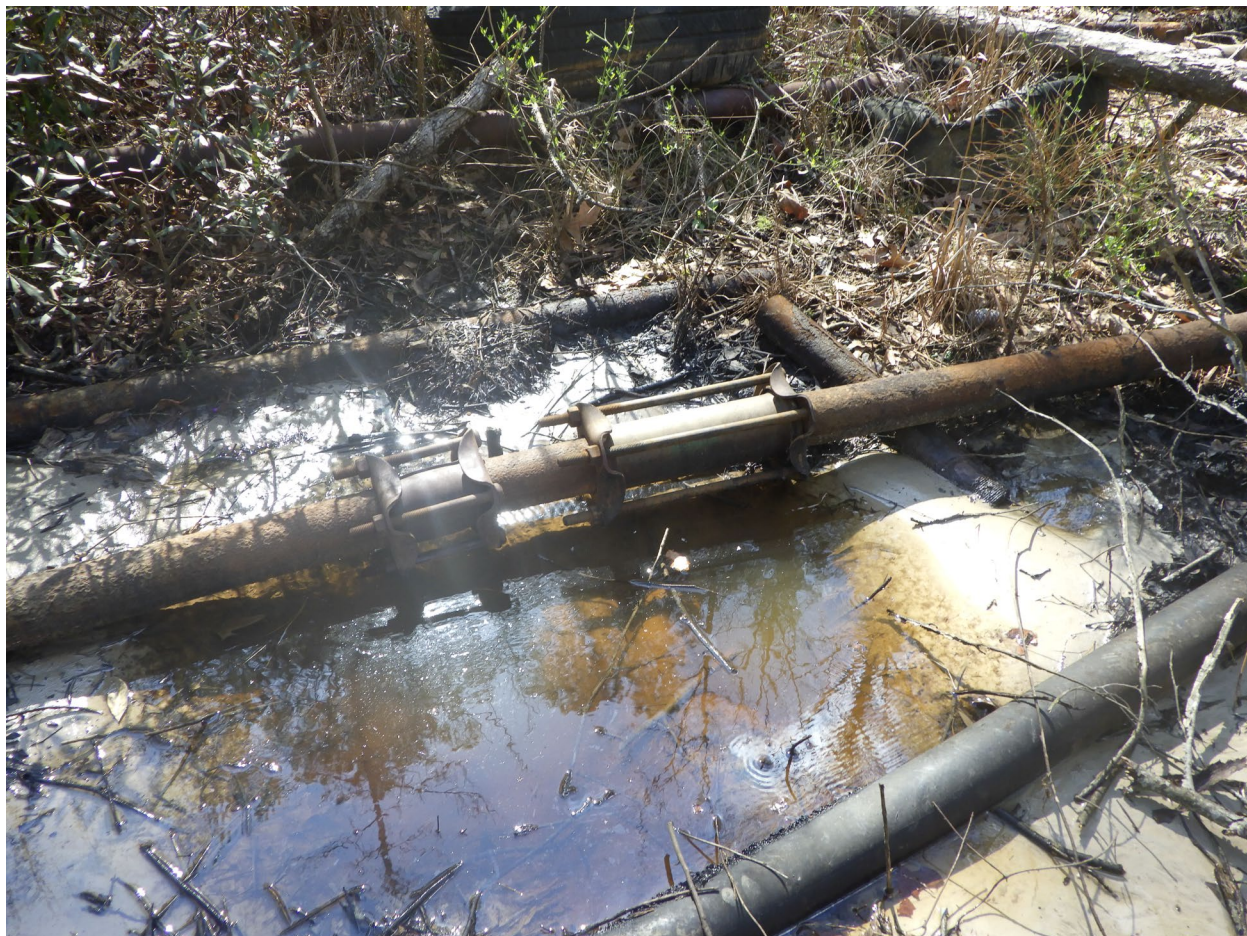
**Description:** Looking ESE, this photo shows an additional metal flowline with an active leak at a coupling on the line.

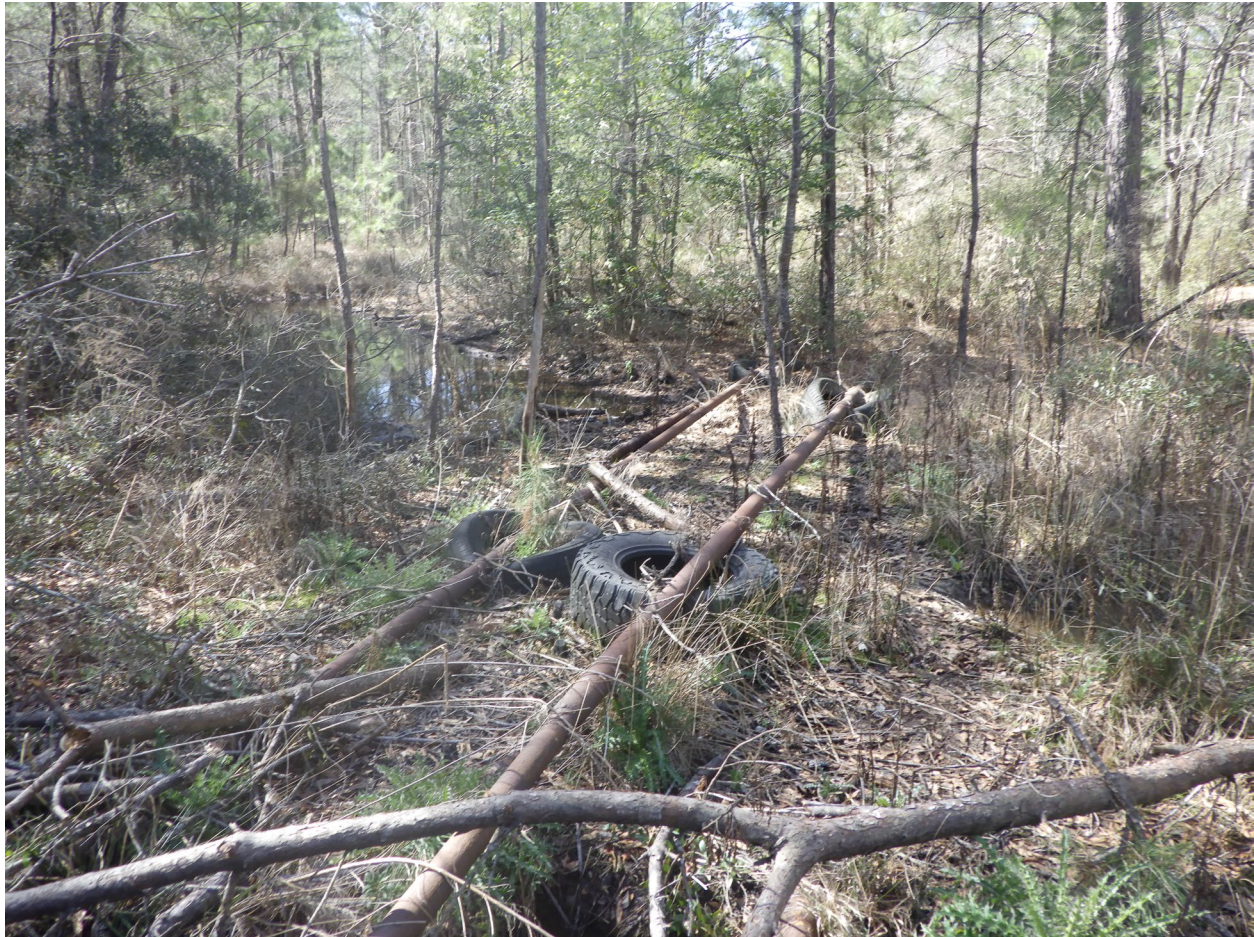
**Description:** Looking S, this photo shows an overview of the area of the second actively leaking flowline from Photo No. 33.
