**Region 6 - Enforcement & Compliance Assurance Division**  
**INSPECTION REPORT**

| Company Name: | City of Bossier City | |
| Facility Name: | Red River WWTP | |
| Identification/Permit Number: | LA0053716 (AI #8832) | |

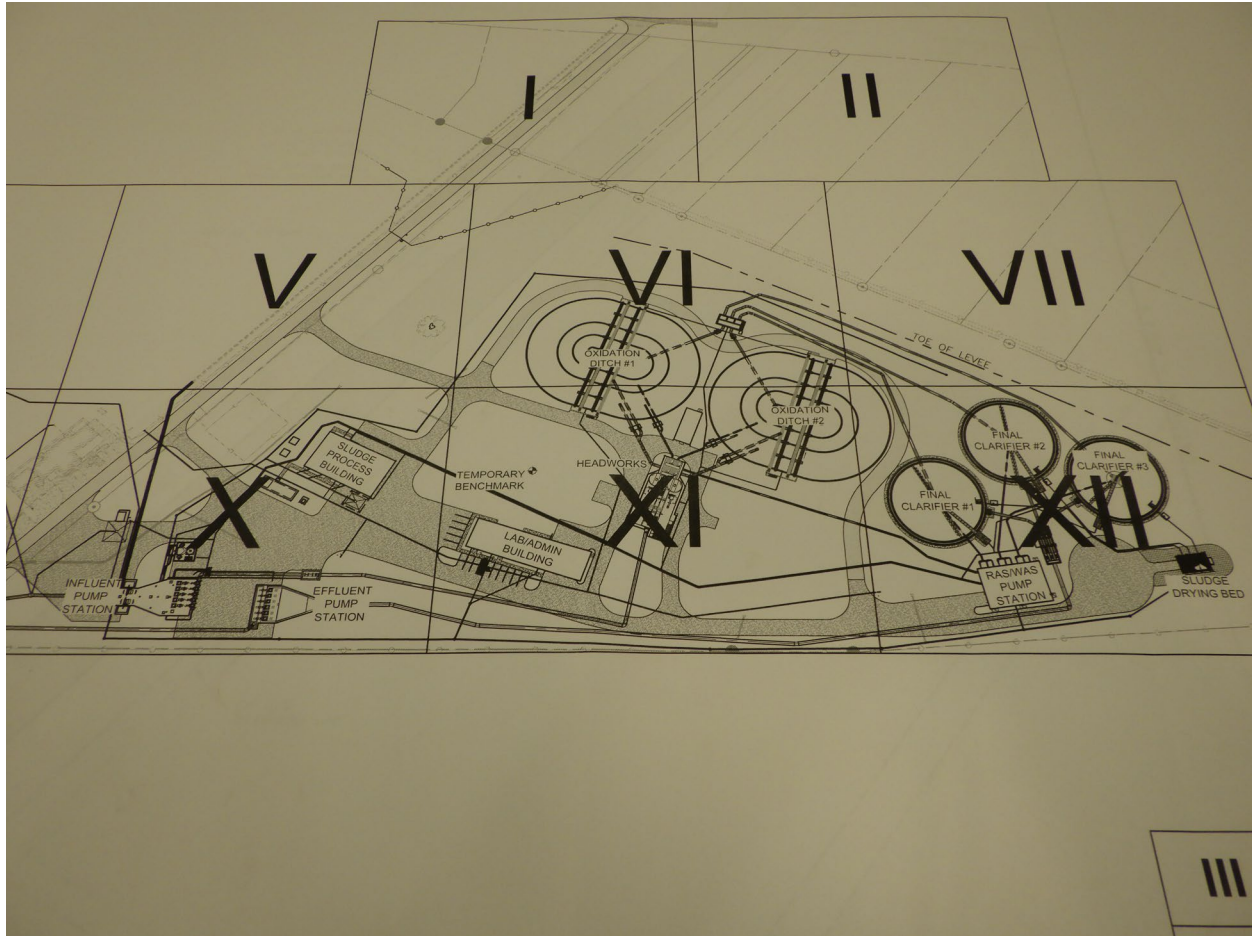
**Description:** Looking E, this photo shows a schematic of the City of Bossier City's Red River WWTP ("facility").

River (subsegment 100101). For a flowthrough schematic of the treatment system, see Photo No. 1 (Appendix A).

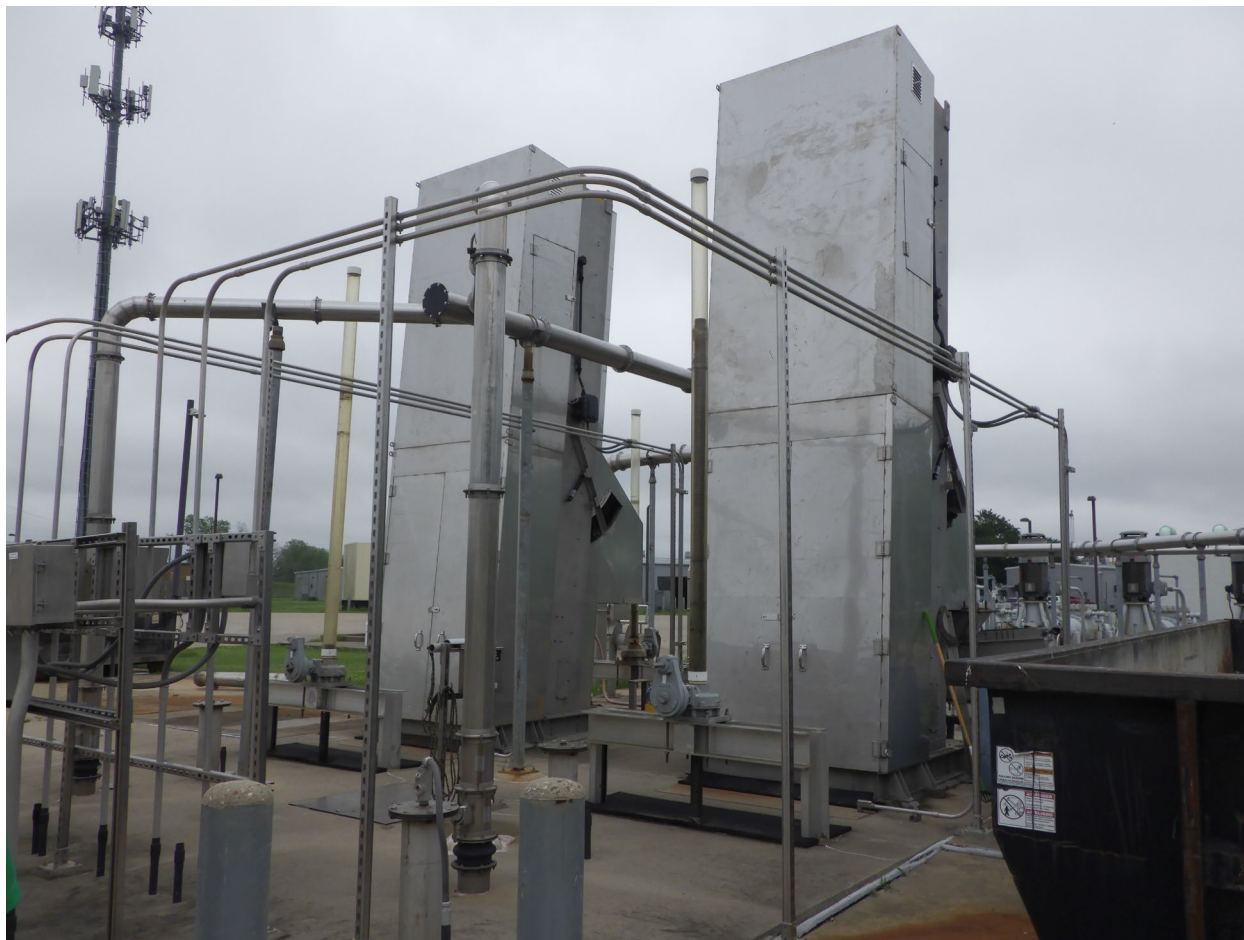
Photo No. 2

**Description:** Looking SE, this photo shows mechanical bar screens prior to the facility's influent pumps.

I observed the mechanical bar screens associated with the influent pumps, the influent pumps (one gravity flow and three force mains), the odor control system for the influent, and the internal magnetic flowmeter for the influent pumps, see Photos No. 2 through No. 5.

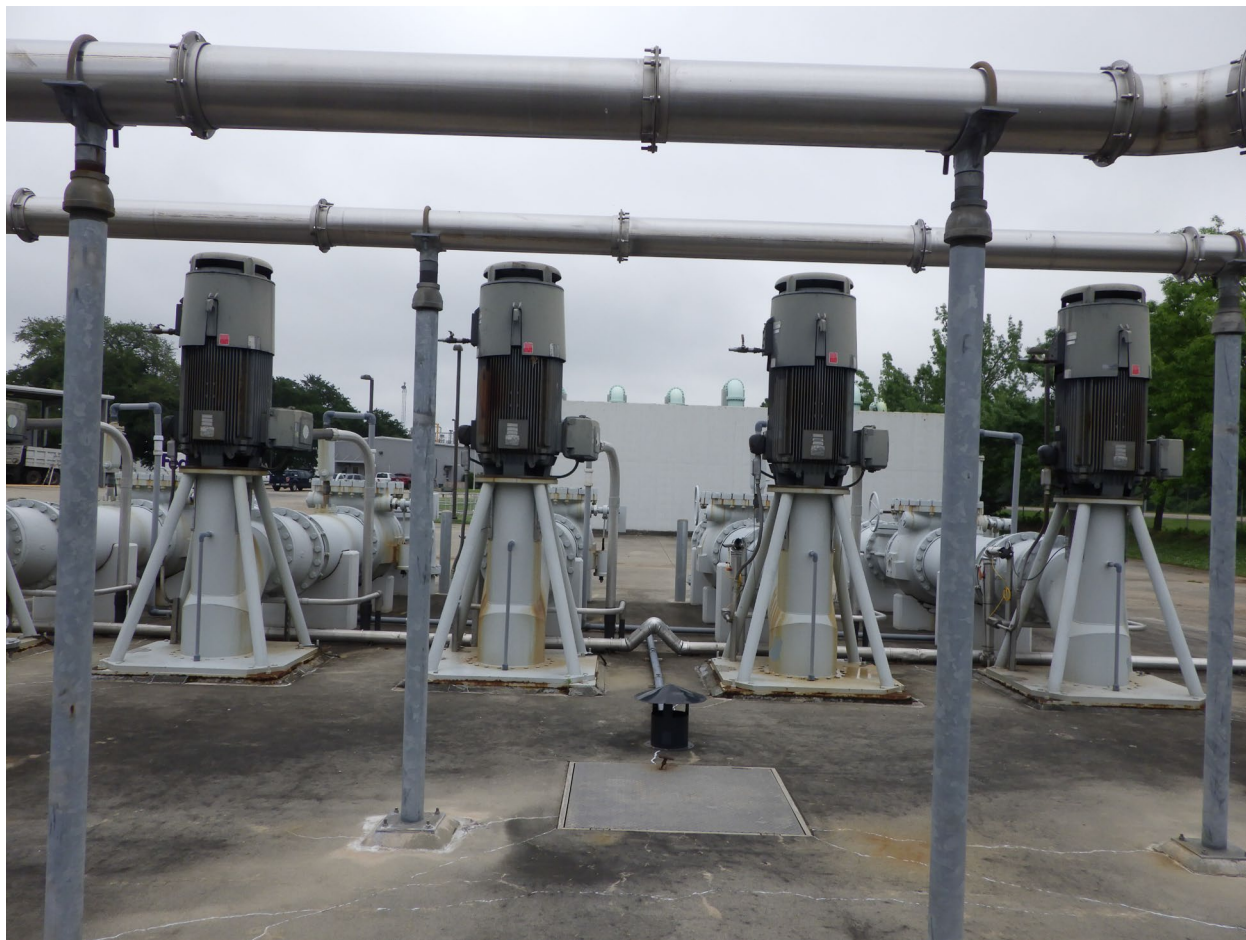
Photo No. 3

**Description:** Looking SE, this photo shows the metered influent pumps for the facility.

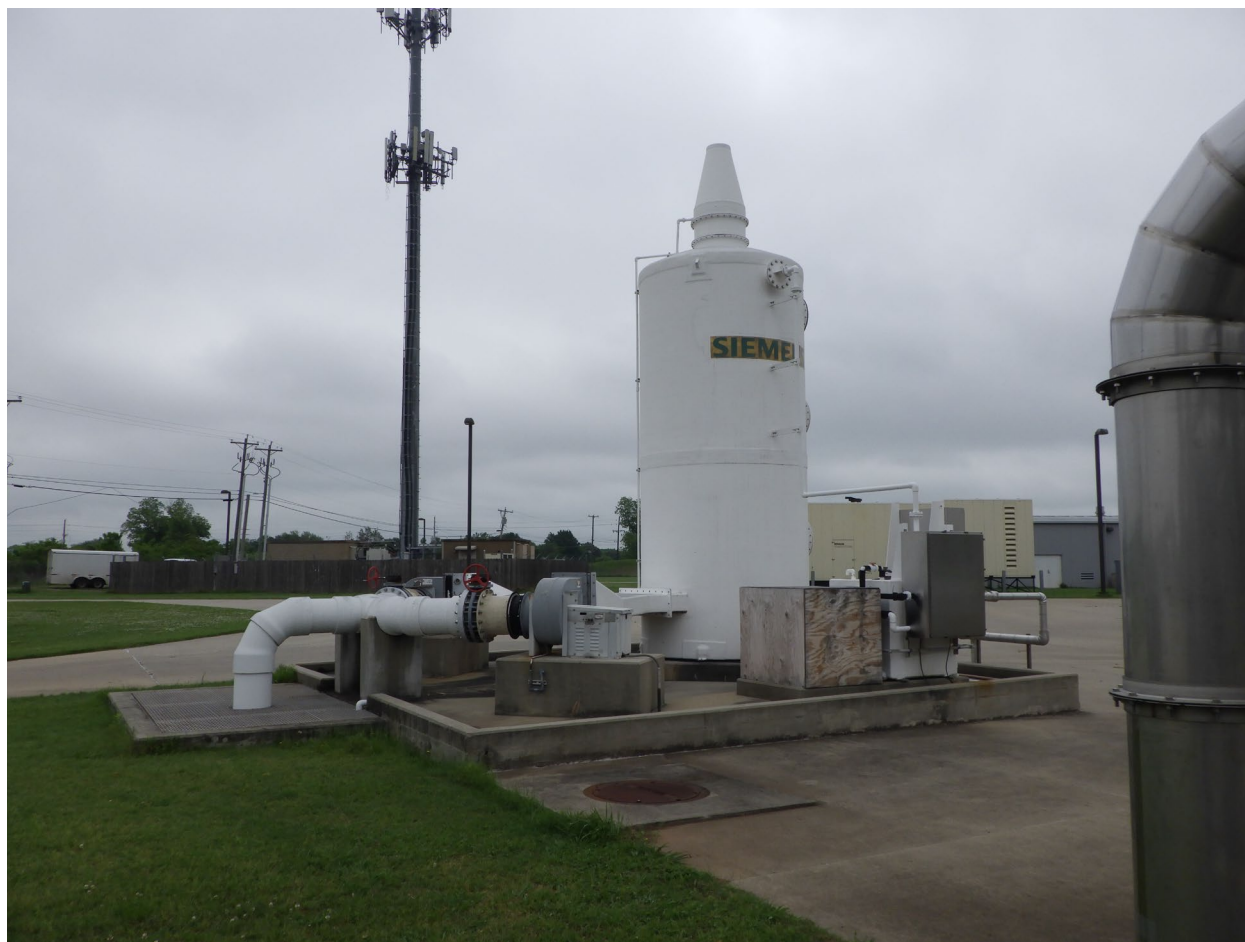
Photo No. 4

**Description:** Looking E, this photo shows odor control system at the influent pumps.

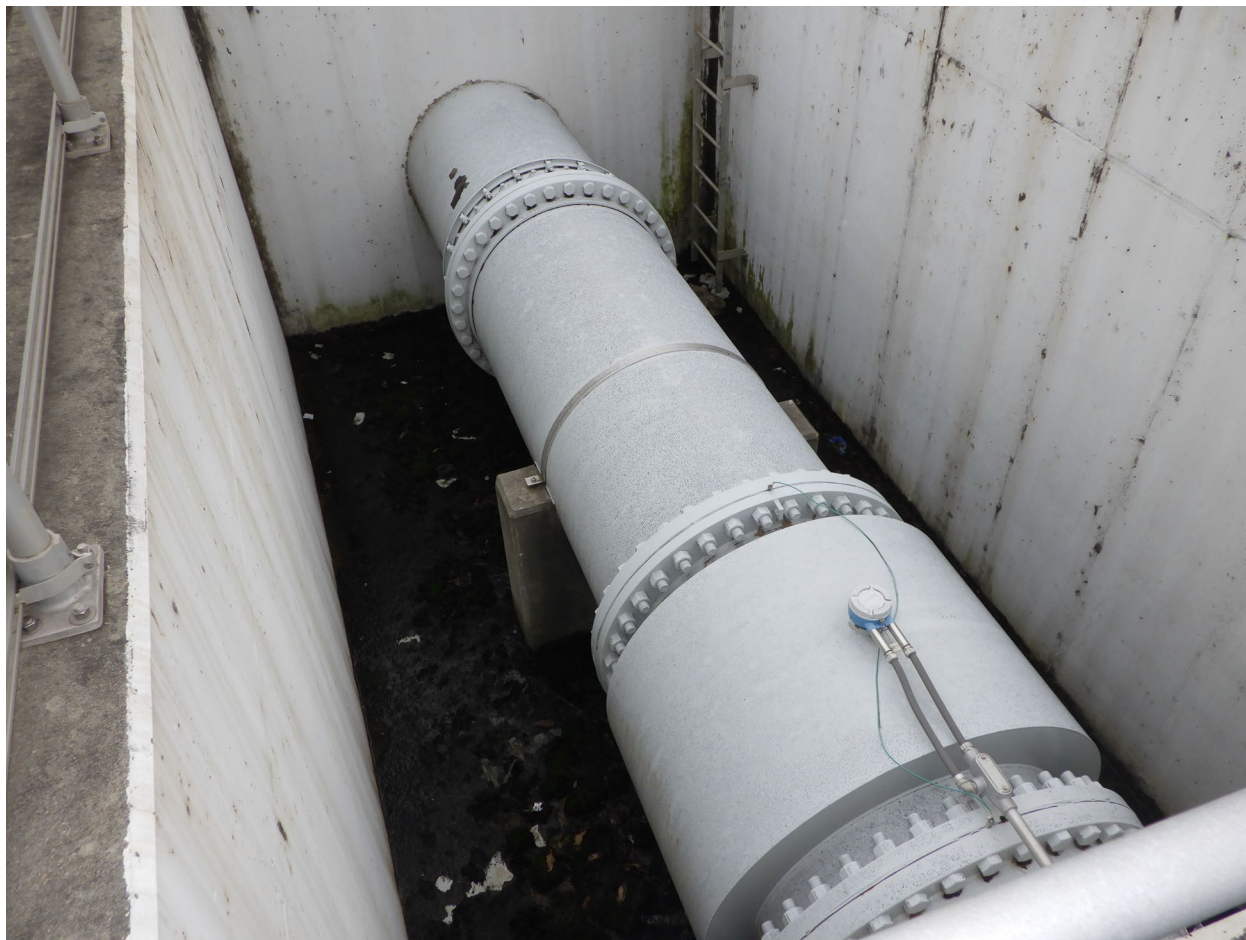
Photo No. 5

**Description:** Looking ESE, this photo shows an influent pipe fitted with a magnetic flowmeter.

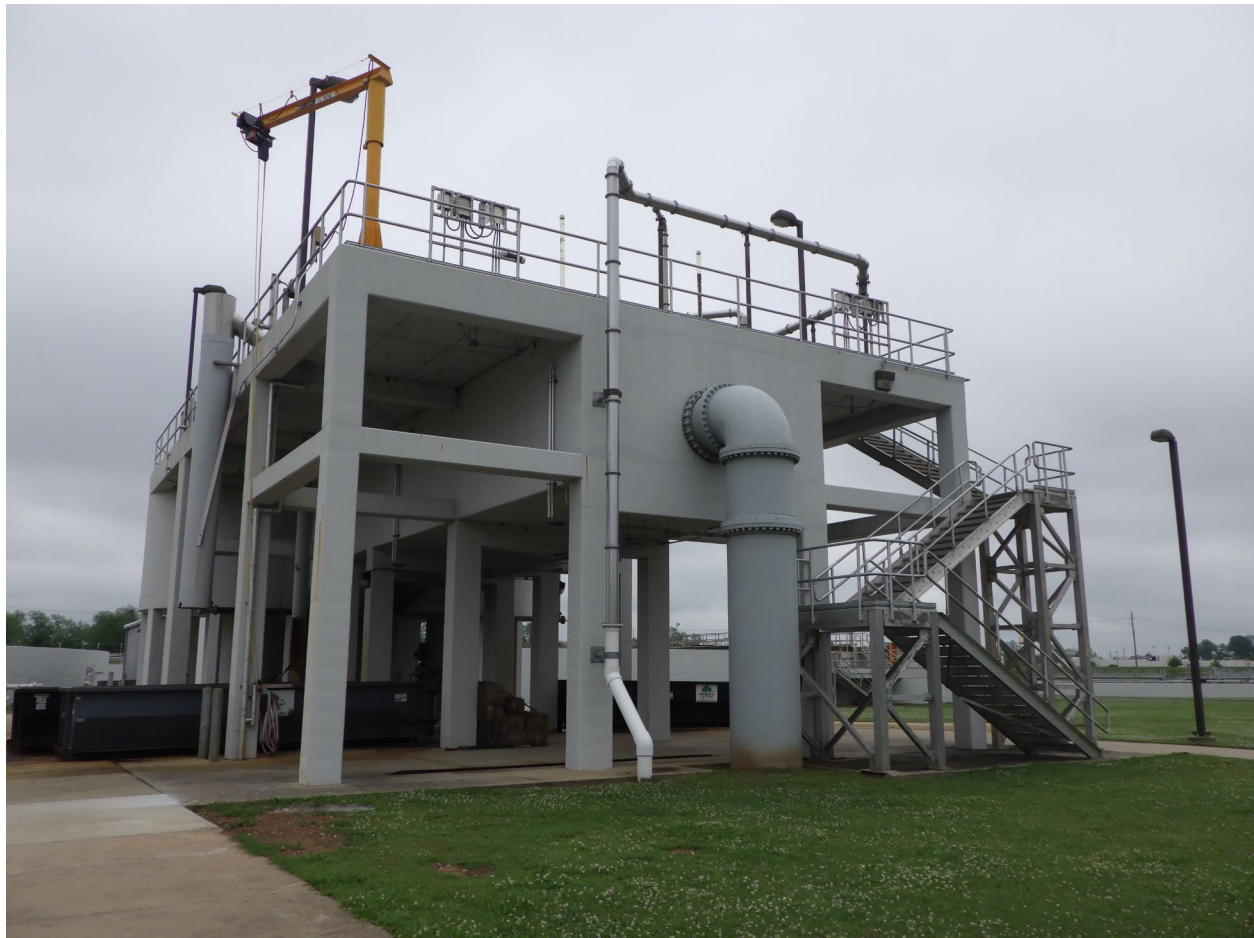
Photo No. 6

**Description:** Looking ESE, this photo shows the headworks for the facility, which has bar screening and grit washing/removal.

I observed the headworks for the facility, which included additional mechanical bar screening and grit washing and removal, see Photo No. 6.

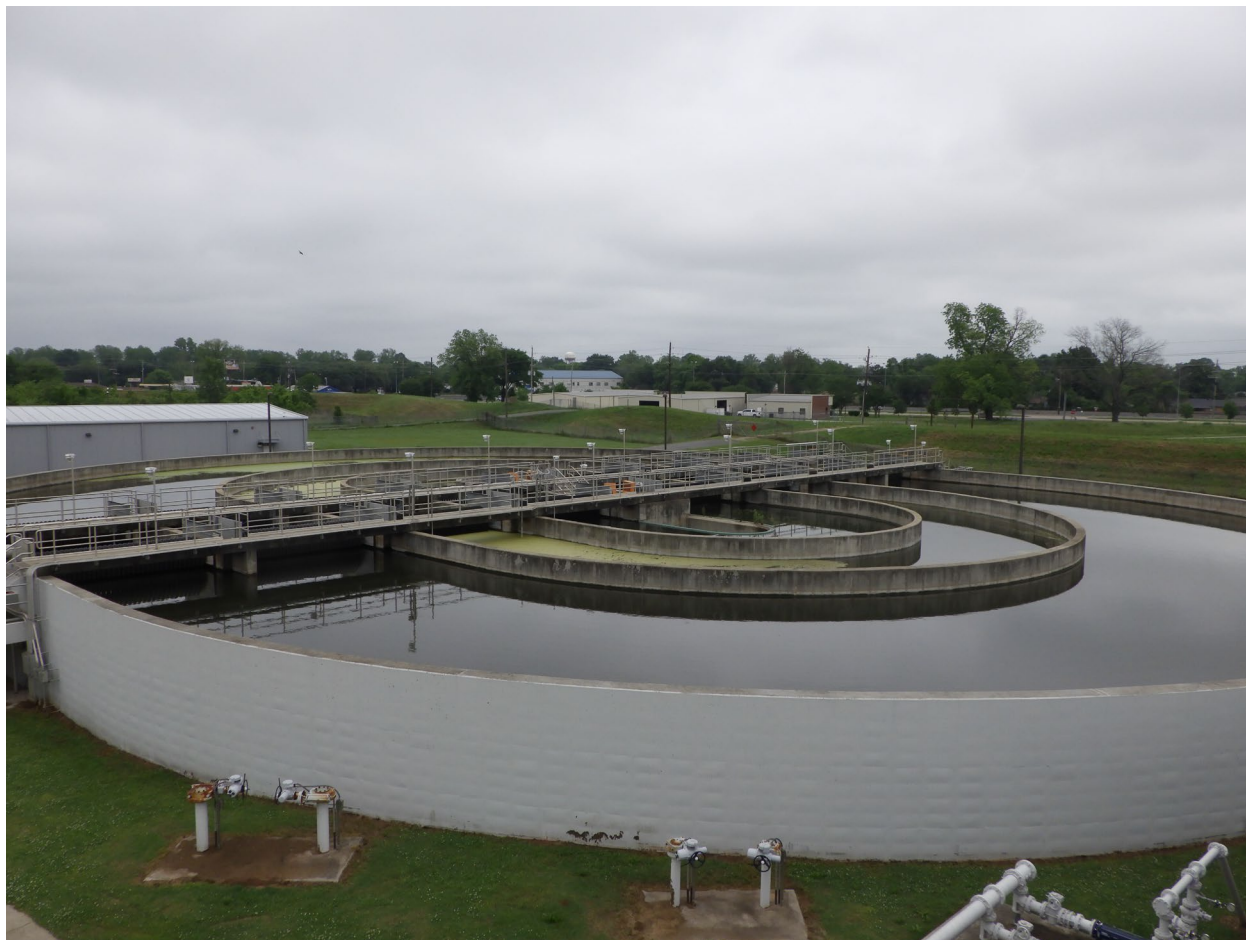
Photo No. 7

**Description:** Looking NNE, this photo shows an overview of one of the oxidation ditches for the facility; not in use (redundancy).

I observed both Orball oxidation ditches for activated sludge (biological treatment), see Photos No. 7 through No. 10. The outer ring of the oxidation ditch is used for nutrient reduction (anoxic zone) with Oxidation-Reduction Potential (ORP) measured to control the velocity of the rotors in the oxidation ditch. The inner ring of the oxidation ditch is used as equalization during high-flow events, which keeps

desired activated sludge from washing out of the system. Activated sludge from the inner ring is routed back to the outer ring for treatment. The facility was built for expansion, and I observed only one of the two oxidation ditches in use at the time of the inspection.

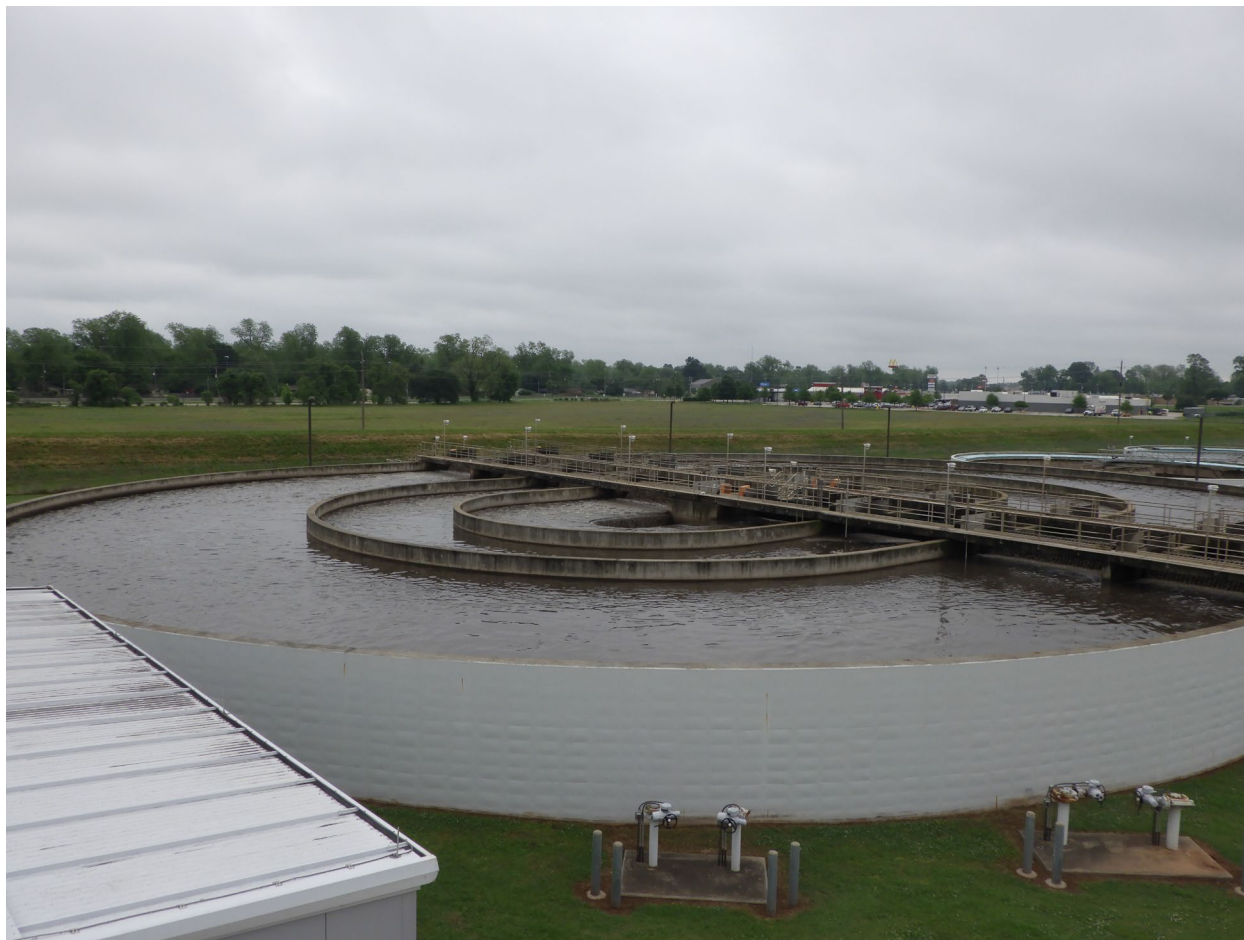
Photo No. 8

**Description:** Looking SE, this photo shows an overview of one of the oxidation ditches for the facility used for biological treatment.

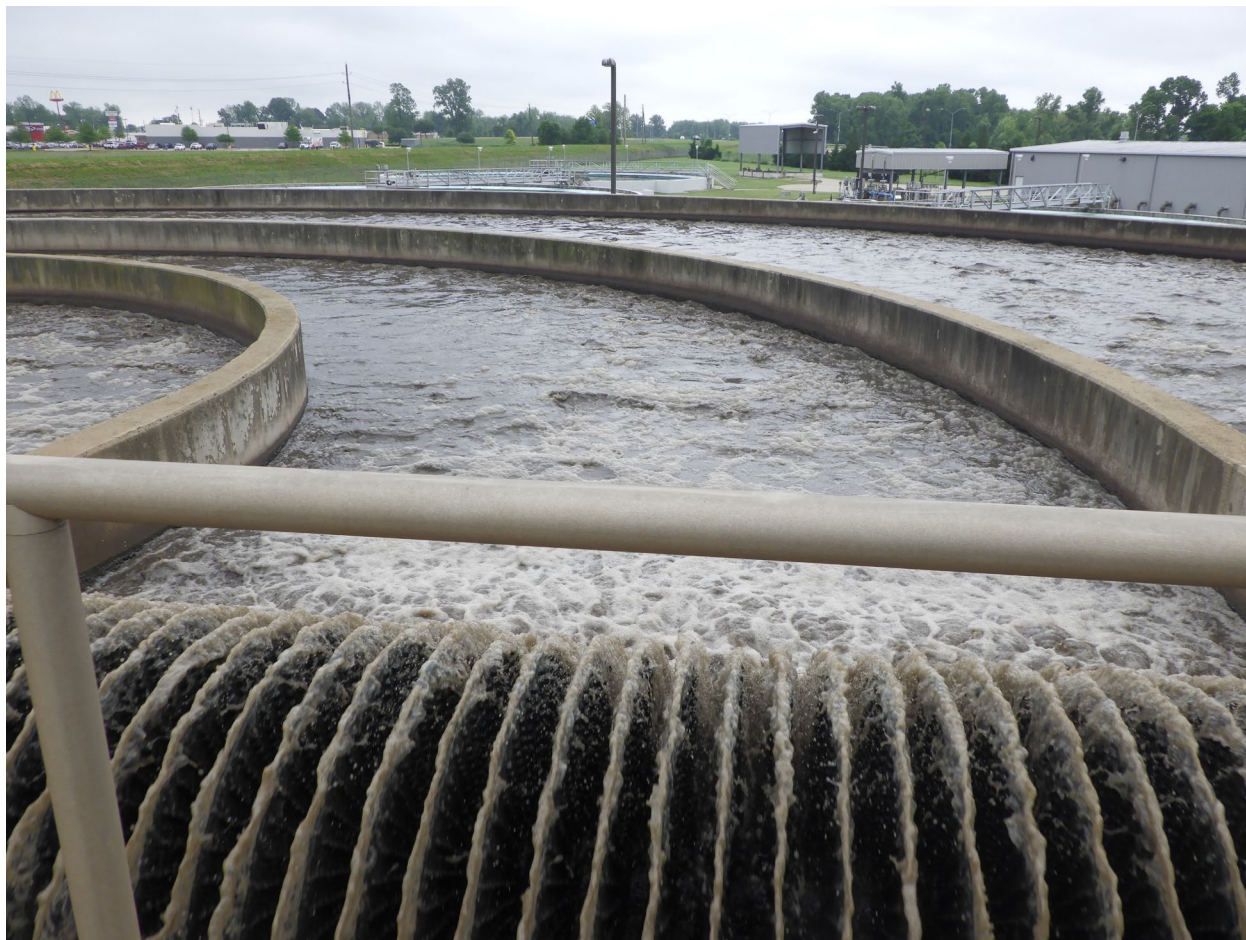
Photo No. 9

**Description:** Looking SSW, this photo shows the outer rings and a rotor for one of the oxidation ditches.

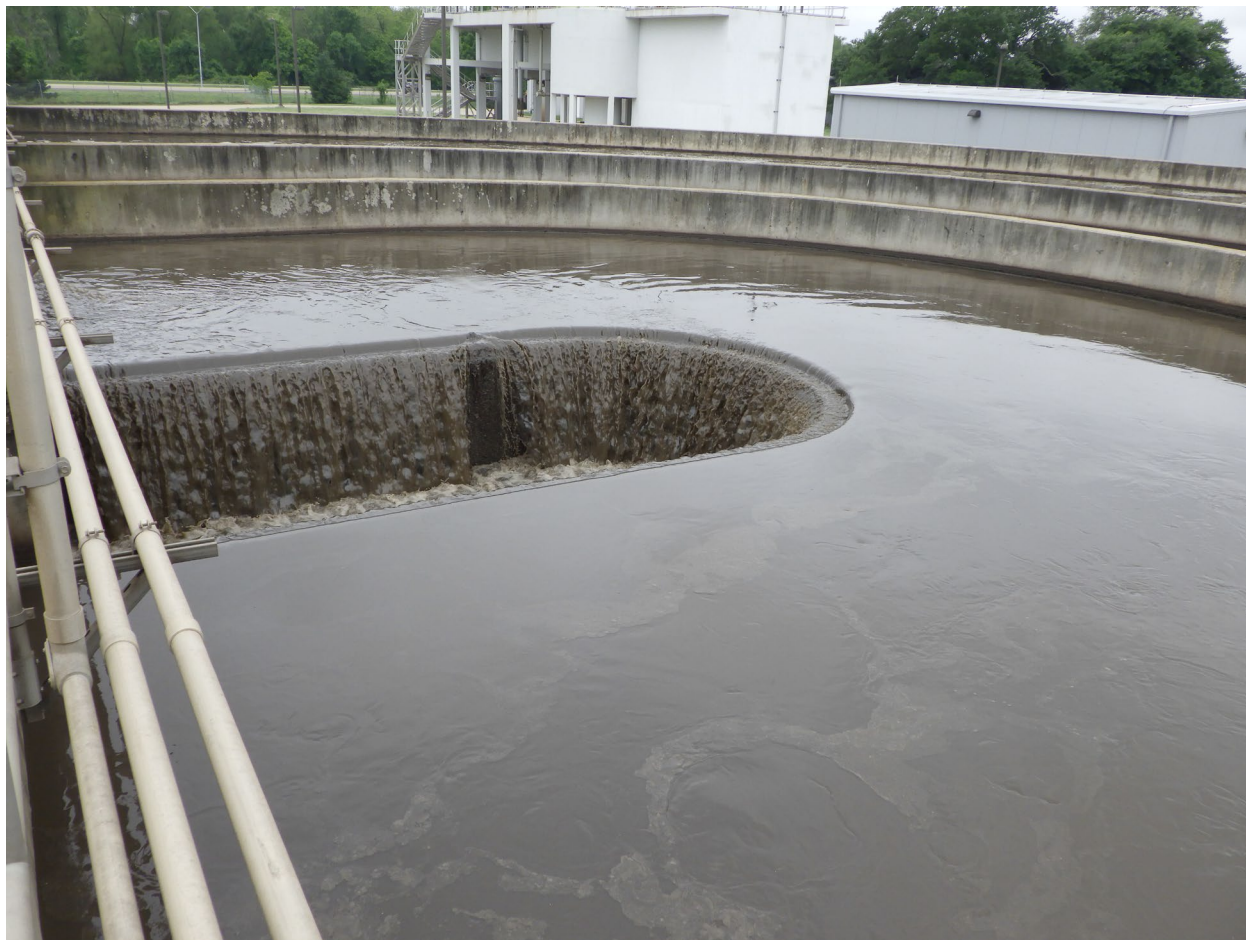
Photo No. 10

**Description:** Looking WSW, this photo shows the inner ring of one of the oxidation ditches.

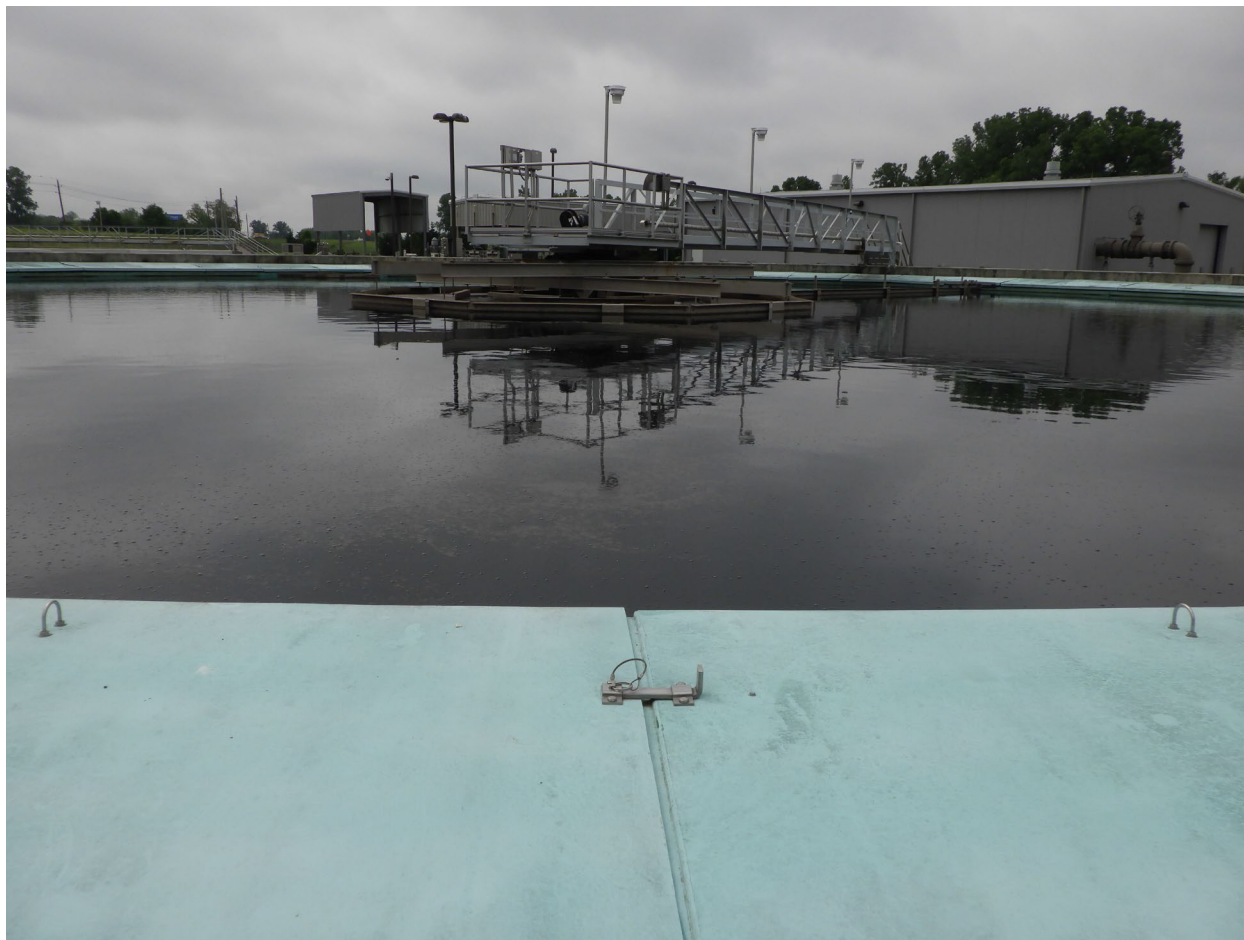
Photo No. 11

**Description:** Looking NNE, this photo shows an overview of one of the final clarifiers at the facility.

I observed three final clarifiers (Tow-Bro brand) and their individual components for activated sludge returning and wasting, see Photos No. 11 through No. 15. The clarifier is designed for top-bottom feed, and activated sludge flows down from the inner baffle to the bottom of the clarifier. The bottom racker arm of the clarifier is equipped with a torque sensor to monitor sludge buildup. Sludge is either returned to the oxidation ditch or wasted to the offsite sludge handling facility. Sludge depth is measured with a sludge judge and maintained at one third (1/3) of the total clarifier depth. The outer ring of the clarifier, which includes a baffle and effluent weir, is completely covered to reduce algae growth. A skimmer arm at the top of the clarifier removes floatable scum and trash. Clarified effluent is routed to either UV disinfection or to be used onsite for cleaning purposes. The facility was built for expansion, and I observed only two out of three clarifiers in use at the time of the inspection.

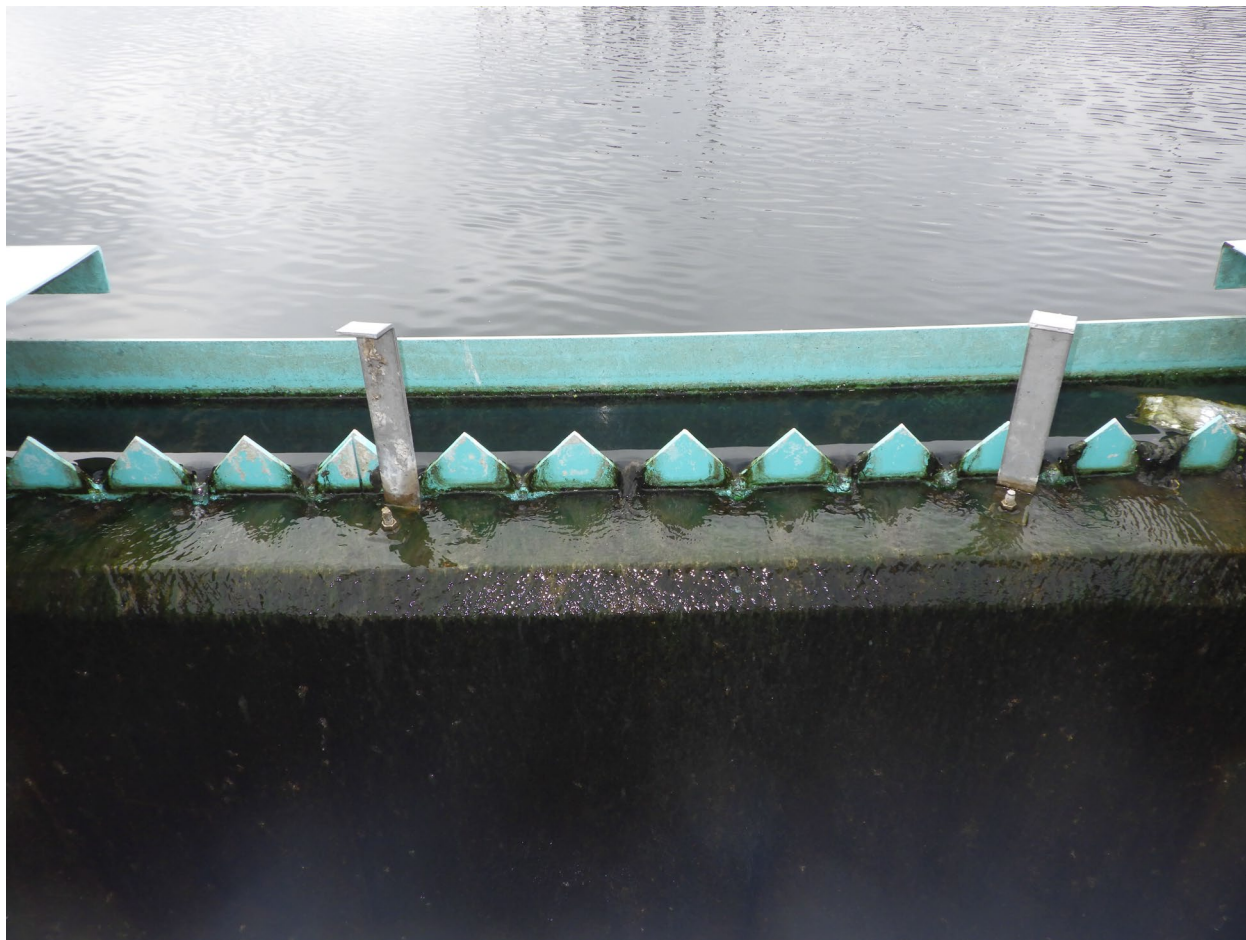
Photo No. 12

**Description:** Looking S, this photo shows the outer baffle and weir underneath the covers of one of the final clarifiers.

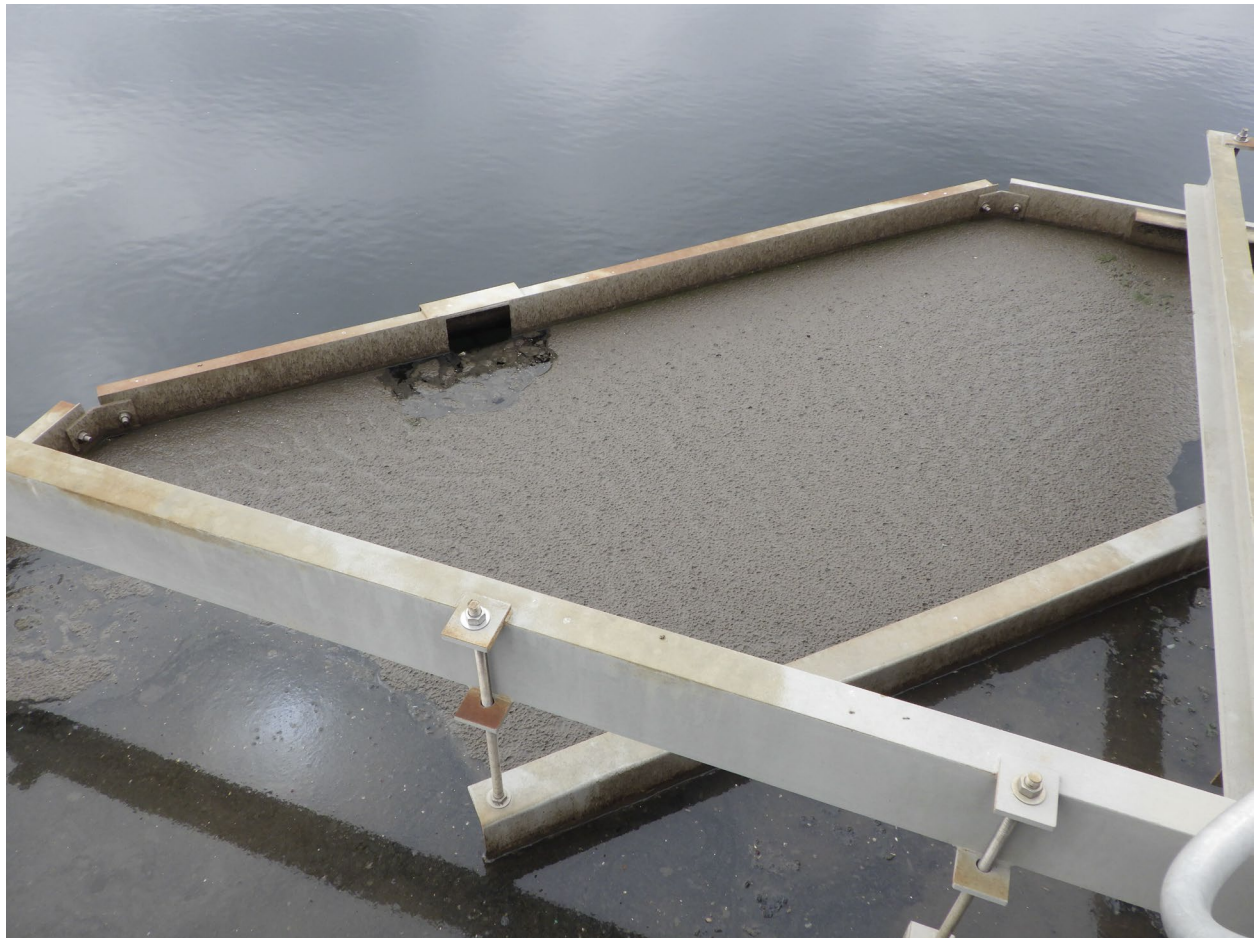
Photo No. 13

**Description:** Looking SSE, this photo shows the inner baffle of one of the final clarifiers.

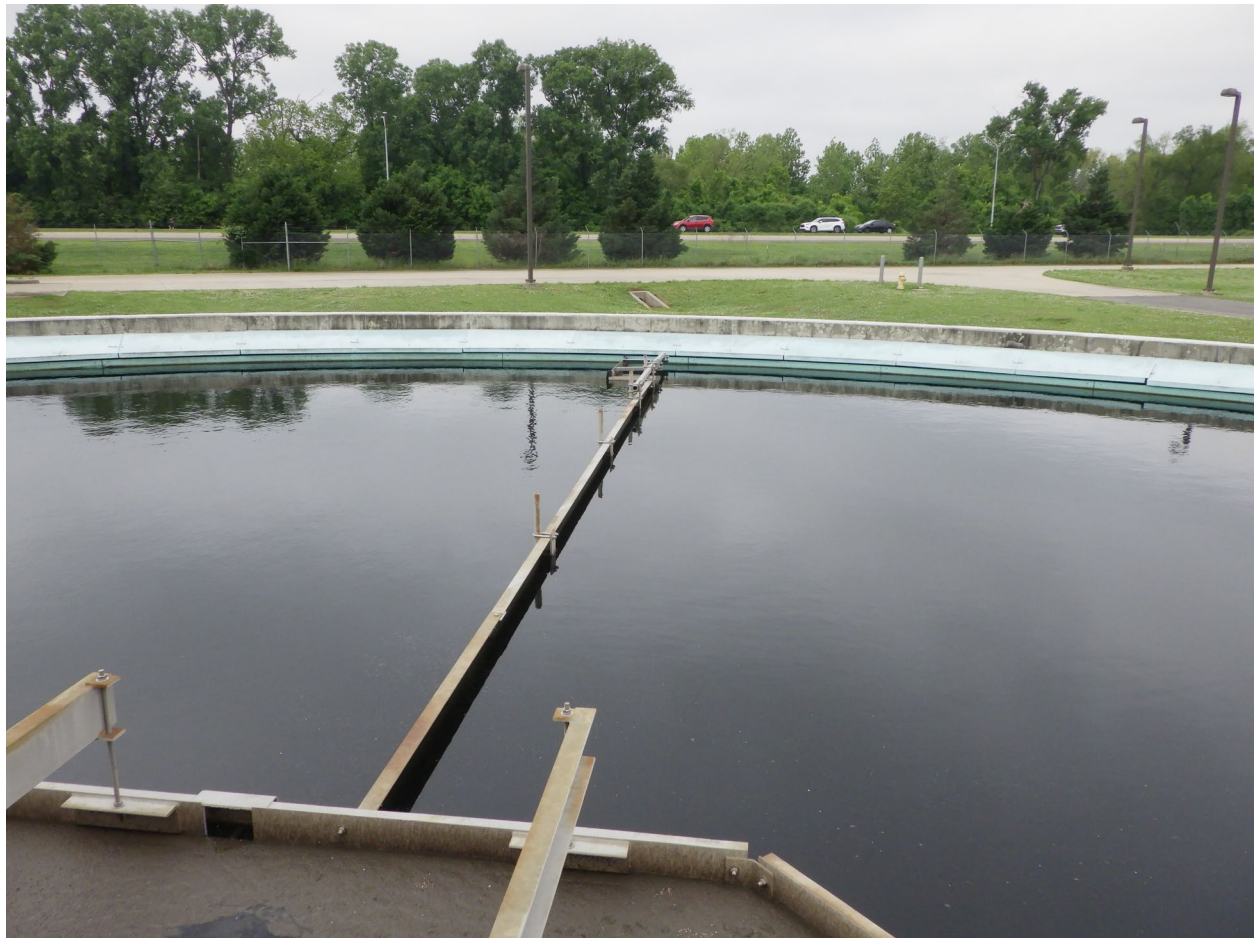
Photo No. 14

**Description:** Looking WSW, this photo shows the skimmer arm for one of the final clarifiers.

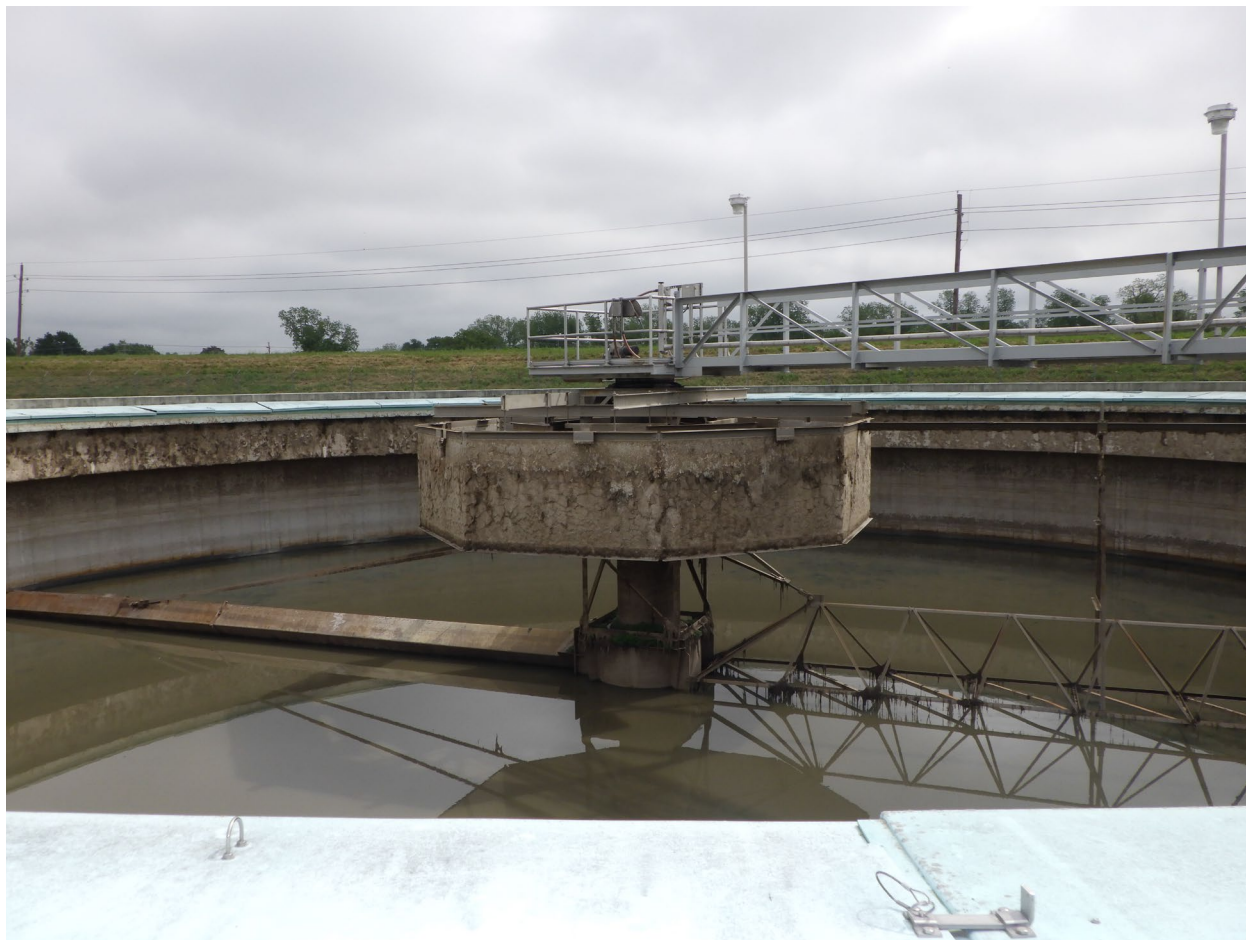
Photo No. 15

**Description:** Looking SE, this photo shows one of the final clarifiers that was not in use at the time of the inspection (redundancy).

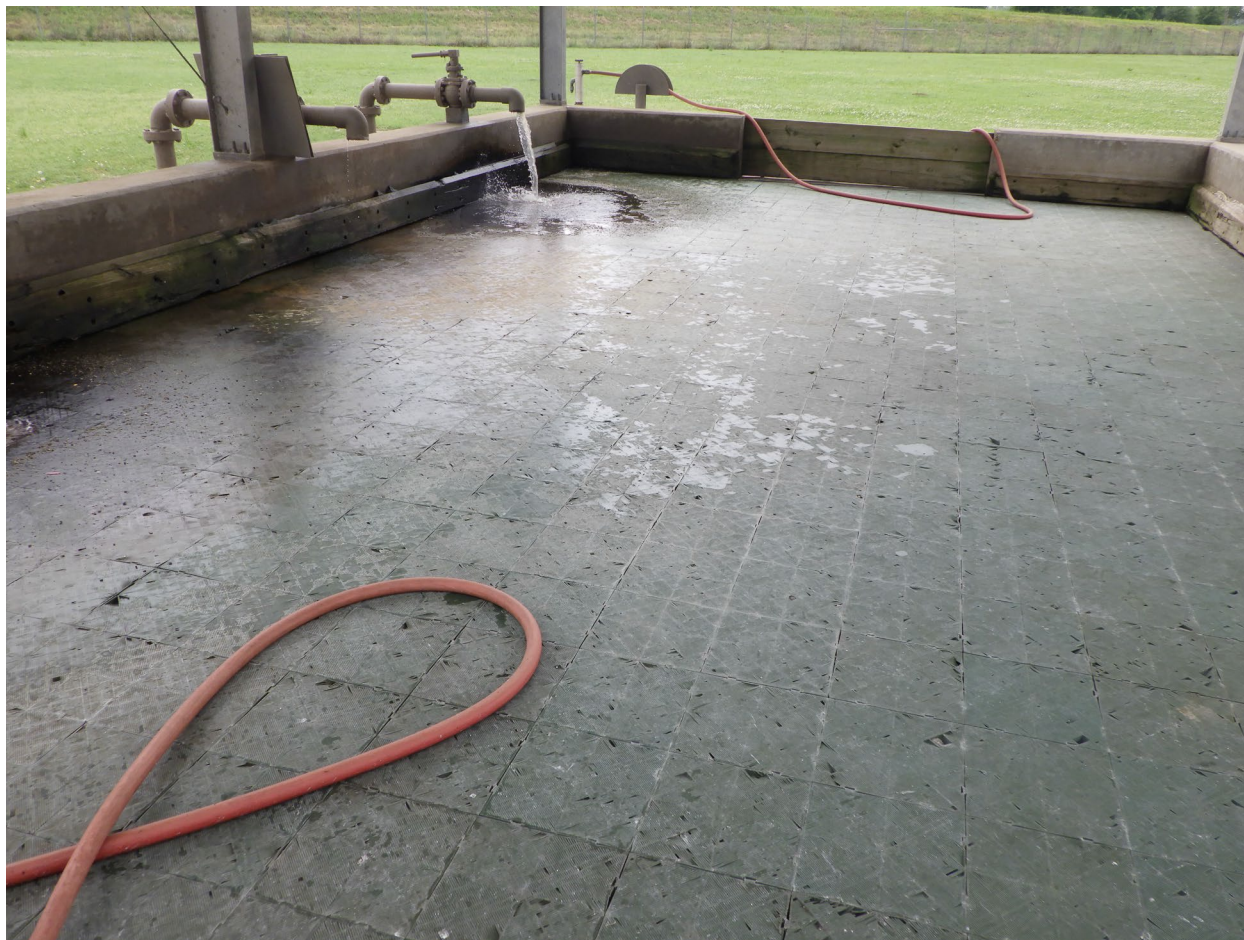
Photo No. 16

**Description:** Looking ESE, this photo shows the scum mat for the final clarifiers.

I observed the “scum beach” that receives floatable scum and trash from the final clarifiers, see Photo No. 16. The scum beach is a drying bed with a tile surface and mixed media for filtration with an underdrain system to route water back through the system.

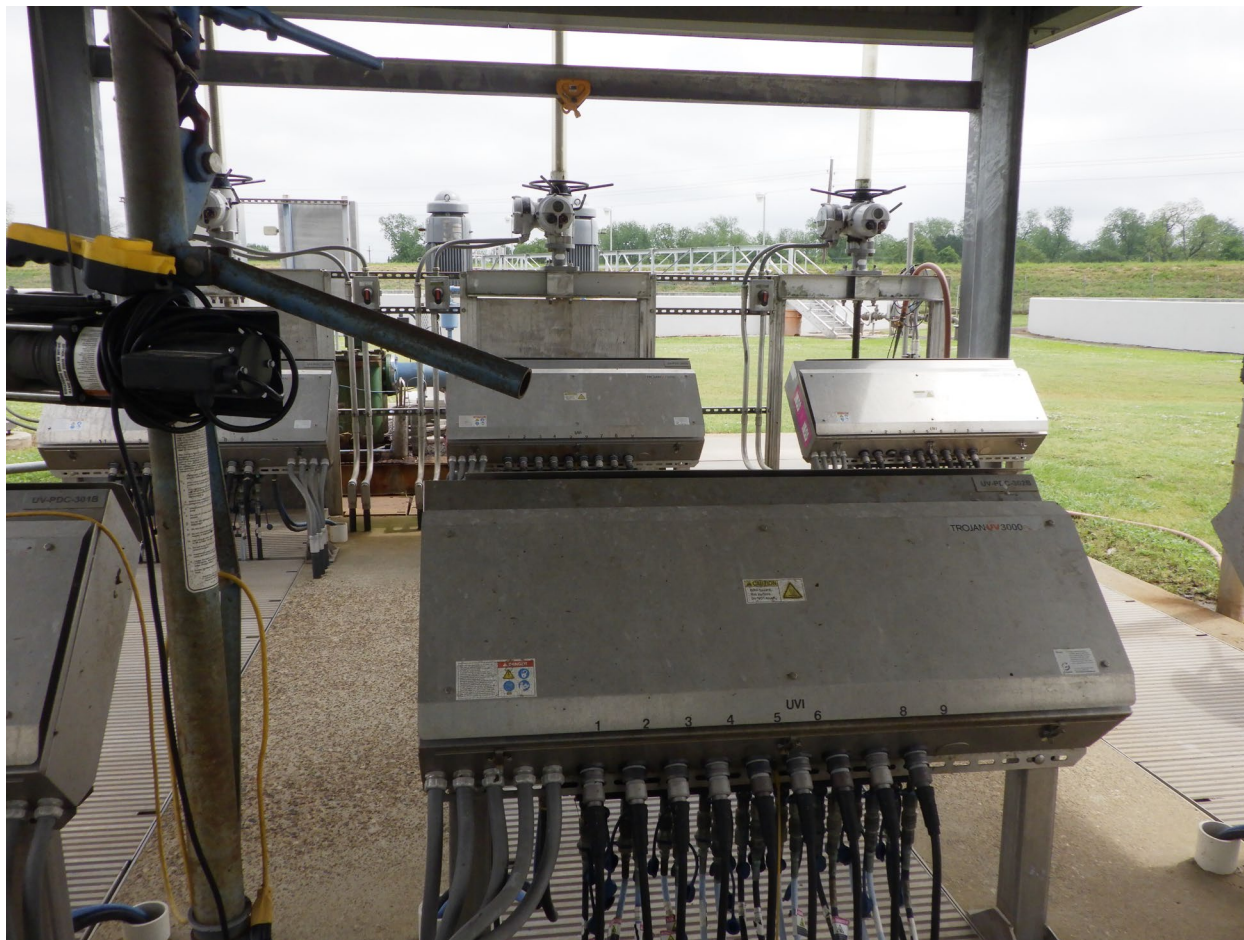
Photo No. 17

**Description:** Looking ENE, this photo shows the UV disinfection units for the facility.

I observed the UV disinfection unit (Trojan brand) for the effluent from the final clarifiers, see Photo No. 17. The UV system is on maintenance and replacement schedules to ensure bulbs are properly cleaned and operating. I observed two of the three UV tracks in use during the inspection.

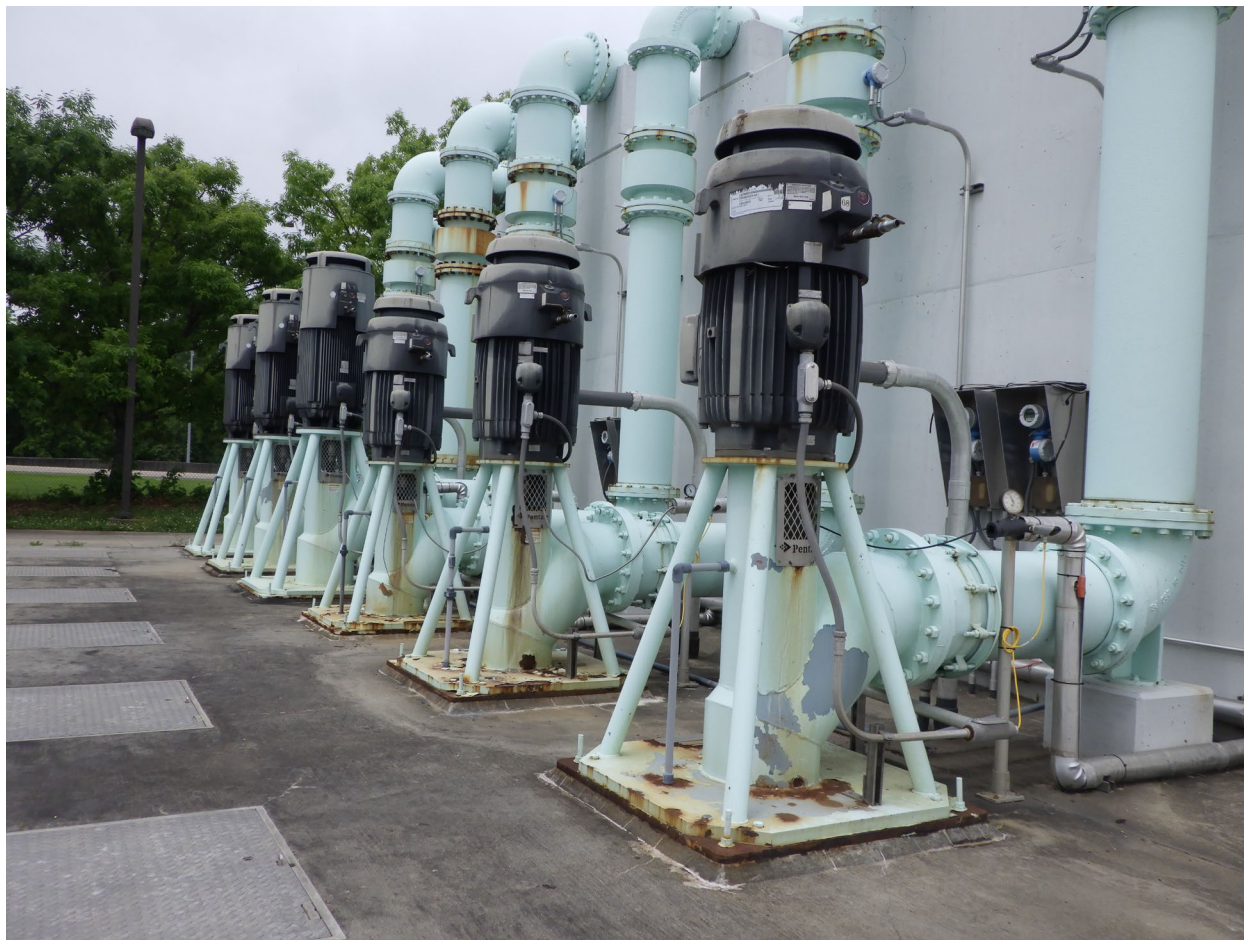
Photo No. 18

**Description:** Looking SW, this photo shows the metered effluent pumps for the facility.

I observed the metered effluent pumps (six total), floating media for algae control, concrete post-aeration and baffles, and the auto-sampler for effluent sampling, see Photos No. 18 through No. 21. Effluent is sampled after UV disinfection and flow measurement. Flow measurement is achieved via magnetic flowmeter with a volume that is totalized using SCADA.
