**Region 6 - Enforcement & Compliance Assurance Division**  
**INSPECTION REPORT**

| Company Name: | City of Bossier City | |
| Facility Name: | Red River WWTP | |
| Identification/Permit Number: | LA0053716 (AI #8832) | |

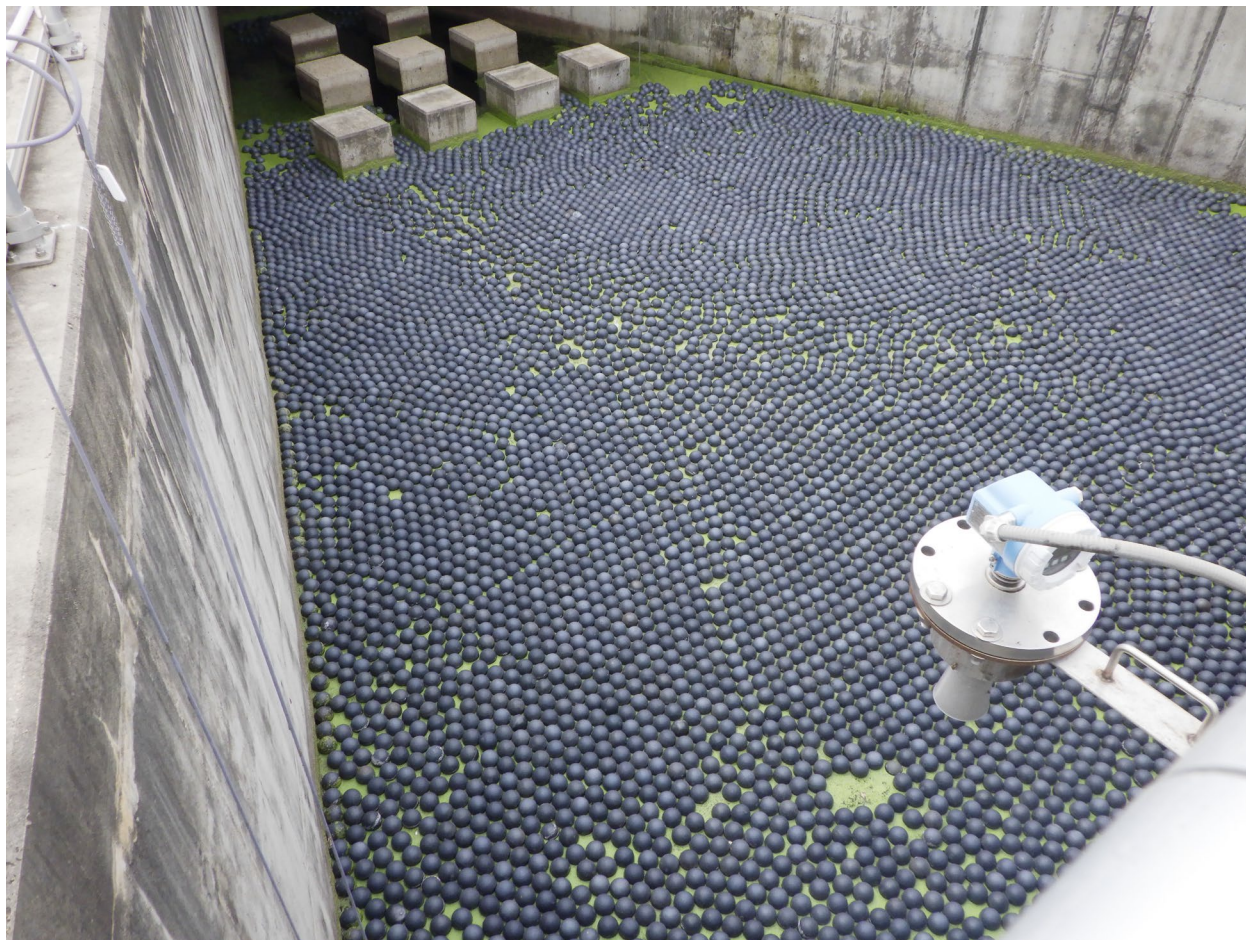
Photo No. 19

**Description:** Looking SSE, this photo shows algae control media and post-aeration at the outfall for the facility.

I observed the metered effluent pumps (six total), floating media for algae control, concrete post-aeration and baffles, and the auto-sampler for effluent sampling, see Photos No. 18 through No. 21. Effluent is sampled after UV disinfection and flow measurement. Flow measurement is achieved via magnetic flowmeter with a volume that is totalized using SCADA.

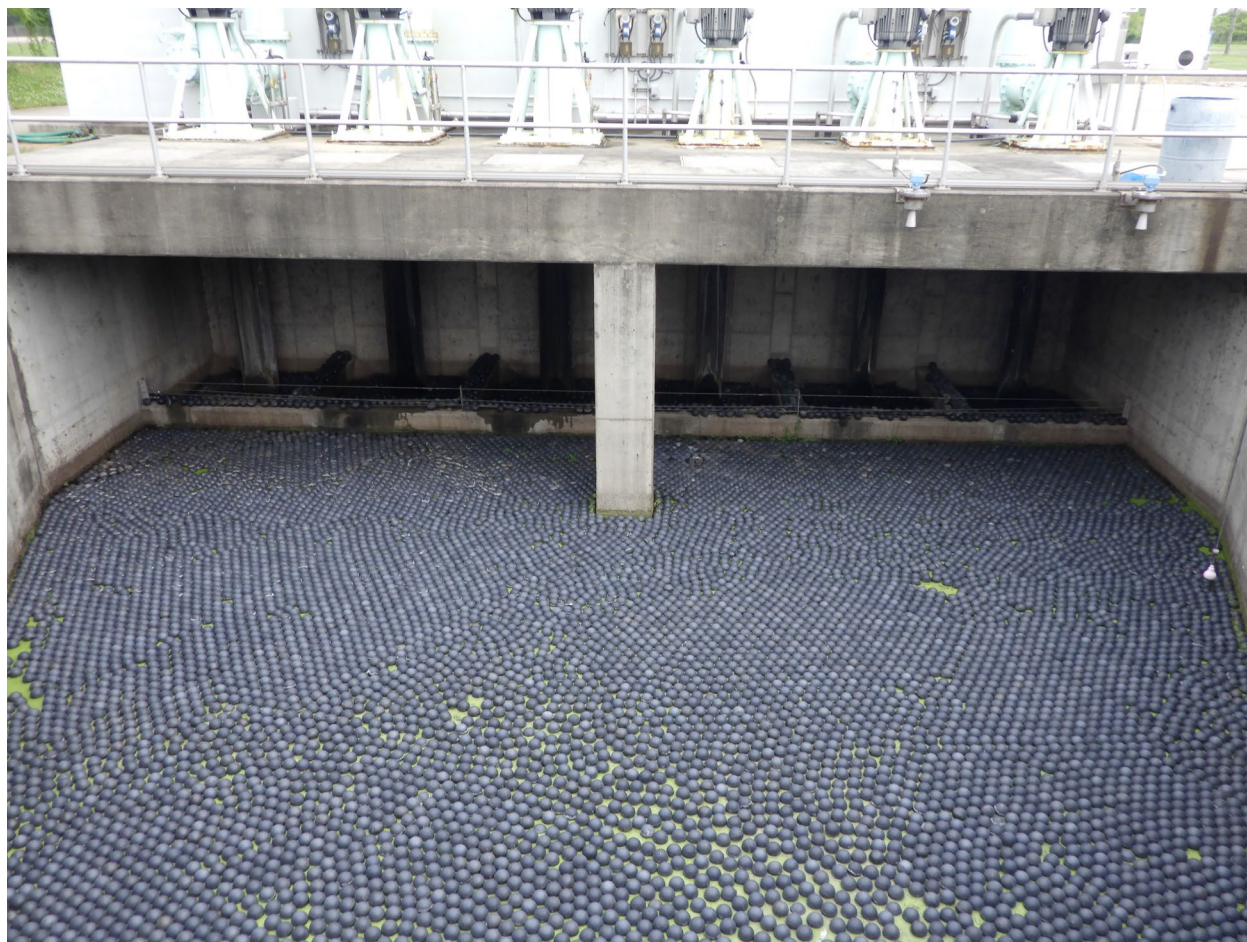
Photo No. 20

**Description:** Looking W, this photo shows a view of the effluent baffle to retain algae control media.

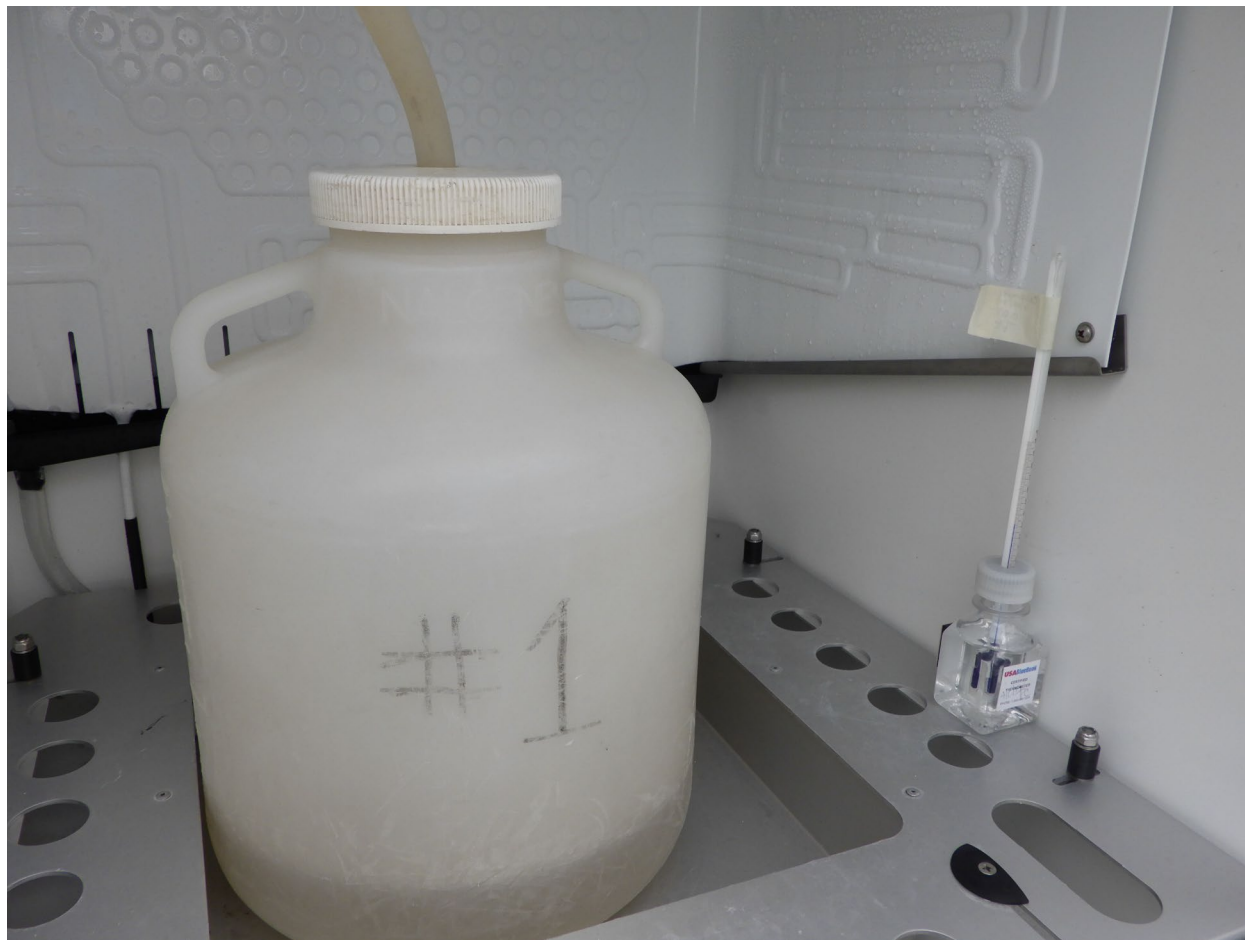
Photo No. 21

**Description:** Looking N, this photo shows the sample container and thermometer for the automatic sampler.

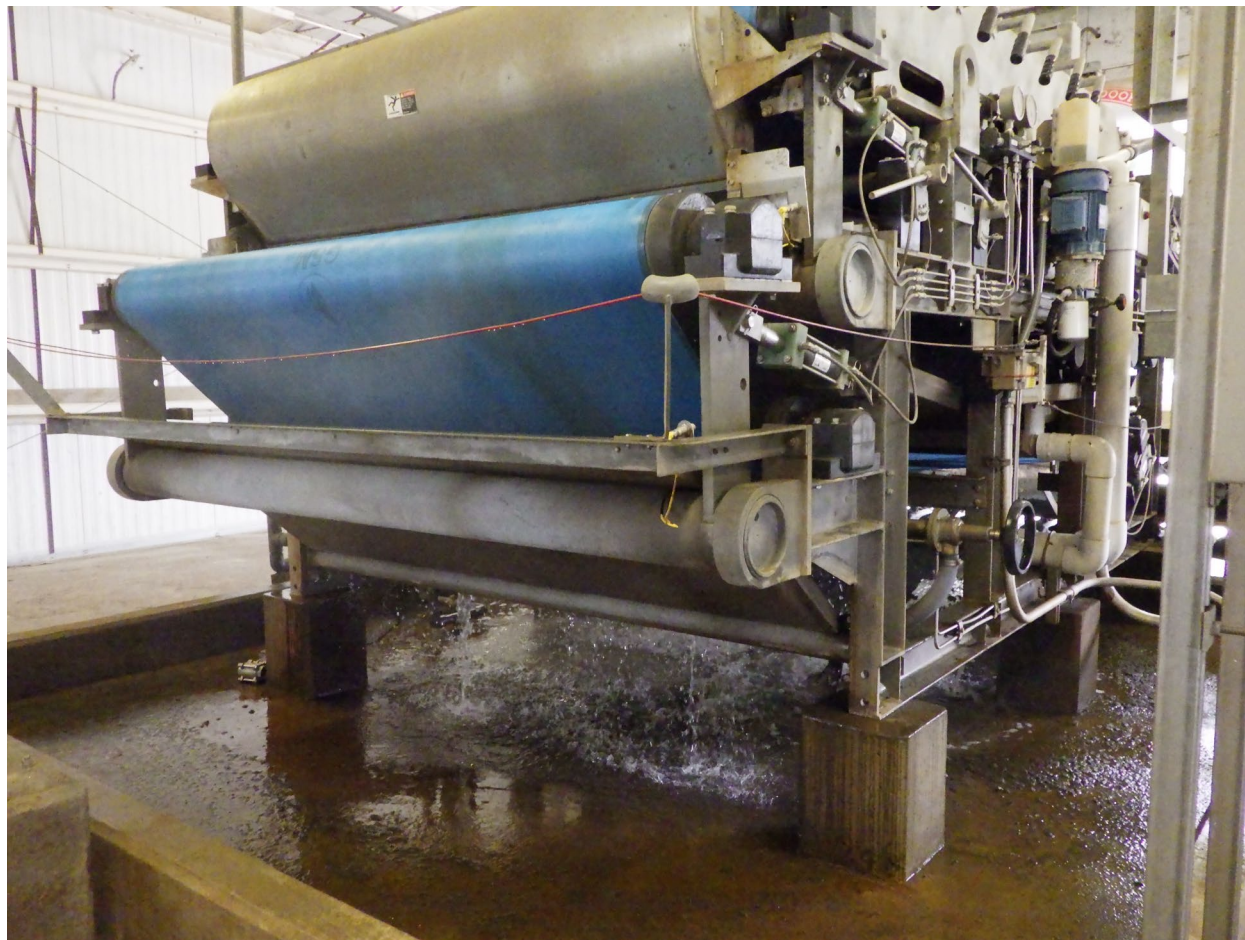
Photo No. 22

**Description:** Looking N, this photo shows one of the belt presses at the sludge processing facility located offsite from the WWTP. Note: photo taken indoors, and metadata was not available from the satellite.

I observed one of the belt presses at the offsite sludge handling facility, see Photo No. 22. Wasted activated sludge is thickened with polymer and pressed by belt press to remove excess water. The Class B bio-solids are stored undercover to continue drying prior to being hauled to the Mundy Landfill.

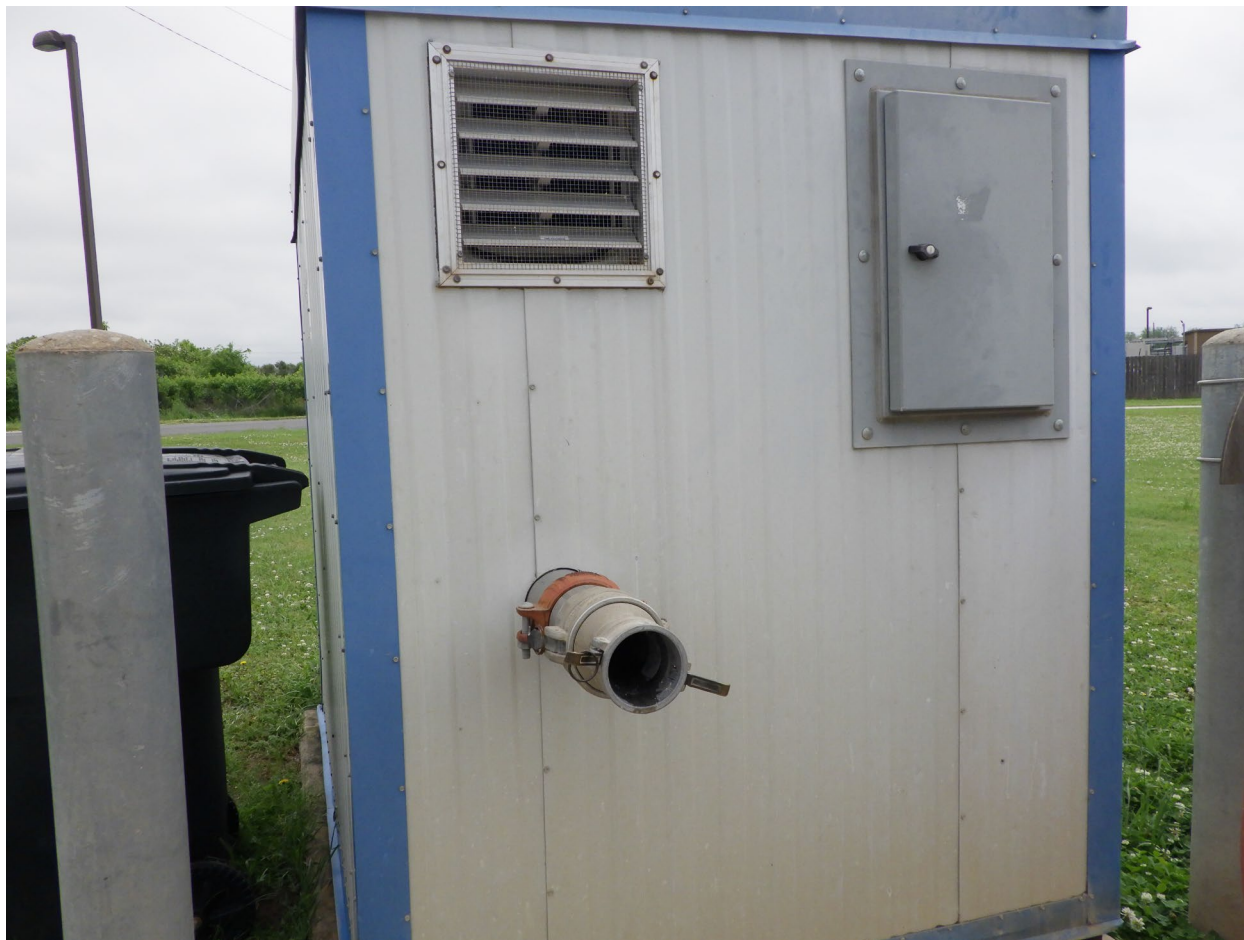
Photo No. 23

**Description:** Looking NE, this photo shows the connector port for permitted septic tank haulers prior to the facility's headworks.

I observed the permitted septic tank hauler delivery system located at the facility, which is prior to the influent pumps, see Photos No. 23 and No. 24. A passcode is provided for hose hookup once the hauler is verified to have a valid permit from the facility. The waste is measured for pH prior to disposal into the treatment plant collection system, and any acidic/basic measurement requires chemical adjustment before waste is accepted into the collection system. Haulers are responsible for maintaining the cleanliness at the delivery system, and there is an enforcement process established by Bossier City.

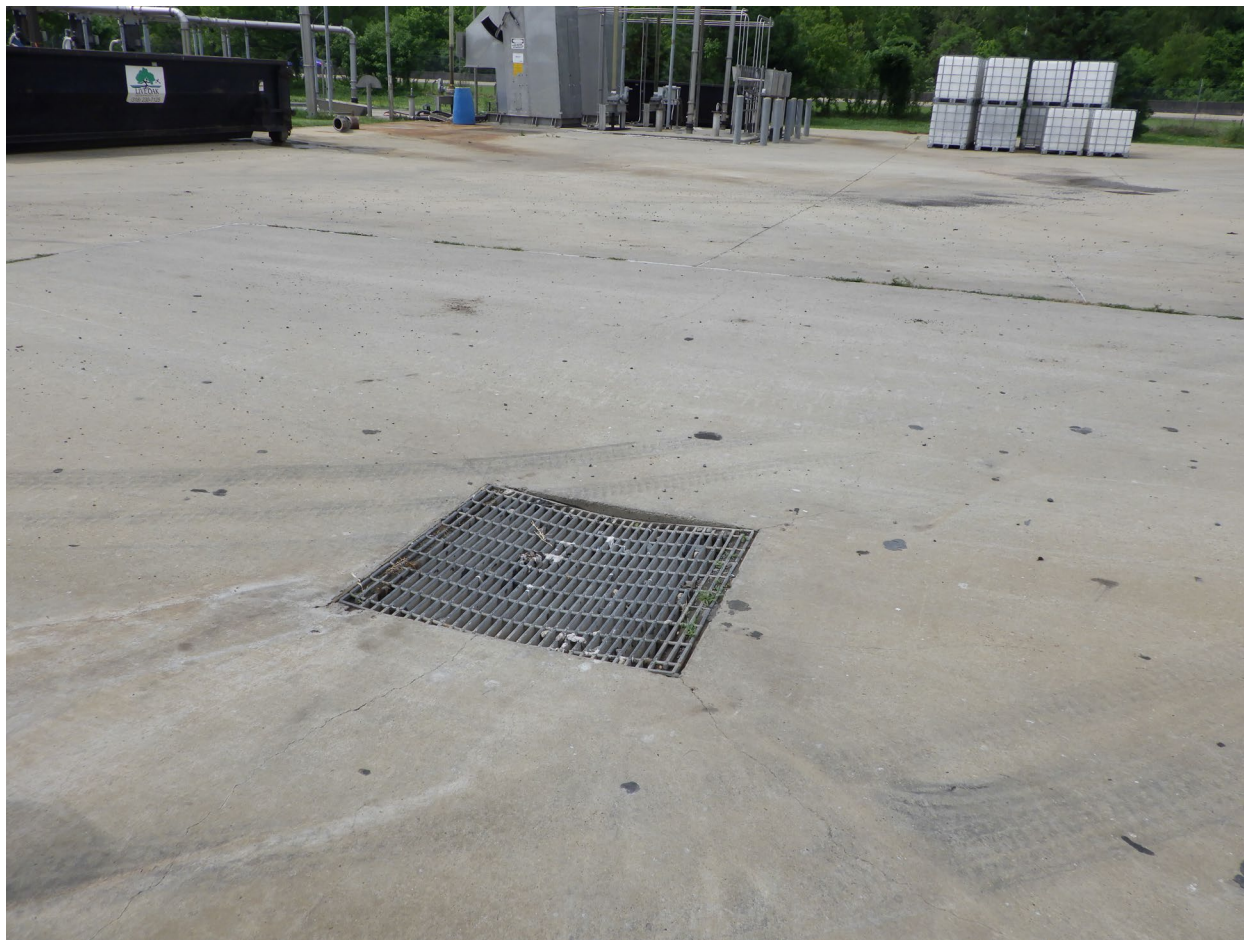
Photo No. 24

**Description:** Looking SSW, this photo shows a drain at the septic tank hauler area that is routed to the headworks for the facility.

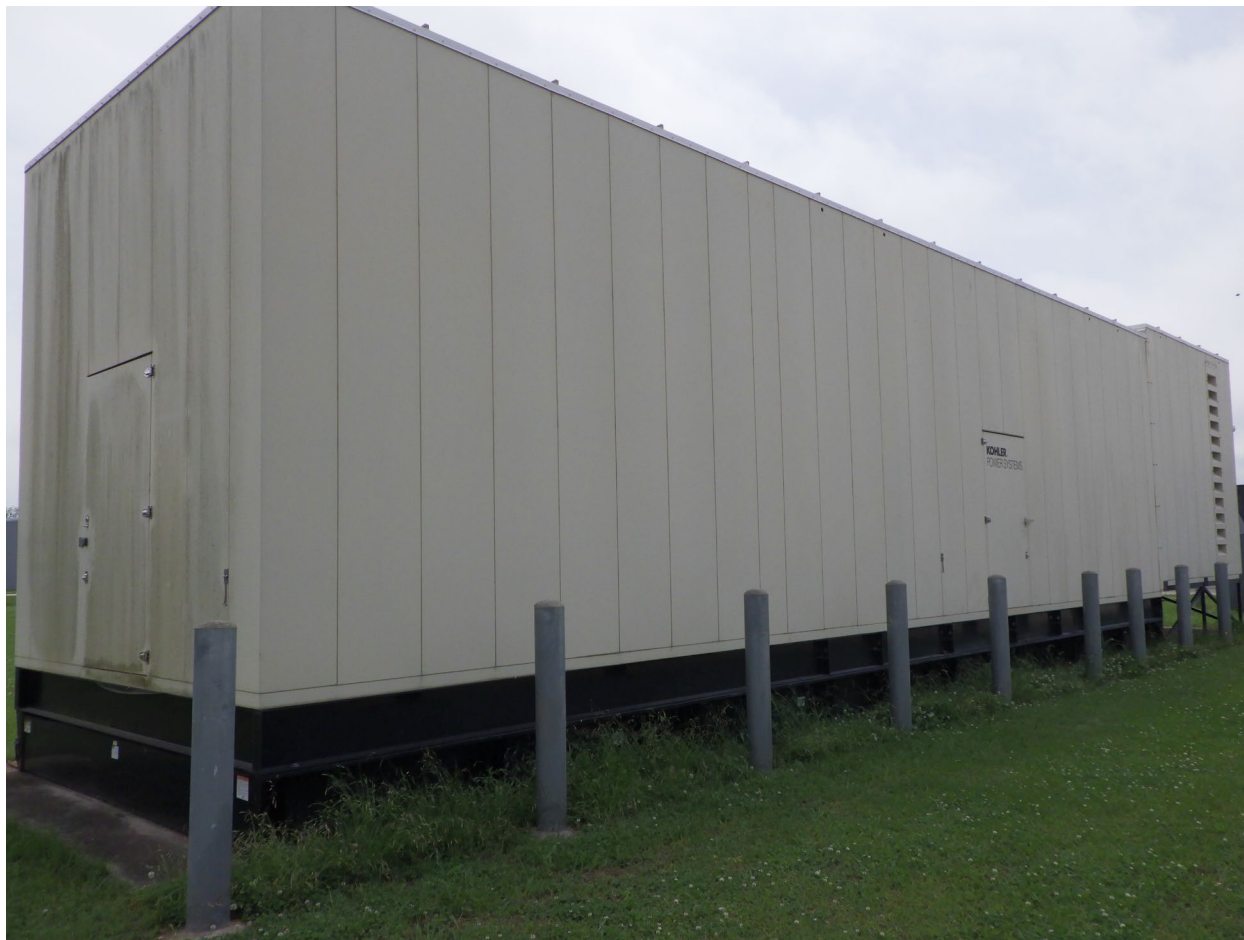
Photo No. 25

I observed the onsite generator used during emergency situations to keep the facility running during possible outages, see Photo No. 25.
