## **RCRA Inspection Report**

Zeon Chemicals, LP  
4100 Bells Lane  
Louisville, Jefferson County, Kentucky 40211

October 20, 2022

Zeon Chemicals, LP  
RCRA CEI Photographs  
William Kappler, US EPA

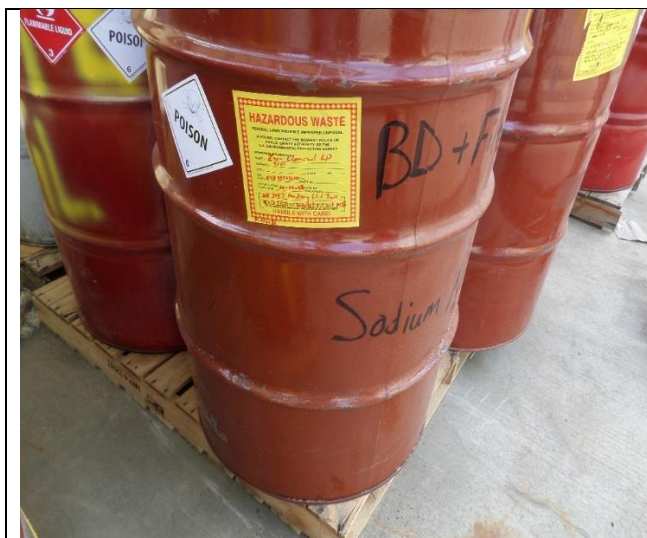
East Side of Building 130, Central Accumulation Area (CAA). Zeon representatives labeled the container with the words "hazardous waste", dated and marked the container with a hazard indicator. Photograph 1 taken at 11:20 a.m.

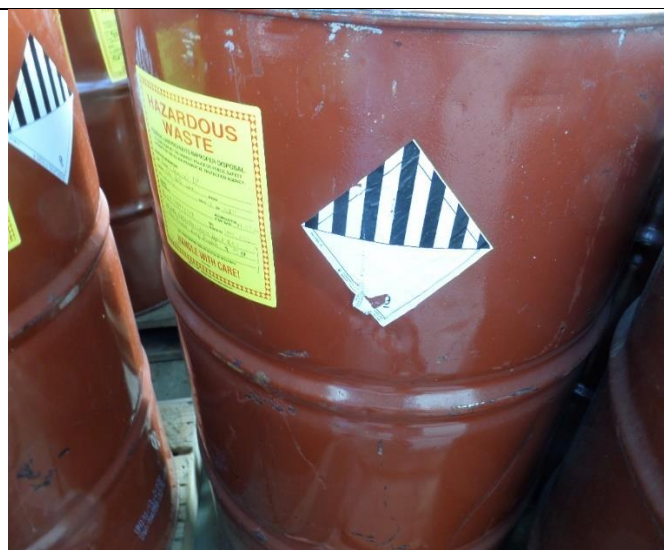
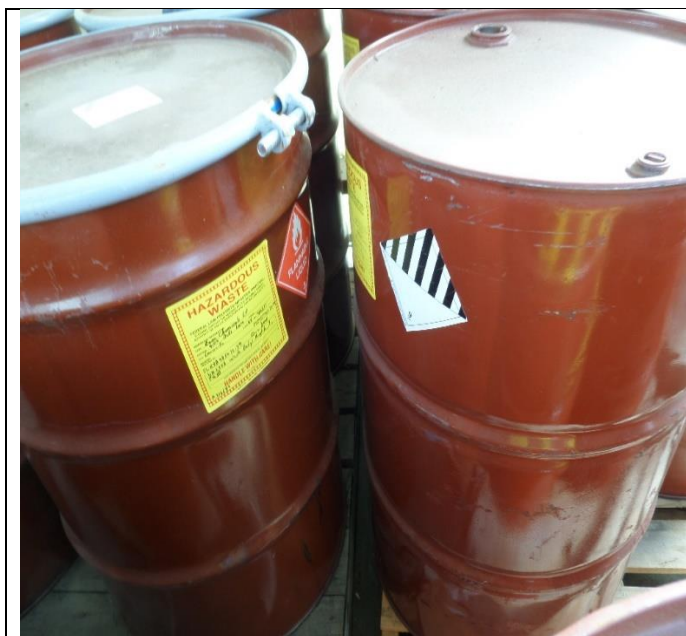
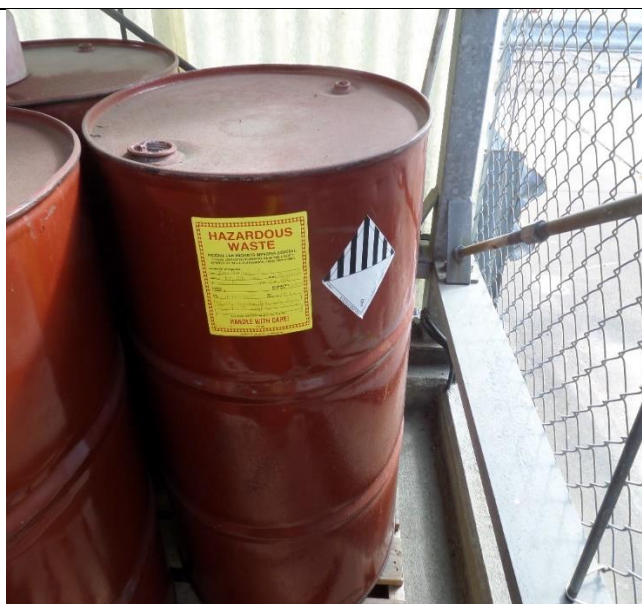
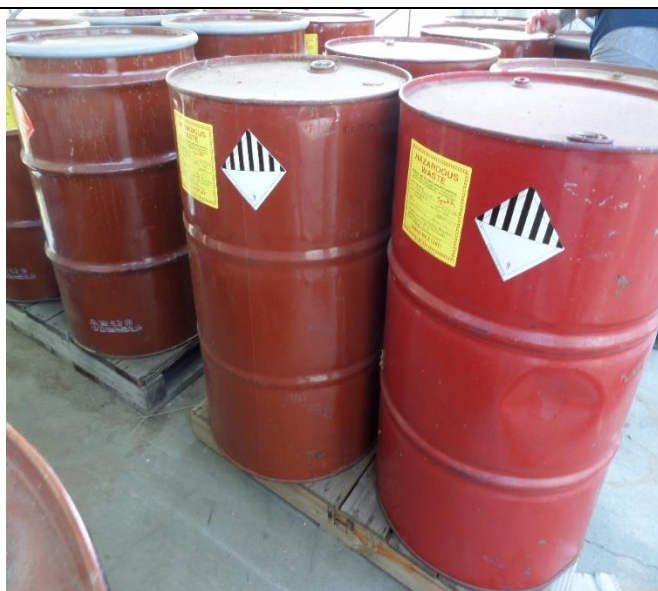
The CAA is constructed with a curbed concrete pad and metal grated dead-end trench. The CAA is constructed with a roof and surrounded by a chain-link fence and gate. Inspectors observed signs indicating the CAA is a hazardous waste area (Photograph 8). Containers accumulate hazardous waste in this area for 90-days or less, prior to off-site shipment to a destination facility. The inspectors observed 20 55-gallon containers accumulating waste ethyl acrylate, waste butyl acrylate, waste sodium nitrate and waste contaminated filters on wooden pallets. The inspectors observed the containers were closed and in good condition. The inspectors observed nine 55-gallon containers labeled with a DOT Class 9 (miscellaneous hazardous materials) pictogram (Photographs 2, 3, 4, 5, and 6). The nine 55-gallon containers were not marked or labeled with an indication of the hazards. Zeon representatives marked the hazardous waste label on the nine containers with the word “ignitable”, indicating the hazard accumulating in the container (Photograph 7). The inspectors observed one 55-gallon container not marked or labeled with the words “hazardous waste”, not marked or labeled with a hazard indicator and not marked with a date. Zeon representatives labeled the container with the words “hazardous waste” and a hazard indicator and marked it with the date November 19, 2022, (Photograph 1). The remaining containers were labeled with the words “hazardous waste”, labeled with a hazard indicator and marked with a date less than 90-days old. Inspectors also observed that the 11 55-gallon containers for which the KDEP had granted an extension to accumulate in the CAA until December 6, 2022, were labeled and dated. Inspectors were able to access each container and observe the information written on each container label. However, the container aisle space was limited in some areas. Inspectors advised Zeon representatives that additional container aisle space needs to be maintained.

East Side of Building 130, CAA. Observed nine containers labeled with a #9 hazard indicator, not an indication of the hazard in the containers. Photograph 2 taken at 11:24 a.m.

East Side of Building 130, CAA. Observed nine containers labeled with a #9 hazard indicator, not an indication of the hazard in the containers. Photograph 3 taken at 11:24 a.m.

East Side of Building 130, Main CAA. Observed nine containers labeled with a #9 hazard indicator, not an indication of the hazard in the containers. Photograph 4 taken at 11:24 a.m.

East Side of Building 130, Main CAA. Observed nine containers labeled with a #9 hazard indicator, not an indication of the hazard in the containers. Photograph 5 taken at 11:24 a.m.

East Side of Building 130, Main CAA. Observed nine containers labeled with a #9 hazard indicator, not an indication of the hazard in the containers. Photograph 6 taken at 11:25 a.m.

**Pursuant to 401 KAR 39:080 Section 1(1) [40 C.F.R. § 262.17(a)(5)(i)(B)] which is a condition of the LQG Permit Exemption, a large quantity generator must mark or label its containers with an indication of the hazards of the contents (examples include, but are not limited to, the applicable hazardous waste characteristic(s) (i.e., ignitable, corrosive, reactive, toxic); hazard communication consistent with the Department of Transportation requirements at 49 CFR part 172 subpart E (labeling) or subpart F (placarding); a hazard statement or pictogram consistent with the Occupational Safety and Health Administration Hazard Communication Standard at 29 CFR 1910.1200; or a chemical hazard label consistent with the National Fire Protection Association code 704).**

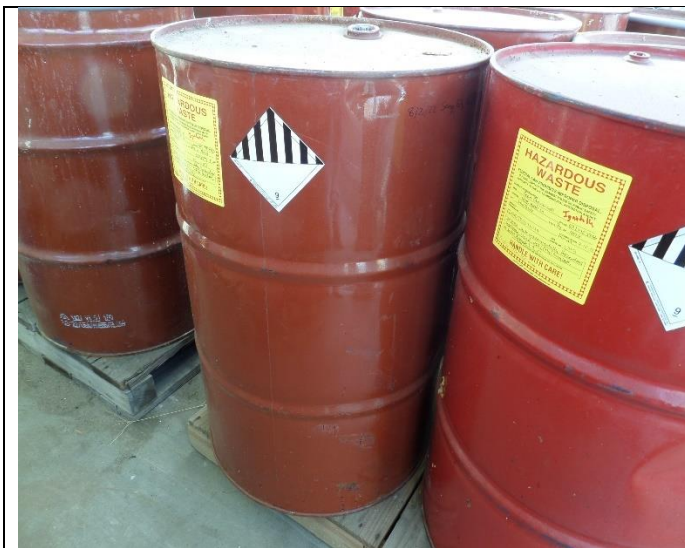
East Side of Building 130, CAA. Zeon representatives marked the nine containers with the word “ignitable” indicating the hazard in the containers. Photograph 7 taken at 11:33ap.m.

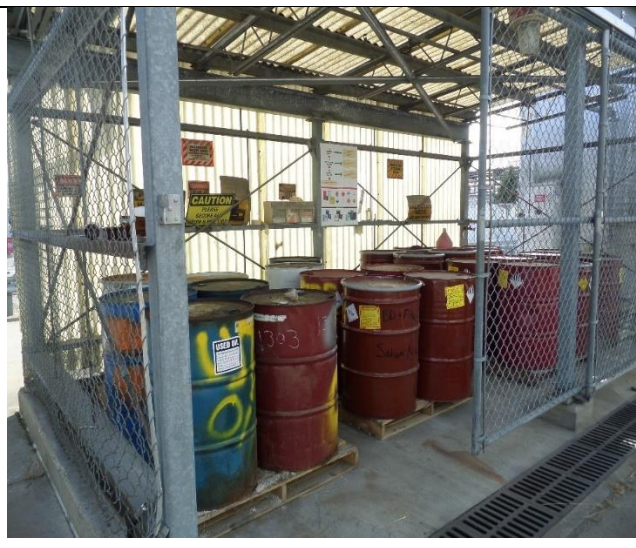
East Side of Building 130, CAA. View of the CAA.  
Photograph 8 taken at 11:35 a.m.

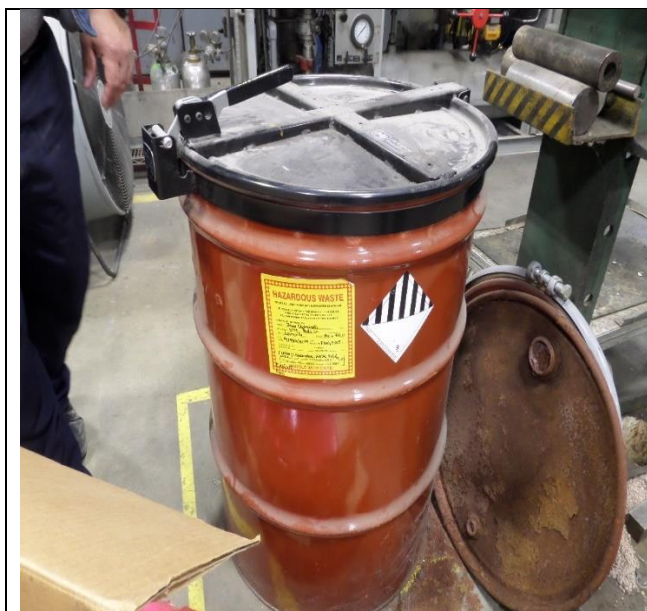
The inspectors observed one 55-gallon container accumulating hazardous waste solids (F003, F005) in the mechanic shop SAA. The 55-gallon container was closed, in good condition, labeled with the words “hazardous waste” and labeled with a DOT Class 9 (miscellaneous hazardous materials) pictogram (Photograph 9). The one 55-gallon container was not marked or labeled with an indication of the hazards. Zeon representatives marked the hazardous waste label on the 55-gallon container with the word “ignitable”, indicating the hazard accumulating in the container (Photograph 10).

Building 130, Mechanic Shop. Observed the containers was labeled with a #9 hazard indicator, not an indication of the hazard in the container. Photograph 9 taken at 11:44 a.m.

**Pursuant to 401 KAR 39:080 Section 1 [40 C.F.R. § 262.15(a)(5)(ii)], which is a condition of the SAA Permit Exemption, a generator must mark or label its containers with an indication of the hazards of the contents (examples include, but are not limited to, the applicable hazardous waste characteristic(s) (i.e., ignitable, corrosive, reactive, toxic); hazard communication consistent with the Department of Transportation requirements at 49 CFR part 172 subpart E (labeling) or subpart F (placarding); a hazard statement or pictogram consistent with the Occupational Safety and Health Administration Hazard Communication Standard at 29 CFR 1910.1200; or a chemical hazard label consistent with the National Fire Protection Association code 704).**

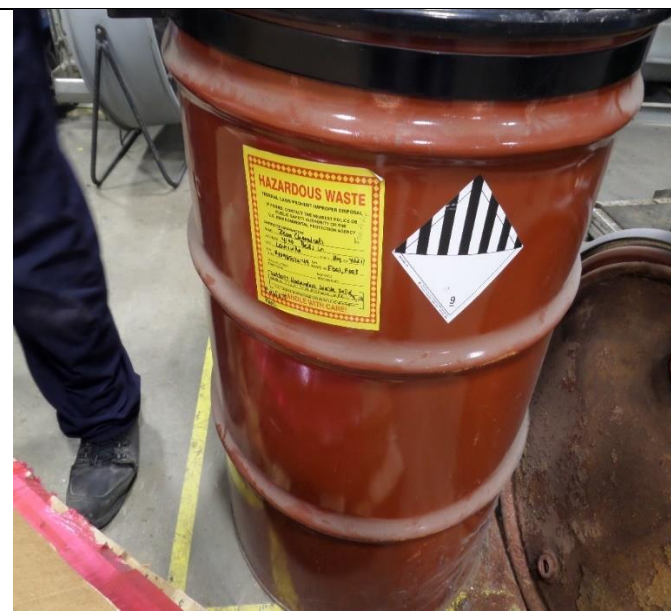
Building 130, Mechanic Shop. Zeon representatives marked the container with the word "ignitable" indicating the hazard in the container. Photograph 10 taken at 11:45 a.m.
