**Region 6 - Enforcement & Compliance Assurance Division**  
**INSPECTION REPORT**

| Company Name: | <b>B Jar Construction Inc.</b> | |
| Site Name: | <b>Unnumbered Tract north of Camino del Llano</b> | |
| Identification/Permit Number: | NMU002204 | |

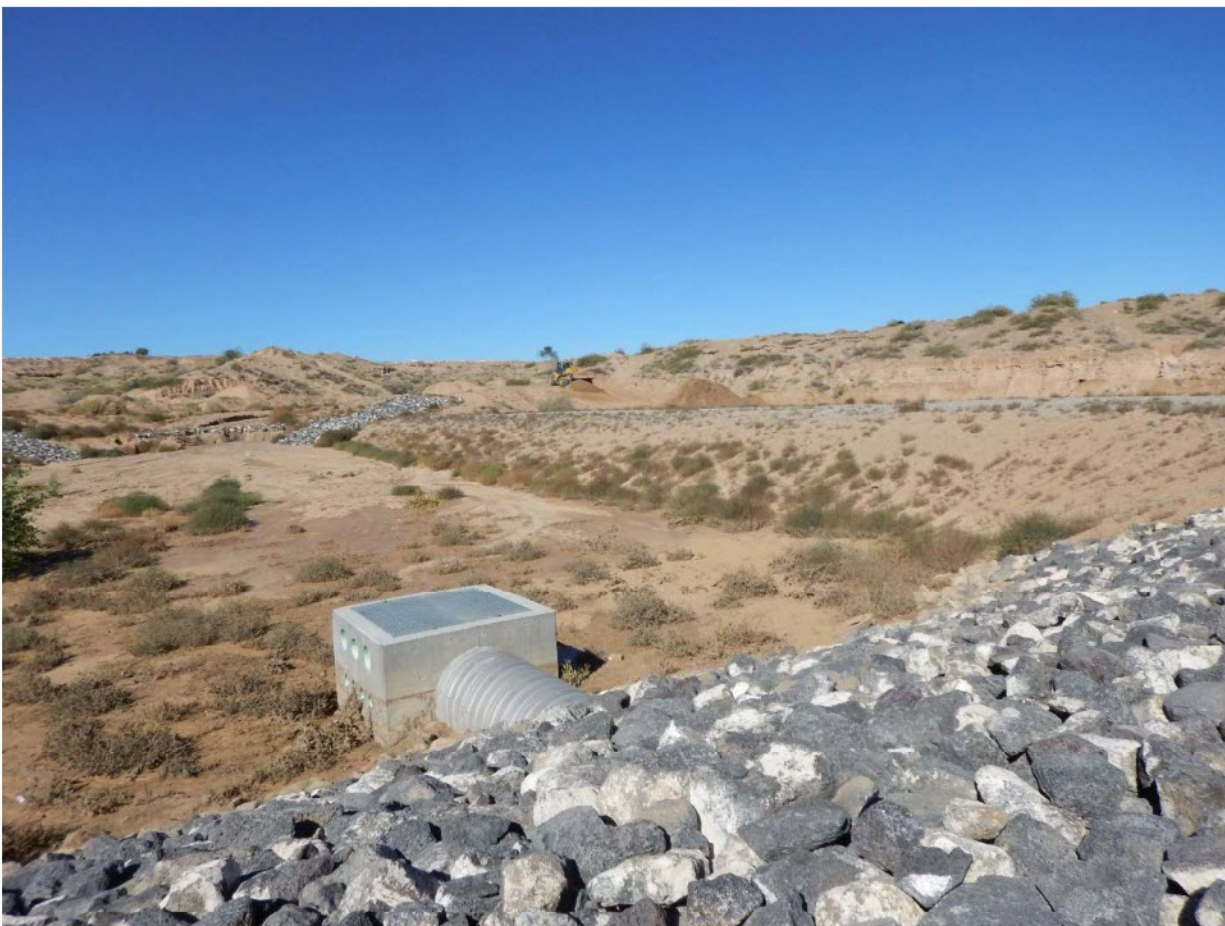
Photo No. 1

| <p>On the date of the inspection, a front-end loader was present at the Site, excavating and stockpiling soil from inside a drainage channel on the property that drains into a retention pond owned by the City of Belen. They were also observed loading stockpiled soil into a haul truck and removing soil from the Site. A berm had been built blocking off flow to the natural drainage channel and disrupting flow to the City of Belen retention pond.</p> | |

Description: View of retention pond owned and maintained by the City of Belen, with the Site in the background. The front end loader and the stockpiled soil can be seen in the background.

As of the time of this inspection, the Site did not have an NPDES active or expired permit in place for potential stormwater discharges.

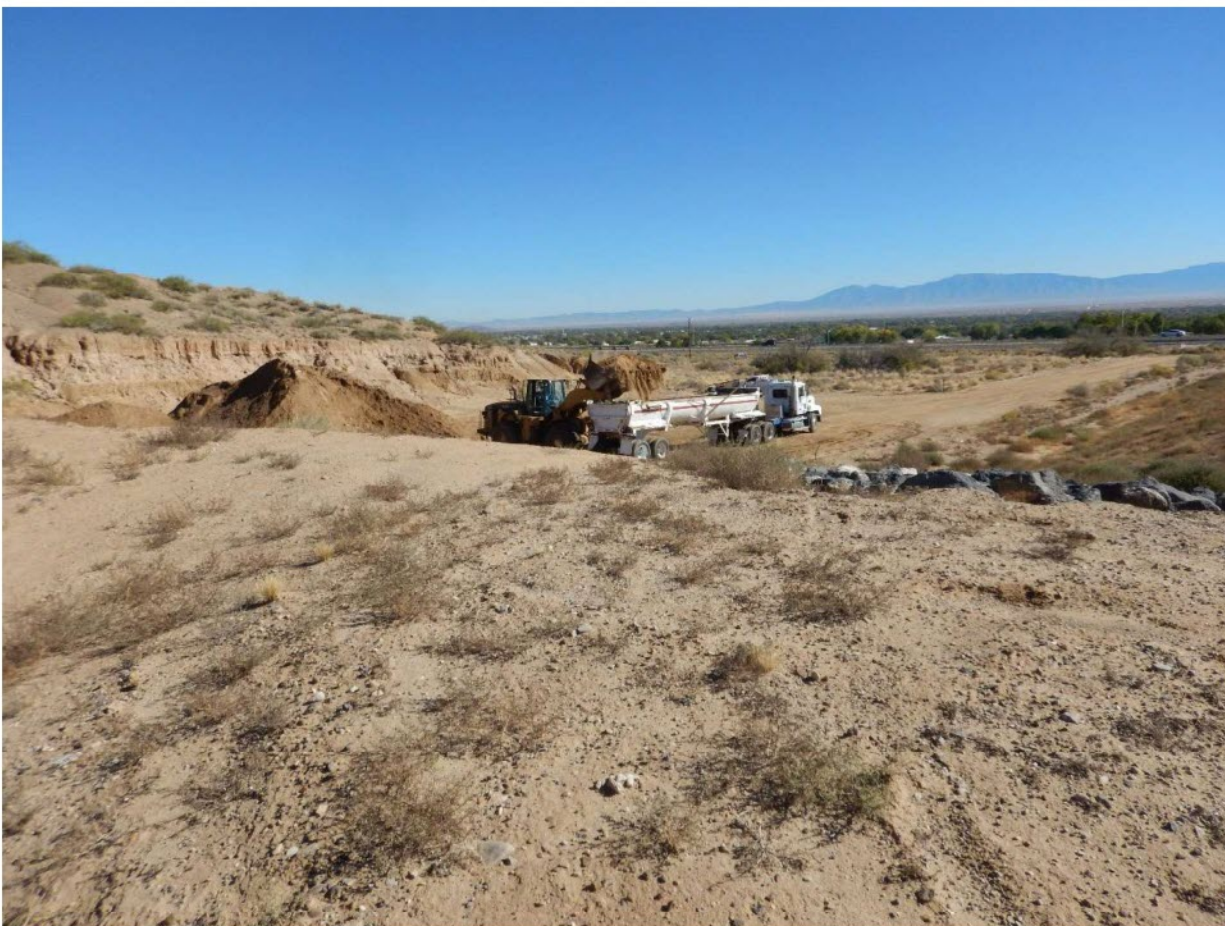
Photo No. 2

Description: View of front-end loader loading stockpiled soil into a haul truck to be taken offsite.

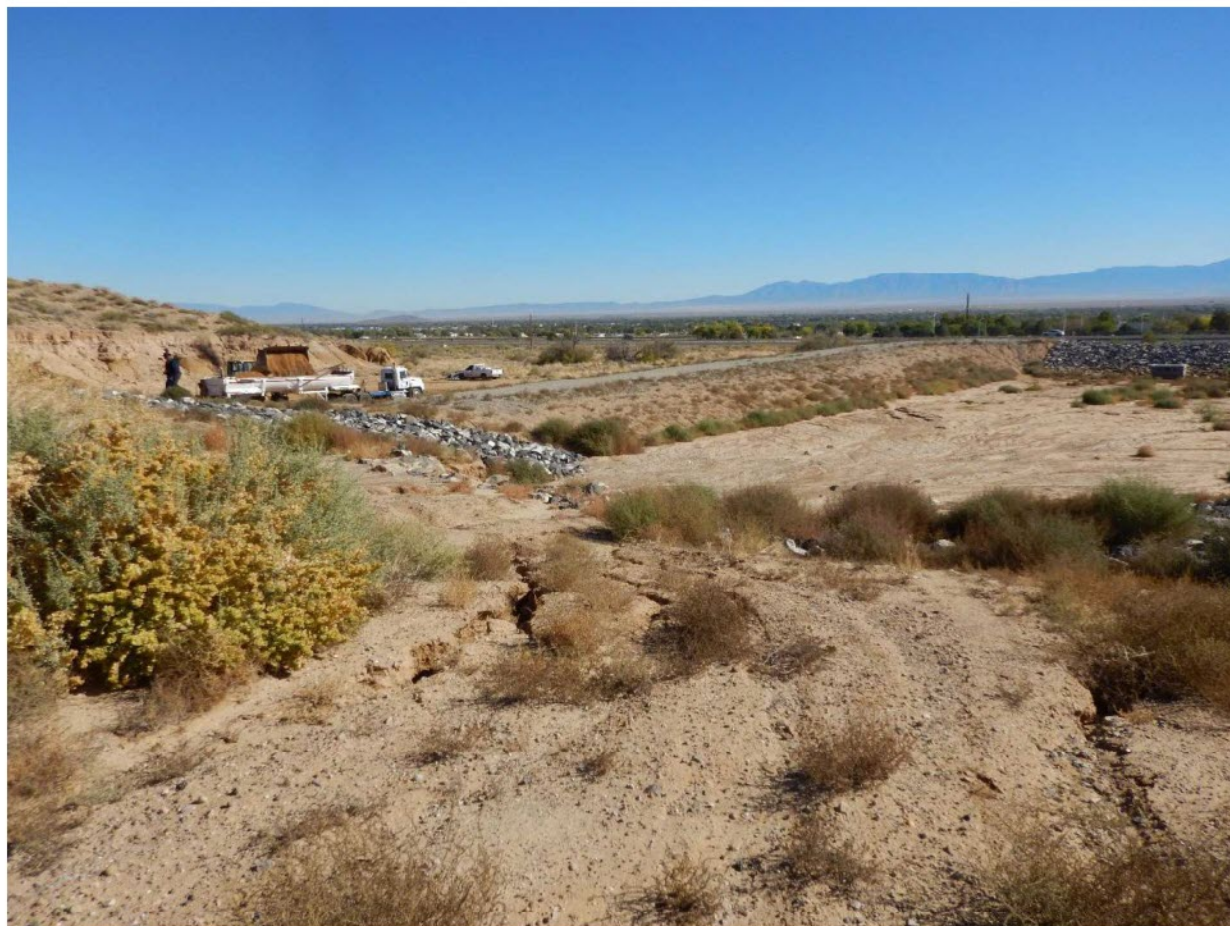
Photo No. 3

Description: View of front-end loader loading stockpiled soil into a haul truck to be taken offsite, with City of Belen retention pond off to the right in the photo.
