# Long Life for Lead Water Services in Many Cities

*Syracuse, Allentown and Clarksburg Among Cities Where Lead Pipe Has Served Well*

## Red Lead is Standard in French Paint Tests

## Century-Old Lead Joints in Water Mains Not Uncommon

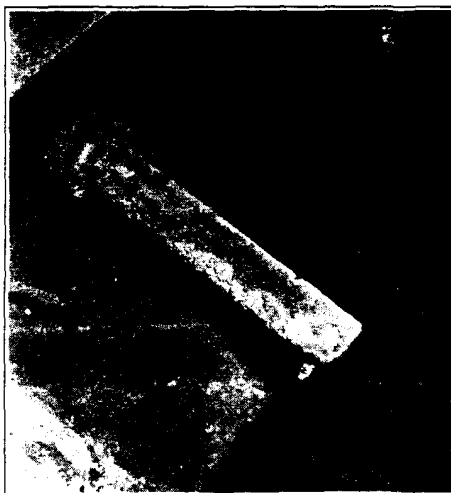
←  
*Cast iron water pipe with cast lead joints laid in 1817 in Philadelphia.*

IN Philadelphia, more than one cast iron water main has lead joints over a century old. Reproduced here is a photograph of one laid in 1817 with the lead joints still in good condition when it was uncovered in 1931. In Boston there is a cast iron main with lead joints more than 85 years old. A cast iron main in Richmond, Va., was laid in 1830 and the records of the Department of Public Utilities in that city show that no leaks have developed in the line, which was laid with cast lead joints. St. Louis has a cast iron main with lead joints laid in 1831 and the joints are still apparently in good condition. Other cast iron mains with lead joints a century or more old in Philadelphia and New York were described in LEAD, May and July, 1932. There are, of course, many more such old installations wherein lead joints, as well as the pipe, are good after many years of service.

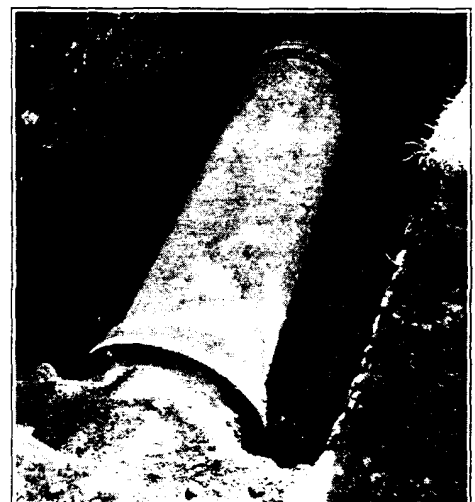
→  
*Eighty-five year old lead-jointed cast iron pipe in Boston.*
